# Chase Knolls Gardens Apartments Hazardous Trees Removal Project

Presented By:

Peter Green, ISA BCMA

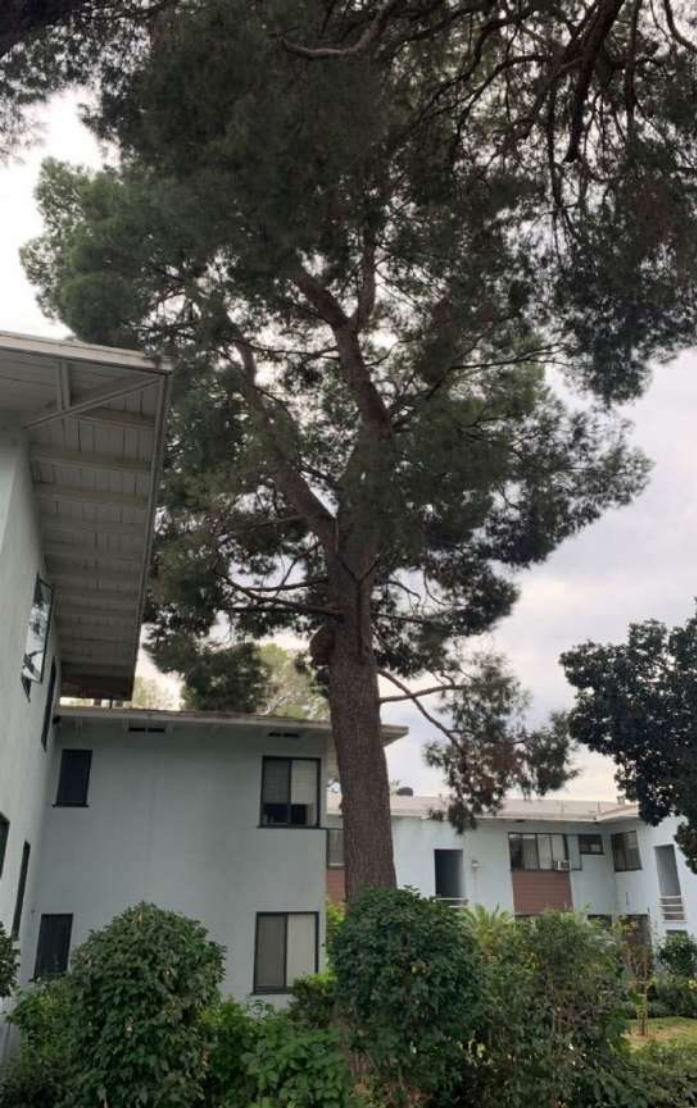
Tree #1 – Aleppo Pine (ID 215)

- Significant lean and weight, fall line directly into occupied structure
- Up-heaving present on tension side
- Mechanical damage to root system from construction
- Limited ability to expand root structure
- Growth limited by close proximity to dominant tree
- Soil continually saturated, root decay is highly likely
- Poor Drainage

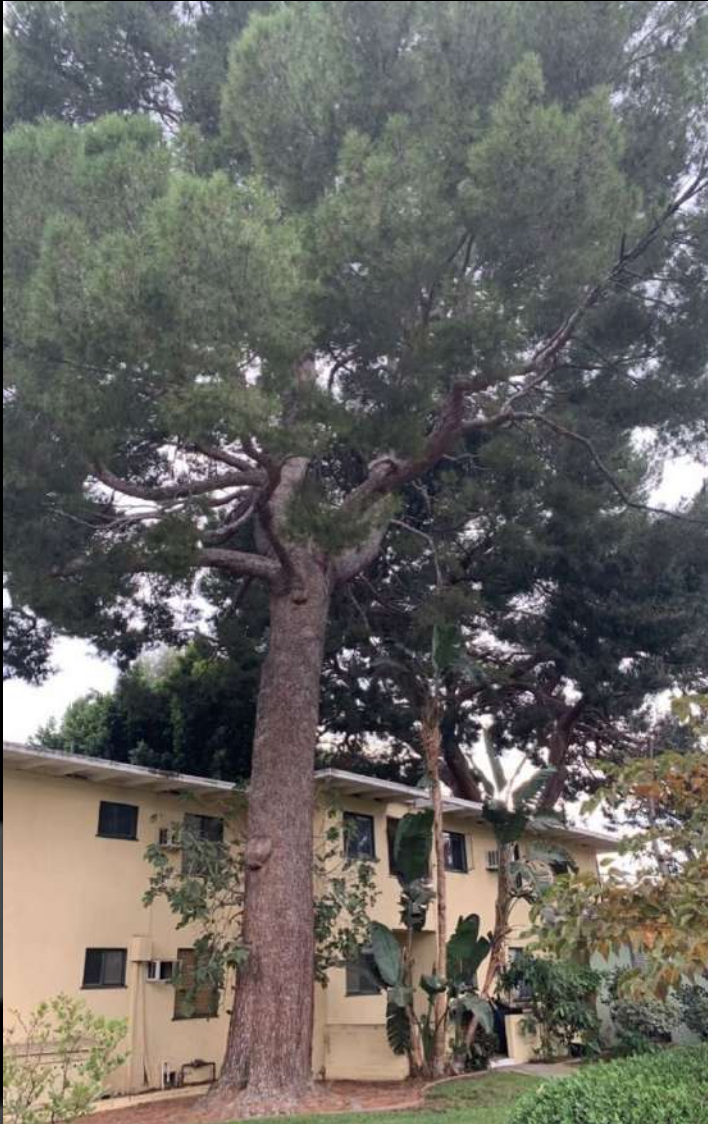
Tree #2 – Aleppo Pine (ID 165)

- Extremely large and unbalanced
- Upheaving noticeable on tension side
- Large reduction in root system from excavation
- If failure occurs, second large Aleppo will be damaged severely
- Structures in fall path will be completely destroyed
- Reduction Pruning will not be effective. Excessive canopy will need to be completely removed. The tree will not survive such reduction. Reduction will also NOT solve root structure issue, lean and weight still significant enough to fail onto structures.
- Second Large Aleppo will benefit as a result of this removal

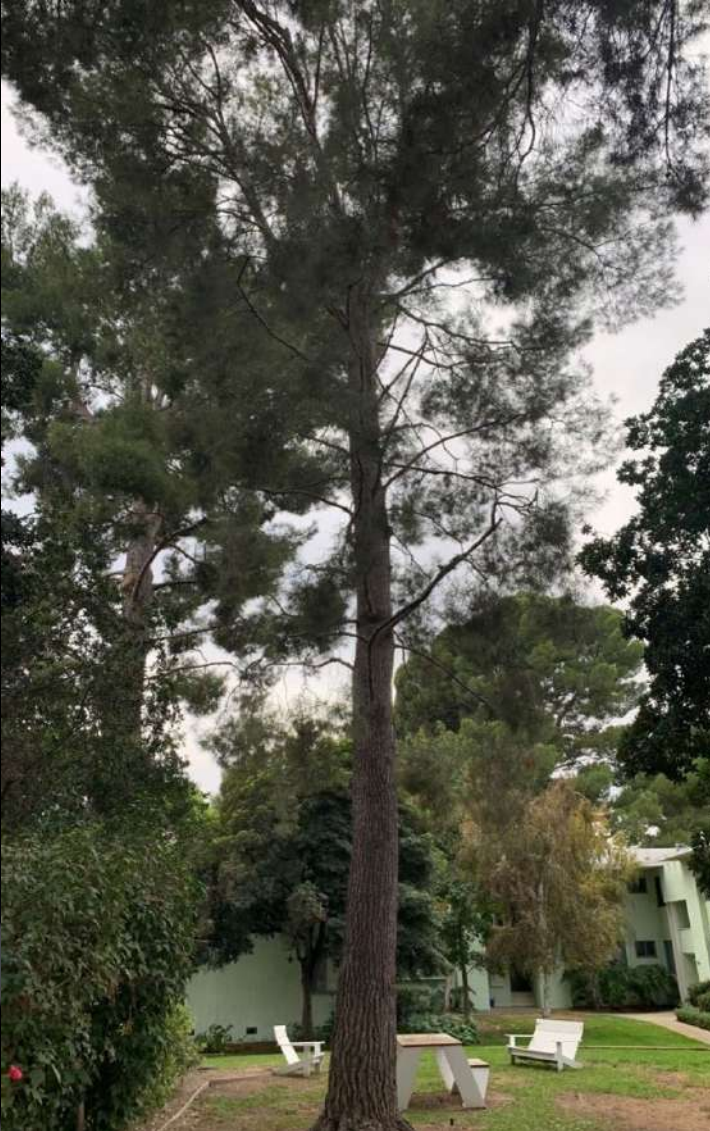
Tree #3 – Aleppo Pine (ID 220)

- Tree is located under the drip line of larger dominant tree.
- Lean has occurred due to phototropism. Tree growth has been and will continue to be negative effect on overall health and longevity of tree.
- Future growth will only increase likelihood of failure do to weight and lean
- If tree were to fail it is unlikely to hit structure significantly. However, due to the shift in the lean, it can be anticipated that the tree will uproot.

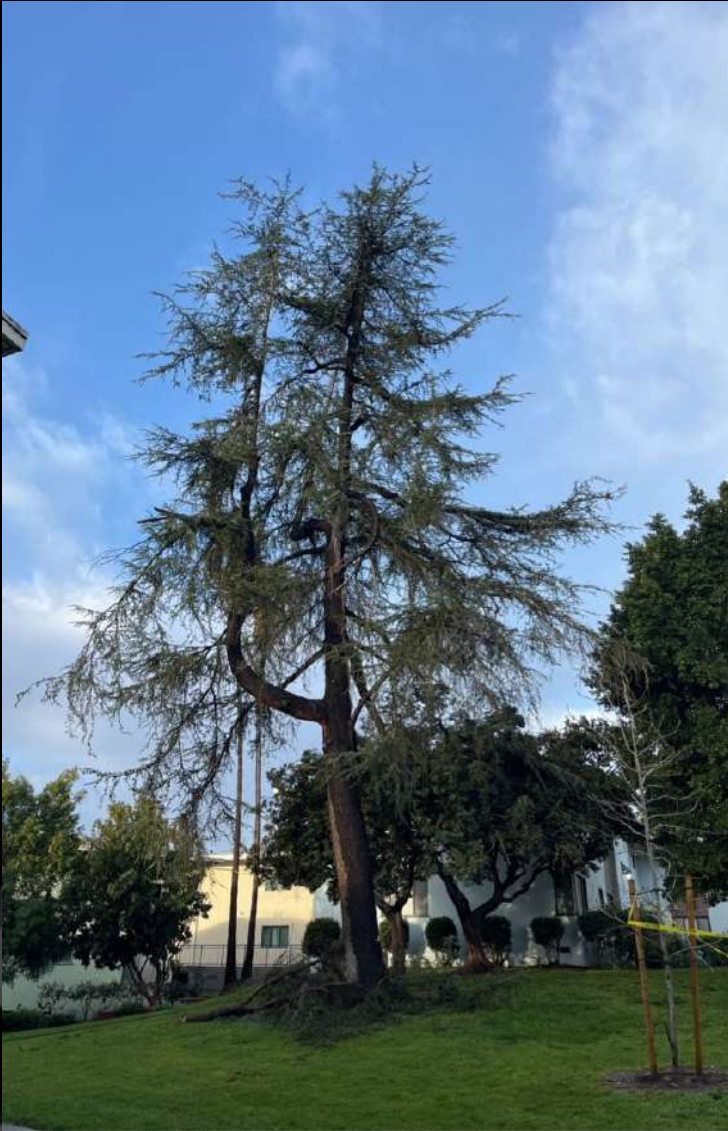
Tree #4 – Deodar Cedar (ID 383)

- Tree showing signs of decline, branch tip die back
- Unbalanced canopy
- Moderate limb drop/damage in latest storm
- Tree planted on man made slope from construction
- Lean and weight towards occupied structure
- Neighboring Deodar failed during last storm, same size and lean
- Upheaval present on uphill slope

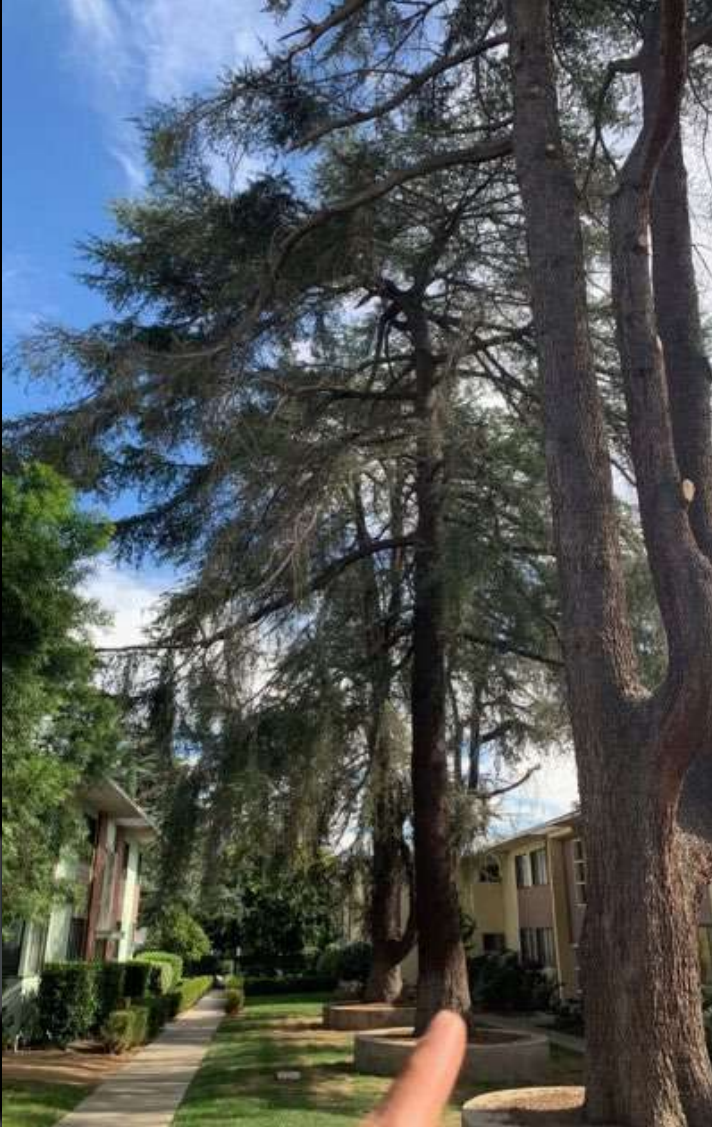
Trees #5,6 and 14 – Deodar Cedars  
(IDs 382, 407 and 405)

- (3) Cedars have had planters built around them and backfilled approx. 3'
- Basal decay is present in all (3) Cedars
- Significant decline present in all (3)
- Improper Pruning has been performed on all (3)
- CODIT not present, flush cuts
- Decay present in cuts
- (3) lean and weight towards occupied structures

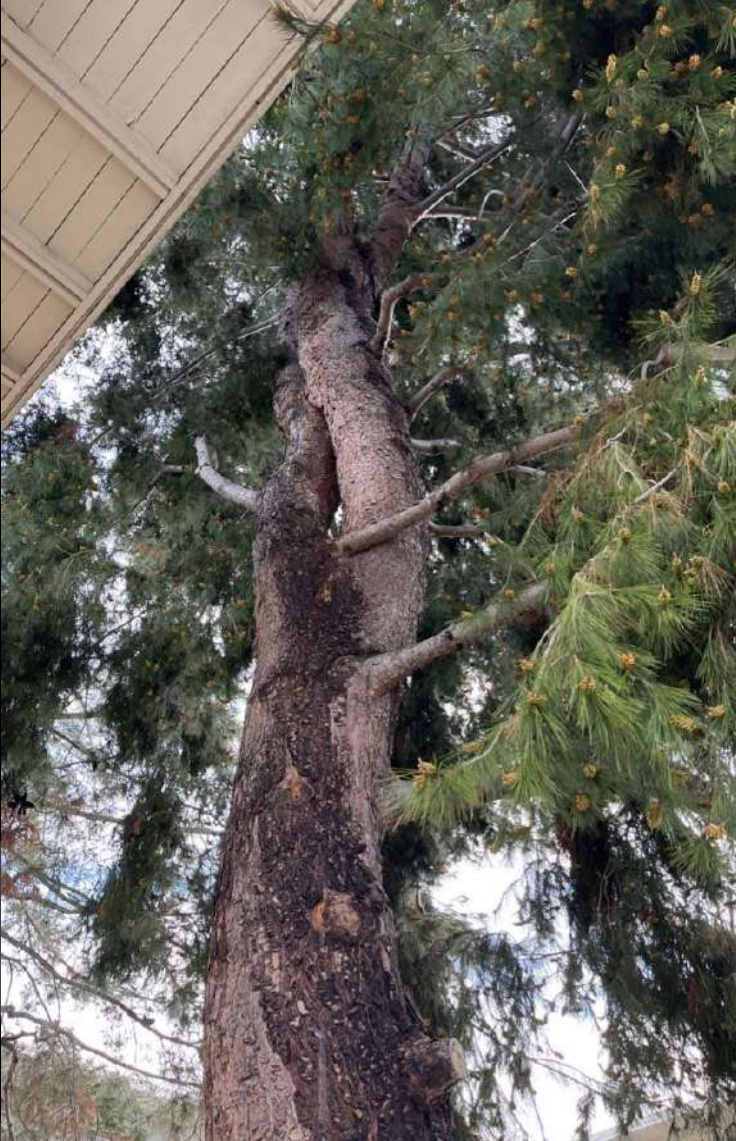
Tree #7 – Aleppo Pine (ID 313)

- Tree has been planted in close proximity to building
- New excavation has occurred for parking structure removing a very large portion of anchoring root system
- Tree showing signs of heavy response growth to damage sustained in root system
- Building limiting the growth outward from base as well
- Tree has very large defect in main trunk 30' from base. Crossing leaders, open wound about 3' in length. This wound is not correctable
- Weight and lean over structure

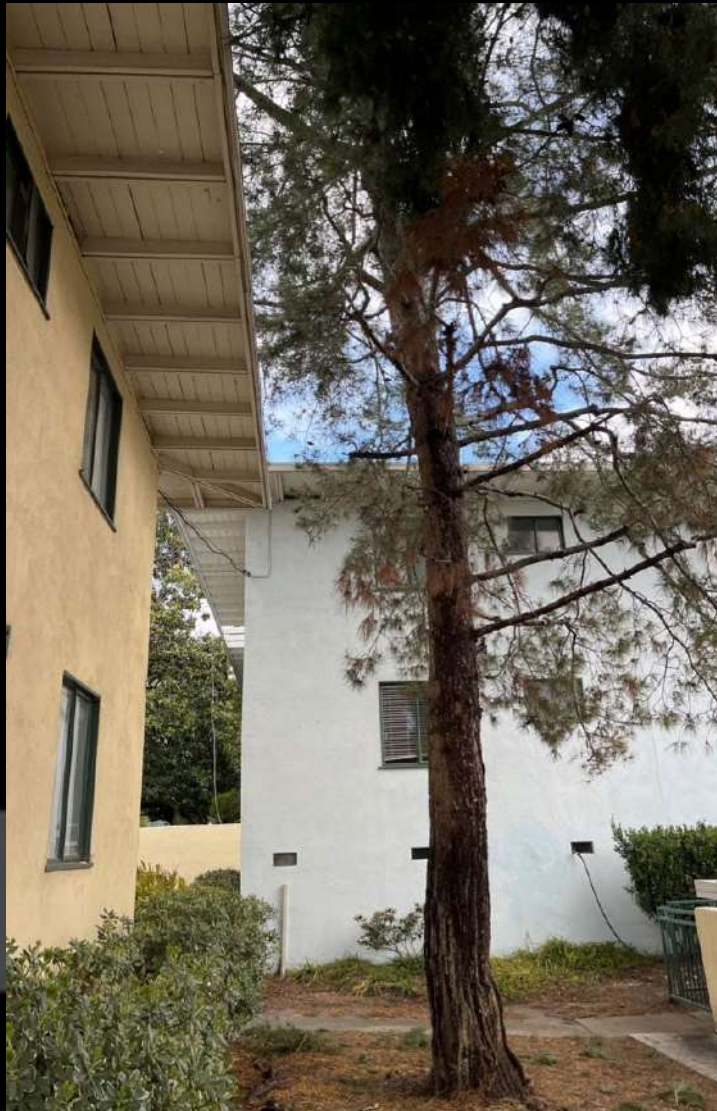
Tree #8 – Aleppo Pine (ID 311)

- Tree is in very poor health. Chlorotic Canopy with significant dieback
- Building limits root expansion
- Significant exudate around entire base
- Indication of extensive section of roots excavated for parking structure.
- Removal recommended to mitigate future damage or injury resulting from failure

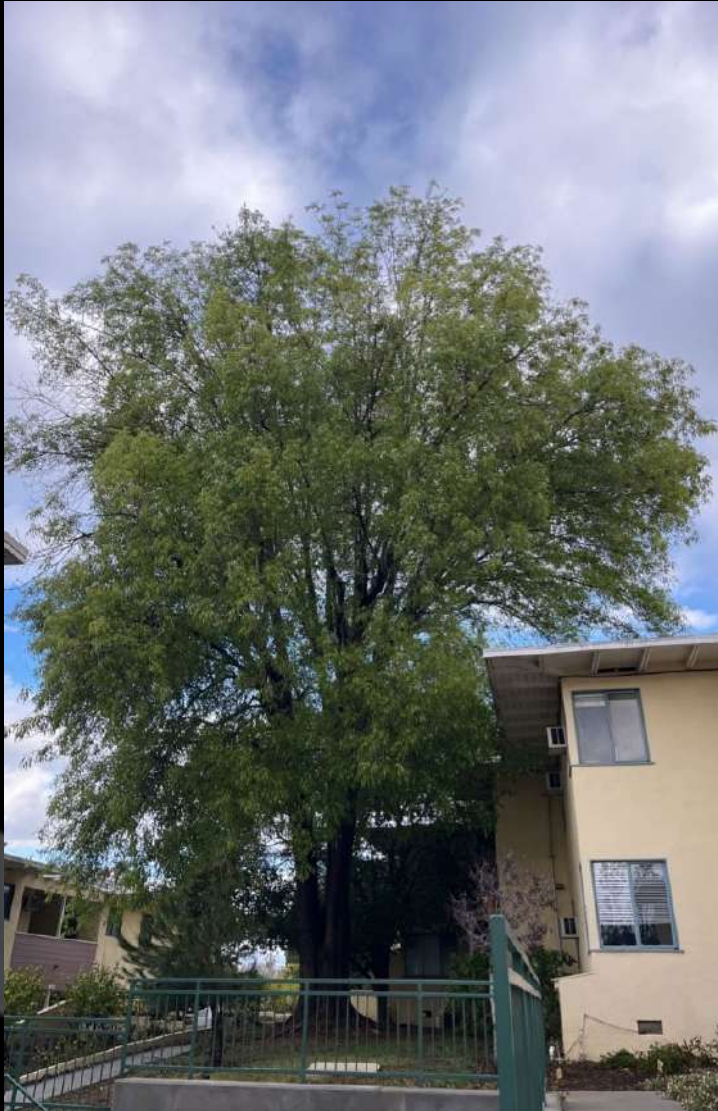
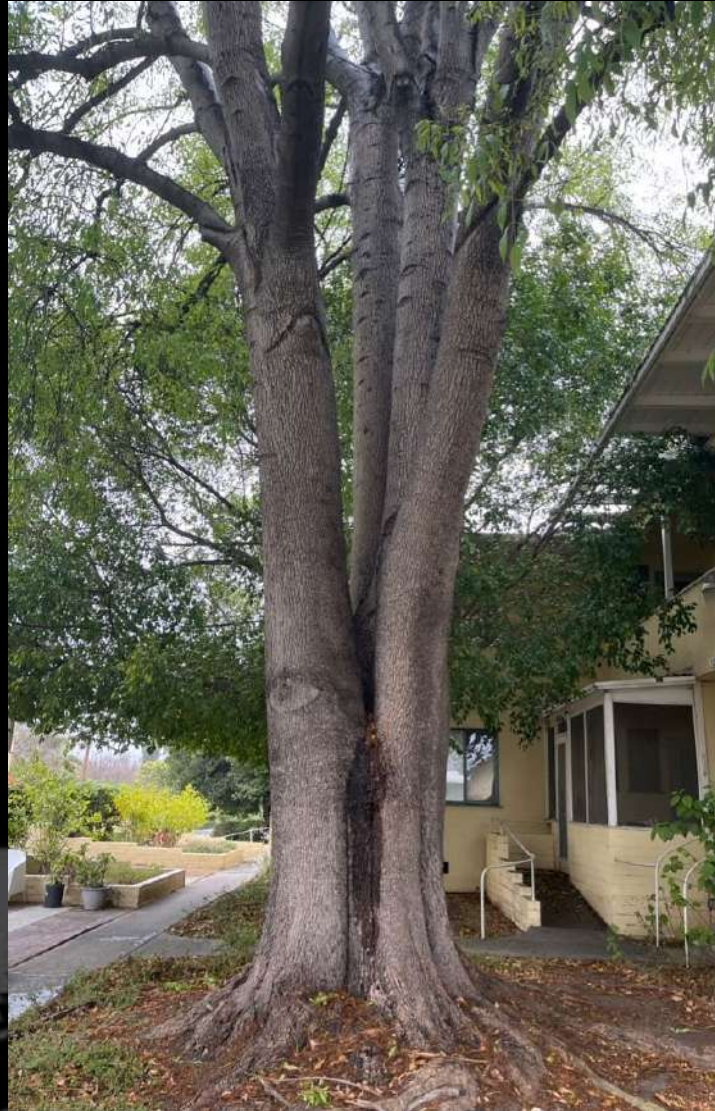
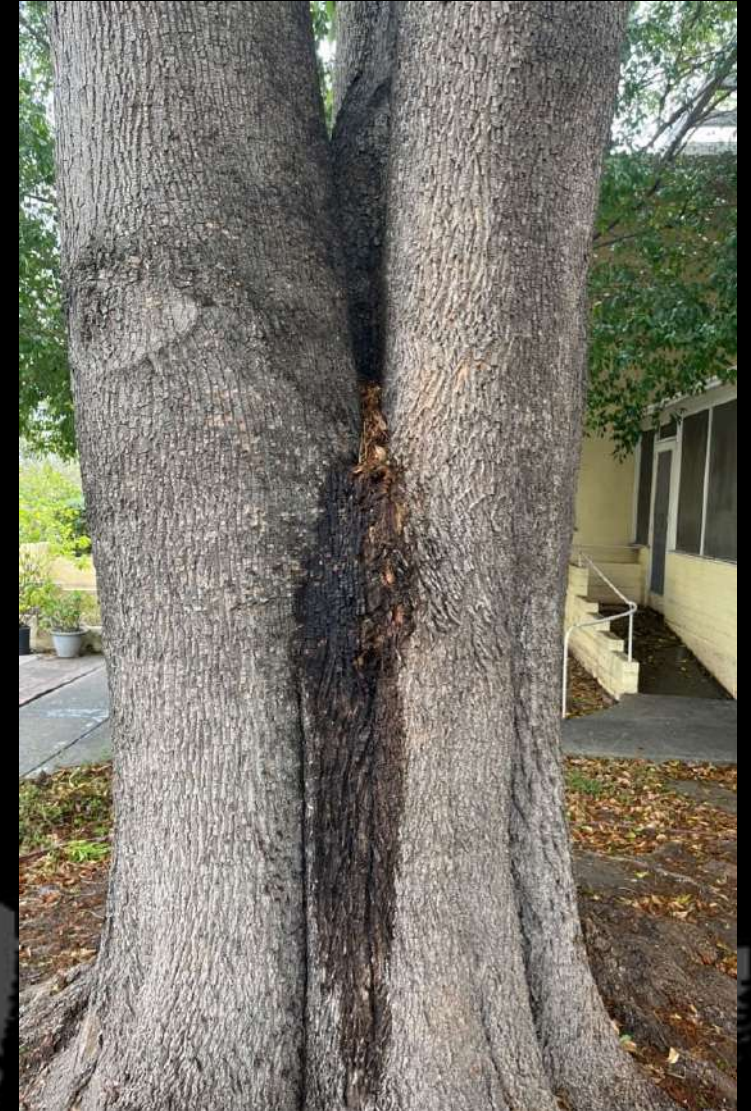
Tree #9 – Shamel Ash  
(ID Possibly 271, 272, 266 or 1489)

- Tree has not been maintained in very long time and its canopy is very full and heavy
- Shamel Ash is the fastest growing of the Ash species and deficiencies need to be corrected in a timely manner during growth. Lack of consistent and proper pruning cuts have increased defects.

- This species should not be placed near structure due to rapid growth, open area is recommended only
- Outlying root structure showing signs of decay, old growth root structure affected by building.

- Sidewalk not showing signs of uplifting, assume root structure not growing. Due to height difference in root flare and walkway, assume roots have been excavated. Power vault box also within drip line. It appears the structural roots of this tree were damaged or severed during upgrade construction of Building 4D. If so, then there is a concern of a loss of supporting structural buttress roots.

- Cabling system installed on 1 major leader, second leader not cabled and is splitting off the main trunk. Existing cabling system is no longer effective.

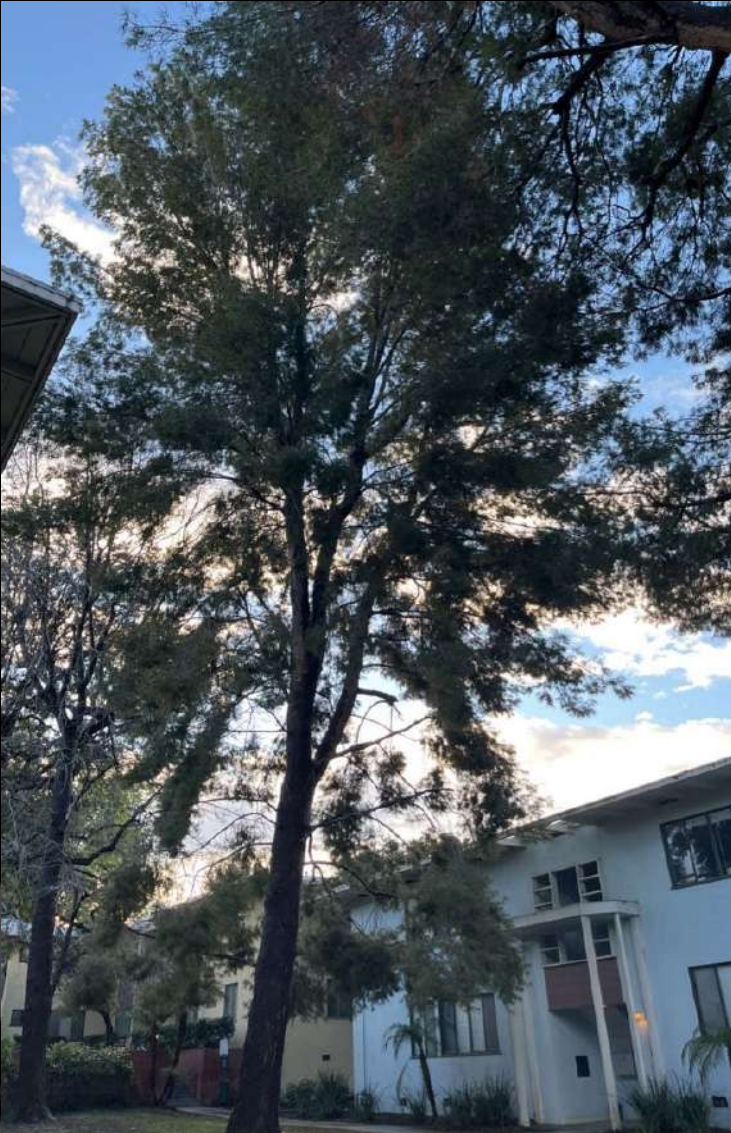
Tree #10 – Aleppo Pine(ID 204)

- Tree appears to be in fair health. Ground compaction present due to placement of tree in open courtyard.
- Outer limb of tree causing in-balance of the canopy, driving weight on slight lean towards building.
- Recommend removing outer limb only, crown clean during maintenance cycle in year 2.
- Recommend root excavation via air spade to reduce soil compaction around root structure
- Recommend tree protection zone placed around tree root area to limit foot traffic and compaction

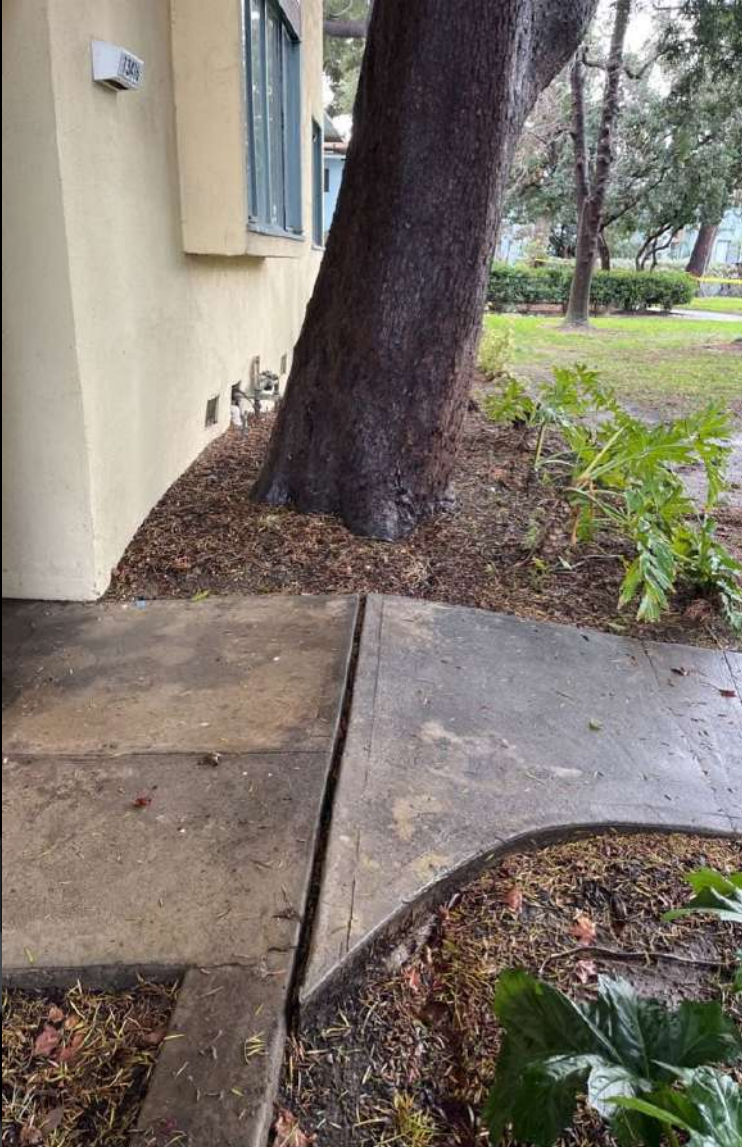
Tree #11 – African Fern Pine (ID 193)

- Tree is growing within 1 foot of the eve of an apartment building with the trunk growing towards another building
- Tree has begun to lift the sidewalk, and has significant canopy weight over apartment structure. (Health and Safety Hazard)
- Tree is begun to uplift and cause damage to building
- Tree growth pattern aggressive, tree should not be installed near building or structures. Open area only

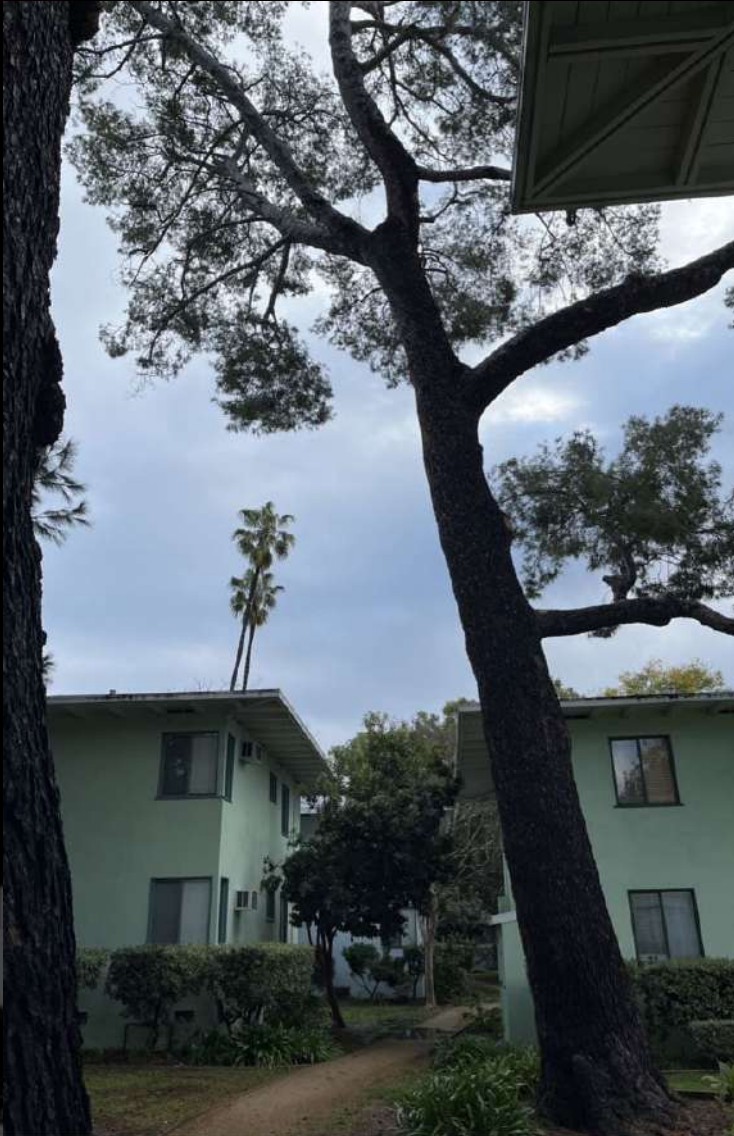
Tree #12 – Aleppo Pine (ID 120)

- Tree has heavy lean towards apartment building
- Noticeable heaving on of roots on the soil surface.
- All of this tree's weight is committed towards a living structure, recommend removal to mitigate hazard towards residents and infrastructure. Moderate High Risk Tree

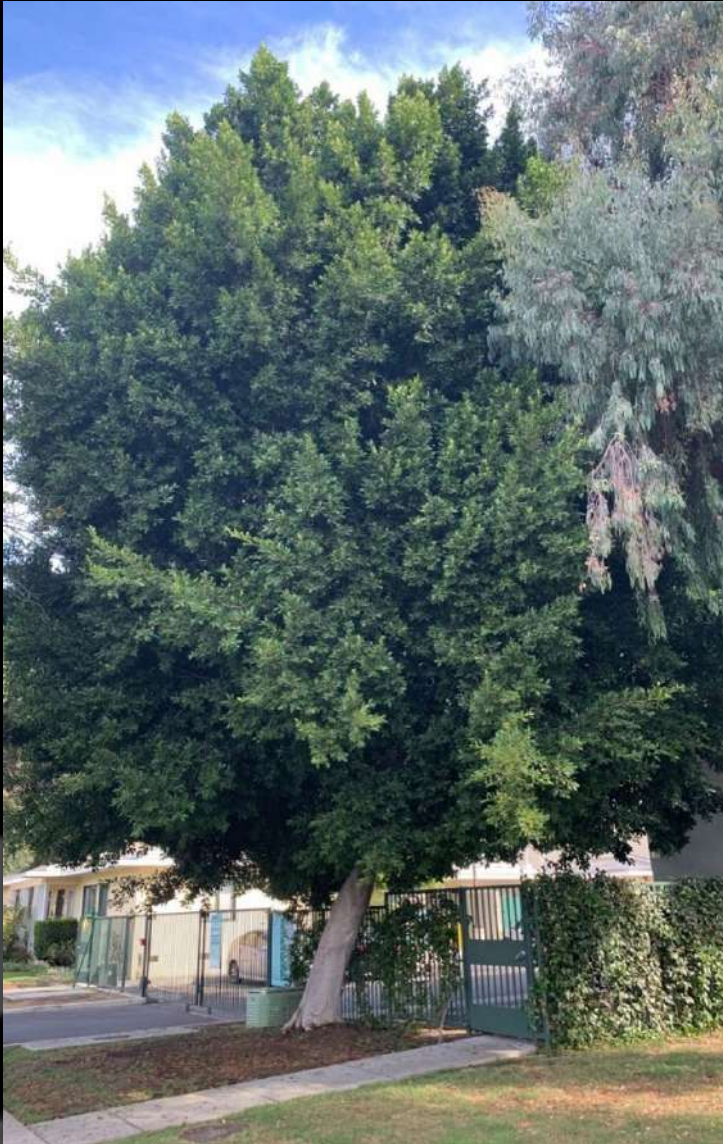
Tree #13 –Indian Laurel Fig (ID 053)

- Trees growing with heavy lean and is within 1 inch of primary fence and is currently growing on top of roof and eve of apartment building.
- Root Structure has been stunted by excavation of storm water drainage, curbing, sidewalk, and parking lot installation
- Recommend for removal before further infrastructure damage occurs.
