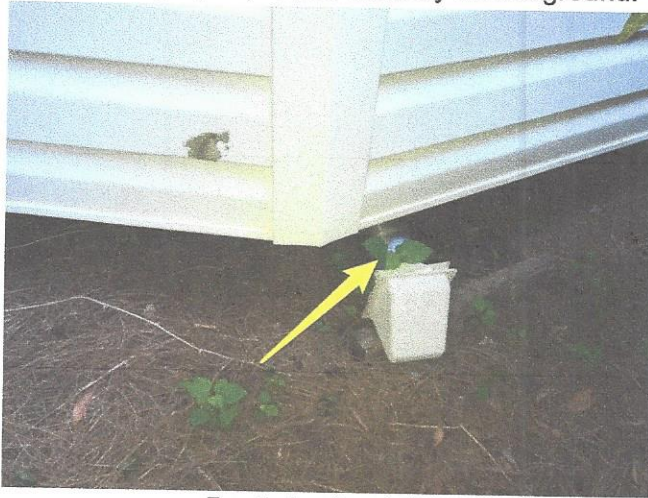
Front below the window

MN RE 62: A detached dry vent termination cover was observed at the front of the home below the bay window originating from the basement laundry room. Recommend reconfiguration of the dryer vent to termination properly rather than lay on the ground.

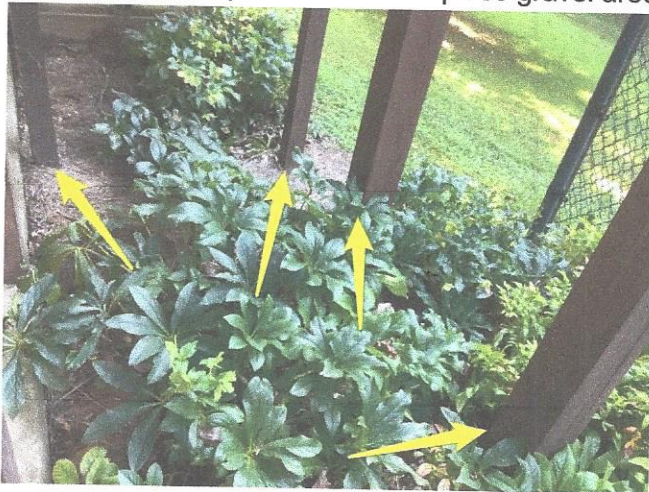
MN 64: Deck posts were found in contact with soil around their bases. Although posts are likely pressure treated which helps prevent decay, for longevity, recommend removing soil from around all posts (down to the footings) and pour concrete or place gravel around posts to extend above soil grade by 2 inches.

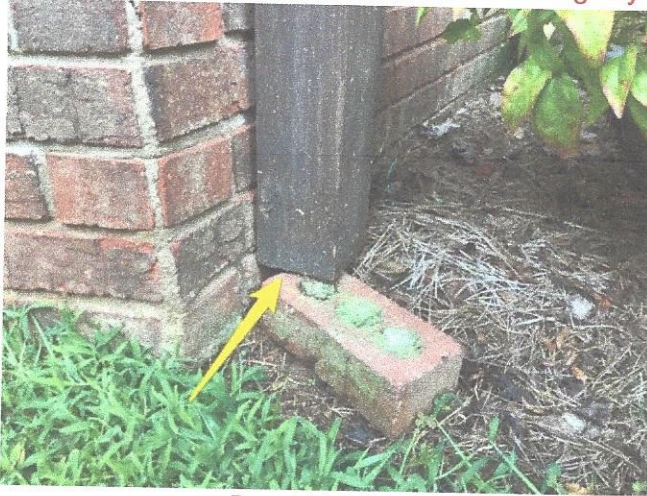
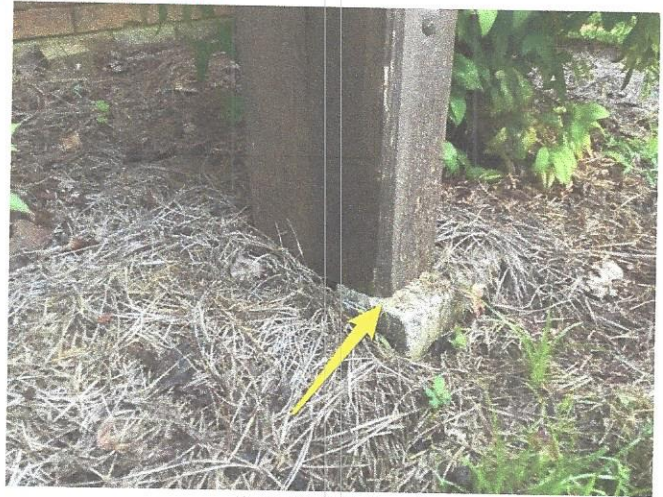
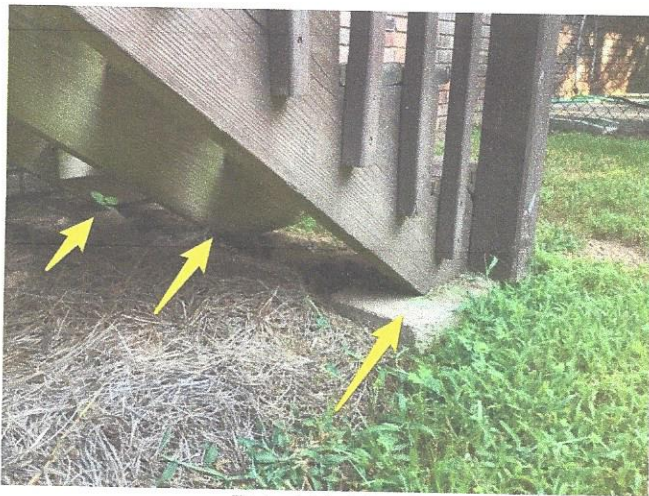
Rear right stairwell

- * **RE 65:** Improper brick, cement block, pre-cast type post supports were observed below the rear right stairs posts. In order to provide proper support for the stairs, recommend replacement of all pre-cast supports with poured-in-place concrete footings by a qualified contractor.

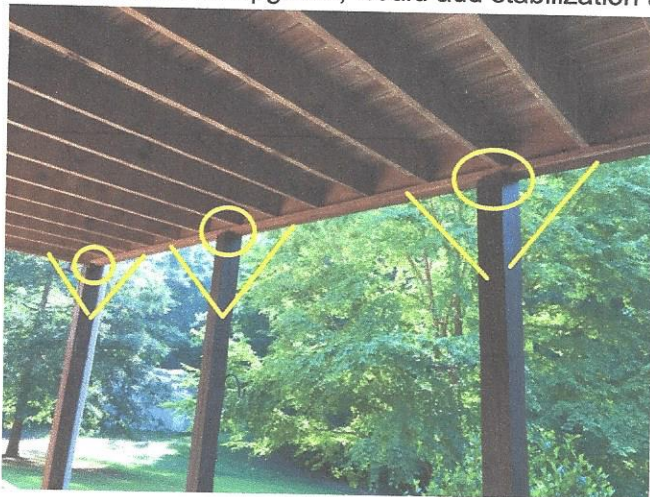
UP 66: Lateral support (diagonal bracing) and mechanical attachment (brackets) between the rear deck support posts and the outer band joist framing were not installed as required by 2012 deck standards, but they were not required when the home/deck was originally built. Adding these structural components would be considered an upgrade, would add stabilization to the deck and help prevent posts from twisting.

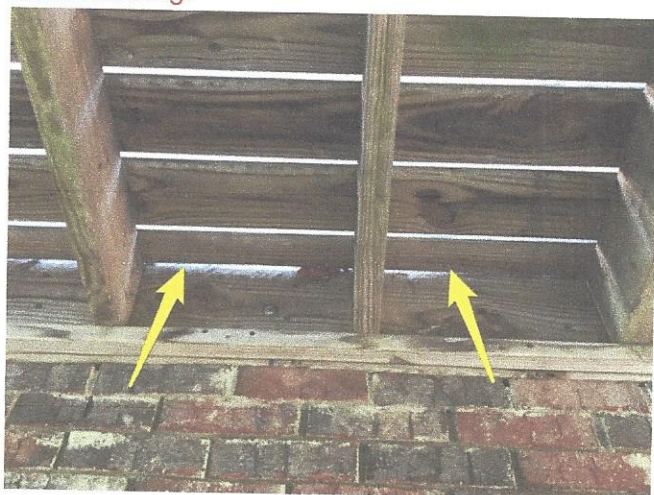
RE 67: Rear deck ledger board flashing was not visible from below or above the deck. When the ledger board attachment to the structure has been installed without flashing this creates a condition conducive to deterioration as water can penetrate to the home's rim joist causing compromise and possible failure at bolt attachments. Recommend flashing the ledger board by a qualified contractor to help prevent deterioration along its connection to the home. Flashing requires that it is installed behind the cladding/siding in order to be effective. At a minimum, the joint between the home and decking requires caulking and regular maintenance to prevent water intrusion behind the ledger board. Note, the backside of the ledger board/rim joist connections could have non-visible damage from possible prolonged water intrusion. One precaution that a deck contractor may suggest would be to add a support beam & posts against the home at the ledger board to ensure the deck has proper support, essentially creating a "stand-alone" deck not dependent on the ledger board attachment to the home. This would also resolve the issue of the current deck standards that prohibit direct attachment of the ledger board directly over brick cladding.

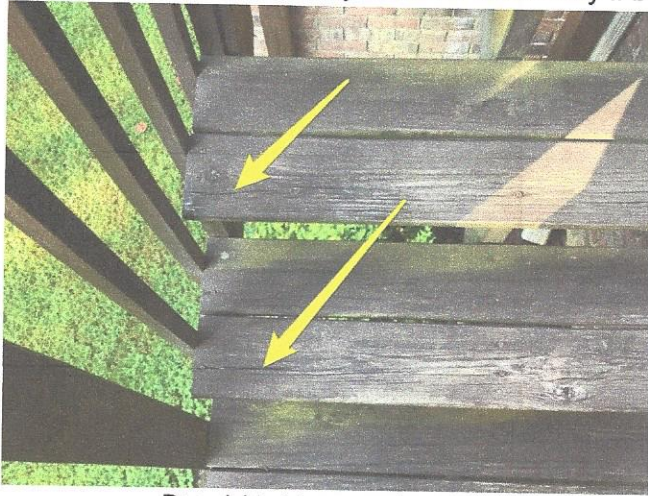
SA MN RE 71: Approximately 5 of the stair treads at the Rear right stairs approximately 5 were found cracked. This appears to be a cosmetic consideration only. Repair for a better appearance would be considered optional, or may become necessary if boards become cracked through and through.

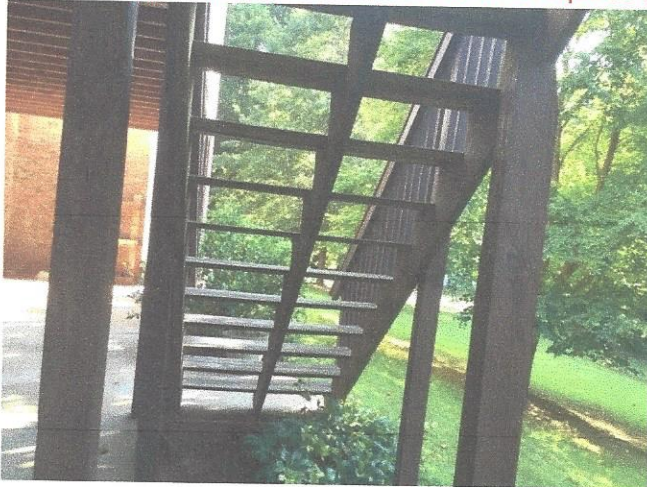
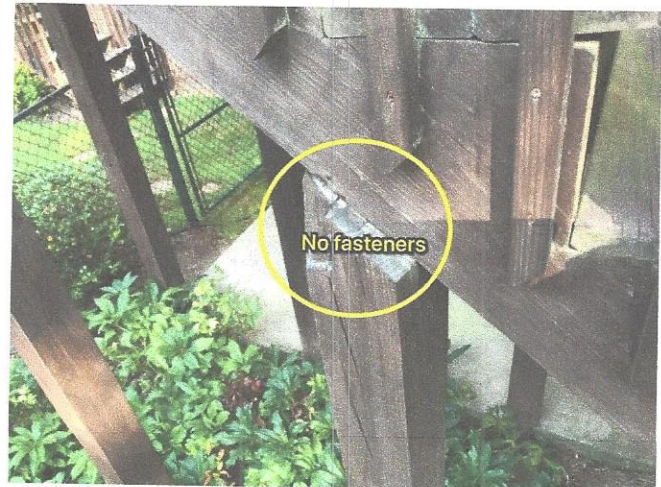
RE 72: The rear deck stairs was found to sway side-to-side with force exerted. Recommend installation of additional bracing under the stairs by a qualified deck contractor to improve the stability of the stairs. Also, a support post was found loose and requires fasteners.
