Atlanta Property Inspections, Inc.

HOME INSPECTION REPORT

210 Park Ridge Circle, Marietta, GA 30068
Inspection prepared for: Steven White & Maria White
Date of Inspection: 7/14/2020 Time: 1:00 PM
Age of Home: 40 Years Old (1980) Size: 1000 SF
Weather: Sunny, Dry Soil, 90 Degrees

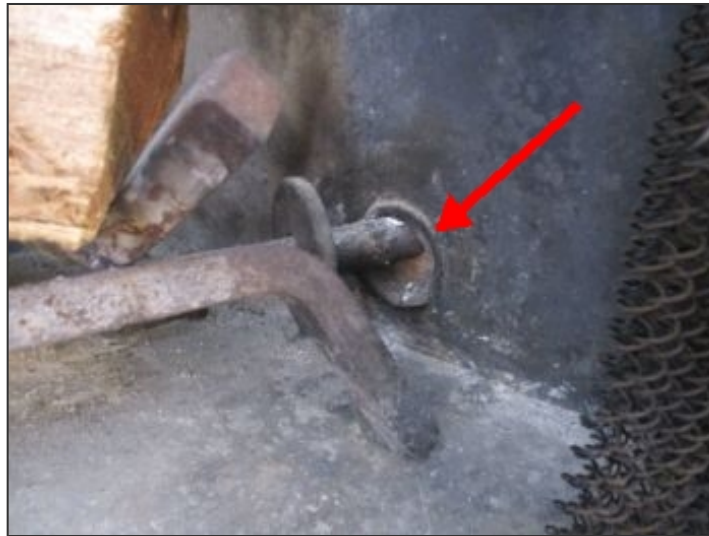
1. The fireplace flue is dirty and should be cleaned soon. Further evaluation and inspection is recommended by a professional chimney sweep or other fireplace professional.
2. The opening in the side panel of the firebox at the gas line penetration is open and unsealed and could allow the passage of hot embers through this opening. It is recommended that this opening be filled with a fire-rated sealant to meet current fireplace safety standards.

Opening at gas pipe in firebox

Further evaluation is recommended by a professional fireplace contractor to determine the full extent of repair needs and costs.

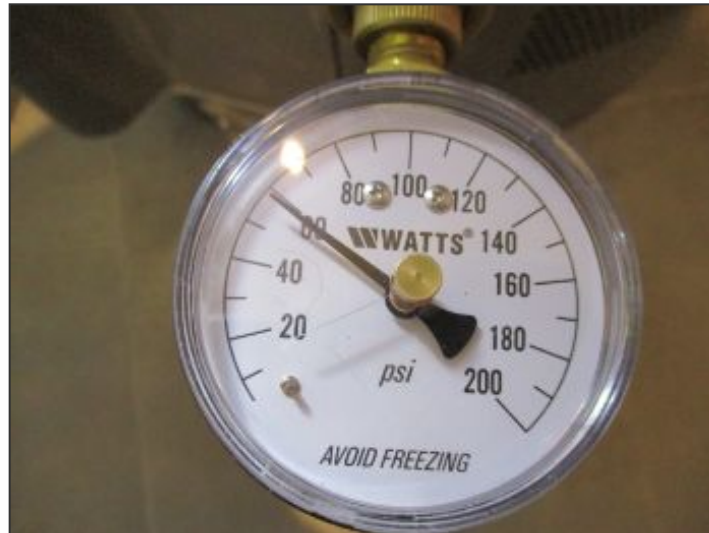
- The supply piping appears to be serviceable, no concerns were noted. A water pressure reading was taken at the water heater and was found to be normal at 60 PSI.

60 PSI normal at water heater

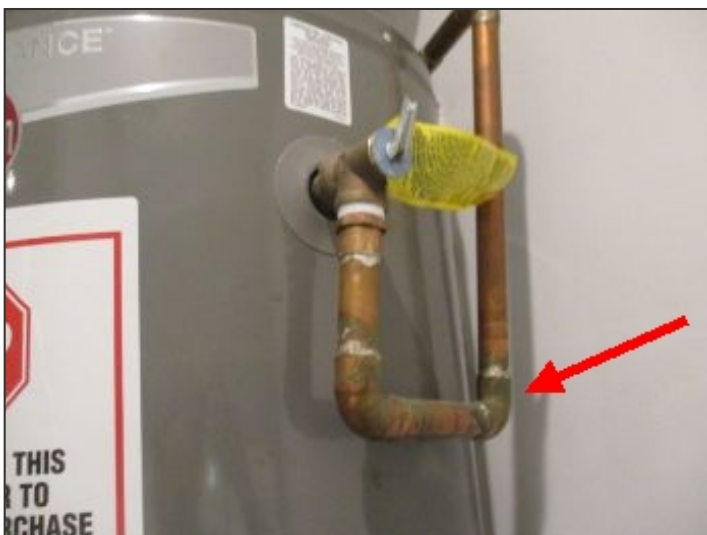
- The temperature and pressure (T&P) relief drain pipe, which runs upward to the ceiling, does not have the required drain valve to empty the drain pipe after testing the T&P valve. The drain pipe now has standing water inside the pipe that could cause future corrosive action on the interior T&P valve. Correction is recommended by a qualified plumbing contractor so that the drain can be emptied after testing.

Missing drain valve at T&P drain pipe

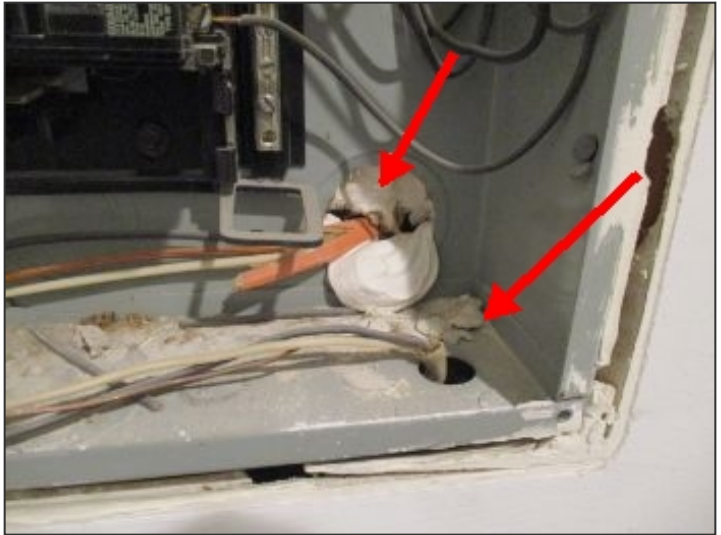
• Two incoming circuits into the panel box are not clamped and secured at the panel entry as required by the National Electric Code (NEC). A minor repair is suggested.

Missing clamps at incoming wires

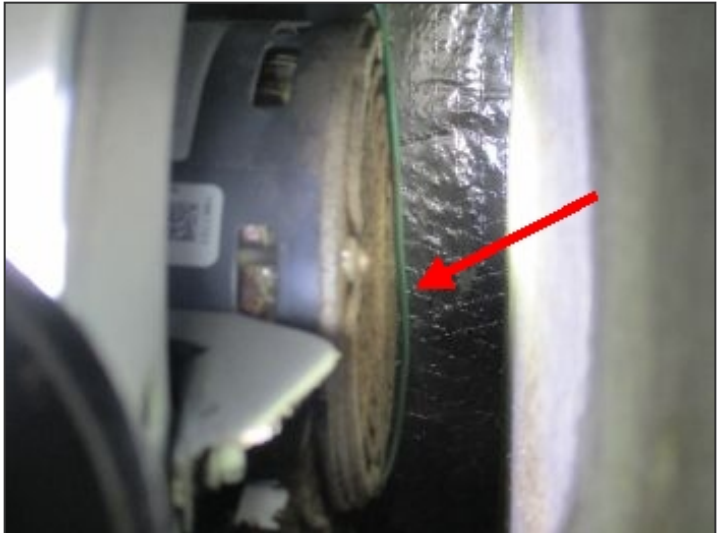
• The blower motor is dirty and has excessive dust and debris. It is recommended that the blower motor be cleaned / serviced by a professional HVAC contractor. In addition, it is recommended that the evaporator coils be checked for cleaning needs as well.

Dirty blower motor

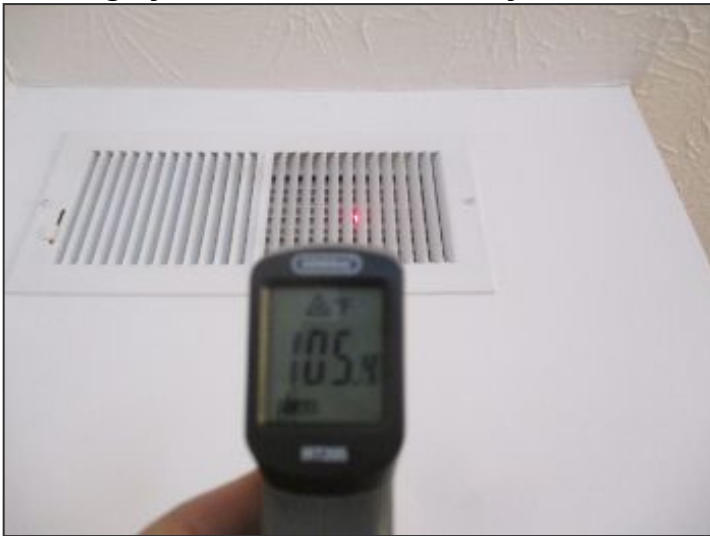
The heat pump was tested and produced heat at 105 degrees. We recommend that you continue to maintain the system and have it serviced regularly, at least once per year for units over 5 years old.

Normal temps at heat pump

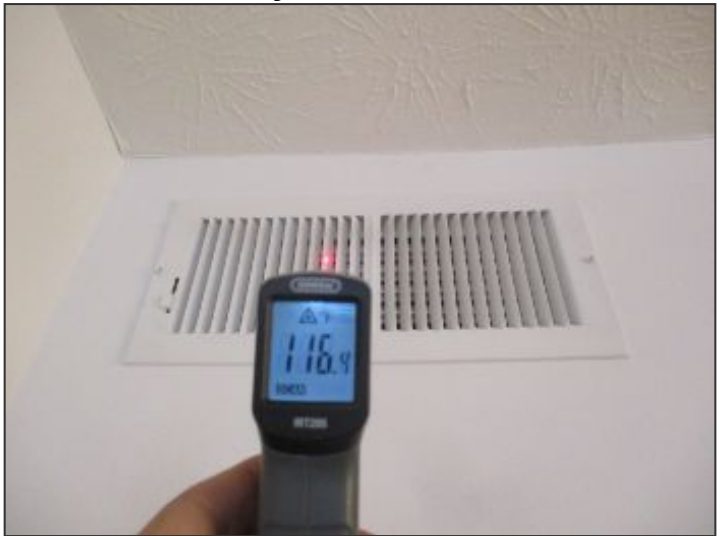
Normal temps at heat strips

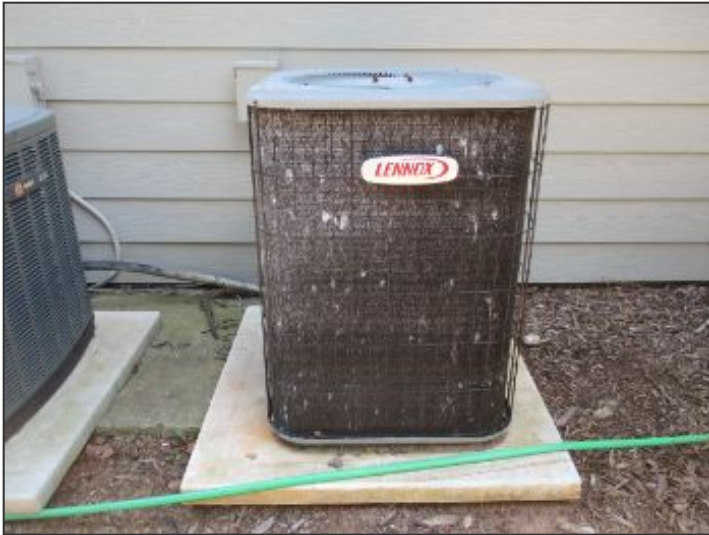
Due to the advanced age of this AC unit, client should budget for replacement soon which is expected to be a major expense. Based on the available manufacturing date on the equipment, the AC unit is at or past the normal expected lifespan of 12-15 years.

High efficiency A/C unit - 2006

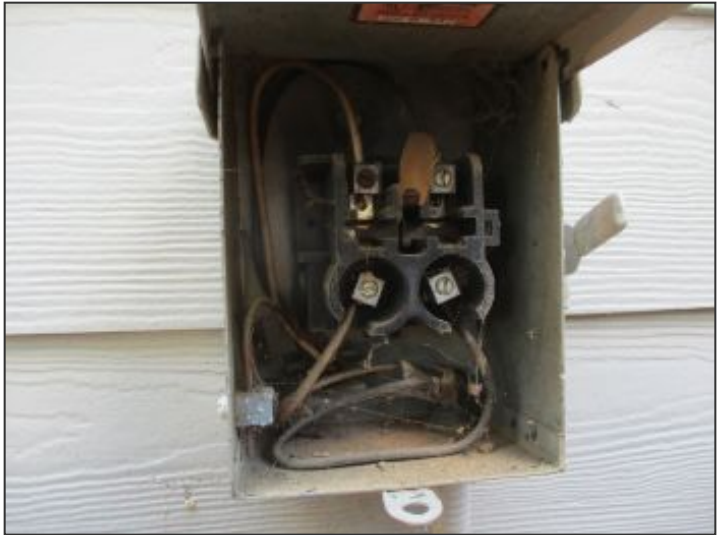
• **The exterior electrical disconnect is missing the required dead front cover, wires are exposed; this condition is a safety concern, correction is advised.**

Missing deadfront cover at A/C disconnect

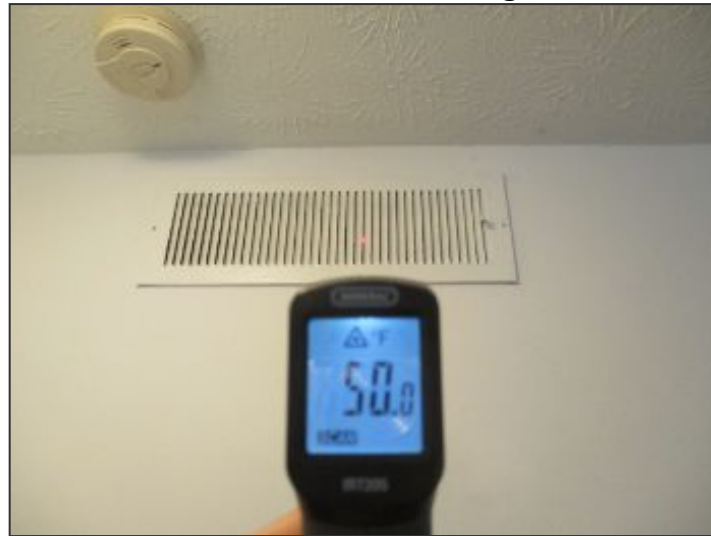
Normal temps at A/C unit
