1.1 EXTERIOR SIDING

1.2 EXTERIOR TRIM

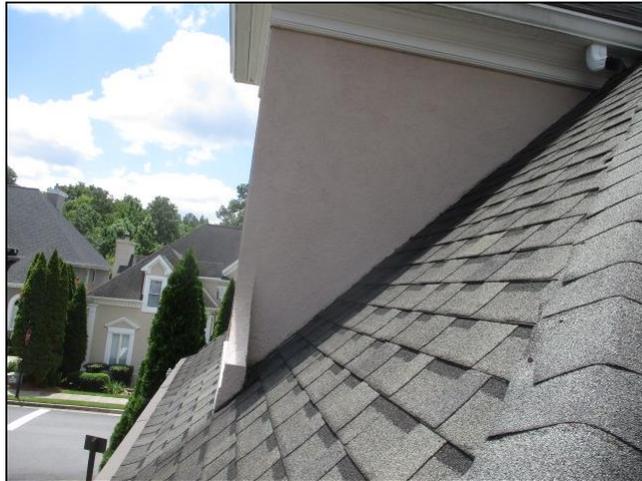
1.1 Item 1(Picture)

👉 The stucco on the dormers may be a hardcoat type, and moisture analysis was not included as a part of this inspection. It is critical that the stucco be well sealed to any dissimilar material used on the house, such as wood or vinyl trim, cables, pipes, ect..., and that roof drainage be kept in good condition. Condition of framing behind stucco is not visible and is not known. See photo for example

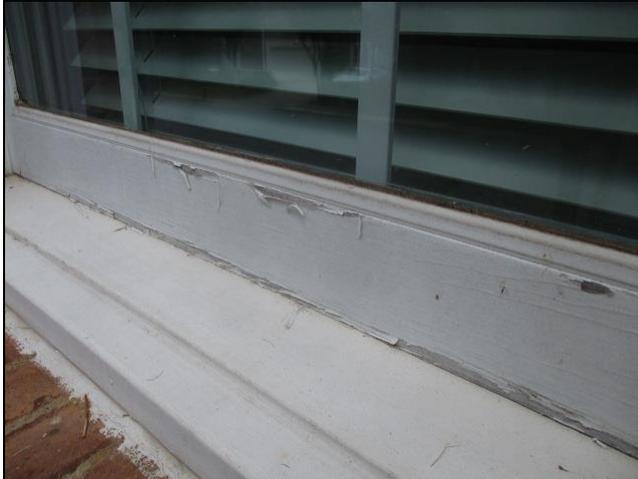
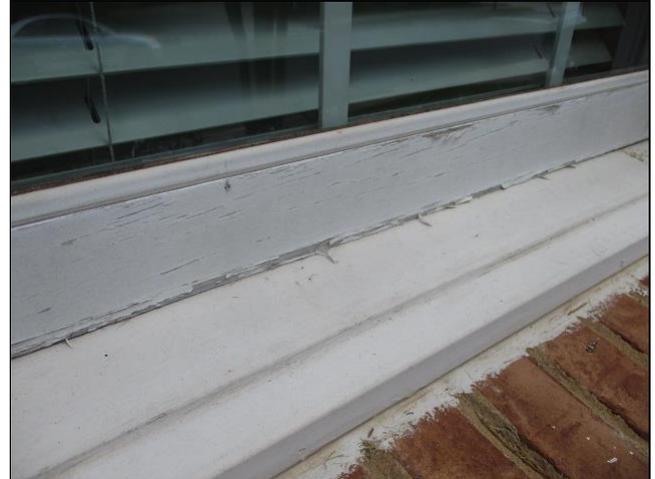
🔧 (1) All exterior trim needs to be painted in the near future to avoid wood rot. This is part of routine maintenance on a home. See photos for examples.

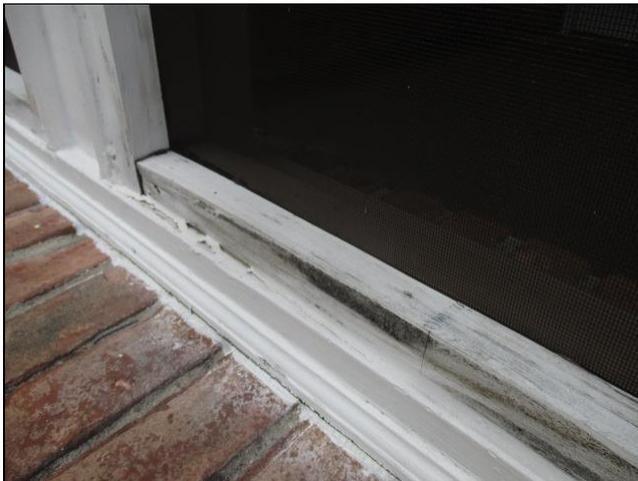
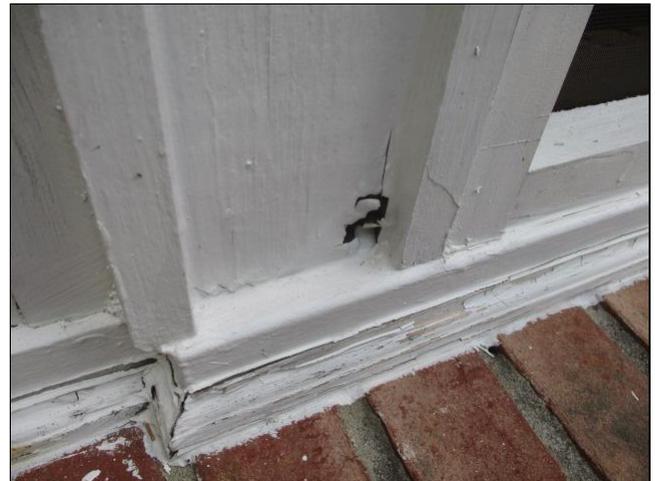
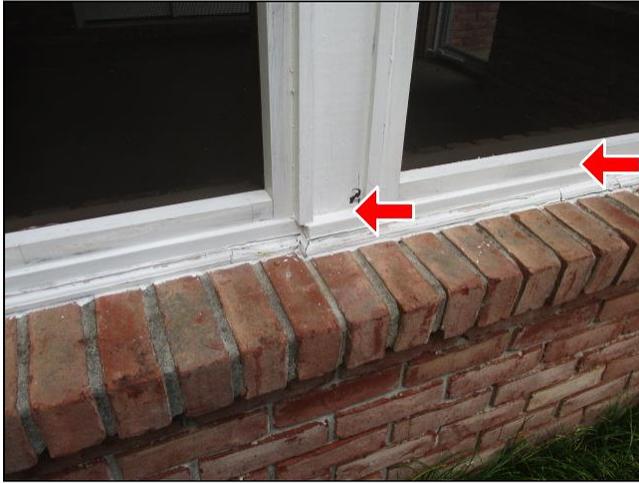
(2) Rot damage found on exterior wood trim at locations pictured.. See photos.. Have all water damaged trim replaced or repaired. It should be understood that that more minor water damage may be present on other trim around the house. This is very common and more should be expected in the future. If water damage occurred in the past, it will occur again in the future.

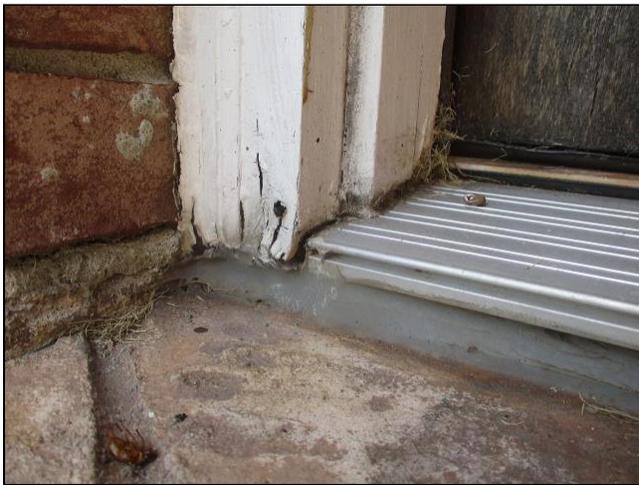
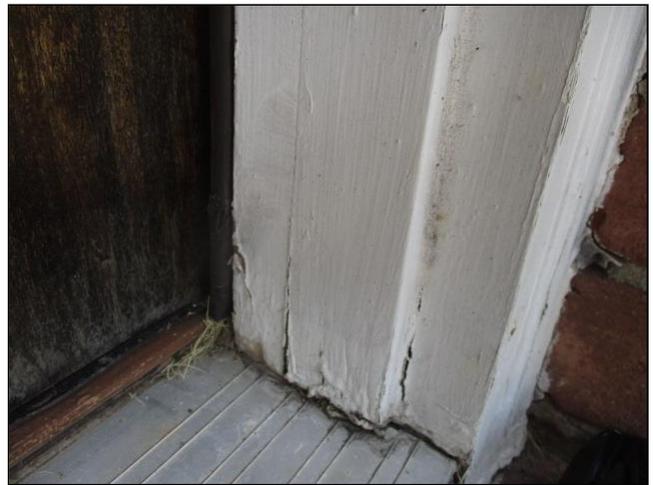
🐿 (1) Minor rot damage on lower part of the front door trim. Repair or replace damaged wood. It is possible that there have been repairs made to this area in the past, and it can be expected that more damage will occur in the future. This area may be prone to future damage. See photo(s).

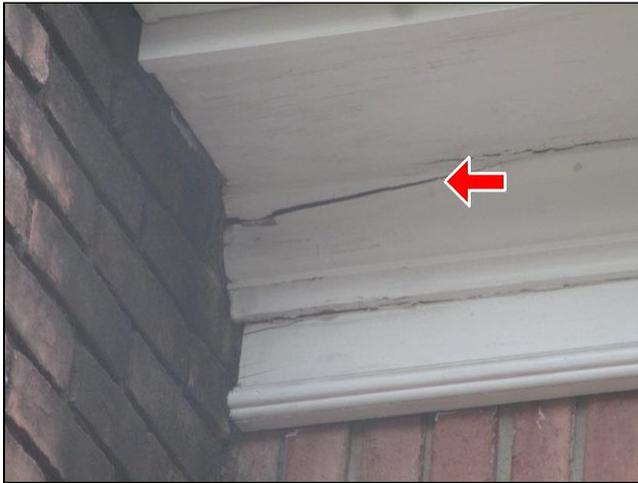
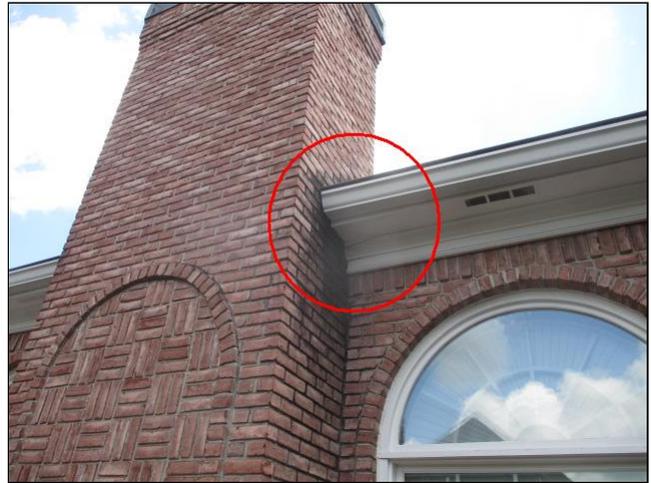
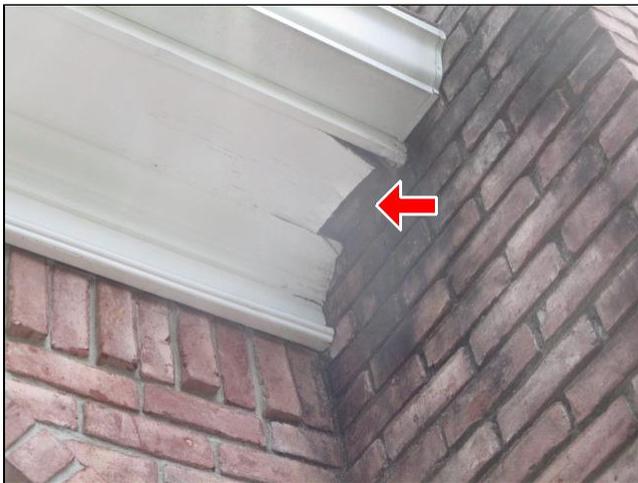
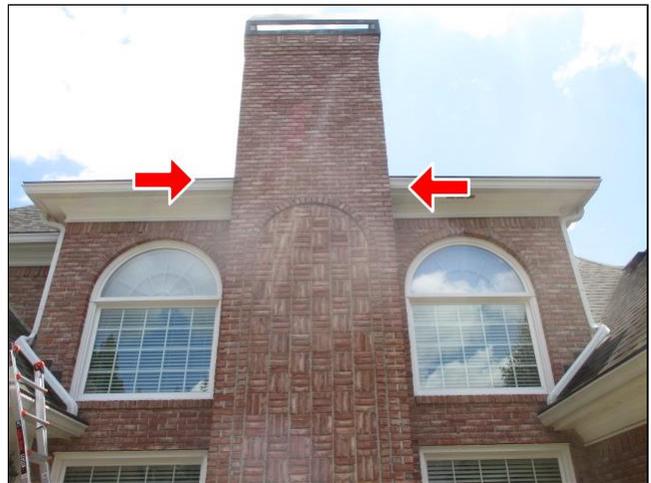
🔧 Water damage found on soffit and fascia trim at chimney area This type of damage often occurs because of leaking and/over over flowing gutters. See photo(s) for locations. Have all damaged wood replaced.

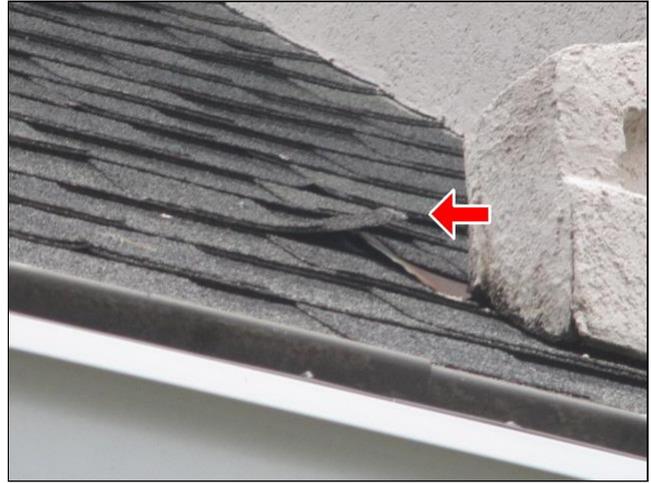
4.0 Item 17(Picture) Damaged shingle

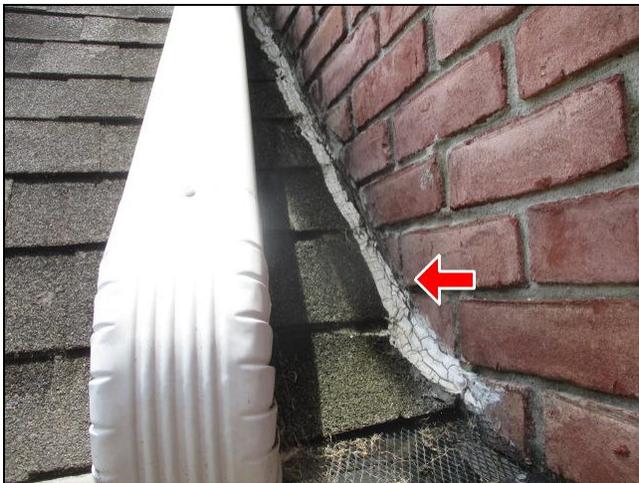
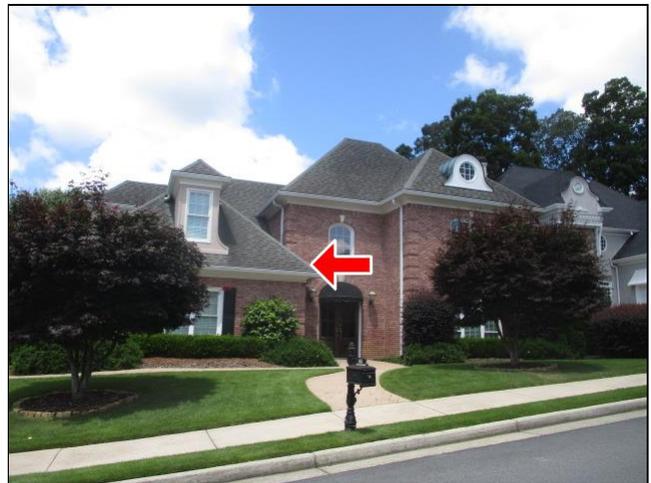
🔧 Sealant at shingles to wall connection is considered a temporary fix and will leak in the future. Have a roofing contractor further evaluate and provide repair solutions. See photos for example and location.

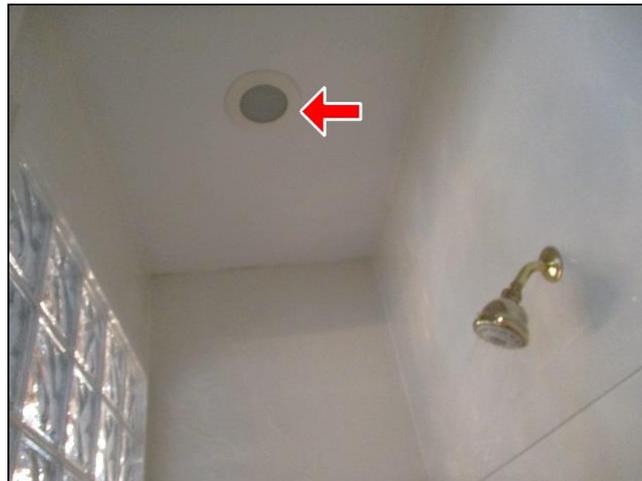
🔧 (1) Light fixture(s) pictured do not work. Replace light bulbs and test. If fixture still does not work have an electrician evaluate and repair or replace.

7.5 Item 1(Picture) Master shower stall

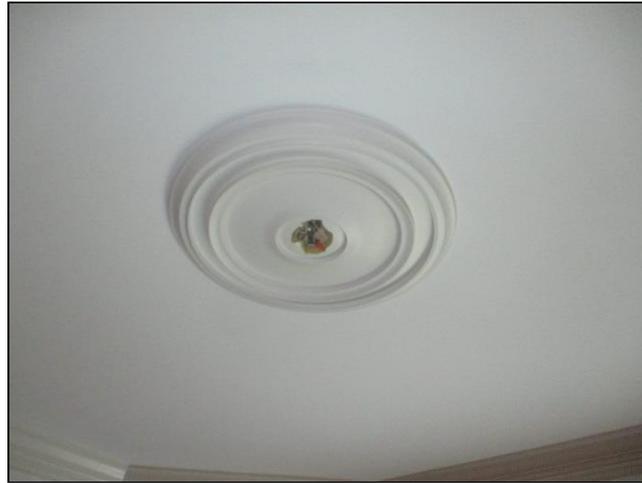
7.5 Item 2(Picture) Dining room

🔧 (2) Light fixture missing in the dining room. Replace. See photo.

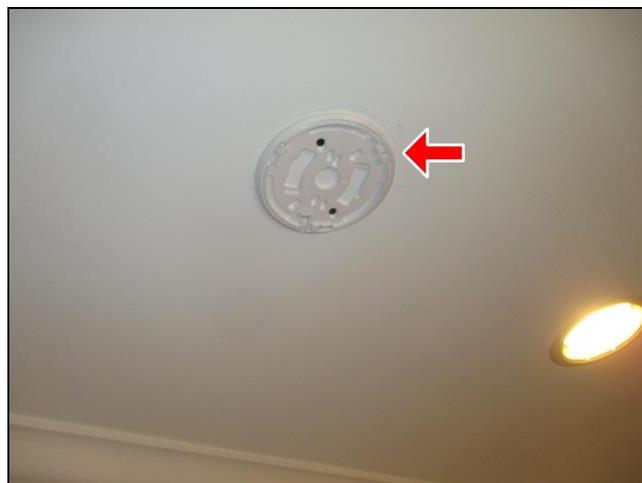
7.7 Item 1(Picture) 2nd floor hallway

🔧 Make all smoke detectors operational. Replace missing detectors pictured. See photo for location.

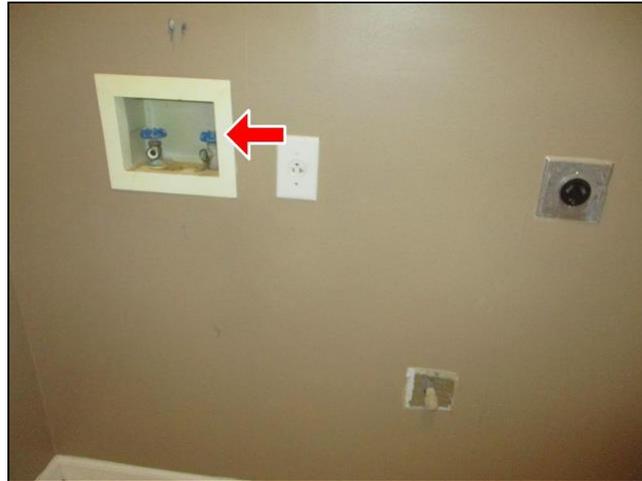
8.2 Item 1(Picture)

🔧 (1) Washing machine hook up valves are seldom turned on or off, and it should be expected that they will leak when the valves are operated. Washing machine hook up valves were not tested and not part of this inspection.

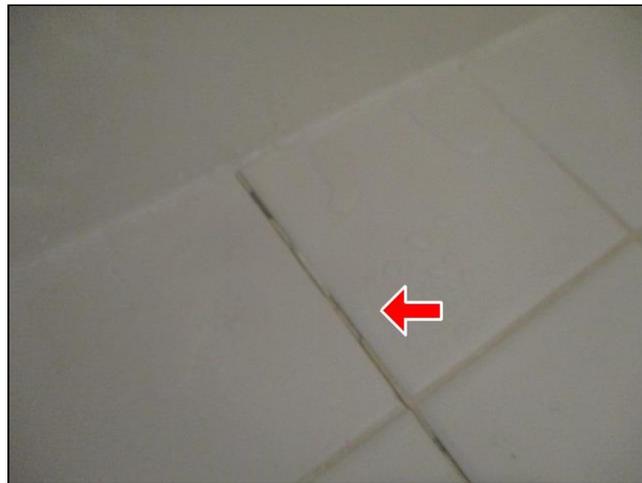
8.2 Item 2(Picture)

🔧 (2) Seal small gaps in tile in the master bath shower stall. This will help prevent leaks behind tile into wall cavity. Condition of framing behind tile is not visible and is not known.

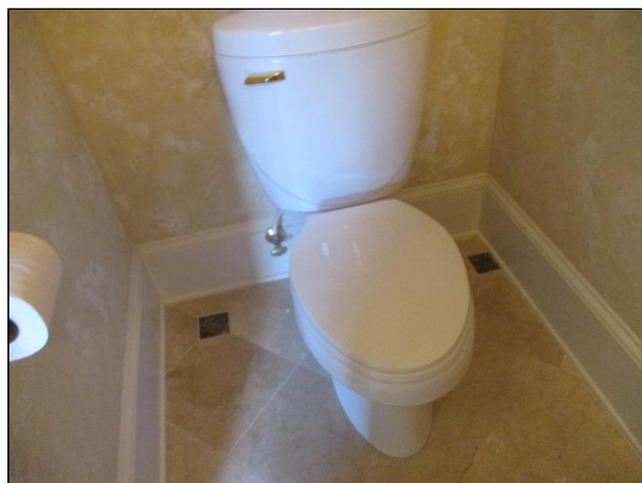
8.2 Item 3(Picture) Foyer bathroom

🔧 (3) Secure the loose toilet(s) to the floor(s) in the location(s) pictured foyer half bath bath(s). Loose toilets can lead to broken wax seals between toilet and drain pipe that can leak on the floor.

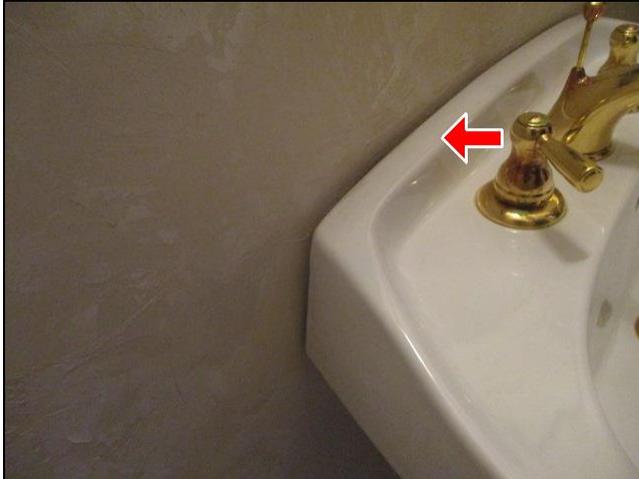
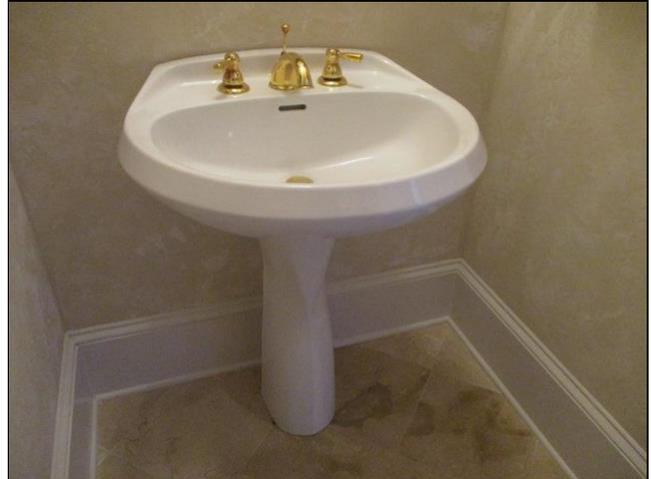
(4) Pedestal sink in the foyer half bath is loose against the wall. Secure the sink to the wall. See photos for location.

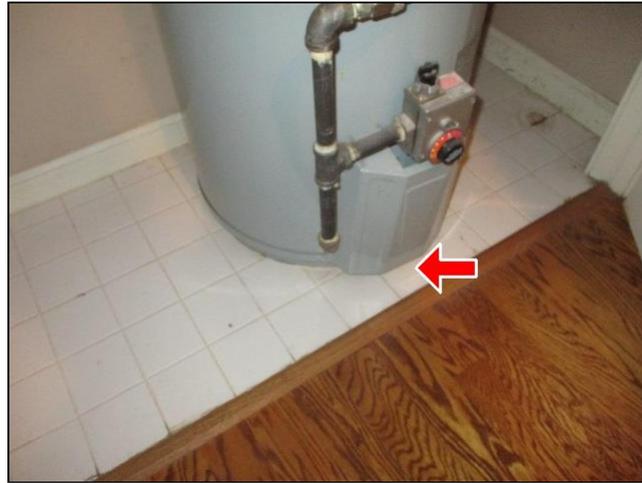
8.4 Item 3(Picture)

🔧 (2) Over flow pan needed under water heater. Recommend having a plumber install the pan to catch and drain water from any future leaks.

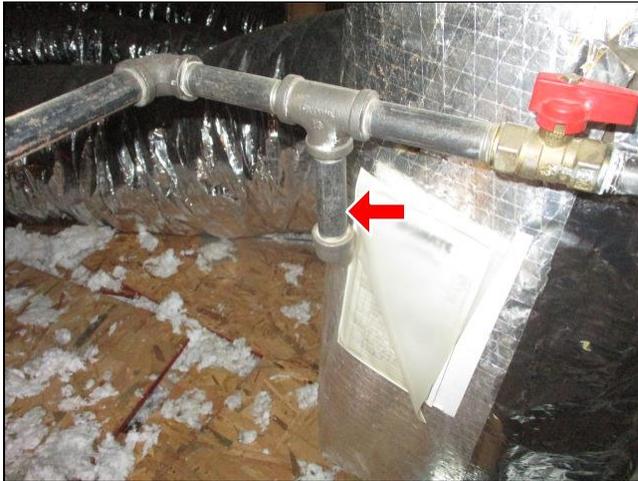
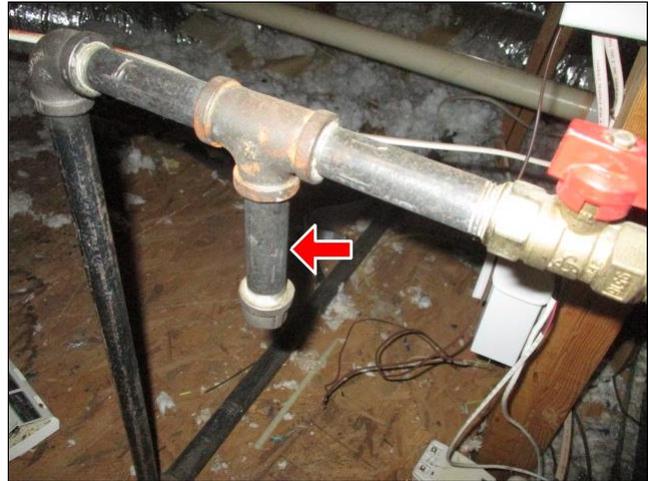
🔧 Sediment traps (or drip legs/slang term) are not installed in the correct orientation for the attic furnace. This was permitted when the home was built, however, it does not meet current standards and the gas companies requirements. Hvac tech can evaluate. Gas company may not connect gas for new owner if this is discovered. See photo(s).
