Inspection Report

Property Address:
3080 Pillement Pl
Alpharetta GA 30022

Date: 7/21/2020	Time: 01:00:00 PM	Report ID: 42066
Property: 3080 Pillement PI Alpharetta GA 30022	Customer: Darshan Patel	Real Estate Professional: Mitali Patel Keller Williams (Atlanta) Atlanta Perimeter

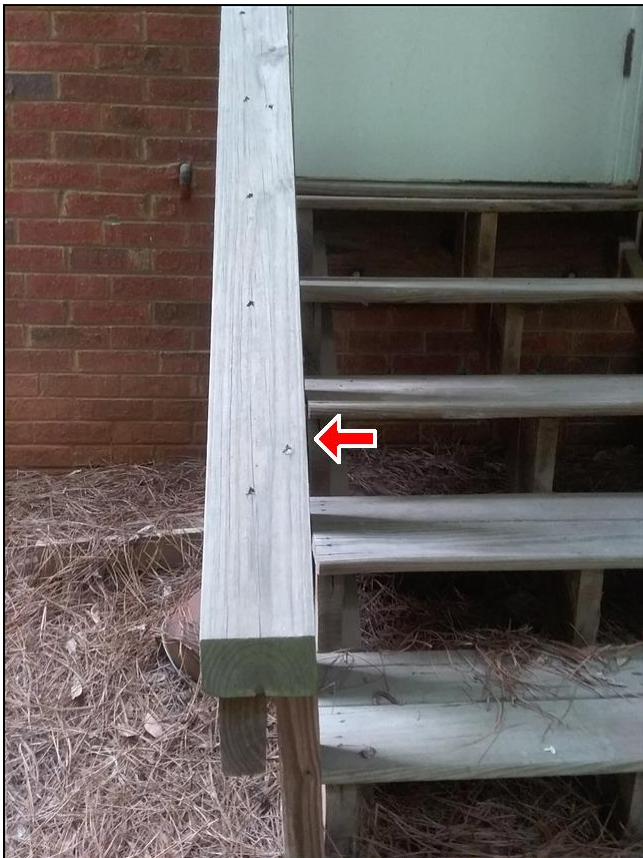
1.0 (1) Handrails oversized at both sets of rear exterior steps. NOTE: Handrails should be graspable. Install as necessary for enhanced safety.

1.0 Item 1(Picture) Oversized hand rails

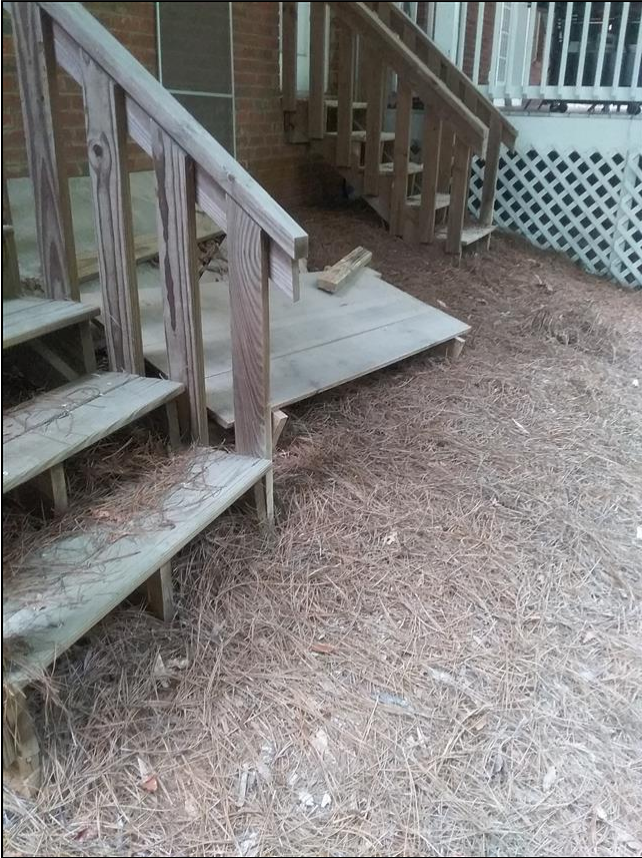
(2) No landings noted at rear exterior stairs. The steps should bear on a concrete landing that is equal to or greater than the width of the stairs and a minimum of 36" in the direction of travel.

1.0 Item 2(Picture) No landing at exterior stairs

(4) Further evaluation and repair of these conditions by a licensed general contractor is recommended.

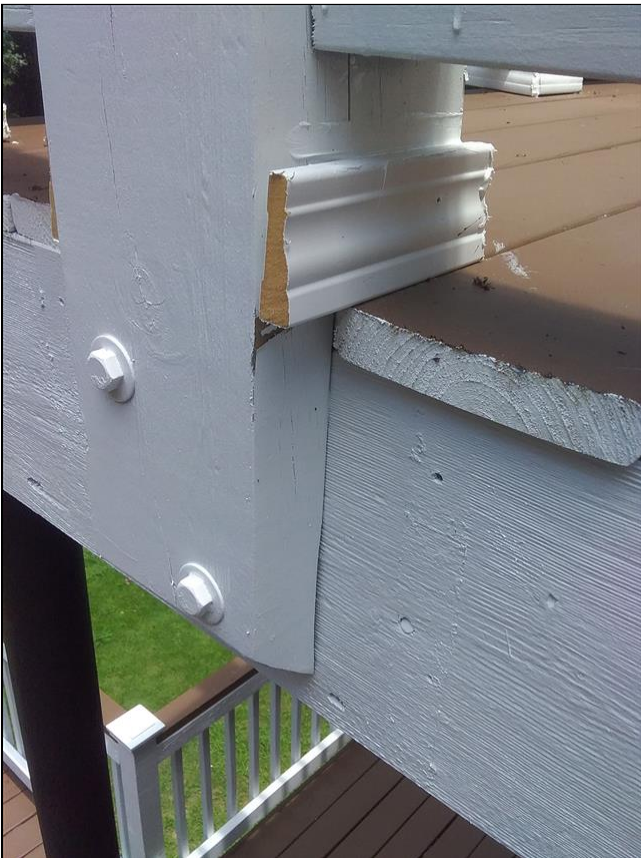
(2) Improper post-to-beam attachment noted at rear deck guard rail. NOTE: Posts should be attached full-width (not notched) and secured with 2 x 1/2" through bolts and washers (not nailed) with hold down straps installed under the deck.

1.1 Item 1(Picture) Improper guard post attachment

(14) Further evaluation and repair of all deck issues by a licensed general contractor is recommended.

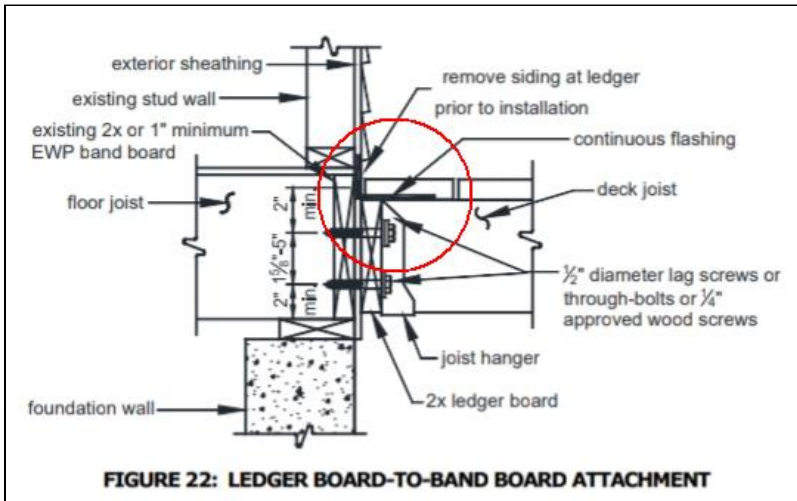
(5) Missing flashing noted at rear deck rim board attached to the home. NOTE: Flashings represent a barrier between intersected/attached features and should be installed to protect interior structural components (i.e. structural panels). Install flashings where necessary.

1.1 Item 5(Picture) Proper flashing installation

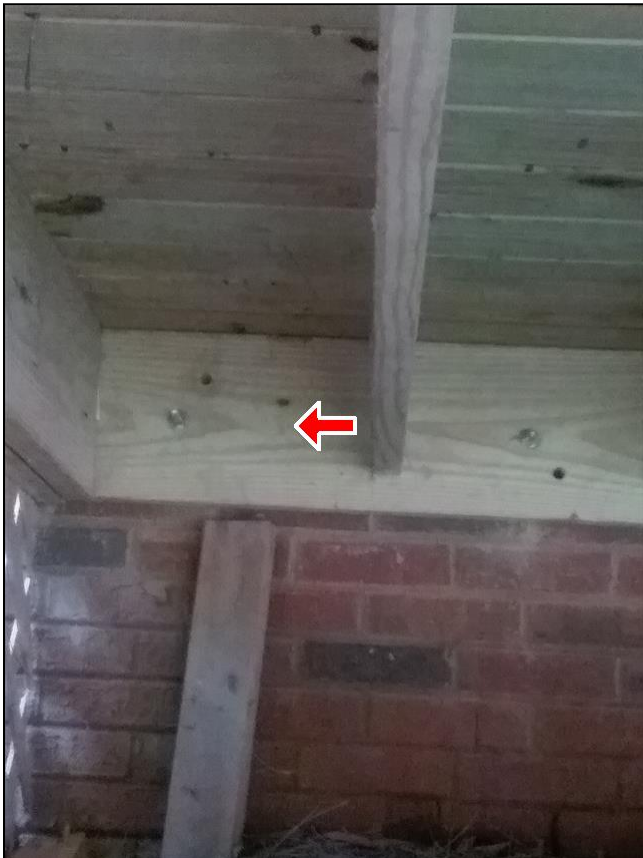
(6) Improper ledger board attachment noted at rear deck. NOTE: Ledger boards should not be attached directly to masonry veneer. Instead these decks should be constructed as "free standing" and not attached directly to the structure.

(7) Insufficient ledger board attachment noted at rear deck. NOTE: Ledger boards should be attached with a double row of 1/2" machine bolts (and washers) at ends of board(s). Repair as necessary for increased deck stability.

1.1 Item 6(Picture) Insufficient attachment

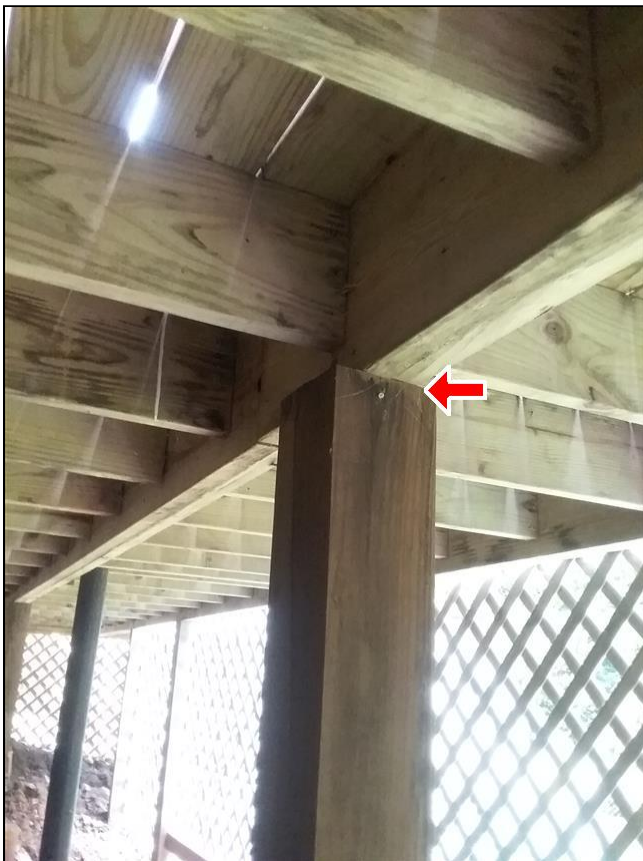
(8) Improper post-to-beam attachment noted at rear deck beam. NOTE: Beams should be supported from below (i.e. cut-in at 4x6" posts and secured with 1/2" through bolts [and washers] or using a post cap connector). Repair as necessary.

1.1 Item 8(Picture) Improper post to beam connection

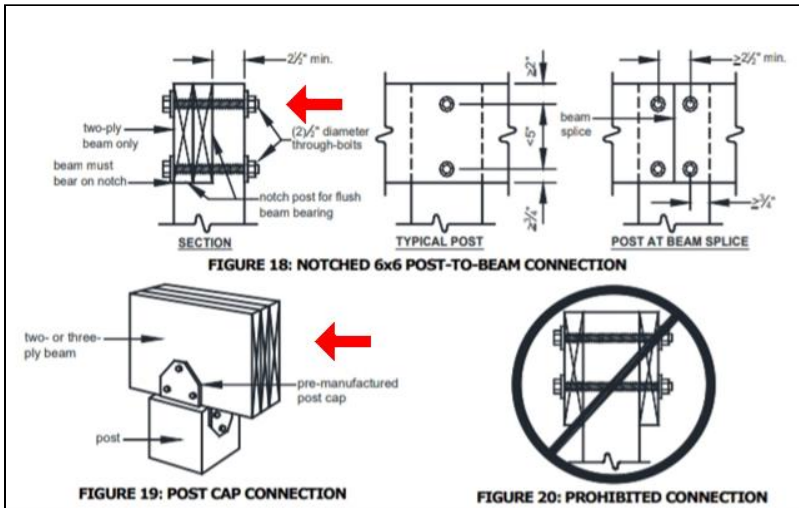
1.1 Item 9(Picture) Accepted post to beam connections

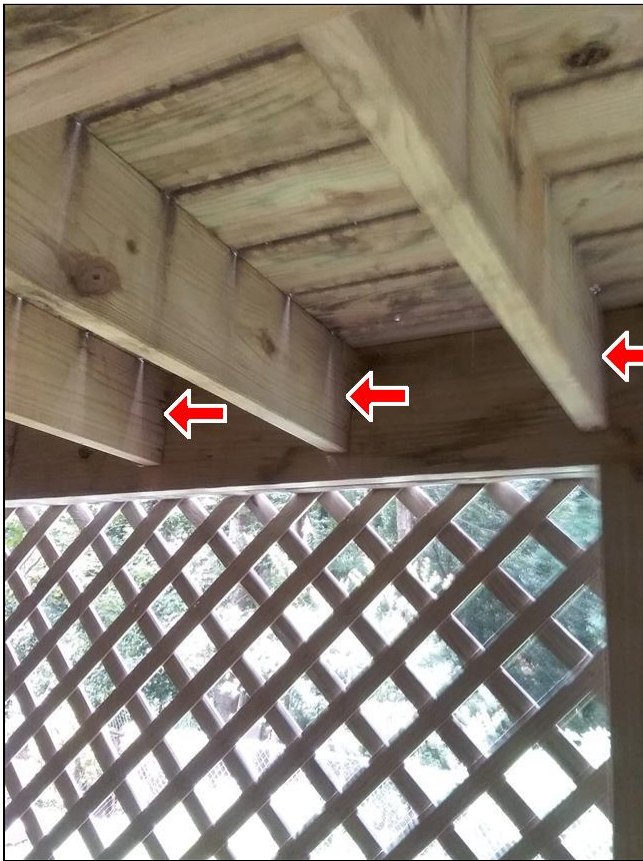
(9) Missing joist hangers noted at rear deck at front joist/rim board intersections. Install joist hangers as necessary.

1.1 Item 10(Picture) Joist hangers should be used

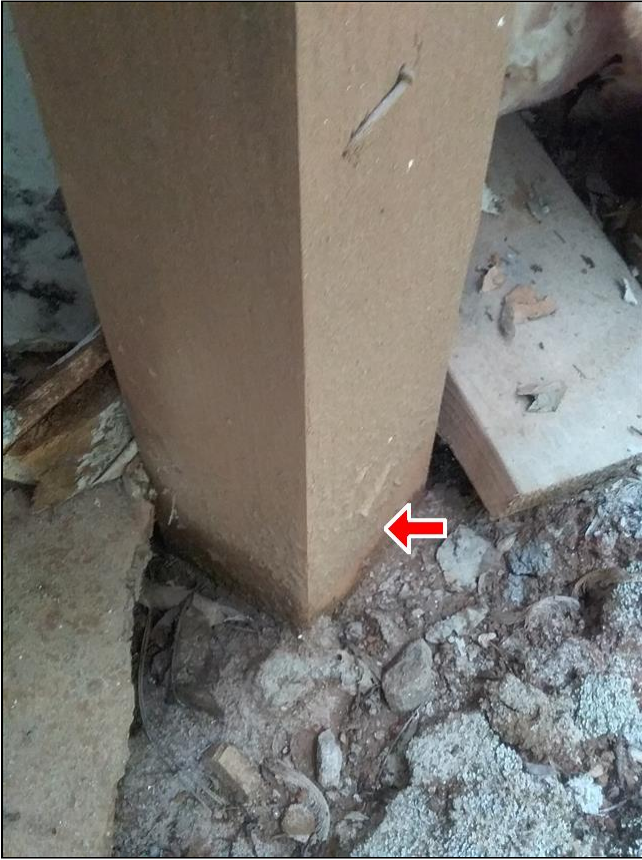
(10) Ground contact noted at rear deck posts. NOTE: Infestation of wood destroying organisms and decay is possible. Monitor and repair as necessary using ground-contact rated materials. Recommend the clearing of soil away from all wood deck members.

1.1 Item 11(Picture) Post in ground contact

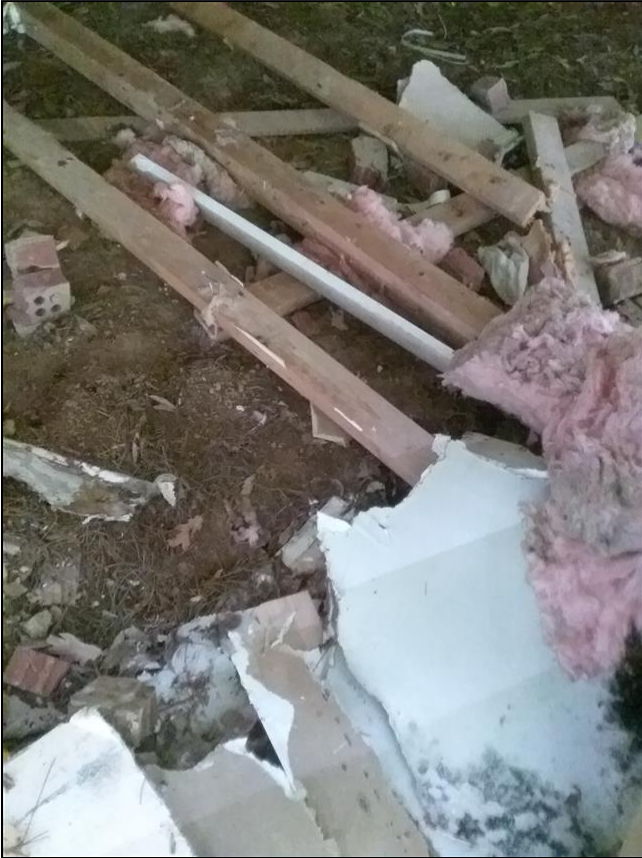
(11) Presence of wood and cellulose debris noted under rear deck. The debris should be cleaned out to avoid attracting wood destroying organisms.

1.1 Item 12(Picture) Wood debris under deck

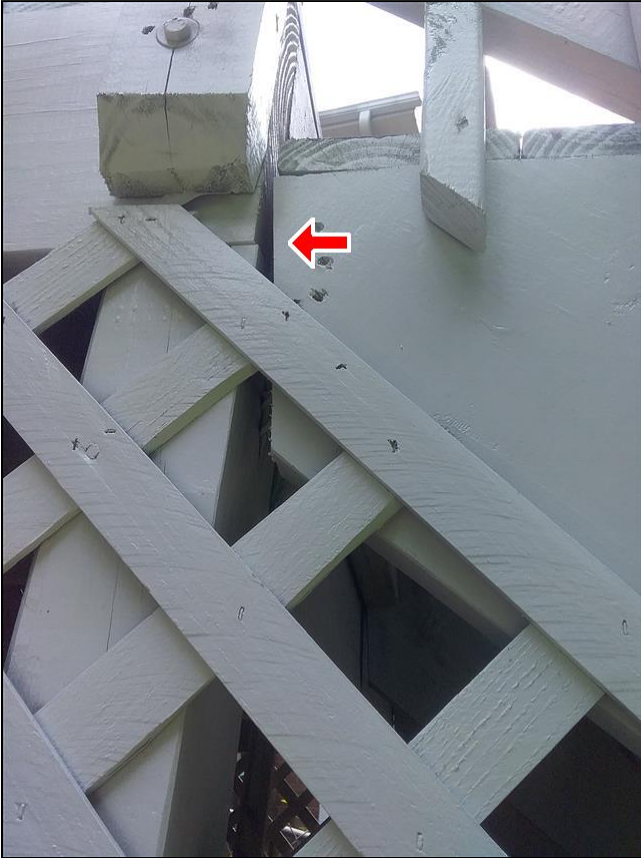
(12) Insufficient support noted at rear deck stair stringers. NOTE: Stringers should be fully supported with hangers at riser. Add supports below stringers.

1.1 Item 13(Picture) Insufficient stair support

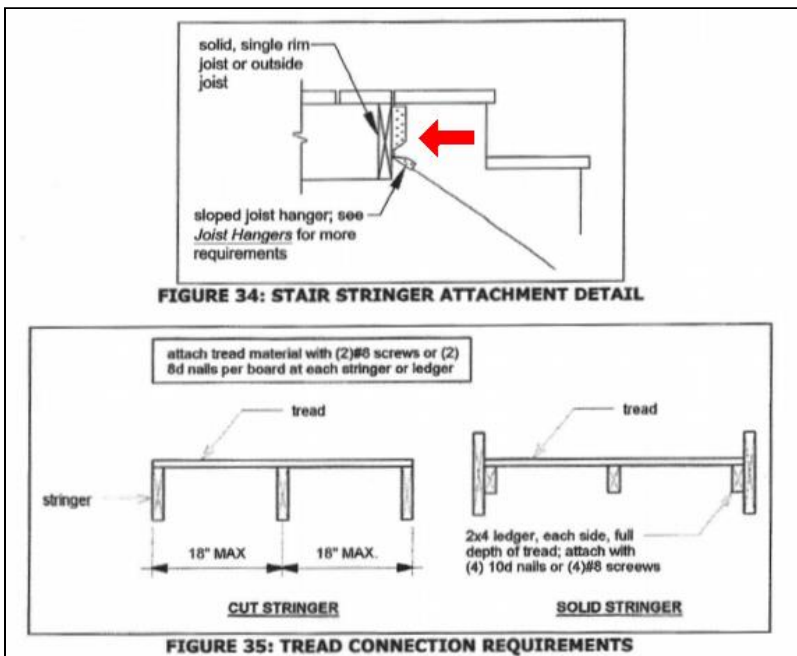
1.1 Item 14(Picture) Proper stair support

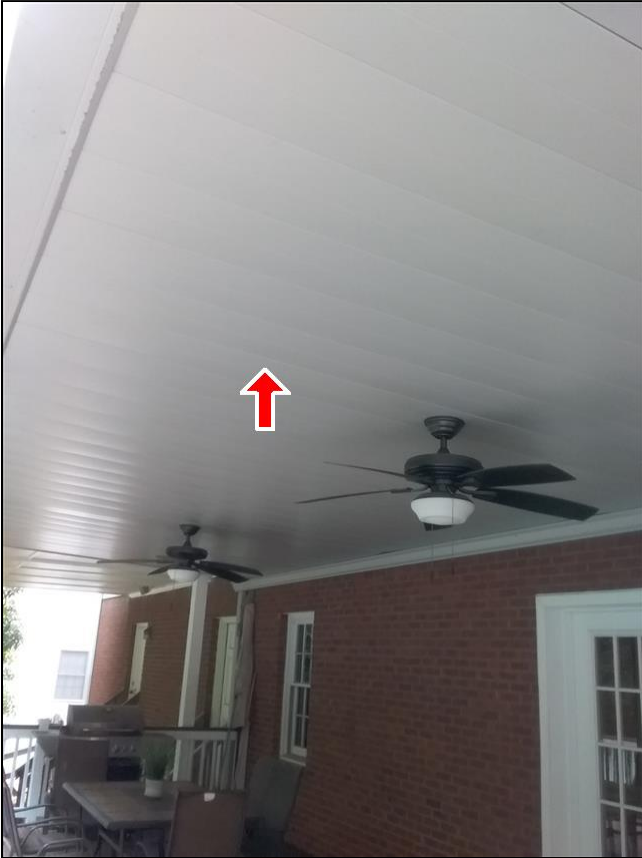
(13) Deck structure below 2nd floor rear deck is covered and not visible. Unable to inspect structure. Monitor and repair as necessary.

1.1 Item 15(Picture) Second floor deck structure covered

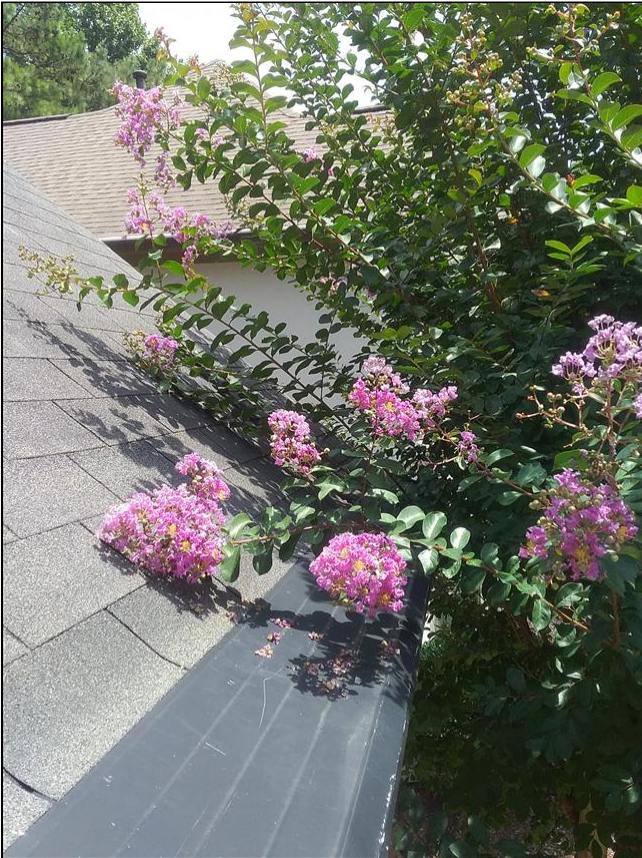
1.2 (1) Branches noted in contact with exterior and roof. Recommend maintaining a distance of at least 6" from the exterior to avoid possible damage to the exterior, or allow animal and moisture entry.

1.2 Item 1(Picture) Branches in contact with roof

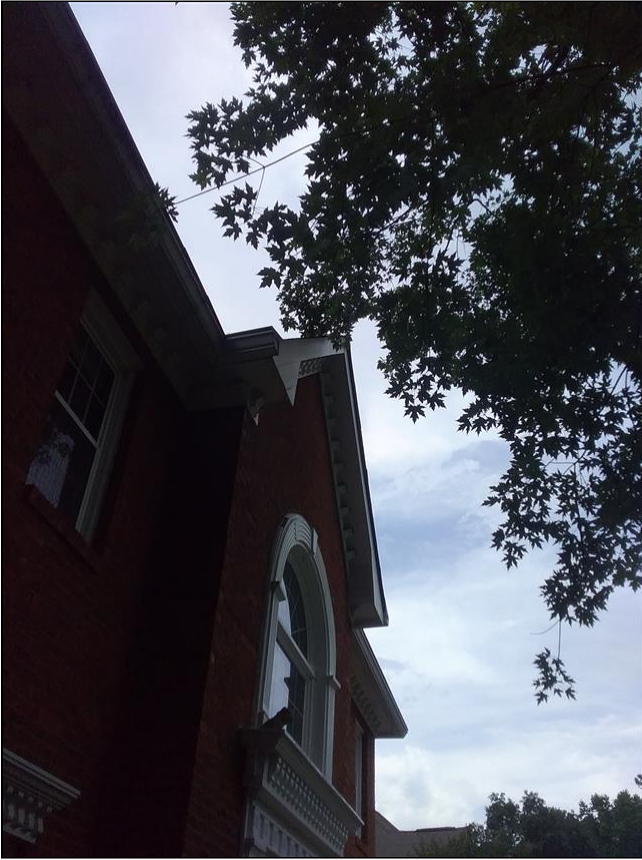
(2) Leaning trees and overhanging branches noted at front of house. Remove/trim trees and/or branches as necessary to avoid hazard to occupants, or potential damage to the roof and exterior. Remedy of this condition by a qualified landscaping contractor is recommended.

1.2 Item 2(Picture) Overhanging branches

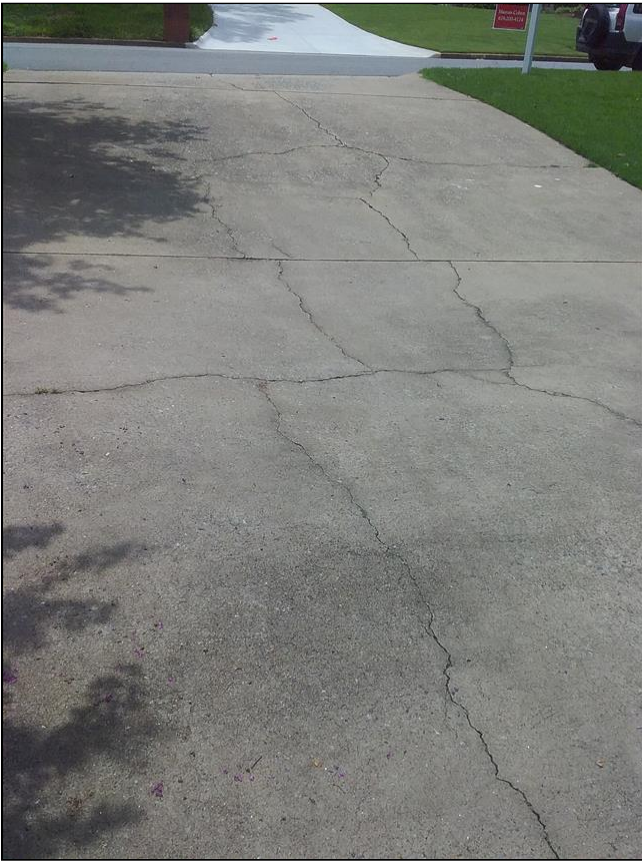
1.3 Common cracks noted at driveway. Monitor and repair, if necessary, using a licensed general contractor.

1.3 Item 1(Picture) Common cracks in driveway

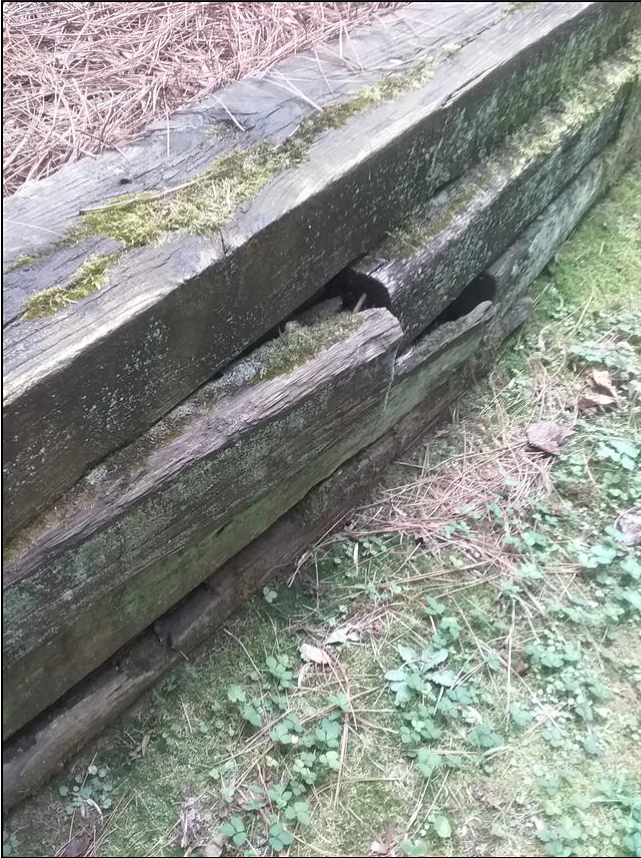
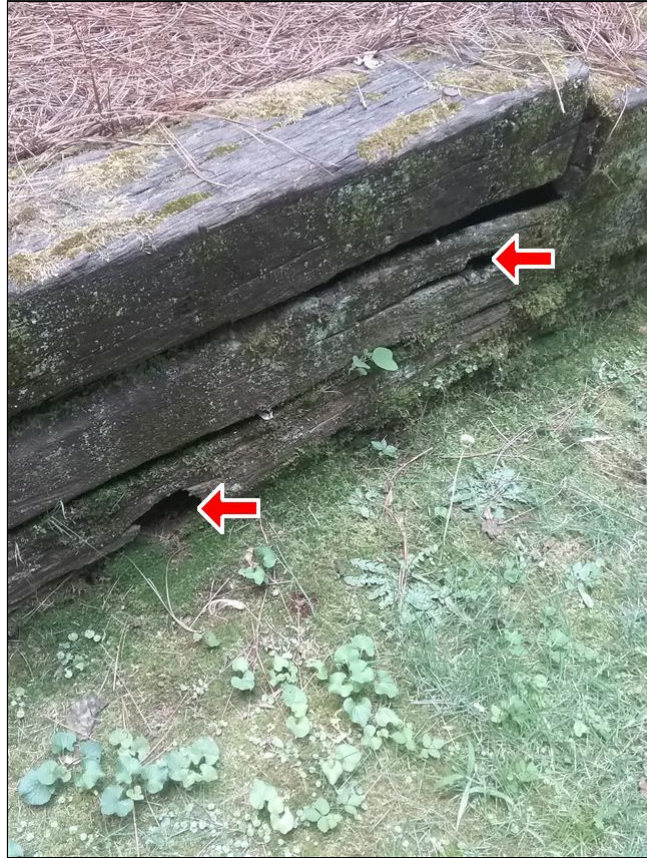
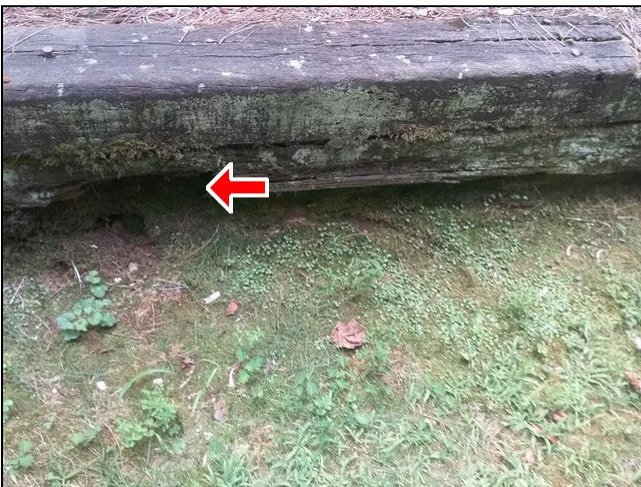
1.5 Decay and bowing noted at rear retaining walls. Recommend consultation with a qualified contractor for further evaluation and repair.

1.5 Item 1(Picture) Bowing retaining wall

1.5 Item 2(Picture) Decay in retaining wall

1.5 Item 3(Picture) Decay in retaining wall

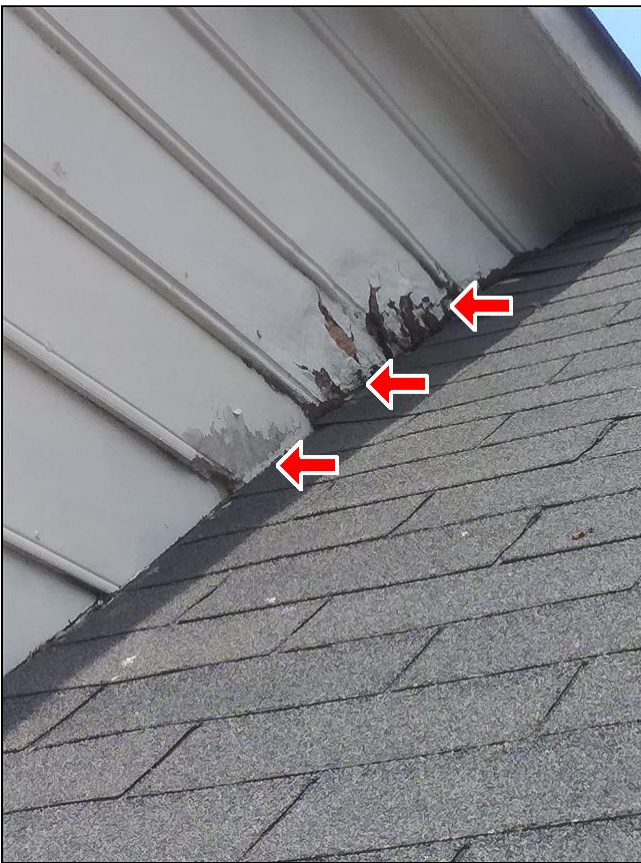
(2) Deterioration noted to siding around dormer windows above garage. This is most likely a result of the close proximity of the siding to the roof coverings. Recommend maintaining a flashed 2" gap between siding and roofing to prevent further moisture damage to siding. Recommend the replacement of all damaged siding to prevent moisture penetration into the wood frame of the house.

2.0 Item 1(Picture) Deterioration of siding

(6) Further evaluation and repair of exterior cladding issues by a licensed general contractor is recommended.

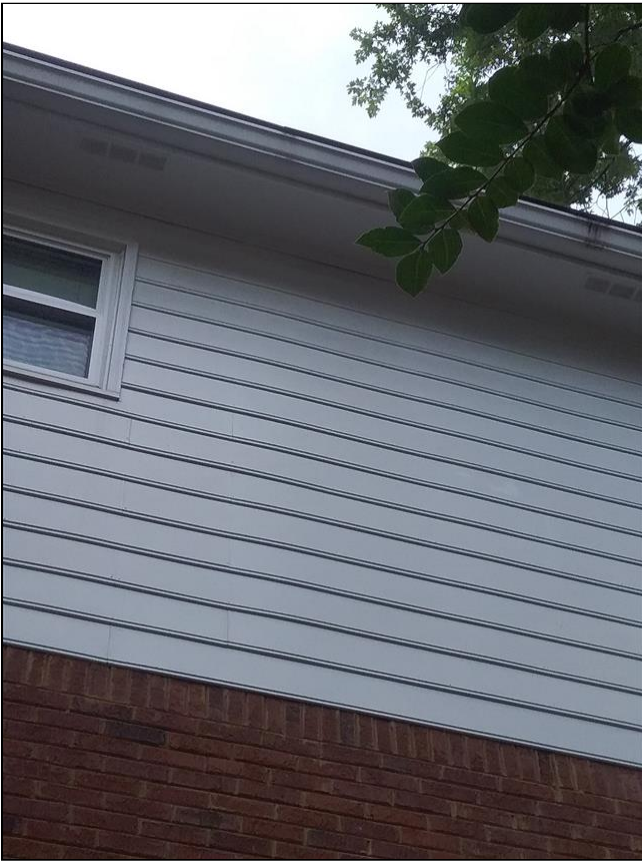
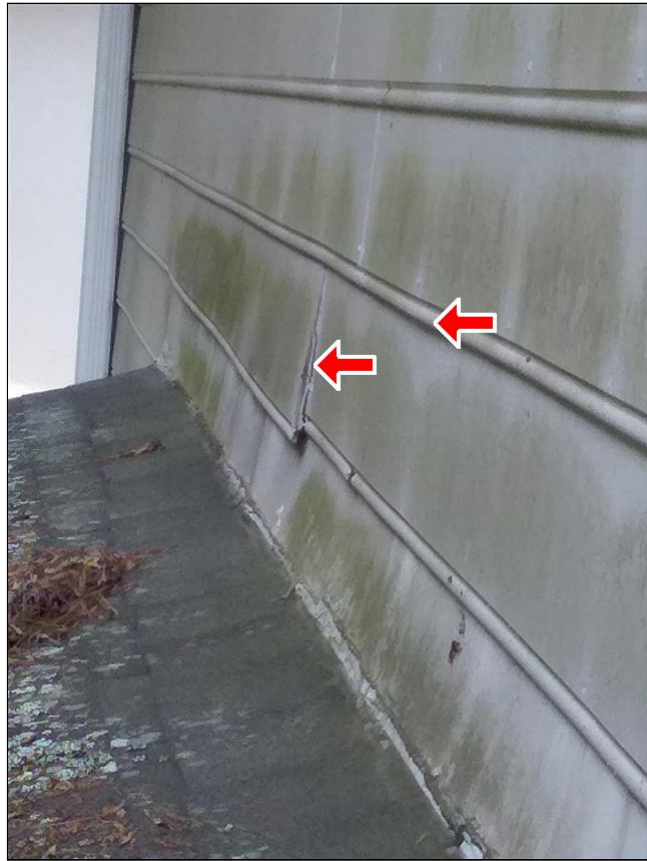
(3) Some swelling of wood composition siding noted on left side and rear of house creating a "wavy" appearance.

2.0 Item 2(Picture) Swollen lap siding

2.0 Item 3(Picture) Swelling at joint

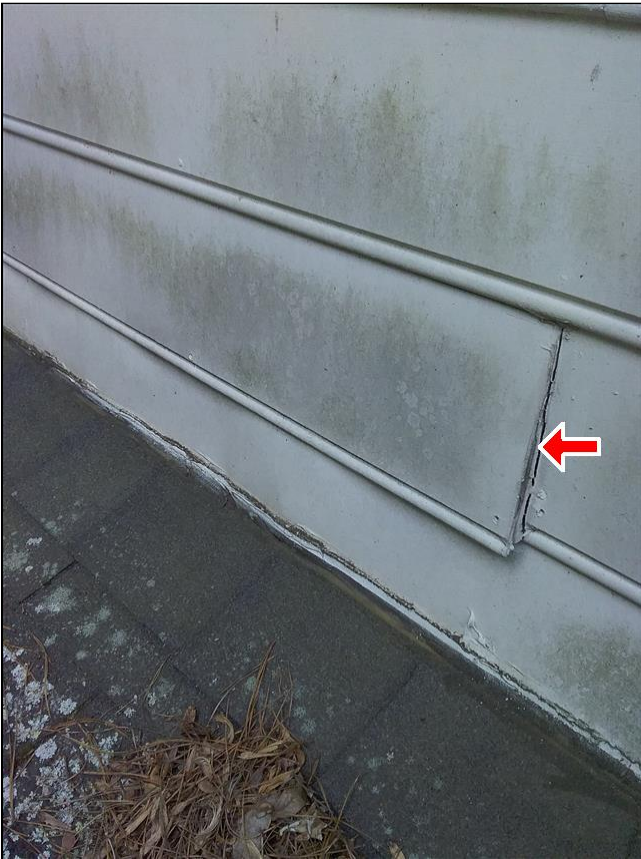
(4) Loose siding noted on right side rear of house. Re-secure siding to prevent possible water penetration behind the siding.

2.0 Item 4(Picture) Loose siding

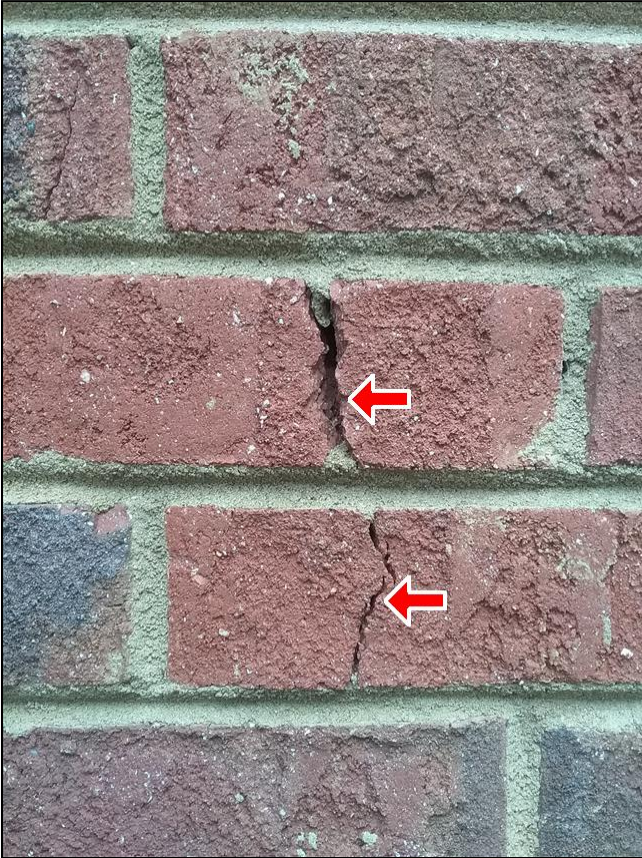
(5) Cracked brick veneer noted on right front side of house. Recommend periodic monitoring to ensure cracking does not worsen.

2.0 Item 5(Picture) Cracked brick veneer

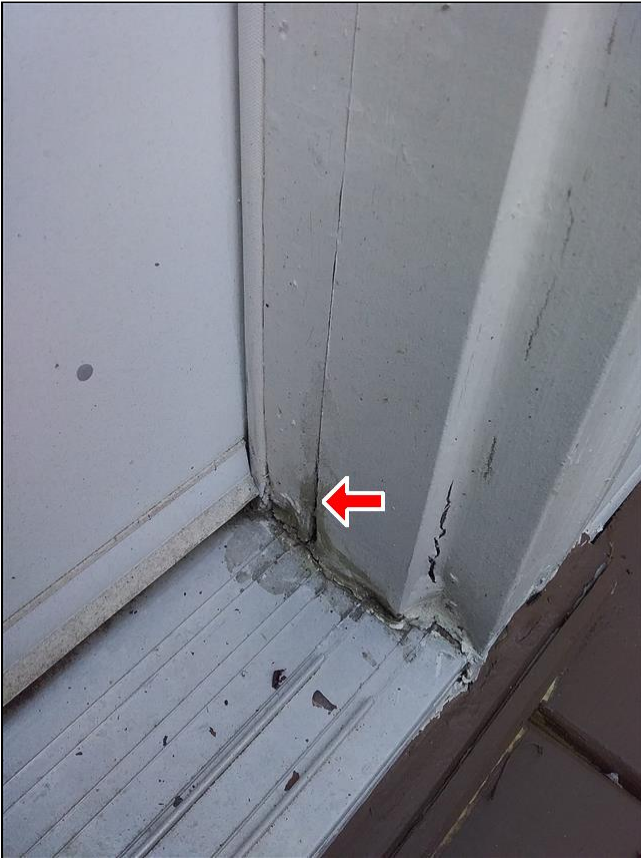
2.1 Trim around double exterior door to deck shows signs of deterioration. Replacement of deteriorated trim by a licensed general contractor is recommended.

2.1 Item 1(Picture) Deteriorated trim

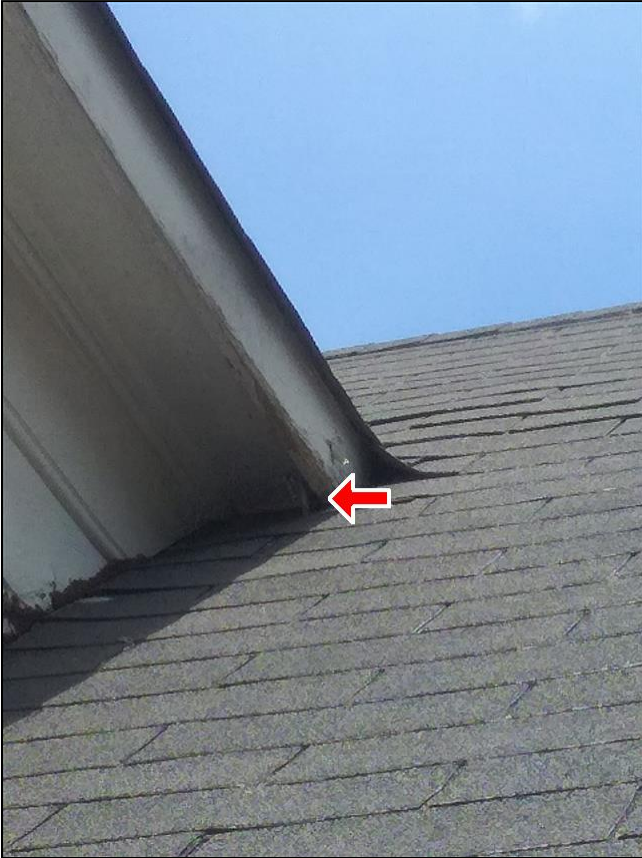
2.2 (1) Deterioration around fascia noted at dormers above garage. This may be due to contact between the wood and roof coverings. Replacement of all damaged fascia is recommended.

2.2 Item 1(Picture) Deteriorated fascia

(3) Further evaluation and repair of fascia issues by a licensed general contractor is recommended.

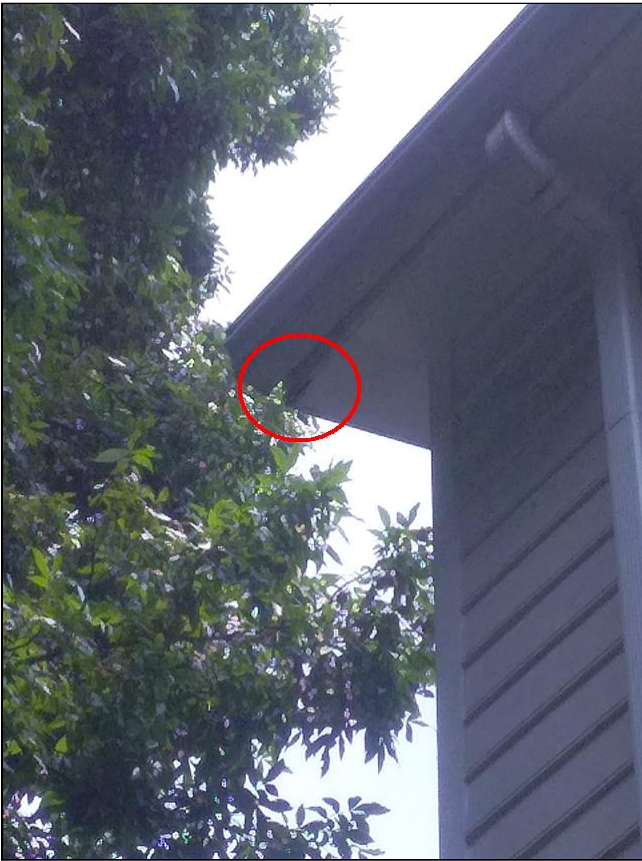
(2) Deterioration noted in fascia at right rear corner of house.

2.2 Item 2(Picture) Deteriorated fascia

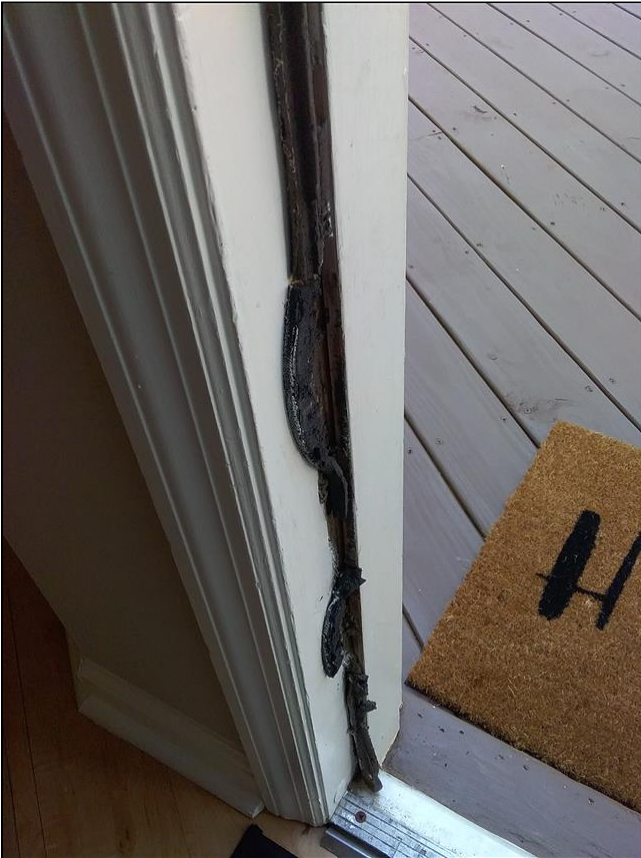
2.3 (1) Damaged weather stripping noted on a rear exterior door. Replace with new weather stripping for a proper seal against outside conditions.

2.3 Item 1(Picture) Damaged weather stripping

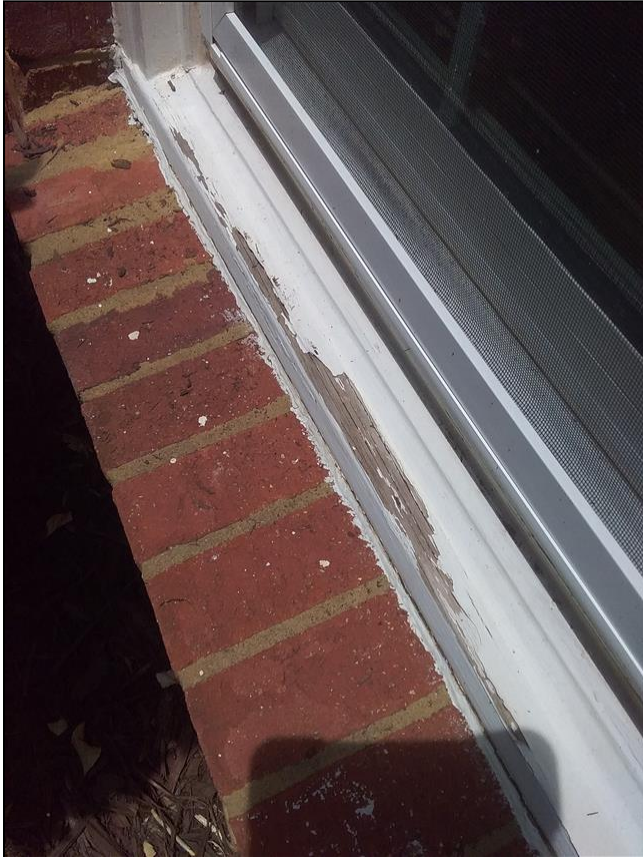
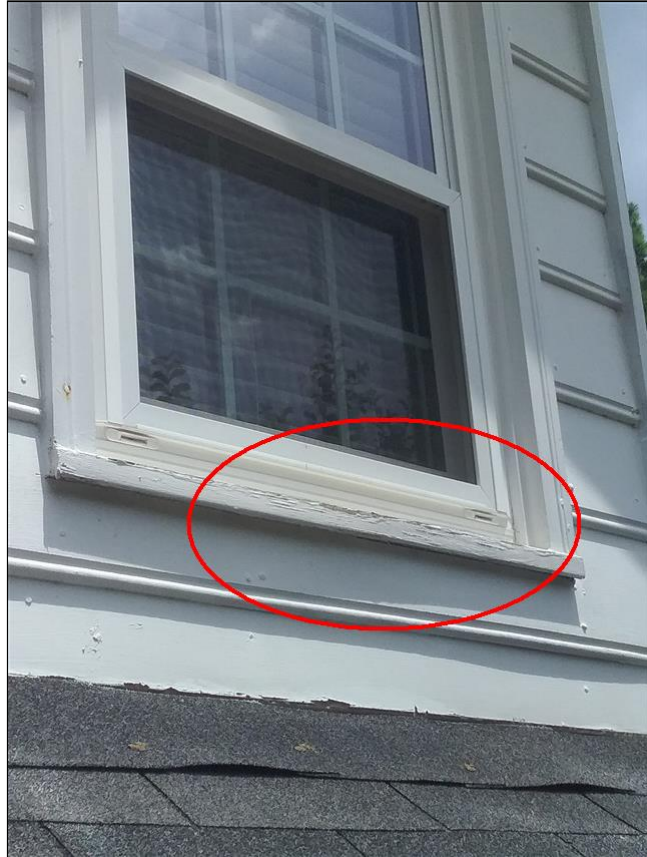
2.4 Bare wood noted on trim on exterior windows in front of house. Recommend proper prep, priming and repainting of all bare wood surfaces by a licensed general contractor to seal out moisture penetration.

2.4 Item 1(Picture) Bare wood on window frame

2.4 Item 2(Picture) Bare wood on window frame

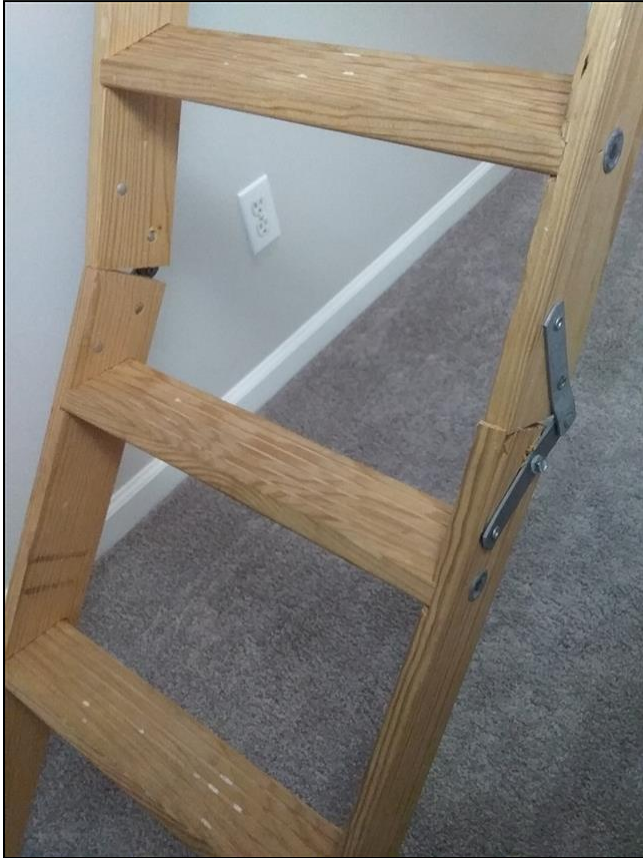
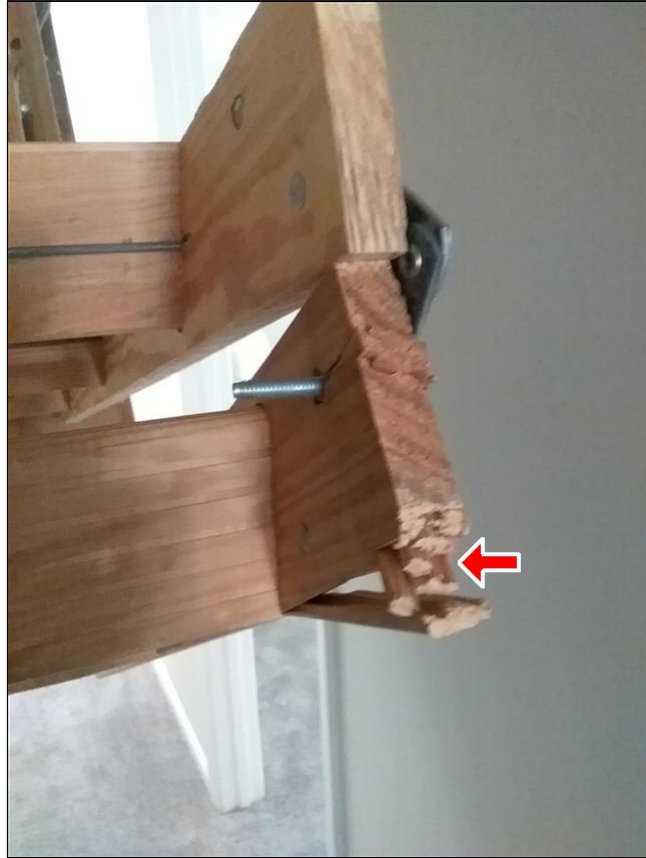
3.0 Attic access ladder is not properly sized. Resize ladder to provide a supported path. Damage noted to bottom section of the ladder. Repair or replace the ladder for enhanced safety.

3.0 Item 1(Picture) Attic ladder is too long

3.0 Item 2(Picture) Damage to lader

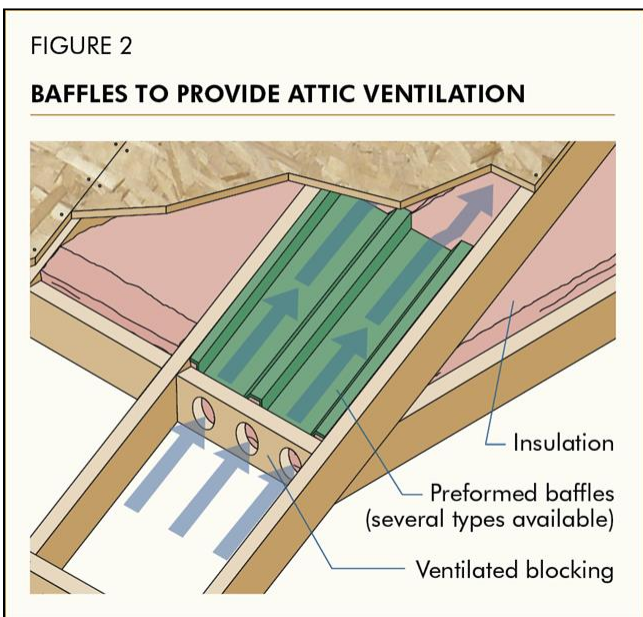
3.3 (1) Missing baffles noted in the attic. NOTE: Baffles should be added at vent locations to prevent displacement of loose insulation into the soffit/eave cavity and restricting air flow through the attic. Refer to attached schematic for typical baffle installation.

3.3 Item 1(Picture) Proper baffle installation

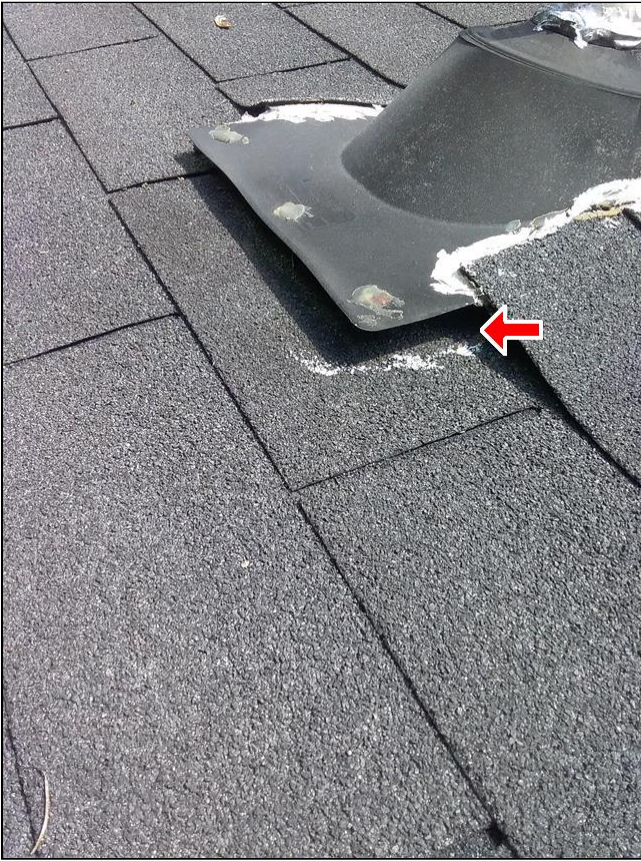
3.6 Gap noted at flashing on plumbing vent at rear right corner of house. Recommend re-securing flashing to prevent possible moisture entry into roof. Further evaluation by a licensed general contractor is recommended.

3.6 Item 1(Picture) Gap between flashing and roof

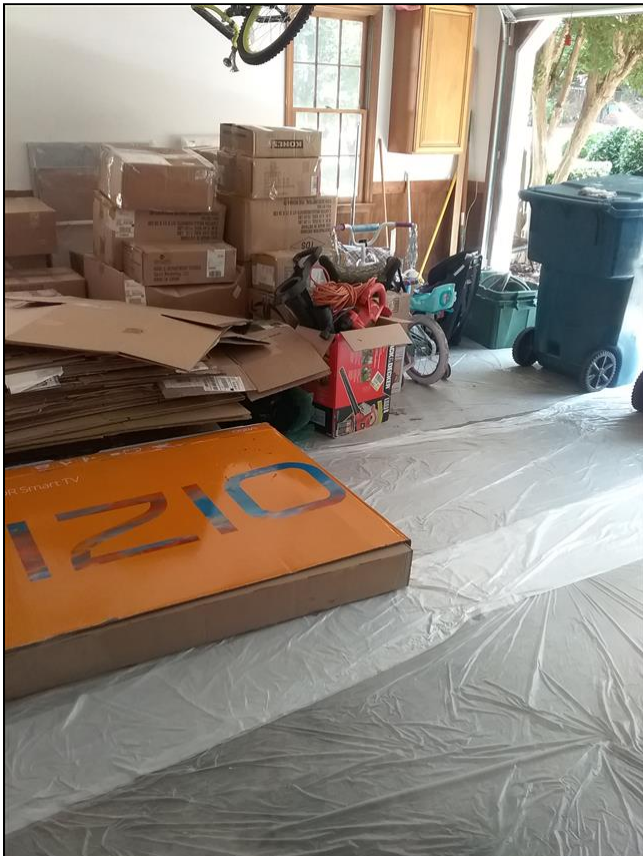
4.2 Plastic covering and stored items prevent full inspection of garage surfaces.

4.2 Item 1(Picture) Plastic covering and stored items in garage

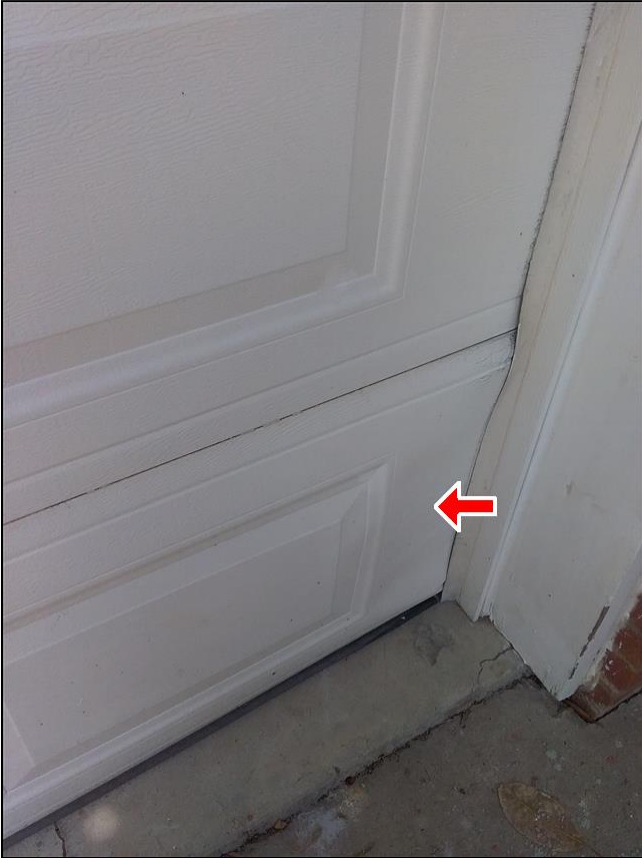
4.3 Damage noted to the lower right corner of garage door. This condition did not impede garage door function. Further evaluation and repair by a licensed overhead door contractor is recommended.

4.3 Item 1(Picture) Damage to garage door

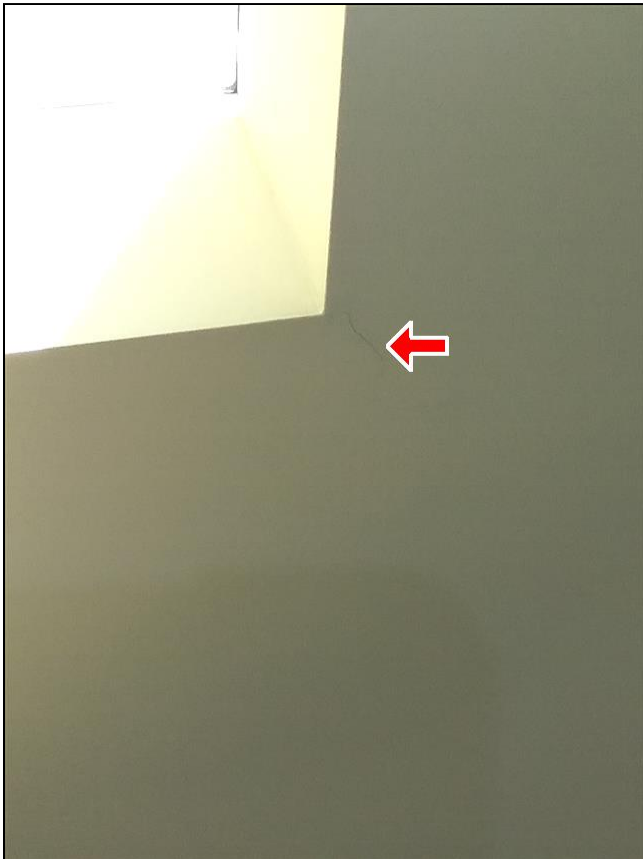
5.0 Some cracking noted at corner of skylight in sun room. No problems noted from this condition at the time of inspection. Recommend further evaluation by a licensed general contractor.

5.0 Item 1(Picture) Crack at sky light

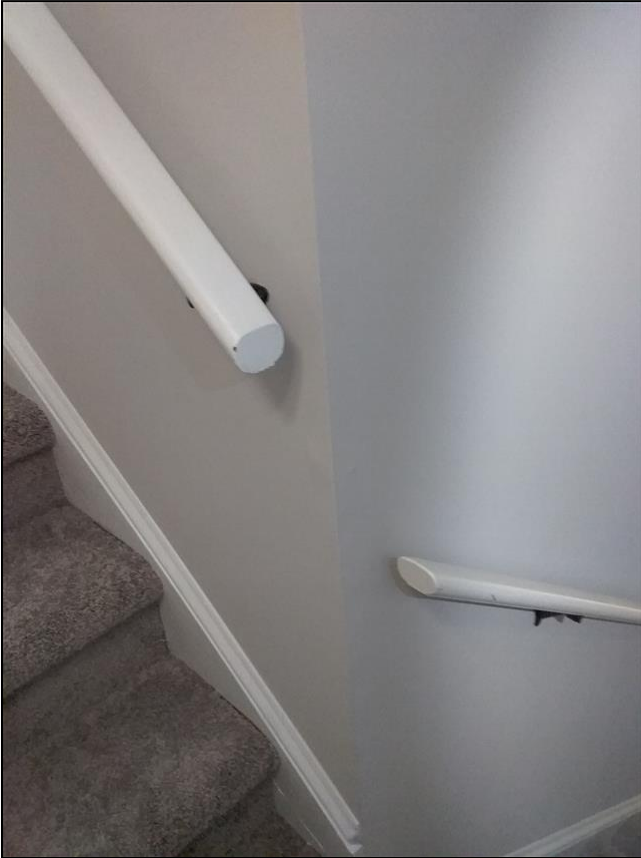
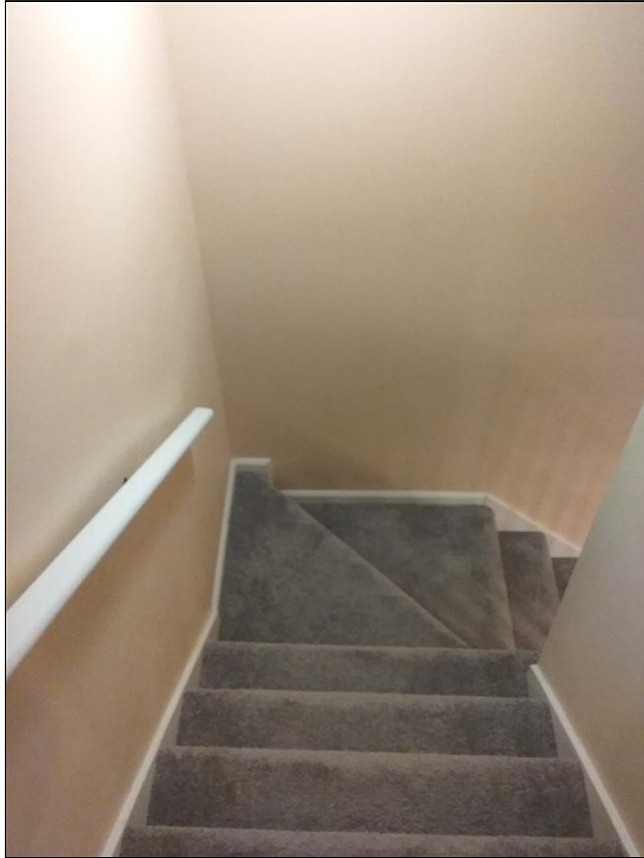
5.3 Missing handrail sections noted at all internal stairwells. NOTE: Handrails should be continuous along the entire stairs. Further evaluation and repair by a licensed general contractor is recommended to maximize stair safety.

5.3 Item 1(Picture) Non continuous hand rail

5.3 Item 2(Picture) Non continuous hand rail
