Inspection Report

Property Address:
3080 Pillement Pl
Alpharetta GA 30022

Date: 7/21/2020	Time: 01:00:00 PM	Report ID: 42066
Property: 3080 Pillement PI Alpharetta GA 30022	Customer: Darshan Patel	Real Estate Professional: Mitali Patel Keller Williams (Atlanta) Atlanta Perimeter

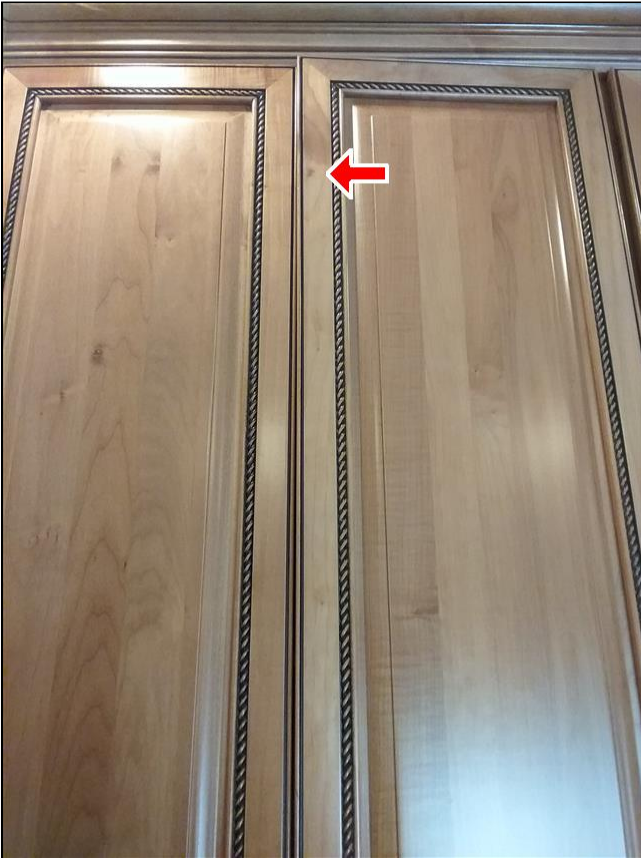
6.7 Several cabinet doors in the kitchen are out of plumb and do not close correctly. Further evaluation and repair by a licensed general contractor is recommended.

6.7 Item 1(Picture) Cabinet doors out of plumb

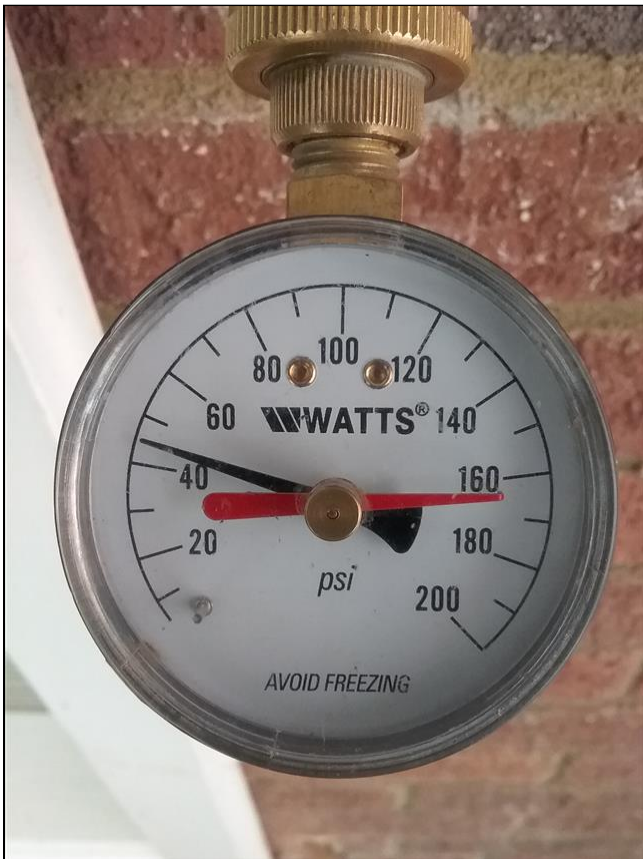
7.1 (1) Water pressure is 45 lb, adequate.

7.1 Item 1(Picture) Water pressure reading

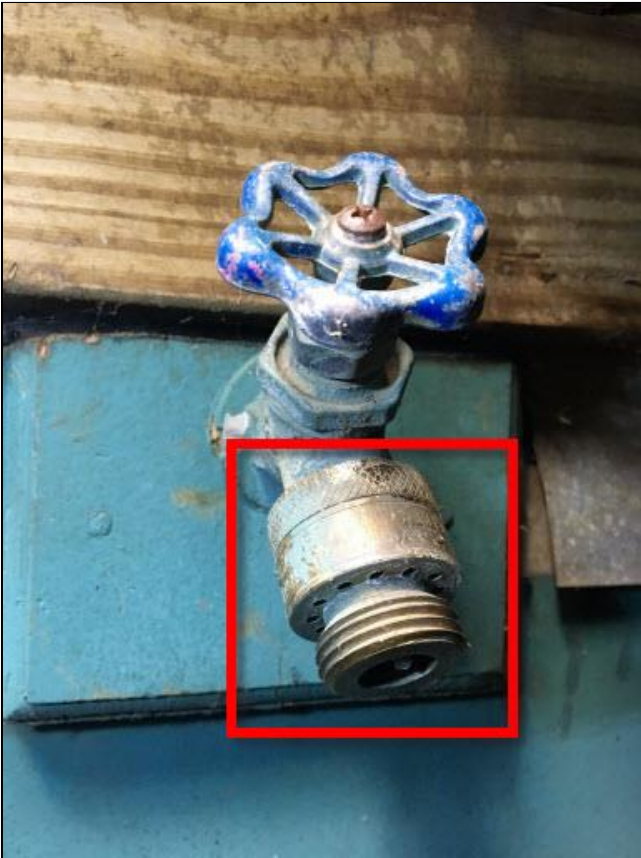
(3) Missing vacuum breakers noted at exterior faucets. NOTE: A backflow preventer should be installed to protect the potable water system against back-siphoning of waste water. Install as necessary.

7.1 Item 2(Picture) Proper vacuum breaker installation

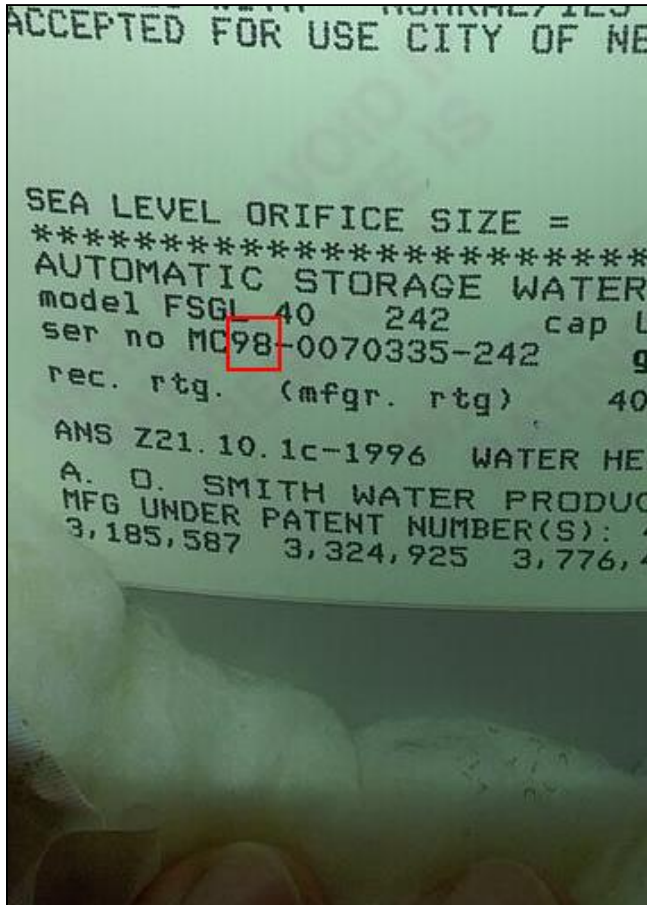
7.3 The water heater is 22 years old. NOTE: The typical life time of a water heater is 10 years. Recommend further evaluation by a licensed plumbing contractor. Budget for replacement.

7.3 Item 1(Picture) Date of manufacture, 1998

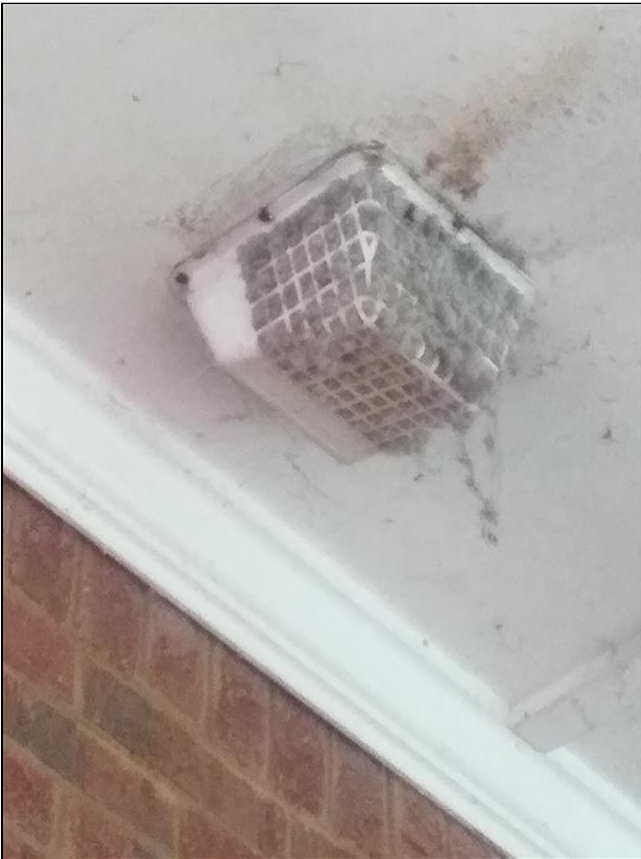
7.4 (1) Lint accumulation noted at dryer vent. Clean vent to avoid fire hazard.

7.4 Item 1(Picture) Lint in dryer vent

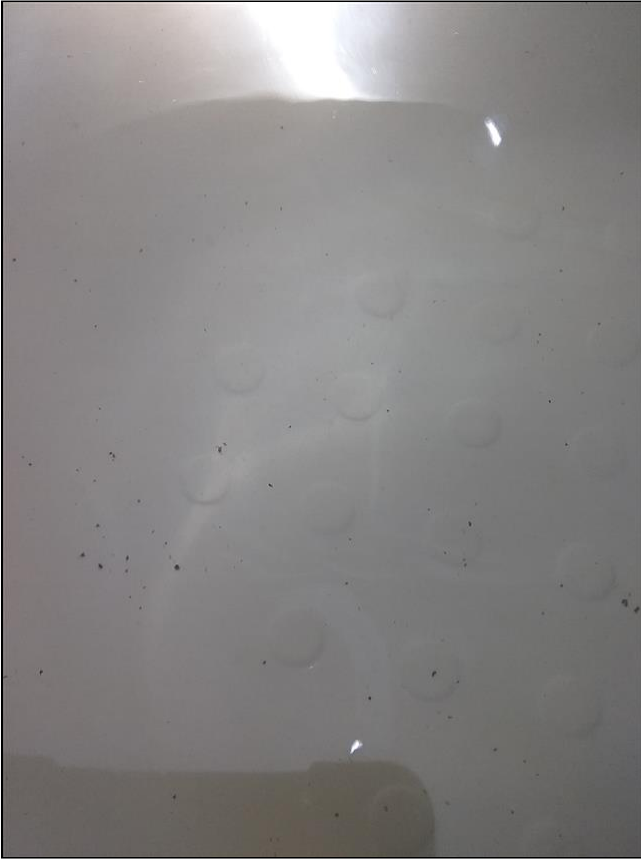
(2) Debris noted in jetted tub after testing. Recommend cleaning the lines before use.

7.5 Item 1(Picture) Debris in jetted tub

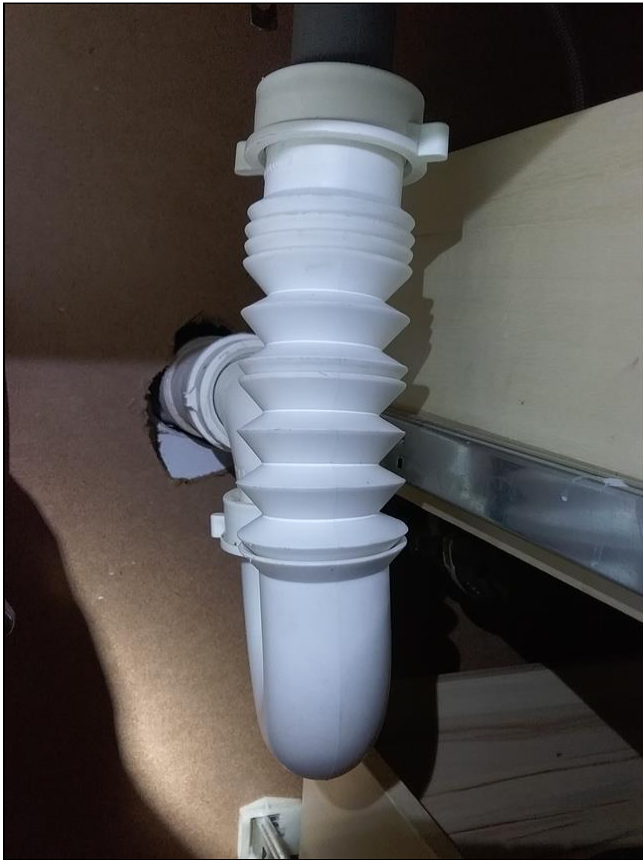
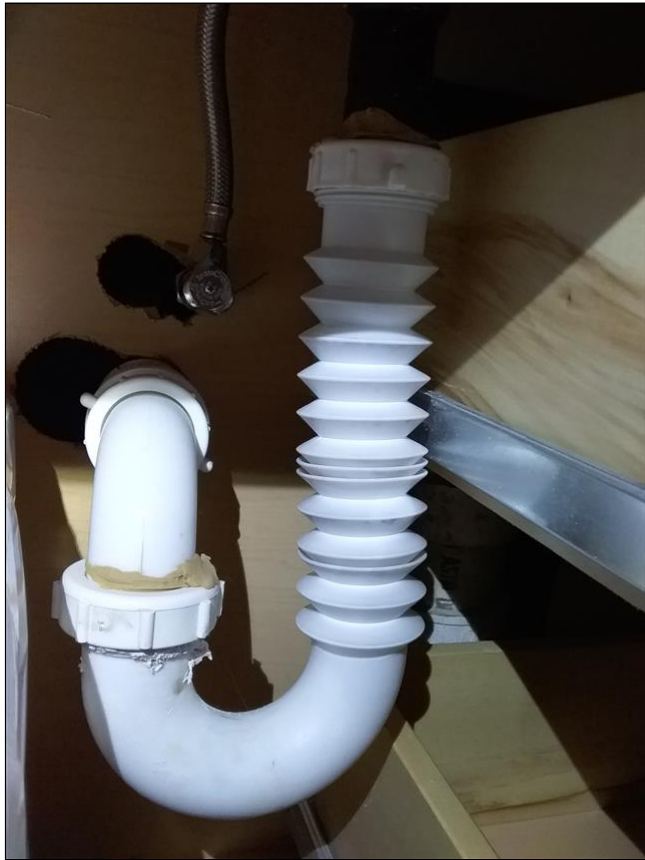
(3) Corrugated pipe noted at 2nd floor hall and basement bathroom drain. NOTE: Drain pipes should be constructed from smooth materials to avoid the trapping of dirt and debris in the pleats. Recommend replacing drain pipe using a licensed plumber.

7.5 Item 2(Picture) Corrugated drain

7.5 Item 3(Picture) Corrugated drain

(7) Further evaluation and repair of all plumbing related issues by a licensed plumbing contractor is recommended.

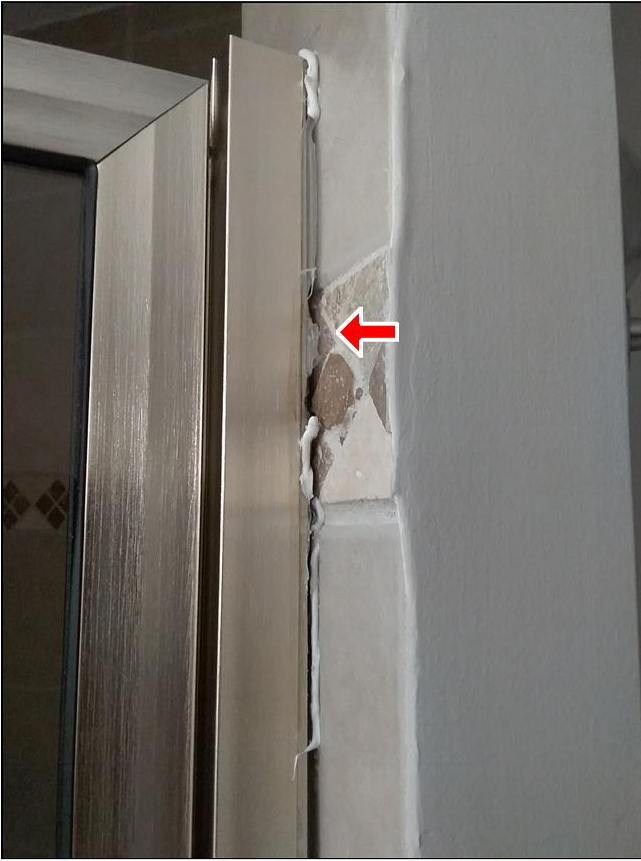
(5) Shower door in master bathroom is loose at it's top hinge. Adjust as necessary using a licensed general contractor.

7.5 Item 4(Picture) Shower door loose at hinge

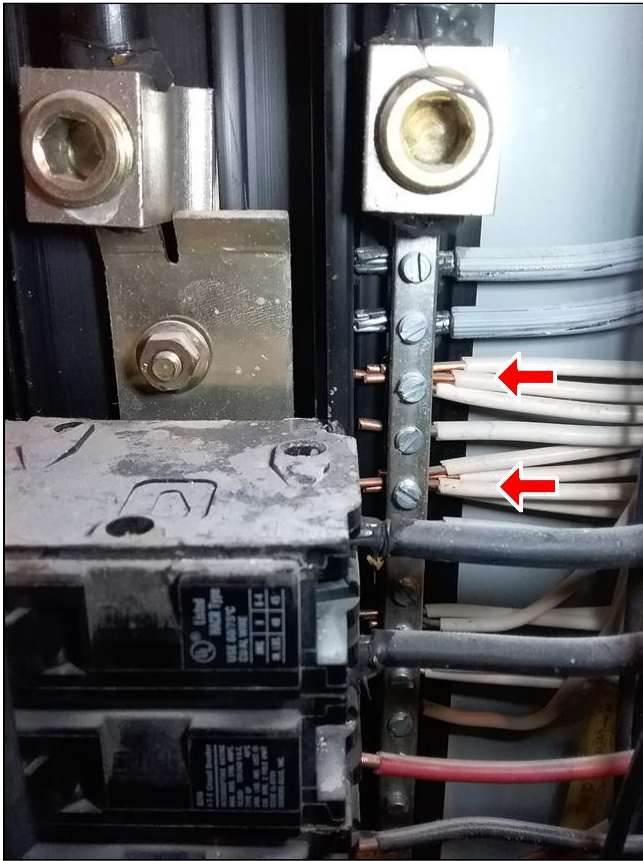
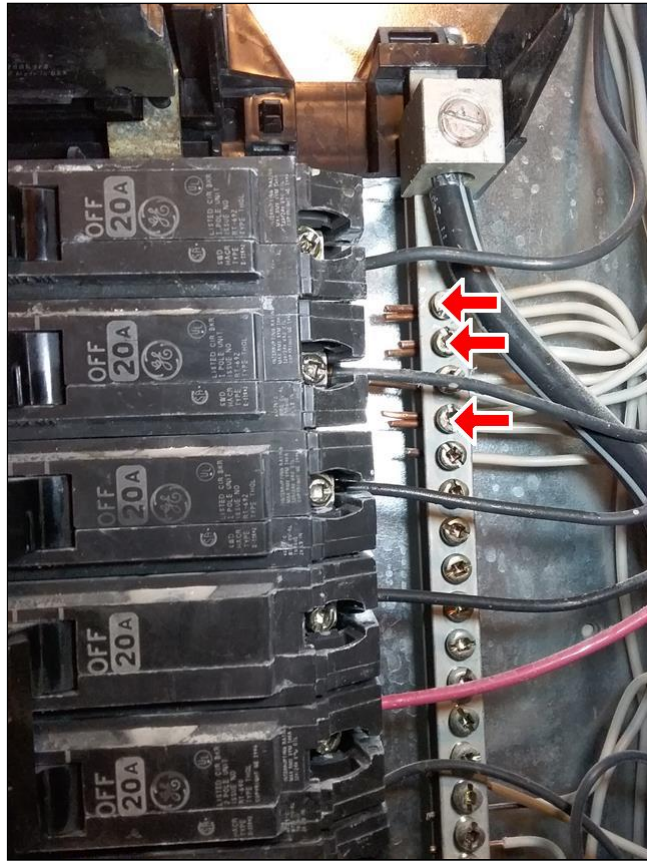
(3) Multiple neutrals terminate under a single lug in both panels. Each neutral should be installed under a separate lug.

8.1 Item 3(Picture) Multiple neutrals under one lug

8.1 Item 4(Picture) Multiple neutrals under one lug

(7) The evaluation and remedy of all electrical issues by a licensed electrician is recommended.

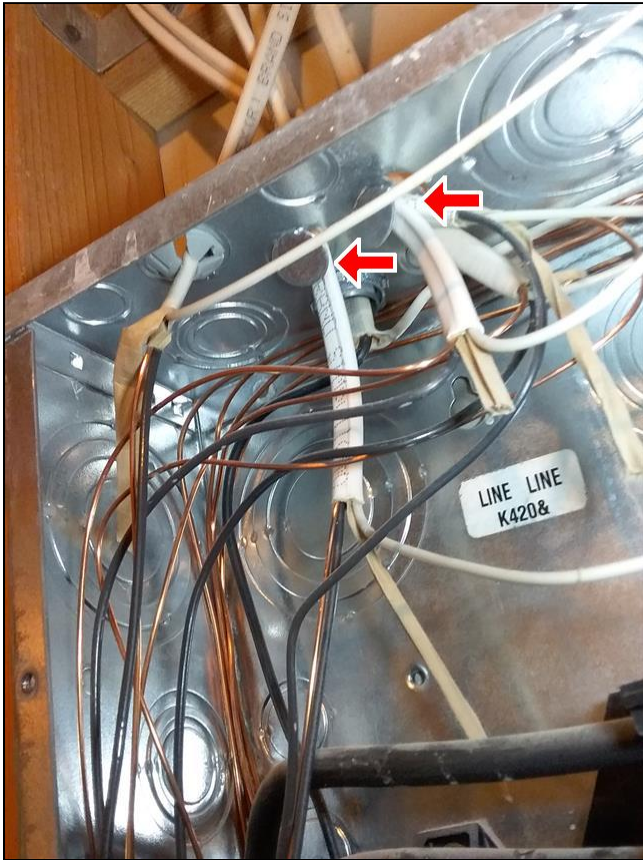
(4) Missing wire connectors noted in sub panel. Wire connectors should be installed where wires enter the box to prevent possible damage to wiring.

8.1 Item 5(Picture) Missing wire connectors

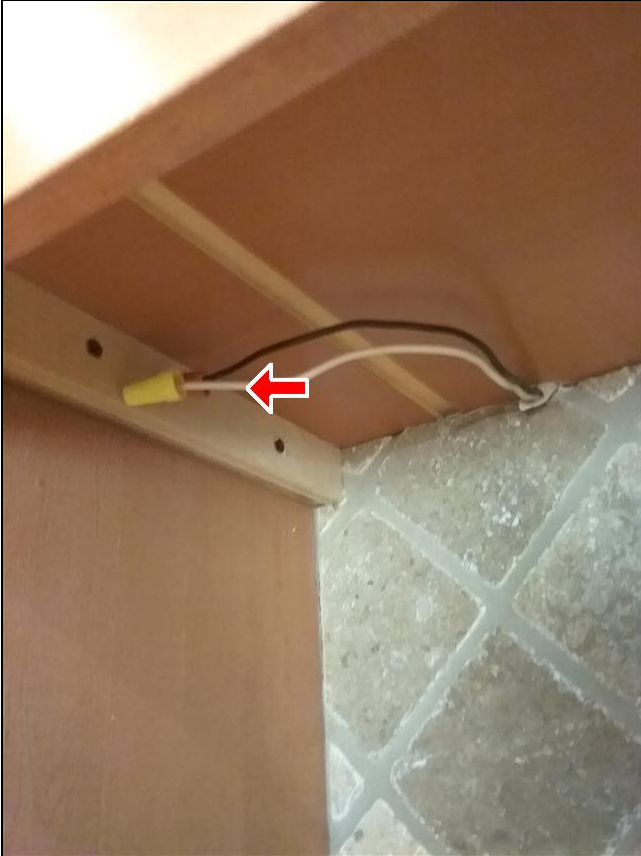
8.2 Exposed wiring noted in kitchen above sink. NOTE: Wiring connections/splices should be protected with approved wiring methods (i.e. junction boxes). Install junction boxes as necessary using a licensed electrician.

8.2 Item 1(Picture) Exposed wiring

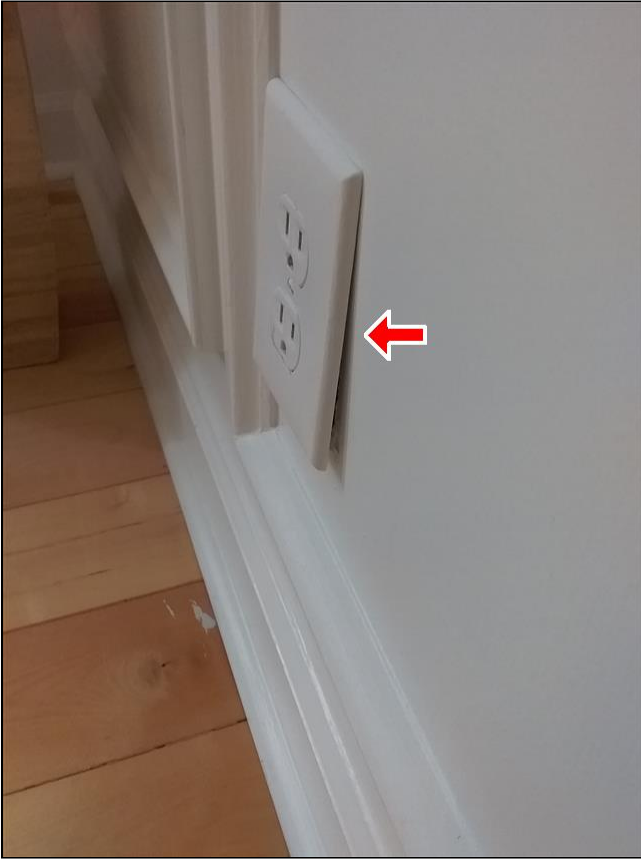
(2) Loose receptacle noted in foyer. Secure the receptacle to avoid potential shock hazard.

8.4 Item 1(Picture) Loose receptacle

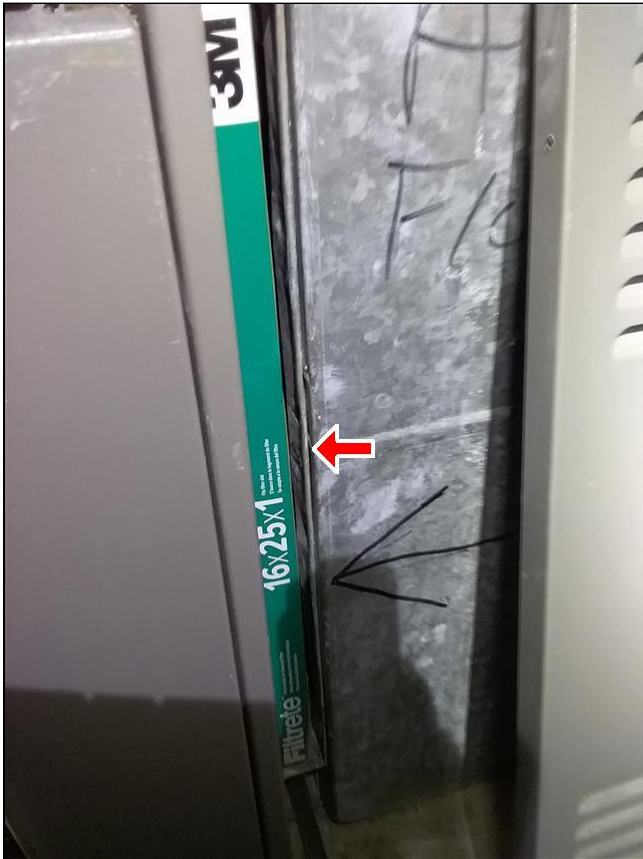
9.0 (1) The serial number of the 1st floor furnace indicates a year of manufacture in 2006 and is 14 years old. NOTE: The typical life expectancy of furnaces is 15 - 20 years. Recommend service/evaluation by a licensed HVAC contractor. Budget for a replacement in the near future.

The disposable filter is dirty and should be replaced.

9.0 Item 1(Picture) Location of filter

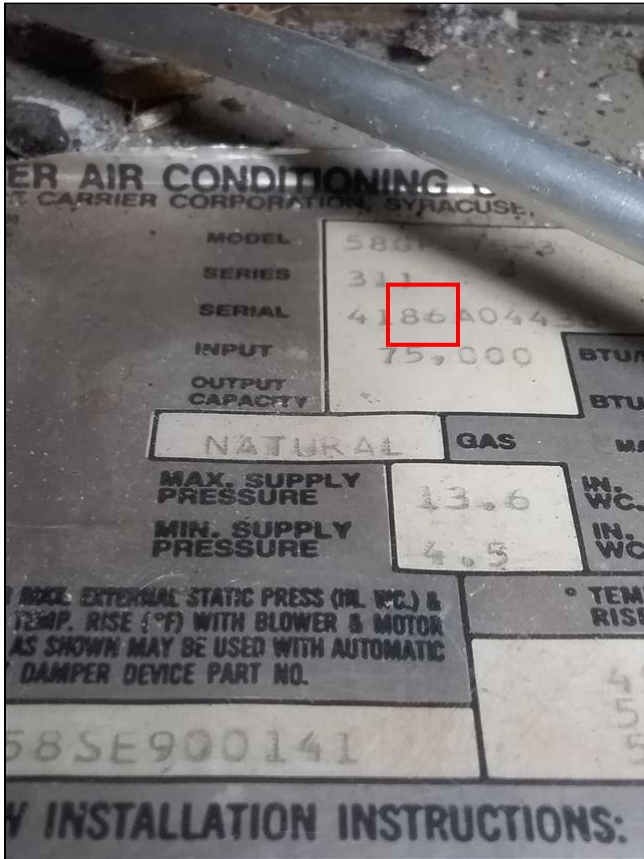
(2) The serial number of the 2nd floor furnace indicates a year of manufacture in 1986 and is 34 years old. Corrosion was noted inside the burn chamber. NOTE: The typical life expectancy of furnaces is 15 - 20 years. Recommend service/ evaluation by a licensed HVAC contractor. Budget for a replacement in the near future.

9.0 Item 2(Picture) Date of manufacture, 1986

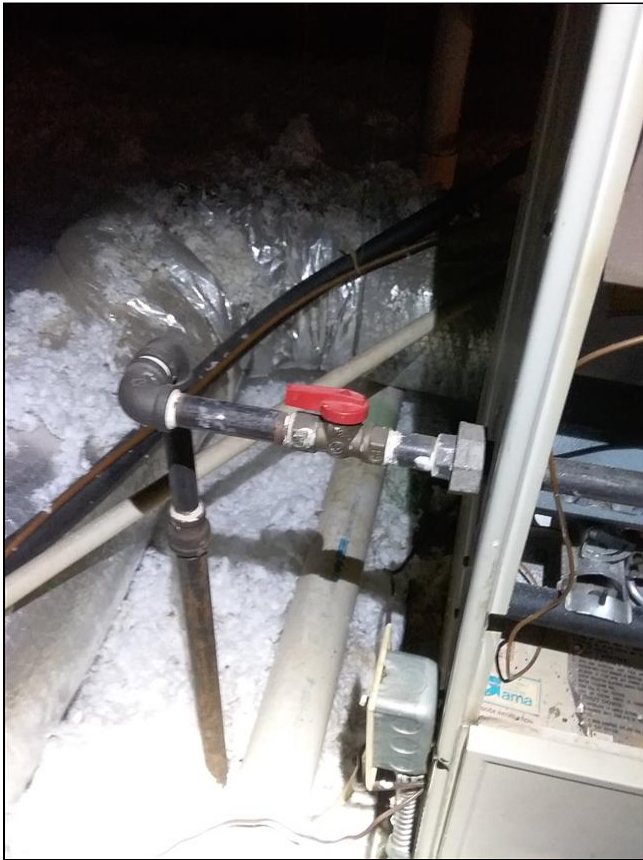
(3) Missing sediment trap noted at the 2nd floor furnace gas supply. NOTE: The sediment trap has to be installed at a turn of gas supply to work as intended. Refer to attached schematic for acceptable sediment trap configuration. Installation of a sediment trap by a licensed HVAC contractor is recommended.

9.0 Item 4(Picture) No sediment trap installed

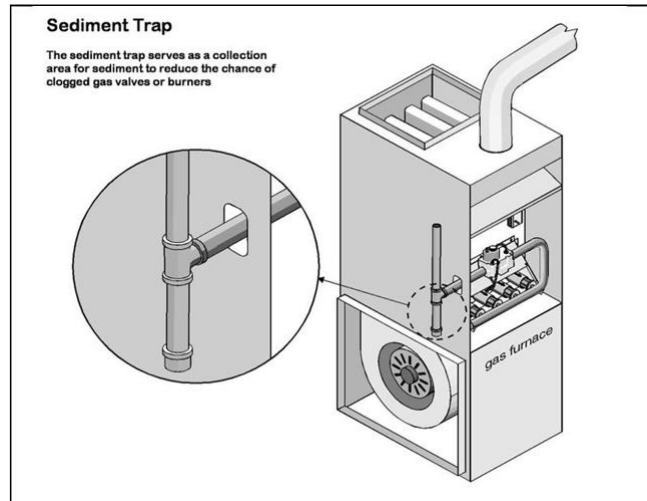
9.0 Item 5(Picture) Proper sediment trap installation

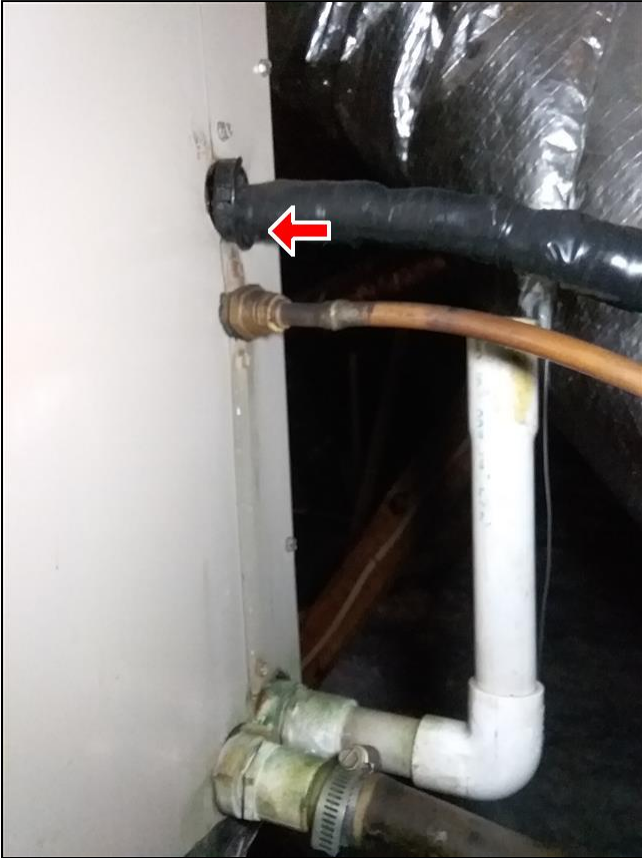
(4) Leaking noted at line set at rear of 2nd floor furnace. Further evaluation repair by a licensed HVAC contractor is recommended.

9.0 Item 6(Picture) Leak noted at rear of furnace

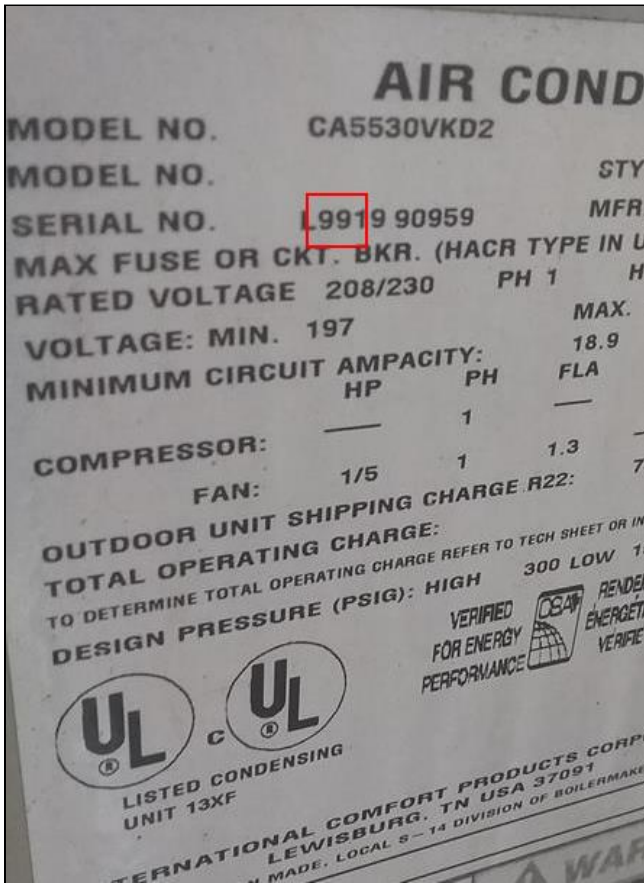
(2) The serial number of the 2nd floor air conditioning unit indicates a year of manufacture in 1999 and is 21 years old.

NOTE: The typical life expectancy of condensers in the Southeast US is 15 - 20 years. Recommend service/evaluation by a licensed HVAC contractor. Budget for a replacement in the near future.

9.4 Item 2(Picture) Date of manufacture, 1999
