Atlanta Property Inspections

HOME INSPECTION REPORT

710 Society Street, Alpharetta, GA 30022
Inspection prepared for: Andrea Cueny
Date of Inspection: 7/22/2020 Time: 1:30 PM
Age of Home: 16 Years Old (2004) Size: 5380 SF
Weather: Sunny, Dry Soil, 85 Degrees

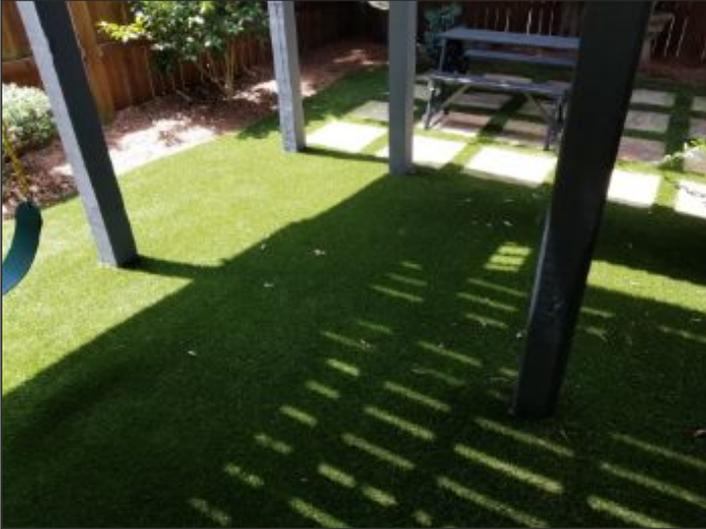
- Wood support posts are present - 6X6.
- The deck support structure appears to be serviceable and is functioning as intended; no concerns were noted except as listed below:
 - The wood support posts are installed below grade which is no longer allowed; this condition can lead to water damage at the lower post areas. Correction is recommended, eliminate all wood to soil contact. In addition, two of the lower deck stair landing posts were found to have rot at the base of the posts (see photos). Replacement of the posts is recommended by a professional deck contractor.

Wood posts below grade at rear deck

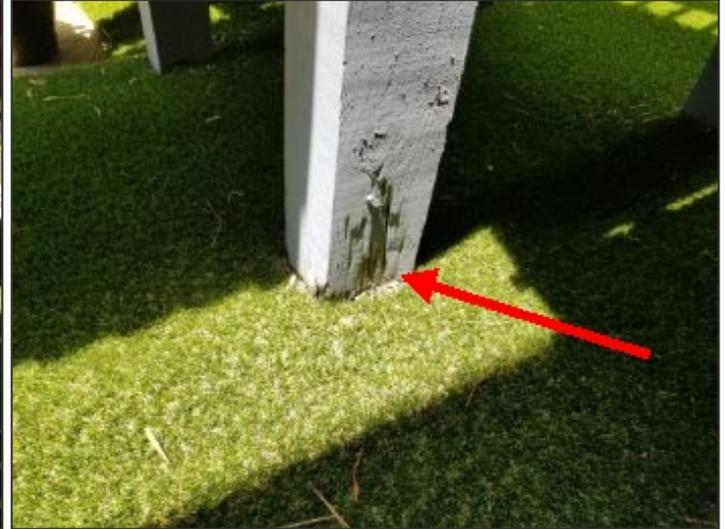
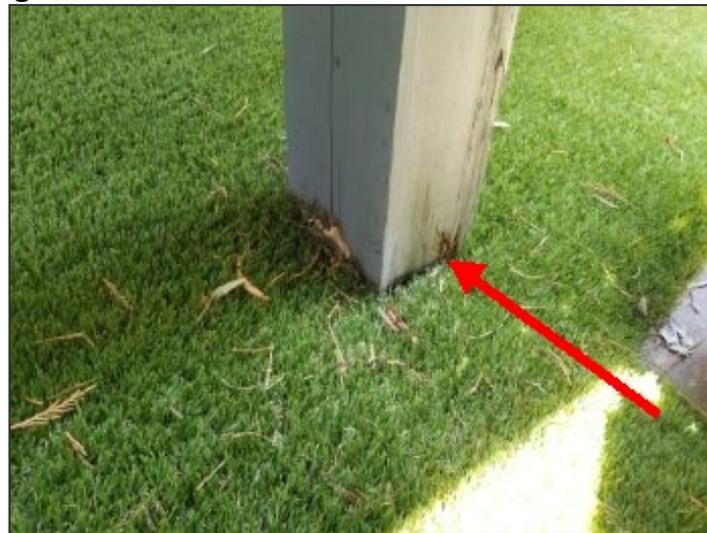
Post rot at deck stair landing

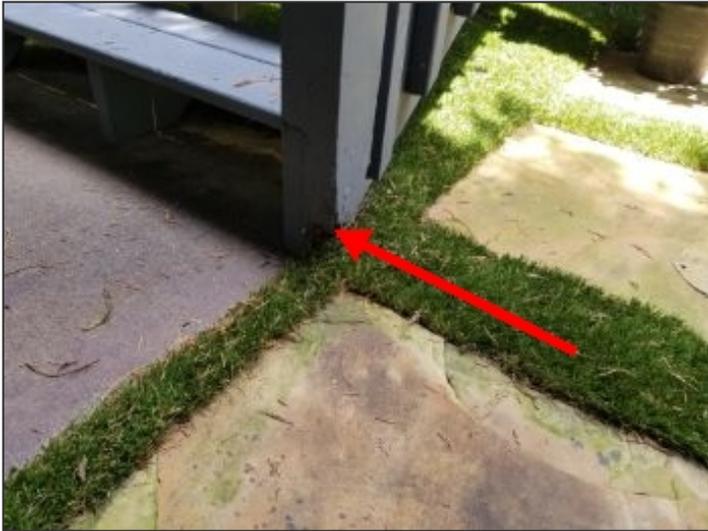
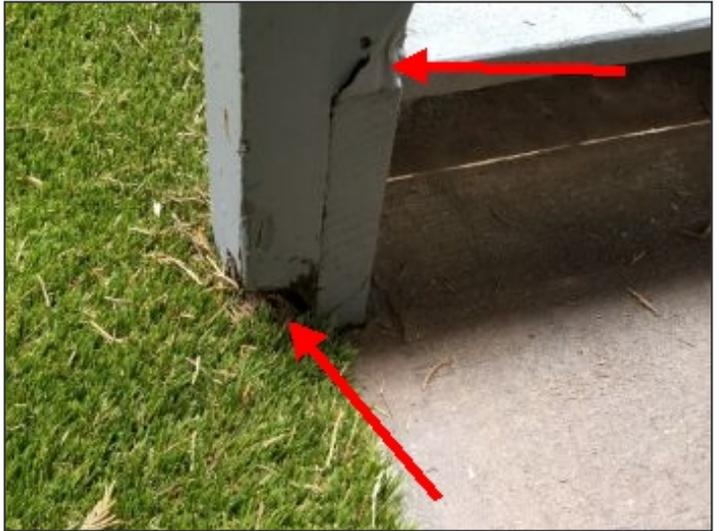
- Wood steps are present at the rear deck
- **The overall condition of the exterior steps and the stairway handrailings appear to be serviceable except as noted below:**
- **Damaged wood was found at the lower rear yard facing rail posts (see photos). Replacement of the rail posts is recommended by a professional deck contactor.**

Damaged wood at rear deck stair rail posts

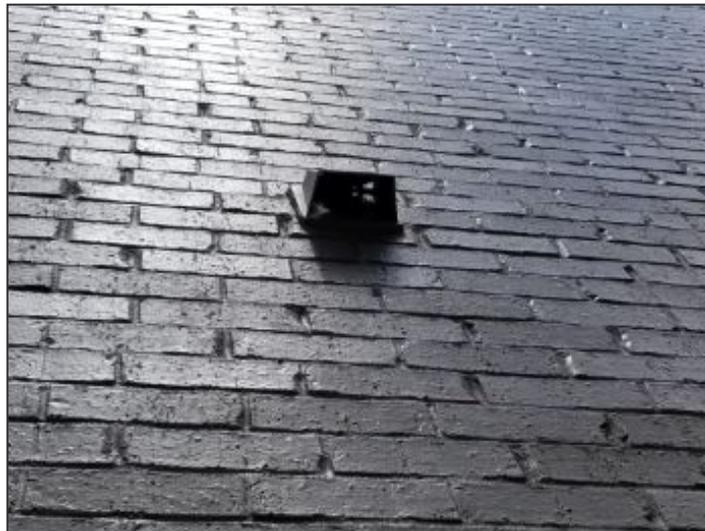
- **The fireplace fresh air cover on the lower chimney is damaged and needs replacement to prevent future water entry inside the chimney (see photo).**

Damaged fresh air vent cover

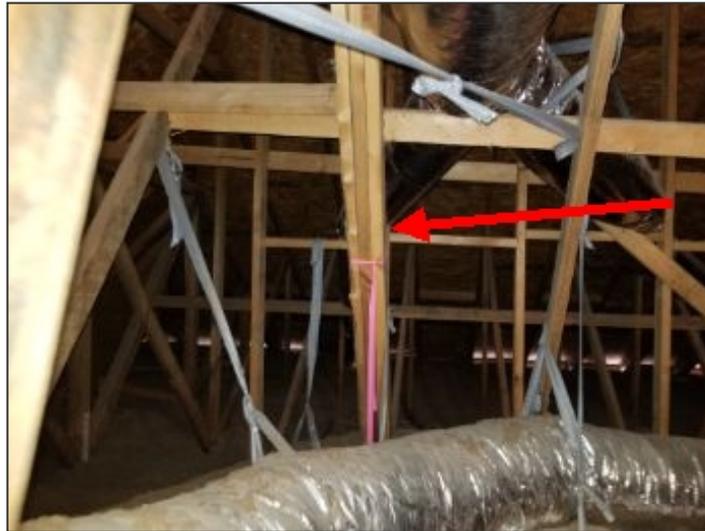
• An engineered roof truss has been cracked, broken or damaged near the attic pull down ladder (see photo). The truss has been braced and the repair appears to be adequate.

Adequately repaired roof truss in attic near pull down ladder

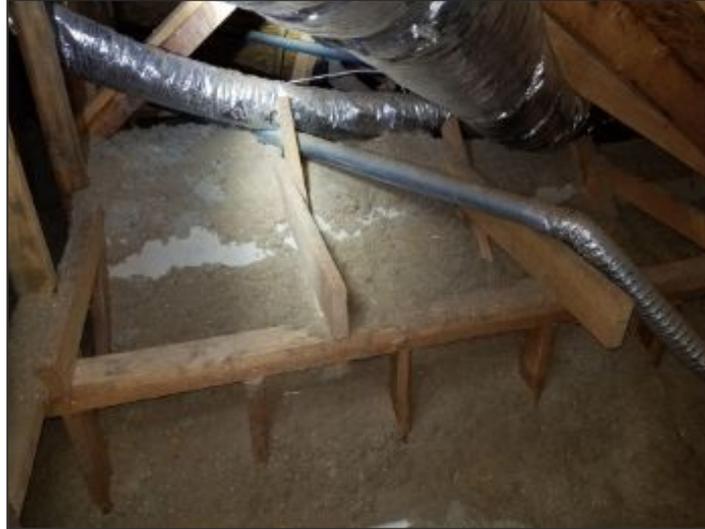
• Missing insulation was observed over portions of the master bathroom vaulted ceiling (see photo). Bare sheetrock is present which will lead to an excessive amount of heat loss in winter and heat gain in the summer months. Correction is recommended.

Missing insulation above master bathroom

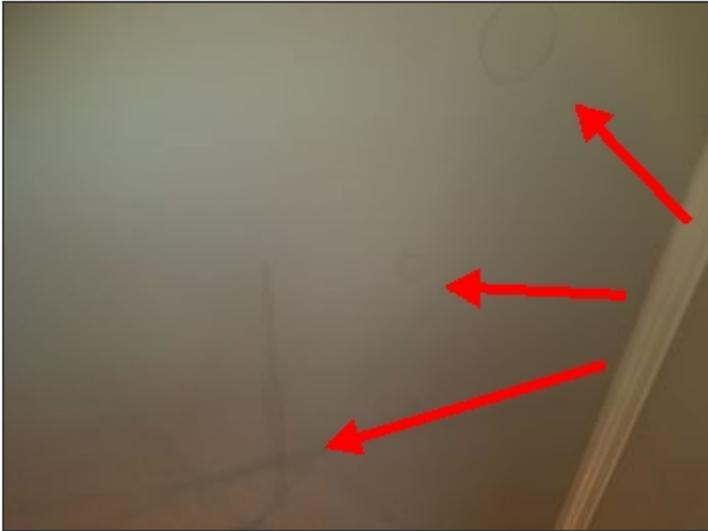
Water stains at eat in kitchen ceiling

1. Ask seller for full disclosure information regarding this leak.
2. Further evaluation may be needed to determine repair needs, if any.
3. Continue to monitor, future repairs may be needed.

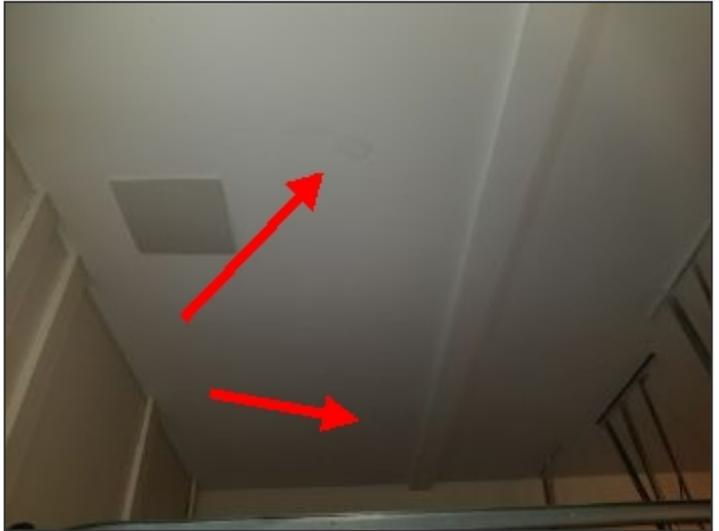
Water stains at garage ceiling

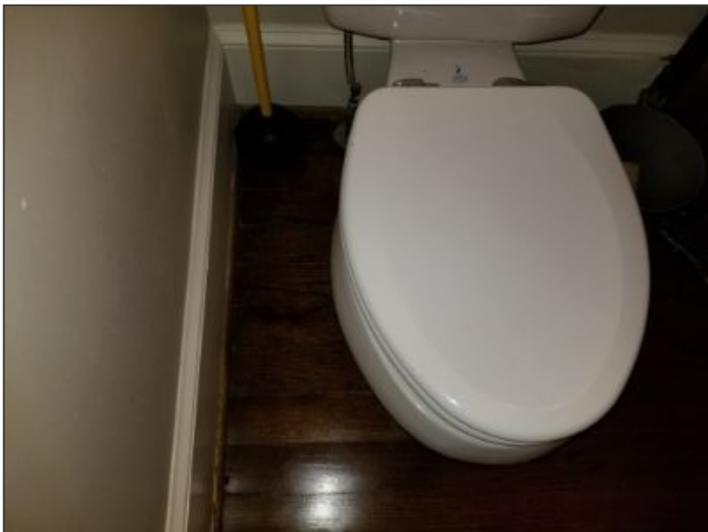
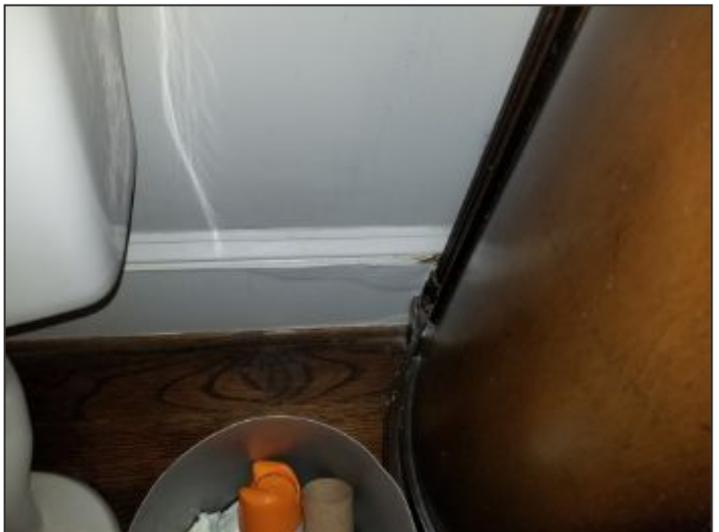
• Evidence of a leak was noted in the main floor half bathroom based on warped hardwood flooring and swollen baseboard trim (see photos). No active leaks were noted at this time. Due to this concern, further evaluation is advised by a professional hardwood flooring contractor to determine the full extent of repair needs and costs - some or all of the flooring may need to be sanded and refinished which could develop into a major expense. In addition, the source of the moisture should be evaluated and corrected if any.

Moisture damaged flooring in half bathroom

Evidence of a leak at half bathroom

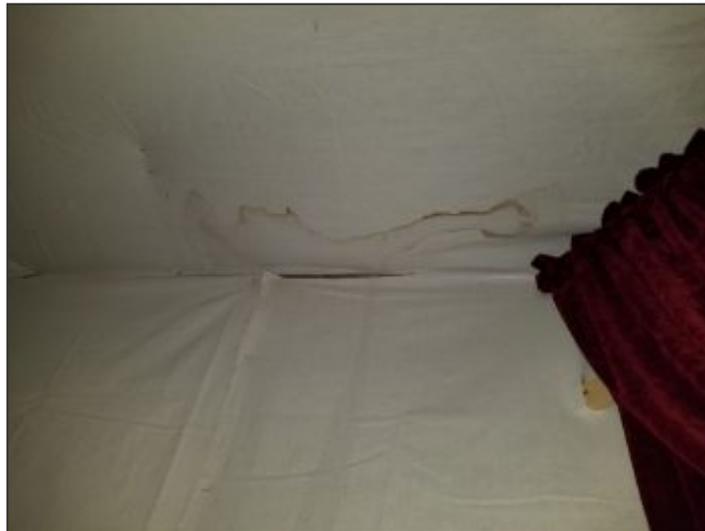
• **There is evidence of a previous leak below the kitchen sink. Water stains were noted on the basement ceiling below the sink location (see photo). No active leaks were noted during testing of the sink, faucet and drain. Continue to monitor.**

Evidence of a leak below kitchen sink - water stain on basement ceiling below

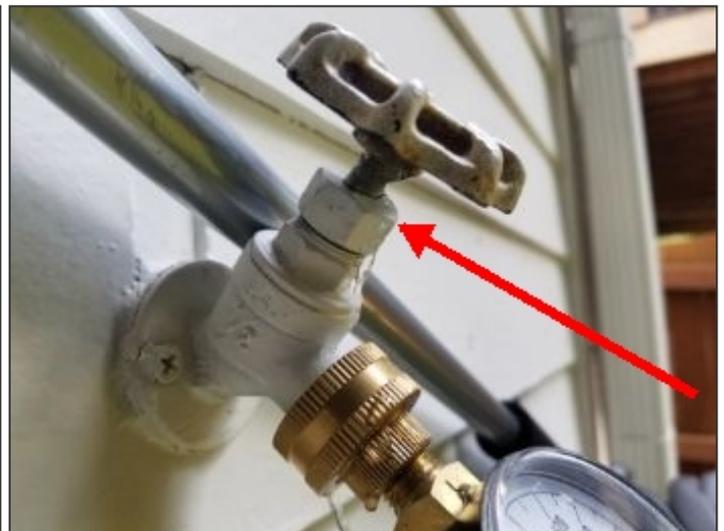
• The rear hose bib handle leaks at the valve stem when the water is turned on (see photo). This condition is an indication of a worn washer inside the hose bib. Repair / replacement of the affected hose bib is recommended.

Active leak at rear hose bib handle

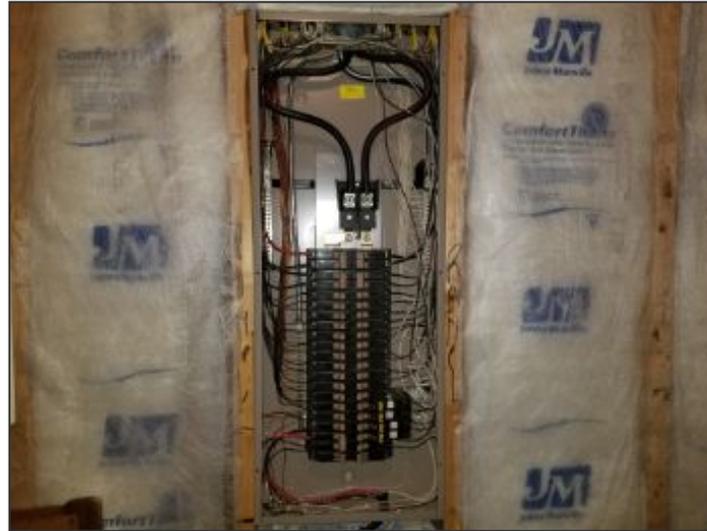
- **Due to the number of circuit breakers in this box (43-44), there is a concern that this panel box is overloaded. Due to this concern, a full evaluation of the electrical panel and system is strongly advised, prior to closing, by a licensed electrician to insure that this panel meets the code requirements and the minimum safety standards of the National Electric Code (NEC).**

View inside main panel box

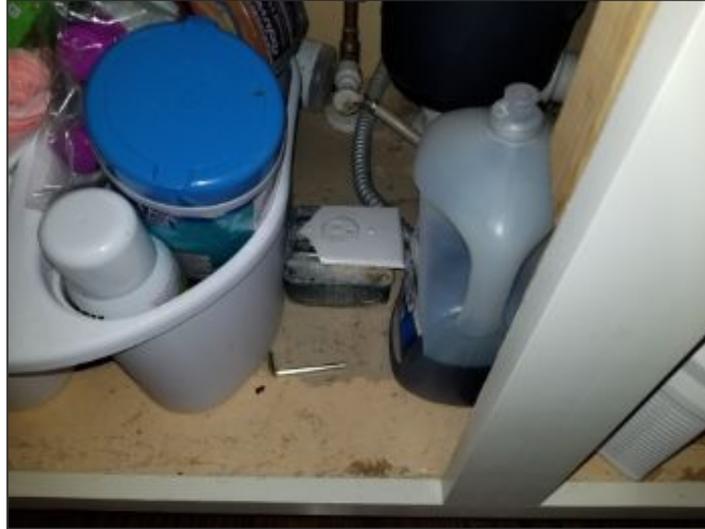
• A floor outlet has been installed inside the kitchen cabinet below the sink which is not recommended (see photo). This condition can allow water to enter the outlet if a leak occurs at the sink or drain, creating an unsafe condition. It is recommended that the outlet be relocated to the side wall of the cabinet instead and should be **GFCI** protected. Correction is advised by a licensed electrician to meet the safety requirements of the National Electric Code.

Floored outlet below kitchen sink

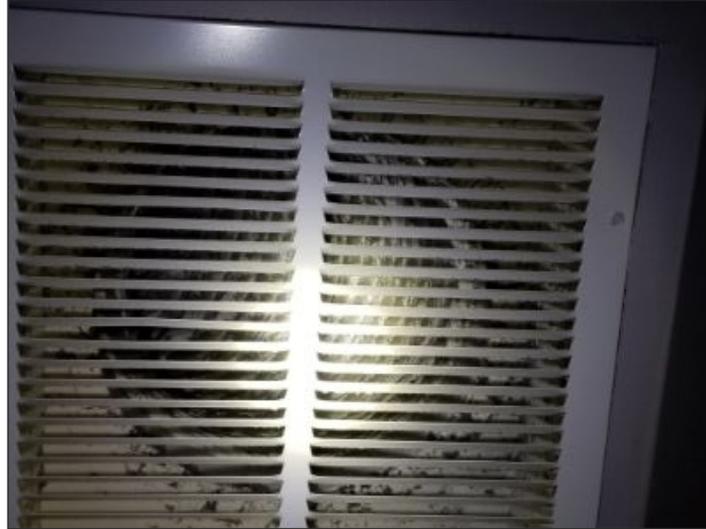
• The interior of HVAC ducts are dirty when viewed from the return vents (see photo); professional duct cleaning is recommended.

Dirty ducts - view of second floor return vent
