Inspection Report

Property Address:
2145 Double Creek Lane
Milton GA 30004

Residential Inspector of America

Property Address 2145 Double Creek Lane Milton GA 30004	Date of Inspection 7/20/2020	Report ID 072020JW727
Customer(s) George and Jennifer Ostyn	Time of Inspection 01:00:00 PM	Real Estate Agent Lisa Williams Century 21 - Results Realty

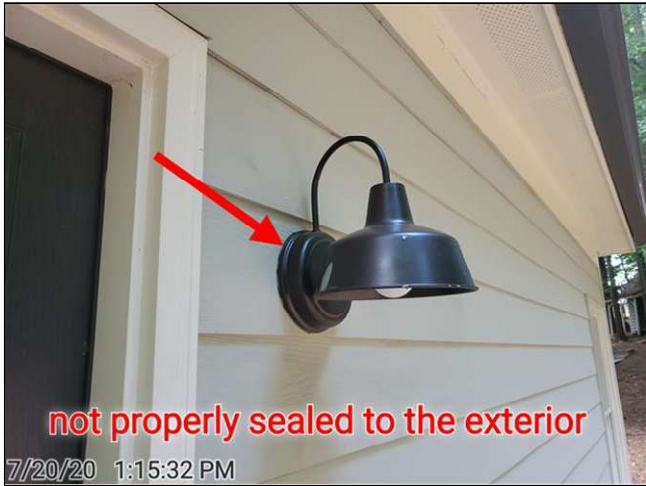
1.1 Item 1(Picture)

Seal the light fixture(s) to the cement fiber board siding around the house to prevent water entry into the wall cavity and fixture box. Have contractor evaluate. See photo(s) for location(s).

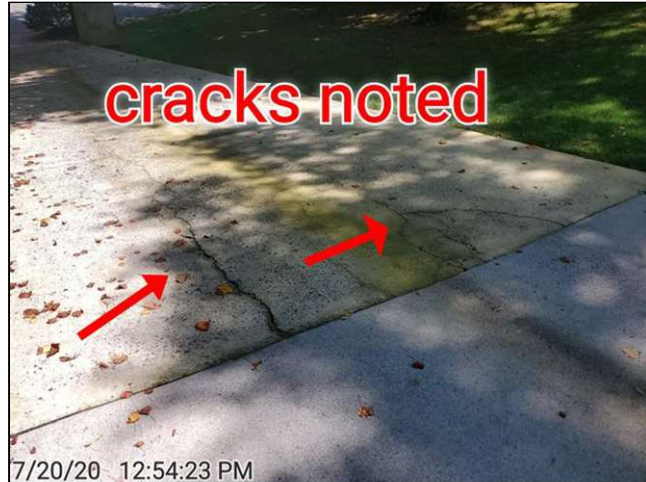
1.4 Item 1(Picture)

(1) There are various cracked and settling portions of the driveway. This issue will continue until repairs are made. See photo(s) for examples.

📷 (1) There are various cracked and settling portions of the driveway. This issue will continue until repairs are made. See photo(s) for examples.

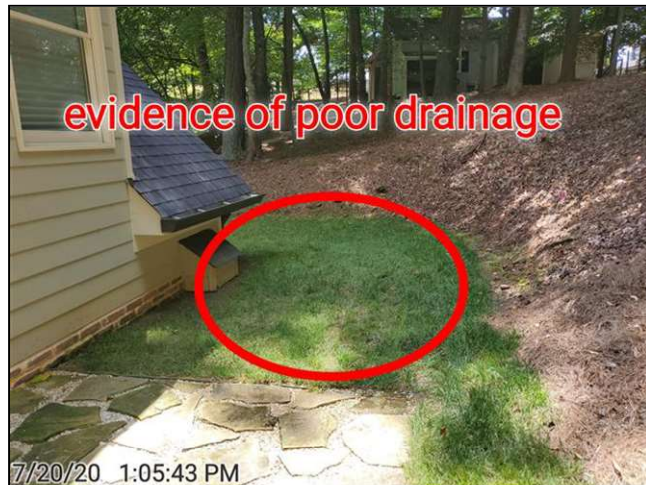
1.4 Item 2(Picture)

(2) The landscape behind the garage may require a trench or drain if water stands or puddles near the home after heavy rain. Recommend to monitor and repair as needed. All rain water should drain at least 5 feet away from the home. See photo(s).

📷 (2) The landscape behind the garage may require a trench or drain if water stands or puddles near the home after heavy rain. Recommend to monitor and repair as needed. All rain water should drain at least 5 feet away from the home. See photo(s).

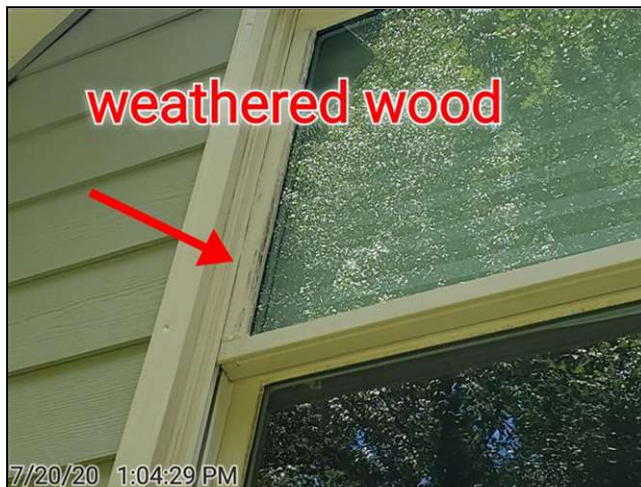
1.6 Item 1(Picture)

📷 All exterior wood trim will need to be painted in the near future. Typical homeowner maintenance suggests that homes be painted every 3-5 years.

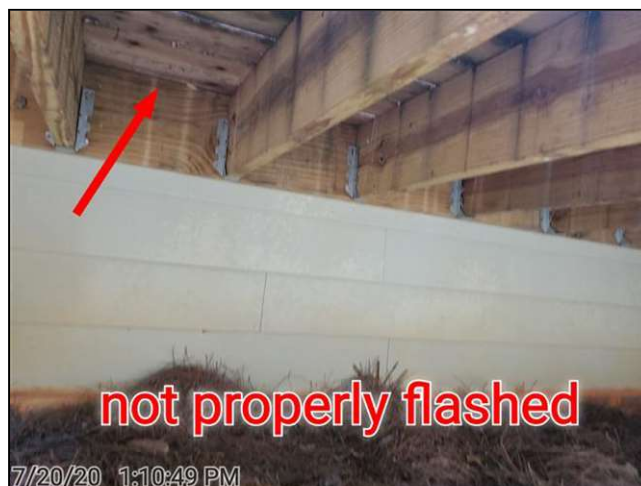
2.4 Item 1(Picture)

(1) No metal flashing could be seen between the rear deck and the rear wall at the garage deck. This was not often enforced or required in older homes, but flashing makes a better seal between the deck and house. Condition of framing between deck and house is not known.
-

🔧 (1) No metal flashing could be seen between the rear deck and the rear wall at the garage deck. This was not often enforced or required in older homes, but flashing makes a better seal between the deck and house. Condition of framing between deck and house is not known.

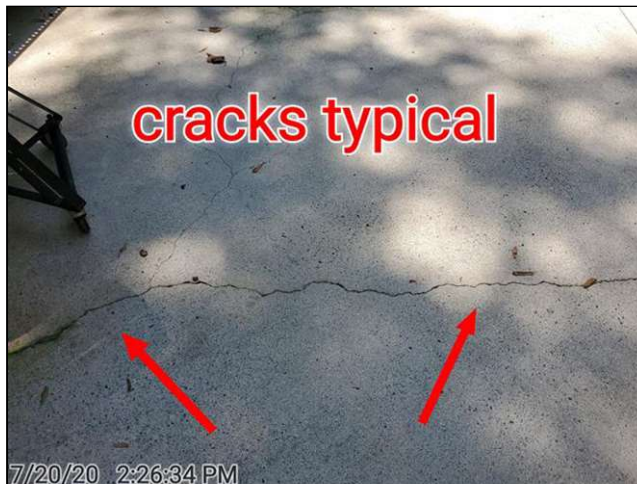
2.8 Item 1(Picture)

(1) Small, non structural cracks in the concrete front and rear patios. Have sealed as needed. It cannot be determined if they will crack anymore, but due to the age of the house, it is likely that settlement is complete.
-

📷 (1) Small, non structural cracks in the concrete front and rear patios. Have sealed as needed. It cannot be determined if they will crack anymore, but due to the age of the house, it is likely that settlement is complete.

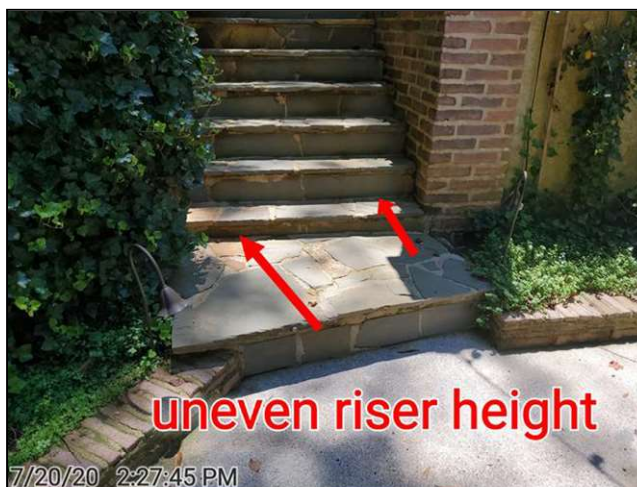
2.8 Item 2(Picture)

(2) Uneven step heights on the steps to the pool area, are likely due to past settlement of the steps. It is not clear if there will be anymore settlement. See photos. Uneven step heights can be a trip hazard.
-

📷 (2) Uneven step heights on the steps to the pool area, are likely due to past settlement of the steps. It is not clear if there will be anymore settlement. See photos. Uneven step heights can be a trip hazard.

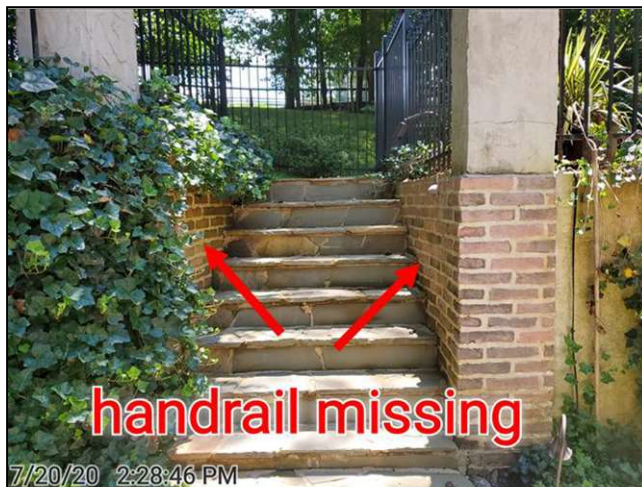
2.8 Item 3(Picture)

(3) Handrail missing on stairs to pool area. Recommend the installation of the missing handrail.

👤 (3) Handrail missing on stairs to pool area. Recommend the installation of the missing handrail.

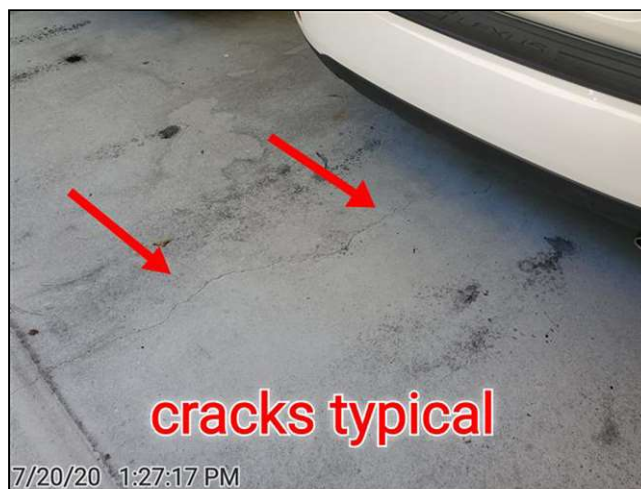
3.2 Item 1(Picture)

Cracks in garage floor are not wide enough to be considered a structural concern and are due to normal settlement and shrinkage of the concrete. Have patched as needed.

📷 Cracks in garage floor are not wide enough to be considered a structural concern and are due to normal settlement and shrinkage of the concrete. Have patched as needed.

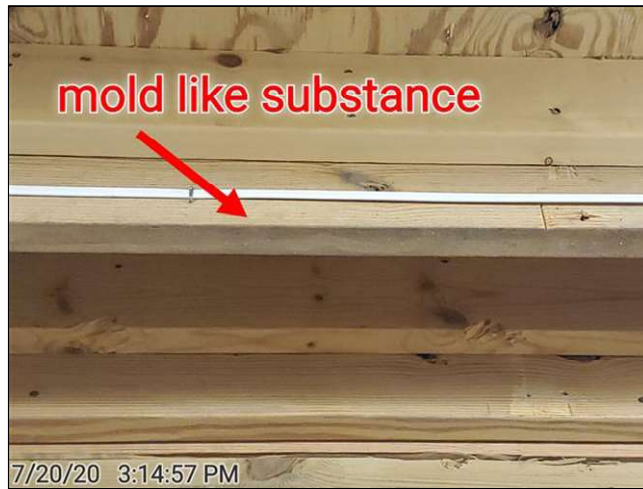
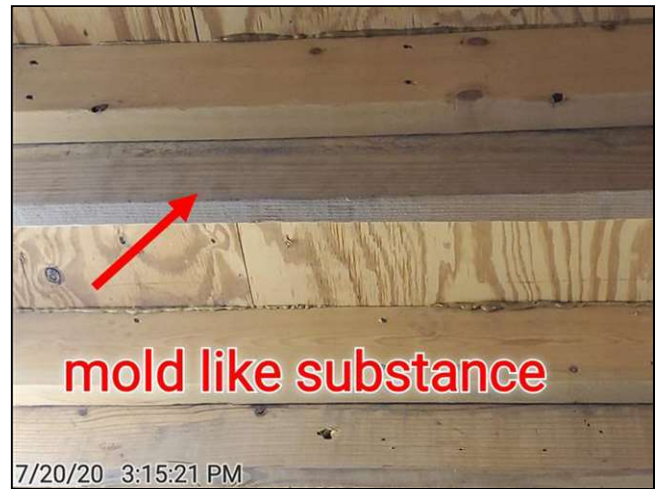
(2) Signs of mold or suspected mold growth is present on the floor system overhead in basement. The underlying cause of mold problems is normally moisture or high humidity. A visual inspection cannot determine the extent of the mold problem or if any health hazards exist. Mold testing is recommended and can be completed if desired. Resolve all mold concerns prior to closing. Please [HERE](#) for more information on mold testing.

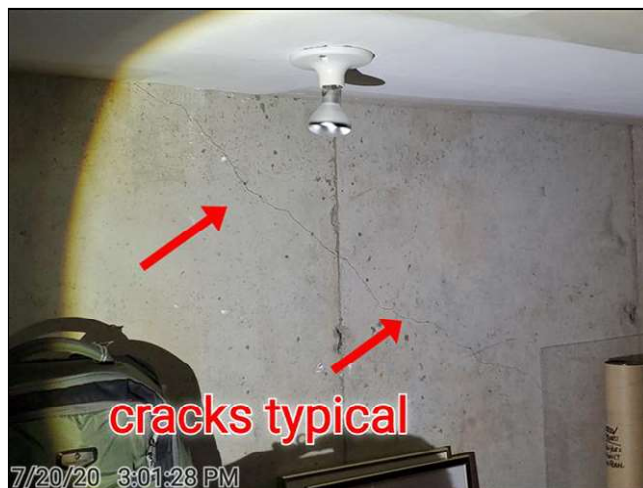
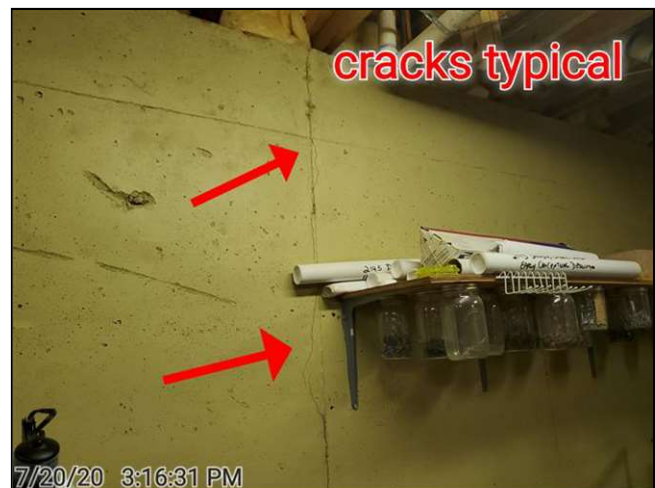
Shrinkage cracking noted to the foundation wall below the stair landing and in the workshop area. This is consider typical. Recommend sealing to help prevent any water penetration.

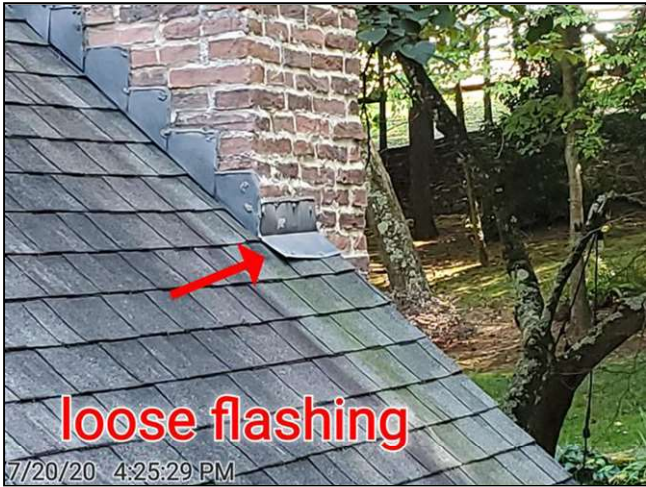
5.1 Item 1(Picture)

Loose chimney flashing noted on the chimney at the back right of the home. This condition could allow water to penetrate the home. Recommend a licensed roofer evaluate and make necessary repairs.

📷 Loose chimney flashing noted on the chimney at the back right of the home. This condition could allow water to penetrate the home. Recommend a licensed roofer evaluate and make necessary repairs.

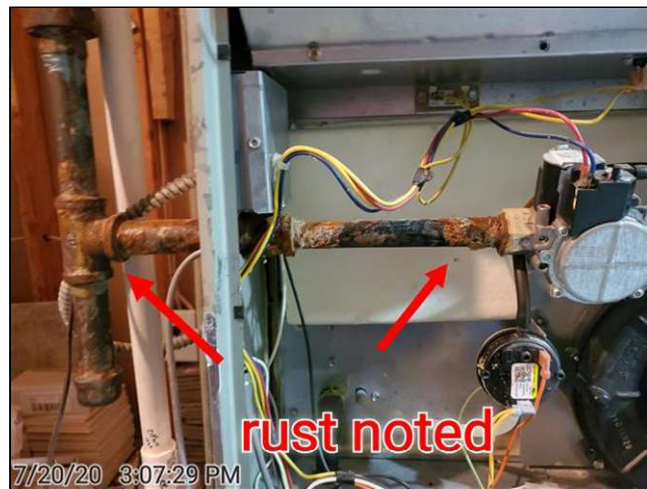
7.0 Item 11(Picture)

(2) Significant rust noted on the gas line on the furnace in the basement. Recommend a licensed HVAC contractor evaluate and make necessary repairs.

🔧 (2) Significant rust noted on the gas line on the furnace in the basement. Recommend a licensed HVAC contractor evaluate and make necessary repairs.

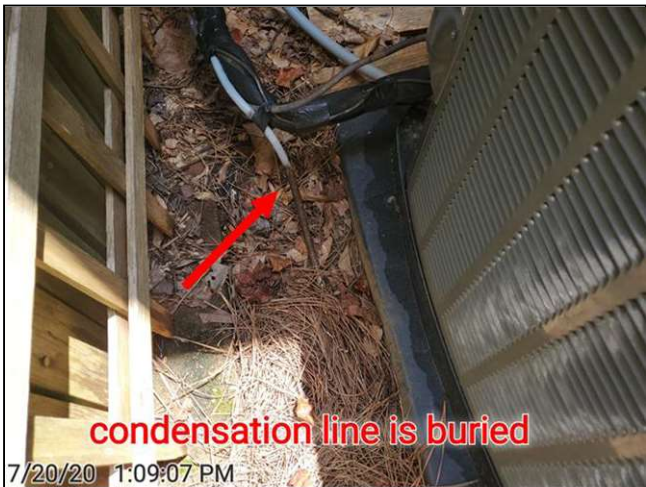
7.7 Item 11(Picture)

(2) The condensate drain lines are buried in the soil for the guest house unit behind the garage. Recommend to have these lines cleared of debris and free flowing. See photo(s).

⚠️ (2) The condensate drain lines are buried in the soil for the guest house unit behind the garage. Recommend to have these lines cleared of debris and free flowing. See photo(s).

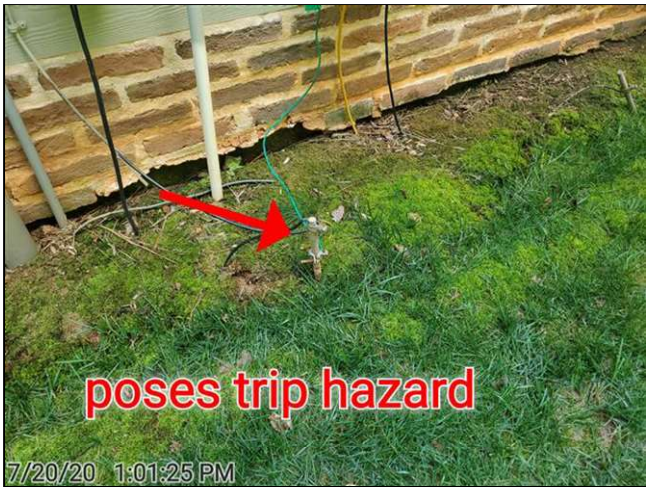
8.1 Item 1(Picture)

The grounding rod is high enough to be a trip hazard for the electrical system on the garage. This rod may need to be placed deeper into the earth. Recommend to have this condition corrected. See photo(s).

The grounding rod is high enough to be a trip hazard for the electrical system on the garage. This rod may need to be placed deeper into to the earth. Recommend to have this condition corrected. See photo(s).

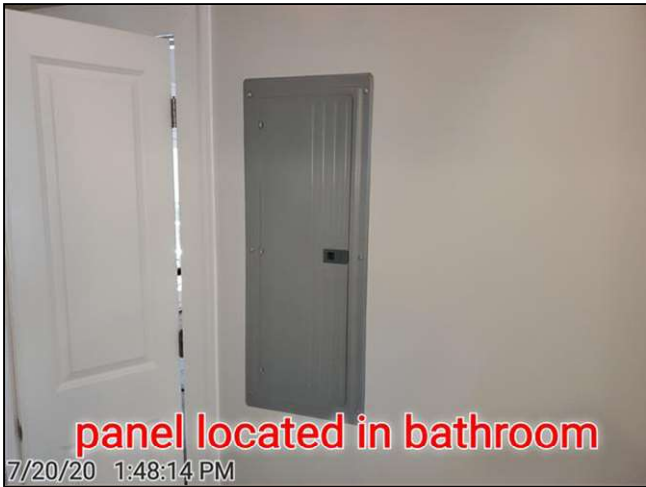
8.2 Item 1(Picture) Guest house electrical panel

(1) The guest house electrical panel is installed in the bathroom. The electrical panel was located in a prohibited area. Electrical panels cannot be located in a closet, bedroom, bathroom, or penetrating garage fire walls. Recommend a licensed electrician evaluate and make necessary repairs.

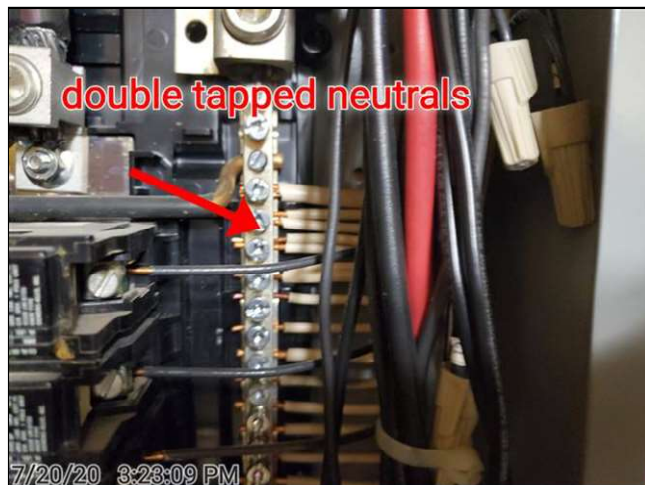
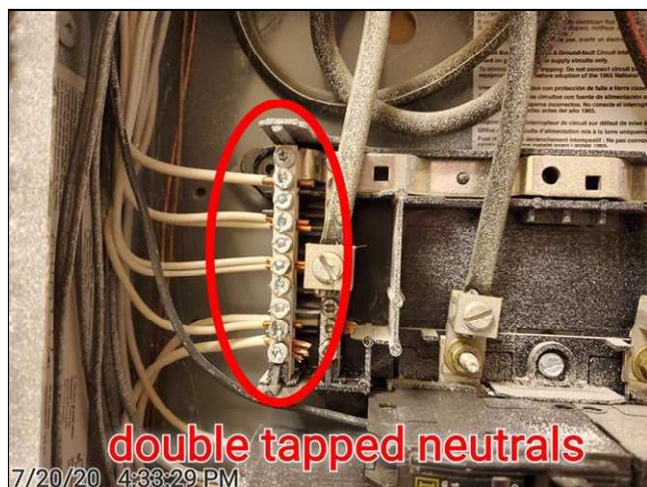
(2) There are multiple neutral wires on the same lug for the bus bar in the main panel in the basement and on the first floor as well as the second floor sub panel. This does not meet current standards but was permitted at the time the home was built. Current standards suggest that neutral wires be placed on individual lugs on the bus bar. Recommend to have electrician inspect and repair as needed. See photo.

🔧 (2) There are multiple neutral wires on the same lug for the bus bar in the main panel in the basement and on the first floor as well as the second floor sub panel. This does not meet current standards but was permitted at the time the home was built. Current standards suggest that neutral wires be placed on individual lugs on the bus bar. Recommend to have electrician inspect and repair as needed. See photo.

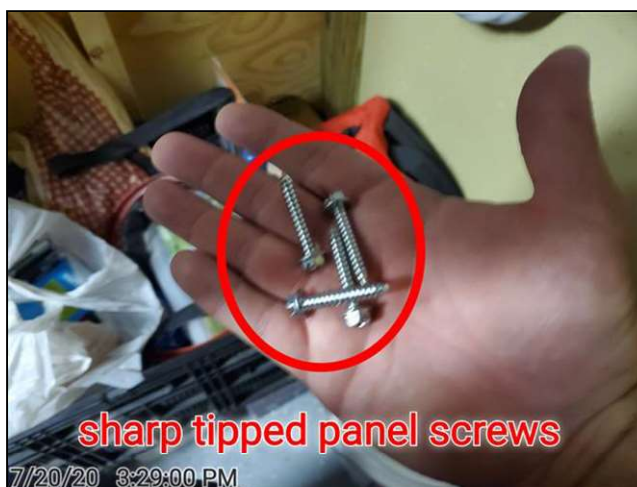
8.2 Item 5(Picture)

(3) Existing screws for the sub panel box in the basement are not the correct type screw. They have a sharp point and can penetrate a wire when inserted. Replace existing screws with proper type blunt end to prevent puncture.

🔧 (3) Existing screws for the sub panel box in the basement are not the correct type screw. They have a sharp point and can penetrate a wire when inserted. Replace existing screws with proper type blunt end to prevent puncture.

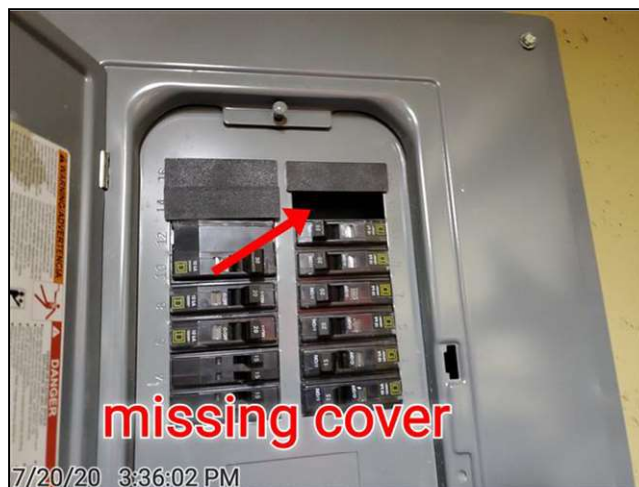
8.2 Item 6(Picture)

(4) Visible opening(s) noted for the sub panel. Plastic plates should cover unused openings in the panel for safety. See photo(s).

🔧 (4) Visible opening(s) noted for the sub panel. Plastic plates should cover unused openings in the panel for safety. See photo(s).

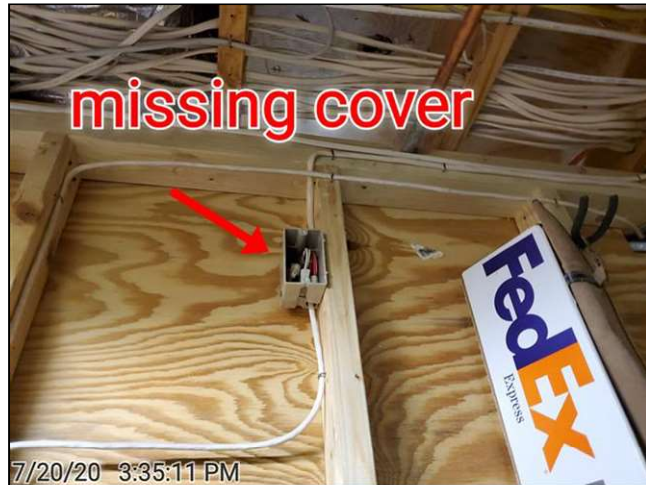
8.4 Item 1(Picture)

(1) Recommend to place a cover on the open junction box(s) in the unfinished basement. Covers are used to control sparking.
-

🔧 (1) Recommend to place a cover on the open junction box(s) in the unfinished basement. Covers are used to control sparking.

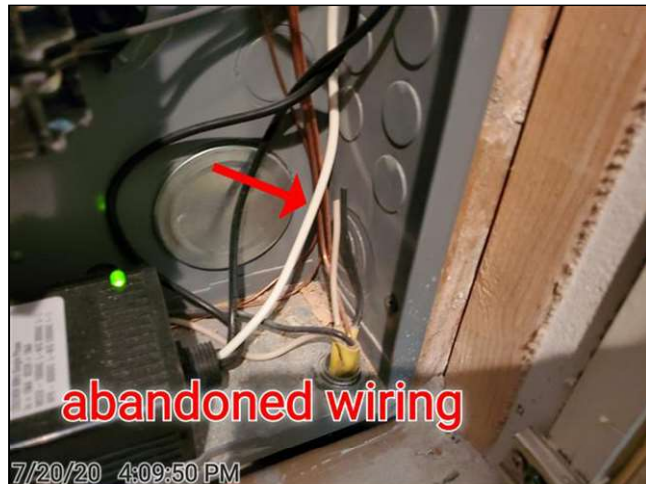
8.4 Item 2(Picture)

(2) Abandoned wiring noted in the first floor main panel. If these wires become energized, this poses a fire hazard. Recommend a licensed electrician evaluate and make necessary repairs.
-

🔧 (2) Abandoned wiring noted in the first floor main panel. If these wires become energized, this poses a fire hazard. Recommend a licensed electrician evaluate and make necessary repairs.

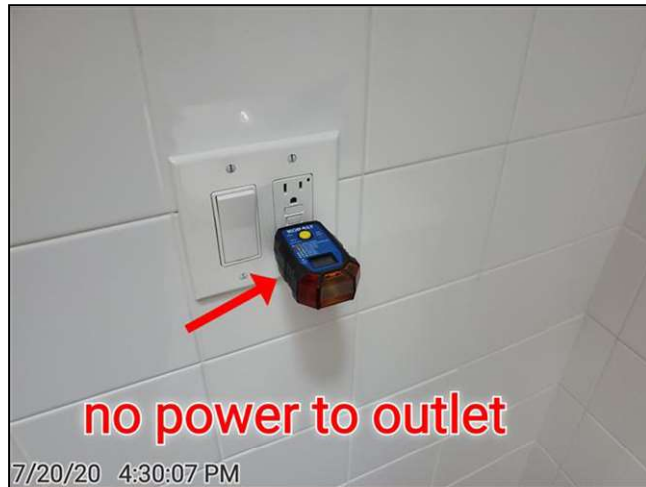
8.4 Item 3(Picture)

(3) The outlet in the front center bed bath upstairs was inoperable at the time of inspection. Recommend a licensed electrician evaluate and make necessary repairs.

🔧 (3) The outlet in the front center bed bath upstairs was inoperable at the time of inspection. Recommend a licensed electrician evaluate and make necessary repairs.

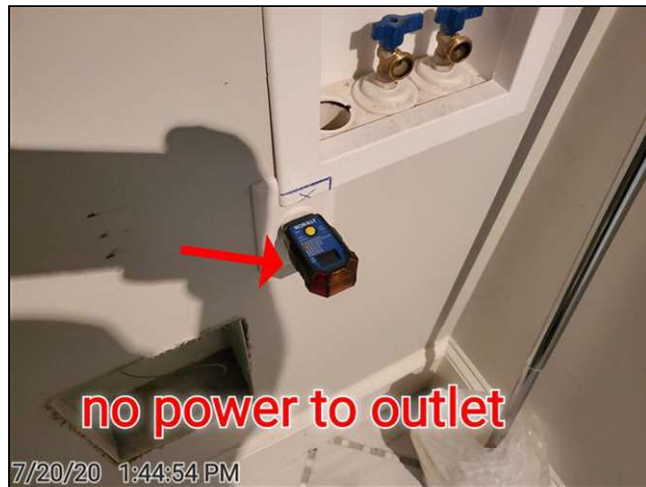
8.5 Item 1(Picture)

(1) The outlet installed in the guest house laundry room had no power at the outlet at the time of inspection. Recommend a licensed electrician evaluate and make necessary repairs.
-

🔧 (1) The outlet installed in the guest house laundry room had no power at the outlet at the time of inspection. Recommend a licensed electrician evaluate and make necessary repairs.

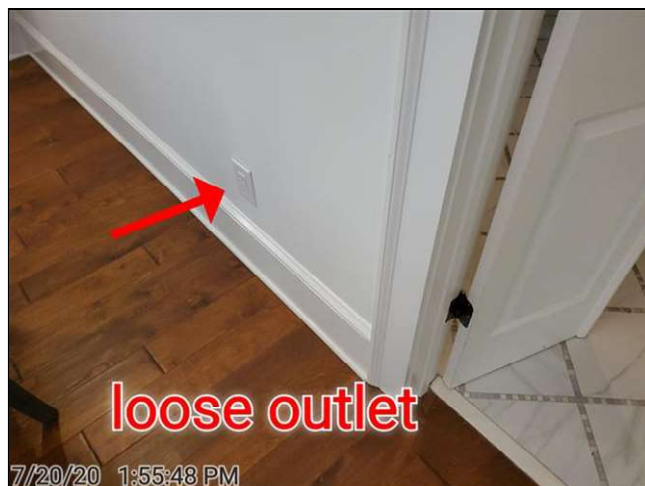
8.5 Item 2(Picture)

(2) Recommend to secure the loose outlet(s) to the wall in the guest house and at the kitchen island in the main home.

- 🔧 (2) Recommend to secure the loose outlet(s) to the wall in the guest house and at the kitchen island in the main home.

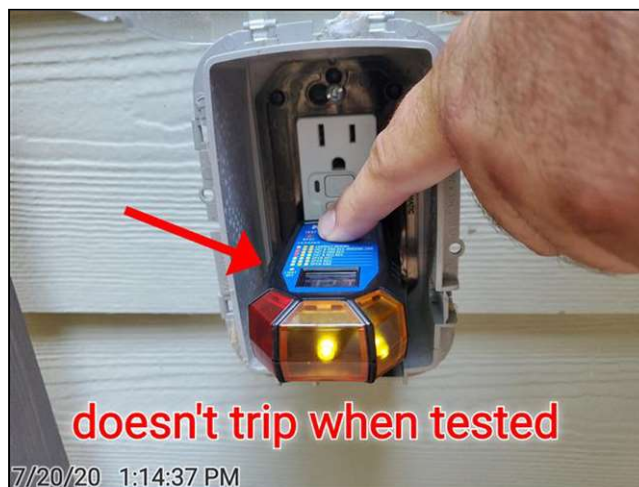
8.7 Item 1(Picture)

The GFCI outlet installed on the garage deck, doesn't trip when tested. Recommend a licensed electrician evaluate and make necessary repairs.

- 🔧 The GFCI outlet installed on the garage deck, doesn't trip when tested. Recommend a licensed electrician evaluate and make necessary repairs.

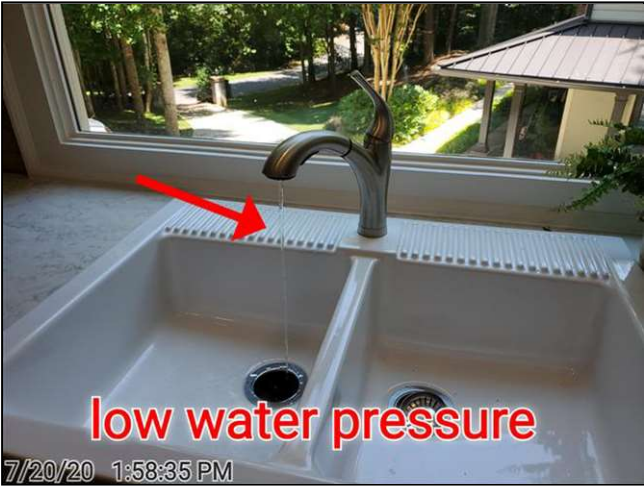
9.1 Item 1(Picture)

(2) Low water pressure noted on the hot water side at the kitchen sink in the guest house. Recommend a licensed plumber evaluate and make necessary repairs.

🔧 (2) Low water pressure noted on the hot water side at the kitchen sink in the guest house. Recommend a licensed plumber evaluate and make necessary repairs.

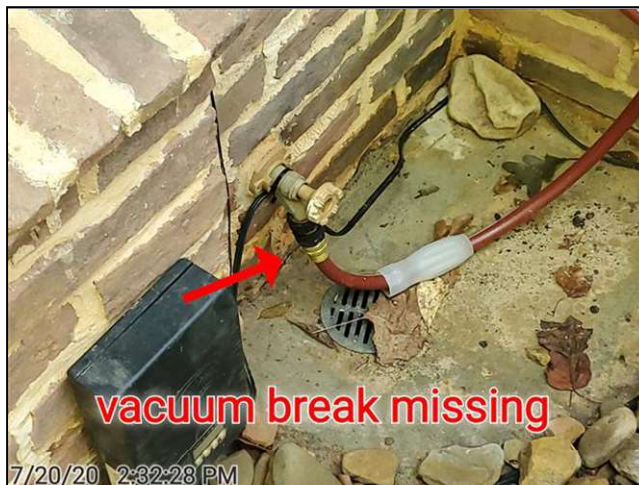
9.1 Item 2(Picture)

(3) Recommend to have vacuum breakers installed on each of the exterior faucets. This will help prevent cross contamination when the faucets are used. This was not required when the home was built. Recommend to have plumber inspect and repair as needed.

- 🔧 (3) Recommend to have vacuum breakers installed on each of the exterior faucets. This will help prevent cross contamination when the faucets are used. This was not required when the home was built. Recommend to have plumber inspect and repair as needed.

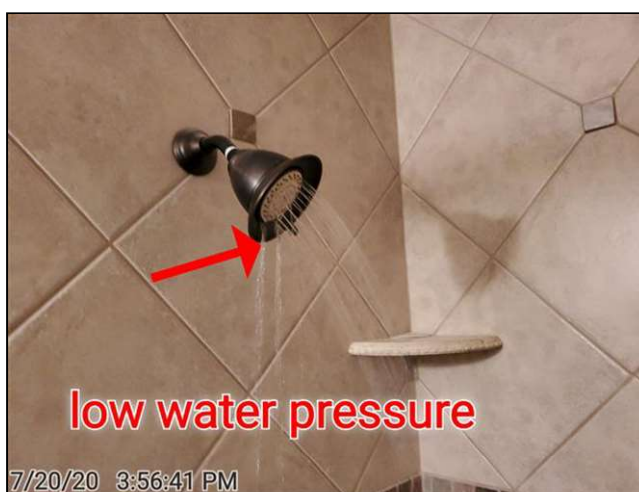
9.1 Item 3(Picture)

(4) Low water pressure noted at the shower in the bath at the front right of the home. Recommend a licensed plumber evaluate and make necessary repairs.

- 🔧 (4) Low water pressure noted at the shower in the bath at the front right of the home. Recommend a licensed plumber evaluate and make necessary repairs.

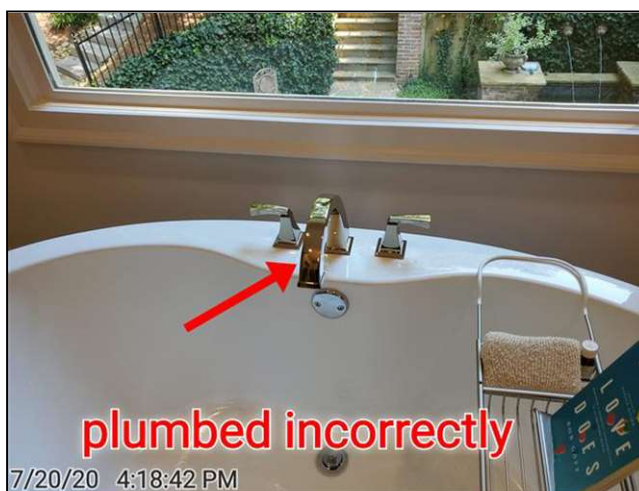
9.1 Item 4(Picture)

(5) The tub in the master bathroom is plumbed incorrectly. The hot water is always on the left, not in this case as the hot water is on the right. Recommend a licensed plumber evaluate and make necessary repairs.

- 🔧 (5) The tub in the master bathroom is plumbed incorrectly. The hot water is always on the left, not in this case as the hot water is on the right. Recommend a licensed plumber evaluate and make necessary repairs.

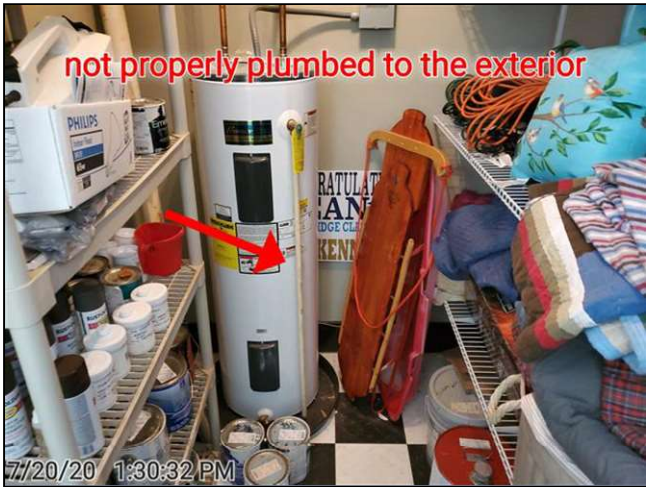
9.3 Item 2(Picture)

(2) The guest house water heater TPR line is not properly plumbed to the exterior. Recommend a licensed plumber evaluate and make necessary repairs.
-

(2) The guest house water heater TPR line is not properly plumbed to the exterior. Recommend a licensed plumber evaluate and make necessary repairs.
