BPG Inspection, LLC

**680 Ocean Avenue
Canton GA 30114**

Client(s): Floyd
Inspection Date: 6/15/2020
Inspector: Tom Collins ,

Date: 6/15/2020	Time: 09:00:00 AM	Report ID: 819064
Property: 680 Ocean Avenue, Canton, GA 30114		Prepared By: Tom Collins

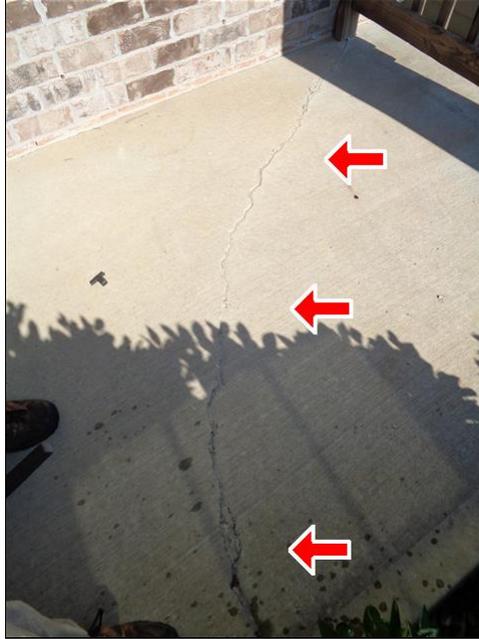
Porch [Inspected]

- ♦ **SERVICE / REPAIR:** Settling of the concrete surfaces observed. Repair can consist of either mud-jacking (injecting concrete under the slab to raise it) or replacement. Recommend having professionally repaired to raise surface back to or at least near the original position and reduce chances of continued settling occurring if not addressed. Item 1(Picture)

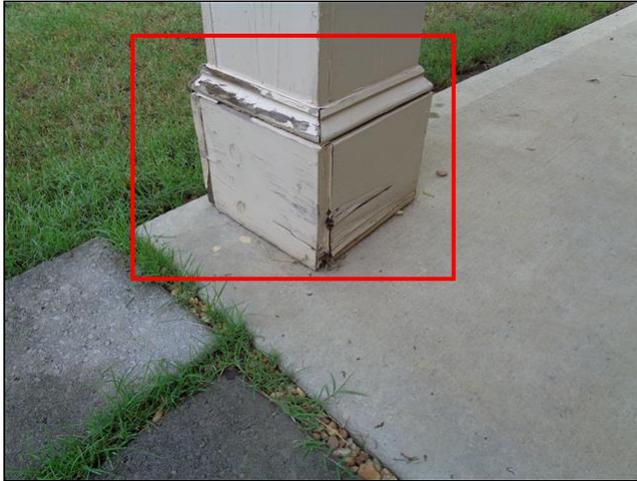
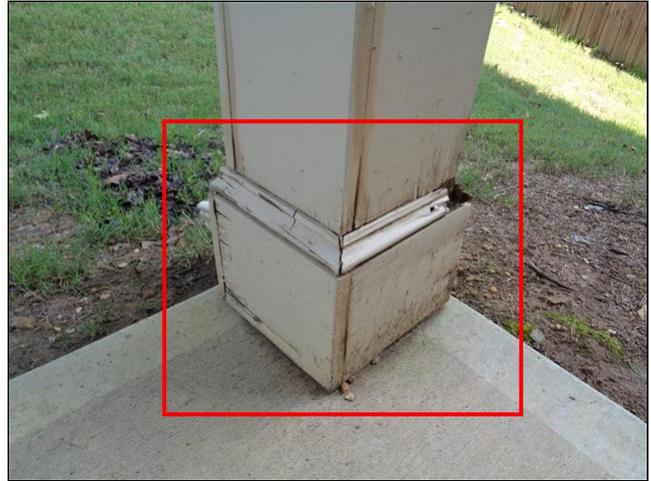
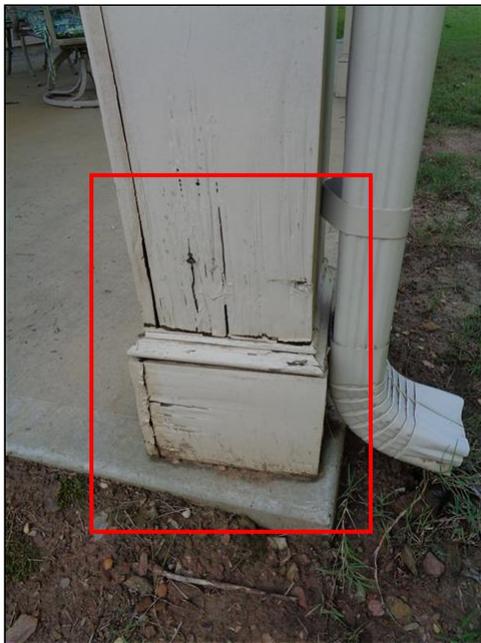
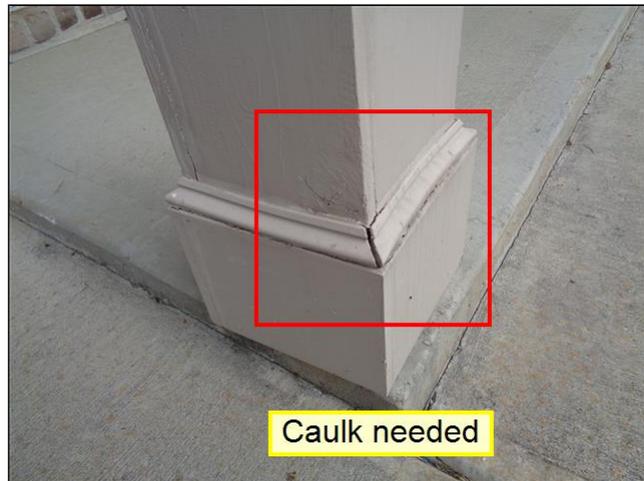
Trim / Soffit / Fascia [Inspected]

- ♦ **SERVICE / REPAIR:** Rot developing in front of home and rear of home. Replacements of affected materials is considered the best solution for long term performance of repair and plastic moldings are available for even better protection - [Contractor should review for additional damage and probe where suspect to insure that all damage is identified and replaced]. Fillers are discouraged but are commonly used in repairs of smaller areas where replacement would be difficult. Fillers should be done by experienced tradesmen and warrantied for a reasonable length of time. Work area should be primed, caulked and painted to match existing finishes. Item 1(Picture) Item 2(Picture) Item 3(Picture) Item 4(Picture)

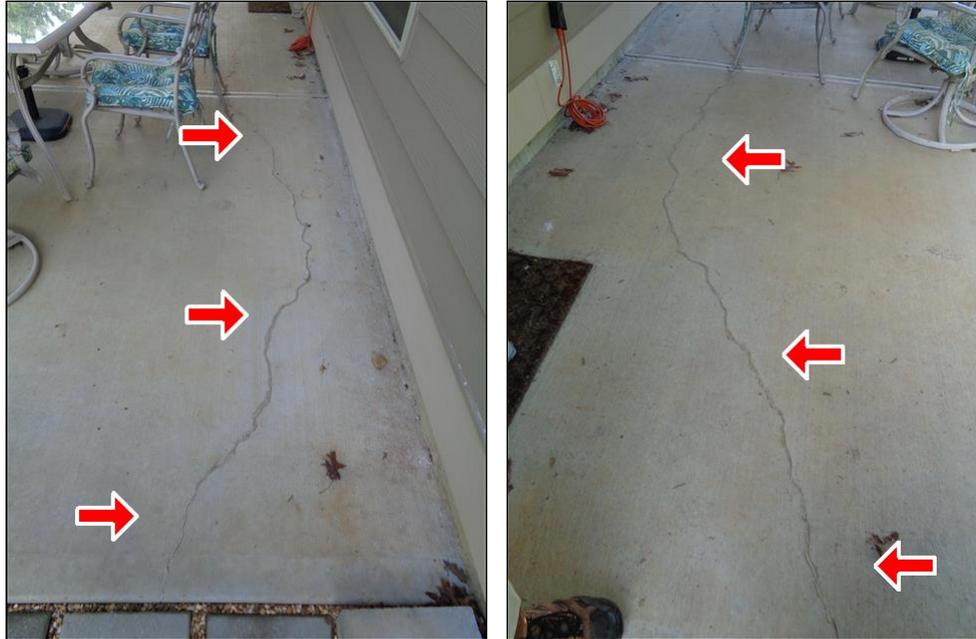
Patio [Inspected]

- ◆ **SERVICE / REPAIR:** Cracks present. This is an indication of settling. We are unable to determine if it is a past problem or an ongoing one. This area should be monitored as repairs may be necessary in the future. If one side of the crack is raised enough to trip over, it is a safety hazard as well as an indication of uneven ground movement. Recommended to seal all open cracks to avoid rain water subsurface erosion and damage from ice. Item 1(Picture)
Item 2(Picture)

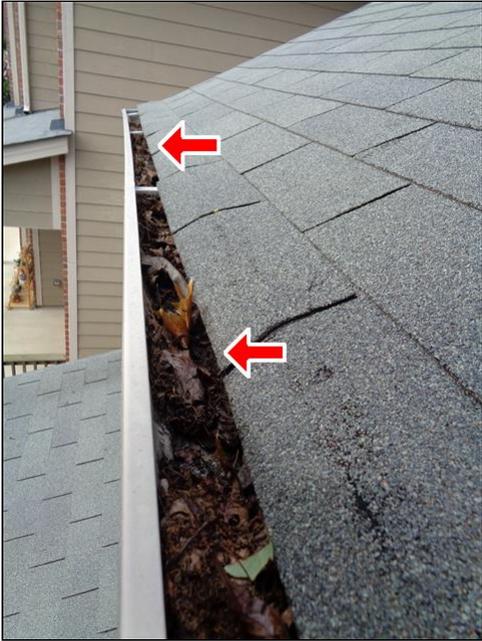
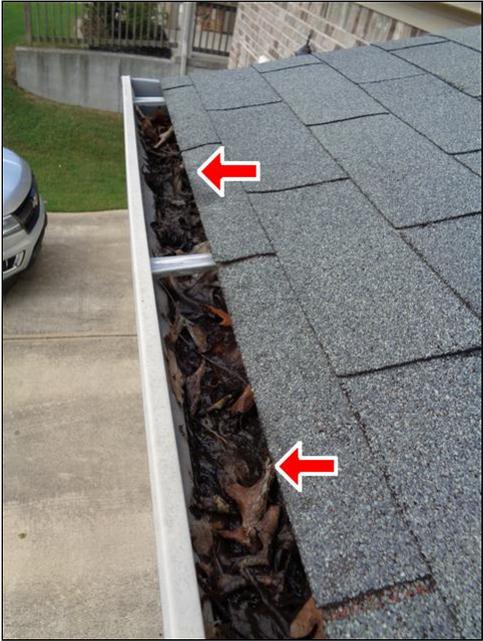
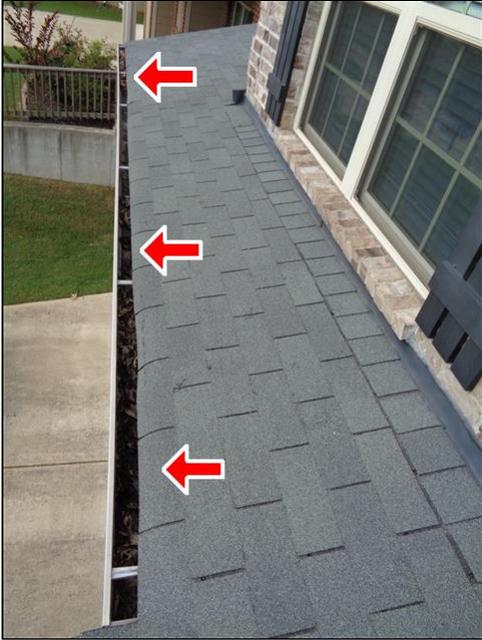
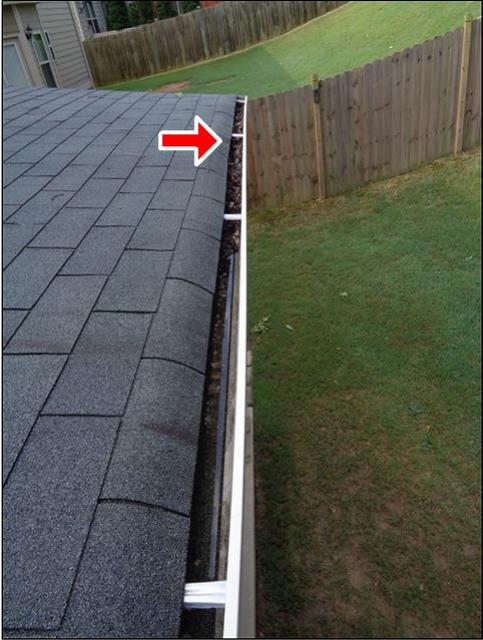
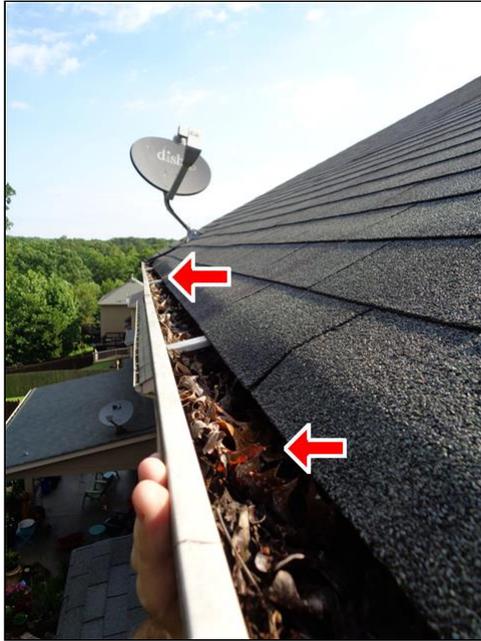
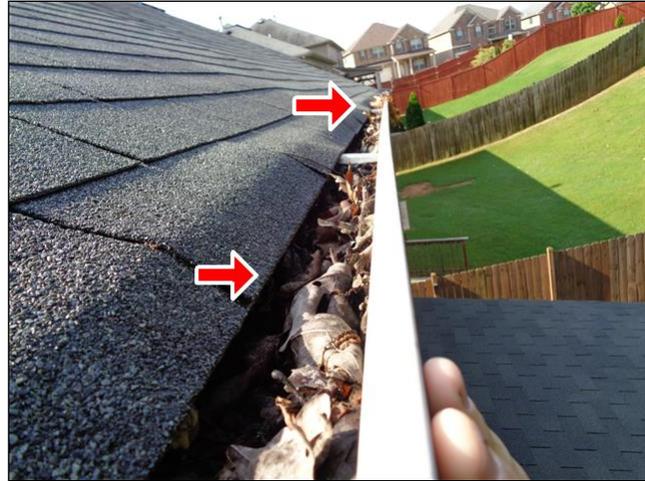
Gutters / Downspouts / Drain Lines [Inspected]

- ❌ ◆ **SERVICE / REPAIR:** Debris present in the gutter system. Cleaning is necessary so that the roof run off will be properly directed away from the home and to prevent water from overflowing and saturating the ground next to the foundation. Sometimes responsible for moisture damage in wood components below. Item 1(Picture) Item 2(Picture) Item 3(Picture) Item 4(Picture) Item 5(Picture) Item 6(Picture)

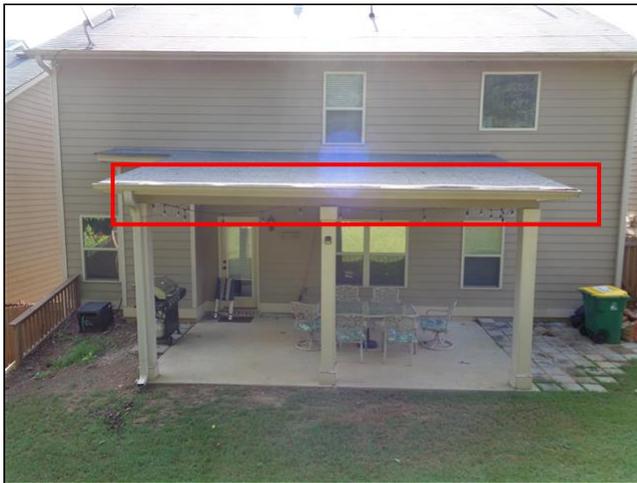
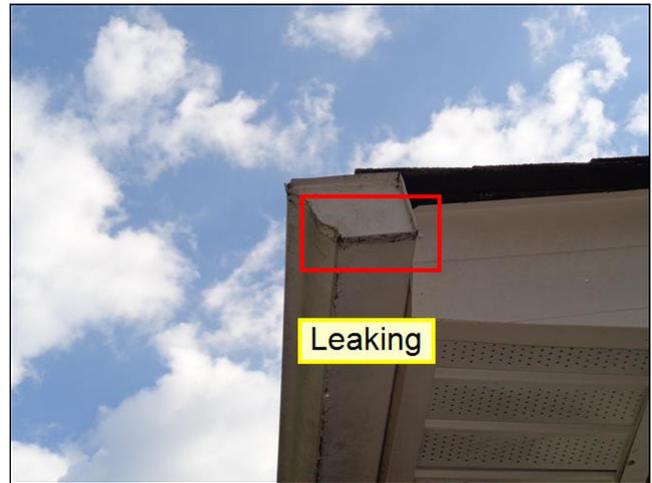
- ❌ ♦ **SERVICE / REPAIR:** Improper slope of the gutters observed located at rear patio. The gutters should be sloped so that all water will drain toward a downspout. Have a roofer or gutter installer evaluate and repair or replace to the extent found. Item 7(Picture) Item 8(Picture)

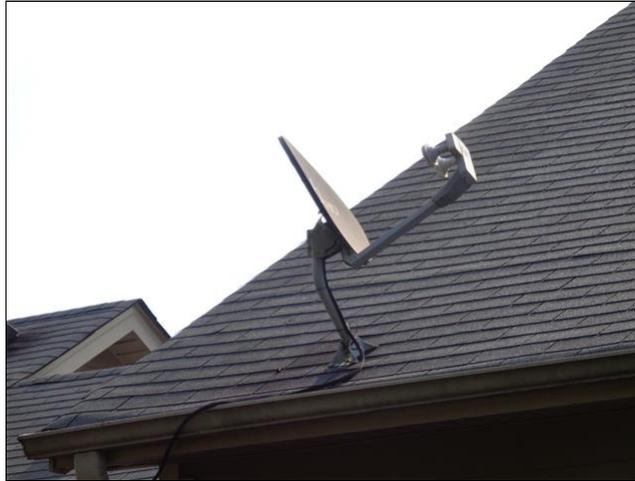
Comments [Inspected]

- 🔍 ♦ **GENERAL NOTE:** Satellite dish found mounted to roof but equipment cannot be checked as part of inspection. Have provider consulted if electing to use this equipment. If dish is removed, mounting brackets are usually left in place to limit potential of leaking. If brackets are removed, be sure to have mounting holes sealed up to avoid leaking. Item 1(Picture)

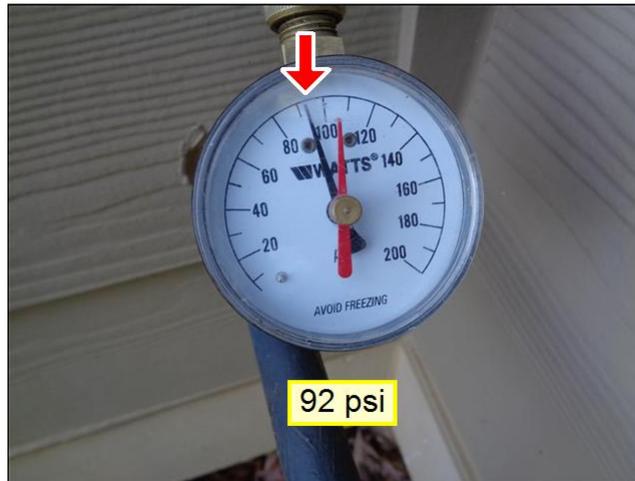
- ❌ ♦ **SERVICE / REPAIR:** The water pressure tested at over 80 PSI. This is considered excessive and adjustment of the pressure regulator is necessary. Correct to have between 40 and 80 PSI. Item 3(Picture)

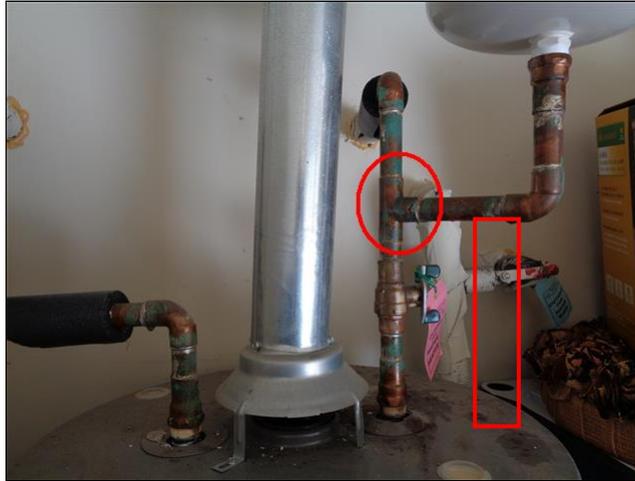
- ❌ ♦ **SAFETY / HEALTH:** Expansion tank required to be supported to reduce stress on lines. Recommend that the condition be corrected. Item 4(Picture)

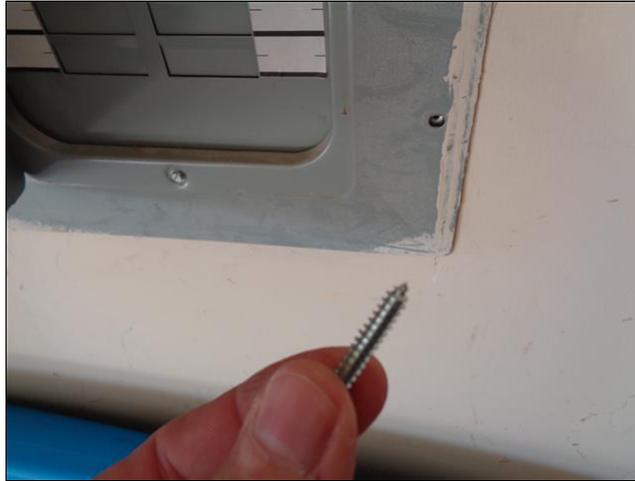
♦ **SAFETY / HEALTH:** The screws currently being used to attach the panel cover are improper. These screws have pointed ends and can pierce the insulation of the wires leading to a short circuit or electrical fire. Only blunt ended screws should be used. Item 2(Picture)

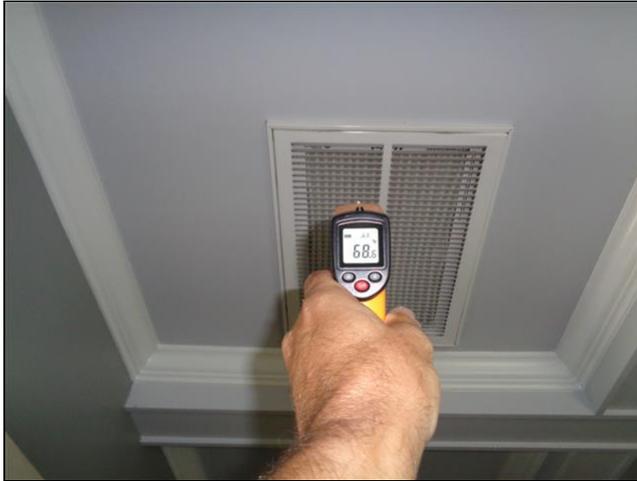
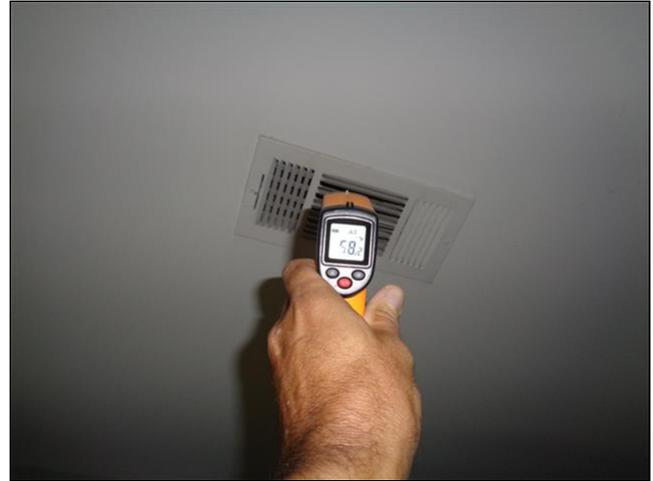
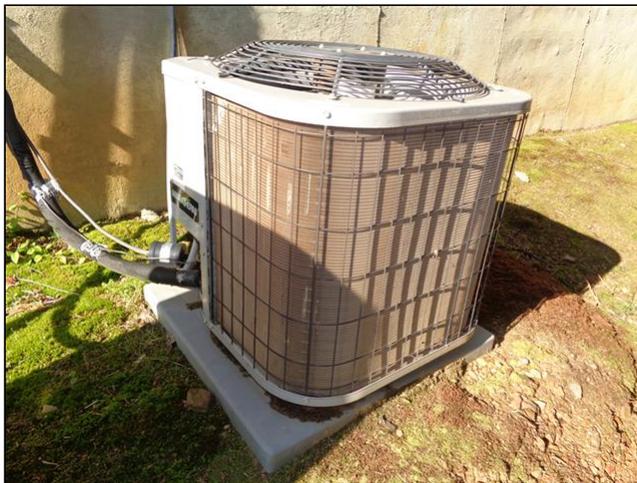
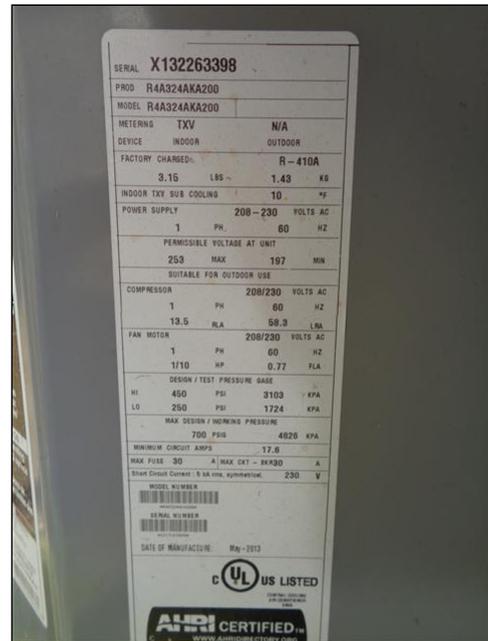
Air Conditioner [Inspected]

- ✘ ♦ **SERVICE / REPAIR:** The temperature difference (differential) between selected return and supply registers on the main living level is inadequate and outside the normal range of 15-20 degrees. **Tested at 10 degrees differential.** Have a licensed HVAC technician evaluate all cooling systems and return them to warrantable condition with normal operating performance per industry standards. (No air flow measurements are made as part of this testing.)
Item 1(Picture) Item 2(Picture) Item 3(Picture) Item 4(Picture)

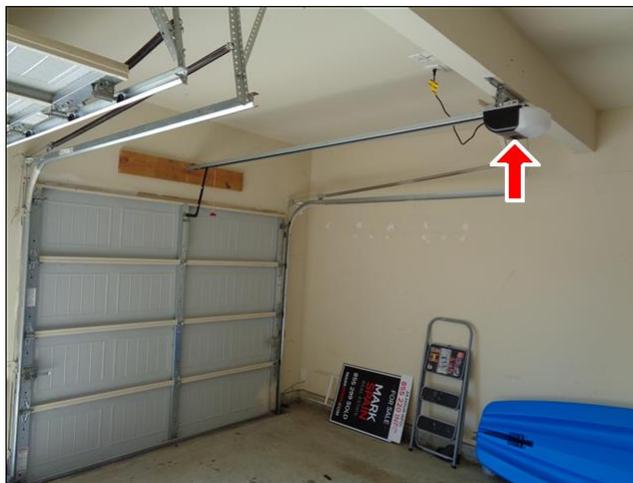
Openers [Inspected]

♦ **SERVICE / REPAIR:** Garage door did not operate when controls used. Have unit serviced and proper operation restored. All safety reverse mechanisms should be verified. Item 1(Picture)

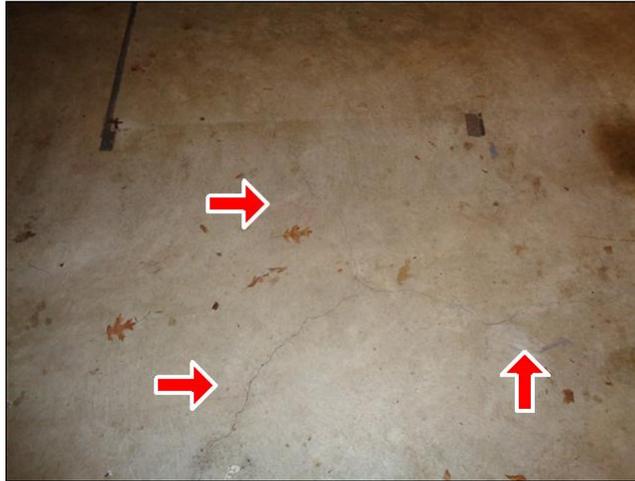
Floor [Inspected]

- 📷 ♦ **GENERAL NOTE:** Common cracks observed in the concrete surfaces. These are expected and are not generally considered significant. Monitor conditions that should not exceed 1/4 inches width or significant differential settlement. Item 1(Picture)

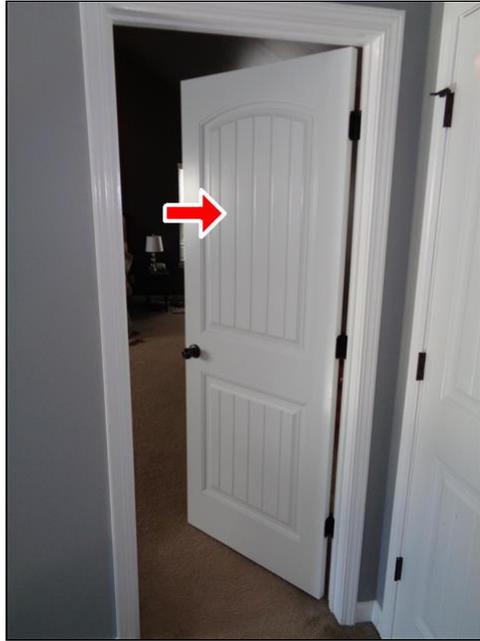
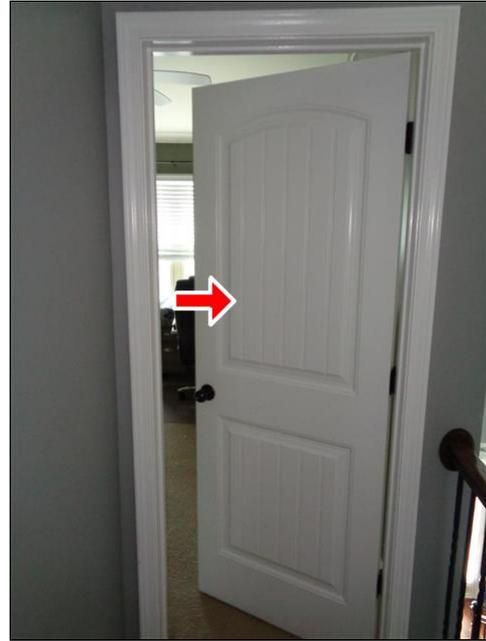
- ❌ ♦ **SERVICE / REPAIR:** Door found to close when opened due to door frame being installed out of plumb. Resetting door is not usually practical. Usually devices can be added to door or modifications made to hinges to keep in open position when opened. Many home owners are satisfied to use a door stop to keep open. **LOCATION:** Master bedroom and right front bedroom Item 1(Picture) Item 2(Picture)

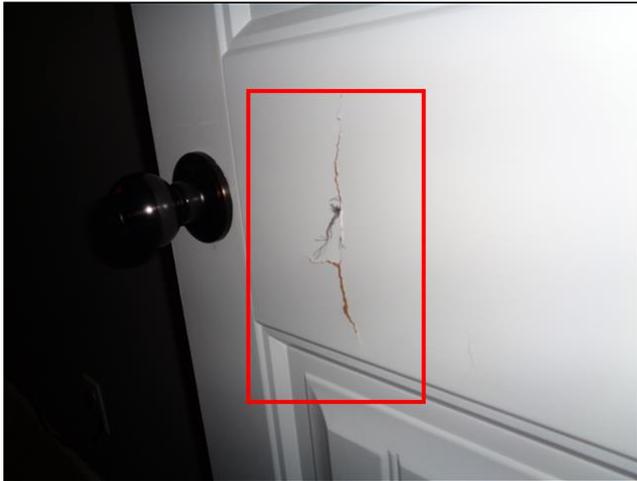
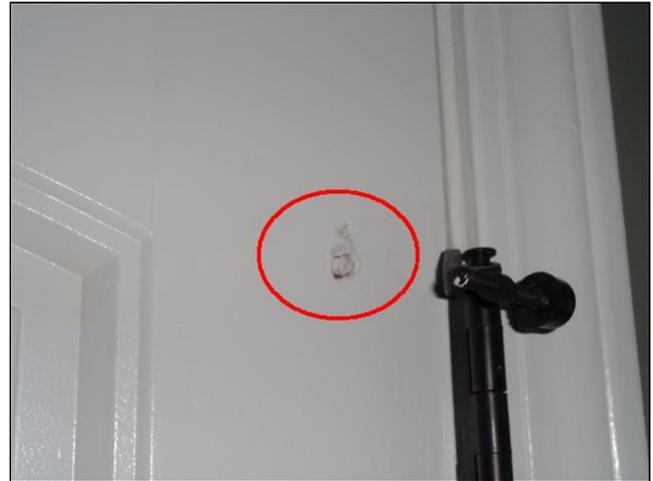
- ❌ ◆ **SERVICE / REPAIR:** Cosmetic damage to the doors observed. Repair or replace doors as needed. **LOCATION:** Left rear bedroom and right rear bedroom closet. Item 3(Picture) Item 4(Picture)

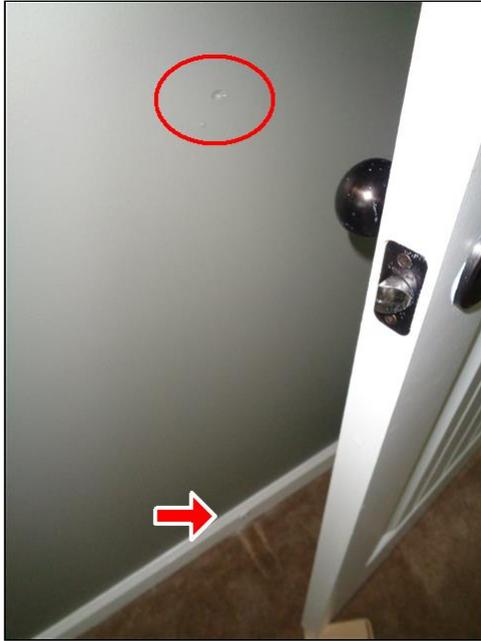
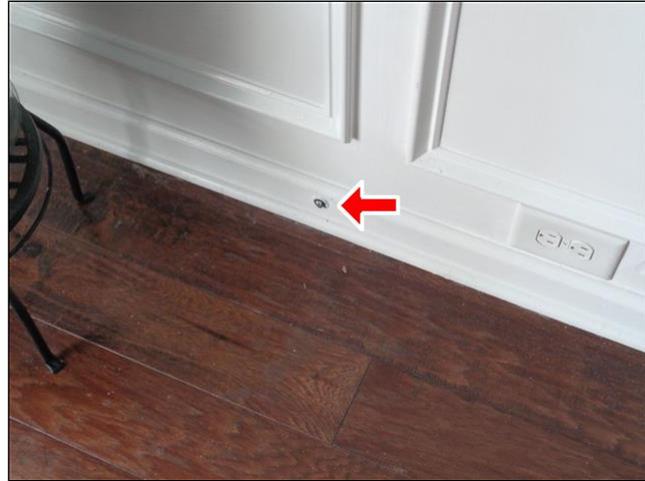
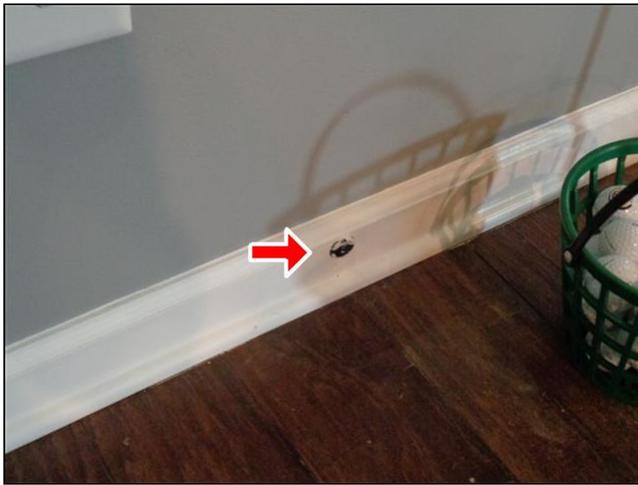
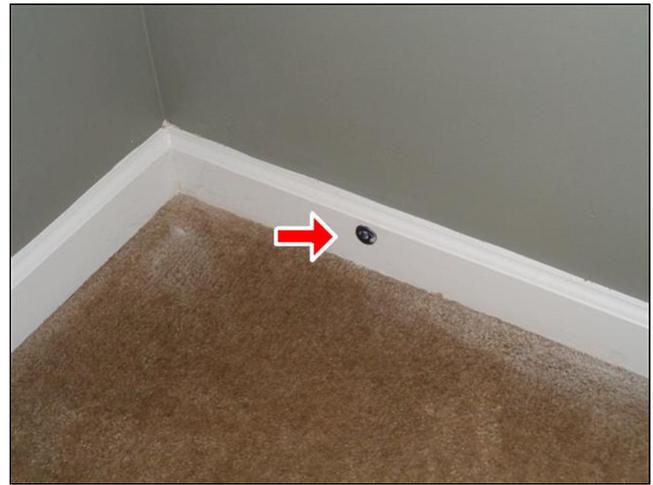
- 📏 ◆ **GENERAL NOTE:** Door stops are typically installed to provide protection to walls from door knob contact and generally found in wall, floor or hinge mount types. Some found either damaged or missing and consider having installed. Item 5(Picture) Item 6(Picture) Item 7(Picture) Item 8(Picture)

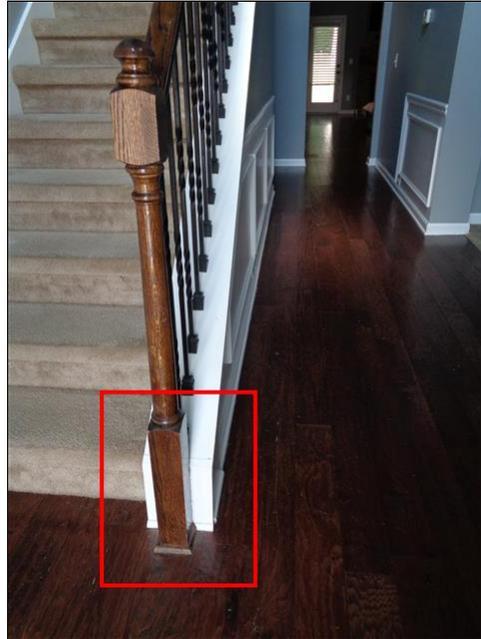
Stairways [Inspected]

- ☒ ◆ **SAFETY / HEALTH:** Loose stair handrail observed. Repair is necessary for safety. Item 1(Picture)

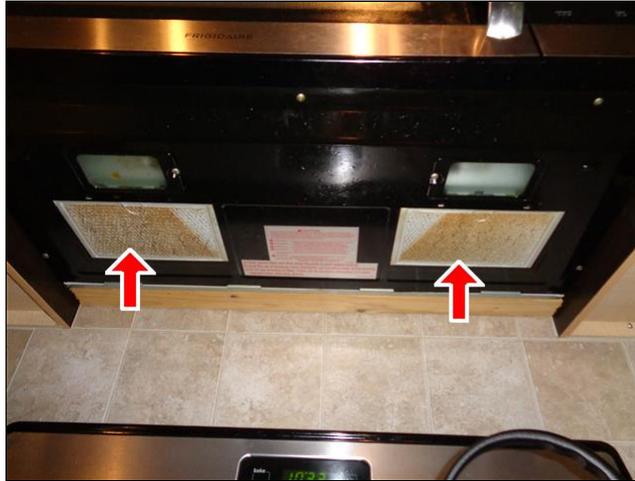
Vent Fans [Inspected]

◆ **SAFETY / HEALTH:** Exhaust fan filter is somewhat dirty with deposits of grease and should be either cleaned or replaced for safety. Item 1(Picture)

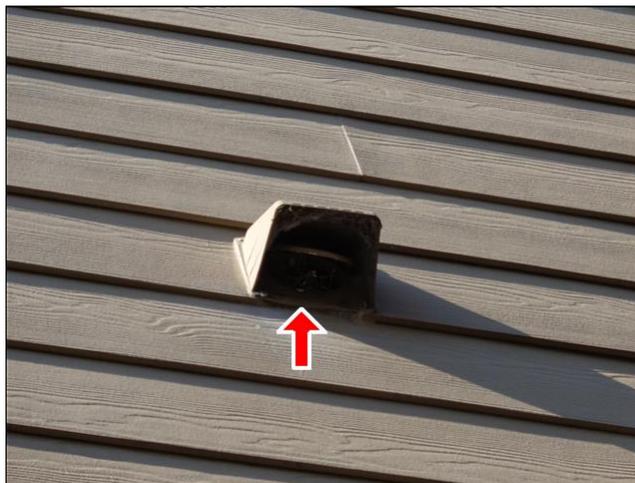
Dryer [Inspected]

- ◆ **GENERAL NOTE:** Dryer energy supply is 4 prong electrical and gas for either possible unit provided.
- ◆ **SERVICE / REPAIR:** The damper on the end of the dryer vent is full of lint. Have the vent cleaned for maximum efficiency and to prevent animal entry. Hood located on right side of home. Item 1(Picture)
