Inspection Report

Property Address:
330 Lockwood Pl
Alpharetta GA 30004

Dana Inspection Services

Date: 7/25/2020	Time: 09:00:00 AM	Report ID: 072520DO1
Property: 330 Lockwood Pl Alpharetta GA 30004	Customer: Bethany Wolfe	Real Estate Professional: Michael Hermance

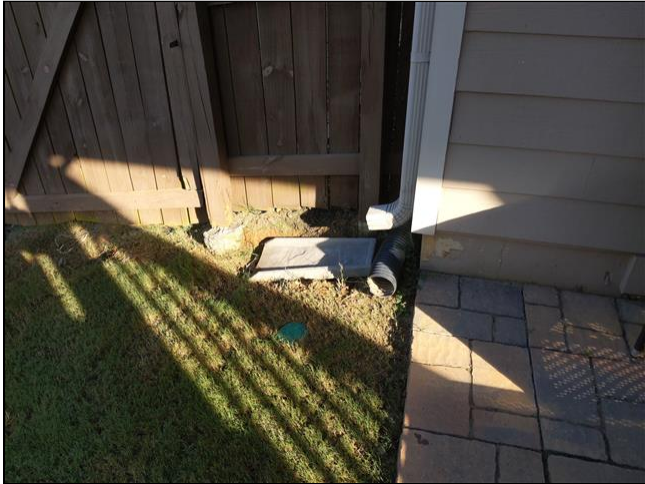
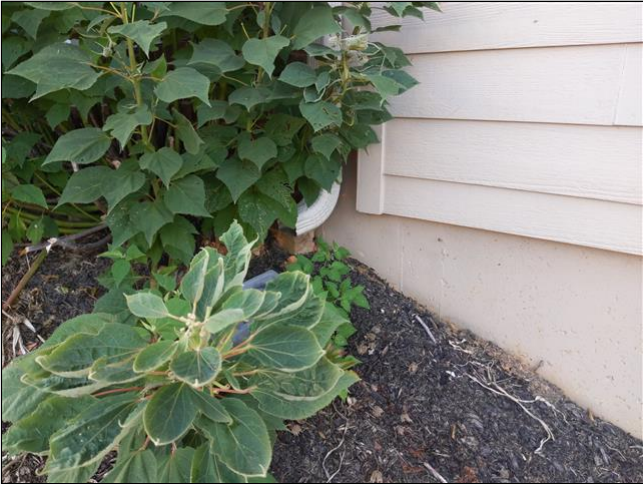
- 1.0 ROOF COVERINGS/DECKING
Comments: Inspected
- 1.1 FLASHINGS
Comments: Inspected
- 1.2 SKYLIGHTS, CHIMNEYS AND ROOF PENETRATIONS
Comments: Inspected
- 1.3 ROOF DRAINAGE SYSTEMS/GUTTERS
Comments: Repair or Replace

It is recommended that all downspouts have downspout extensions.

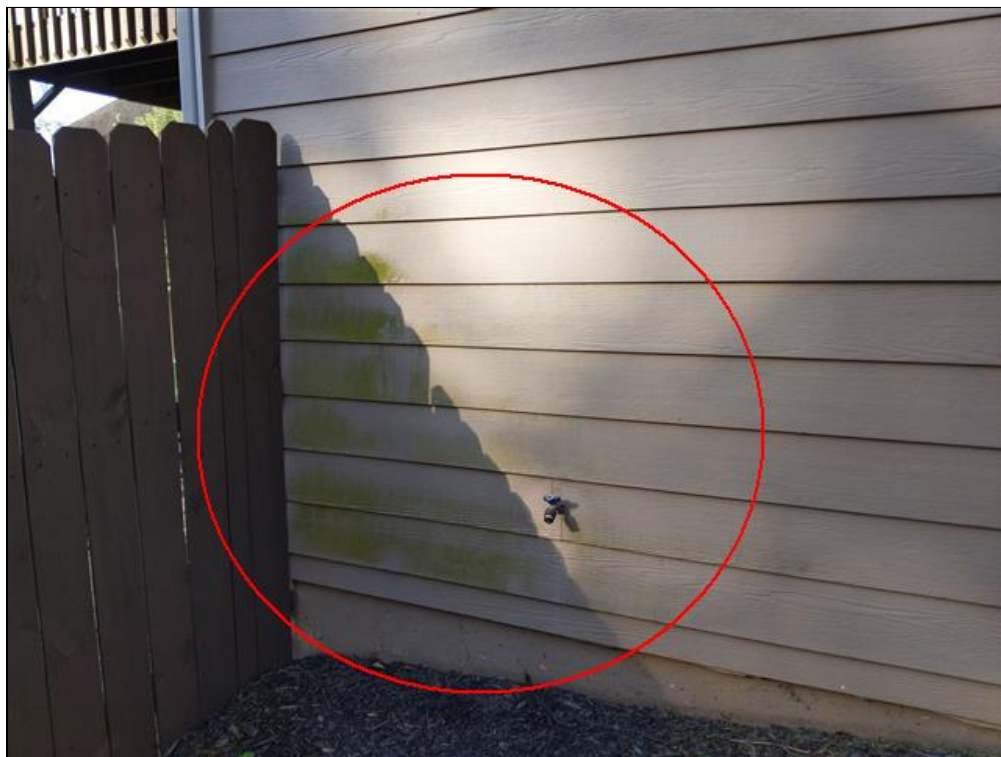
(1) Algae growing on siding. This can damage or shorten the life expectancy of the paint and/or the siding. Recommend having this area cleaned.

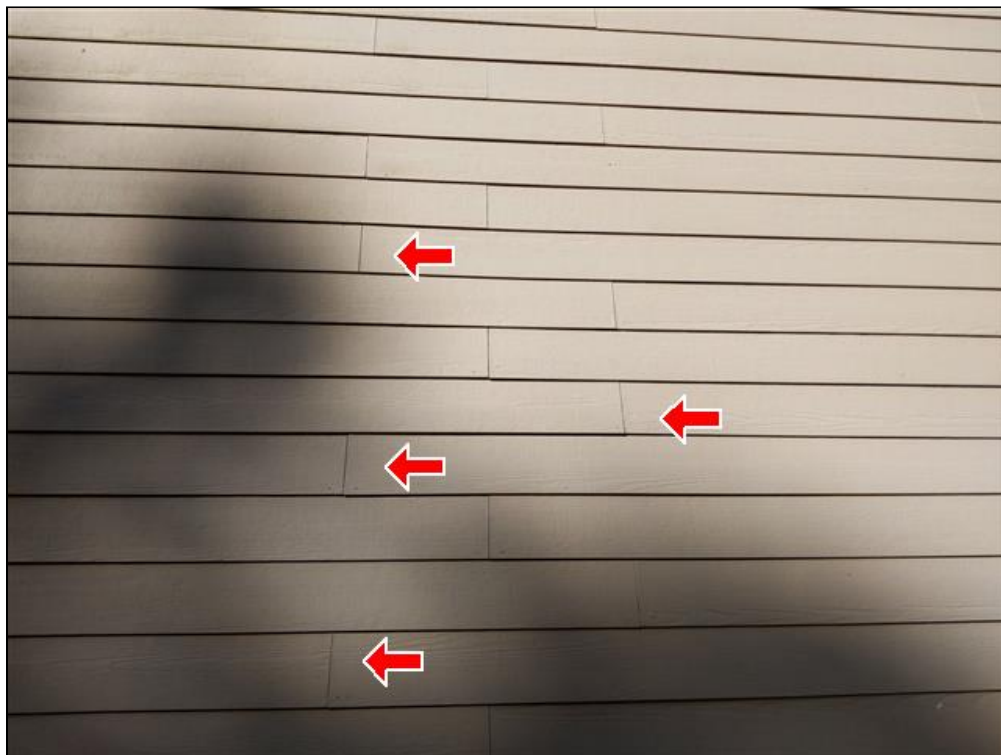
(2) All but joints of fiber seem exciting should be sealed with a caulk. Recommend a qualified painter repair.

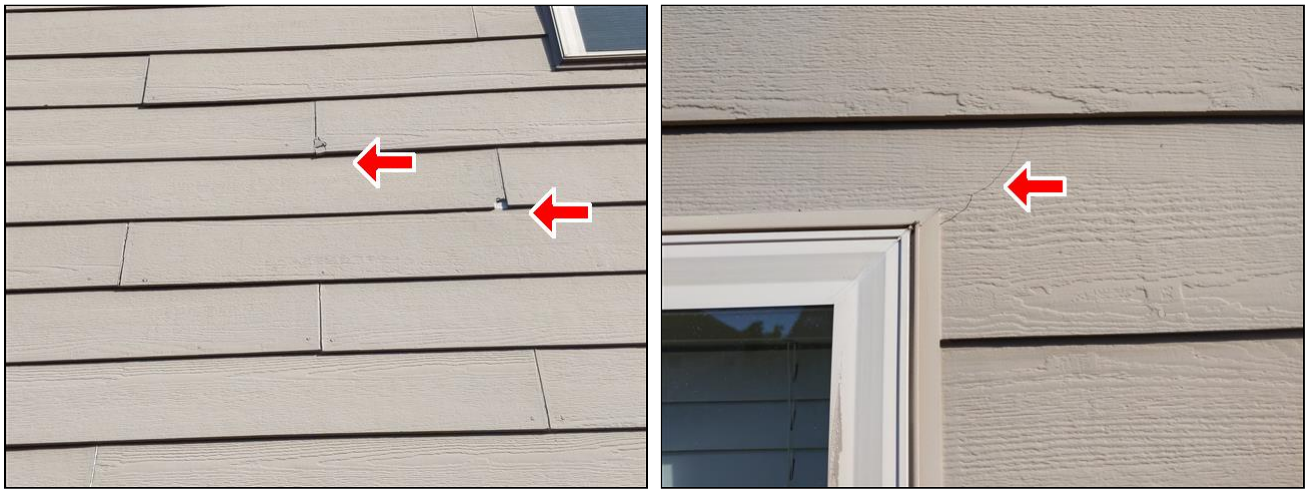
(3) Damage to fiber cement siding. Recommend qualifying siding contractor repair.

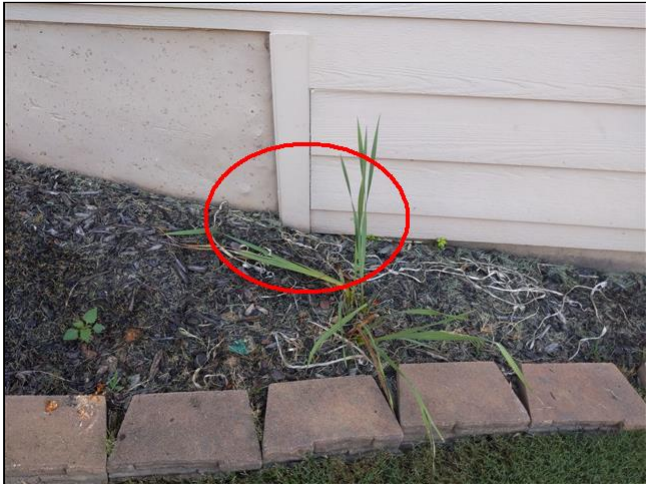
(4) Wood trim and siding and direct contact with soil. Is required to be a 2 to 4-in gap between siding/trim and soil. This is to prevent water damage and/or wood boring insect damage.

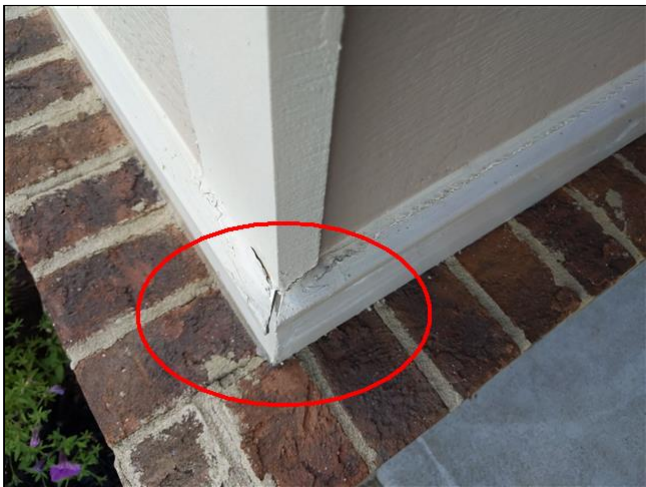
(5) Loose trim by front door.

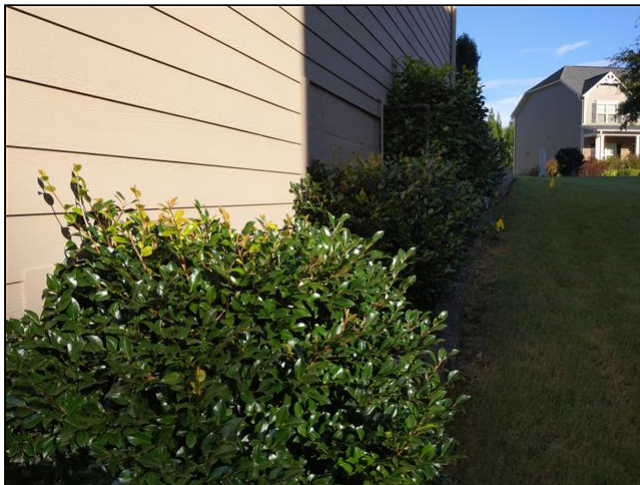
All vegetation in contact with the house or roof should be cut back or removed.

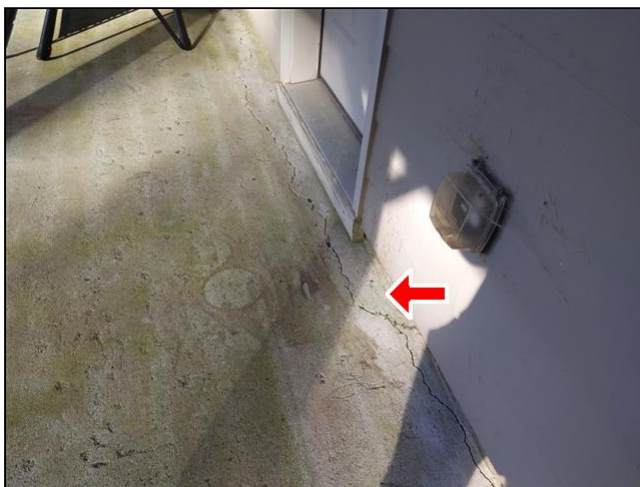
Common settling or curing cracks were observed on the rear patio concrete.

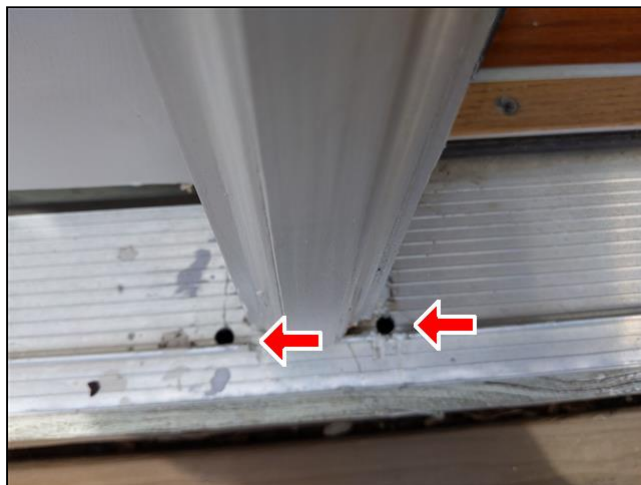
Holes around the bottom of the back door for the deck. These holes need to be sealed with a silicone based product. This will prevent water intrusion into the wall structure.

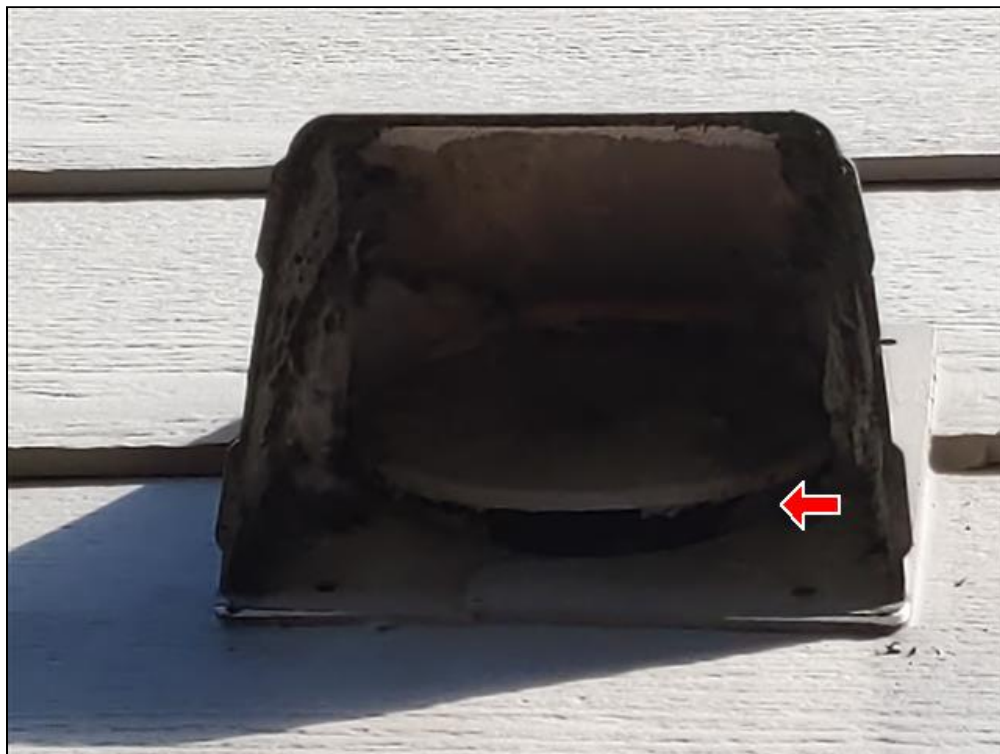
(1) The laundry vent hood at the exterior right is dirty and causing the damper to no longer close.

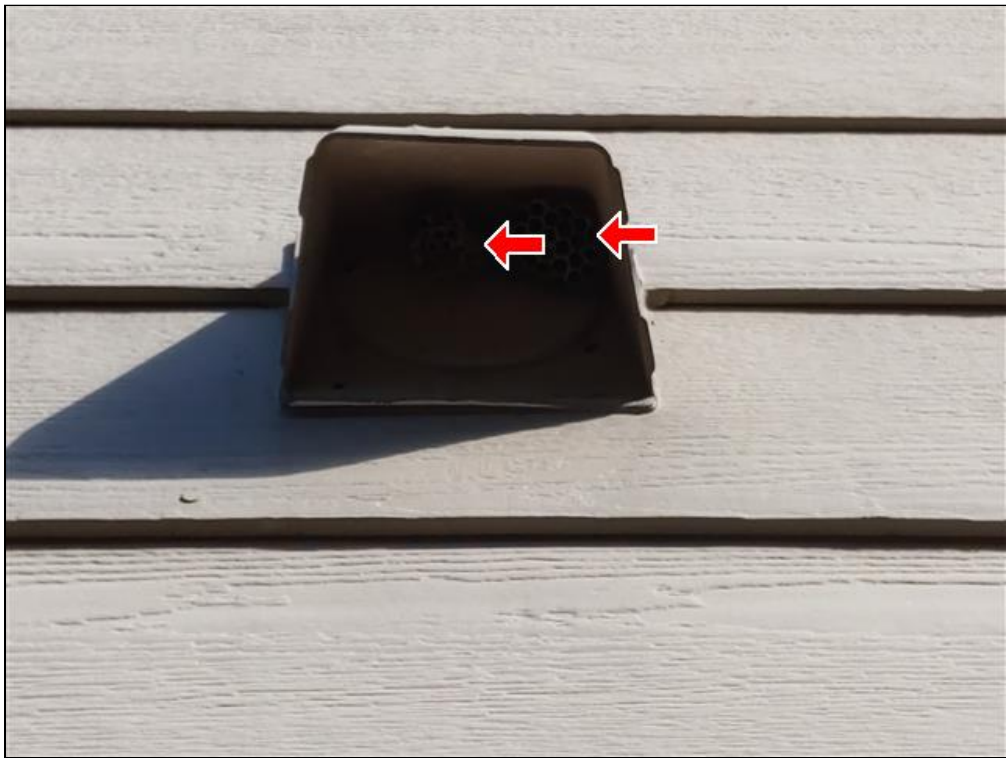
(2) Wasp nest are preventing the vent from opening.

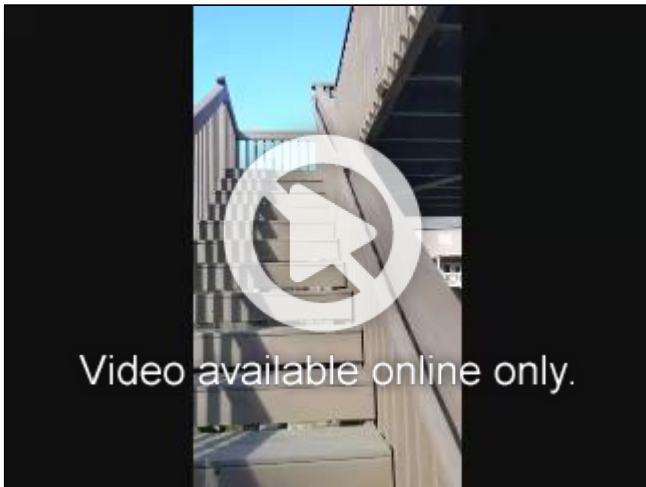
(1) Loose stairs. Have repaired by qualified deck contractor .Please see video

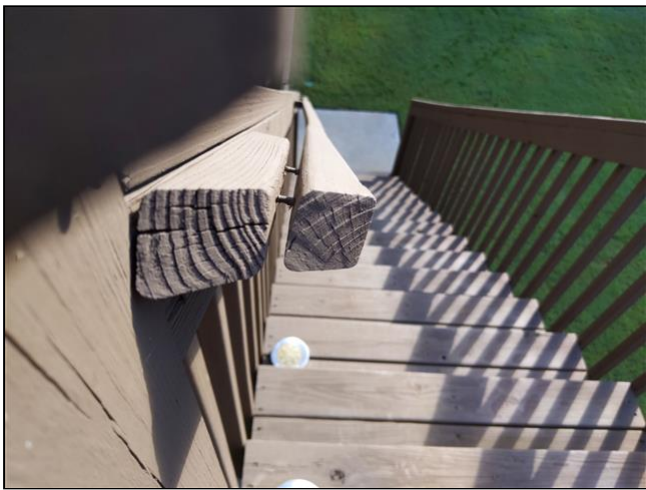
(2) Loose handrail.

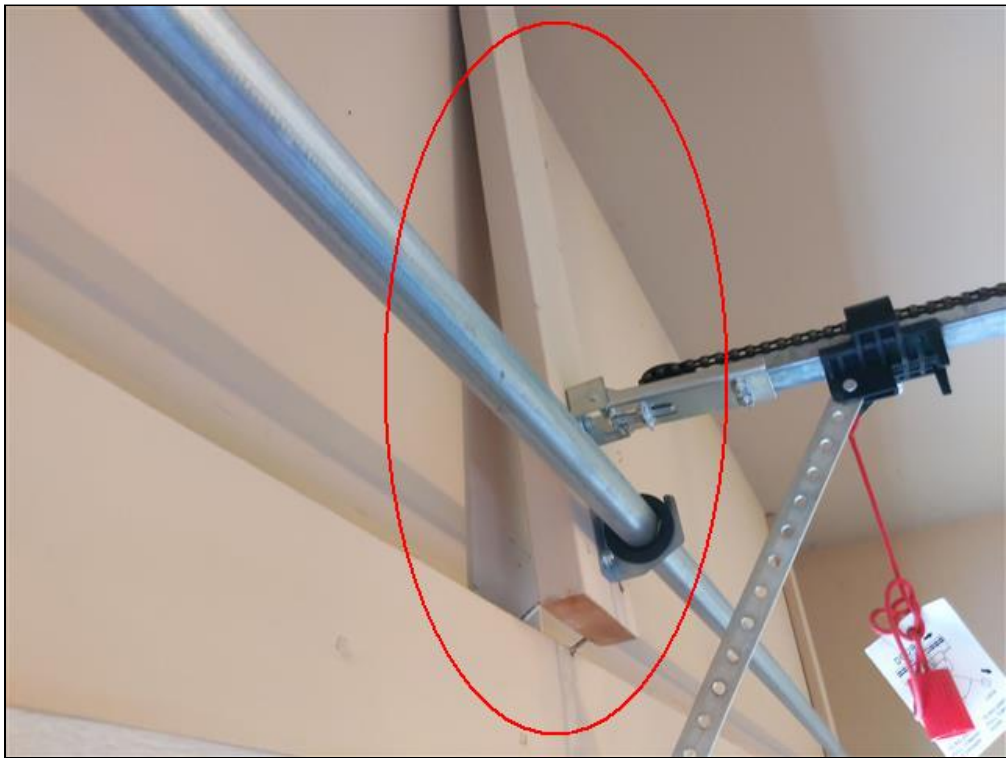
Wood framing that holds the garage door components to the wall is extremely loose and in danger of giving way. Recommend overhead door contractor repair.

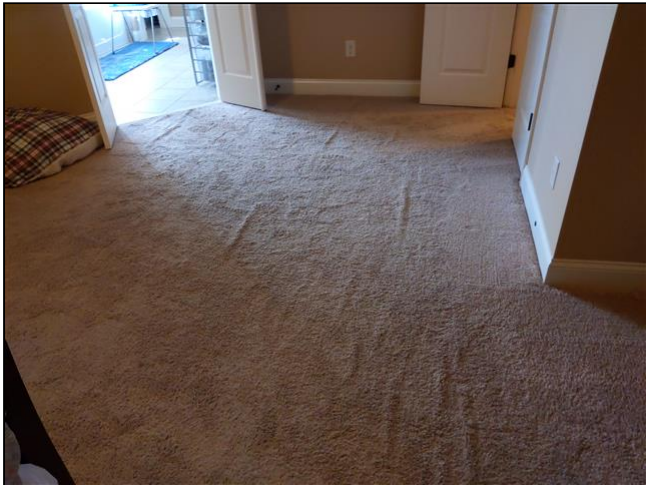
Carpet needs to be stretched in a master bedroom.

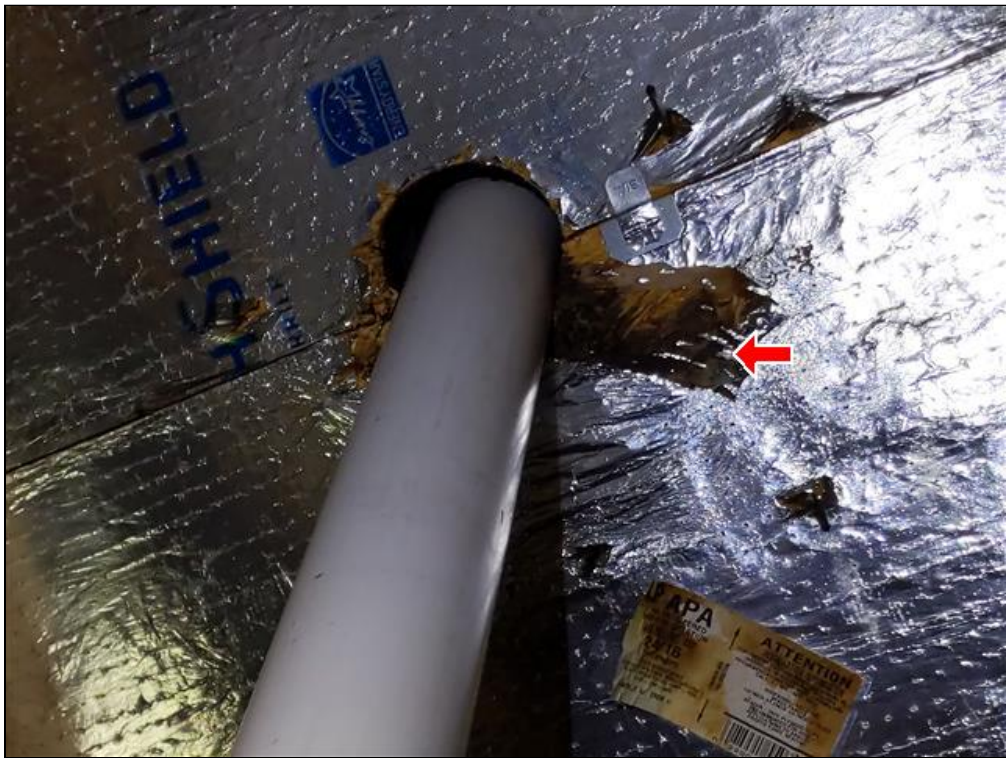
Evidence of a leak around the exhaust flue for the HVAC. Recommend a roofer evaluate and repair.

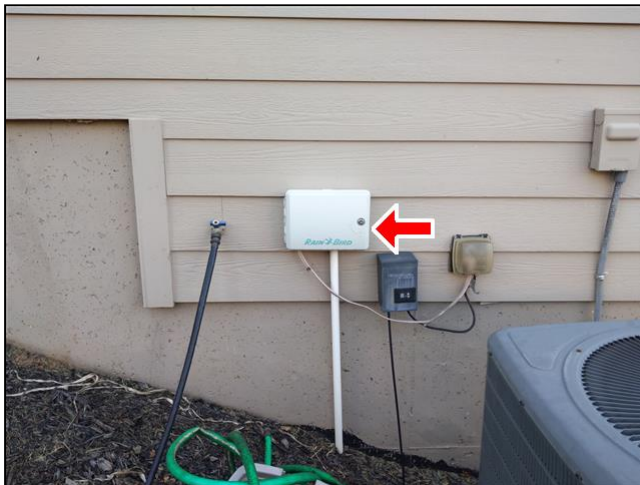
A irrigation system control panel was observed by the air conditioner but is a specialized component that was not tested. Contact the seller to provide information on how it operates or have evaluated by a qualified irrigation professional.

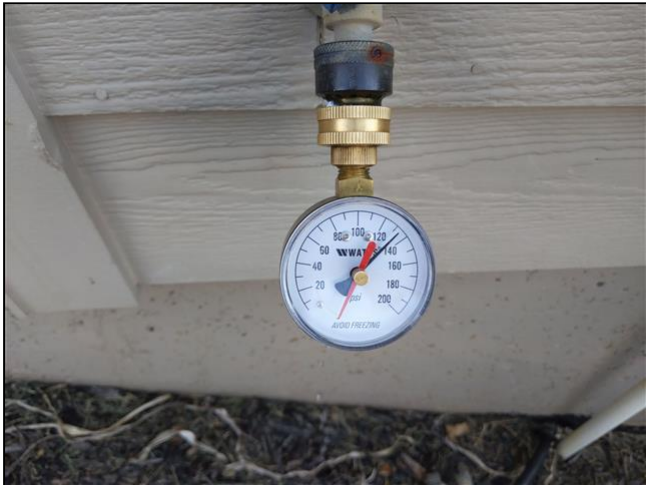
The water pressure for the whole house was tested at the exterior hose and found to be approximately 130psi, which is well above the maximum 80psi allowed for residential use. This can cause supply lines to burst and other plumbing problems and usually indicates the pressure reducing valve (PRV) has gone bad. Have further evaluated and repaired by a qualified plumber.

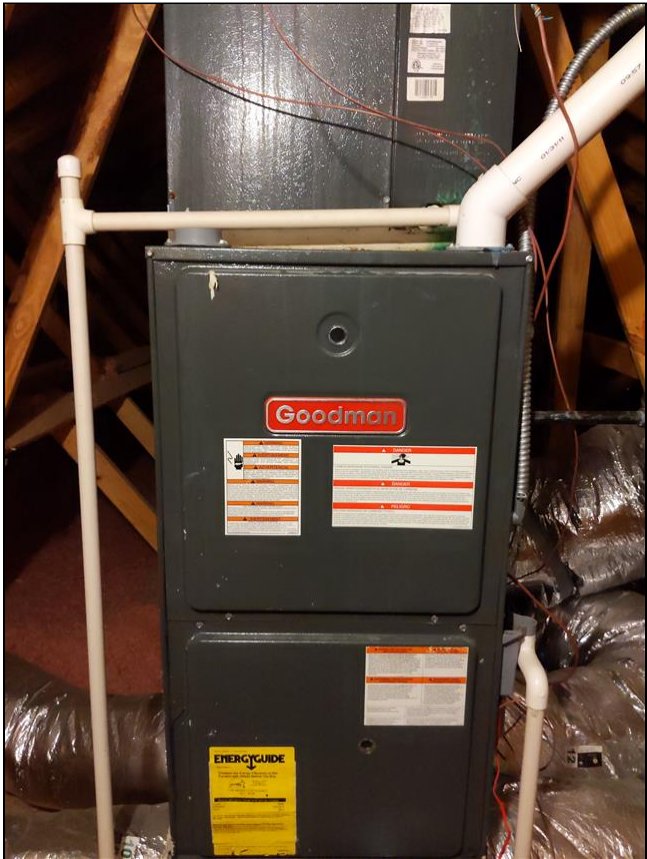
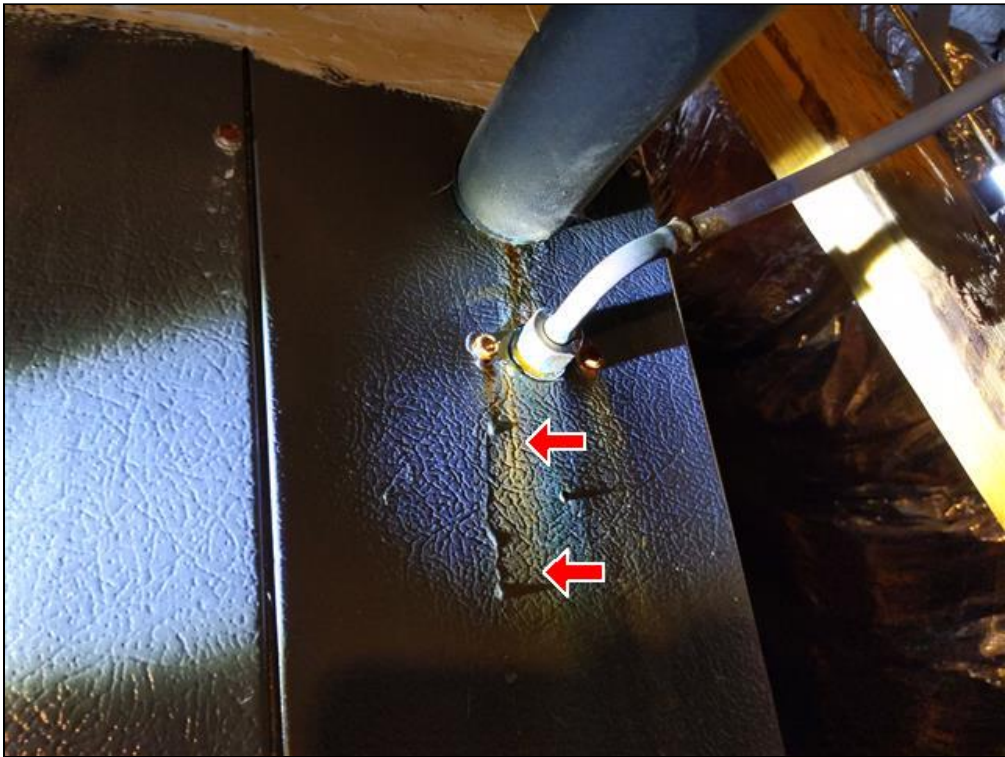
Sweating and rust to the furnace in the attic at the coil entrance. Recommend having a qualified HVAC contractor evaluate.

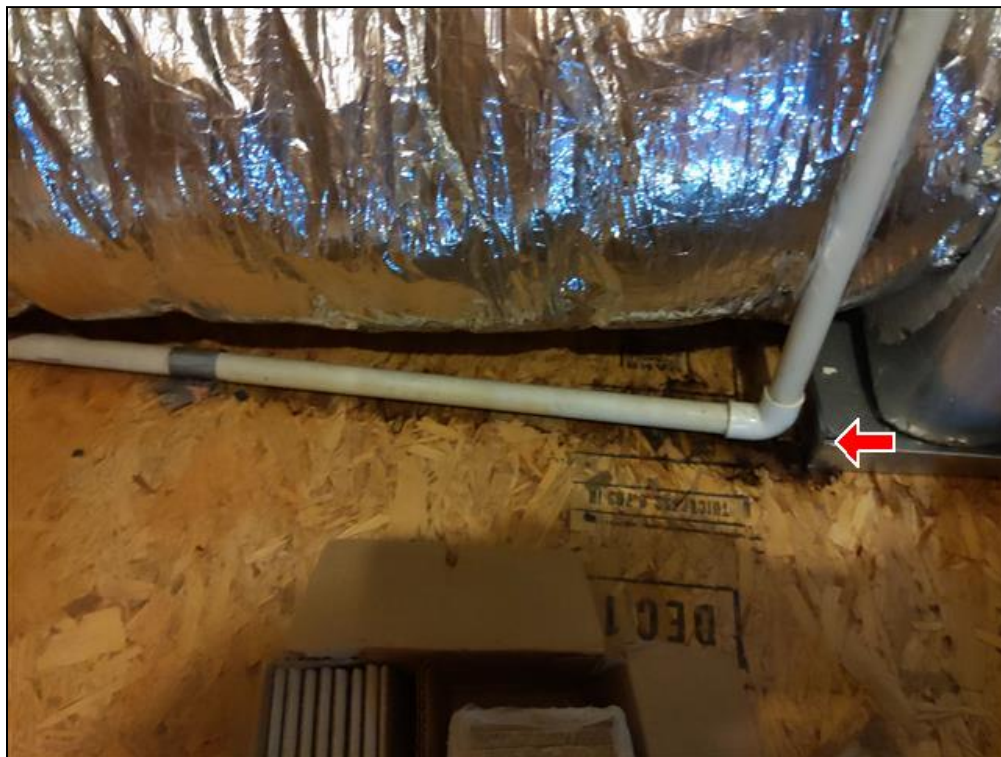
Sleeve insulation is needed on the condensate drain line trap in the attic to prevent the pipe from sweating in the summer.

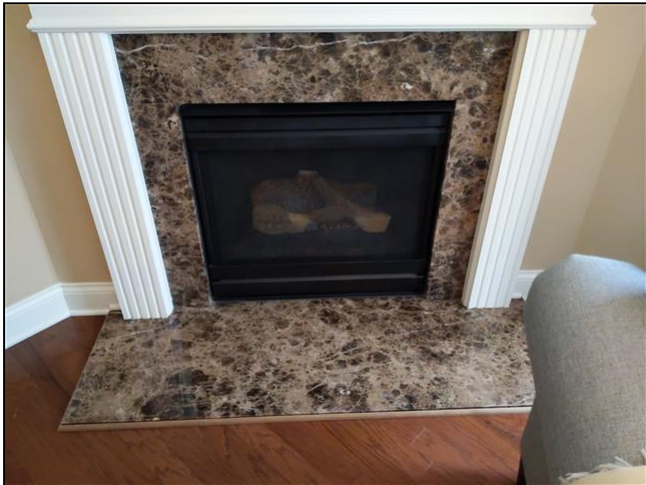
I was unable to light the fireplace using normal controls. Recommend current homeowner prove functionality.
