INSPECTION REPORT
1130 Compton Way
Suwanee GA 30024

INSPECTED BY
Shane Gauthier
Encompass Home
Inspections

7/24/2020

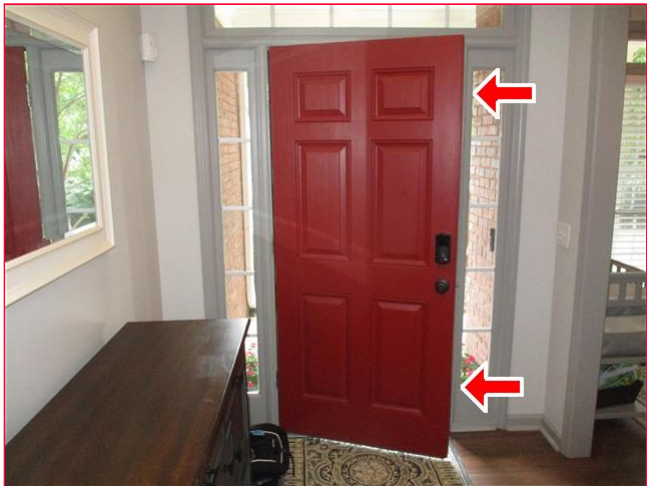
SERVICE / REPAIR: The exterior door sticks and is difficult to operate at front entrance. Modify or repair as necessary to operate normally.

3.6 Item 1(Picture) front entrance door (possible loose hinges)

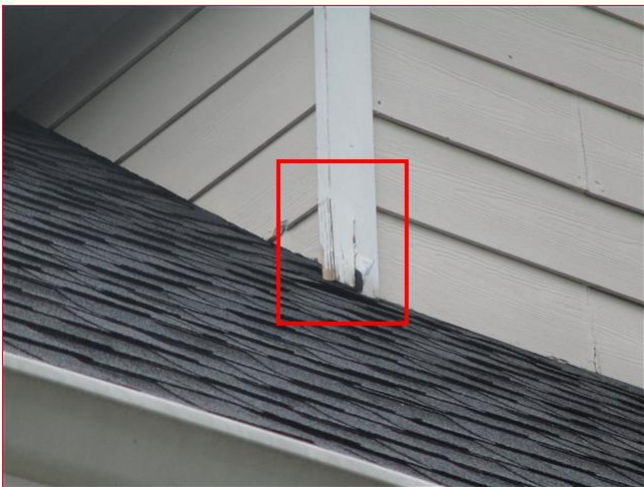
3.7 Item 1(Picture) right side of the house q

SERVICE / REPAIR: Wood rot and deterioration are present. Evaluate all areas and replace/repair all wood rot to the extent found to prevent further damage to any area. All replacement wood should be primed on all sides, caulked and painted as required. Any damage on the exterior wall or trim that allows openings into the wall cavity or interior can cause significant water damage over time if not repaired.

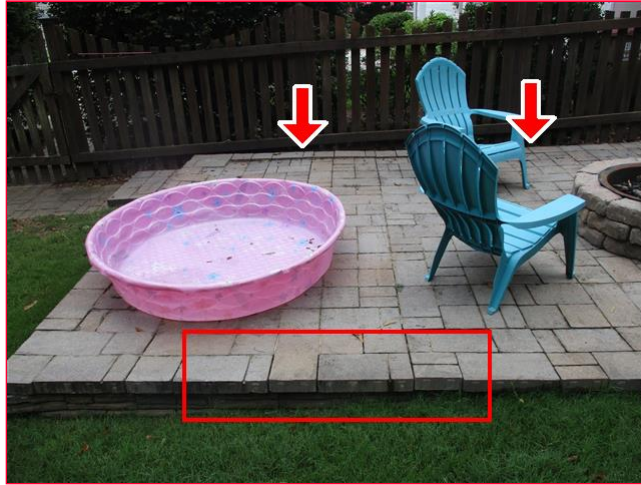
SAFETY / HEALTH: Loose and uneven areas of patio surfaces noted from settling/erosion of the base material. Recommend a landscaper to repair.

3.13 Item 1(Picture) uneven and loose walking surfaces at the rear paver patio

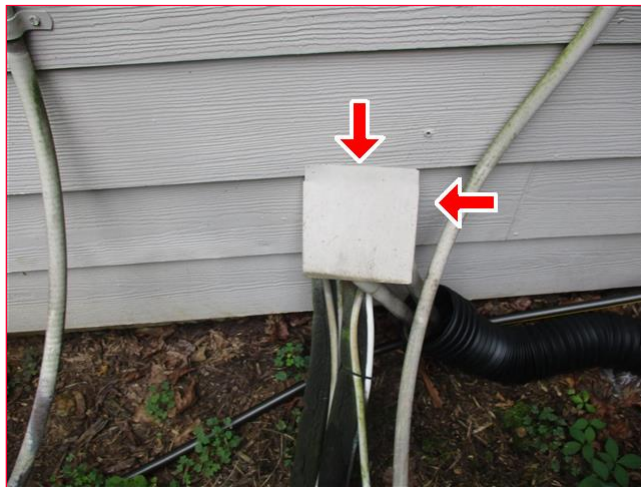
SERVICE / REPAIR: Missing/ damaged vent cover noted. Replacement is necessary to prevent pest and water entry.

3.21 Item 1(Picture) replace the damaged vent hood on the left side of the house at the HVAC lines

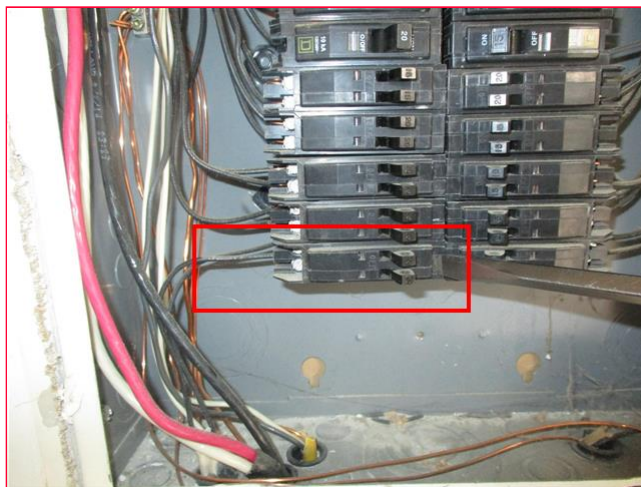
SAFETY / HEALTH: Breaker (or fuse) oversized for circuit wire serving the main panel box. Should be 15 amp maximum due to serving a 14 gauge circuit. Replacement by electrician recommended - confirm that not oversized for other reasons that should be corrected.

6.3 Item 1(Picture) lower left breaker

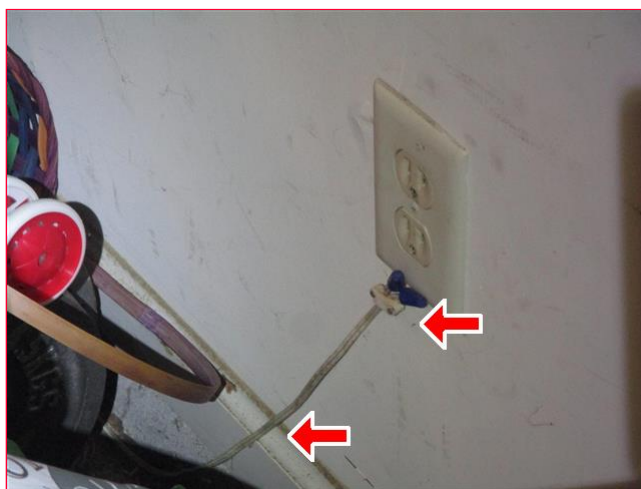
SERVICE / REPAIR: Lower voltage wiring (similar to a lamp cord) is in use as permanent wiring. This wiring is not intended to be used for permanent use and needs to be replaced. Advise a licensed electrician to correct as needed for safety.

6.4 Item 1(Picture) garage: have the wiring corrected for safety and the spliced connection contained in a junction box with a cover

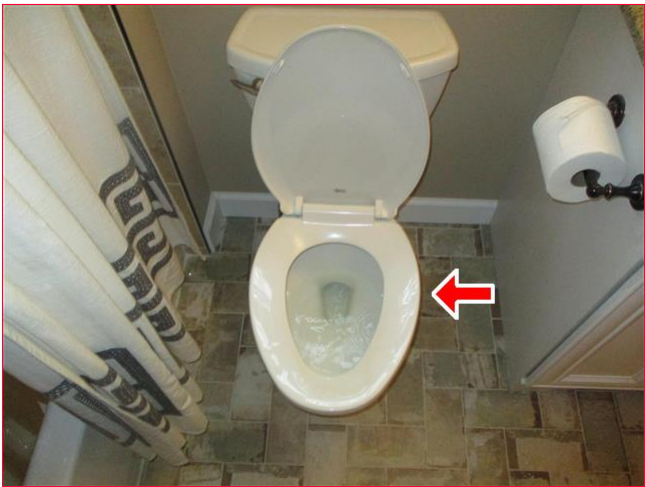
12.1 Item 1(Picture) second floor hall bath

(1) **SERVICE / REPAIR:** The toilet is loose at the base when checked. This is allowing the base to pivot and often results in leaking if not corrected. Recommend that the condition be corrected.

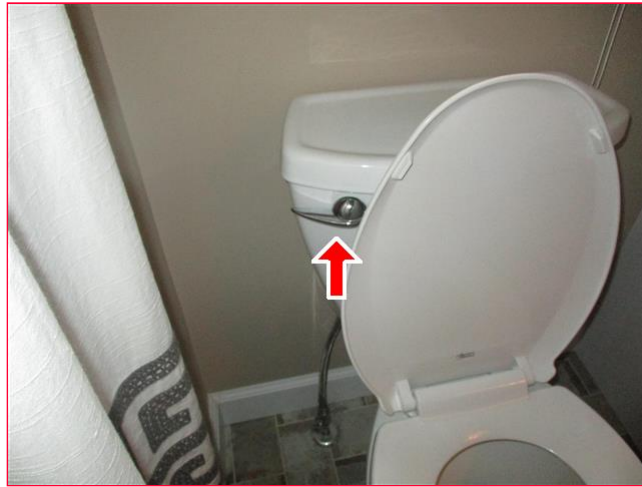
12.1 Item 4(Picture)

(2) **SERVICE / REPAIR:** Flushing the toilet at Upstairs hall bathroom requires holding down the handle to flush completely. Recommend having tank assembly modified to flush with a normal push down and release to obtain normal flush. Recommend that the condition be corrected.

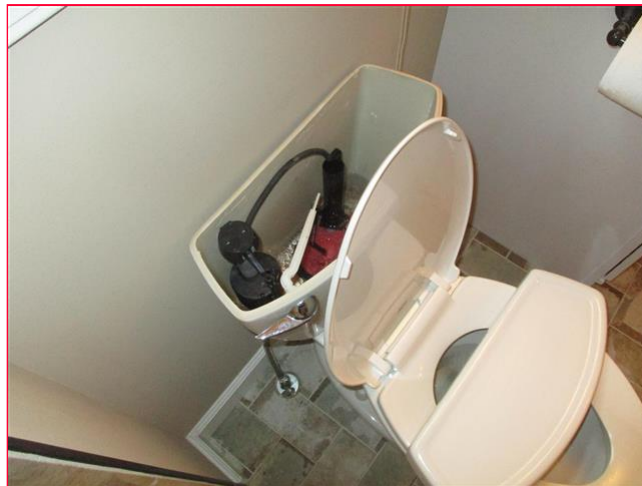
12.1 Item 5(Picture) upstairs hall bath

(3) **SERVICE / REPAIR:** Toilet found to fill slowly after flushing. Have fill device repaired or replaced to function normally..

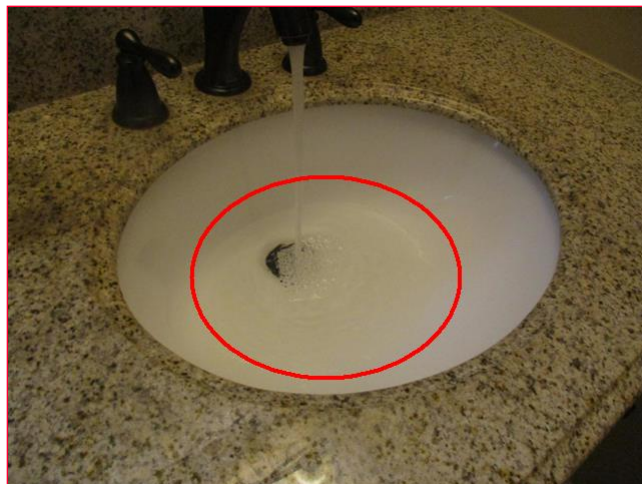
12.2 Item 1(Picture) upstairs hall bath

(1) **SERVICE / REPAIR:** Slow drain observed at Upstairs hall bathroom sink and should be cleaned and/or cleared to function normally. May require disassembly of drain line to clear properly.

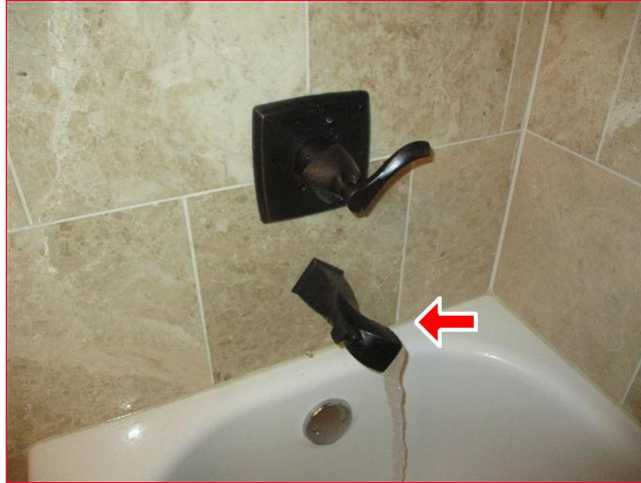
(2) **SERVICE / REPAIR:** Fill spout not tight to tub wall at Upstairs hall bathroom. Modify and seal to prevent moisture access behind wall assembly.

12.3 Item 2(Picture) tub spout is loose and should be secured, once secured seal around to keep water from entering the wall

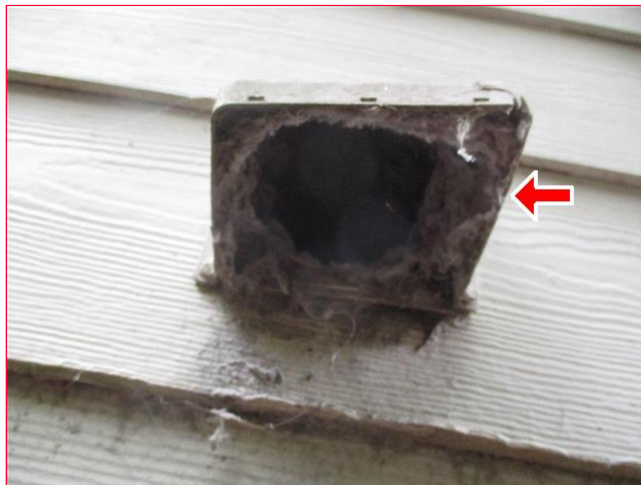
SERVICE / REPAIR: The damper on the end of the dryer vent is full of lint. Have the vent cleaned for maximum efficiency and to prevent animal entry. Hood located on side of house.

13.1 Item 1(Picture) clear all lint from the dryer line

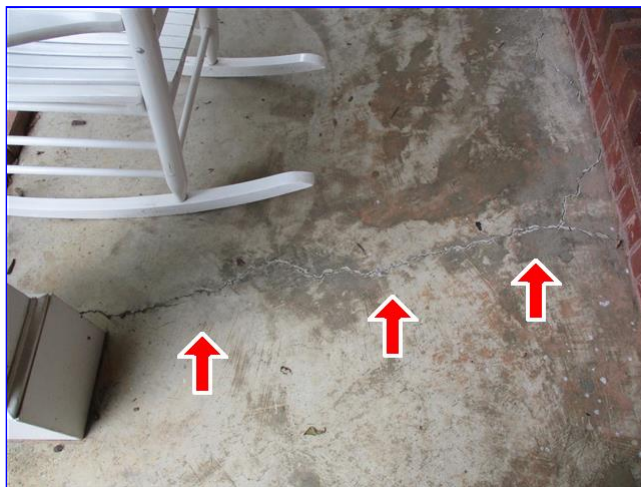
3.3 Item 1(Picture) sample photo

SERVICE / REPAIR: Cracks present. This is an indication of settling. We are unable to determine if it is a past problem or an ongoing one. This area should be monitored as repairs may be necessary in the future. If one side of the crack is raised enough to trip over, it is a safety hazard as well as an indication of uneven ground movement. Recommended to seal all open cracks to avoid rain water subsurface erosion and damage from ice.

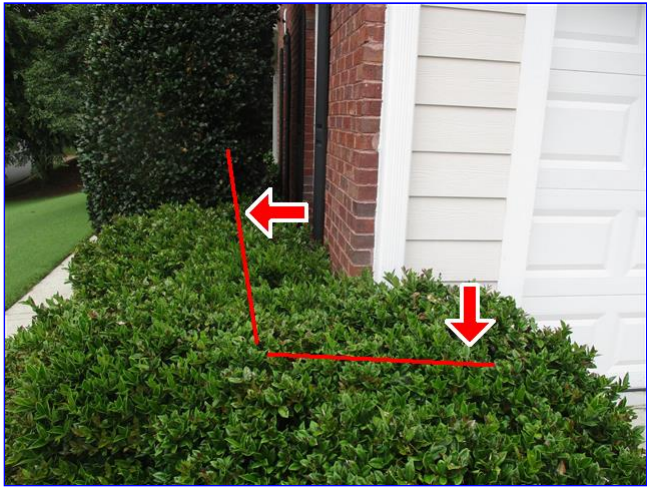
GENERAL NOTE: Plant growth adjacent to building limits inspection of wood trim elements. Keep trimmed back to reduce chances of developing moisture damage. If damage found after trimming back, have repaired or replaced as necessary.

3.22 Item 1(Picture) trim all vegetation to allow for at least a 12 to 18 inch gap

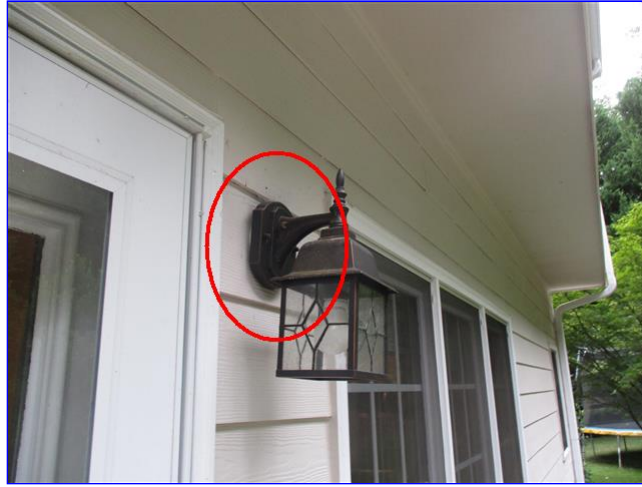
SERVICE / REPAIR: Loose lighting fixture noted. Recommend condition be corrected to prevent stress on wires and the potential for electric shock.

6.8 Item 1(Picture) secure all loose light fixtures and seal around to prevent water entry

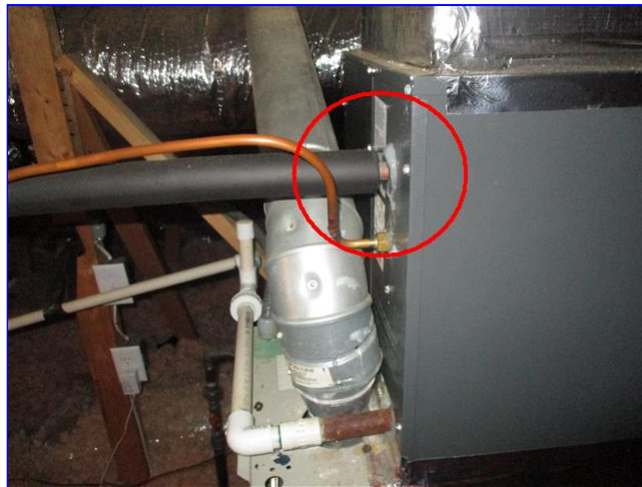
7.0 Item 5(Picture) attic

(3) **SERVICE / REPAIR:** The insulation on the A/C refrigerant line(s) does not extend all the way to the coil housing. This can allow condensate to drip into the furnace or onto other surfaces below. Recommend install insulation where missing.

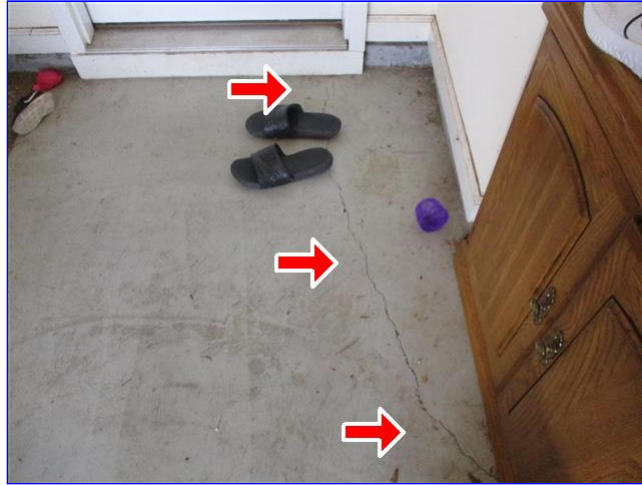
9.3 Item 1(Picture)

GENERAL NOTE: Common cracks observed in the concrete surfaces. These are expected and are not generally considered significant. Monitor conditions that should not exceed 1/4 inches width or significant differential settlement.

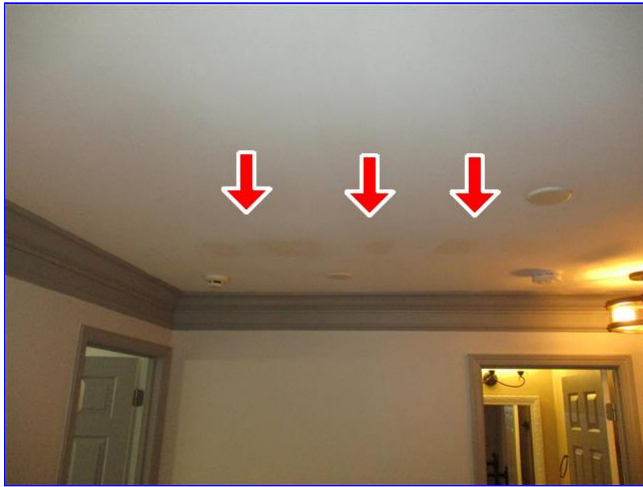
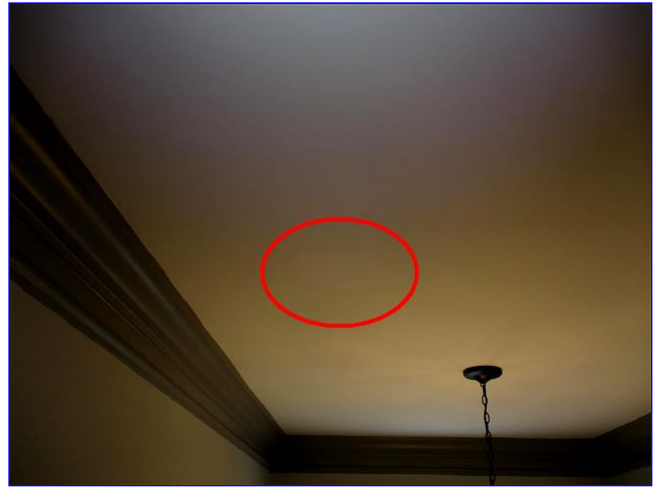
GENERAL NOTE: Touch ups and repairs noted in ceiling(s) during inspection. Seller to disclose cause of problem including extent of repairs made for buyer's future reference. Usually requires full area painting to reduce obvious conditions. Primer needed on stained areas to avoid bleeding back through when painted.

10.0 Item 1(Picture) second floor hall

10.0 Item 2(Picture) second floor hall

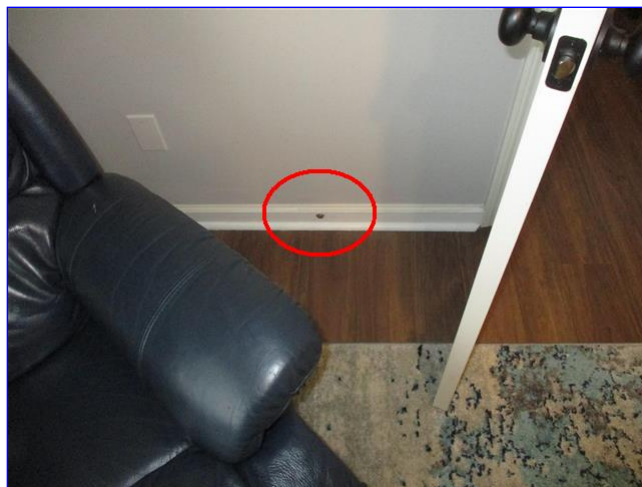
GENERAL NOTE: Door stops are typically installed to provide protection to walls from door knob contact and generally found in wall, floor or hinge mount types. Some found either damaged or missing and consider having installed.

10.2 Item 1(Picture) install door stops at all locations missing them

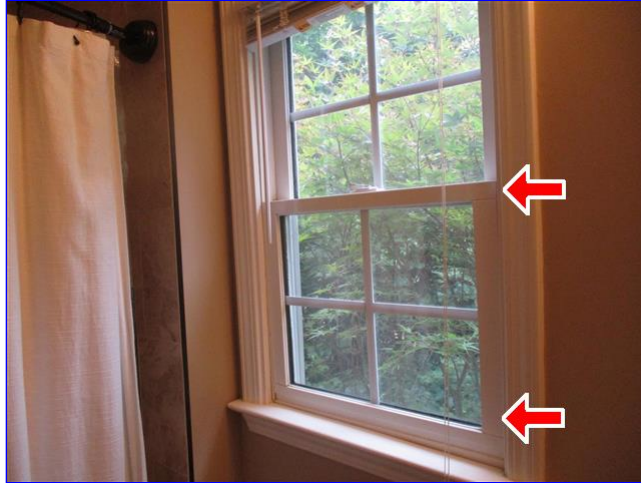
SERVICE / REPAIR: Paint causes many windows to stick and they should be modified to open normally for the average person. At least one window in each sleeping room must be operable as a means of emergency egress.

10.3 Item 1(Picture) repair all windows so they will open for safety and ventilation of the house

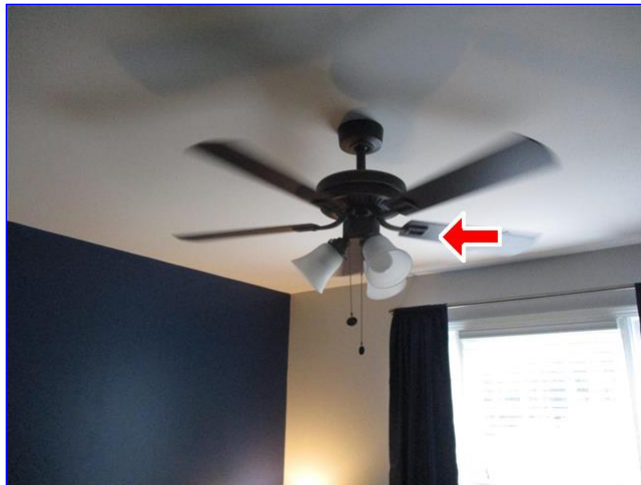
10.6 Item 1(Picture) front bedroom

SERVICE / REPAIR: Ceiling fan somewhat out of balance and produces an unsafe feeling during operation at certain speeds. Correct to function normally.

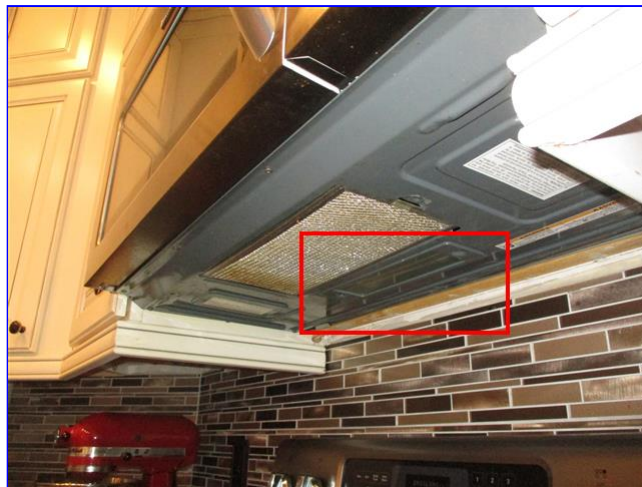
SERVICE / REPAIR: Microwave surface light not functional at time of inspection. Verify if bulb is burned out and repair if required.

11.6 Item 1(Picture) replace the bulb and test the appliance for function

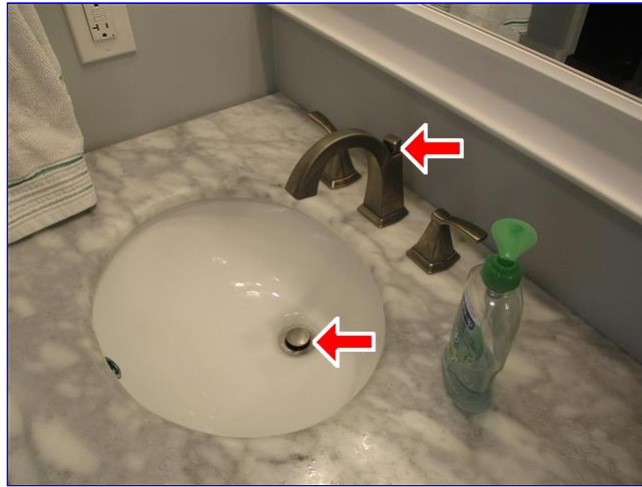
12.2 Item 2(Picture) left side sink

(2) **SERVICE / REPAIR:** Pop up drain assembly not functional should be repaired or replaced at Master bathroom vanity sink(s).

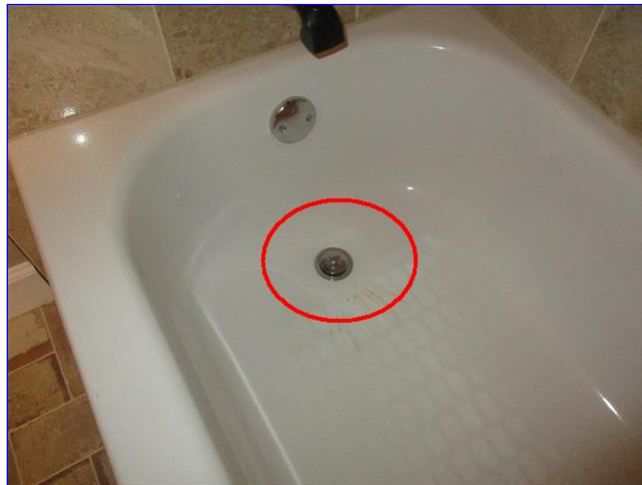
12.3 Item 1(Picture) hall bathroom

(1) **SERVICE / REPAIR:** Tub stopper installed fails to engage to hold water as would be necessary for taking baths at Upstairs hall bathroom. Have device repaired or replaced.

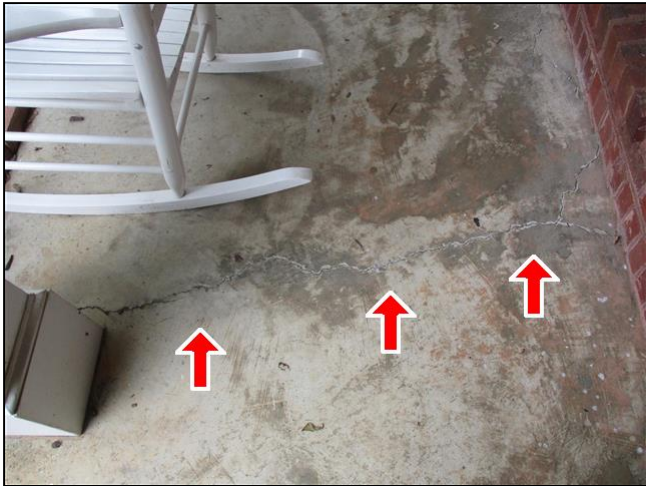
3.3 Item 1(Picture) sample photo

SERVICE / REPAIR: Cracks present. This is an indication of settling. We are unable to determine if it is a past problem or an ongoing one. This area should be monitored as repairs may be necessary in the future. If one side of he crack is raised enough to trip over, it is a safety hazard as well as an indication of uneven ground movement. Recommended to seal all open cracks to avoid rain water subsurface erosion and damage from ice.

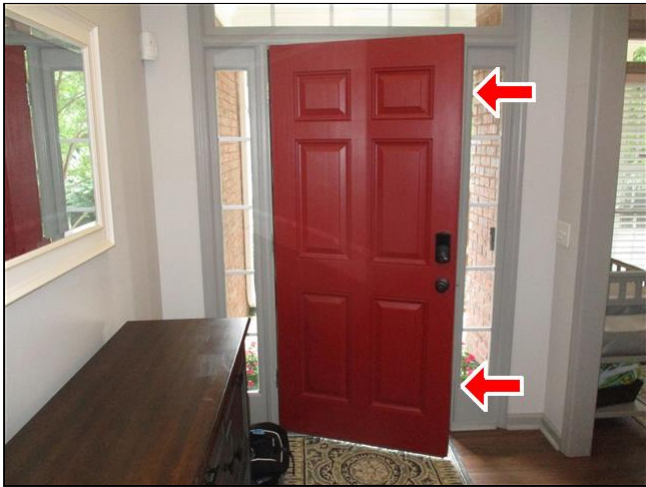
SERVICE / REPAIR: The exterior door sticks and is difficult to operate at front entrance. Modify or repair as necessary to operate normally.

3.6 Item 1(Picture) front entrance door (possible loose hinges)

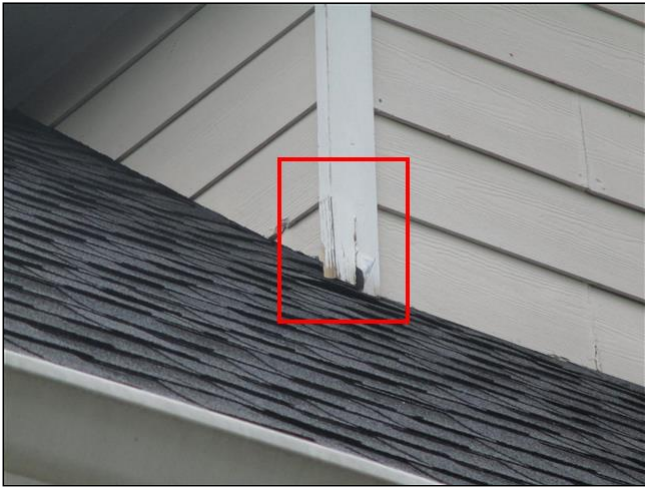
3.7 Item 1(Picture) right side of the house q

SERVICE / REPAIR: Wood rot and deterioration are present. Evaluate all areas and replace/repair all wood rot to the extent found to prevent further damage to any area. All replacement wood should be primed on all sides, caulked and painted as required. Any damage on the exterior wall or trim that allows openings into the wall cavity or interior can cause significant water damage over time if not repaired.

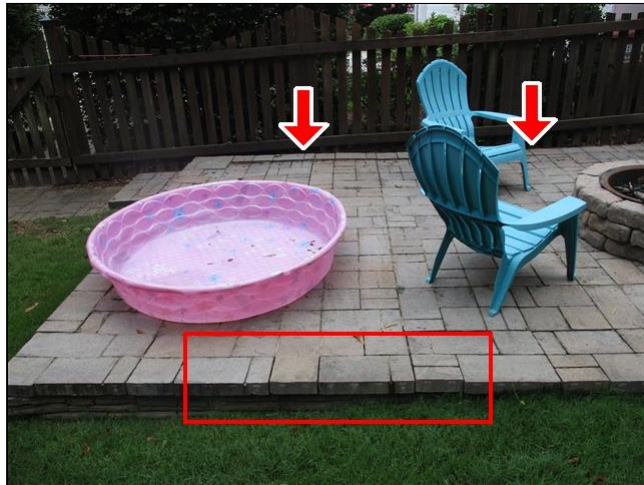
SAFETY / HEALTH: Loose and uneven areas of patio surfaces noted from settling/erosion of the base material. Recommend a landscaper to repair.

3.13 Item 1(Picture) uneven and loose walking surfaces at the rear paver patio

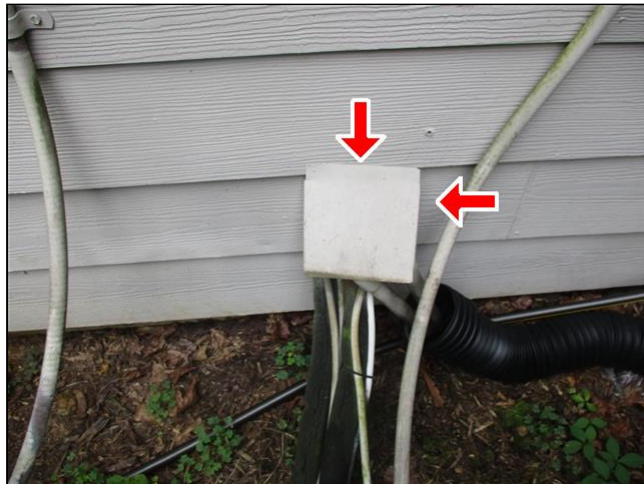
SERVICE / REPAIR: Missing/damaged vent cover noted. Replacement is necessary to prevent pest and water entry.

3.21 Item 1(Picture) replace the damaged vent hood on the left side of the house at the HVAC lines

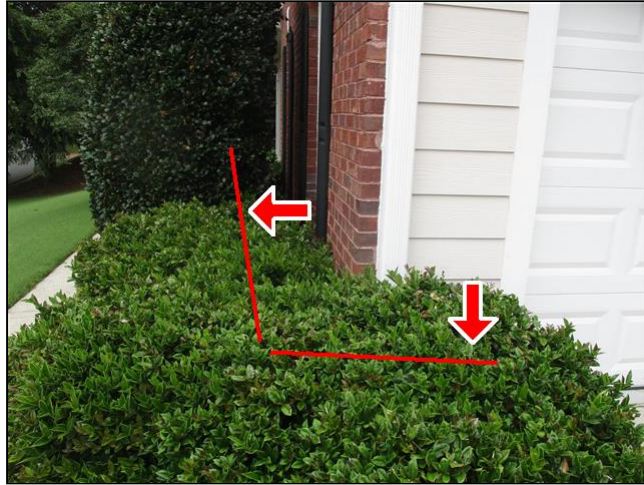
GENERAL NOTE: Plant growth adjacent to building limits inspection of wood trim elements. Keep trimmed back to reduce chances of developing moisture damage. If damage found after trimming back, have repaired or replaced as necessary.

3.22 Item 1(Picture) trim all vegetation to allow for at least a 12 to 18 inch gap

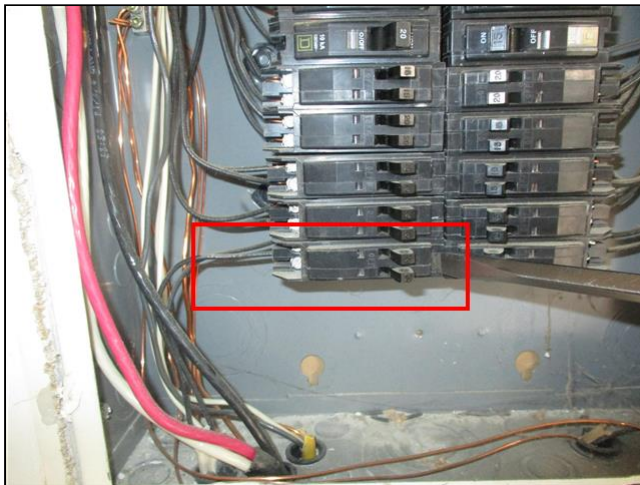
SAFETY / HEALTH: Breaker (or fuse) oversized for circuit wire serving the main panel box. Should be 15 amp maximum due to serving a 14 gauge circuit. Replacement by electrician recommended - confirm that not oversized for other reasons that should be corrected.

6.3 Item 1(Picture) lower left breaker

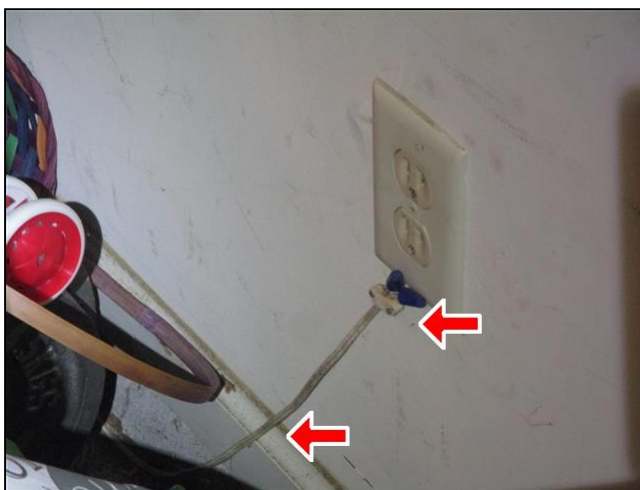
SERVICE / REPAIR: Lower voltage wiring (similar to a lamp cord) is in use as permanent wiring. This wiring is not intended to be used for permanent use and needs to be replaced. Advise a licensed electrician to correct as needed for safety.

6.4 Item 1(Picture) garage: have the wiring corrected for safety and the spliced connection contained in a junction box with a cover

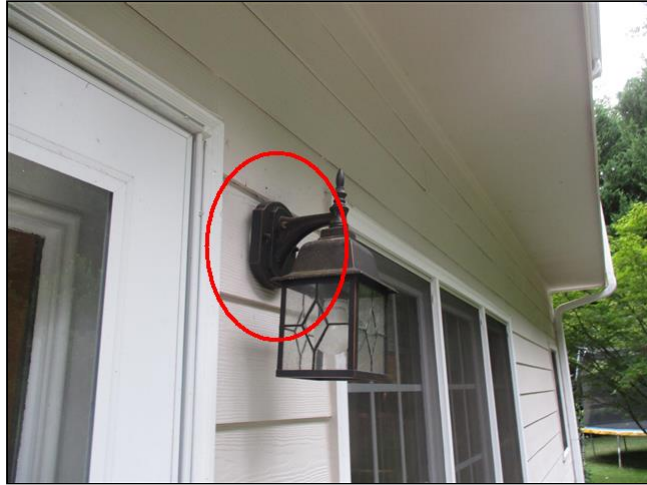
SERVICE / REPAIR: Loose lighting fixture noted. Recommend condition be corrected to prevent stress on wires and the potential for electric shock.

6.8 Item 1(Picture) secure all loose light fixtures and seal around to prevent water entry

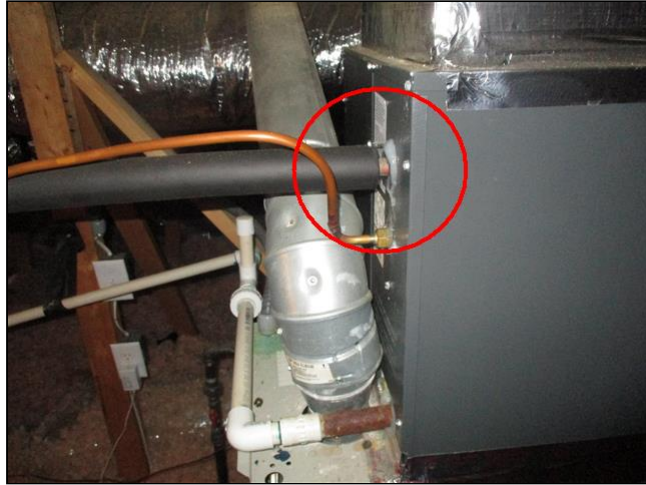
7.0 Item 5(Picture) attic

(3) **SERVICE / REPAIR:** The insulation on the A/C refrigerant line(s) does not extend all the way to the coil housing. This can allow condensate to drip into the furnace or onto other surfaces below. Recommend install insulation where missing.

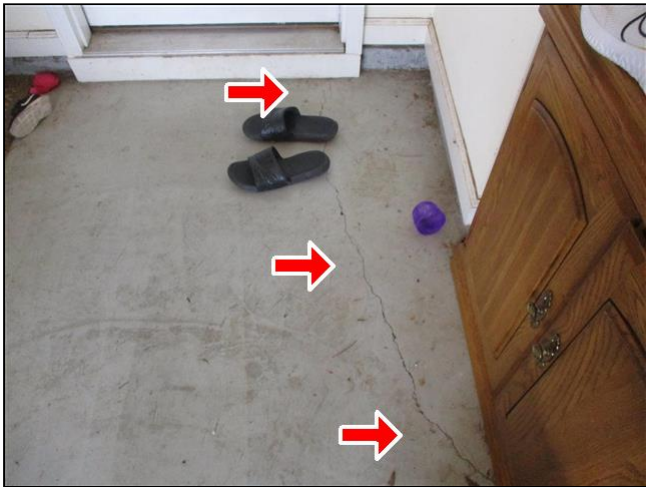
9.3 Item 1(Picture)

GENERAL NOTE: Common cracks observed in the concrete surfaces. These are expected and are not generally considered significant. Monitor conditions that should not exceed 1/4 inches width or significant differential settlement.

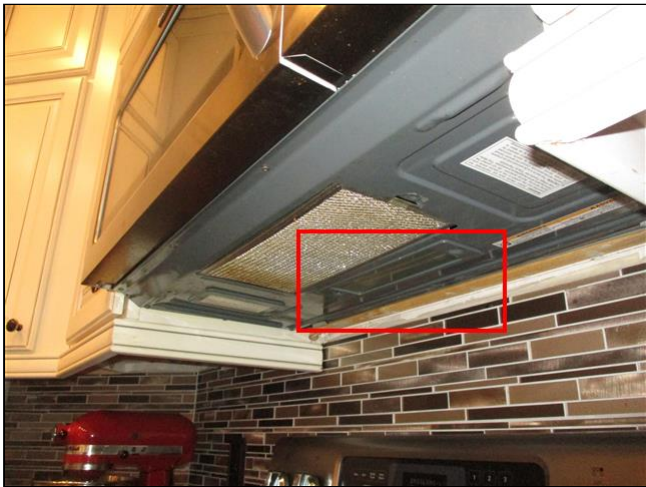
SERVICE / REPAIR: Microwave surface light not functional at time of inspection. Verify if bulb is burned out and repair if required.

11.6 Item 1(Picture) replace the bulb and test the appliance for function
