Trademark Home Inspection Co.

Inspection Report

3555 Horizon Ct, Cumming, GA 30041

Date of Inspection: 7/28/2020 Time: 09:00am

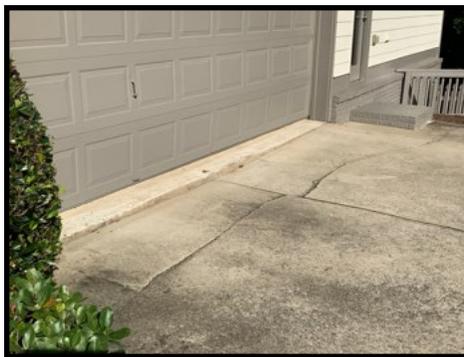
1.2. Minor settlement and uneven cracks noted. The cracks may present a trip hazard and should be leveled and repaired as needed.

Cracked/displaced section of driveway

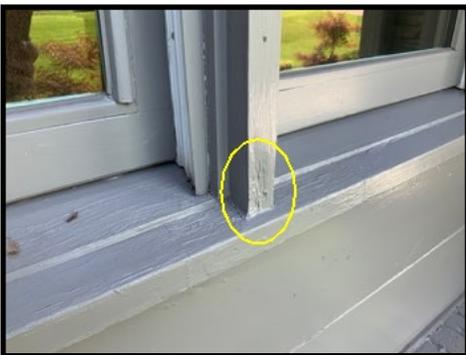
3.4. Several areas of the trim around the home are damaged and should be repaired. Aside from the visibly damaged trim, any non visible materials that may have been also damaged should be repaired as well. See photographs for examples and locations.

Damaged trim at the front sitting room window

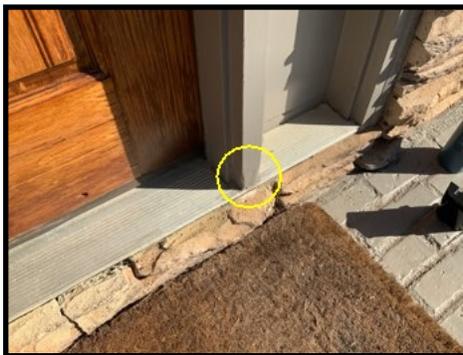
Damaged trim at the front entry door

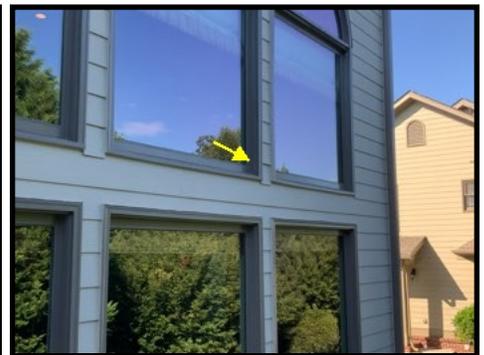
Damaged trim at the rear living room window

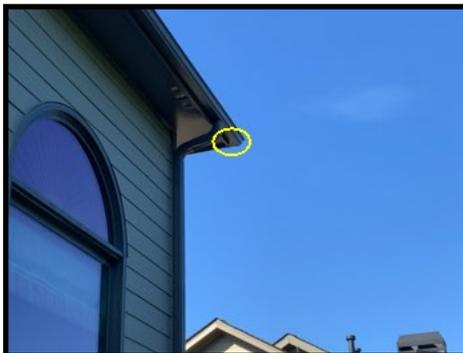
Damaged fascia at the left rear corner of the home

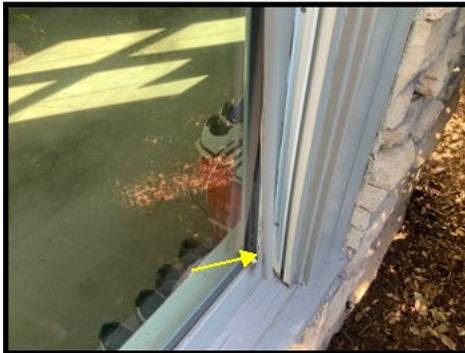
5.3. Damage is noted at the sash of the window at the garage. Damage to the sash usually requires replacement of the window.

Damaged trim at the front garage window

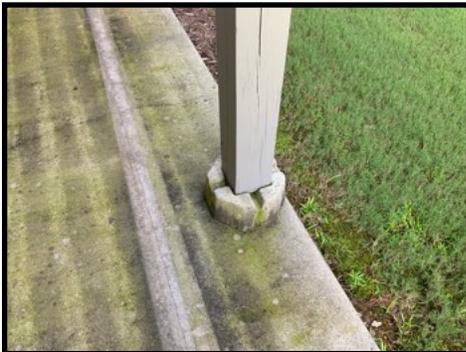
1.4. The minimum width of the footings should be is 12 inches, patios and pre-cast concrete piers do not qualify as proper footing for deck construction. We recommend a review of the deck footings by a qualified deck contractor

1.5. Support post not anchored to the slab or footing. Anchored post prevent lateral displacement and uplift. Have supports and footings reviewed and repaired by a licensed decking contractor as needed.

Pre-cast footings should be replaced with adequate/secured footings

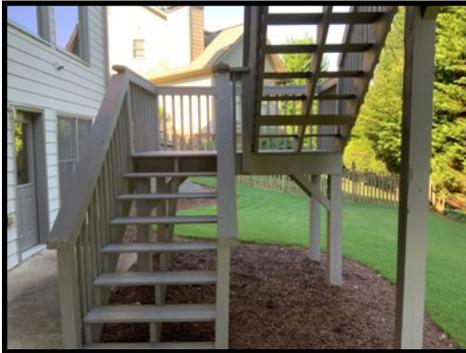
2.1. Open risers noted at stairs outside the home. This is a possible fall hazard for small children. It is recommended to have these closed off if small children are present. See photographs for locations and examples.

Open risers at exterior stairs

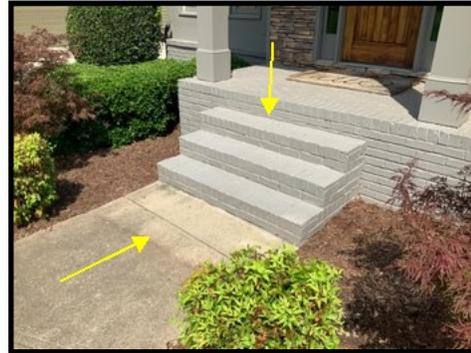
2.2. Front stoop stairs and sidewalk have settled and should be repaired as needed. Recommend further evaluation by a qualified contractor.

Settlement at front stoop/sidewalk

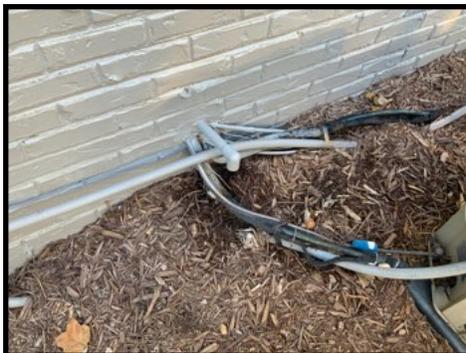
Condensate drain lines should be extended away from the home

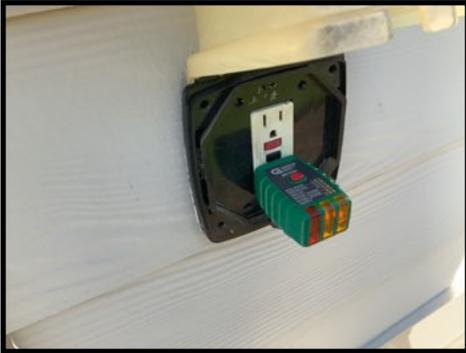
7.3. Multiple GFCI outlets around the home did not trip when tested and should be replaced. Have a licensed electrician correct. Exterior outlets may fail over time and should be repaired as needed.

Faulty GFCI outlet at the right side of the home

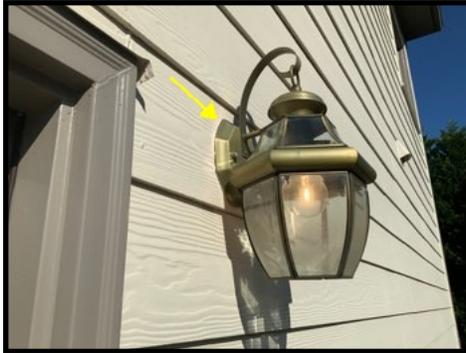
Caulk exterior light fixtures around the home as needed

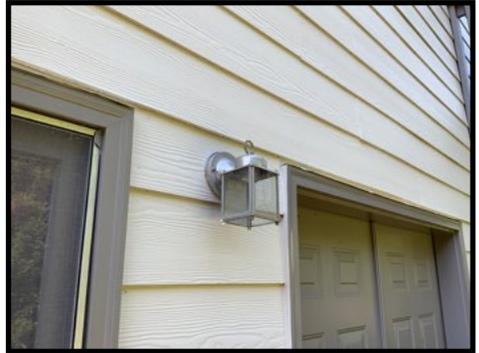
7.2. One or more exterior light bulbs appeared to be blown. Have replaced as needed. If replacing the bulb does not fix the issue, consult with a licensed electrician for further.

Inoperable light fixture at the rear basement door

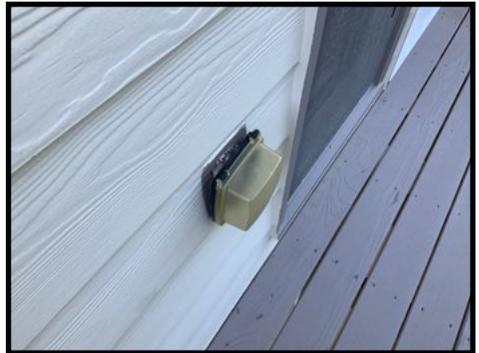
Loose cover at the rear deck

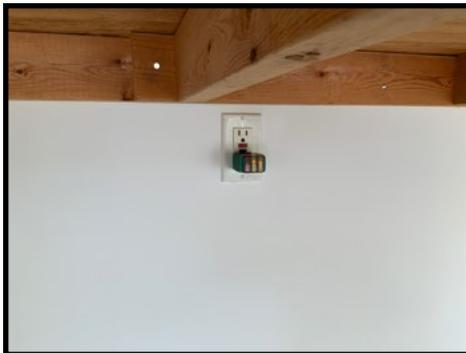
Faulty GFCI outlet in the garage

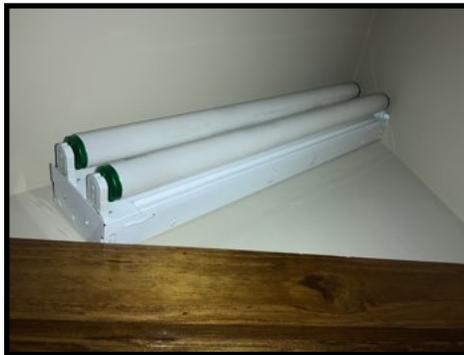
8.4. Multiple non functioning lights noted around the home. Most likely these are due to blown bulbs. Suggest replacing bulbs for proper operation. If replacing the bulbs does not fix the issue, consult a licensed electrician to respond and repair. See photographs for locations and details.

Inoperable light fixture in the basement bedroom closet

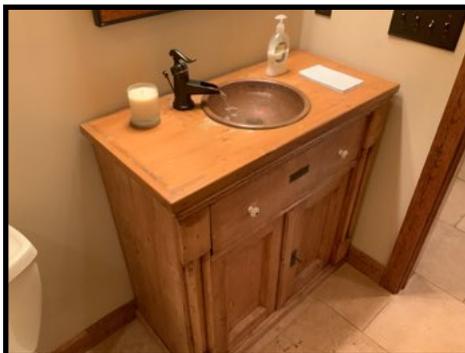
3.1. Loose freestanding sink/cabinet combination noted in the home. Suggested to have secured to prevent any possible tipping and subsequent damage to the water lines. See photographs for locations.

Secure the loose vanity in the basement level bathroom

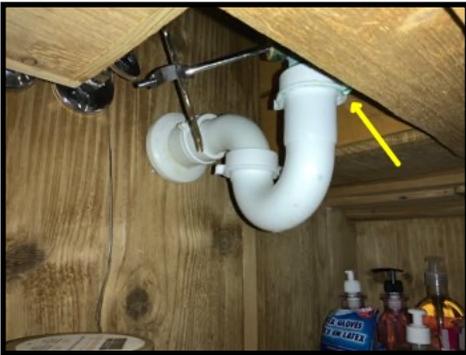
4.4. Leaking noted at the drain lines beneath one or more bathroom sinks. Suggested to have the drain lines reviewed and repaired by a licensed plumber as needed. See photographs for locations.

Active leak at the basement bathroom sink drain

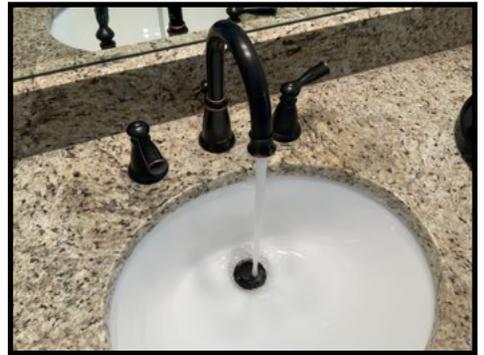
Non functioning drain stopper at the left side master bathroom sink

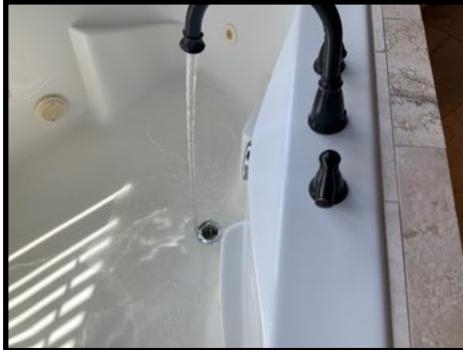
Missing drain stopper at the master bathroom tub

6.2. Motor briefly activated to ensure motor was serviceable. Due missing drain stopper, the tub was not filled to test water flow through jets.

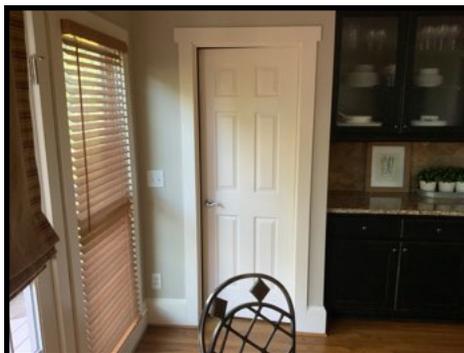
4.1. One or more misaligned doors noted inside the home. It is not uncommon for interior doors to not latch properly or stick on the frame. Typically minor adjustments are all that are needed to correct the situation. See photographs for locations and details.

Kitchen pantry door does not latch properly

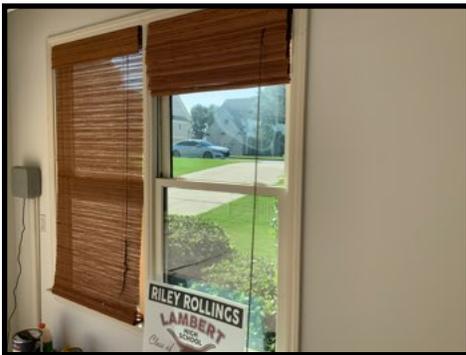
5.3. Fogging or condensations noted at one or more interior thermal pane windows around the home. This is indicative of a broken seal which will reduce visibility and the insulating capability of this window. To restore visibility and regain the insulating capability, replacement of this window pane is required. See photographs for locations and details.

Fogged glass at the front garage window

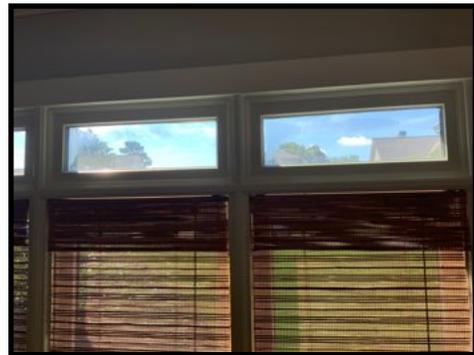
Fogged glass at the front dining room windows
