# Inspection Report

385 Woodbrook Way

Lawrenceville, GA 30043

Saturday, August 01, 2020

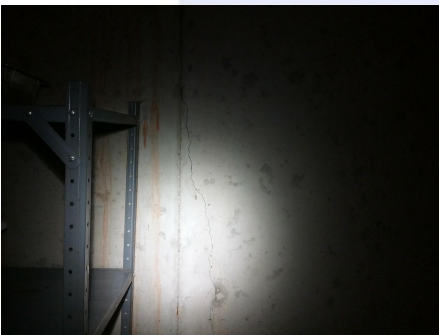
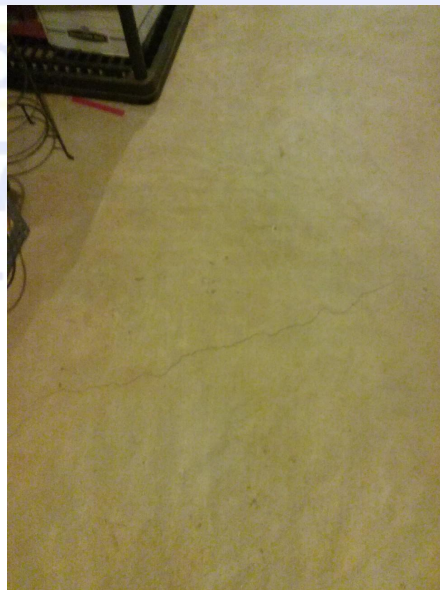
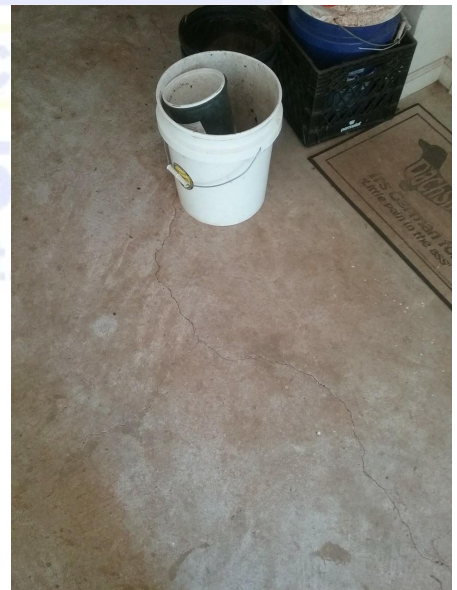
**15:** Small cracks less than 1/8" were observed at front center and left side foundation wall/slab. Small cracks are not unusual in any building and they can occur for a variety of reasons. We cannot legally render an opinion without being a licensed structural engineer. If cracks grow to exceed 1/4" in width across the crack further evaluation would be warranted. Smaller cracks are usually just monitored for future movement before repairs are undertaken. We recommend you inquire with the seller as to any past history of movement, history of evaluation and/or repairs attempted.

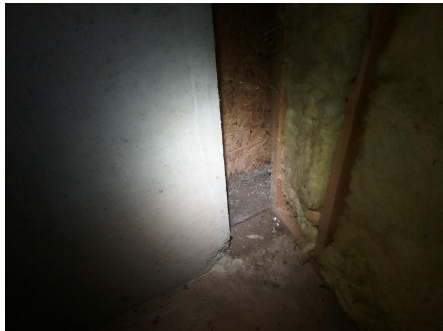
**s-17:** Stains noted on wood trim or the foundation wall were visible in the left side of the basement. As these stains appear to be inactive at the time of the inspection we recommend monitoring in the future for any evidence of moisture intrusion.

**17:** Stains noted on wood trim or the foundation wall were visible in the left side of the basement. As these stains appear to be inactive at the time of the inspection we recommend monitoring in the future for any evidence of moisture intrusion.

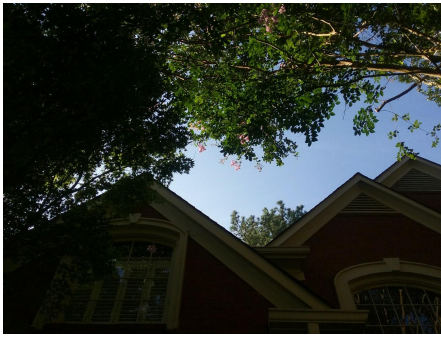
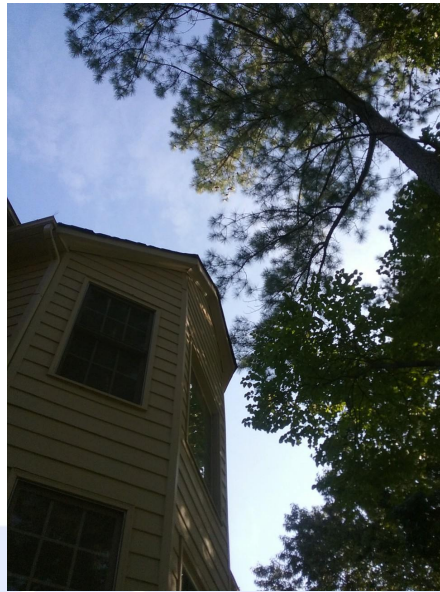
**s-28:** Trees are touching or overhanging the front right and rear center of the roof. Recommend trimming to avoid roof surface damage and wildlife entry.

**28:** Trees are touching or overhanging the front right and rear center of the roof. Recommend trimming to avoid roof surface damage and wildlife entry.

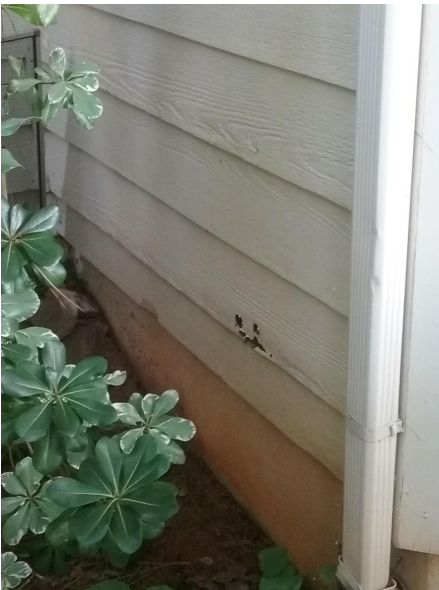
**s-35:** Swelling/moisture damage observed at the following locations: rear right

**35:** Swelling/moisture damage observed at the following locations: rear right

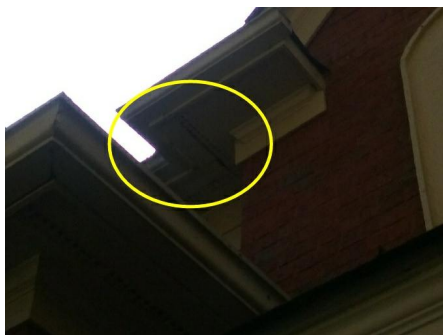
**s-38:** Moisture damaged exterior wood trim in need of repairs by a licensed contractor was observed at several locations around the exterior of the home to include but not limited to the front center

**38:** Moisture damaged exterior wood trim in need of repairs by a licensed contractor was observed at several locations around the exterior of the home to include but not limited to the front center

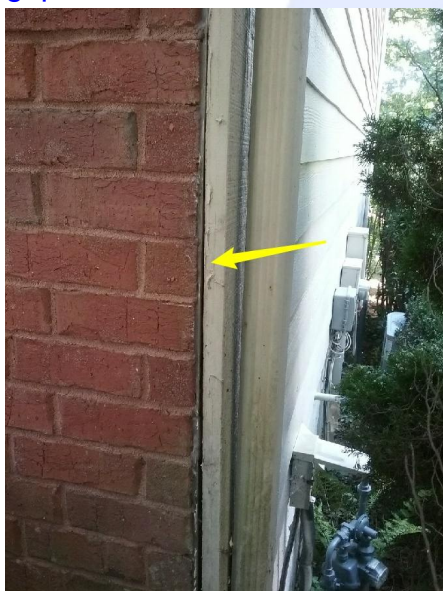
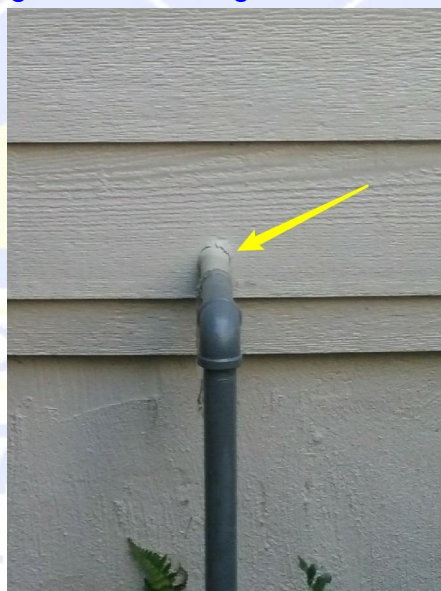
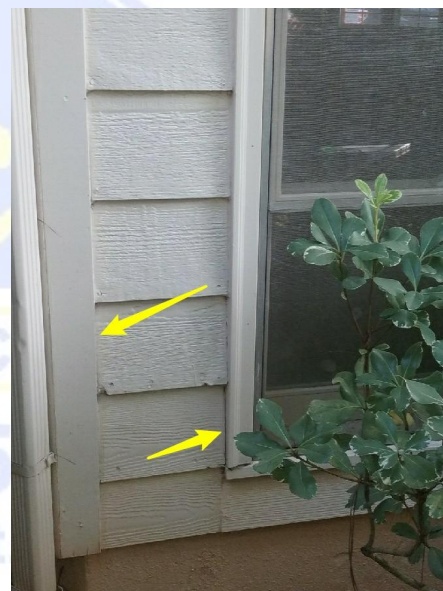
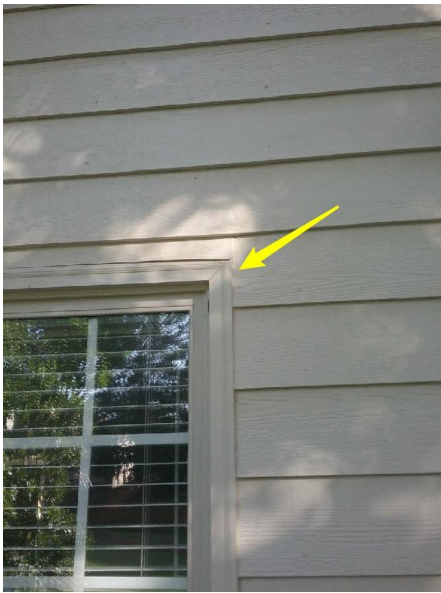
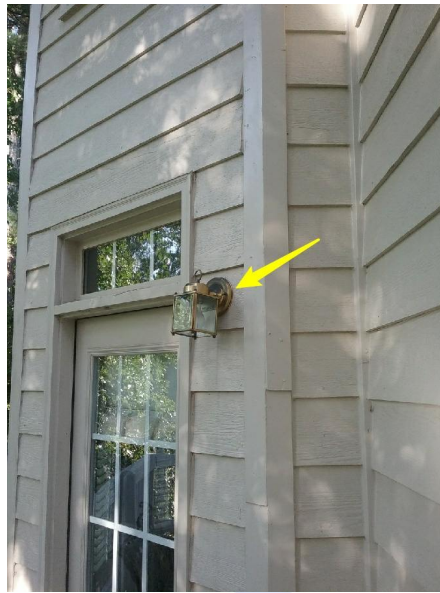
**s-39:** Unsealed caulking gaps observed at penetrations for wires/pipes/vents and dissimilar material junctions including and not limited to the front right trim, right side gas pipe, rear right window, rear center window, exterior lighting fixtures and electrical outlets . All penetrations should be completely sealed to prevent any possibility of water entry. Failure to properly seal all gaps can result in moisture damage to the framing.

**39:** Unsealed caulking gaps observed at penetrations for wires/pipes/vents and dissimilar material junctions including and not limited to the front right trim, right side gas pipe, rear right window, rear center window, exterior lighting fixtures and electrical outlets . All penetrations should be completely sealed to prevent any possibility of water entry. Failure to properly seal all gaps can result in moisture damage to the framing.

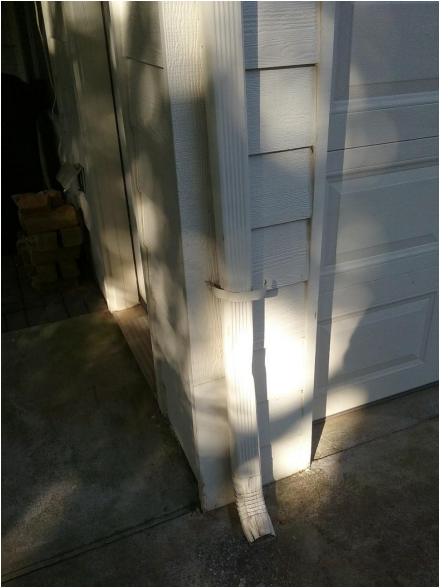
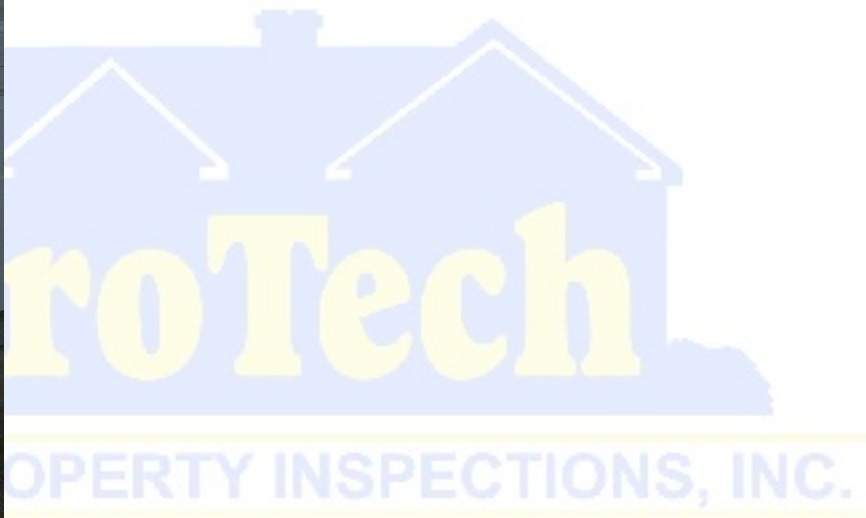
**s-57:** Secure downspouts to the wall where loose.

**57:** Secure downspouts to the wall where loose.

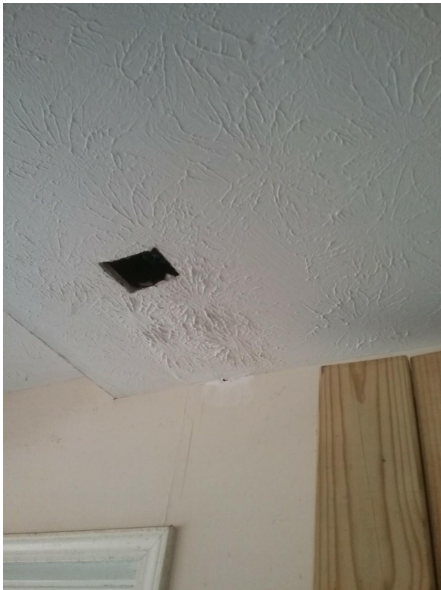
**59:** Repair/ seal any openings in the garage firewall with approved materials to restore its fire rating.

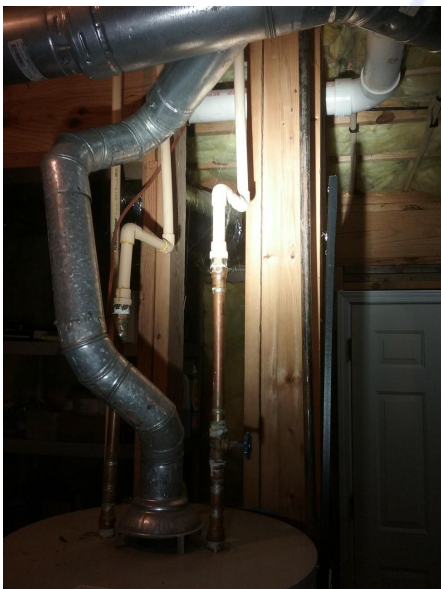
**s-74:** An expansion device was not present or visible on the cold water supply located near the water heater at the time of the inspection, we recommend further evaluation and repairs by a licensed plumbing contractor.

**74:** An expansion device was not present or visible on the cold water supply located near the water heater at the time of the inspection, we recommend further evaluation and repairs by a licensed plumbing contractor.

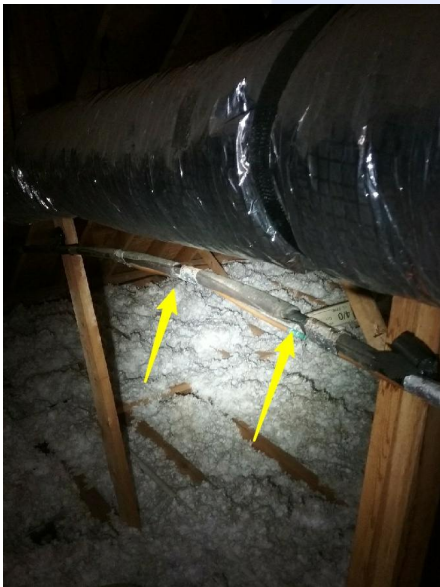
**s-90:** The suction line insulation is damaged in the attic and is needed for proper operation. If left in current condition, condensation can form on the outside of the refrigerant line and drip down onto finished surfaces.

**90:** The suction line insulation is damaged in the attic and is needed for proper operation. If left in current condition, condensation can form on the outside of the refrigerant line and drip down onto finished surfaces.

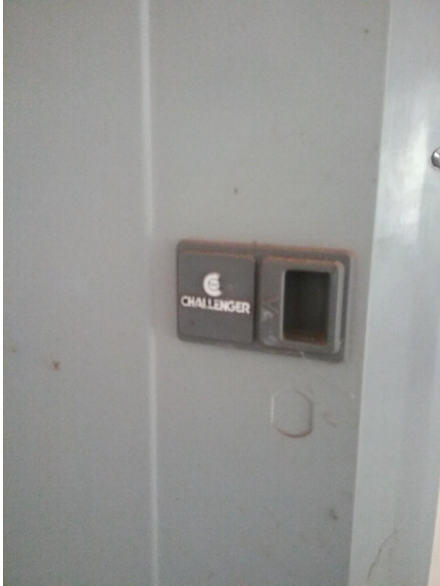
**s-101:** Challenger electric panel- This brand of electric panel has had problems where the breakers connect to the panel that may require replacement of the panel. Most problems cannot be seen without removal of the breakers for evaluation. We recommend further evaluation by an electrician familiar with problems associated with this type of panel and repairs done as needed. This is a fairly new problem so some electricians may not be aware of this concern.

**101:** Challenger electric panel- This brand of electric panel has had problems where the breakers connect to the panel that may require replacement of the panel. Most problems cannot be seen without removal of the breakers for evaluation. We recommend further evaluation by an electrician familiar with problems associated with this type of panel and repairs done as needed. This is a fairly new problem so some electricians may not be aware of this concern.

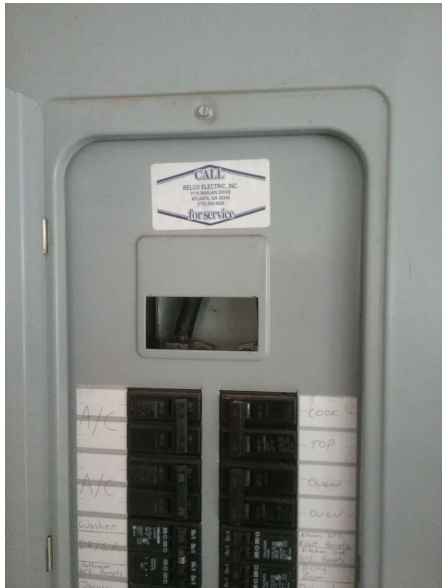
**103:** Unsealed opening(s) were observed inside the electrical sub panel. Recommend further evaluation and repairs by a licensed electrician.

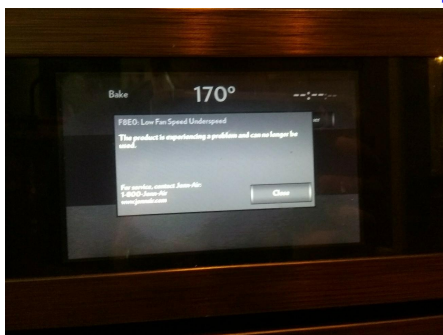
**s-117:** Oven bake element is inoperative. Repair is recommended by a qualified repair man.

**117:** Oven bake element is inoperative. Repair is recommended by a qualified repair man.

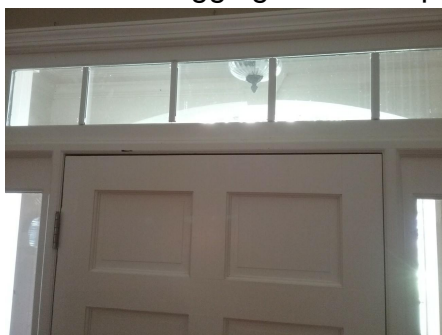
**127:** Door sagging and not square in the opening.

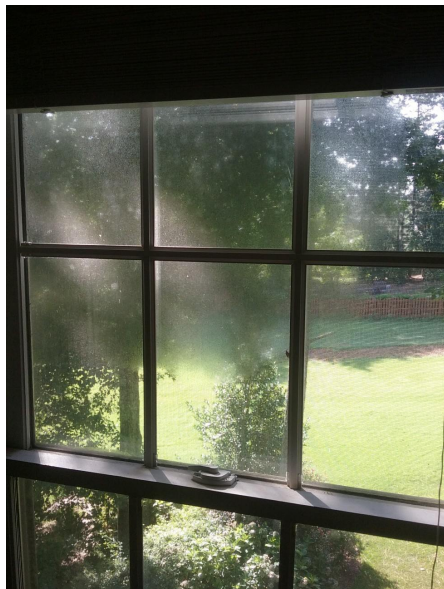
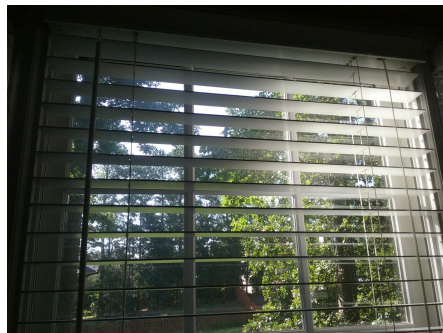
**s-134:** Broken seals resulting in fogging glass were observed in the master bedroom, front sitting room. Under different weather conditions other windows may show failed seals that are not apparent on the day of inspection.

**134:** Broken seals resulting in fogging glass were observed in the master bedroom, front sitting room. Under different weather conditions other windows may show failed seals that are not apparent on the day of inspection.

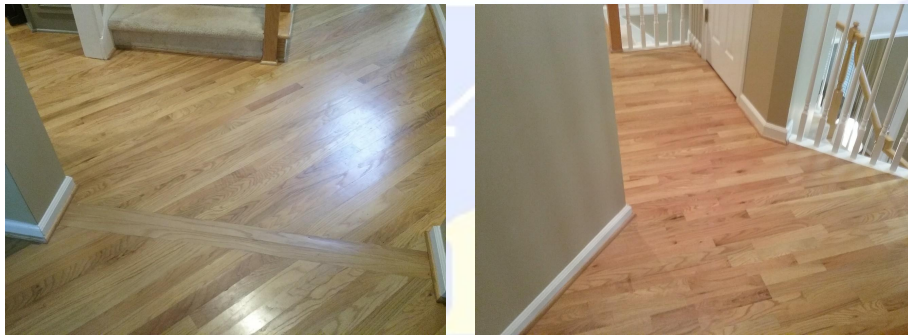
**s-146:** Some squeaking noted in the main floor, upper hallway.

**146:** Some squeaking noted in the main floor, upper hallway.

**147:** Squeaks are the result of two materials rubbing against each other. Repairs involve securing the floor so that it does not move. Unfortunately, due to the normal expansion and contraction of the building it is not possible to stop all the squeaks everywhere. You can usually stop one or at least move it from a given area, by screwing or nailing the floor in the area that is making the noise.

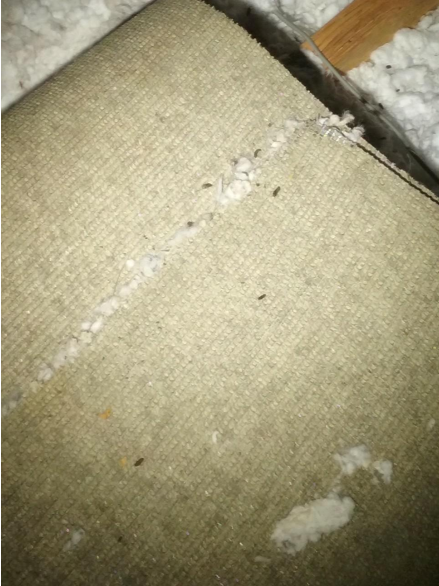
**s-157:** Wildlife droppings were observed in the attic. Monitor the attic for any wildlife activity and remove if found. Consult a pest control company to determine the full extent of any infestation or damage.

**157:** Wildlife droppings were observed in the attic. Monitor the attic for any wildlife activity and remove if found. Consult a pest control company to determine the full extent of any infestation or damage.
