Property Inspection Report

**Property address: 420 Fawn Glen Dr
Roswell GA 30075-6353**

Inspection date: Thursday, July 16, 2020

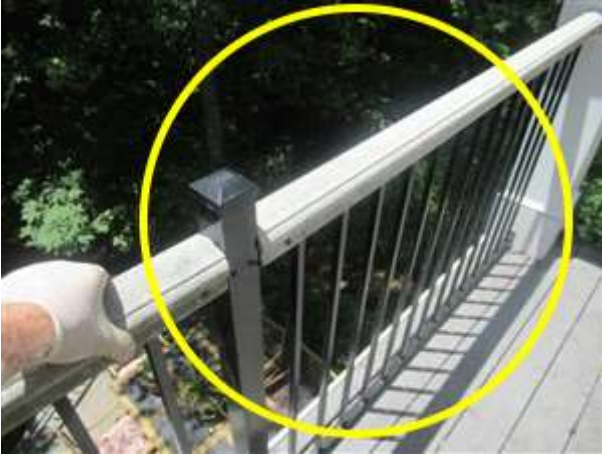
Photo 6-1 Master bedroom deck railing.

Guardrails are loose and/or wobbly in one or more areas. This is a safety hazard. A qualified contractor should evaluate and make repairs as necessary, such as installing new fasteners or hardware, installing additional fasteners and/or installing additional railing components as necessary so they are securely attached.

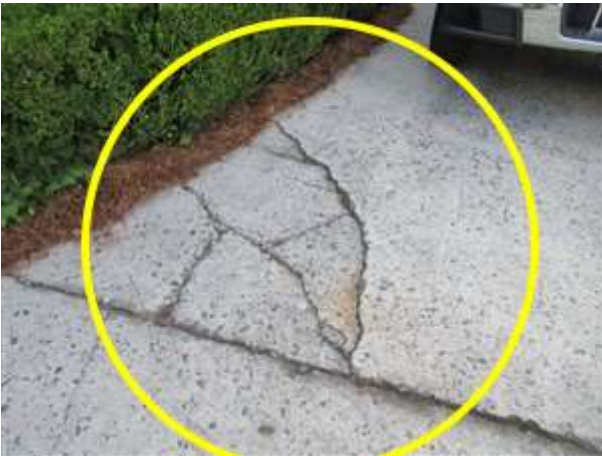
Photo 7-1

One or more trip hazards were found in the driveway due to cracks, settlement and/or heaving. Recommend having a qualified contractor evaluate and repair or replace driveway sections as necessary to eliminate trip hazards.

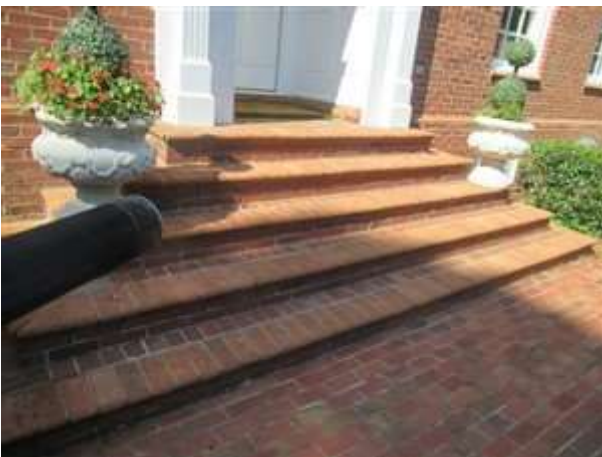
Photo 8-1

One or more flights of stairs with four or more risers have no handrail installed. This is a safety hazard. A qualified contractor should install graspable handrails that your hand can completely encircle at stairs where missing, and as per standard building practices.

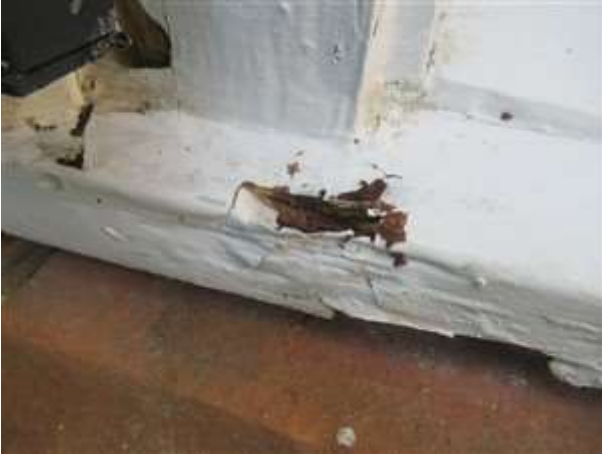
**Photo 9-1**

Exterior trim appears to be damaged in one or more areas. Recommend having a qualified contractor evaluate and make any necessary repairs.

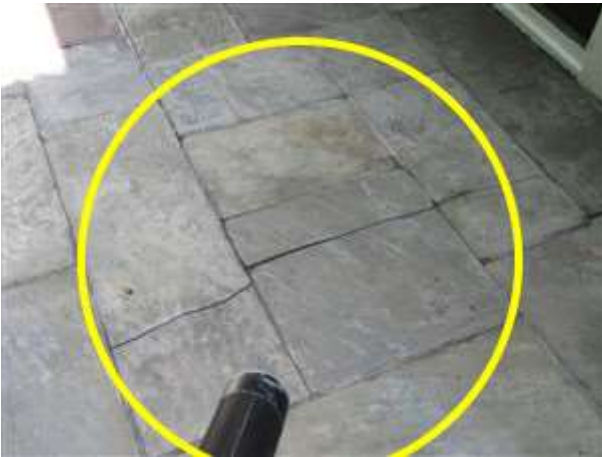
**Photo 10-1**

One or more deck stone tiles are damaged. This can allow water intrusion and damage to wood below. Recommend having a qualified contractor evaluate and make any necessary repairs.

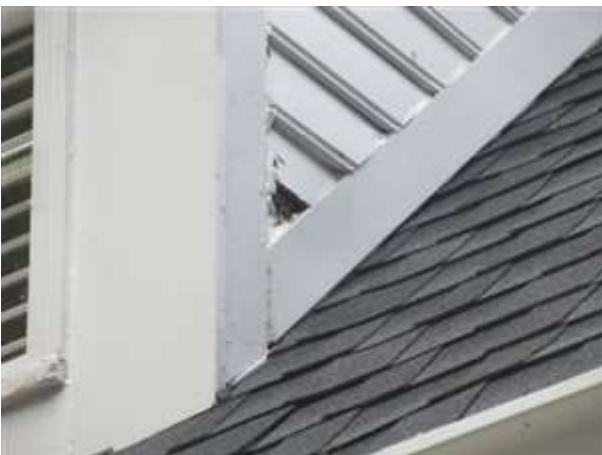
**Photo 11-1**

Siding is damaged and/or deteriorated in one or more areas. A qualified contractor should evaluate and make repairs and/or replace siding as necessary to prevent water and vermin intrusion.

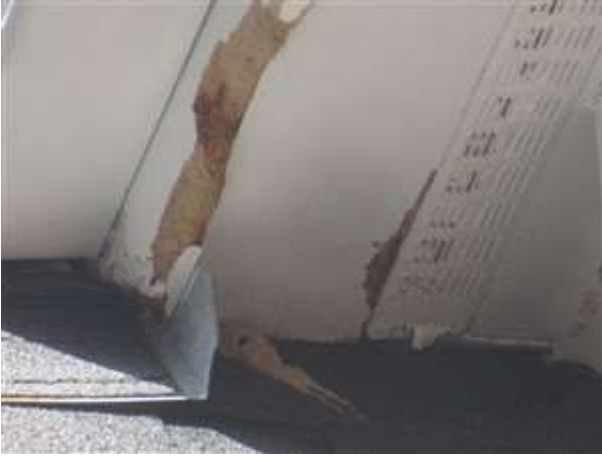
**Photo 12-1**

Fascia boards are damaged or deteriorated in one or more areas. A qualified contractor should evaluate and make repairs as necessary.

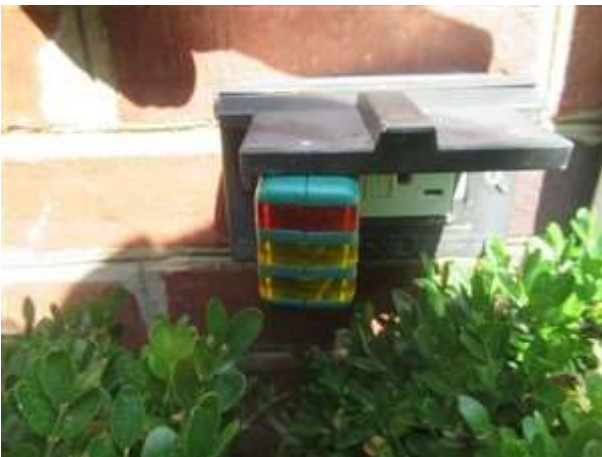
**Photo 13-1**

One or more electric receptacles appear to have no power. Recommend asking the property owner(s) about this. Switches may need to be operated to make some receptacles energized. If necessary, a qualified electrician should evaluate and make repairs as necessary.

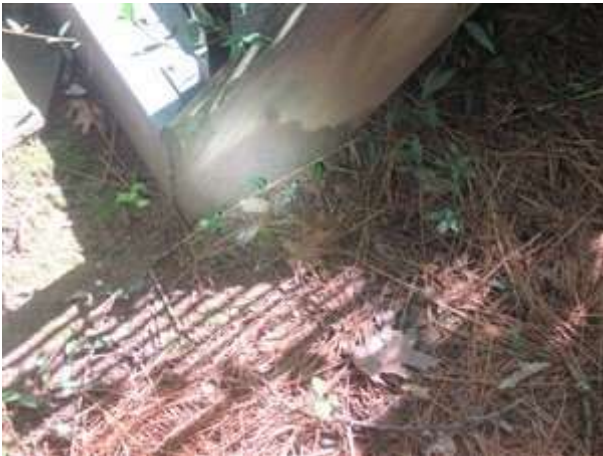
Photo 14-1

Wood beams, joists and/or support posts are too close to the soil in some areas. This is a conducive condition for wood destroying insects and organisms. Standard building practices require the following clearances to soil below:

Efforts should be made, such as grading and/or removing soil, to maintain these clearances. If this is not practical, then installing borate based Impel rods to prevent rot or monitoring this area in the future.

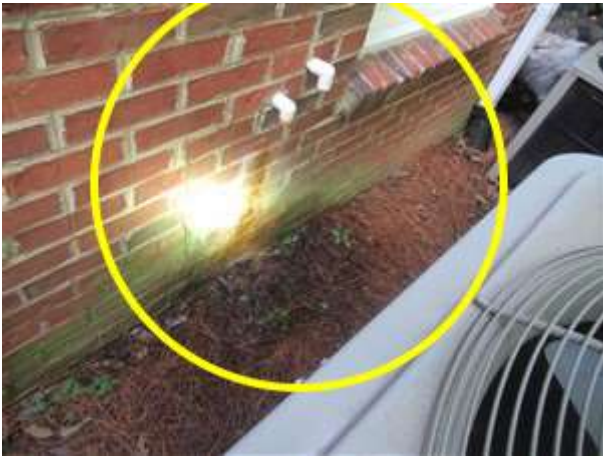
Photo 15-1

The HVAC condensation drainage lines are discharging too close to the foundation. This is a conducive condition for wood destroying organisms. Recommend that the drain pipes be extended so that condensation drains away from the foundation.

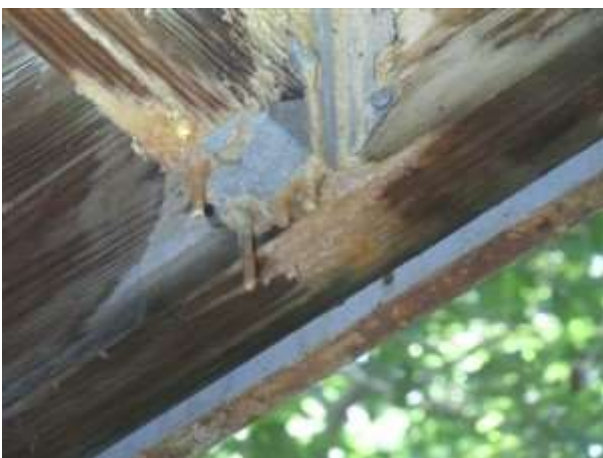
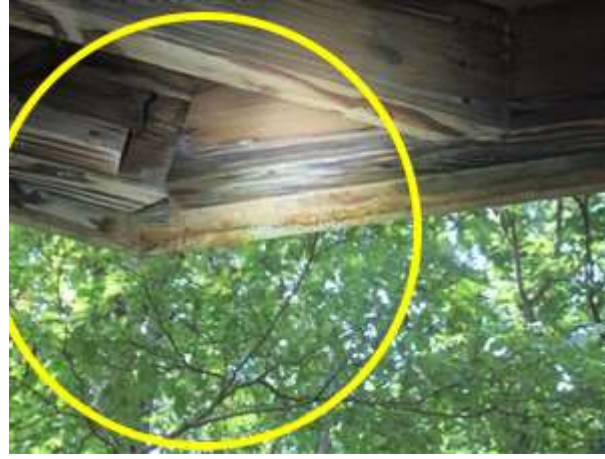
A wood destroying fungus was noticed on the deck frame below the deck. This can be caused by moisture escaping between the stone tiles and the wood. Recommend having a qualified contractor evaluate and make any necessary repairs.

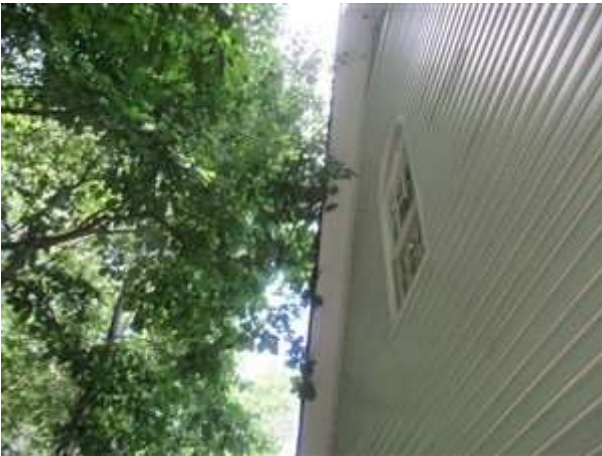
**Photo 18-1**

Trees and/or shrubs are in contact with or are close to the roof edge(s) in one or more areas. Damage to the roof may result, especially during high winds. Vegetation can also act as a conduit for wood destroying insects. Vegetation should be pruned back and/or removed as necessary to prevent damage and infestation by wood destroying insects.

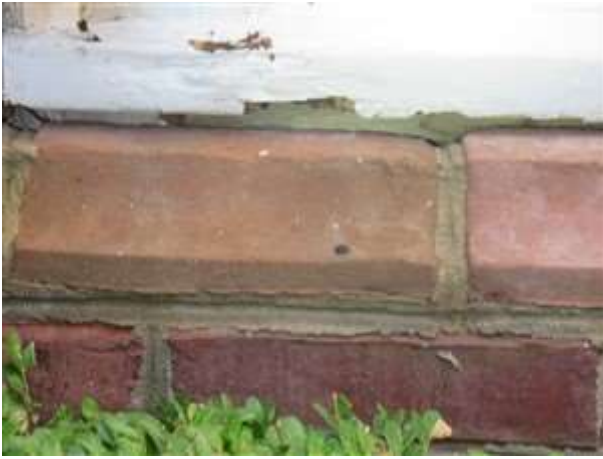
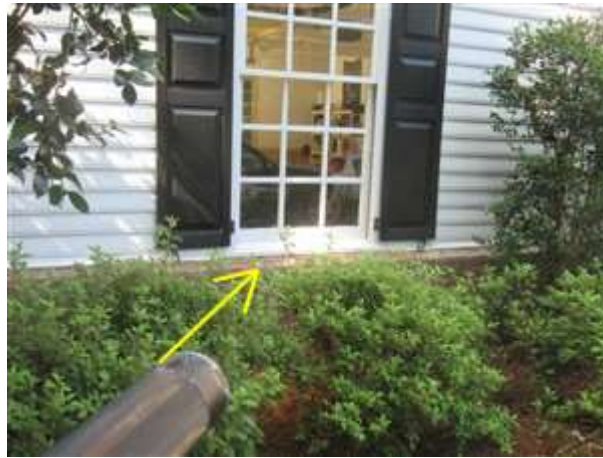
Caulk is missing or deteriorated in some areas and should be replaced and/or applied where necessary. For more information on caulking, visit [The Ins and Outs of Caulking](https://www.reporthost.com/lunsproatl/420Fawnglendrive/).

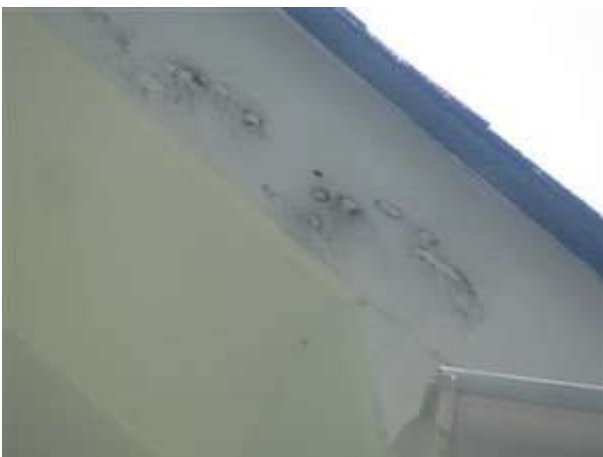
Photo 20-1

20) 🛠️💧 The exterior finish in some areas is failing. A qualified contractor should prep (pressure wash, scrape, sand, prime caulk, etc.) and repaint or restrain areas as needed and as per standard building practices.

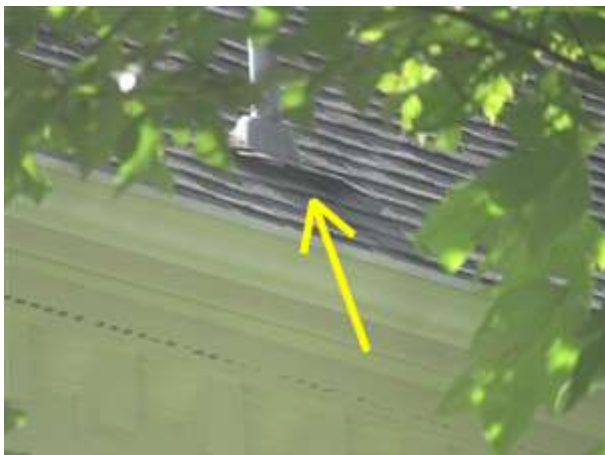
One or more duct flashings are lifting at the base or are improperly installed so that water or vermin intrusion may occur. A qualified contractor should make repairs as necessary, such as permanently fastening down the lifted edge(s), or reinstalling flashings.

Photo 22-1 Located on the right side of the roof.

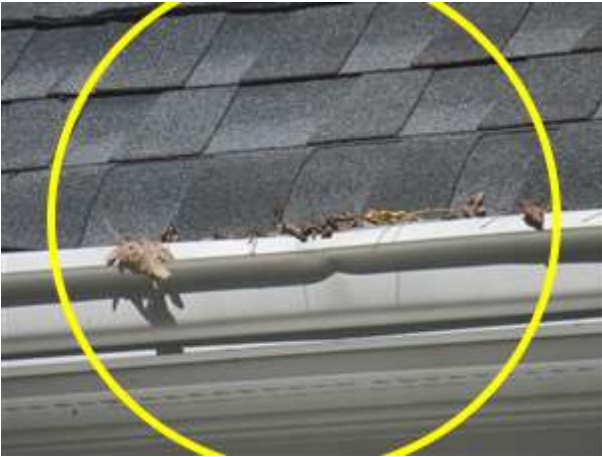
Photo 23-1

Debris has accumulated in or on one or more gutters. This is a conducive condition for wood destroying insects since gutters may overflow and cause water to come in contact with the structure's exterior or make water accumulate around the foundation. Gutters should be cleaned now and as necessary in the future.

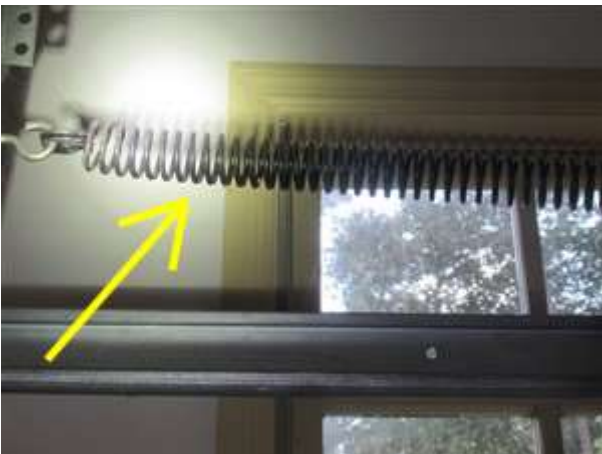
**Photo 25-1**

25) 🛠️ 🔍 Safety containment cables are missing for one or more vehicle door springs. This is a safety hazard. Safety containment cables prevent springs from snapping free and causing damage or injury. A qualified contractor should evaluate and make repairs or replace components as necessary.

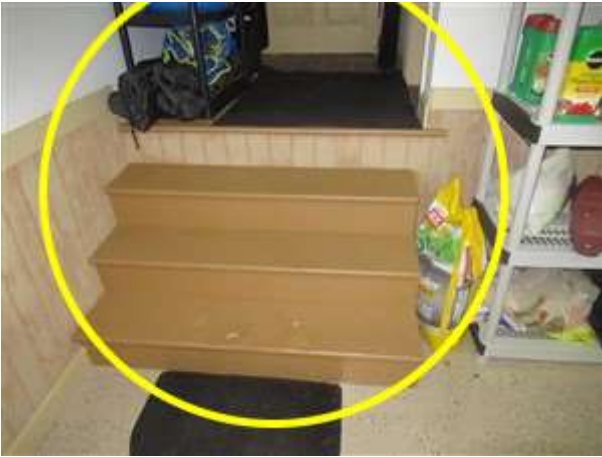
Photo 26-1

One or more flights of stairs with four or more risers have no handrail installed. This is a safety hazard. A qualified contractor should install graspable handrails that your hand can completely encircle at stairs where missing, and as per standard building practices.

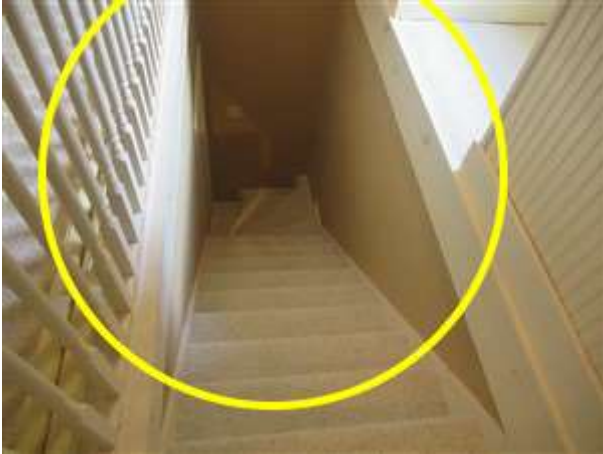
Photo 29-1

One or more flights of stairs with four or more risers have no handrail installed. This is a safety hazard. A qualified contractor should install graspable handrails that your hand can completely encircle at stairs where missing, and as per standard building practices.

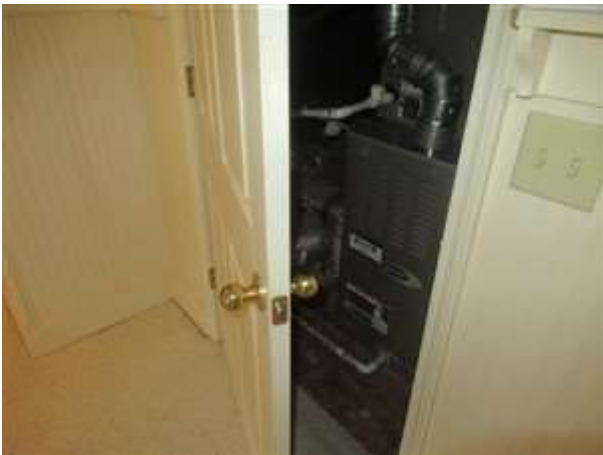
Photo 30-1

The attic access door is a hollow body interior door. The attic area door should be solid, have weather stripping and a threshold to provide a good seal and prevent energy loss. Recommend having a qualified contractor evaluate and make any necessary repairs.

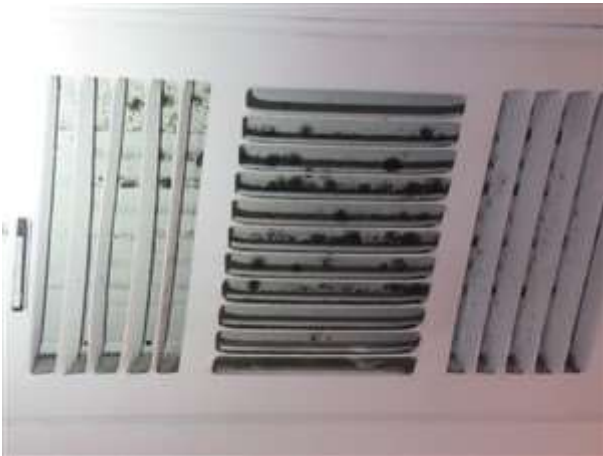
Photo 39-1

Significant amounts of what appears to be mold is visible in one or more sections of supply and/or return air ducts. If it is mold, it can be a health hazard, especially for those with allergies or respiratory problems. The Environmental Protection Agency (EPA) recommends considering having ducts professionally cleaned when "there is substantial visible mold growth inside hard surface (e.g., sheet metal) ducts or on other components of your heating and cooling system". For more information on duct cleaning in relation to indoor air quality, visit: <http://www.epa.gov/iaq/pubs/airduct.html>

100) A significant amount of microbial growth (possible mold) was visible in one or more sections of supply and/or return air ducts for the heating or cooling system. If this is mold, it can be a health hazard, especially for those with allergies or respiratory problems. The Environmental Protection Agency (EPA) recommends considering having ducts professionally cleaned when "there is substantial visible mold growth inside hard surface (e.g., sheet metal) ducts or on other components of your heating and cooling system." The client may wish to have a qualified industrial hygienist or indoor air quality specialist evaluate the ducts and/or have a qualified contractor clean the ducts. For more information on duct cleaning in relation to indoor air quality, visit: <http://www.reporhost.com/?DUCTCLEAN>

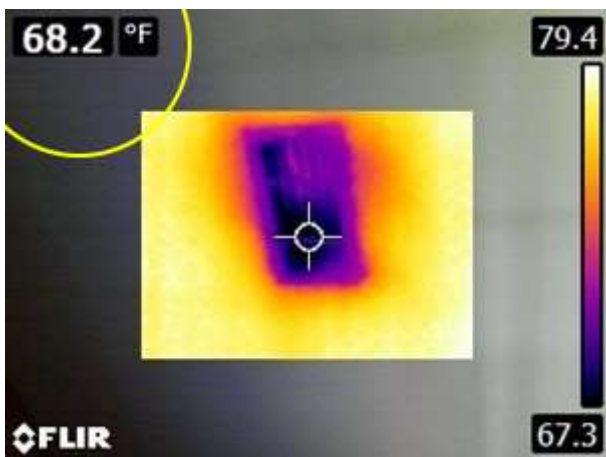
Supply air from the upstairs air conditioning system was not cool enough. It should be 14 to 20 degrees Fahrenheit cooler than at the return duct(s), or current room temperature. This may be caused by refrigerant loss, dirty coils, a failing compressor, an over sized fan, or a deficient return air system. A qualified heating and cooling contractor should evaluate and repair as necessary.

Photo 40-1 Upstairs incoming a/c air temperature.

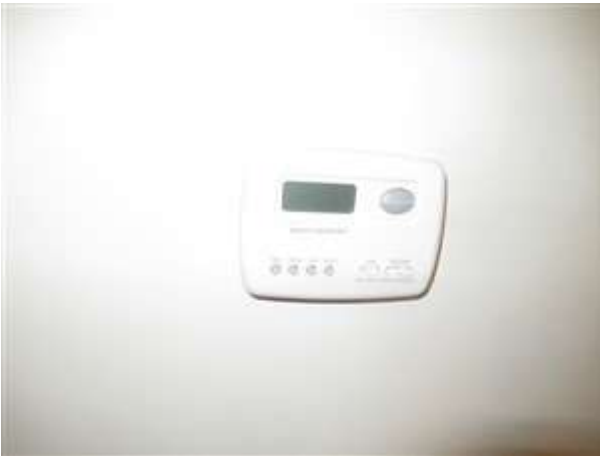
Photo 41-1

The thermostat in the upstairs hallway on the left side of the house, was not functional at the time of the inspection. Recommend having a qualified contractor evaluate and make any necessary repairs.

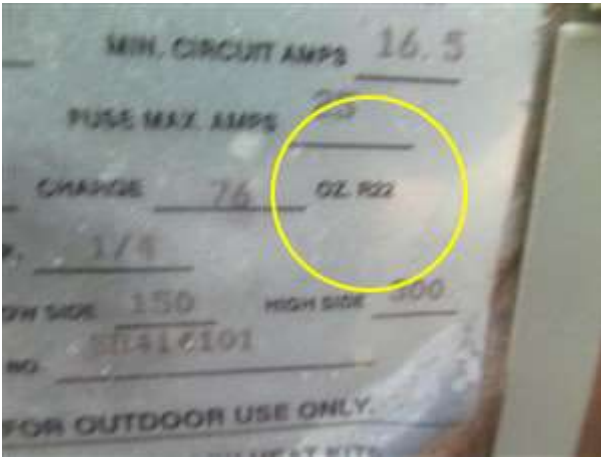
Photo 46-1

The sunroom a/c system appears to use R-22 as the refrigerant. This has been discontinued and by 2020 will likely no longer be available. Newer systems use 410-A refrigerant. Client should be aware of this and budget for replacement in the future. See the following link for more information. <http://www.startribune.com/does-your-air-conditioner-use-r-22-refrigerant-here-s-why-you-should-care/428178123/>

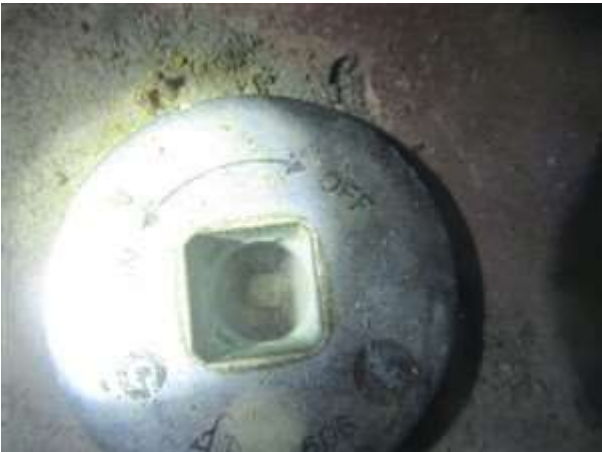
Photo 58-1

The basement fireplace gas valve was not functional at the time of the inspection. It appears dirt or debris prevents the gas key from turning the valve. Recommend having a qualified contractor evaluate and make any necessary repairs.

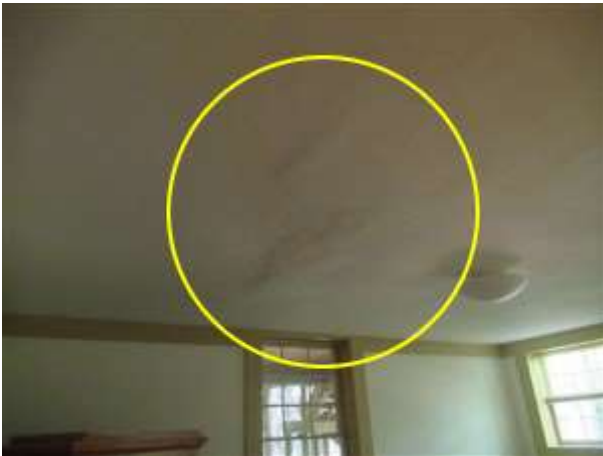
Photo 62-1

A past ceiling repair was noticed in the basement bedroom. No moisture was found in this area at the time of the inspection. The repair appears to be substandard. The client may wish to have this repaired for aesthetic reasons.

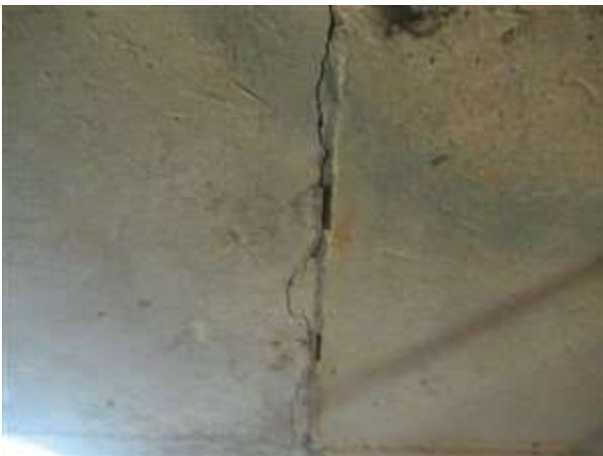
Photo 63-1

Minor cracks were found in the basement concrete foundation wall. These do not appear to be a structural concern at the time of the inspection and no water intrusion was noticed at the time of the inspection. Recommend monitoring these in the future.

97) One or more cracks were found in the foundation. This may increase moisture in the building due to water infiltration. A qualified person should seal cracks as necessary. Numerous products exist to seal such cracks including hydraulic cement, resilient caulks and epoxy sealants.

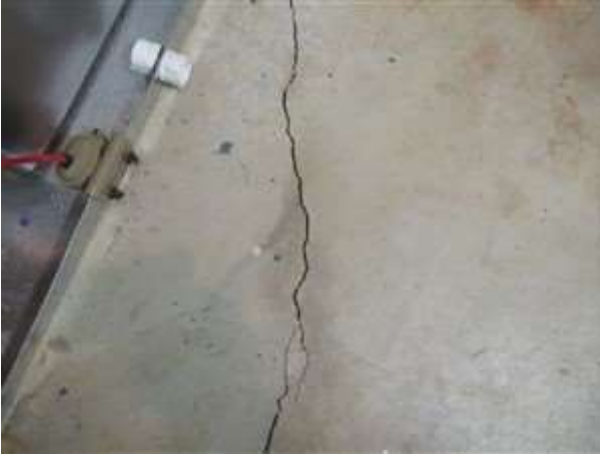
**Photo 64-1**

One or more cracks were found in the basement slab. These cracks do not appear to be a structural concern at the time of the inspection. Recommend monitoring these in the future and have them sealed if flooring is to be installed.

98) Cracks were found in one or more sections of slab floors. This may increase moisture in the building due to water infiltration. A qualified person should seal cracks as necessary. Numerous products exist to seal such cracks including hydraulic cement, resilient caulks and epoxy sealants.

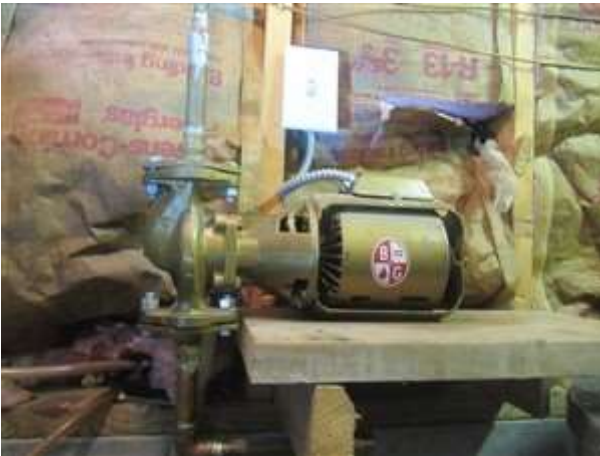
**Photo 65-1**

There is a pump in the utility area of the basement on the right side of the house. It was not clear what is the purpose of this pump. Recommend asking the seller for any information regarding this

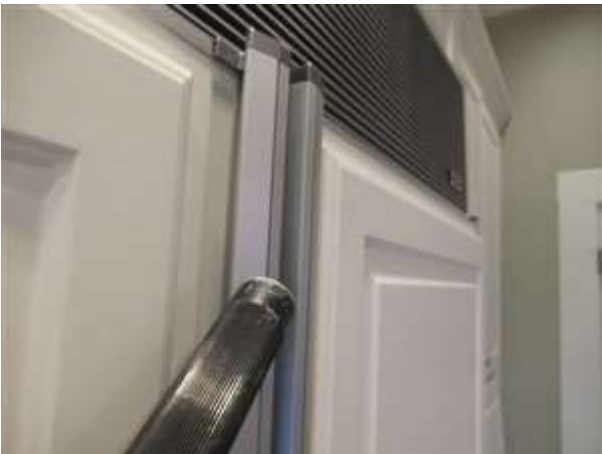
Photo 68-1

The refrigerator door does not appear to close completely. Recommend having a qualified contractor evaluate and make any necessary repairs.

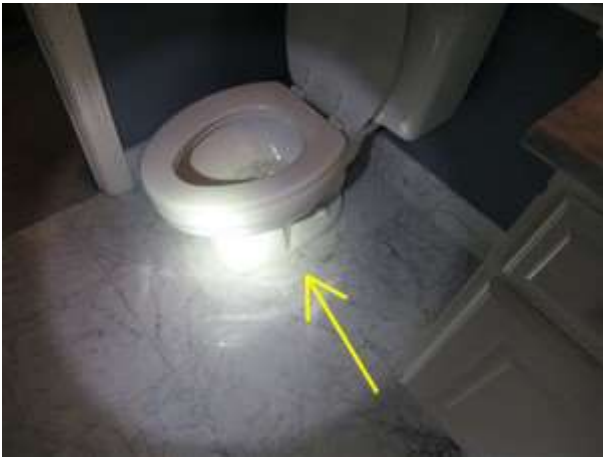
Photo 76-1

The upstairs front bedroom bathroom and one jack and jill bathroom toilets are loose. A qualified contractor should remove the toilet(s) for further evaluation and repairs if necessary. A new wax ring should be installed and toilet(s) should be securely anchored to the floor to prevent movement and leaking.

101) Toilets in one more bathrooms were loose. This may increase moisture in the building. A qualified contractor should remove the toilet(s) for further evaluation and repair as necessary. A new wax ring should be installed and toilet(s) should be securely anchored to the floor to prevent movement and leaking.

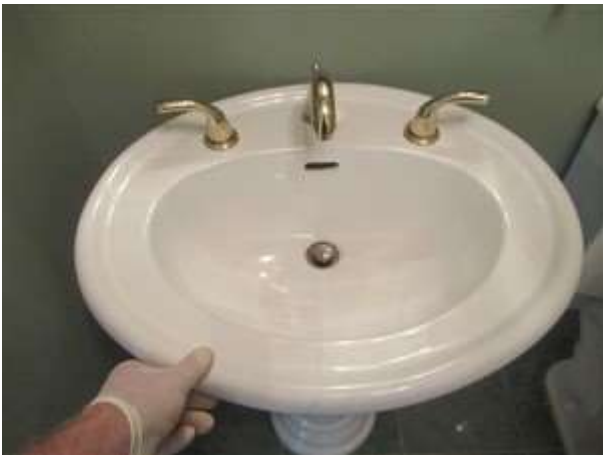
Photo 77-1

The main floor bathroom sink is loose, or not securely attached to the wall behind it. A qualified contractor should evaluate and repair as necessary.

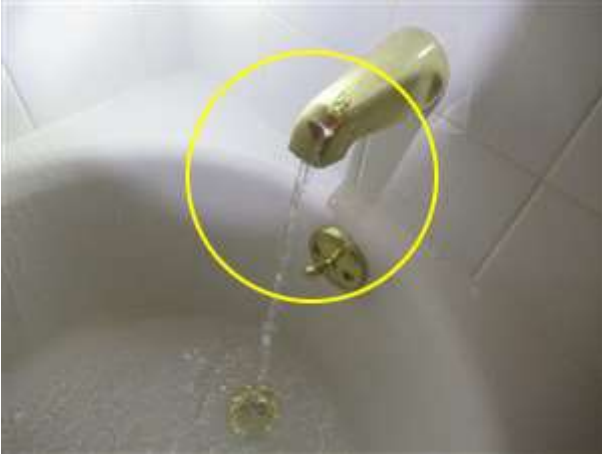
**Photo 78-1**

The shower diverter valve for the main floor bathroom bathtub faucet is defective. A significant amount of water comes out of the bathtub spout when the shower is turned on. Water will be wasted as a result. A qualified plumber should evaluate and replace components or make repairs as necessary.

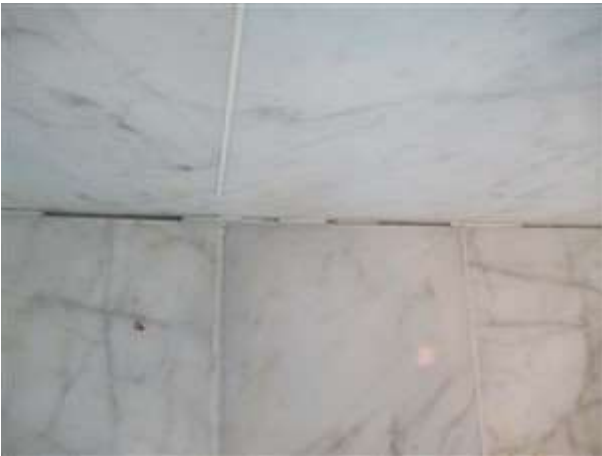
**Photo 79-1**

Caulk is missing or deteriorated along the base of the front bedroom bathroom shower, where flooring meets the shower. It should be replaced where deteriorated and/or applied where missing to prevent water intrusion and damage to the floor structure.

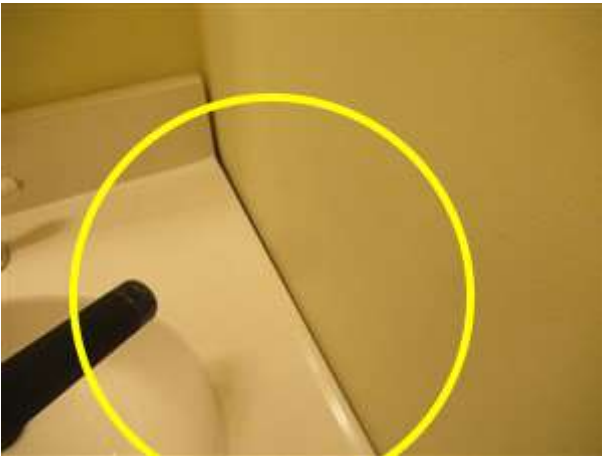
**Photo 80-1**

Caulk is missing and/or deteriorated where countertops meet backsplashes in wet areas, such as around sinks. Caulk should be replaced where deteriorated and/or applied where missing to prevent water damage.

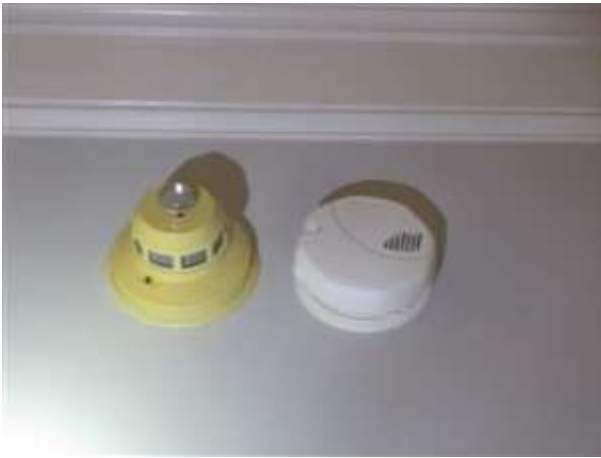
Photo 83-1

Based on the age of this structure and the appearance of existing smoke alarms, the alarms may be older than 5 years old. According to [National Fire Protection Association](#), aging smoke alarms don't operate as efficiently and often are the source for nuisance alarms. Older smoke alarms are estimated to have a 30% probability of failure within the first 10 years. Newer smoke alarms do better, but should be replaced periodically as required by the manufacturer. Unless you know that the smoke alarms are new, replacing them when moving into a new residence is also recommended by NFPA.

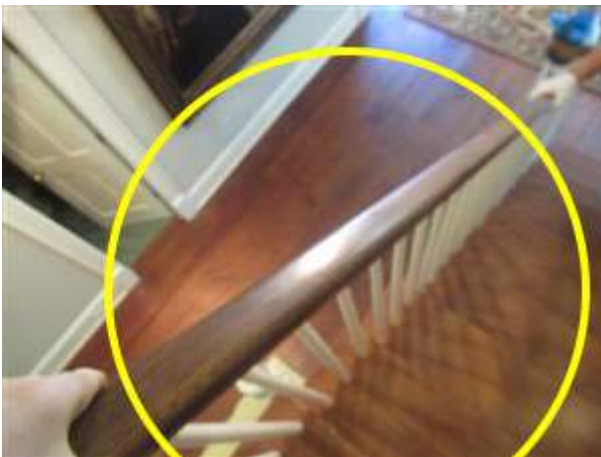
Photo 84-1

Handrail(s) at some stairs are loose. This is a safety hazard. A qualified contractor should make repairs as necessary. For example, installing new fasteners and/or hardware so handrails are securely attached.

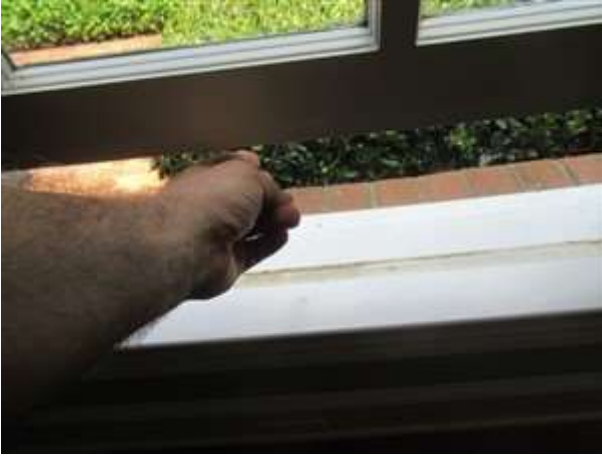
**Photo 85-1**

Screen(s) in one or more windows are missing. The client(s) should ask the property owner(s) about this. Screens are often removed for window cleaning and they may be stored somewhere. If not, then recommend installing screens where missing.

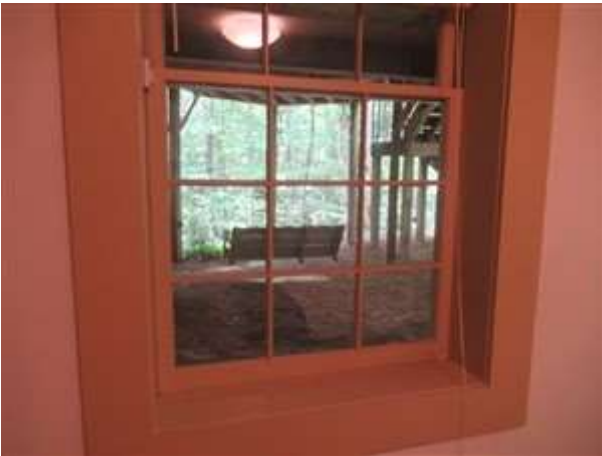
**Photo 86-1**

One or more windows that were built to open, will not open, or open only minimally due to their being painted shut, damaged and/or deteriorated in some way. Repairs should be made as necessary, and by a qualified contractor if necessary so windows open fully, and open and close easily.

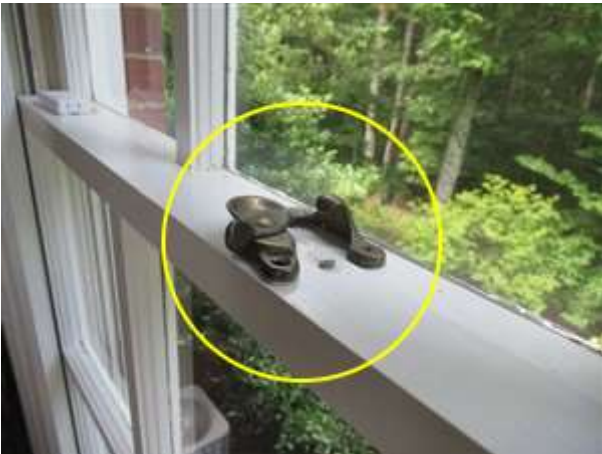
Lock mechanisms on one or more windows are missing and/or damaged so that they are inoperable. Repairs should be made by a qualified contractor or service technician so that windows lock and unlock easily.

**Photo 87-1** Front office window.

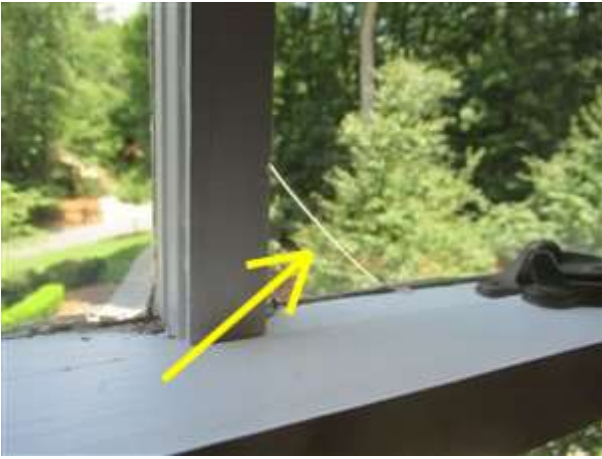
Photo 88-1

Glass in one window in the upstairs front bedroom above the garage, is broken. A qualified contractor should replace glass where necessary.

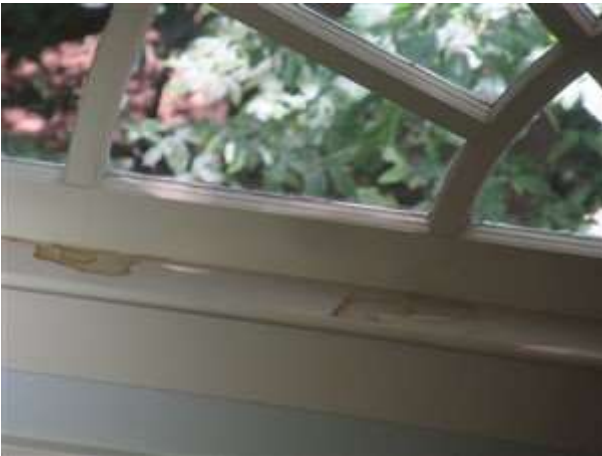
Photo 89-1

Water stains were noticed on the ledge of the family room back window frame. This is an indication of water intrusion, possibly from the window frame. Recommend having a qualified contractor evaluate and make any necessary repairs.

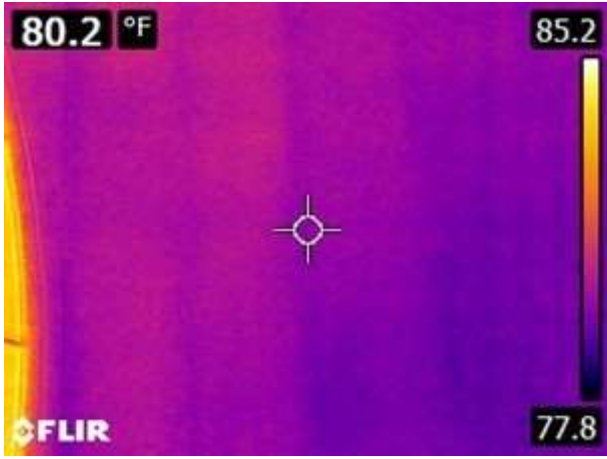
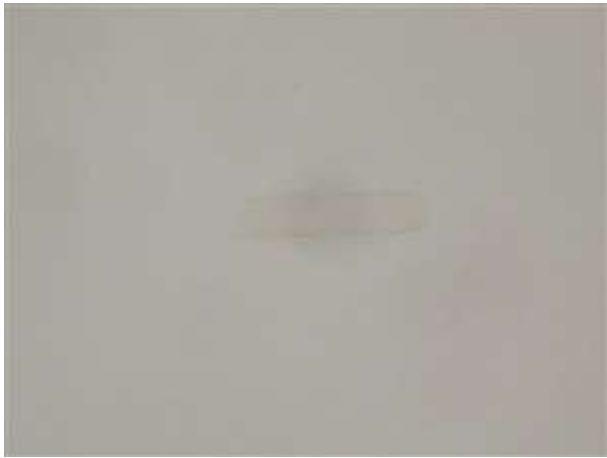
Stains were found in one or more ceiling areas. However, no elevated levels of moisture were found. The stain(s) may be due to past roof and/or plumbing leaks. Recommend asking the property owner(s) about this, and monitoring the stained area(s) in the future, especially after heavy or prolonged rain. If elevated moisture is found in the future, a qualified contractor should evaluate and repair as necessary.

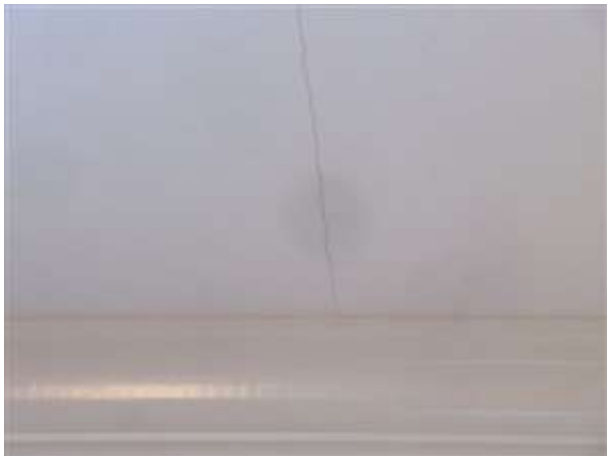
Photo 91-1

Minor cracks or nail pops were found in ceilings in one or more areas. They do not appear to be a structural concern, but the client(s) may wish to repair these for aesthetic reasons.

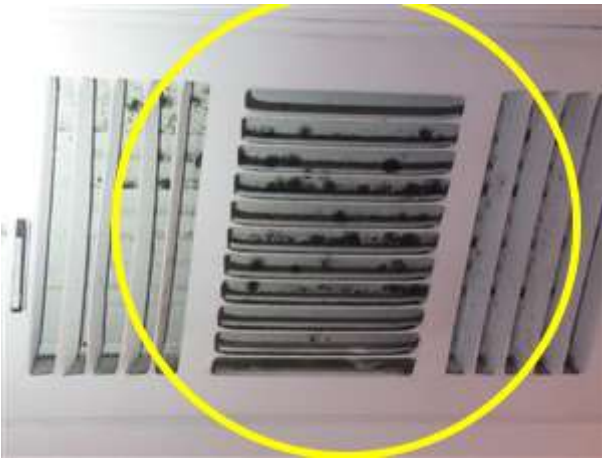
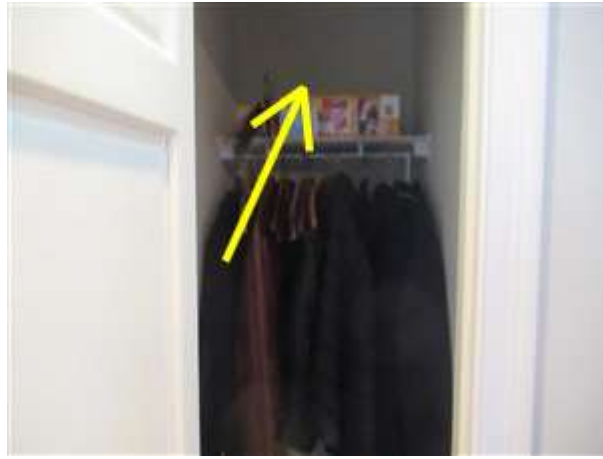
A visible biological growth suspected to be mold was found in several places.
