Property Inspection Report

Property address: **120 Grand Cres**

Inspection date: **Wednesday, August 5, 2020**

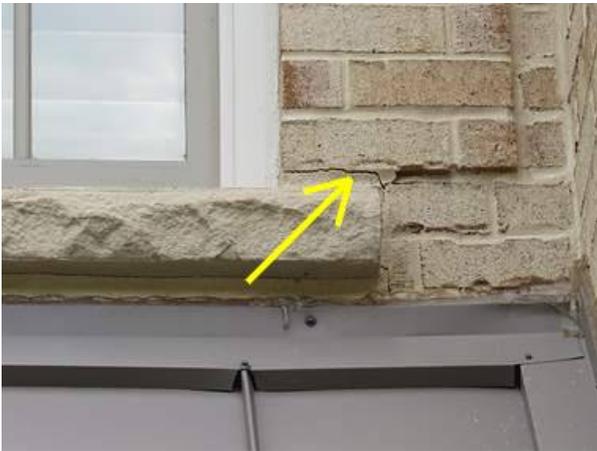
Photo 4-1

The masonry (brick or stone) veneer was deteriorated or damaged in some areas. Where cracks or openings are exposed, water can enter the wall structure causing mold, fungal growth and structural damage. This is a conducive condition for wood-destroying organisms. Recommend that a qualified contractor repair as necessary. For example, by repointing mortar or replacing broken or missing masonry.

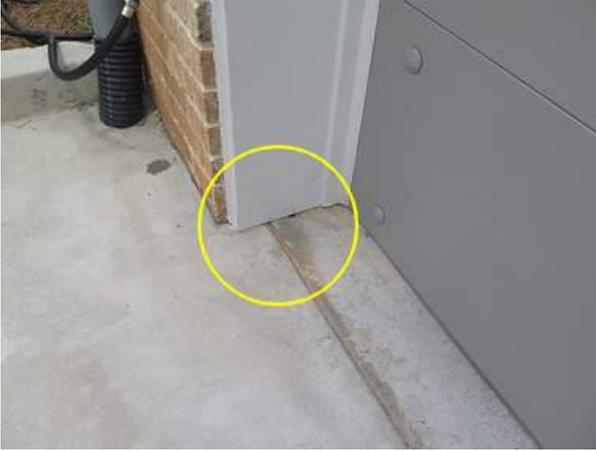
Photo 5-1

Untreated wood siding and/or trim was in contact with concrete or masonry at the exterior. Moisture collected between the two materials or wicking up into the wood is a conducive condition for wood-destroying organisms. Wood siding or trim should be installed with a minimum clearance of 1-2 inches between it and concrete or masonry below it at building exteriors. Monitor these areas for rot or infestation in the future and repair if needed. Recommend that a qualified person repair per standard building practices. For example, by trimming siding or trim as needed.

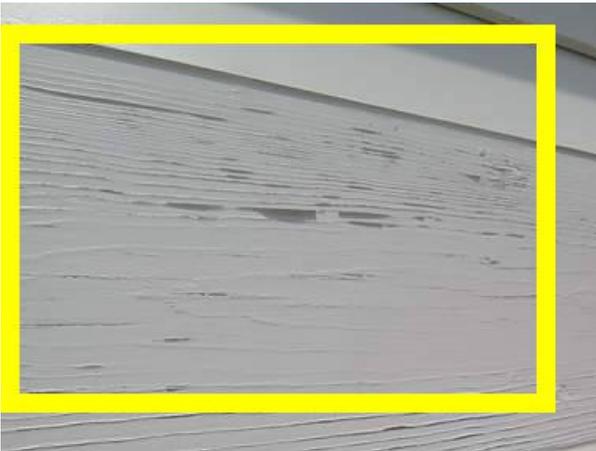
Photo 6-1

- 6) 🛠️💧 The paint or stain finish in some areas was failing (e.g. peeling, faded, worn, thinning). Siding and trim with a failing finish can be damaged by moisture. Recommend that a qualified contractor prep (e.g. clean, scrape, sand, prime, caulk) and repaint or restain the building exterior where necessary and per standard building practices. Any repairs needed to the siding or trim should be made prior to this.

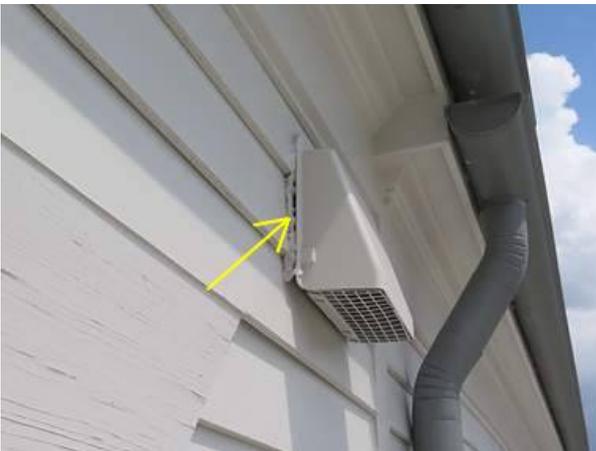
Photo 7-1

- 7) 🛠️💧 Sealant was deteriorated in some areas. For example, at wall penetrations. Recommend that a qualified person renew or install sealant (caulking) as necessary. Where gaps are wider than 1/4 inch, an appropriate material other than sealant should be used. For more information, visit: <https://www.reporthost.com/?CAULK>

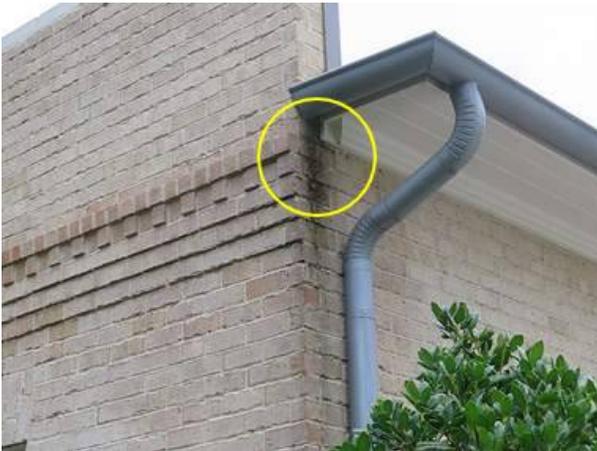
Photo 9-1

Kick-out flashing was missing at one or more locations. Such flashing should be located at the bottom of slopes where roof surfaces intersect with exterior walls above. It directs rainwater away from exterior walls and into gutters so that rainwater is less likely to run down the front surfaces of siding or flow behind siding. Recommend that a qualified contractor install kickout flashings where missing and per standard building practices (min. 4" x 4").

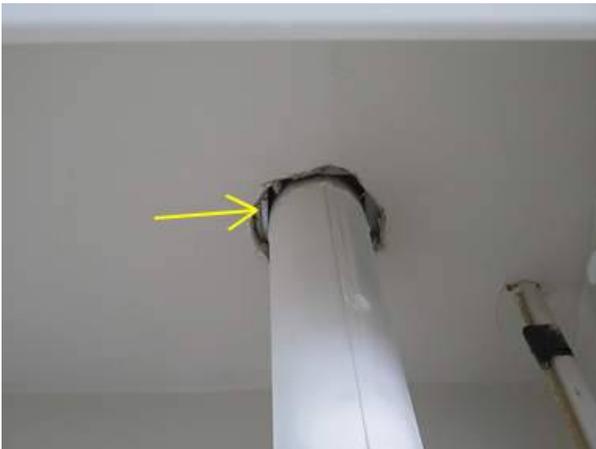
Photo 13-1

One or more gaps were found in the attached garage walls or ceilings. Current standard building practices call for wooden-framed ceilings and walls that divide the house and garage to provide limited fire-resistance rating to prevent the spread of fire from the garage to the house. Recommend that a qualified person repair per standard building practices. For example, by patching openings or holes, firestopping holes or gaps with fire-resistant caulking, and/or installing fire-resistant wall covering (e.g. Type X drywall on ceilings with a living space above). For more information, visit: <https://www.reporhost.com/?AGFR>

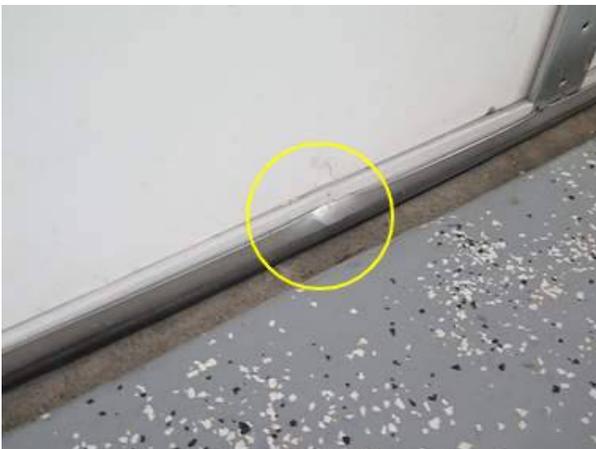
Photo 14-1

One or more garage vehicle doors had minor damage or deterioration. Although serviceable, the client may wish to repair or replace such doors for appearances' sake.

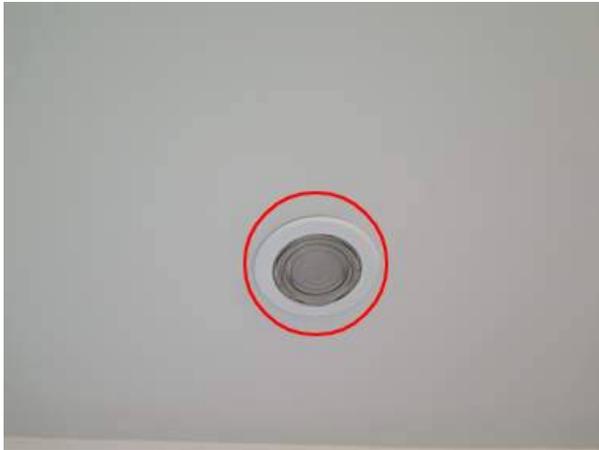
Photo 16-1

16) One or more light fixtures were inoperable (didn't turn on when nearby switches were operated). Recommend further evaluation by replacing bulbs and/or consulting with the property owner. If replacing bulbs doesn't work and/or no other switch(es) can be found, then recommend that a qualified electrician evaluate and repair or replace light fixtures as necessary.

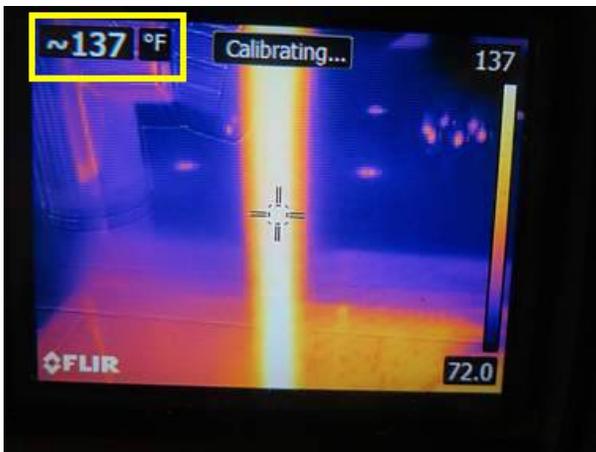
Photo 23-1

23) + The hot water temperature was greater than 120 degrees Fahrenheit. This is a safety hazard due to the risk of scalding. The thermostat should be adjusted so the water temperature doesn't exceed 120 degrees. If the water heater is powered by electricity, a qualified person should perform the adjustment, since covers that expose energized equipment normally need to be removed. For more information on scalding dangers, visit:

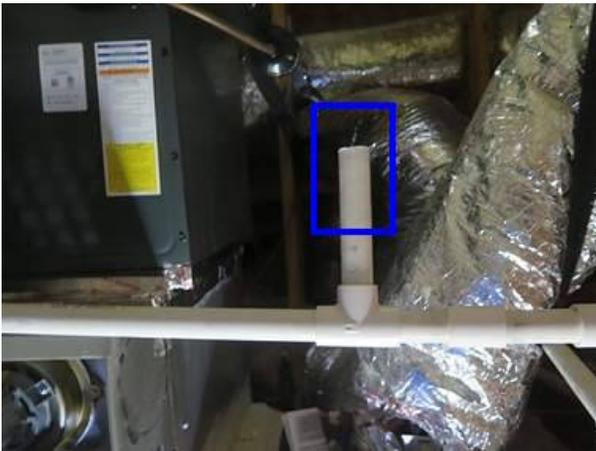
Photo 26-1

The air handler's primary condensate drain line trap was missing and/or missing cap. A U-shaped trap with a 2-inch drop should normally be installed to prevent air from moving in or out of the air handler during operation. Without a correctly configured trap, efficiency can be reduced, or condensate water can be pulled into the equipment resulting in wet insulation or components, or microbial growth. Recommend that a qualified HVAC contractor repair per standard building practices.

Without a trap, this doesn't happen. Air that is lost through the condensate drain in blow-through systems primarily is an efficiency issue. Failure to install a trap on a blow-through system can be likened to drilling a hole in the ducts for each drain connection. As for draining away condensate, the pressure around the pan on a blow-through system almost guarantees the pan will drain, trapped or not.

Trapping is a major issue on draw-through systems. Untreated air can be drawn into the airstream while the system is running. If the coil is located in an attic or other warm space, there is even greater reason for concern. As on a blow-through system, an untrapped drain on a draw-through system is an efficiency issue. But more importantly, the air being sucked through the drainpipe can prevent the pan from draining, causing it to run over.

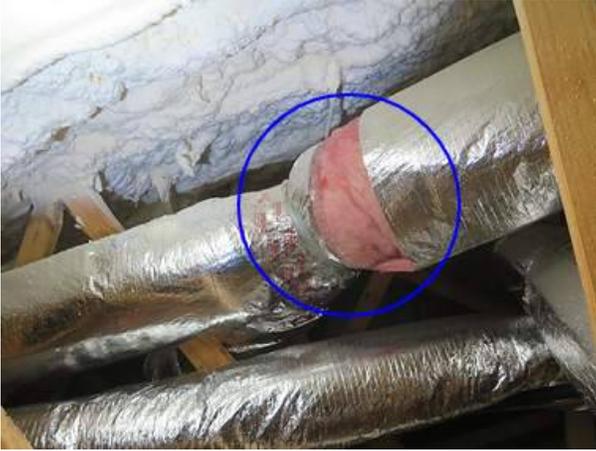
Photo 27-1

One or more heating or cooling ducts in an unconditioned space (e.g. crawl space, attic or basement) were not insulated, or the insulation was damaged or deteriorated. This can result in reduced energy efficiency, moisture inside heating ducts, and/or "sweating" on cooling ducts. Recommend that a qualified person repair per standard building practices. For example, by wrapping ducts in insulation with an R-value of R-8.

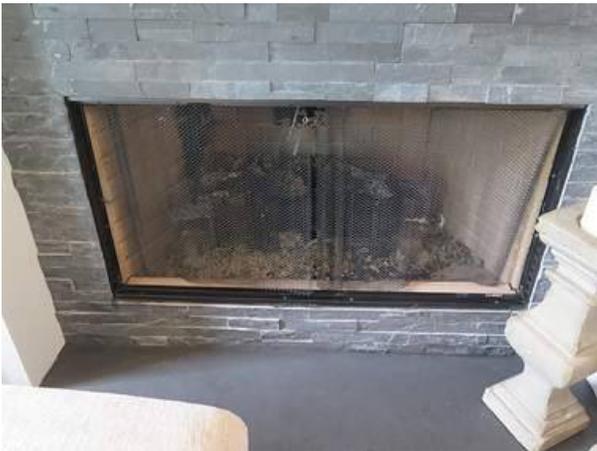
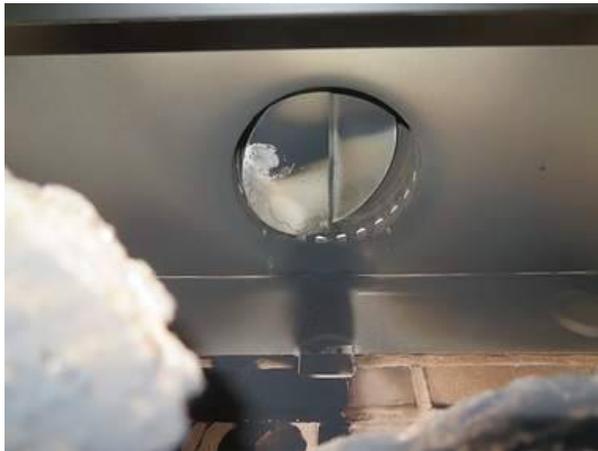
Recommend that the client review all available documentation for gas-fired fireplaces and stoves. Depending on how they are operated (for routine heating versus ambiance), such appliances normally need servicing annually or every few years. Consult with the property owner and/or a qualified specialist to determine if service is needed now.

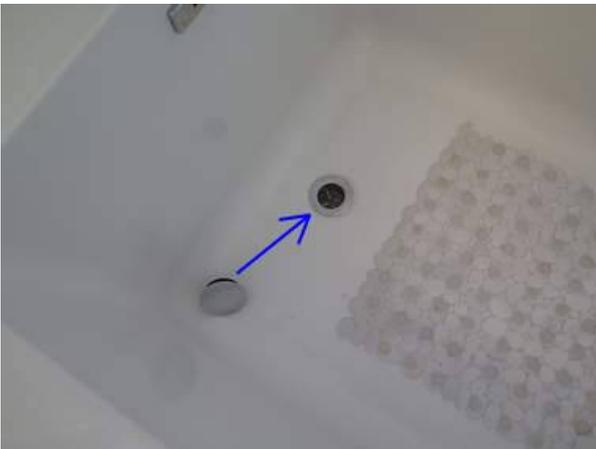
Photo 40-1

40) 🛠️ The bathtub drain stopper mechanism at location(s) #D and E was loose. Recommend that a qualified person repair or replace as necessary.

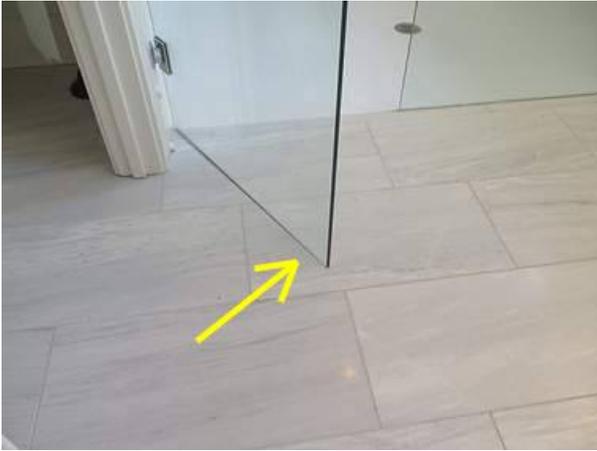
Photo 41-1

The shower door at location(s) #A was dragging on the tile floor below and would not open fully. Recommend that a qualified person repair as necessary.

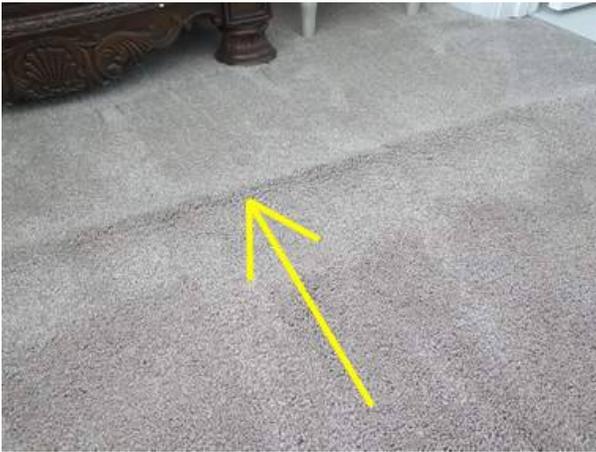
Photo 45-1

Carpeting in one or more areas was loose. Recommend that a qualified contractor repair as necessary. For example, by stretching or replacing carpeting.

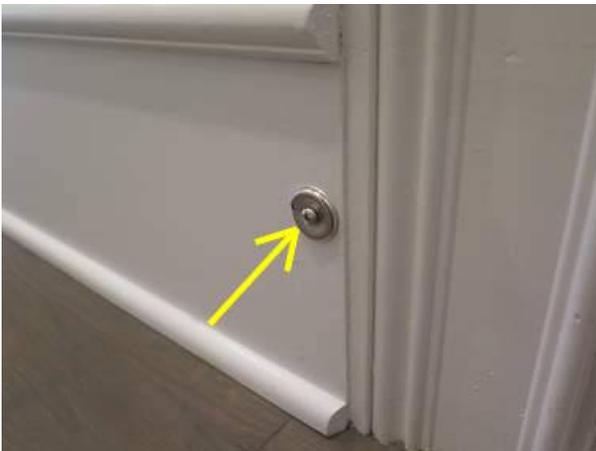
Photo 46-1

Fixtures such as door stops, towel bars, shelving, and/or toilet paper holders are missing in one or more areas. Recommend having a qualified contractor install fixtures where missing.

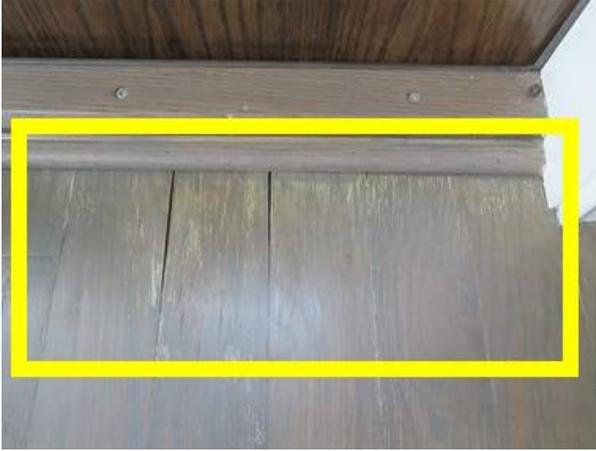
Photo 47-1

Wood flooring in one or more areas was significantly worn, deteriorated or damaged. Recommend that a qualified contractor refinish wood flooring as necessary.

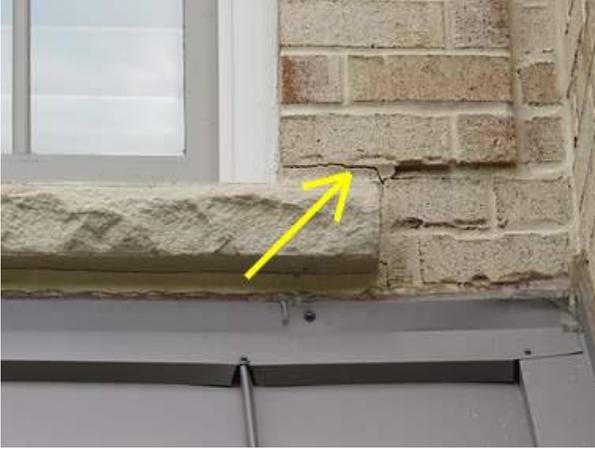
Photo 4-1

The masonry (brick or stone) veneer was deteriorated or damaged in some areas. Where cracks or openings are exposed, water can enter the wall structure causing mold, fungal growth and structural damage. This is a conducive condition for wood-destroying organisms. Recommend that a qualified contractor repair as necessary. For example, by repointing mortar or replacing broken or missing masonry.

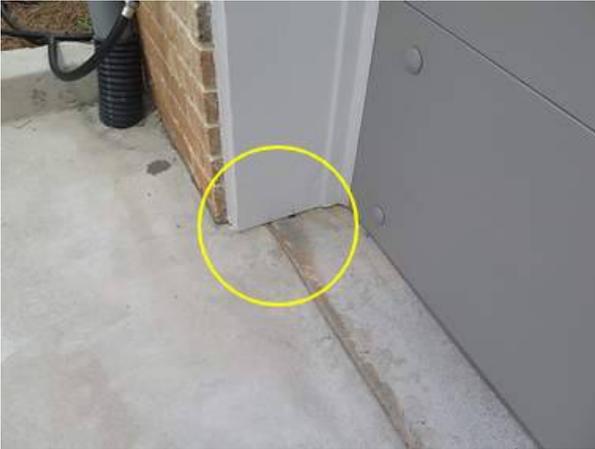
Photo 5-1

Untreated wood siding and/or trim was in contact with concrete or masonry at the exterior. Moisture collected between the two materials or wicking up into the wood is a conducive condition for wood-destroying organisms. Wood siding or trim should be installed with a minimum clearance of 1-2 inches between it and concrete or masonry below it at building exteriors. Monitor these areas for rot or infestation in the future and repair if needed. Recommend that a qualified person repair per standard building practices. For example, by trimming siding or trim as needed.

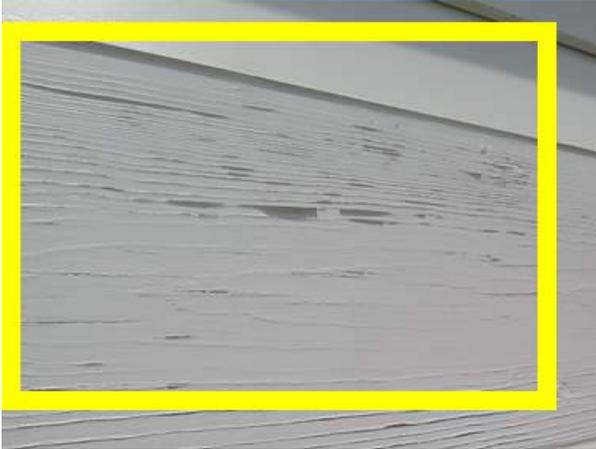
Photo 6-1

The paint or stain finish in some areas was failing (e.g. peeling, faded, worn, thinning). Siding and trim with a failing finish can be damaged by moisture. Recommend that a qualified contractor prep (e.g. clean, scrape, sand, prime, caulk) and repaint or restain the building exterior where necessary and per standard building practices. Any repairs needed to the siding or trim should be made prior to this.

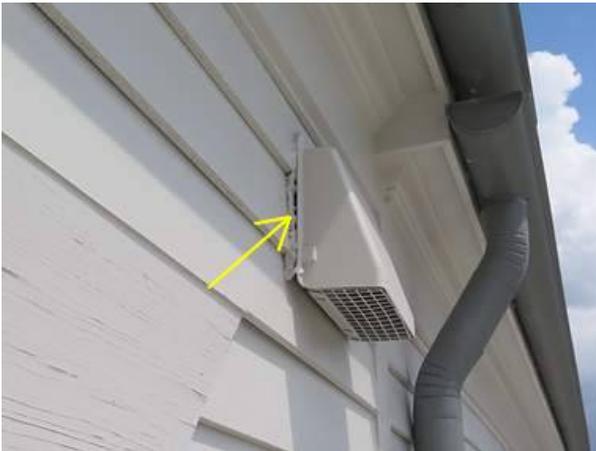
Photo 7-1

Sealant was deteriorated in some areas. For example, at wall penetrations. Recommend that a qualified person renew or install sealant (caulking) as necessary. Where gaps are wider than 1/4 inch, an appropriate material other than sealant should be used. For more information, visit:

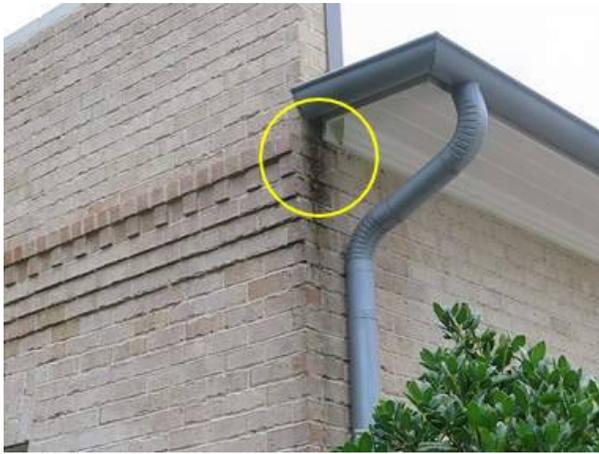
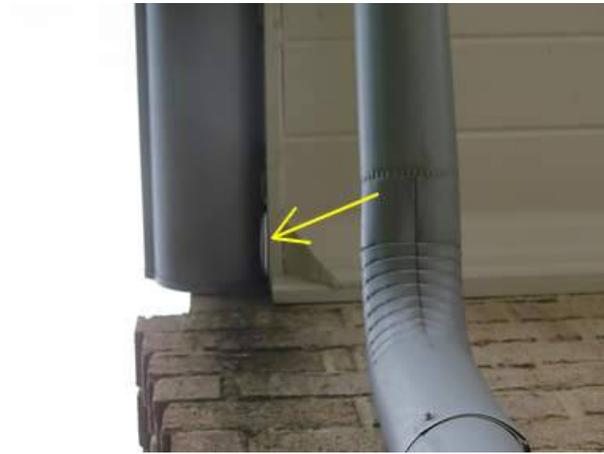
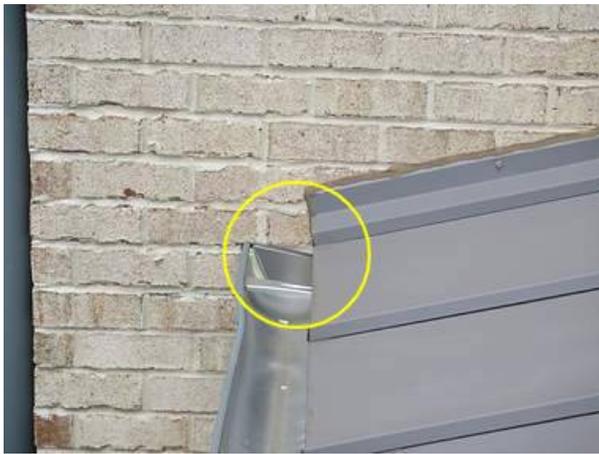
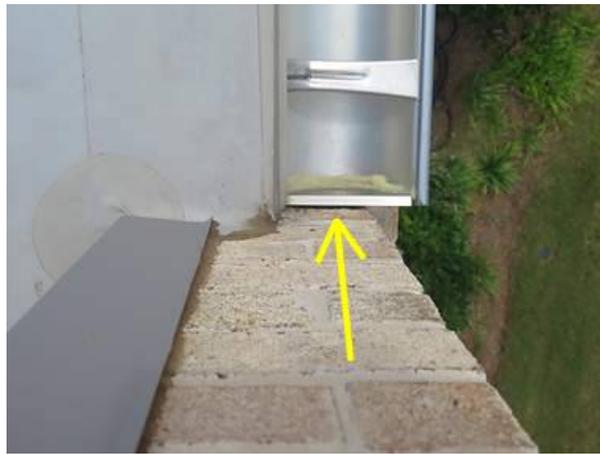
Kick-out flashing was missing at one or more locations. Such flashing should be located at the bottom of slopes where roof surfaces intersect with exterior walls above. It directs rainwater away from exterior walls and into gutters so that rainwater is less likely to run down the front surfaces of siding or flow behind siding. Recommend that a qualified contractor install kickout flashings where missing and per standard building practices (min. 4" x 4").

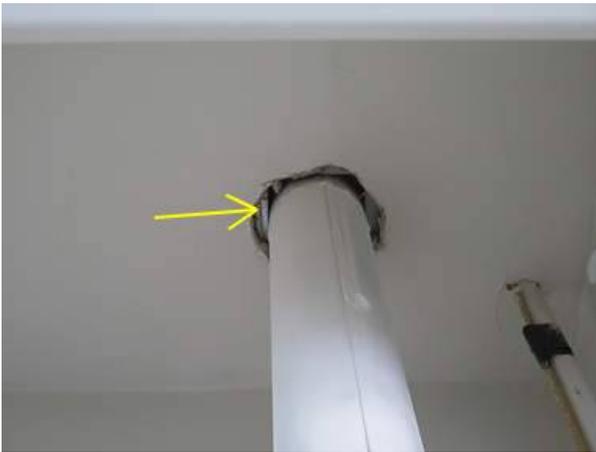
Photo 13-1

One or more gaps were found in the attached garage walls or ceilings. Current standard building practices call for wooden-framed ceilings and walls that divide the house and garage to provide limited fire-resistance rating to prevent the spread of fire from the garage to the house. Recommend that a qualified person repair per standard building practices. For example, by patching openings or holes, firestopping holes or gaps with fire-resistant caulking, and/or installing fire-resistant wall covering (e.g. Type X drywall on ceilings with a living space above). For more information, visit: <https://www.reporthost.com/?AGFR>

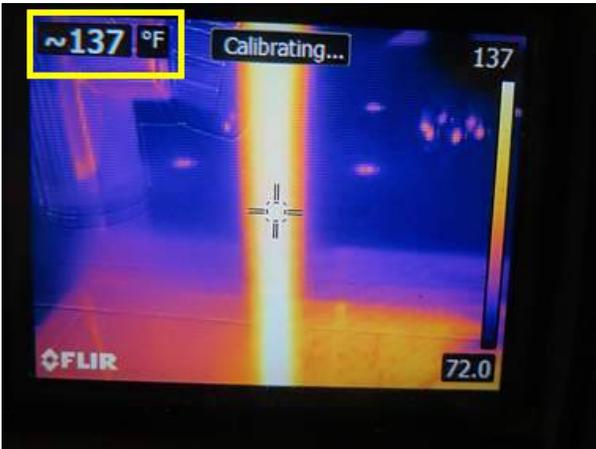
Photo 23-1

The hot water temperature was greater than 120 degrees Fahrenheit. This is a safety hazard due to the risk of scalding. The thermostat should be adjusted so the water temperature doesn't exceed 120 degrees. If the water heater is powered by electricity, a qualified person should perform the adjustment, since covers that expose energized equipment normally need to be removed. For more information on scalding dangers, visit: <https://www.reporthost.com/?SCALD>

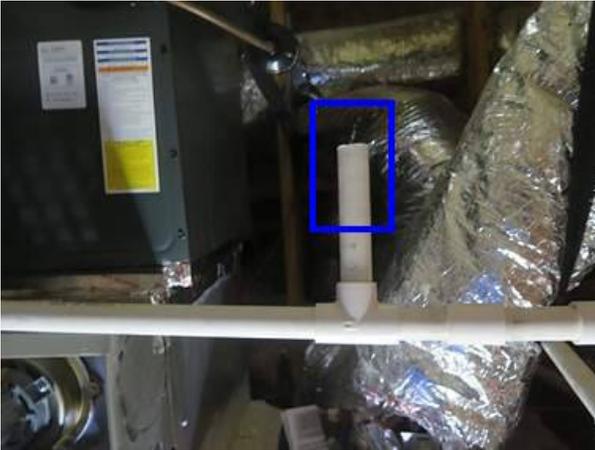
Photo 26-1

The air handler's primary condensate drain line trap was missing and/or missing cap. A U-shaped trap with a 2-inch drop should normally be installed to prevent air from moving in or out of the air handler during operation. Without a correctly configured trap, efficiency can be reduced, or condensate water can be pulled into the equipment resulting in wet insulation or components, or microbial growth. Recommend that a qualified HVAC contractor repair per standard building practices.

Without a trap, this doesn't happen. Air that is lost through the condensate drain in blow-through systems primarily is an efficiency issue. Failure to install a trap on a blow-through system can be likened to drilling a hole in the ducts for each drain connection. As for draining away condensate, the pressure around the pan on a blow-through system almost guarantees the pan will drain, trapped or not.

Trapping is a major issue on draw-through systems. Untreated air can be drawn into the airstream while the system is running. If the coil is located in an attic or other warm space, there is even greater reason for concern. As on a blow-through system, an untrapped drain on a draw-through system is an efficiency issue. But more importantly, the air being sucked through the drainpipe can prevent the pan from draining, causing it to run over.

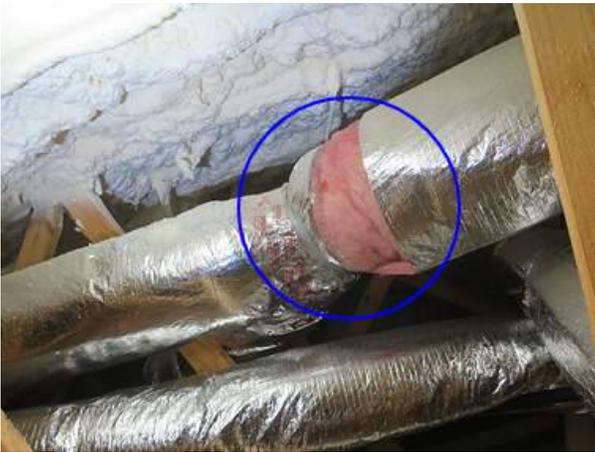
Photo 27-1

27) 🔧 One or more heating or cooling ducts in an unconditioned space (e.g. crawl space, attic or basement) were not insulated, or the insulation was damaged or deteriorated. This can result in reduced energy efficiency, moisture inside heating ducts, and/or "sweating" on cooling ducts. Recommend that a qualified person repair per standard building practices. For example, by wrapping ducts in insulation with an R-value of R-8.

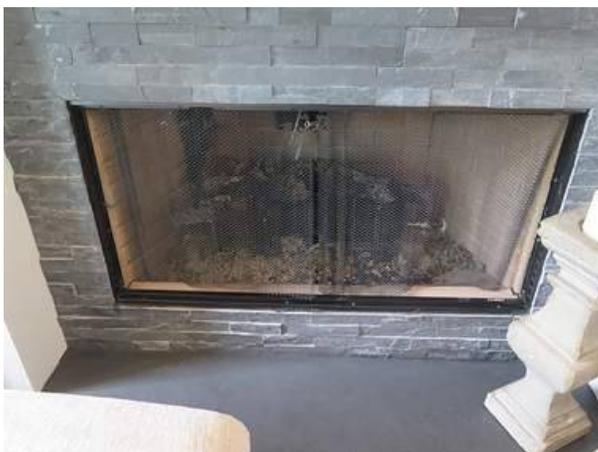
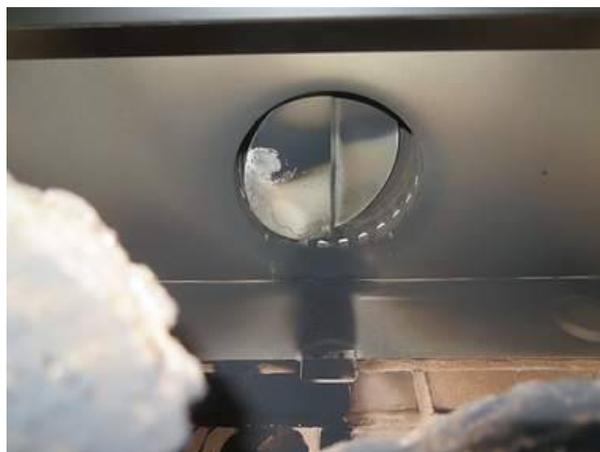
31) 🚧 🔍 Recommend that the client review all available documentation for gas-fired fireplaces and stoves. Depending on how they are operated (for routine heating versus ambiance), such appliances normally need servicing annually or every few years. Consult with the property owner and/or a qualified specialist to determine if service is needed now.

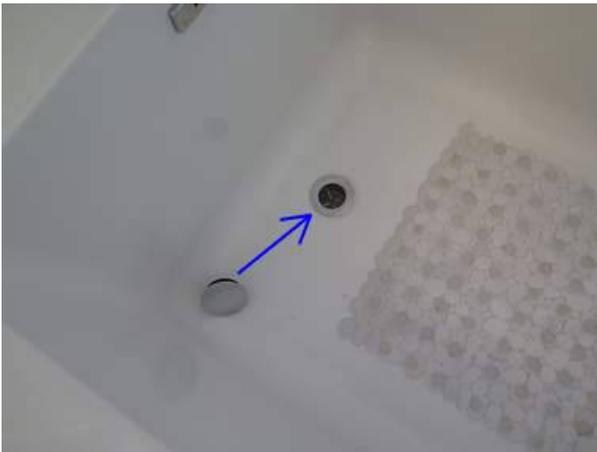
Photo 40-1

The bathtub drain stopper mechanism at location(s) #D and E was loose. Recommend that a qualified person repair or replace as necessary.

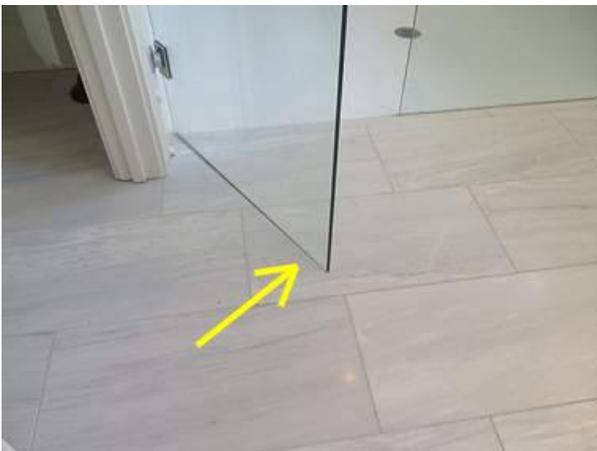
Photo 41-1

The shower door at location(s) #A was dragging on the tile floor below and would not open fully. Recommend that a qualified person repair as necessary.

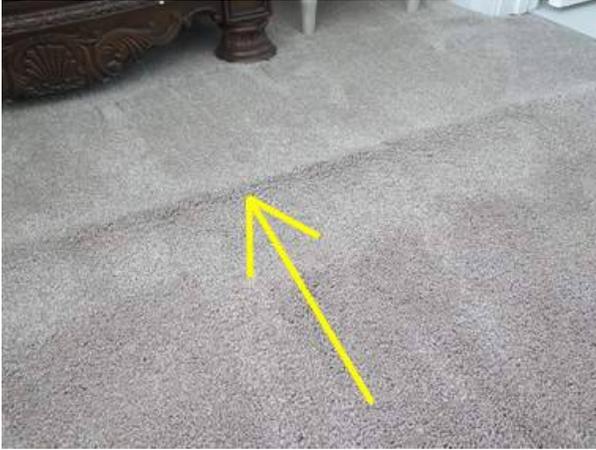
Photo 45-1

Carpeting in one or more areas was loose. Recommend that a qualified contractor repair as necessary. For example, by stretching or replacing carpeting.

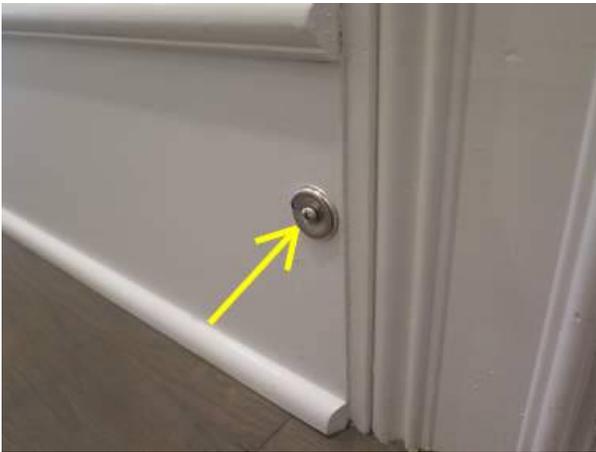
Photo 46-1

Fixtures such as door stops, towel bars, shelving, and/or toilet paper holders are missing in one or more areas. Recommend having a qualified contractor install fixtures where missing.

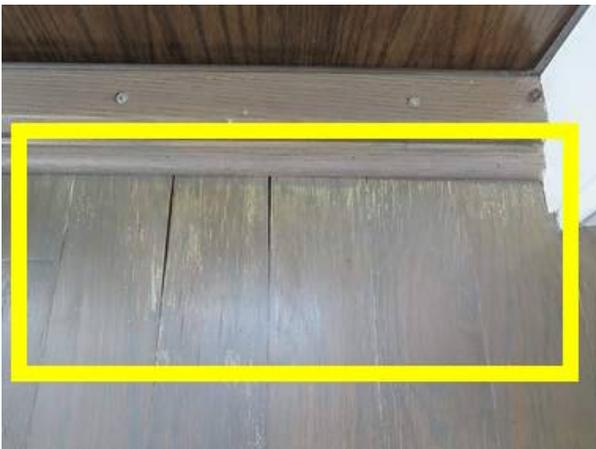
Photo 47-1

Wood flooring in one or more areas was significantly worn, deteriorated or damaged. Recommend that a qualified contractor refinish wood flooring as necessary.
