General Summary

Nier Building Inspections

Customer
Brian Taylor

Address
2010 Arminda Ct
Alpharetta Georgia 30022

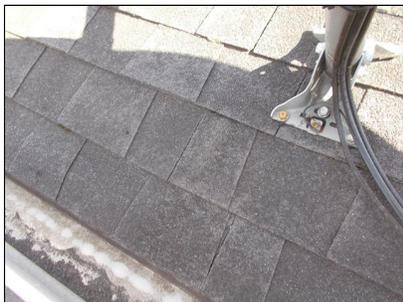
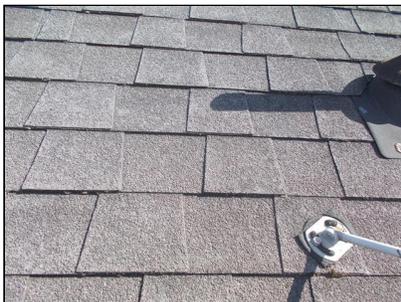
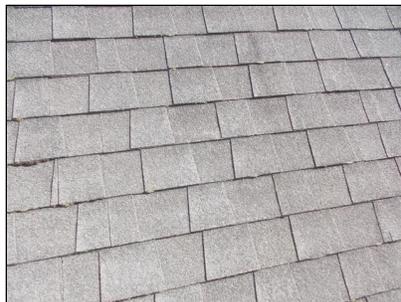
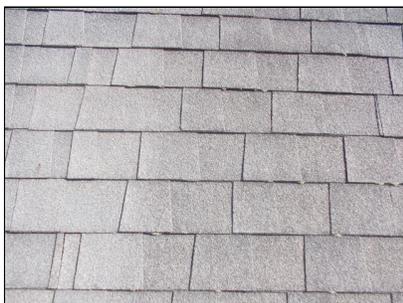
(2) The roof covering is older, and the life of covering nearing the end of its functional life. The covering does need to be replaced. The shingles were noted as brittle and many areas the granules showed heavy wear, the underlying shingle matrix was beginning to show in various locations. While this covering could last a year it needs to be replaced in the very near future.

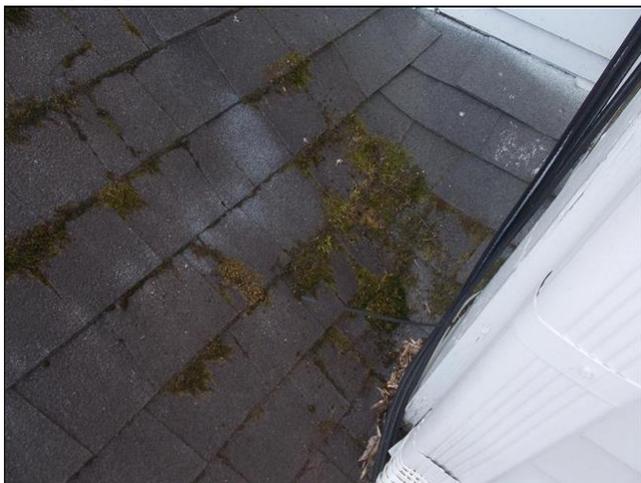
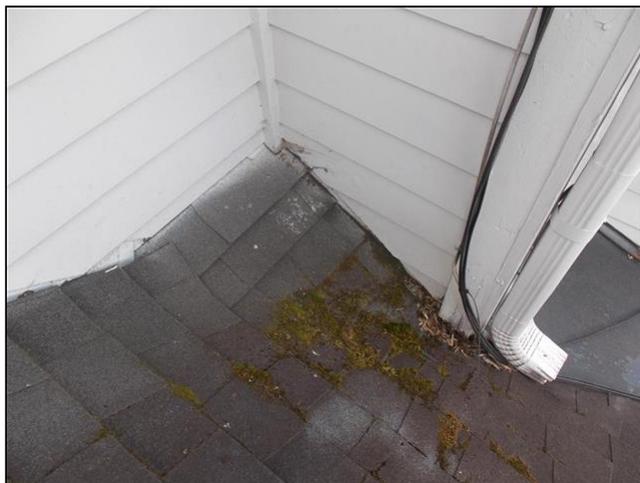
(4) There was moss growing on the shingles on the back of the home. Recommend having the roof cleared of damaging growth.

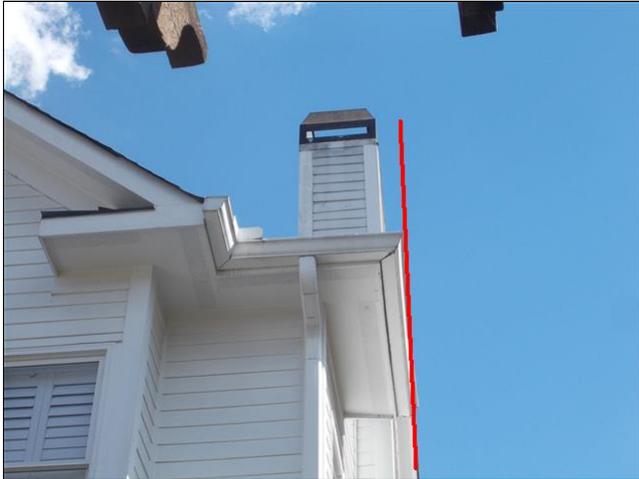
1.2 Item 1(Picture)

(1) The chimney appeared to lean slightly toward the house. Recommend having a contractor evaluate and repair as needed.

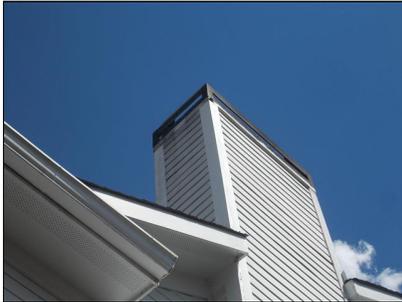
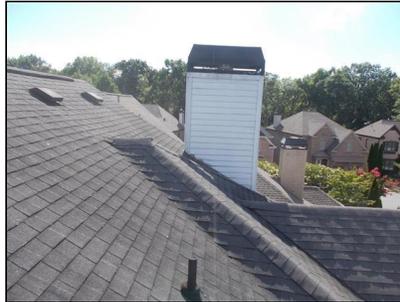
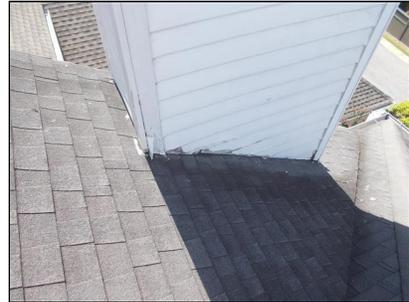
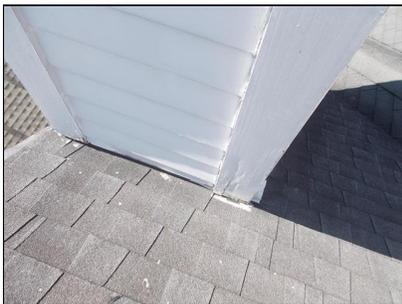
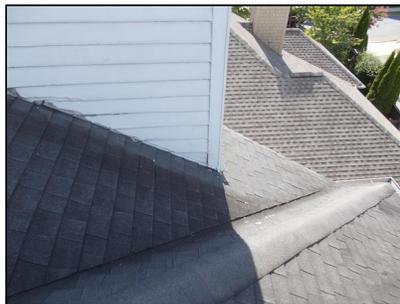
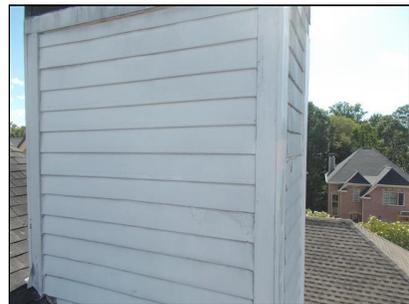
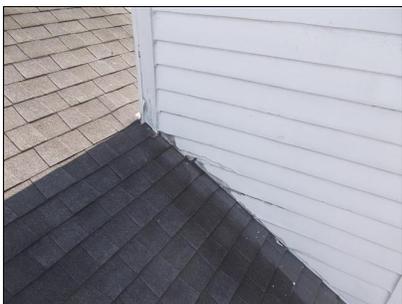
(2) The trim and siding around the fireplace chimney is showing signs of water intrusion and deterioration. Recommend having a carpenter repair and replace all deteriorated siding and trim on the chimney surround. Properly prime and paint.

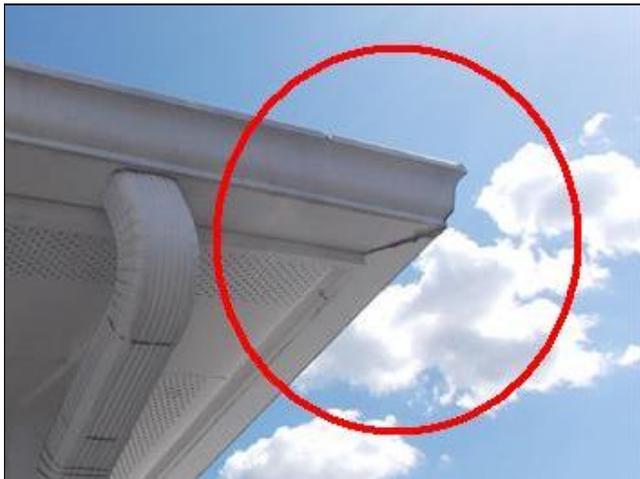
1.3 Item 1(Picture)

The gutter appears to leak at the seam on the front, rear and sides of home. Recommend having a gutter installation company evaluate and repair as needed.

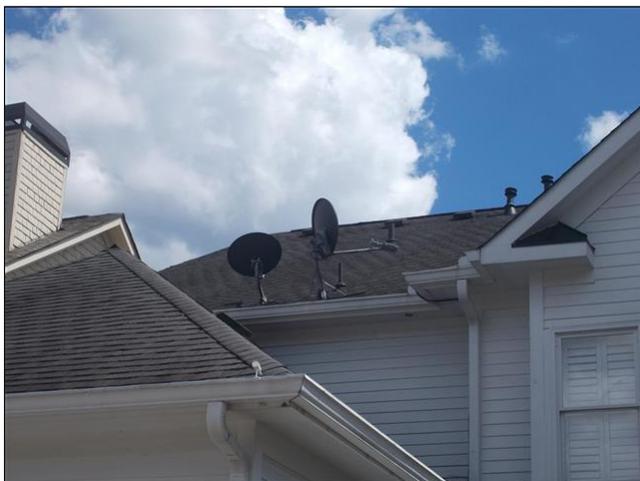
1.4 Item 1(Picture)

There were two satellite dishes attached to the roof. Devices attached to the roofing material can develop into a roof leak and if it is no longer used it is recommended that it be removed and damaged shingles replaced.

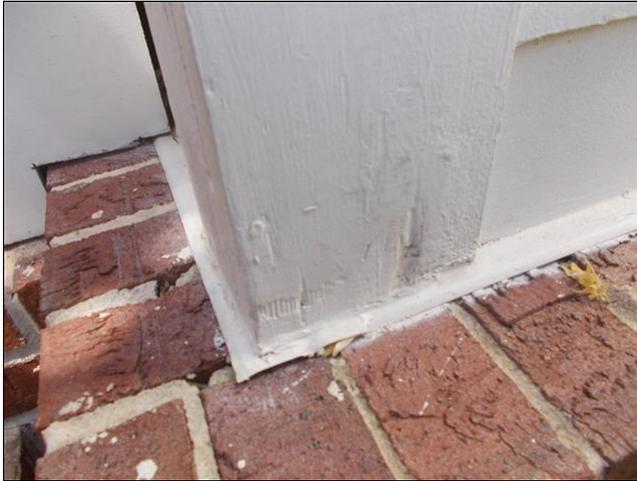
2.2 Item 1(Picture)

(1) The front corner board by the front porch was showing evidence of caulked repairs. This is a very amateurish attempt at correcting rot and deterioration and should be properly cut out and repaired. Recommend having all siding components repaired and painted with a quality paint to prevent further deterioration.

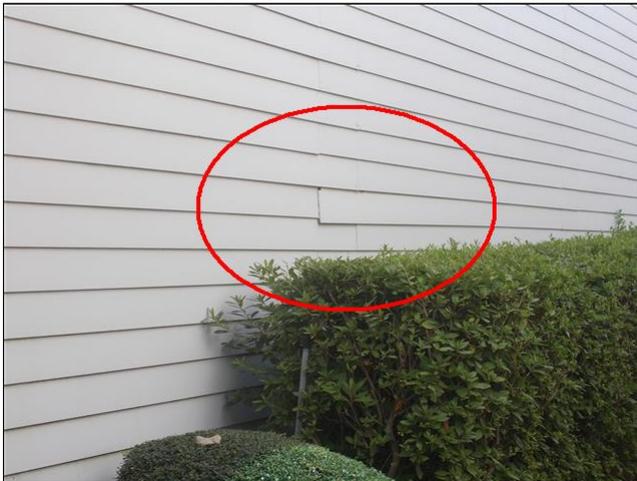
2.2 Item 2(Picture)

(2) There was a piece of siding on the right side of the home that appeared to be loose. Recommend having a contractor properly re-secure the siding and seal as needed.

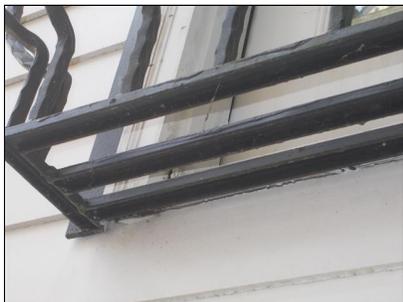
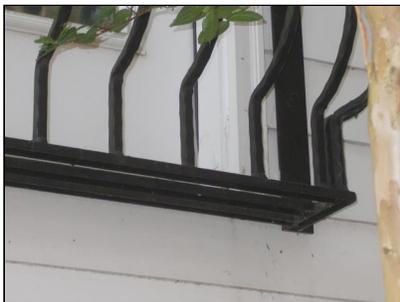
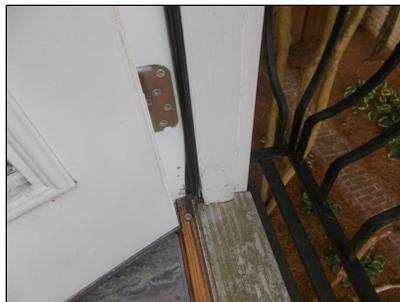
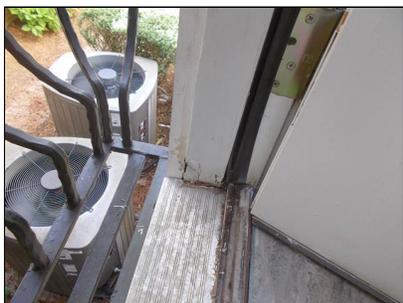
(1) Trim at the bedroom balcony door was noted as deteriorated on both sides. Recommend having a contractor evaluate and properly repair or replace as needed.

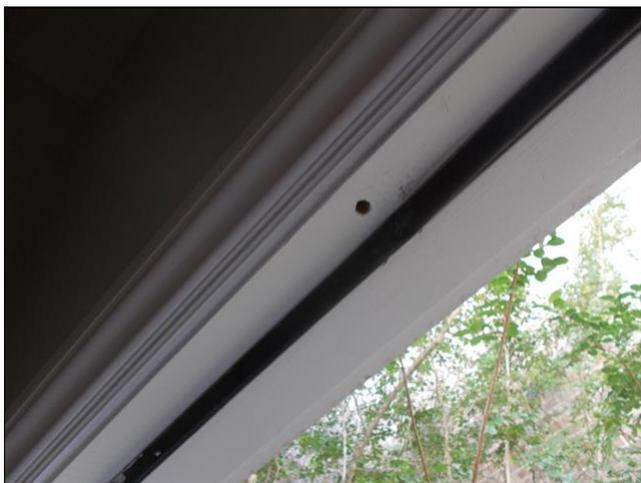
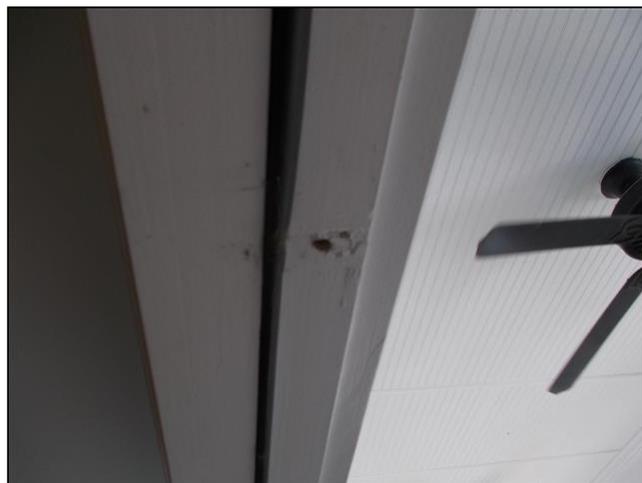
(2) The plate for the top jamb bolt was missing at the top jamb on the double door. The jamb lock has a small plate with two screws securing it to the jamb to prevent the hole from widening. Recommend having the trim carpenter install as noted.

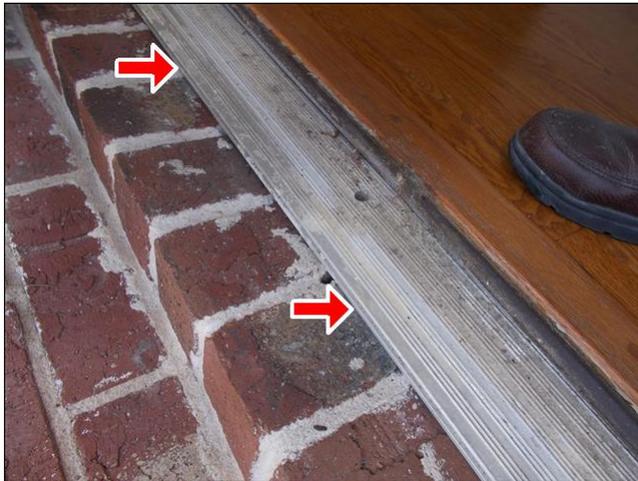
2.3 Item 7(Picture)

(3) All of the doors on the building were noted as in need of caulking along the threshold at the brick connection. Recommend having painting professional caulk all trim where needed, paint and seal.

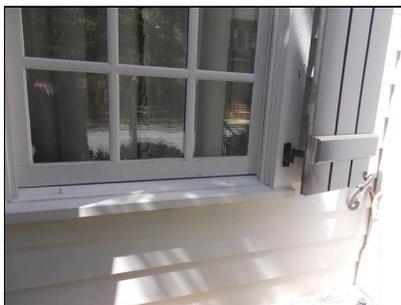
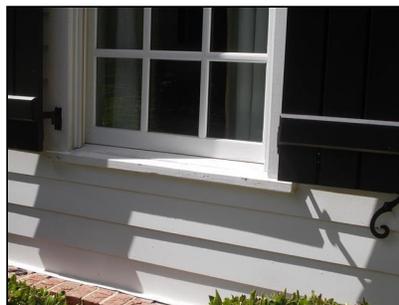
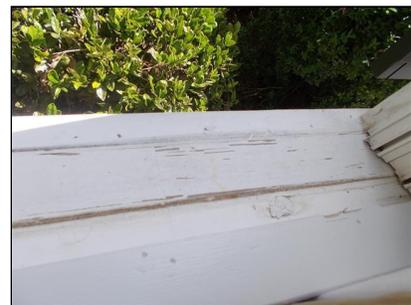
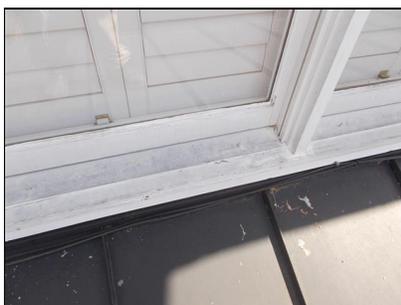
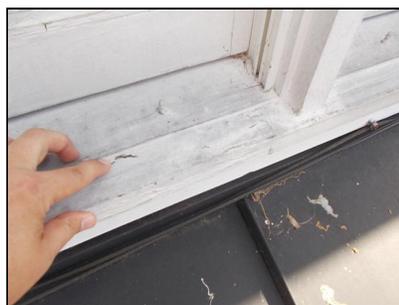
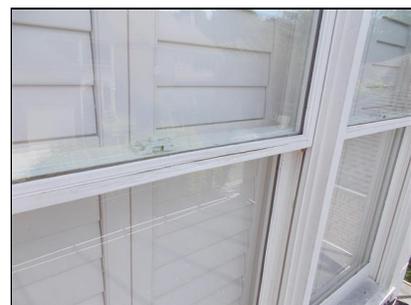
(1) The wooden exterior window trim around the home was noted as in need of painting. All exterior paintable surfaces should be coated in a quality weather resistant paint and maintained periodically. Typically painting is needed every 5 years or so. Recommend having a qualified painting company paint exterior wooden windows and trim on the home.

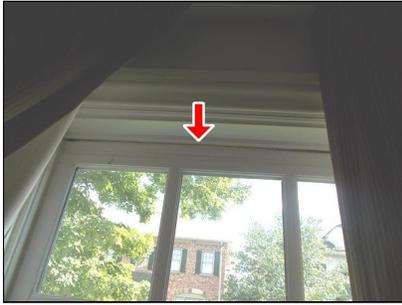
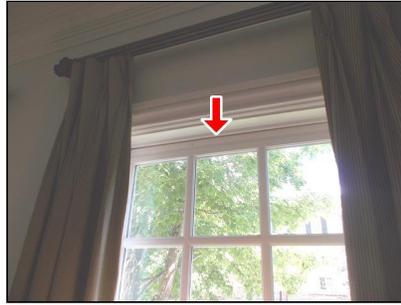
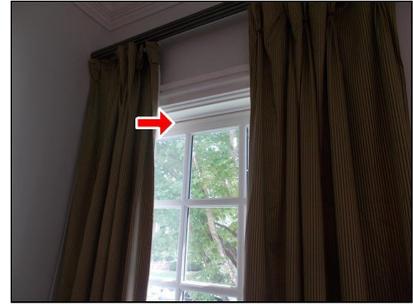
(2) The front windows were noted as open along the top of the window. There was clearly a gap to the outside. Recommend having a window professional evaluate the windows and repair or replace as needed.

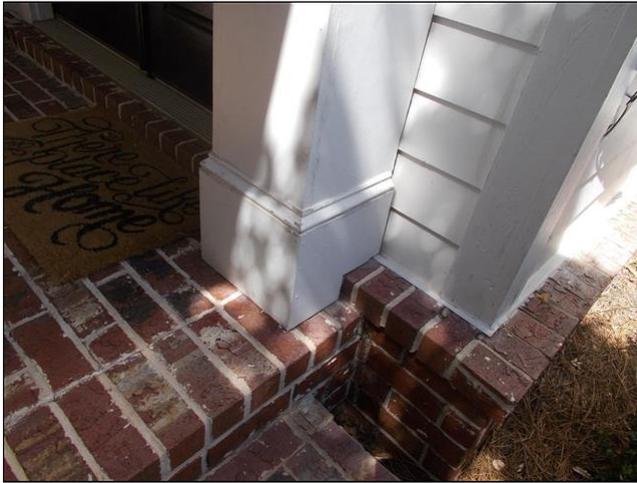
2.5 Item 1(Picture)

The paint on the porch columns and trim was noted as showing signs of weathering was beginning to deteriorate. Recommend having all porch components repaired and painted with a quality paint to prevent further deterioration. Typically painting is needed every 5 years or so.

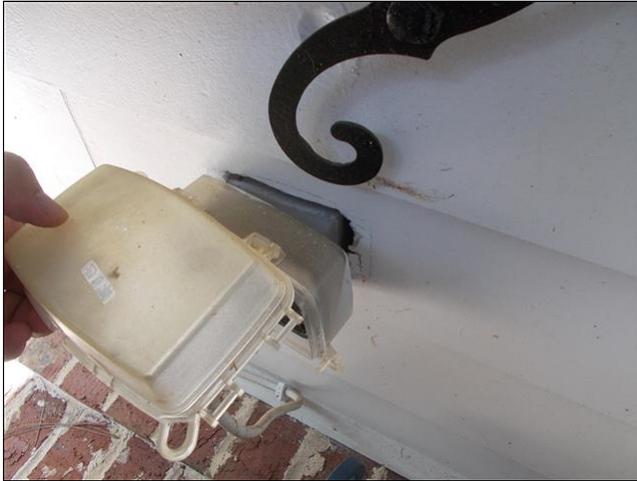
2.6 Item 1(Picture)

(1) The front exterior receptacle was noted as being loose at the wall connection. Receptacles must be securely and rigidly mounted to wall surface when device boxes are recessed in walls for safety. Recommend having a licensed electrician properly secure all receptacles as needed for safety.

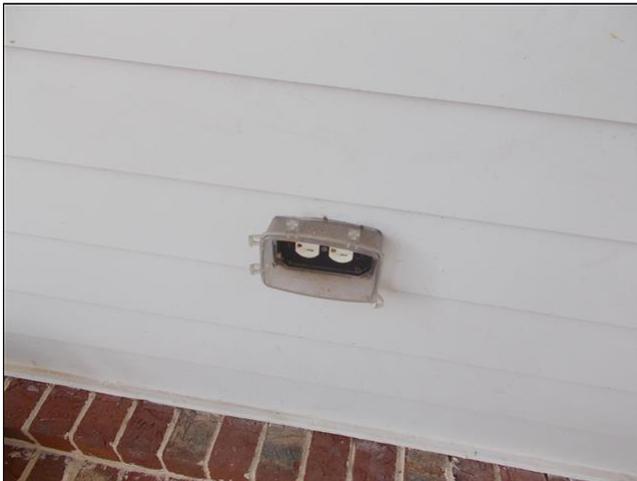
2.6 Item 3(Picture)

(3) The bubble cover on the receptacle on the back patio was noted as broken and in need of being repaired. Recommend having an electrician evaluate and repair or replace as needed.

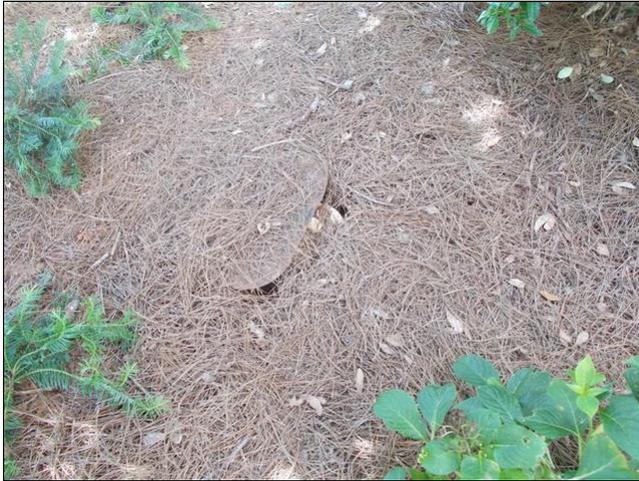
2.7 Item 1(Picture)

(1) The plumbing cleanout hand-well in the front yard was observed as open. Upon closer evaluation it was noted the plumbing drain was raised up and the lid could not close properly. This is likely due to the dirt supporting the hand-well, settling and compacting. Recommend having the hand-well adjusted or the drain line cut off so the lid will properly close.

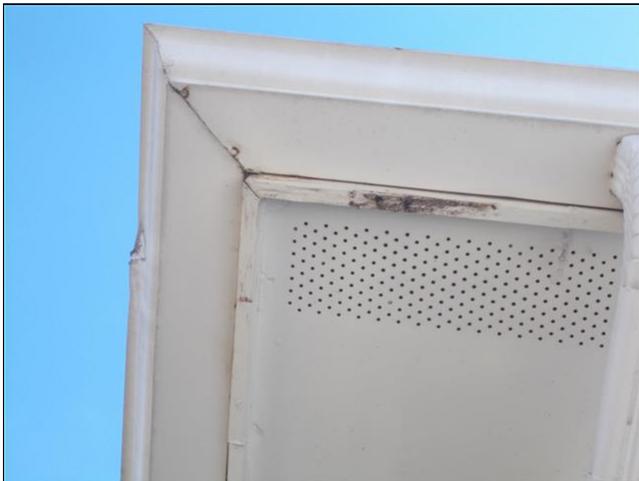
2.10 Item 3(Picture)

(2) The fascia around the home were noted as showing evidence of deterioration and in need of minor repairs. Recommend having a carpenter repair as noted.

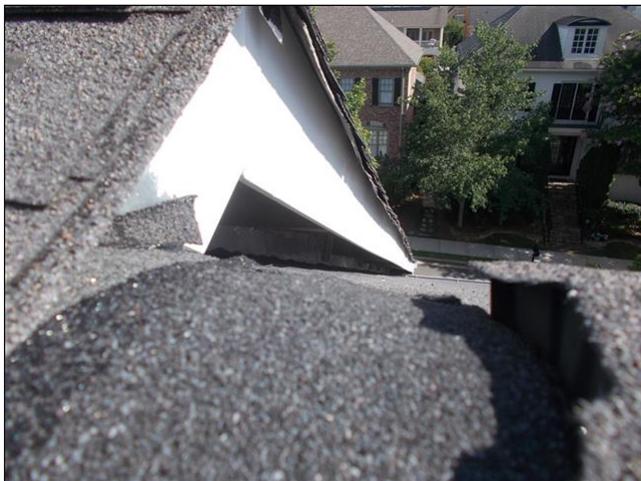
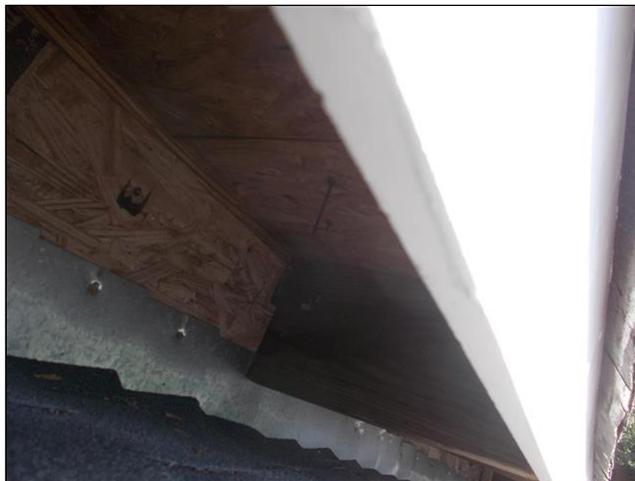
(3) The overhang on the upper roof was noted as missing the soffit material and was open at the time of the inspection. Recommend having a contractor properly finish the soffit and close the area to prevent insects or vermin to enter the home.

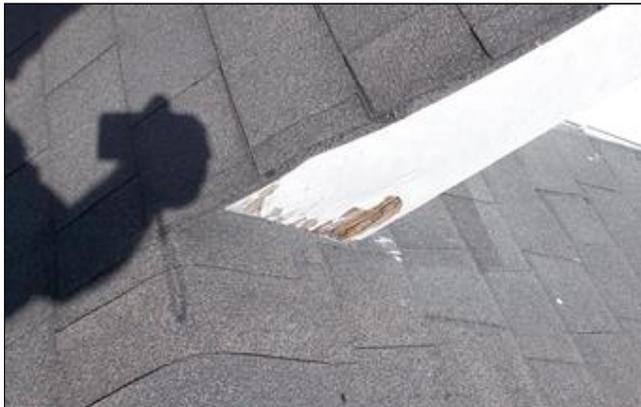
2.10 Item 6(Picture)

(4) The fascia up on the roof showed water damage and were in need of repair. Recommend having a contractor repair or replace all damaged fascia and soffit.

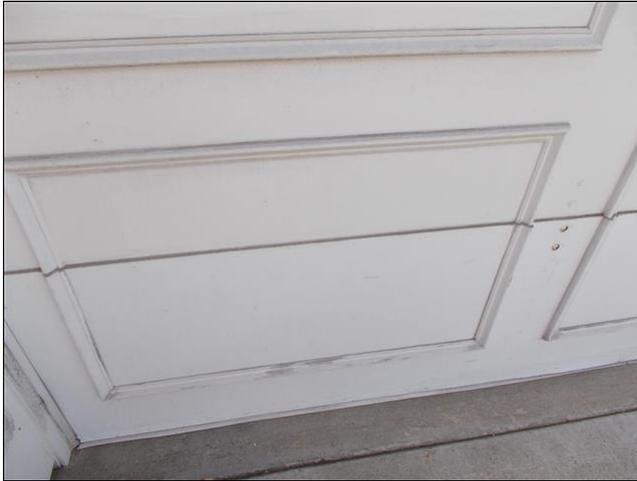
3.4 Item 1(Picture)

The garage door was noted as weathered and in need of being re-painted. Recommend having a contractor refinish as noted.

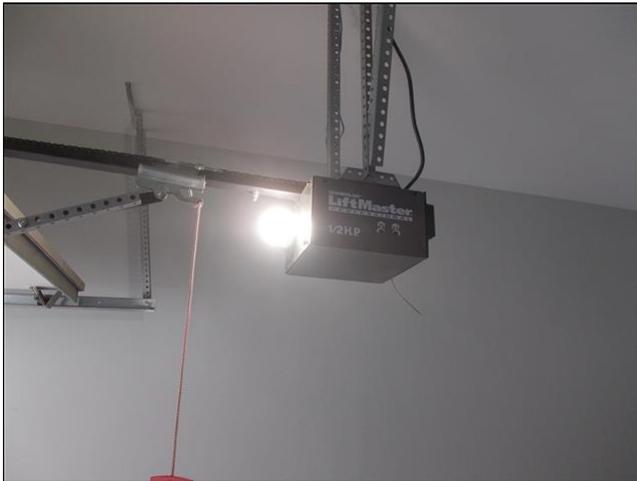
3.6 Item 1(Picture)

(1) The covers for the lights on the openers were missing. Recommend having the light covers replaced.

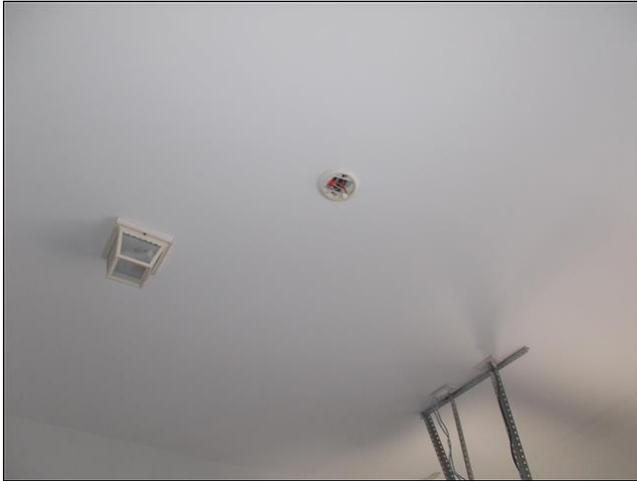
3.7 Item 1(Picture)

The smoke detector in the garage was noted as missing. Recommend having the seller replace the alarm as noted.

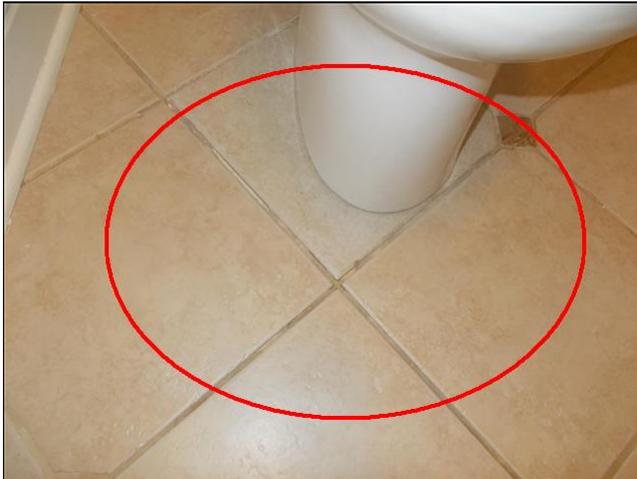
4.3 Item 1(Picture)

The master bath tile floor was noted as having several tile that were lacking grout between the tiles. Recommend having a contractor evaluate and repair or replace the tile floor as needed.

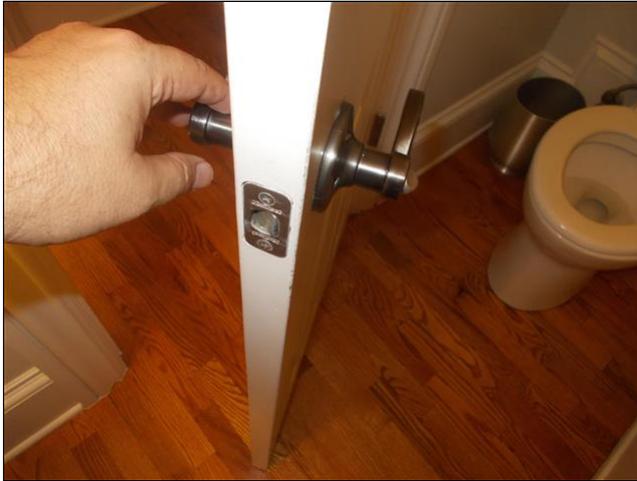
4.6 Item 1(Picture)

(1) The latch for the half bath door was stuck and did not function properly. Recommend having a handy man repair as needed.

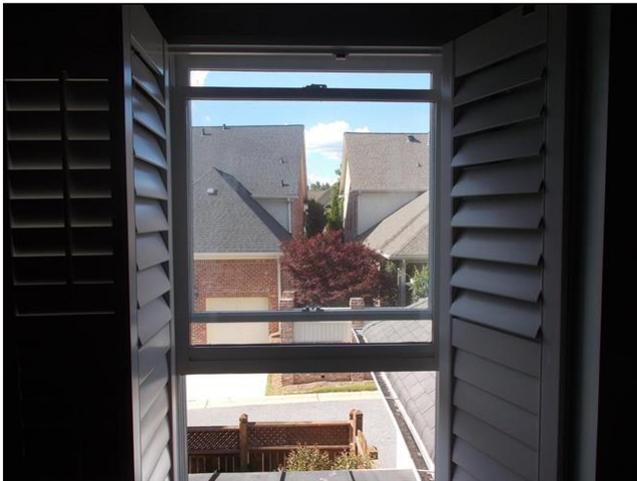
4.7 Item 1(Picture)

Some of the windows were checked for operation and upon opening the window in the master bedroom it was extremely difficult to close. Recommend having a window professional evaluate all of the windows and repair as needed.

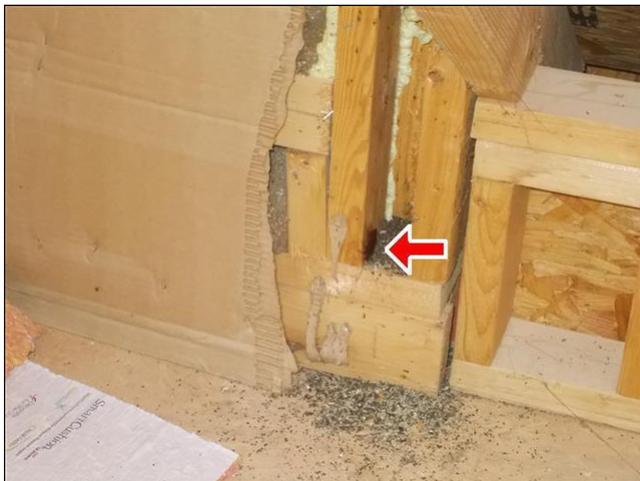
5.5 Item 4(Picture)

(2) There was a cockroach in the attic. Recommend having a pest company treat and verify the property is clear.

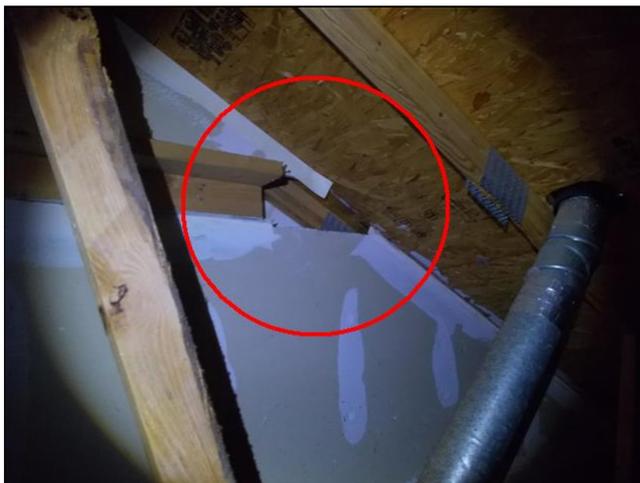
5.7 Item 1(Picture)

The home is protected on one side by a fire-resistant assembly which was designed as a vertical rated assembly from the floor to the underside of the roof deck, gaps and penetrations are not allowed. There was a fairly large hole at the end of the roof brace on the side which needed to be properly sealed. Recommend having contractor fill gaps on either side of attic where roof decking is exposed, with type X sheetrock.

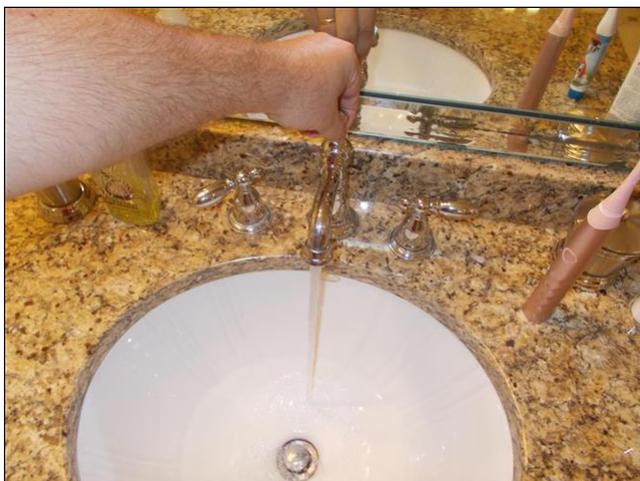
6.2 Item 3(Picture)

(2) Some of the vanity drain stoppers did not work at the time of the inspection. Recommend having a plumbing contractor repair or replace as needed.

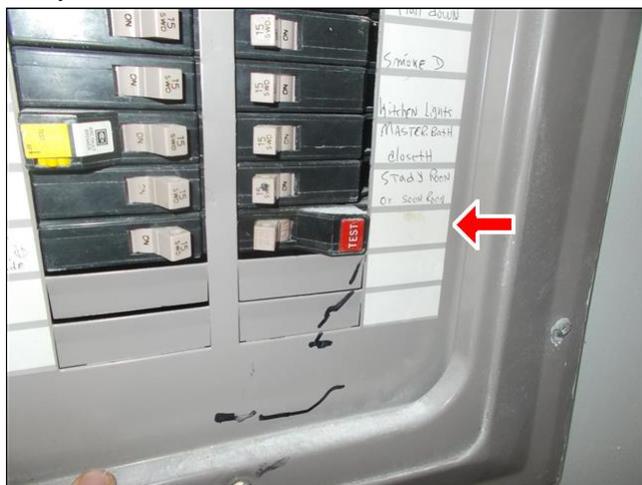
7.0 Item 3(Picture)

(2) There was a GFCI breaker in the panel that was not properly labeled or identified. Recommend correcting for safety reasons.

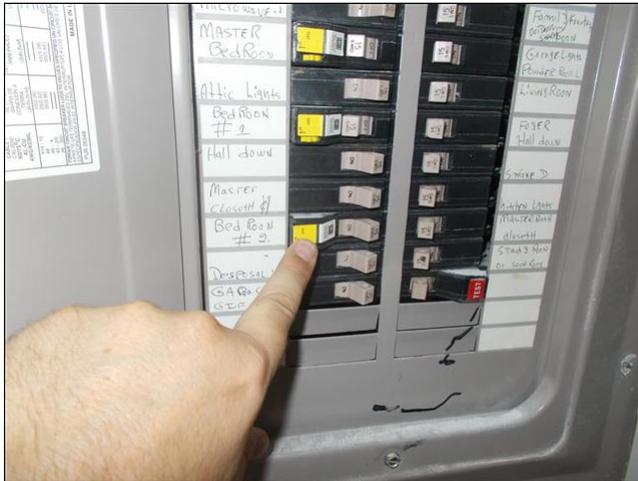
7.1 Item 1(Picture)

(1) One of the Arc fault breakers failed to trip when it was tested. Recommend having an electrician repair or replace as needed.

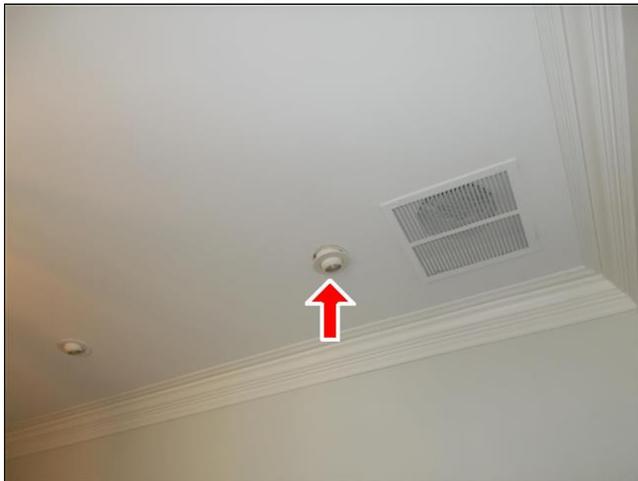
7.2 Item 1(Picture)

(1) The can light in the front room was loose from the ceiling. Recommend having a licensed electrician evaluate and repair as noted.

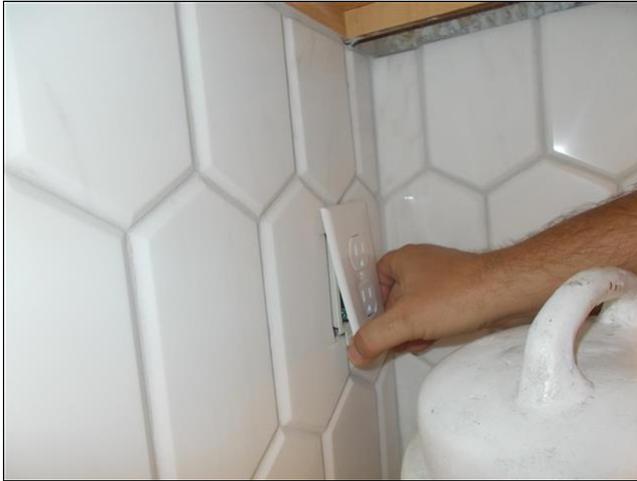
7.2 Item 2(Picture)

(2) There was a receptacle device in the kitchen that was noted as loose and in need of being re-secured. Recommend having a licensed electrician repair as noted.

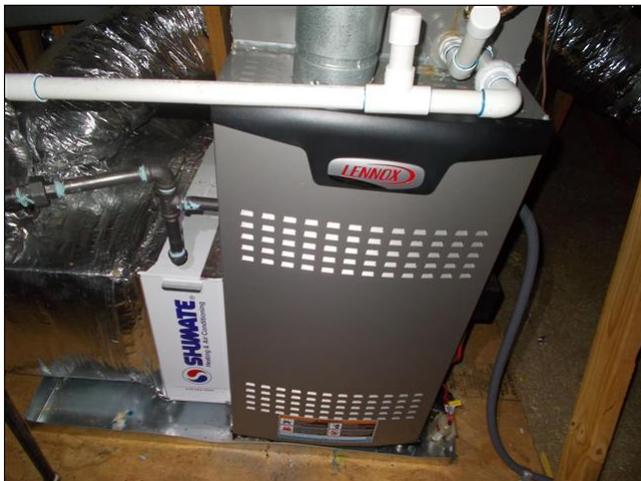
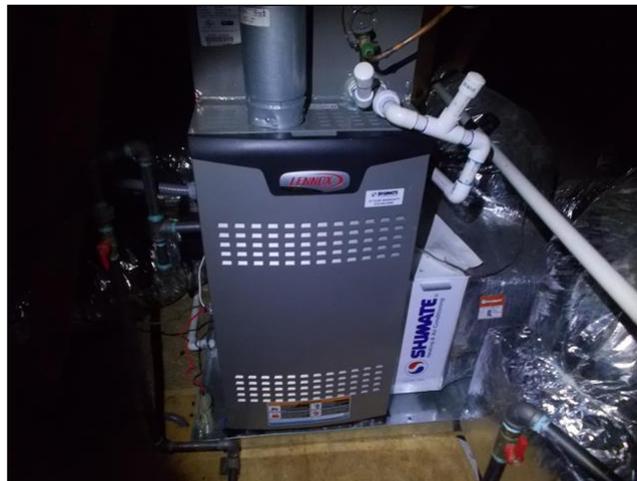
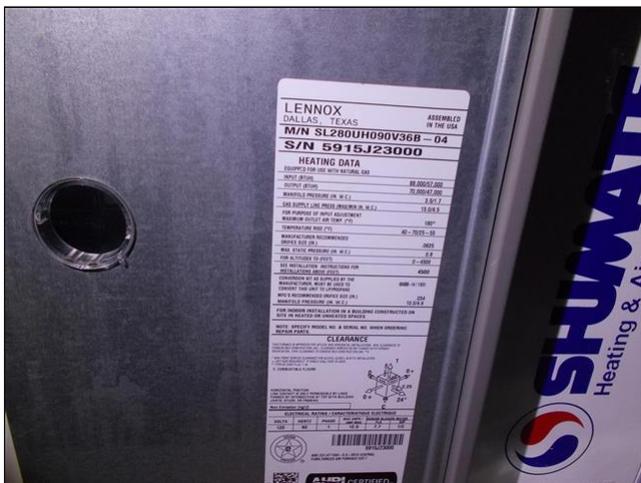
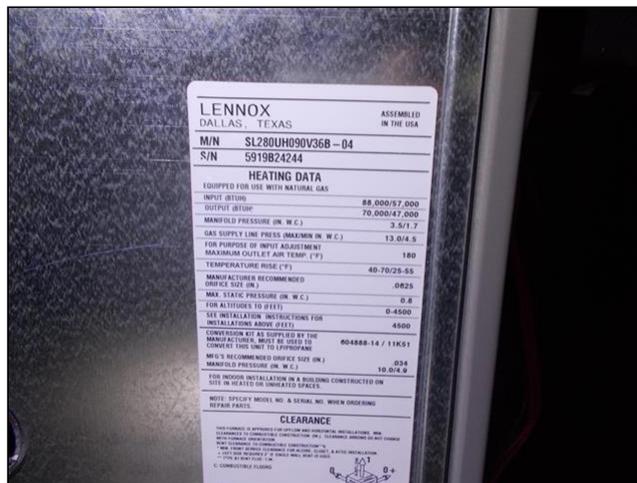
The furnaces did not appear to have been professionally serviced recently. One unit was manufactured in 2015 and the other was 2019.

Recommend having the HVAC system professionally cleaned, serviced and evaluated by an HVAC company including but not limited to: lubricating the motors and moving parts, check and adjust blower fan belt tension, tighten all electrical connections, check all controls, evaluation of the heating elements, refrigerant levels, clean condenser coils, check cooling coil and linesets.

Replace and or clean filters at least four times a year, or based on the recommendations of the filter manufacture.

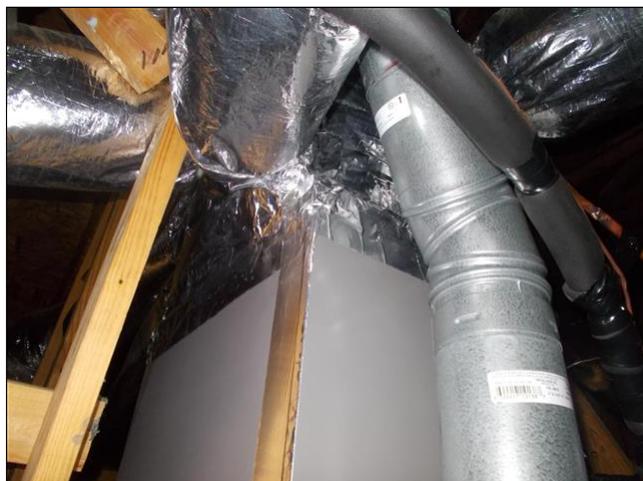
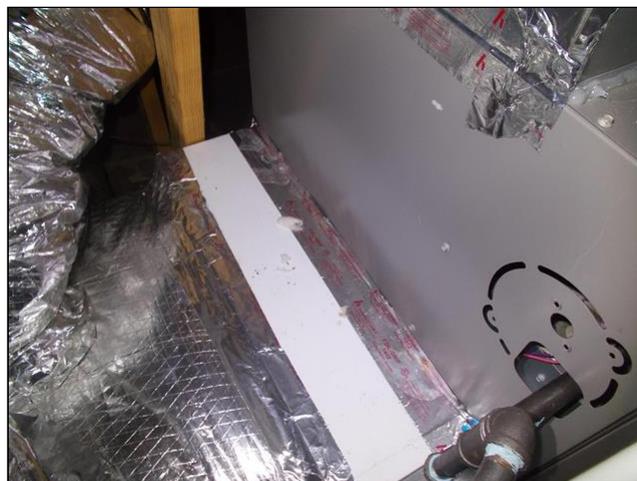
(2) The plenum connections and joints are not air tight; the attic unit was drawing in and exhausting attic air during operation. This reduces efficiency and can adversely affect the living area. Joints and connections in air distribution piping must be taped and sealed with mastic in an approved manner for effective operation and maximum efficiency. Recommend having HVAC contractor tape or seal all seams and joints with an approved product.

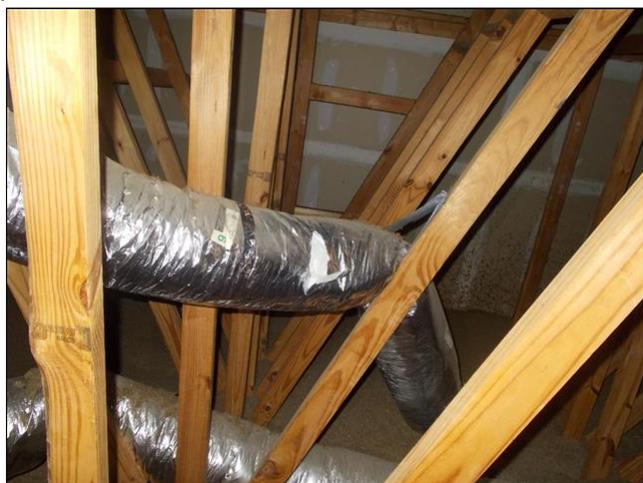
8.3 Item 5(Picture)

(3) Some of the ductwork in the attic was noted as having the outer foil torn or ripped and was in need of being repaired. Tears in air distribution piping must be taped and sealed in an approved manner for effective operation and maximum efficiency. Recommend having HVAC contractor tape or seal all foil jackets with an approved product.

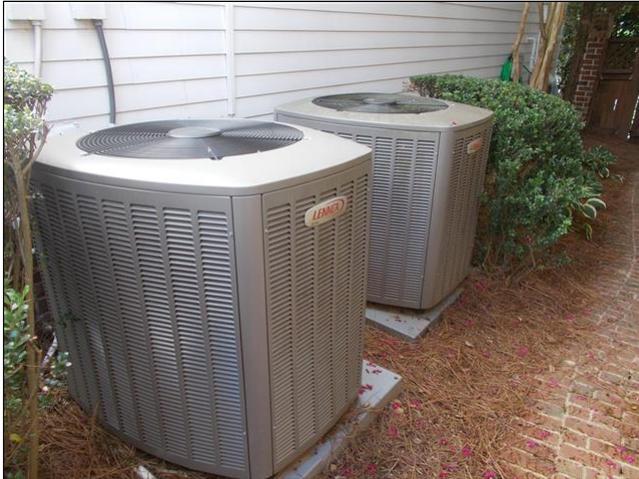
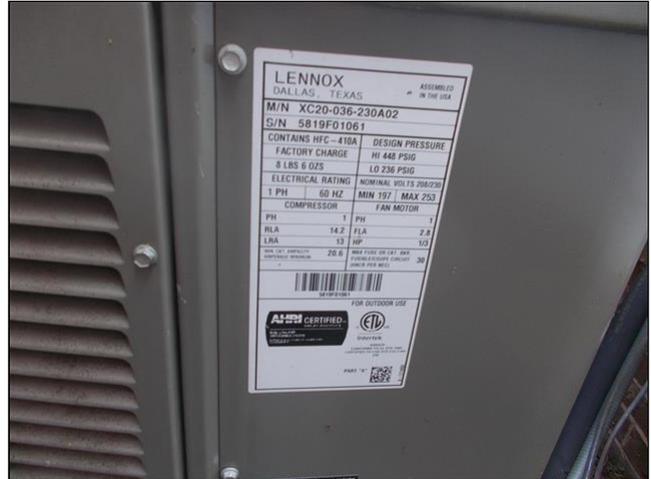
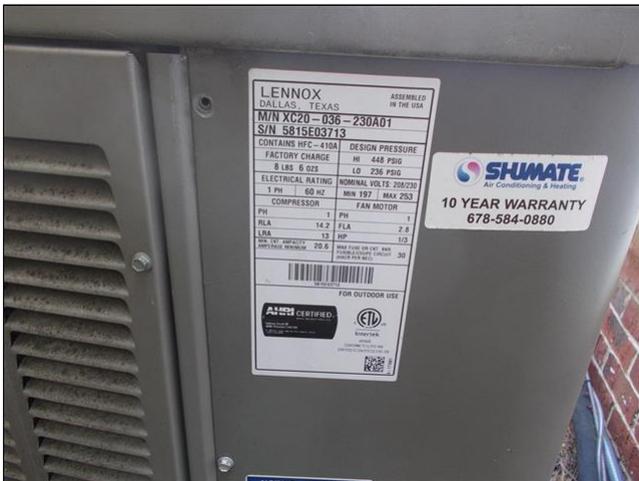
One of the two compressors outside (AC units) appeared to be older (2015) and the other appeared to be newer (2019). Due to the outside temperatures being so low these units could not be tested for effectiveness for cooling. It cannot be determined how long the AC will last before a replacement is necessary. Preventive maintenance and annual servicing can prolong the longevity of the units.

Recommend having an HVAC contractor evaluate the entire system and repair or replace components as needed.

An upgraded system would be more cost efficient to operate.

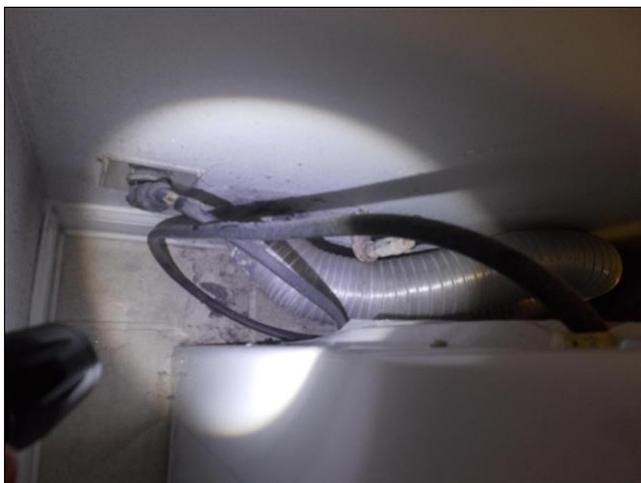
9.2 Item 1(Picture)

(1) There was a considerable amount of lint behind the dryer at the exhaust connection, thus suggesting there was an exhaust issue where the lint was being pushed out around the pipe. Recommend having a contractor repair and clean as needed.

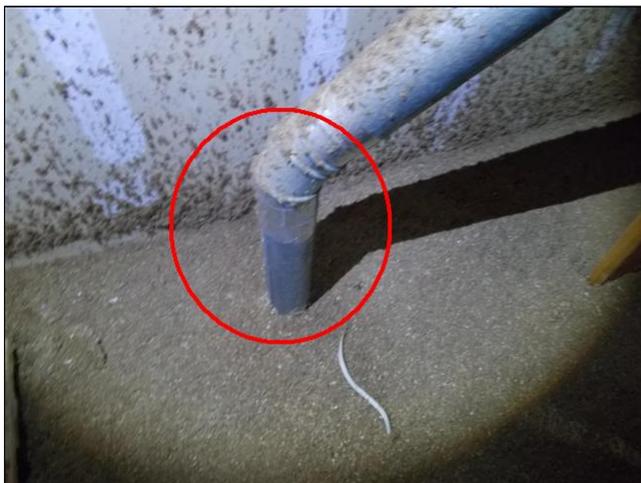
9.2 Item 2(Picture)

(2) It appears the dryer duct ran up into the attic and was full of lint and in need of being cleaned this can result in overworking the dryer equipment thus resulting in inefficient drying of clothing or potential fire hazard. Recommend having a duct cleaning company or a general contractor clean all lint from exhaust duct.

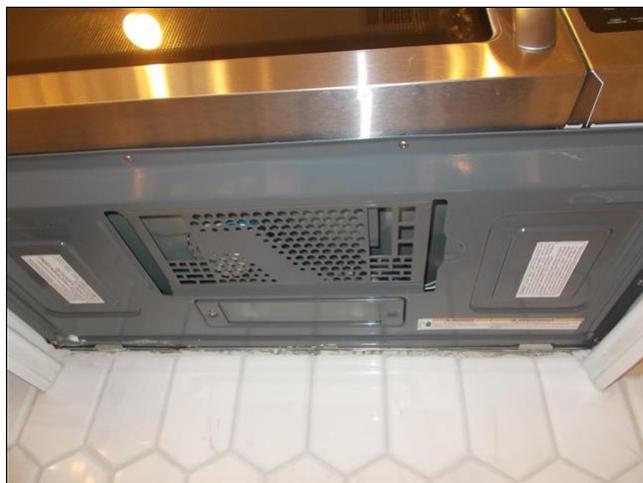
10.3 Item 1(Picture)

The hood was built into the microwave unit and was not vented to the outside and the grill was missing. Recommend having an appliance professional replace the grill.
