Inspection Report

Property Address:
10895 Kimball Crest Dr
Alpharetta GA 30022

Residential Inspector of America
Inspector: Andrew Binosa
3276 Buford Dr, Ste 104-306
Buford, GA 30519
770.476.4963

Date: 8/8/2020	Time: 09:00:00 AM	Report ID: 080720AB227
Property: 10895 Kimball Crest Dr Alpharetta GA 30022	Customer: Santosh Gokhale	Real Estate Professional: Rupali Dalvi

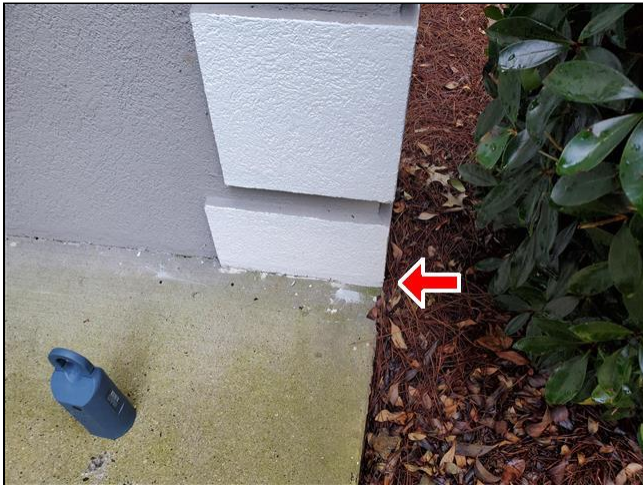
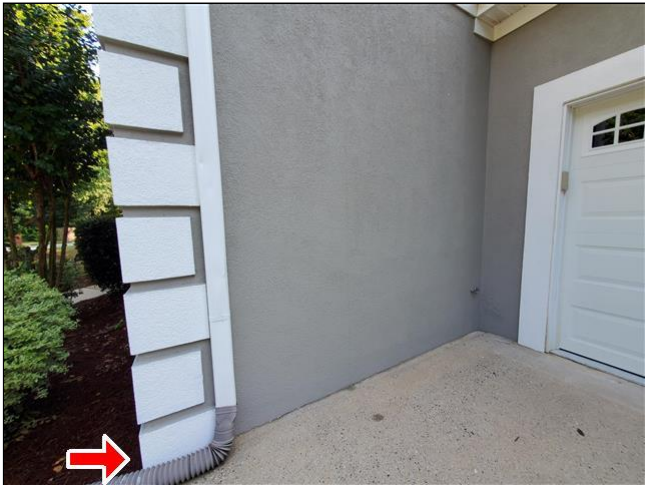
🔧 (1) The synthetic stucco quoins are installed below grade and is not finished along the bottom edges. Stucco should be trimmed away from the soil and finished off on a 45 degree angle, as per standard practices for stucco. This work should be done by an experienced stucco contractor.

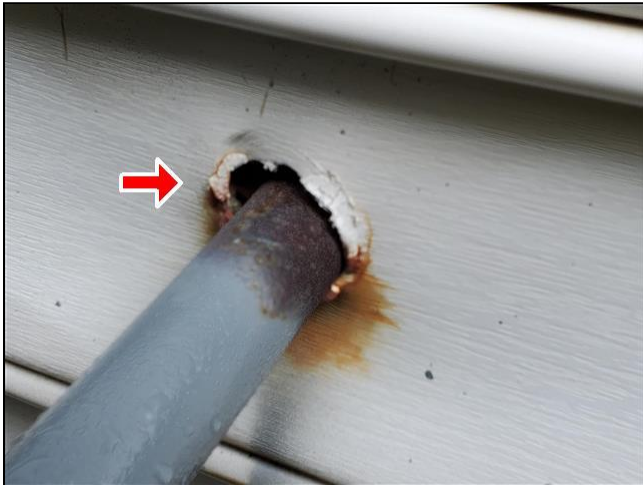
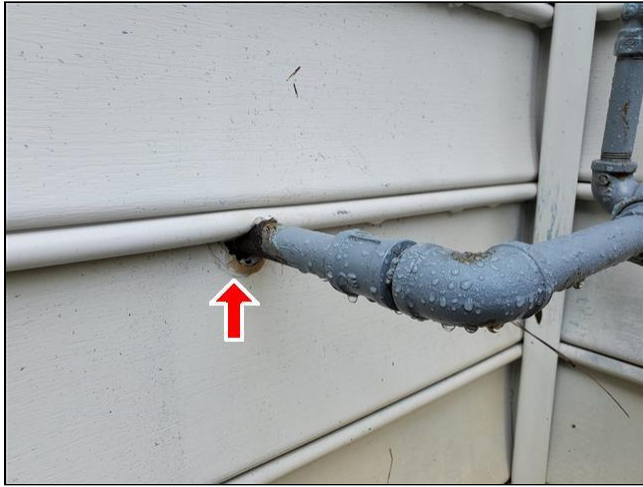
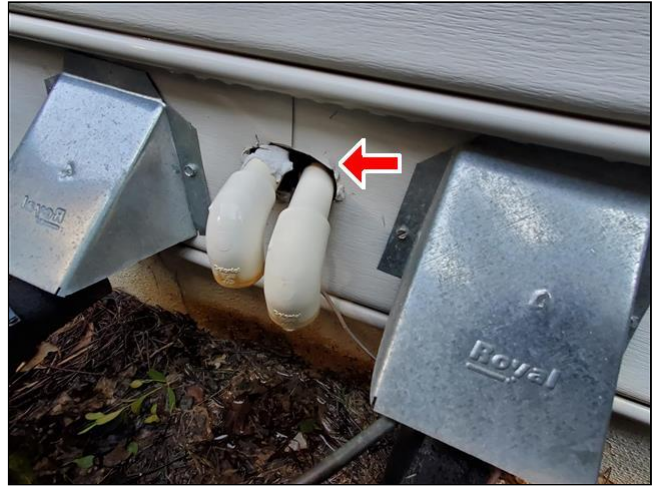
- 1) Have the exterior wall penetrations sealed as per inspection report point 1.1 (2). Pictures are on Page 9 and 10 on the inspection report.
- 2) Repair or Replace the opening between garage and the residence (garage door) as per inspection report point no 2.5 (page 15 on the report)
- 3) Have the lint built-up removed at the dryer exhaust outlet as well as dryer duct as per inspection report point no 5.2 (1)
- 4) Repair or Replace the damaged exterior vent cover as per inspection point 5.2(2) and the defective exterior flap cover as per inspection point 5.2 (3)
- 5) Demonstrate that the fire place in the family room is functional as during inspection, inspector could not get it to function.

🔧 (2) Have all exterior wall penetrations sealed. Ignoring these breaks in a building's thermal barrier threatens the durability of the house and the health of its occupants. Knowing where these penetrations are and how to seal them makes it possible to reduce utility bills, prevent drafts and stop the infiltration of moisture and all the problems that come with it.

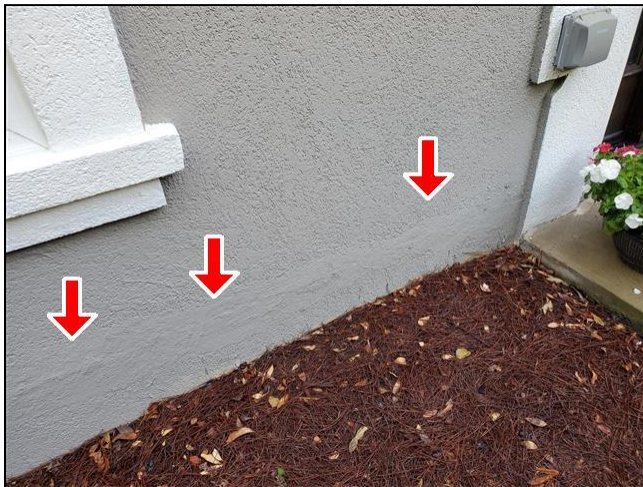
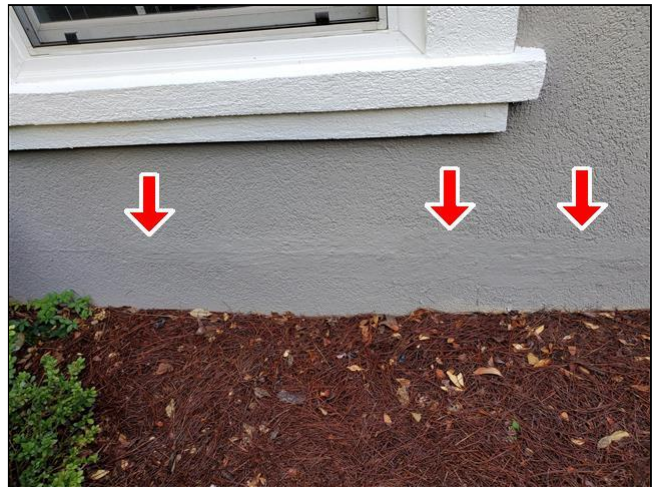
🔧 (3) The stucco is the hardcoat type, and moisture analysis was not included as a part of this inspection. It is critical that the stucco be well sealed to any dissimilar material used on the house, such as wood or vinyl trim, cables, pipes, etc..., and that roof drainage be kept in good condition. Condition of framing behind stucco is not visible and is not known.

Previous re-patching job was noted at front and right side. See photos.

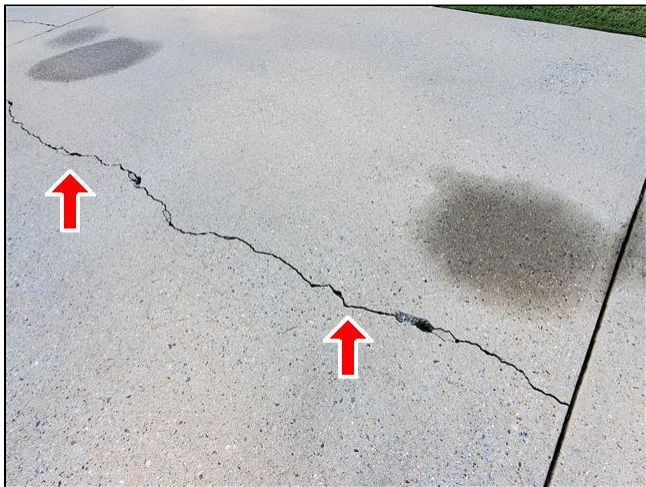
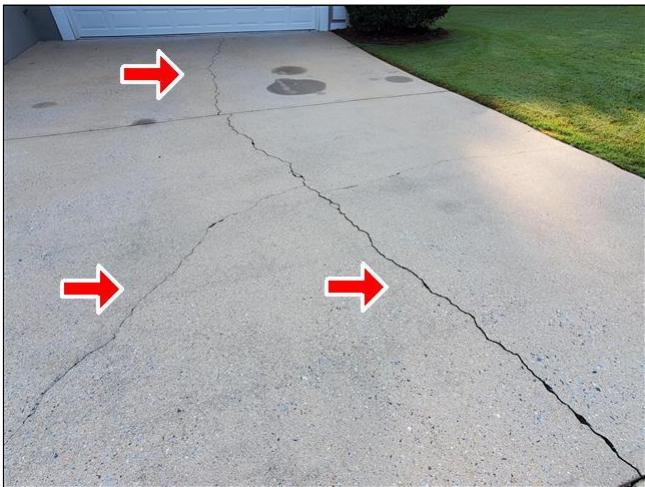
(1) Cracks noted at numerous locations of driveway/walkway. Cracks are normal on concrete after many years. However, cracks will need to be sealed to prevent further damage from the freeze/thaw cycles which is part of the ongoing maintenance of a concrete driveway that will need to be performed on a regular basis.

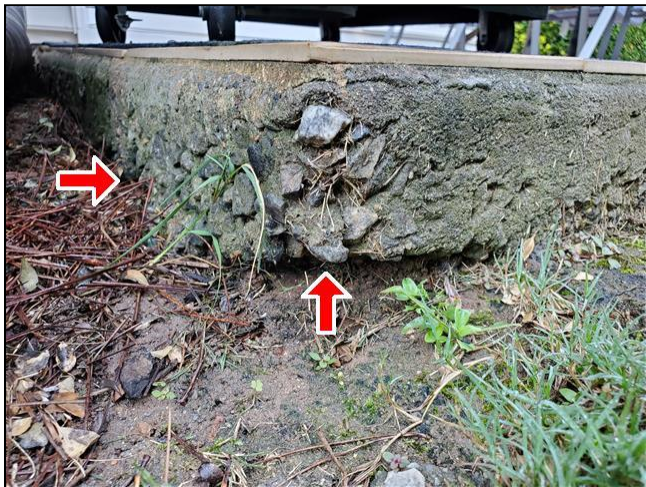
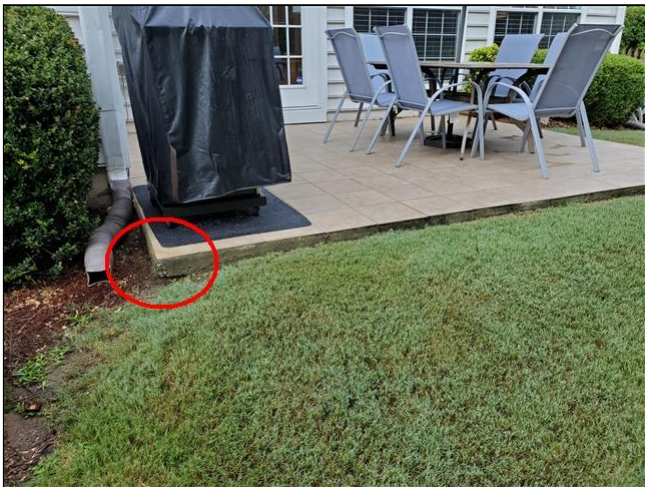
(2) Expansive clay soil often leads gaps under the concrete driveways, sidewalks or patio. As the temperature spikes in the summer, the intense heat zaps moisture from the soil. During periods of excessive dryness, the soil contracts, creating cave-like cavities or gaps in the soil below the slab. Recommend to consult with a licensed professional to further evaluate and repair.

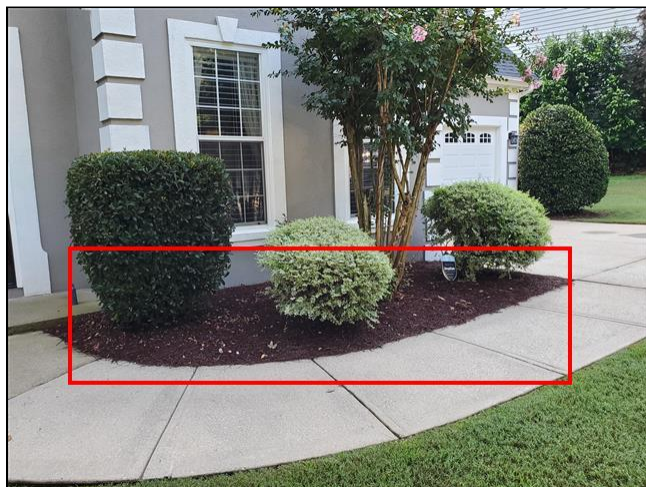
1.5 Item 5(Picture)

🔧 (3) The garden area formed by the front wall of the house, and the side walk from the driveway to the front landing, may prohibit quick drainage of run off water. These garden areas often are slow to drain and can cause water entry in the basement. See photo(s).

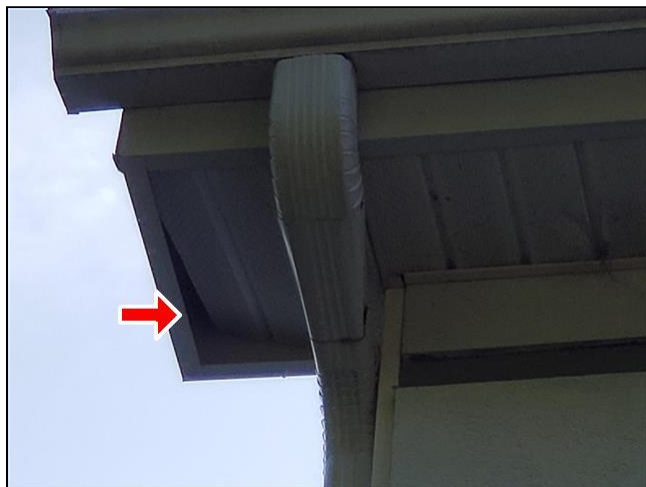
1.6 Item 1(Picture)

🔧 Soffit material at eave shown in the photos have been pushed in. Recommend to have seller adjust to avoid pest entry.

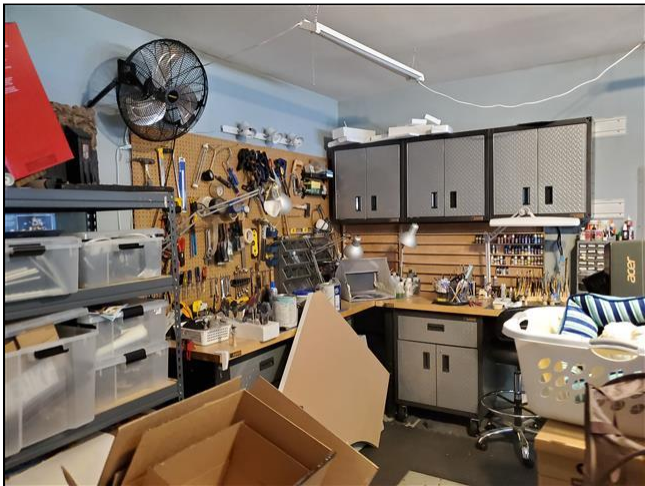
2.1 Item 1(Picture)

Garage inspection was limited due to the amount of stored items being in the garage at the time of the inspection. See photo(s). Buyer should resolve all concerns prior to closing.

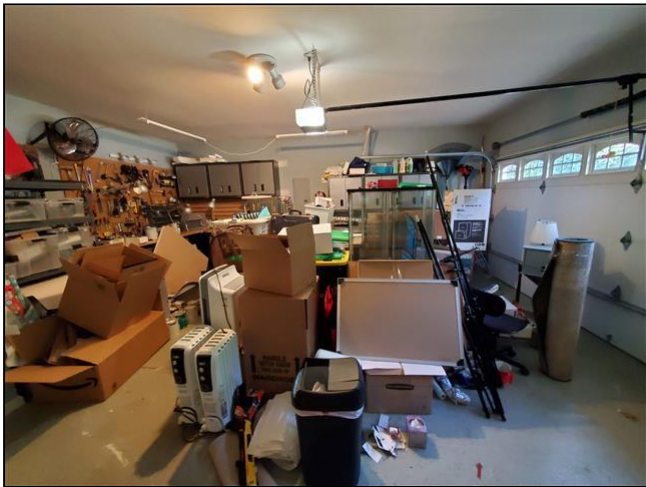
2.2 Item 1(Picture)

Many stored items in the garage limiting visual inspection.

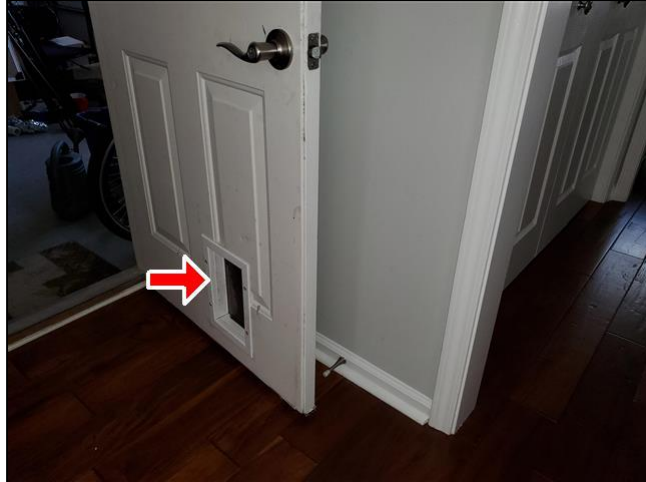
2.5 Item 1(Picture)

Openings between the garage and the residence shall be equipped with solid wood doors not less than 1-3/8" (35 mm) in thickness, solid- or honeycomb-core steel doors not less than 1-3/8" (35 mm) thick, or 20-minute fire-rated doors with self-closer. If doors have windows, the glass should be fire-rated. Door should not have any opening for pets.

Doors should have tight seals around their joints to prevent seepage of fumes into the living areas of the house. Carbon monoxide, with the same approximate density as air (and often warmer than surrounding air), will easily rise above the base of an elevated door and leak through unsealed joints.

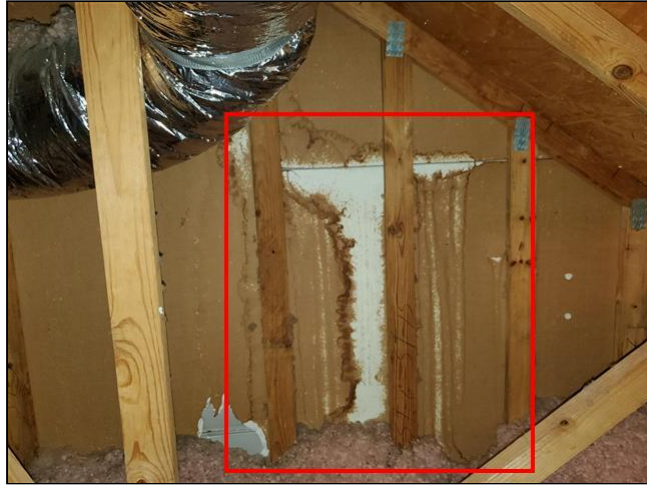
3.4 Item 7(Picture)

(2) Moisture stains noted on the side wall in the attic. Stains were dry at time of inspection. This is typical with vinyl siding when the exterior is powerwashed. Power washing can allow water to penetrate through the siding when the water is forced or sprayed in an upward position toward the vinyl siding material. Care should be taken when getting the siding powerwashed in the future.

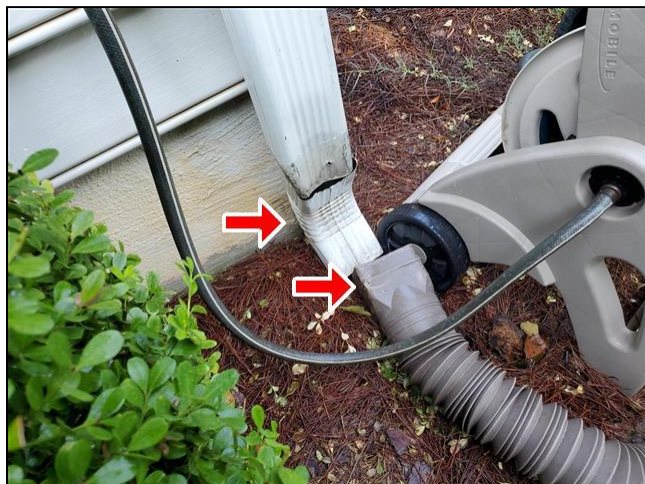
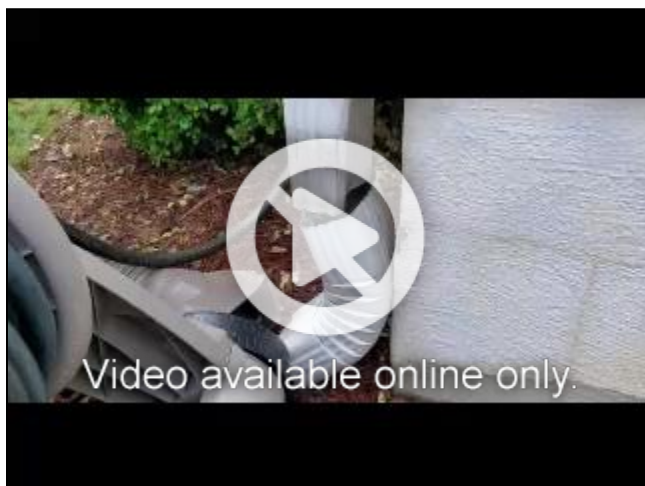
🔧 (1) Reconnect the downspout shown in the photos. The bottom elbow and the corrugated extension have been disconnected allowing water to saturate the ground near the foundation.

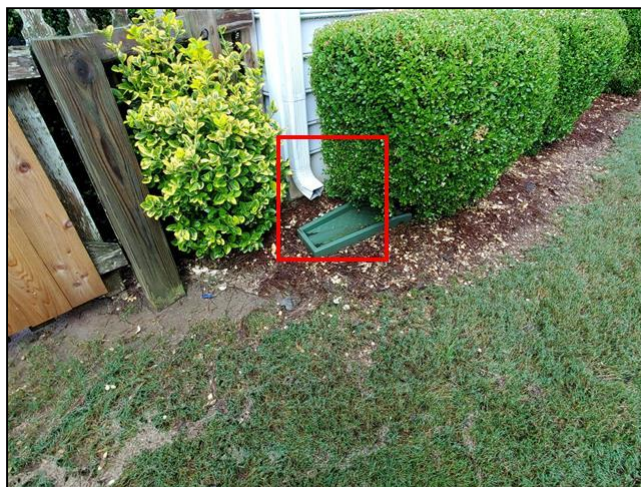
4.3 Item 4(Picture)

🔧 (2) The ground drain lines need extending or be connected to an underground drain pipe below the surface to divert water further away and direct roof spillage away from the building in order to avoid insect & rot infestation and damage.

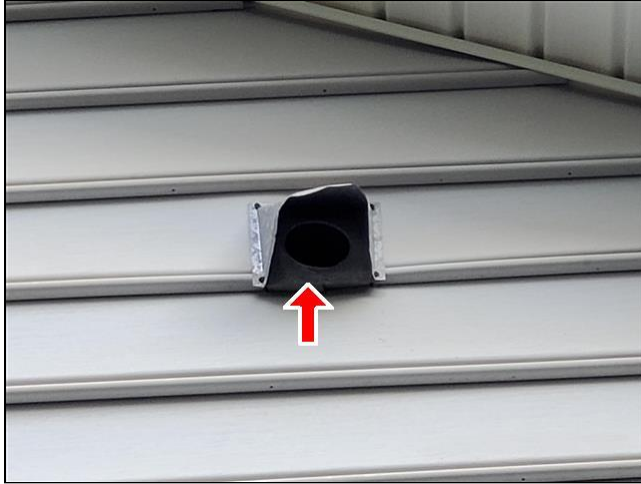
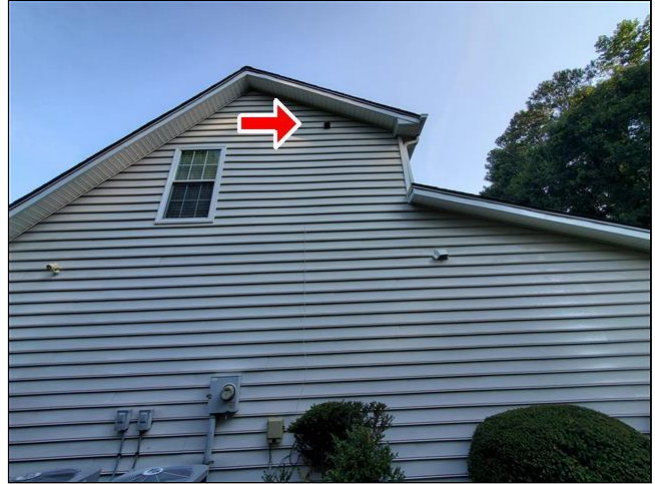
🔧 (2) Damaged exterior vent cover noted at right side. Have cover flap replaced to avoid moisture and pest entry.

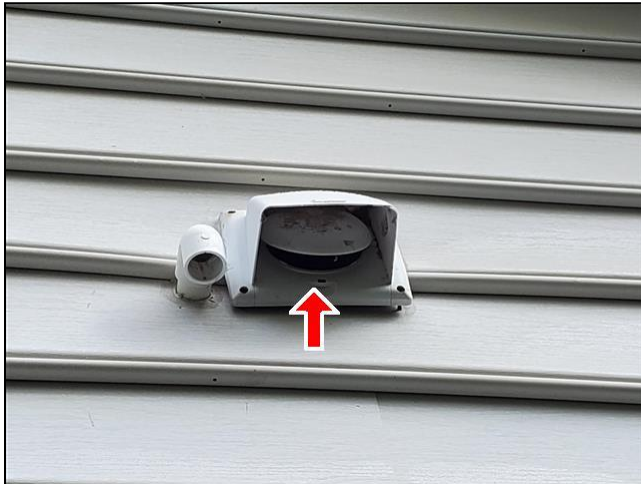
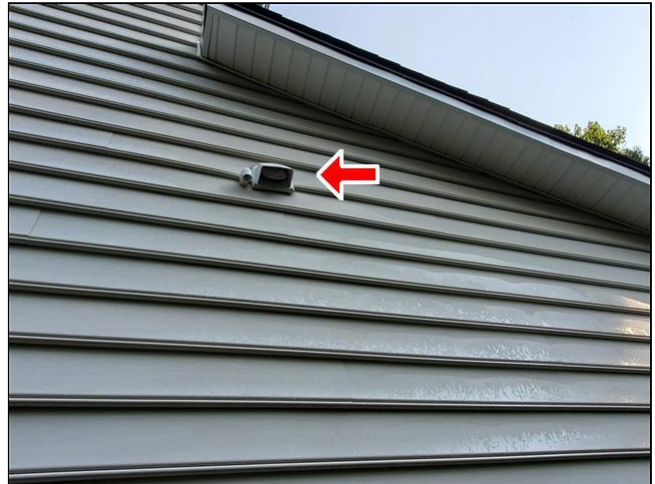
🔧 (3) Defective exterior exhaust cover flap. Have replaced or adjust so that the flap closes completely to avoid pest entry.

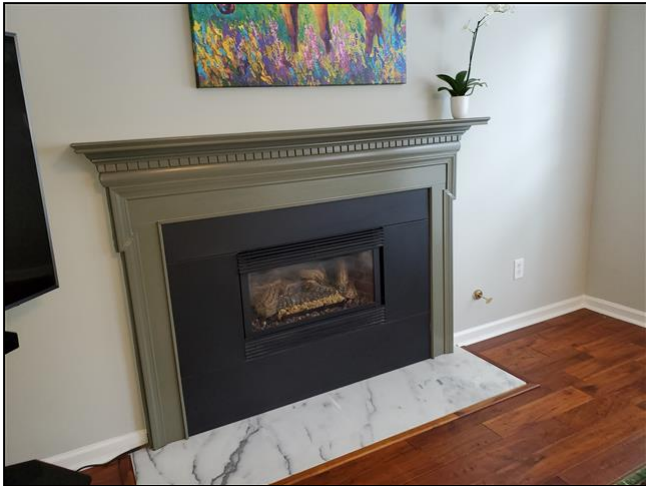
6.5 Item 1(Picture)

👉 Fire place(s) in the family room was not tested. Could not be lit during the inspection after several attempts were made. Have owner demonstrate that the unit(s) work.

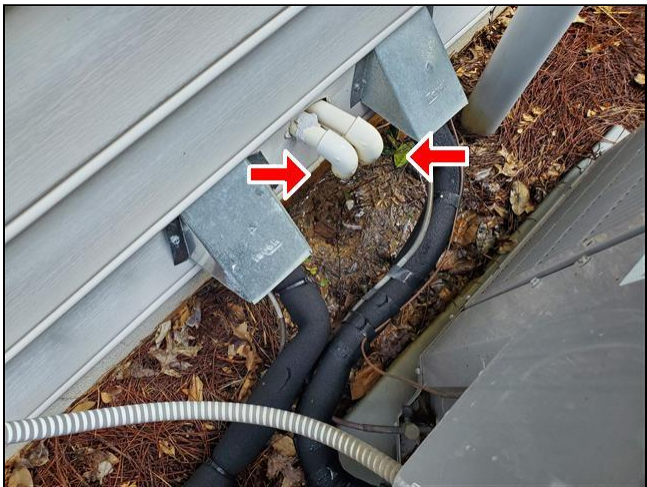
6.6 Item 4(Picture)

(2) Water pooling noted at the back of the AC condensers outside caused by the condensation drain pipe. Recommend to extend the drain pipes away from the foundation area to avoid saturating the soil.

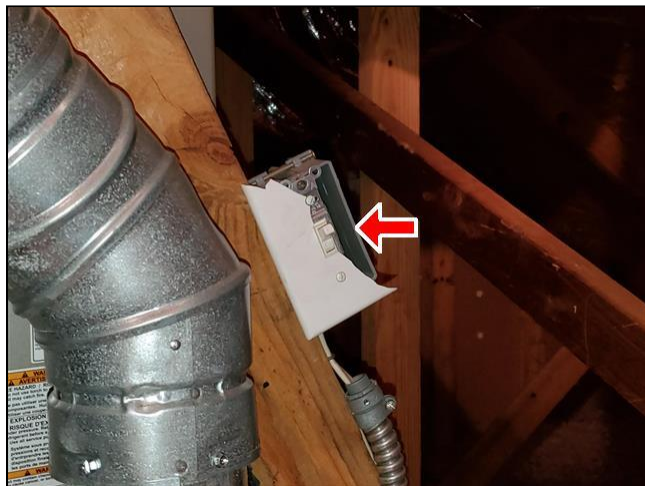
7.4 Item 1(Picture)

🔧 Broken switch cover plate noted in the attic near the furnace. Have cover replaced for safety.

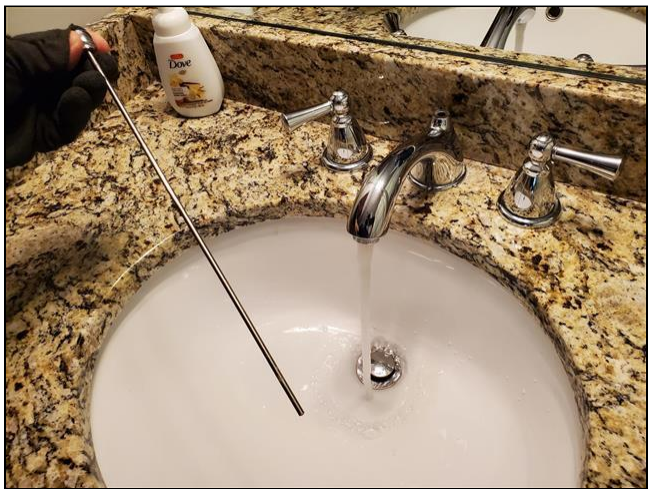
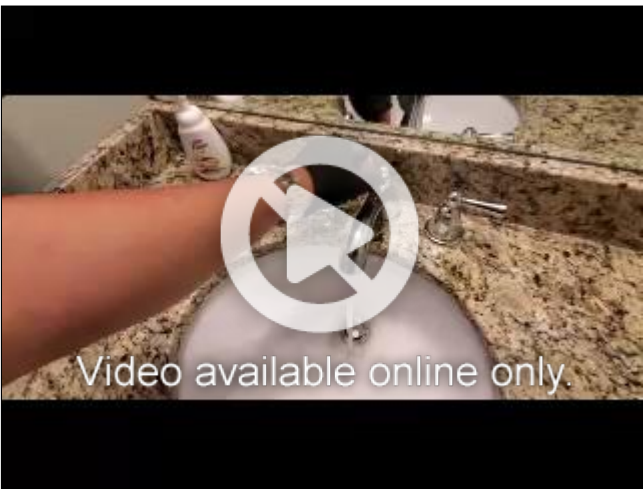
Defective drain stopper noted in bathrooms. Have repaired or adjusted as needed.

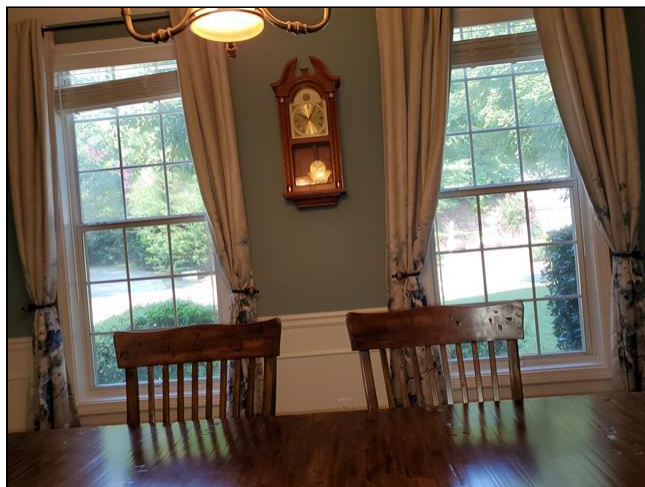
👉 (1) Replace all "fogged" windows. The seal between the panes of glass has failed allowing moisture to enter between the panes. It is possible that more may fog in the future. Have window contractor evaluate all windows because it is highly likely that if one window has had a seal failure, that more seal failures in different windows will occur. See photos for examples. It is difficult to identify seal failure in windows when the weather is rainy, over cast, foggy or the glass is wet from recent rains or condensation. Buyer should resolve all concerns prior to closing.

9.5 Item 1(Picture) dining room (both)

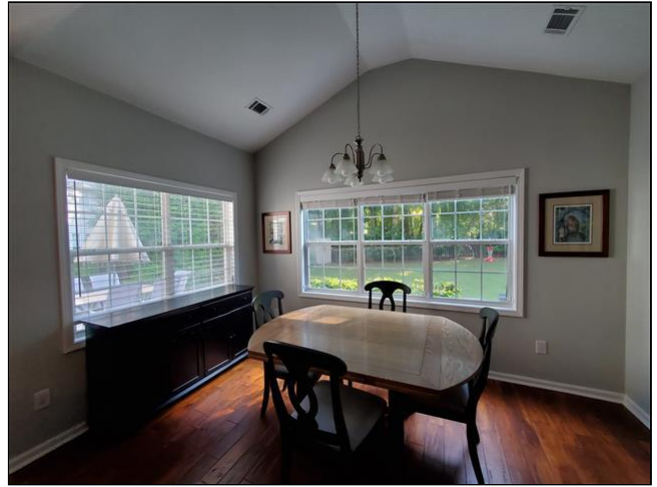
9.5 Item 4(Picture) breakfast nook

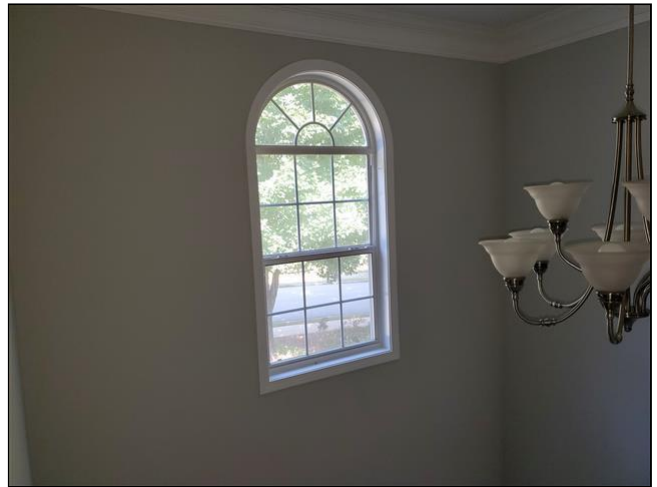
9.5 Item 6(Picture) foyer (2nd floor)

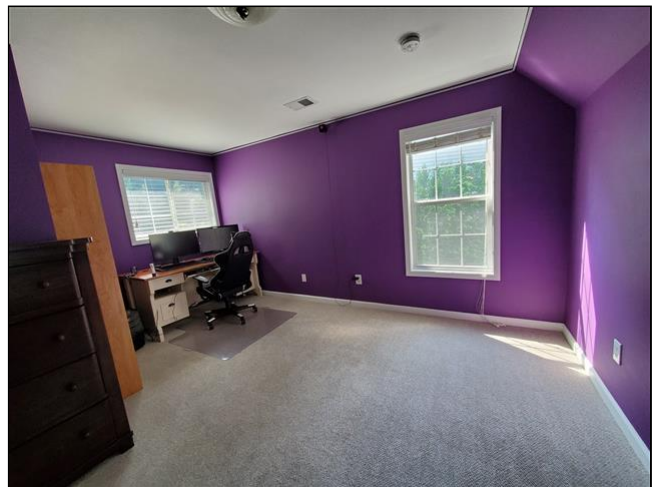
9.5 Item 8(Picture) front right bedroom

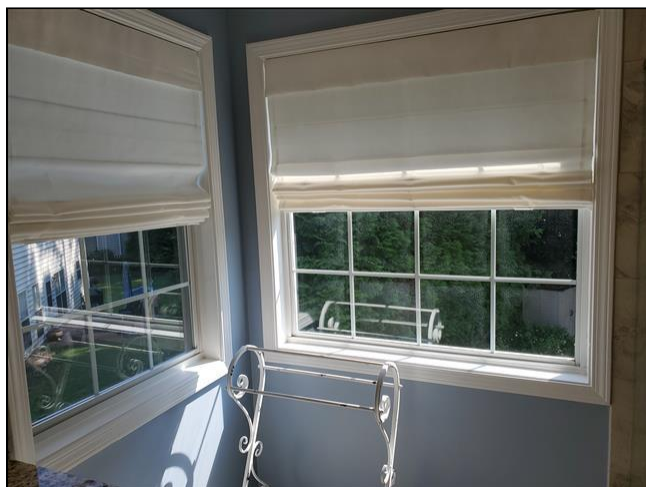
9.5 Item 11(Picture) master bath

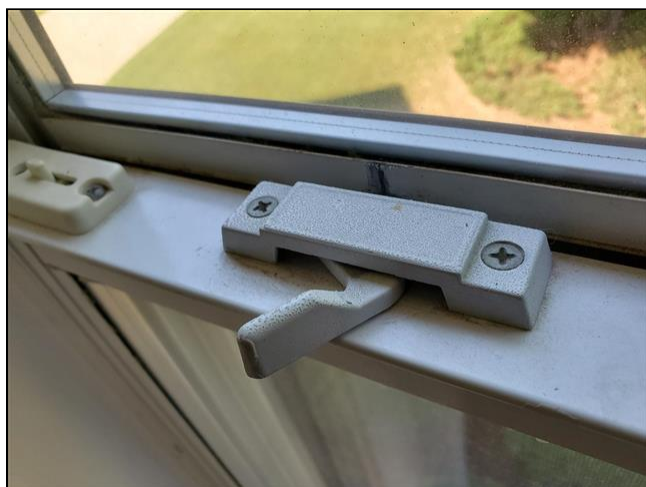
9.5 Item 12(Picture)

🔧 (2) A few window lock hardware were difficult to lock in place. Have owner check all and ensure that all lock hardware locks in place.

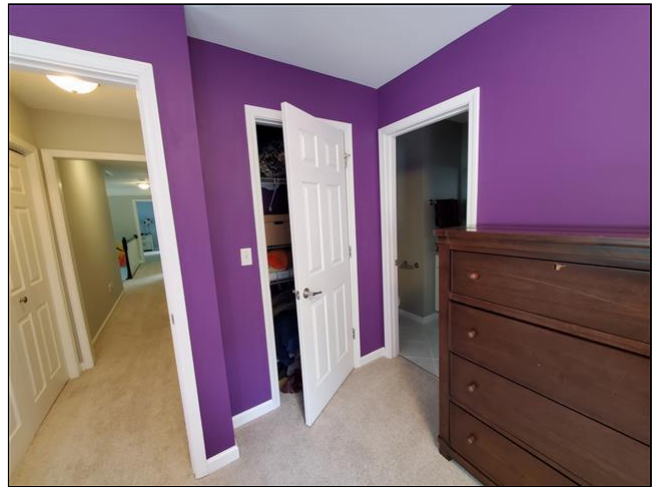
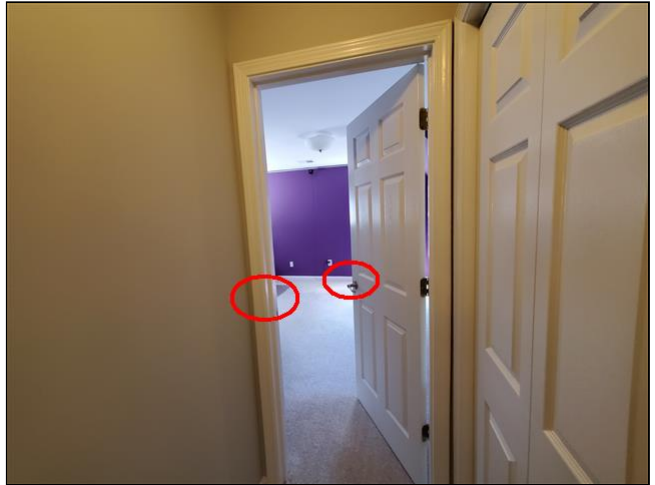
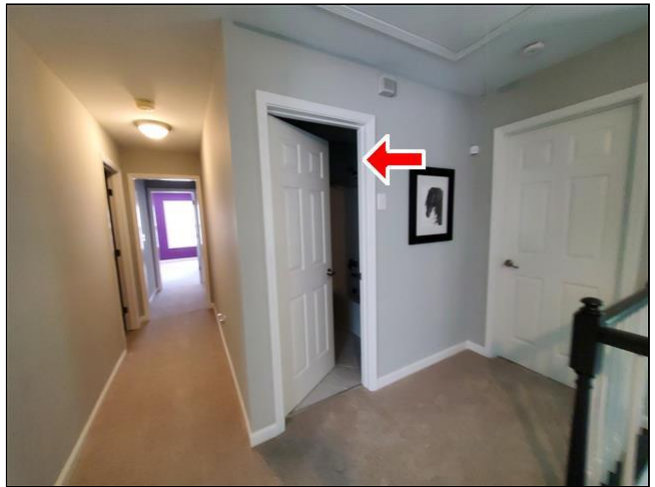
Adjust interior doors in photos so that they will close and latch.

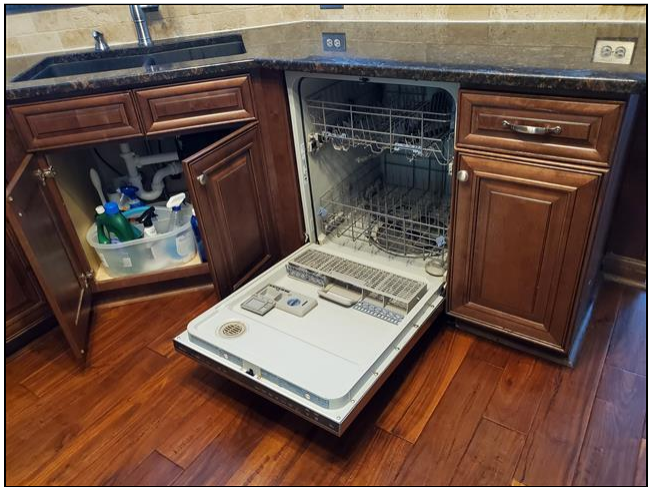
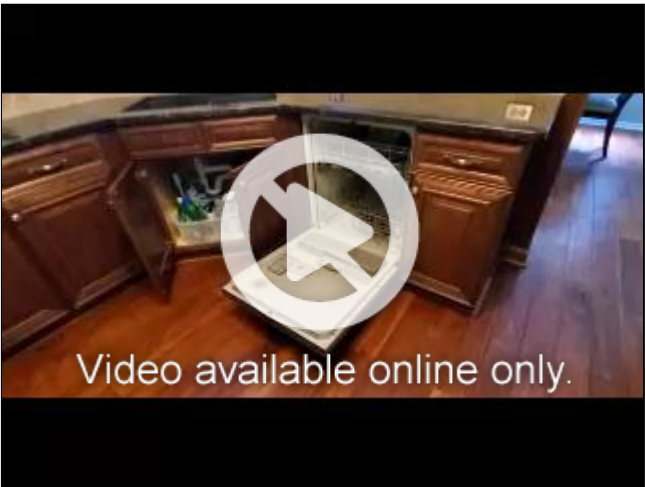
🔧 (1) Worn spring on dishwasher door. Doors falls open. Replacement spring needed.
