Home and Stucco Inspection

585 Croydon Lane
Alpharetta, GA 30022

HOME AND STUCCO INSPECTION REPORT

Dated 08/07/2020

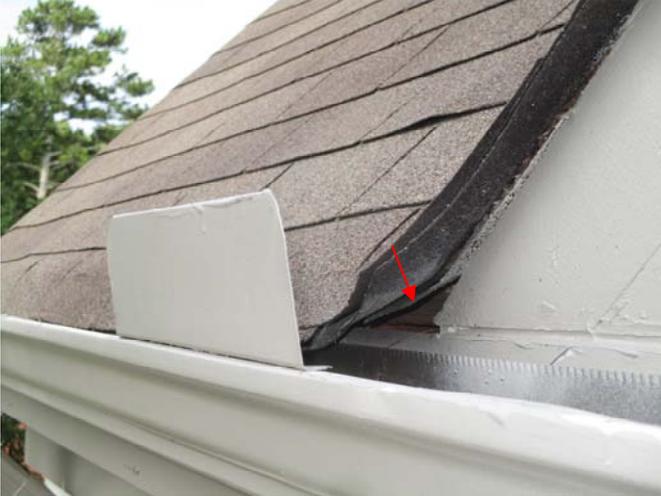
A construction gap was present between the fascia board and the roof decking at the bottom of the roof valley located above the garage door.

1. Evidence of rodent activity was visible in the attic areas of the home (trampled/damaged insulation and a rodent carcass). Please consult with the homeowner about this issue. A construction gap was present between the fascia board and the roof decking at the bottom of the roof valley located above the garage door and a rodent access hole was present above the gable return in the left, front corner of the upper attic (see photos). A squirrel carcass was also present in the insulation in the left, front corner of the upper attic (see photo). A qualified rodent exclusion contractor should evaluate these areas and seal as needed. The rodent carcass should be removed and the perimeter of the roof evaluated for construction gaps between the fascia boards and the roof decking and sealed with metal flashing to prevent future rodent entry. The rodent issue should then be monitored in the future.

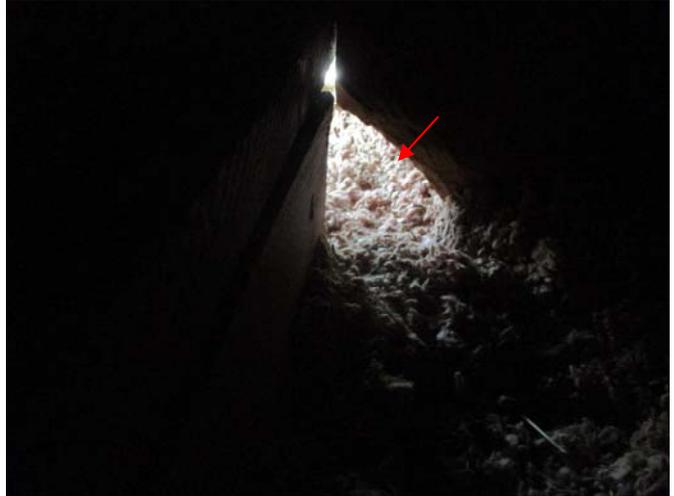
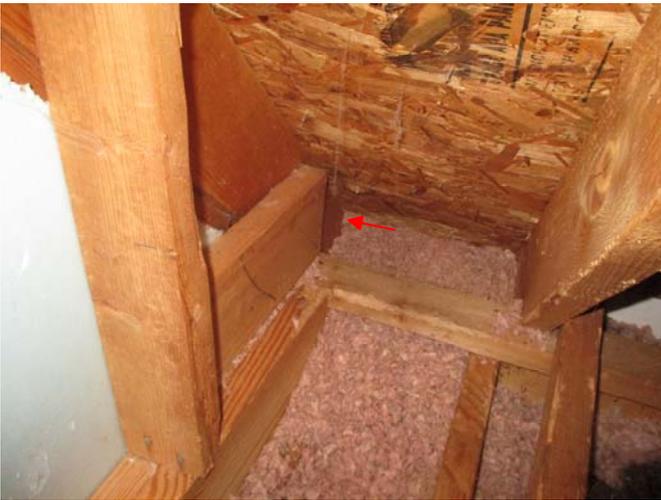
A rodent access hole was present above the gable return in the left, front corner of the upper attic.

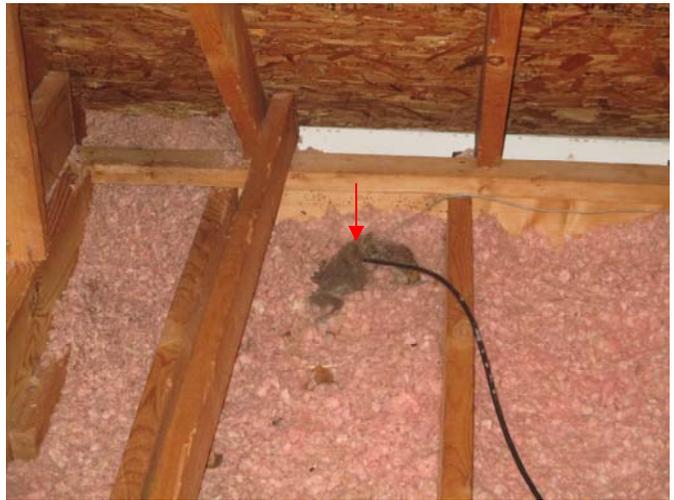
A squirrel carcass was also present in the insulation in the left, front corner of the upper attic.

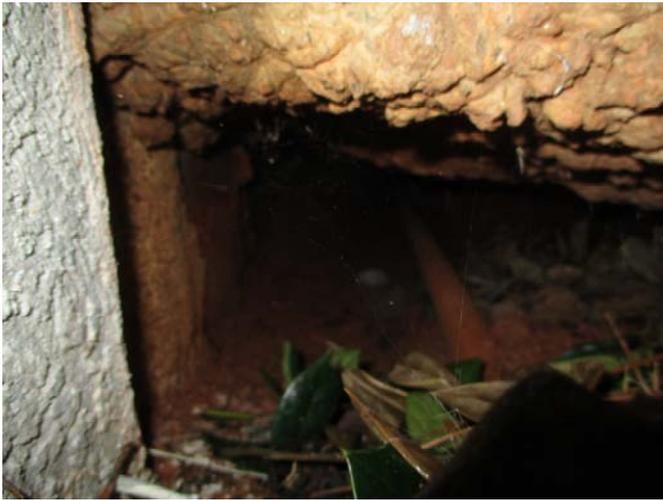
A large void was present in the soil below the rear portion of the front stoop.

3. A large void was present in the soil below the rear portion of the front stoop (see photo). A qualified foundation repair contractor should evaluate this issue and repair as needed to prevent future settlement of the stoop.

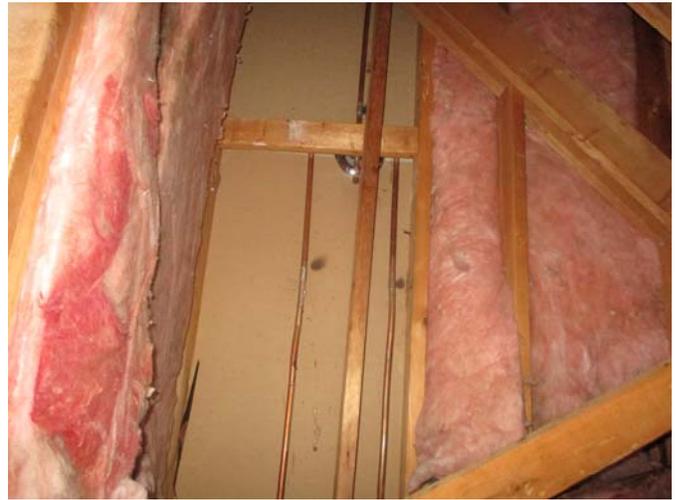
A qualified contractor should install the missing insulation in the rear wall of the knee wall portion of the attic located off the right wall of the master bedroom closet.

6. A qualified contractor should install the missing insulation in the rear wall and replace the rodent damaged batt insulation in the left wall of the knee wall portion of the attic located off the right wall of the master bedroom closet (see photos).

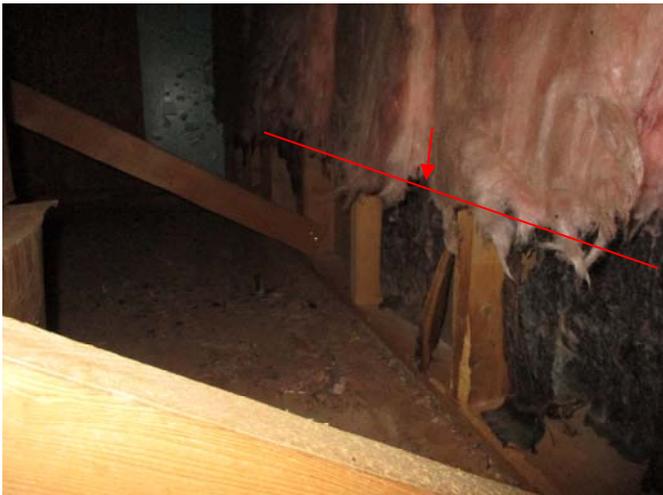
A qualified contractor should replace the rodent damaged batt insulation in the left wall of the knee wall portion of the attic located off the right wall of the master bedroom closet.

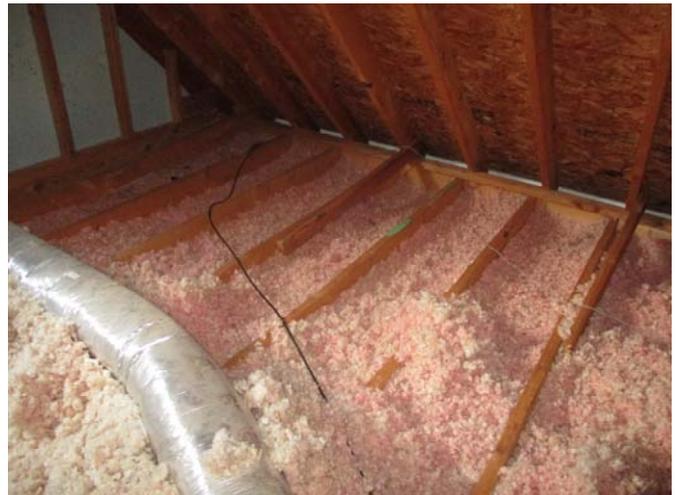
The blown-in insulation in the floor of the upper attic has been trampled in various areas from previous rodent activity.

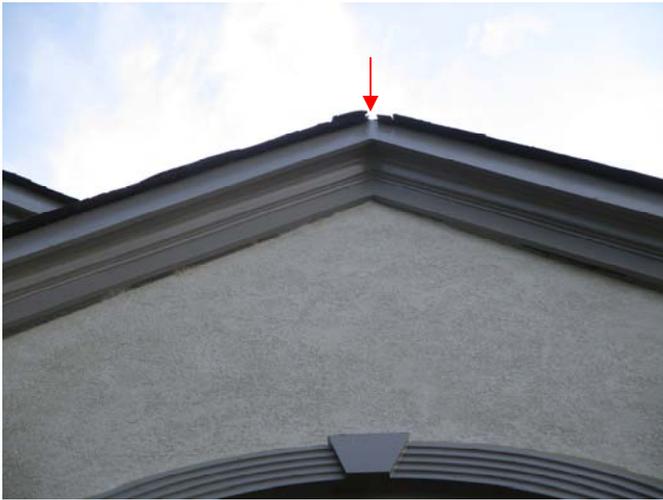
The shingle is cracked at the gable peak located above the window in the front wall of the foyer.

8. The shingle is cracked at the gable peak located above the window in the front wall of the foyer (see photo). Moisture stains were present on the roof decking above the chimney chase in the back, left corner of the upper attic and on the roof decking above the bay windows in the rear wall of the master bedroom (see photos). A licensed roofer should replace the cracked shingle and evaluate the shingles above the moisture stains and the flashing around the chimney chase and address as needed.

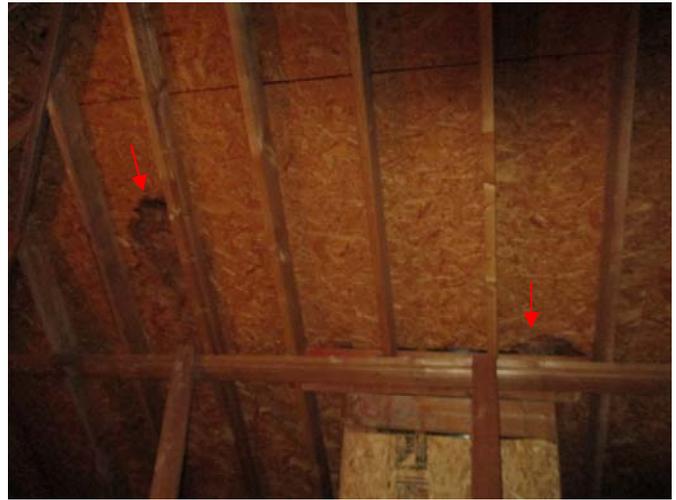
Moisture stains were present on the roof decking above the chimney chase in the back, left corner of the upper attic.

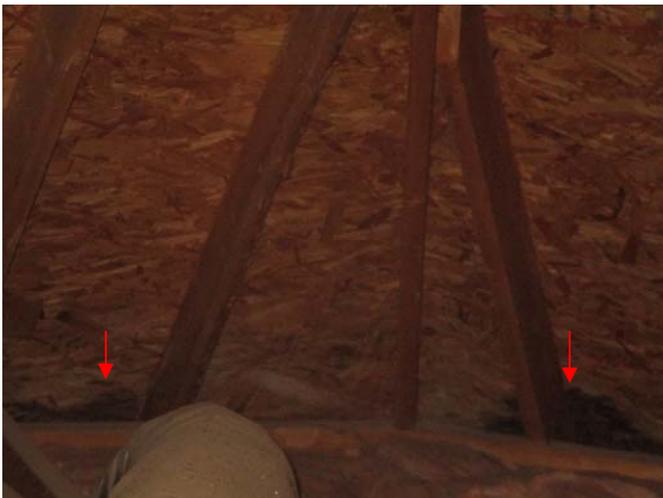
Moisture stains were present on the roof decking above the bay windows in the rear wall of the master bedroom.

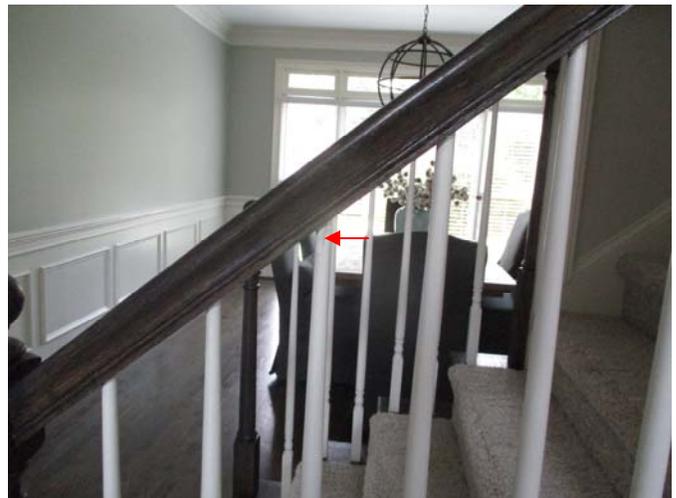
Replace the cracked spindle in the railing on the right side of the stairwell located in the right, front corner of the family room.

6. Replace the cracked spindle in the railing on the right side of the stairwell located in the right, front corner of the family room and in the railing at the top of the stairwell in the foyer (see photos).

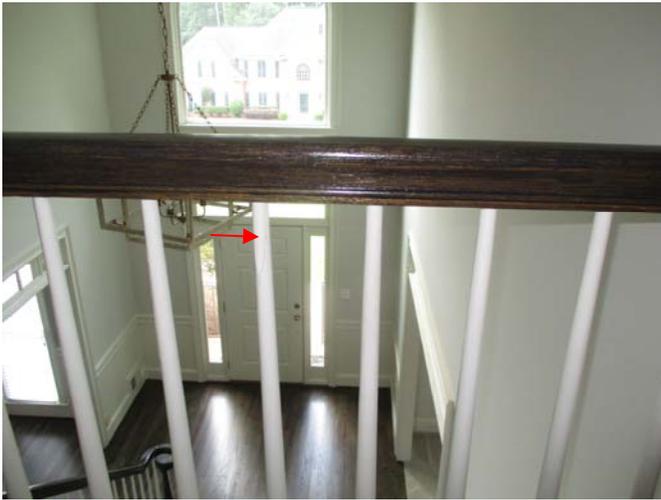
Replace the cracked spindle in the railing at the top of the stairwell in the foyer.

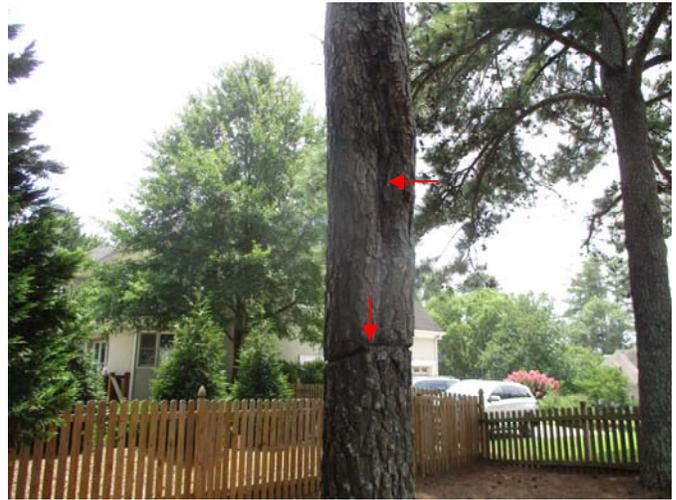
A chain is embedded in the lower portion of the pine tree located on the right side of the backyard and it appears that this tree was struck by lightning in the past.

7. A chain is embedded in the lower portion of the pine tree located on the right side of the backyard and it appears that this tree was struck by lightning in the past (see photo)? Recommend having this tree evaluated by a certified arborist to ensure that's it's healthy.

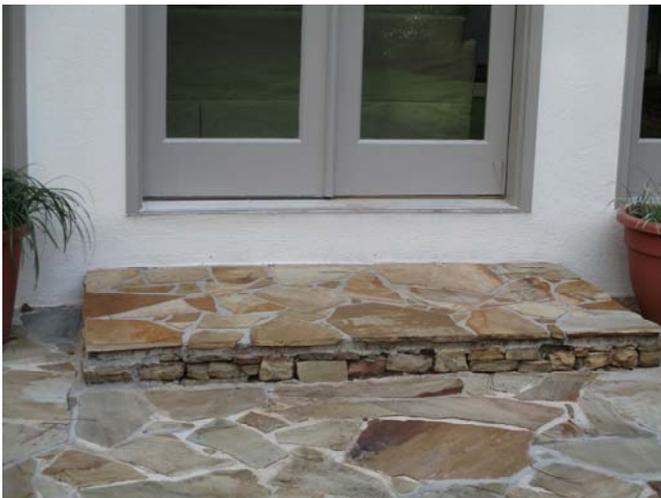
The excessive height between the threshold and the stone step outside the exterior French doors in the rear wall of the family room presents a possible trip hazard.

8. The excessive height between the threshold and the stone step outside the exterior French doors in the rear wall of the family room presents a possible trip hazard (see photo). A qualified contractor should evaluate this issue and address as needed.

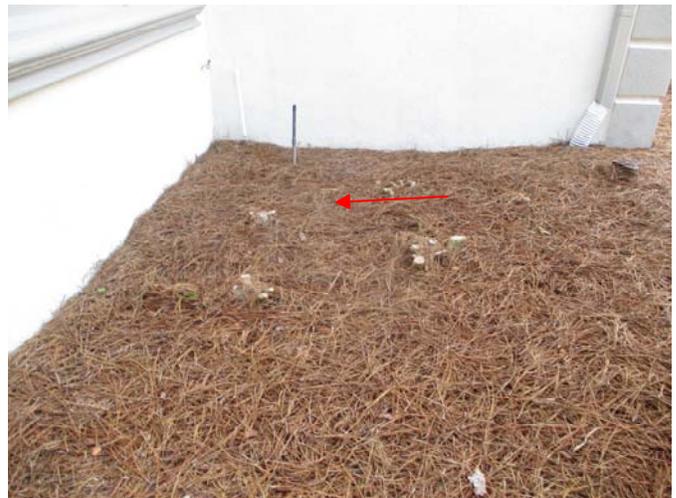
Negative grading was present in the soil outside the front wall of the formal dining room.

1. Trim the tree limbs away from the window in the front wall of the master bedroom closet as needed and as part of routine maintenance.
2. Negative grading was present in the soil outside the front wall of the formal dining room and a basin was present in the soil on the right side of the stone steps outside the exterior door in the laundry room, which will contribute to water accumulation in these areas during rains (**see photos**). Recommend having these areas evaluated by a qualified landscaping contractor.

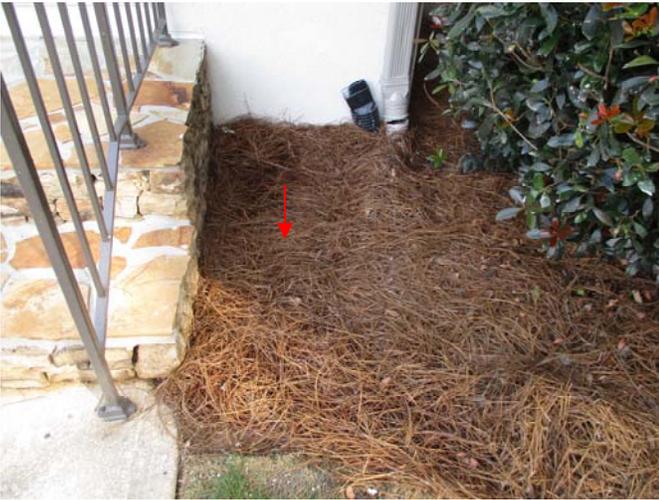
A basin was present in the soil on the right side of the stone steps outside the exterior door in the laundry room.

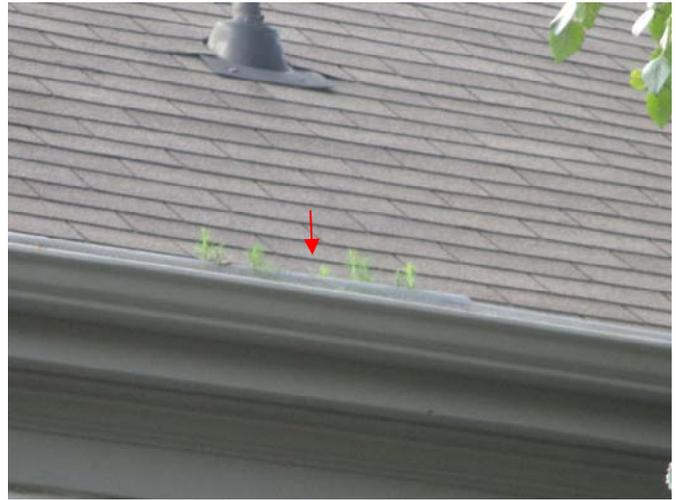
The insides of the gutters and downspouts should be cleaned prior to closing as part of routine maintenance.

4. The insides of the gutters and downspouts should be cleaned prior to closing as part of routine maintenance (**see photo for example**).
5. Recommend adjusting and installing a longer elbow on the bottom of the downspout located on the left side of the garage door to help divert water away from the foundation and stucco system.

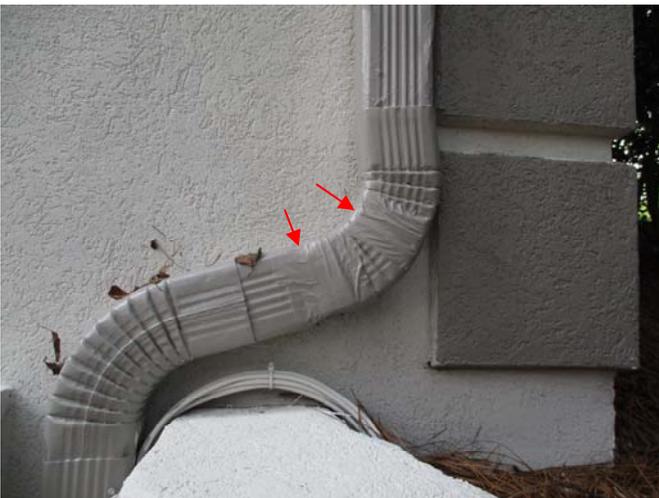
The lower portion of the downspout has been taped above retaining wall at the left, front corner of the home due to this section of the downspout being rusted.

7. The lower portion of the downspout has been taped above retaining wall at the left, front corner of the home due to this section of the downspout being rusted (**see photo**). A qualified contractor should evaluate and replace this section of the downspout.

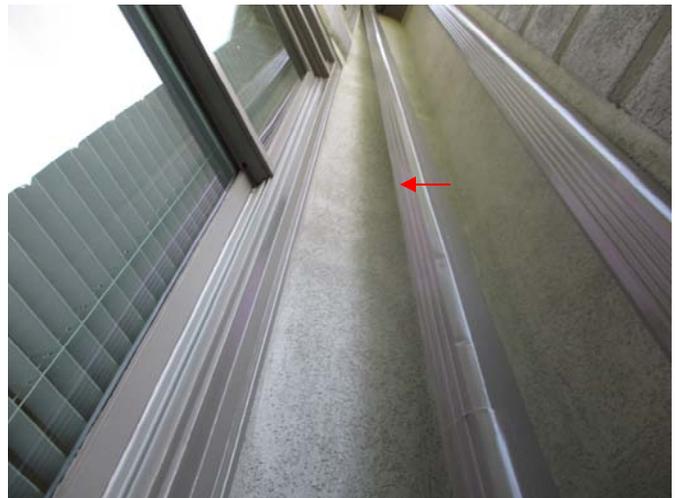
A qualified contractor should secure the downspout to the EIFS system on the right side of the bay windows at the left, front corner of the home and ensure the downspout straps penetrating the EIFS system are sealed with caulking.

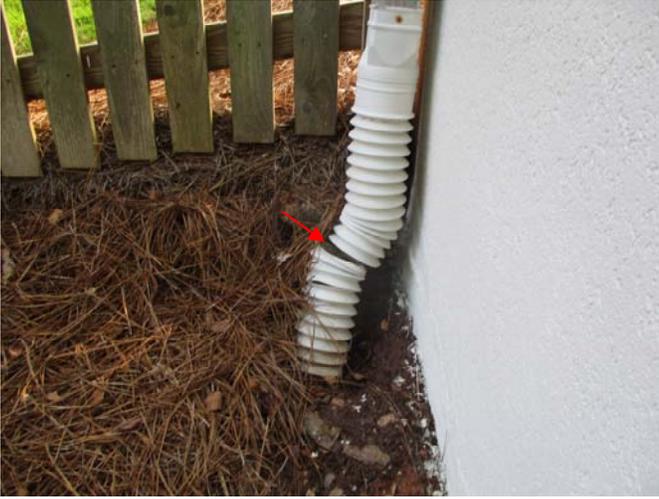
Replace the damaged downspout extension at the back, left corner of the home to help prevent water accumulation along the foundation wall.

10. Replace the damaged downspout extension at the back, left corner of the home to help prevent water accumulation along the foundation wall (see photo).

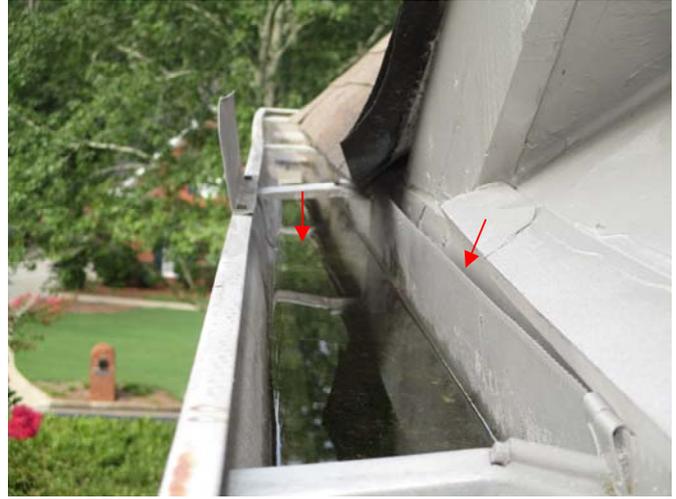
Ponding water was present inside the rear portion of the gutter located above the garage door due to an inadequate pitch of this gutter towards the downspout. A qualified contractor should adjust this gutter and apply caulking along the top of this gutter to help prevent overflow and moisture damage to the fascia board.

11. Ponding water was present inside the rear portion of the gutter located above the garage door due to an inadequate pitch of this gutter towards the downspout. A qualified contractor should adjust this gutter and apply caulking along the top of this gutter to help prevent overflow and moisture damage to the fascia board (see photo).

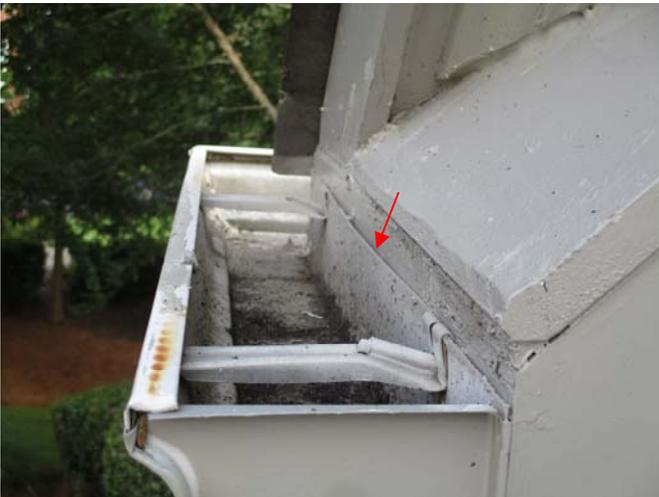
Caulking should be applied along the top of the gutters located below the gable returns on the front of the home to help prevent future moisture damage to the fascia boards.

12. Caulking should be applied along the top of the gutters located below the gable returns on the front of the home to help prevent future moisture damage to the fascia boards (see photo for example).

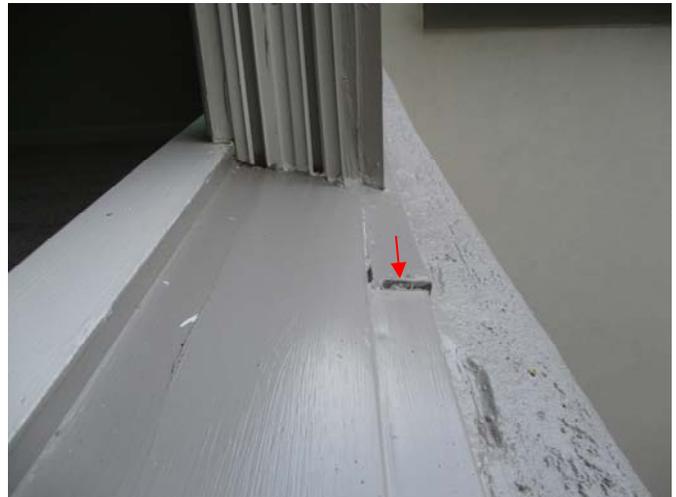
Seal the open joint in the sill below the left window in the front, center bedroom to prevent future moisture entry.

13. Seal the open joint in the sill below the left window in the front, center bedroom to prevent future moisture entry (see photo).
14. Secure the upper portion of the shutter on the right side of the window in the front wall of the master bedroom closet.

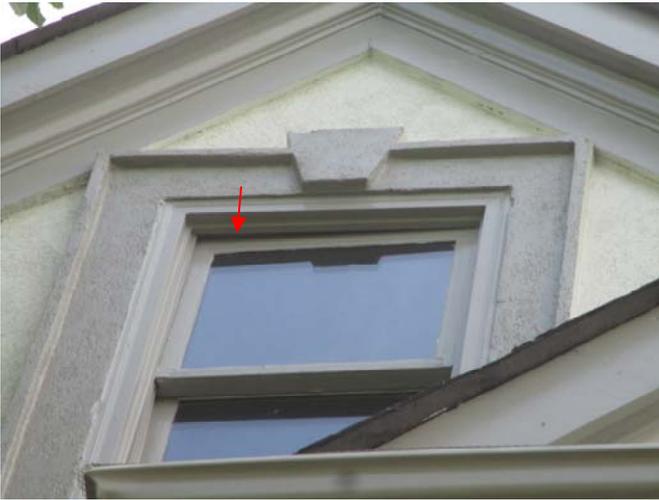
The upper sash is displaced in the window located in the front wall of the attic.

15. The upper sash is displaced in the window located in the front wall of the attic (see photo). A qualified contractor should evaluate and repair as needed to help prevent future moisture/insect entry.

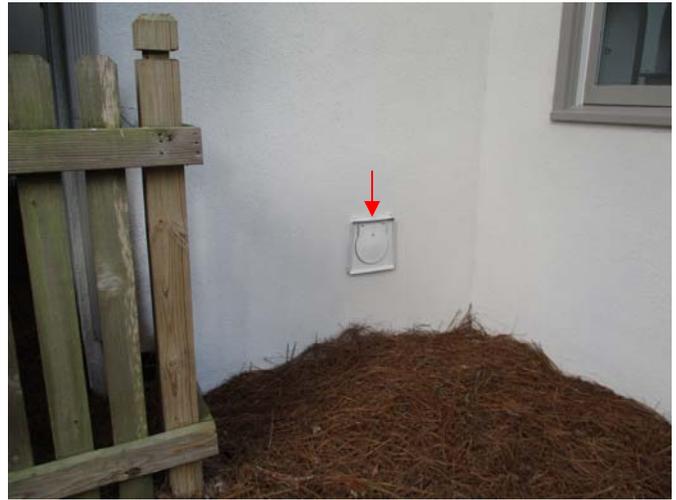
A qualified contractor should install the missing vent hood over the vent for the downdraft exhaust fan located below the rear wall of the kitchen.

16. The metal furnace flues and the metal chimney cap located on top of the chimney chase should be painted with a rust-inhibiting paint.
17. A qualified contractor should install the missing venthood over the vent for the downdraft exhaust fan located below the rear wall of the kitchen and over the dryer vent located outside the rear wall of the laundry room (see photos).

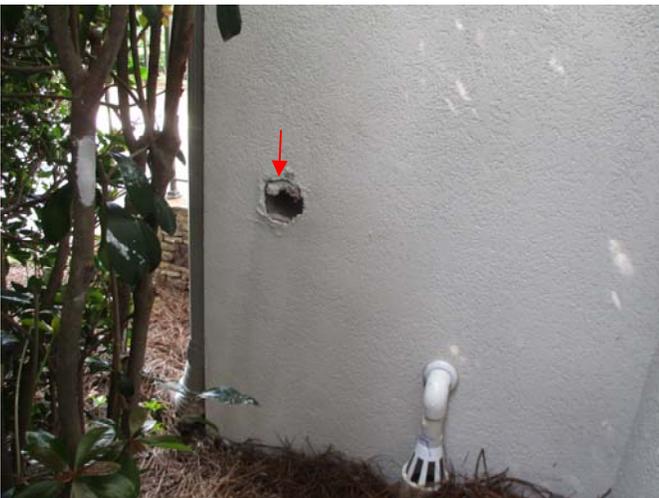
A qualified contractor should install the missing vent hood over the dryer vent located outside the rear wall of the laundry room.

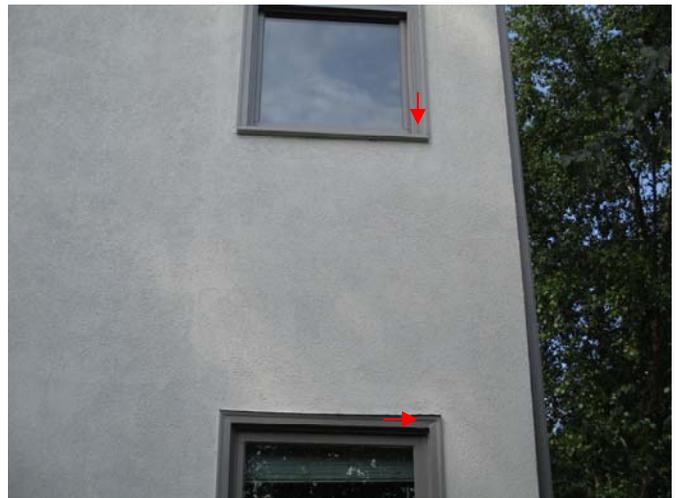
Moisture damage was present at the brick mould above the left side of the left window in the guest bedroom (main floor) and at the bottom of the brick mould on the left side of the left window in the back, left bedroom.

18. Moisture damage was present at the brick mould above the left side of the left window in the guest bedroom (main floor) and at the bottom of the brick mould on the left side of the left window in the back, left bedroom (see photo). A qualified contractor should evaluate and replace the damaged wood as needed.

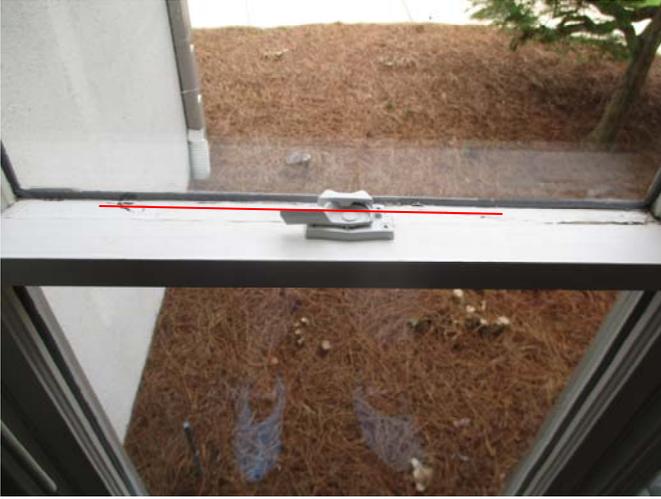
Minor moisture damage was present on the interior frame below the upper piece of glass in the right window in the formal dining room.

19. Minor moisture damage was present on the interior frame below the upper piece of glass in the right window in the formal dining room (see photo). A qualified contractor should evaluate and repair the damaged wood as needed.

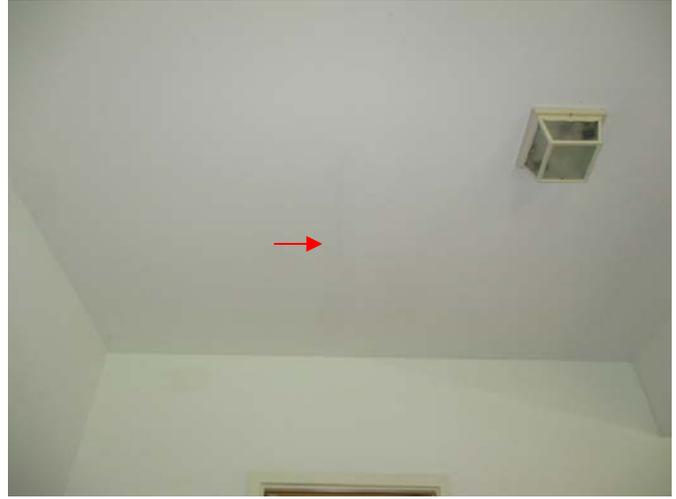
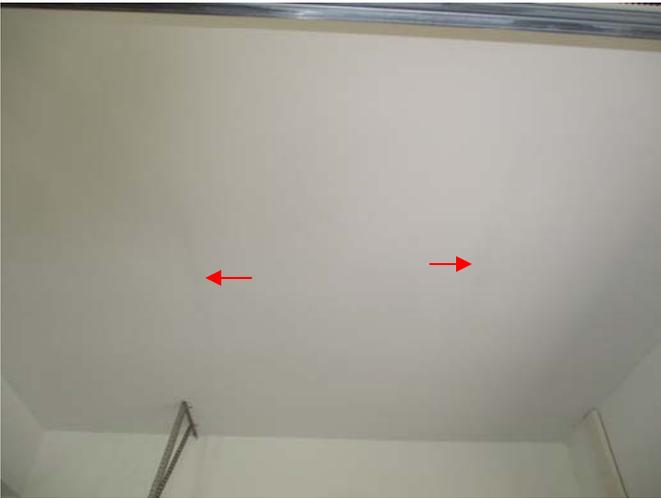
There appears to be inactive moisture stains on the rear portion of the garage ceiling.

20. Screens were not installed on the windows in the home at the time of the inspection.
21. There appears to be inactive moisture stains on the rear portion of the garage ceiling (see photos). Please consult with the homeowner about previous plumbing leaks in these areas.

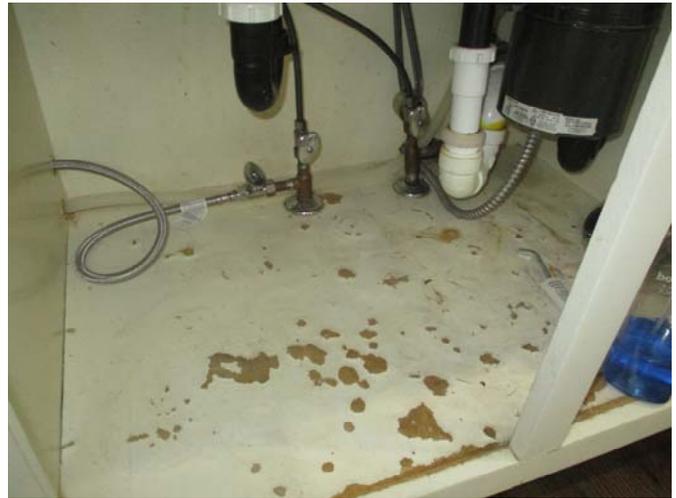
Moisture damage was present on the cabinet shelving below the kitchen sink.

22. Install the missing strike-plate for the lock located above the left side of the right exterior French door in the rear wall of the family room.
23. Moisture damage was present on the cabinet shelving below the kitchen sink and below the right sink in the master bathroom, which is cosmetic in nature (see photos). Please consult with the homeowner about previous plumbing leak(s) in these areas – replace the damaged shelving as desired.

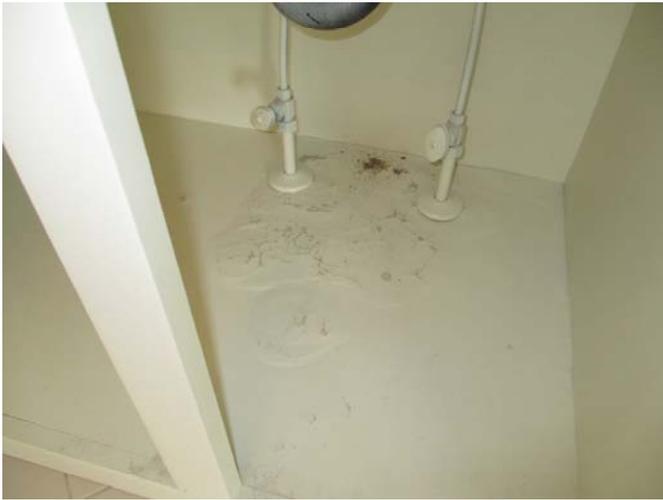
Moisture damage was present on the cabinet shelving below the right sink in the master bathroom.

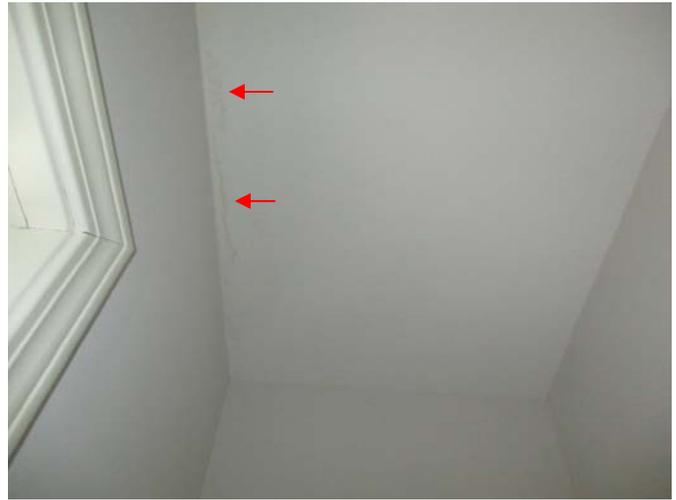
Inactive moisture stains were present on the ceiling of the rear closet in the back, left bedroom, which may be related to gutter overflow.

26. Inactive moisture stains were present on the ceiling of the rear closet in the back, left bedroom, which may be related to gutter overflow (see photo)? Please consult with the homeowner about these stains – re-paint and monitor in the future during rains.

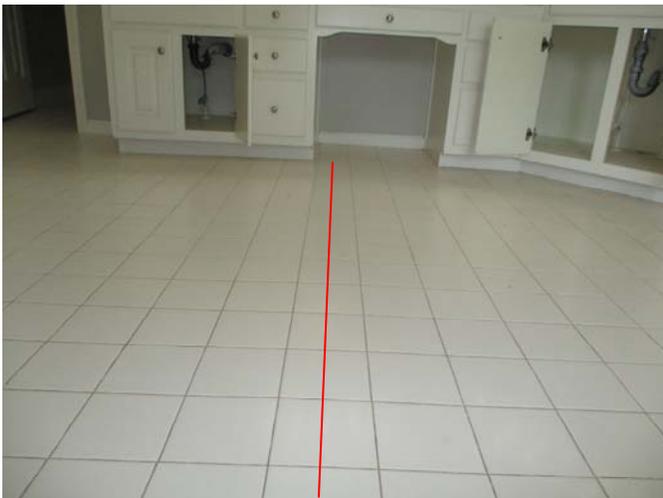
A ridge was present in the center portion of the tiled floor in the master bathroom which has caused a hairline crack in the floor tiles.

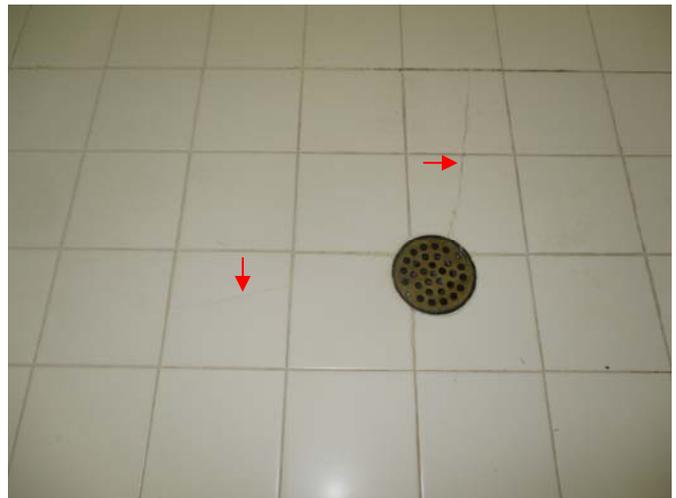
Hairline cracks were present in the tiles around the drain in the floor of the master shower stall, which is mainly cosmetic in nature.

32. Hairline cracks were present in the tiles around the drain in the floor of the master shower stall, which is mainly cosmetic in nature (see photo).

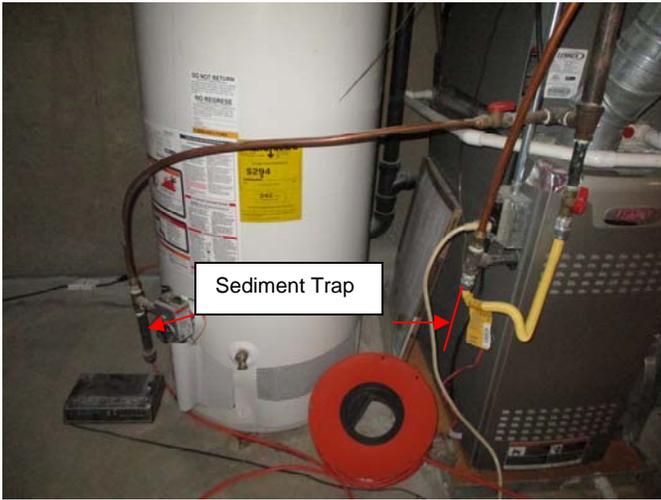
A sediment trap is missing on the gas line entering the main floor furnace.

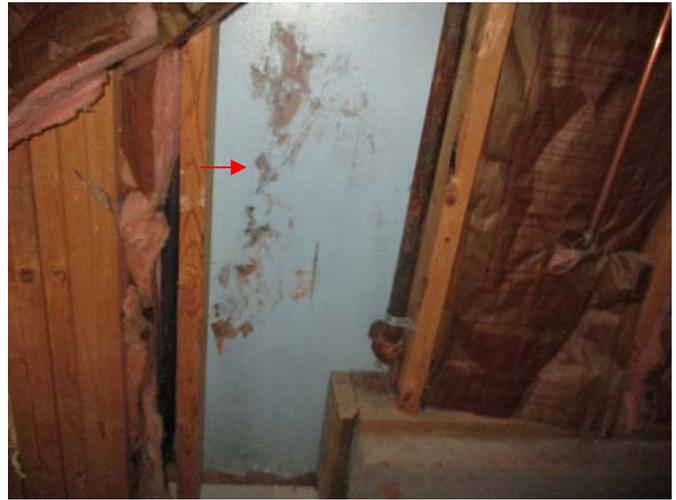
There appears to be past termite trails on the rigid foam wall sheathing located above the lower step-down in the foundation in the back, left corner of the basement.

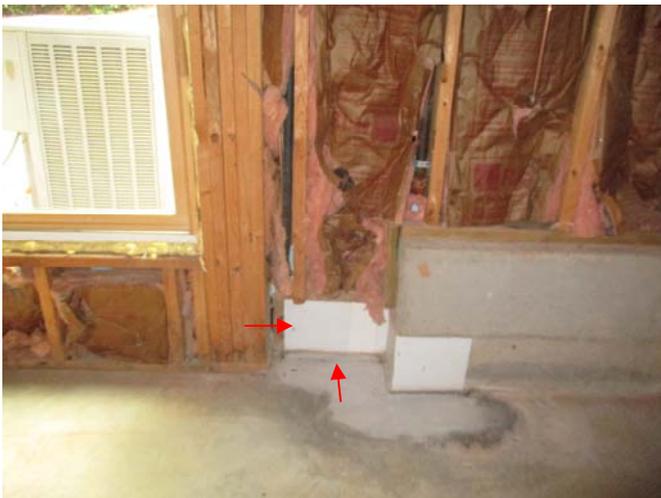
A qualified contractor should re-install the wall studs and sill plate along the lower step-down in the foundation in the back, left corner of the basement.

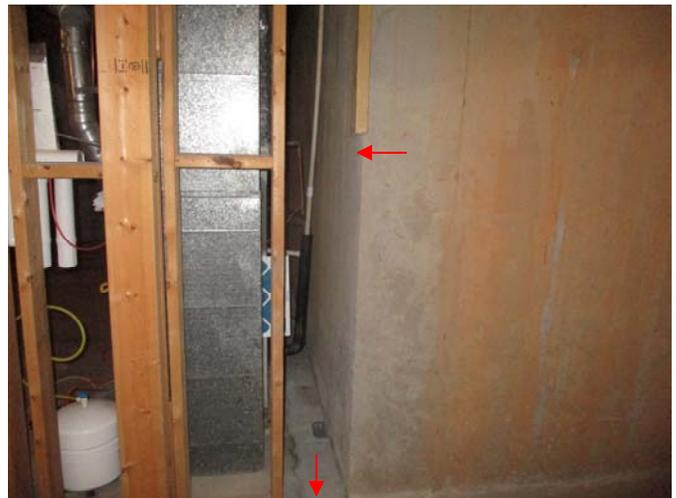
A qualified contractor should re-install the wall stud and sill plate along the foundation behind the main floor furnace in the basement.
