Inspection Report

Property Address:
920 Pebblestone Ct
Alpharetta GA 30009

Dana Inspection Services, Inc.

General Summary of Repairs

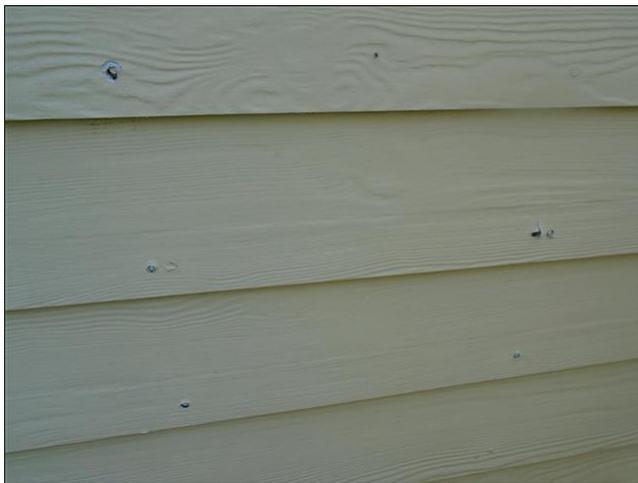
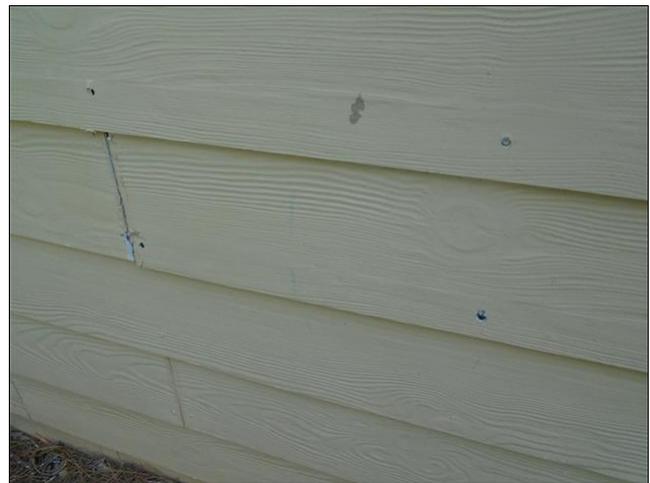
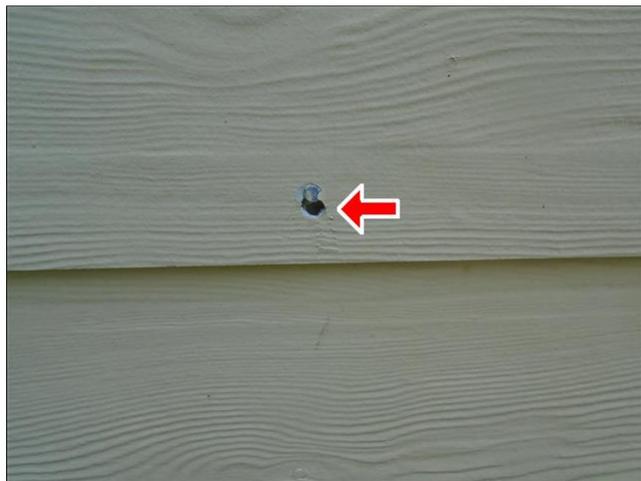
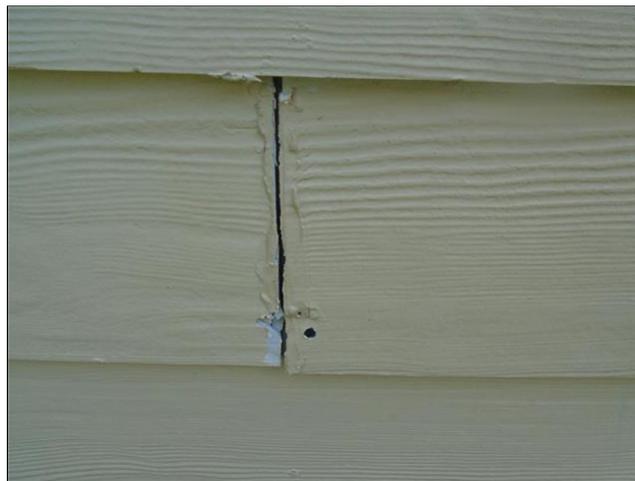
Nails that are to secure siding on the right side of the house should be repaired/sealed as needed to prevent water intrusion at the oversized holes. Recommend further evaluation by a qualified siding contractor.

Right side of house (example)

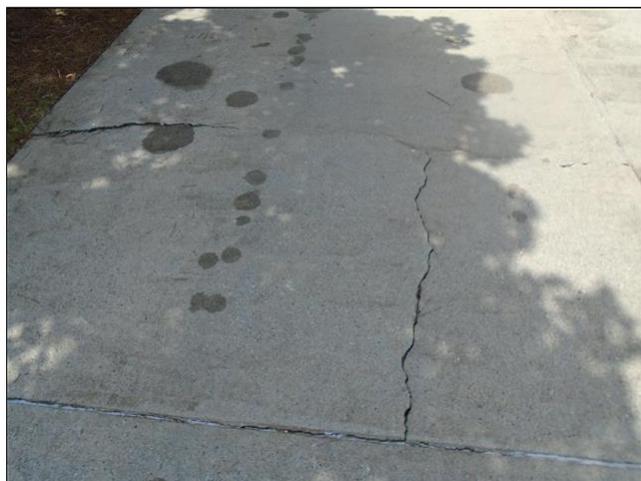
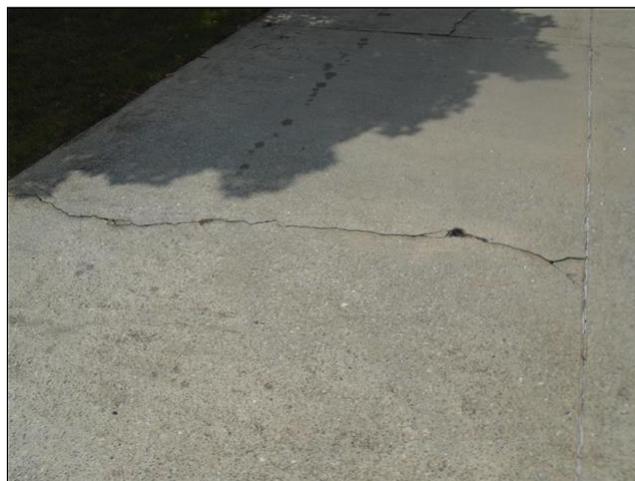
Cracks and displacement were observed at the concrete driveway.

Driveway slab (example)

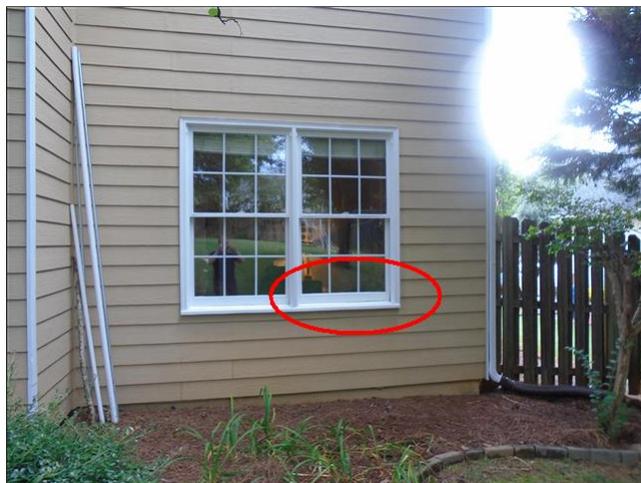
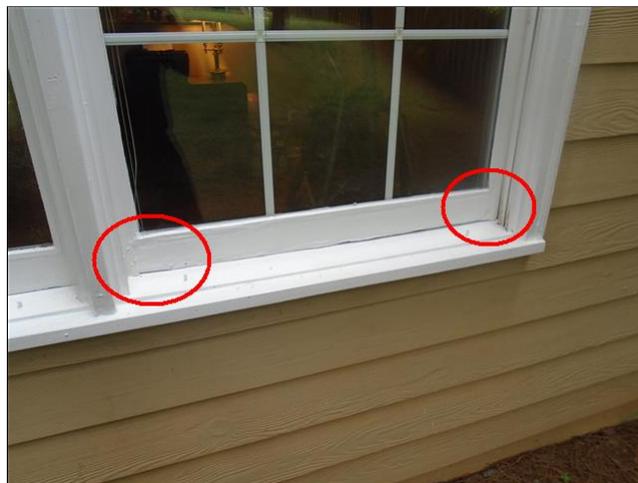
Rear of house

(1) Wood rot was observed at the lower window sash at the left rear corner of the main floor level. Recommend further evaluation by a qualified contractor for repairs as needed.

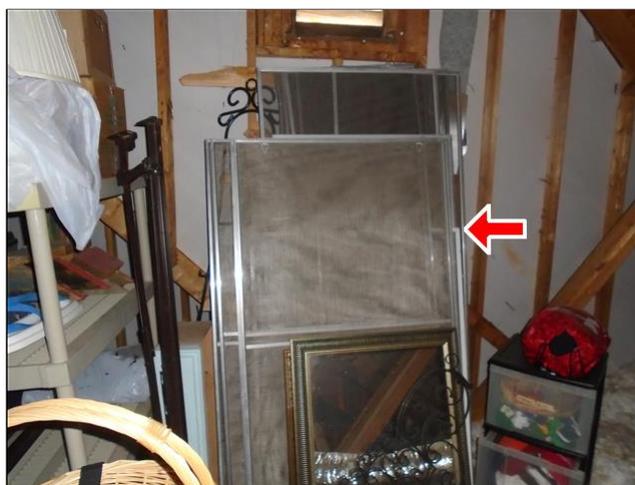
Attic

(2) Exterior window screens were observed to be stored in the attic.

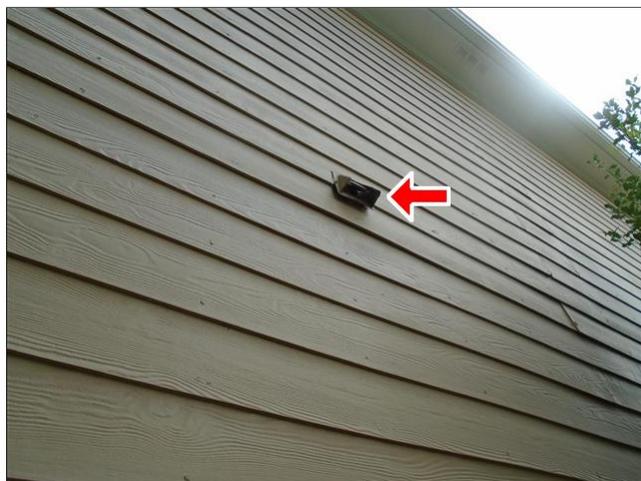
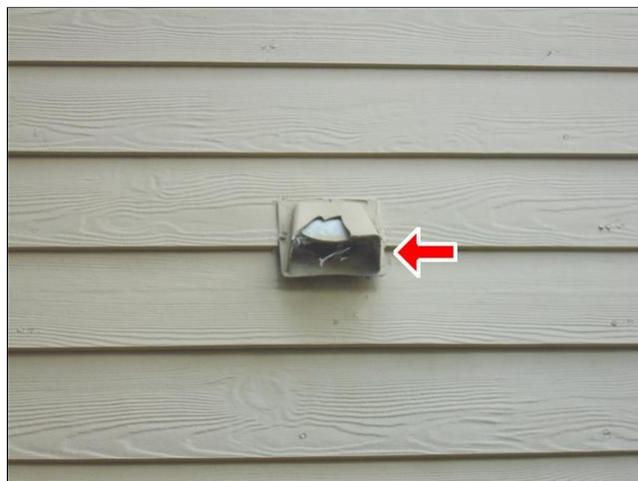
Left side of house

The vent hood and flap on the left side of the house are damaged and should be replaced.

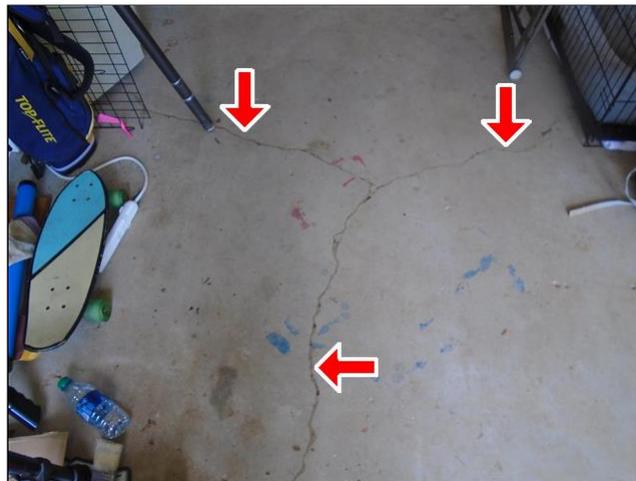
Common curing or settling cracks were observed on the garage floor.

Garage slab (example)

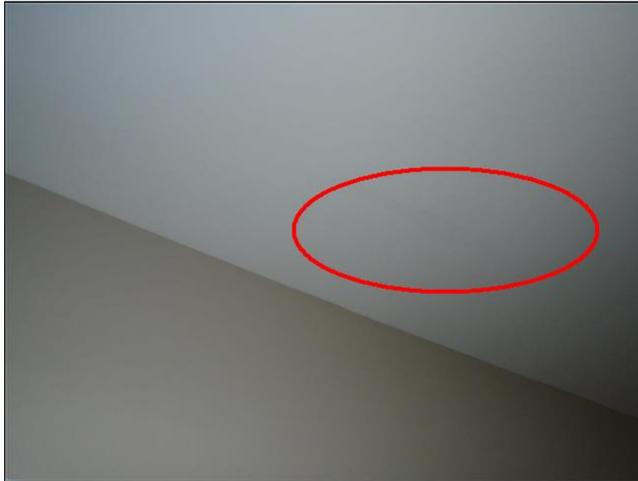
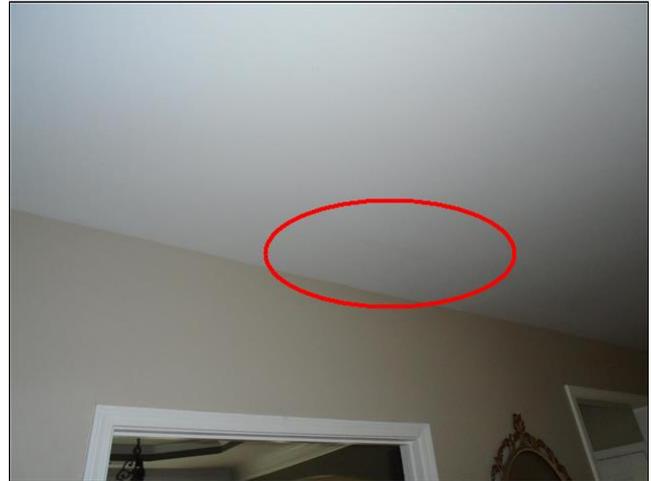
Family room

A moisture stain was observed on the front ceiling of the family room. After running the upstairs plumbing fixtures, it did not show signs of moisture when viewed with an infrared camera and appears to be an old stain. Recommend cosmetic repairs and monitor for changes.

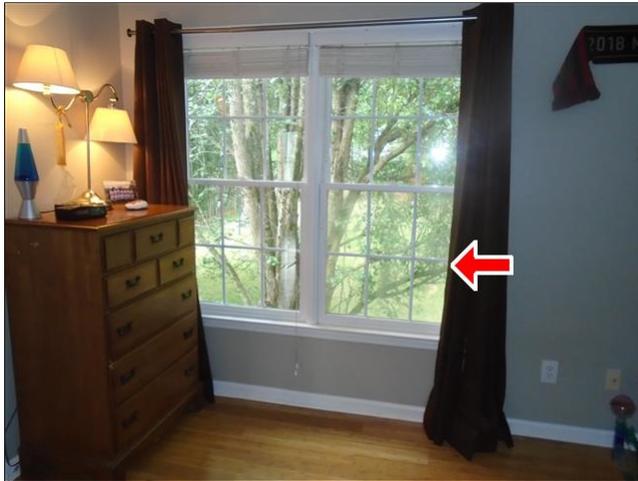
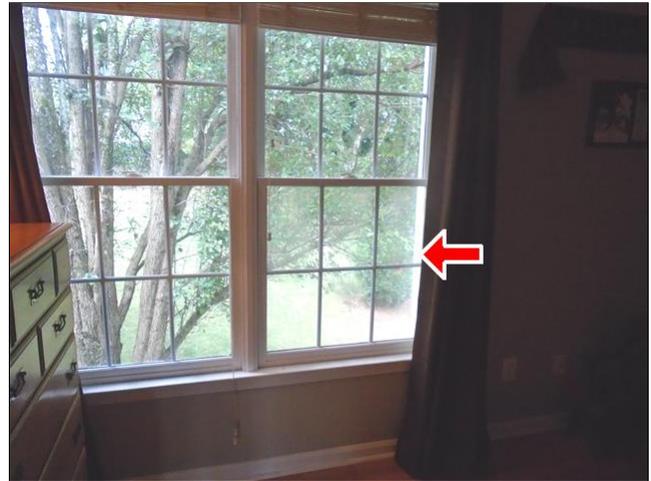
Left rear 2nd floor

(1) A window appears to be fogging in the left rear 2nd floor bedroom. This may indicate the seal between the thermal panes has failed. Recommend further evaluation of windows by a qualified window professional for repairs as needed.

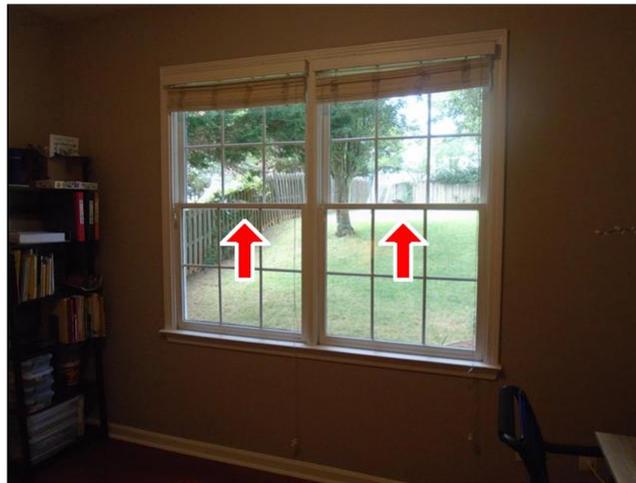
Example

(2) Several windows were stuck shut and should be repaired.

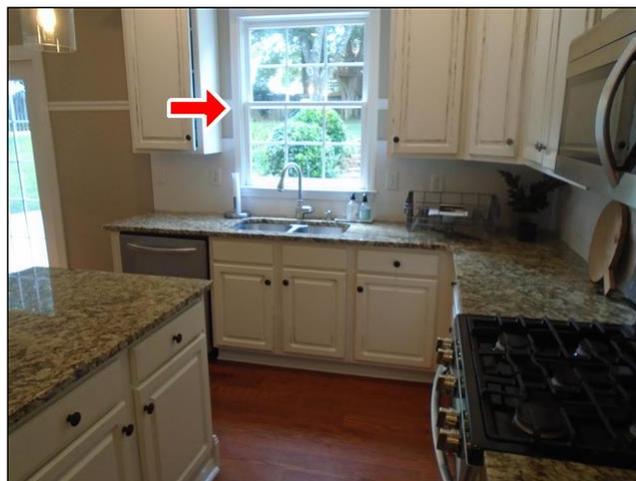
Kitchen

(3) A crack was observed in the window above the kitchen sink.

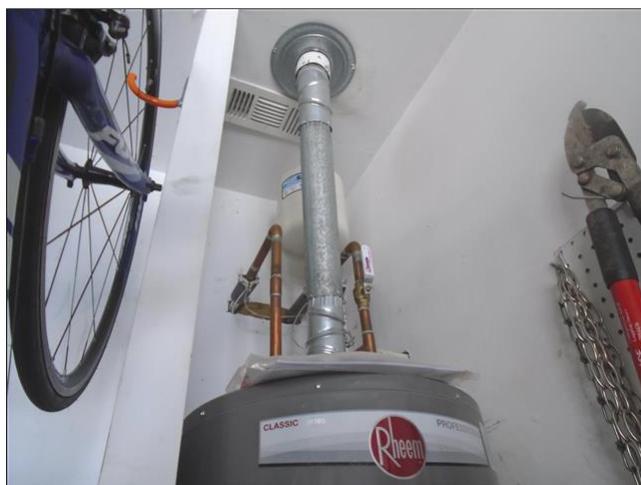
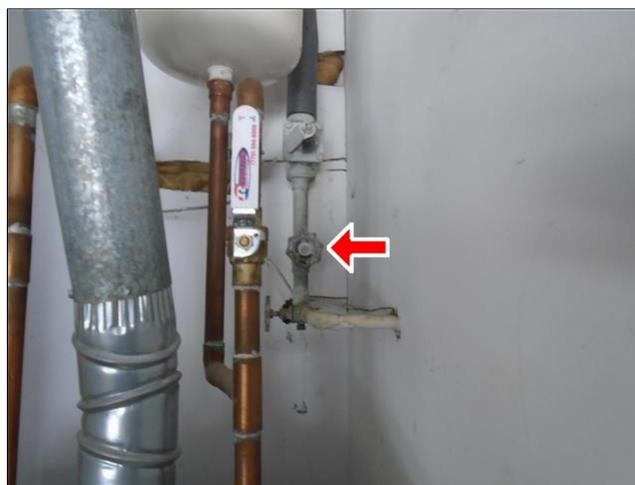
The water service main shut off valve is located in the garage, above the water heater.

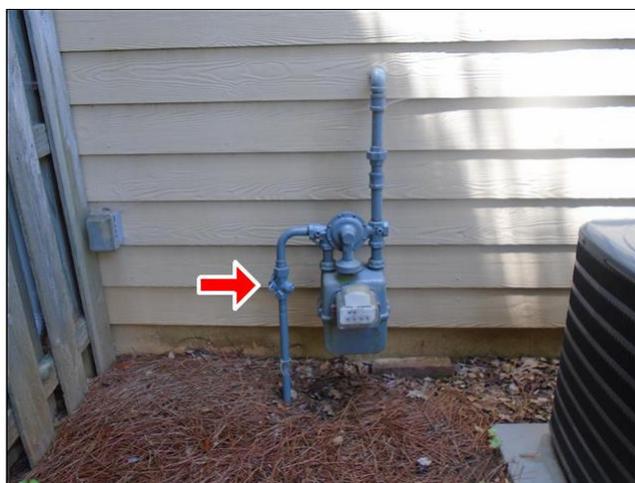
Left side of house

The main fuel shut off is at the gas meter outside.

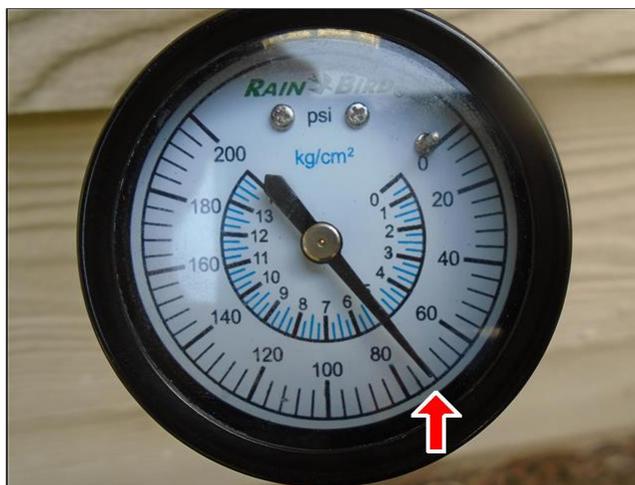
Right side hose bibb

The whole home water pressure was tested at the right side hose bibb and found to be approximately 72 psi. Pressures between 40 - 80 psi are considered acceptable for residential use.

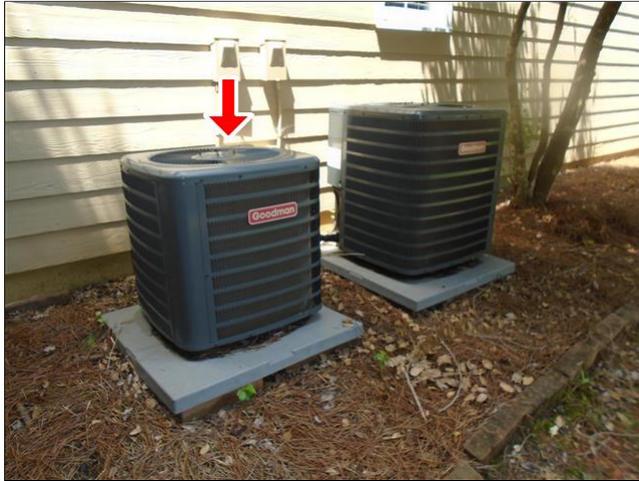
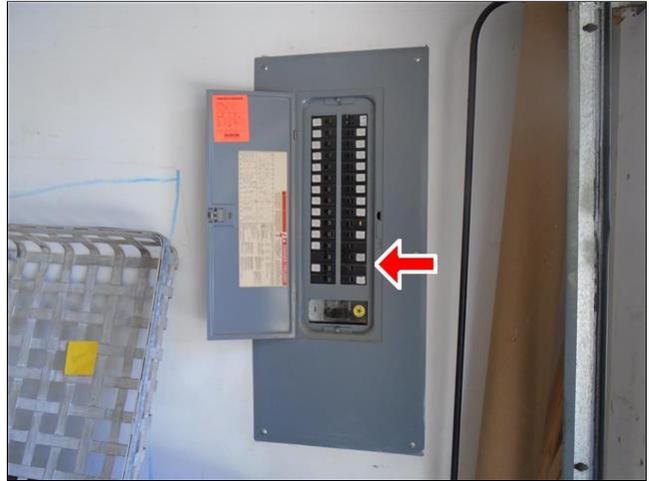
(1) One of the A/C condensing units is over-amped. The manufacturer recommends it be connected to a maximum 15 amp breaker when it appears to be connected to a 25 amp one. This may cause damage to the unit by not tripping when needed and should be evaluated and repaired by a qualified electrician.

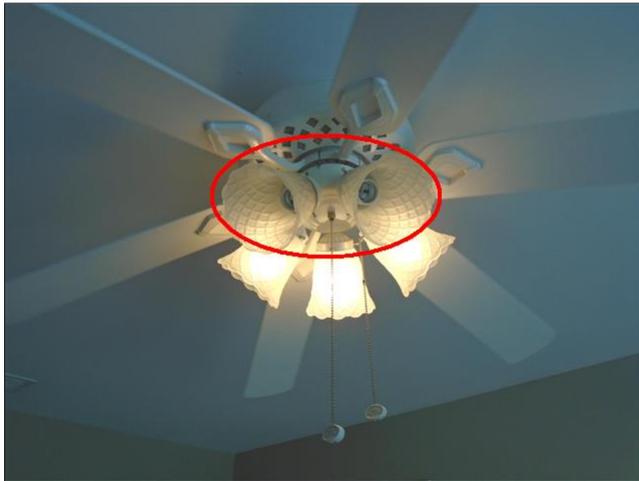
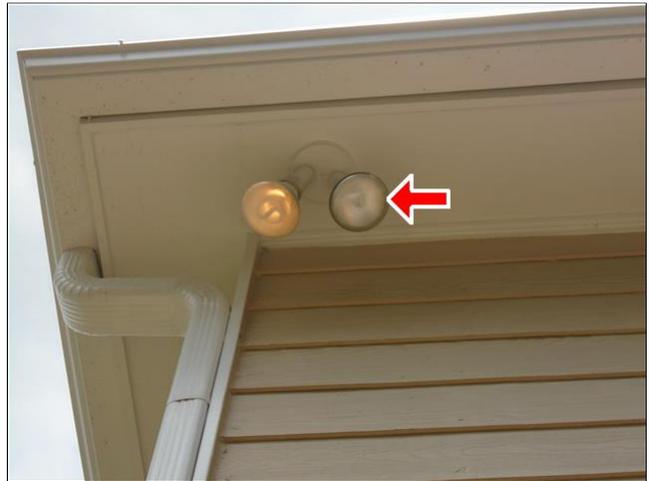
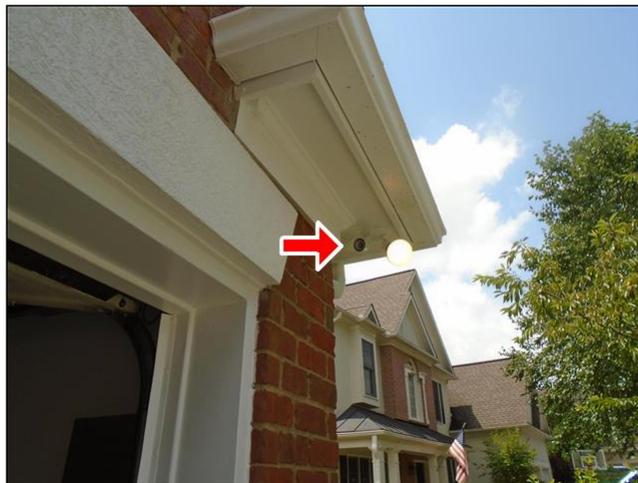
(2) Have all burnt out or missing light bulbs in and around the house replaced where needed.

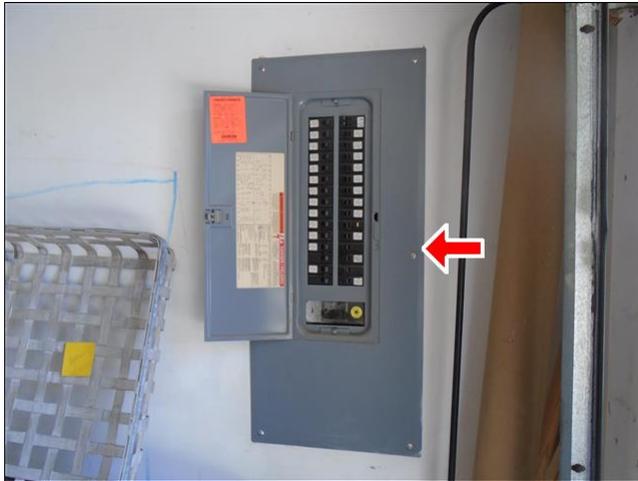
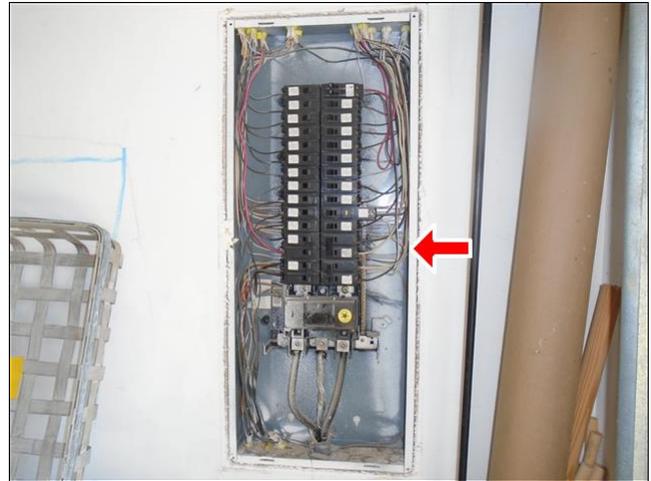
The electrical service main panel is located in the garage.

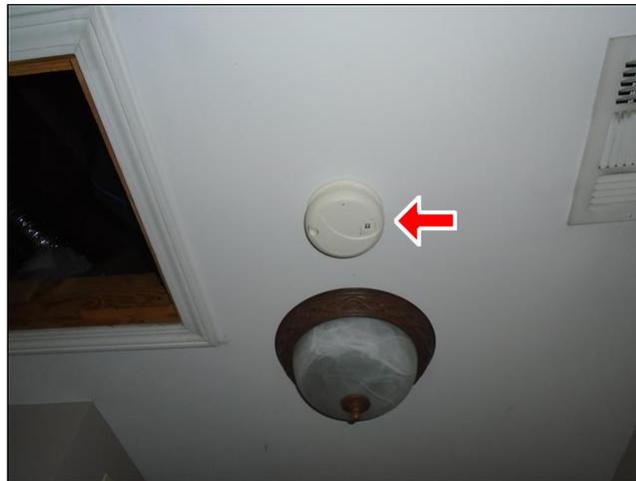
2nd floor hallway ceiling (example)

The smoke alarms were not functional when tested. Recommend replacement as needed by a qualified contractor.

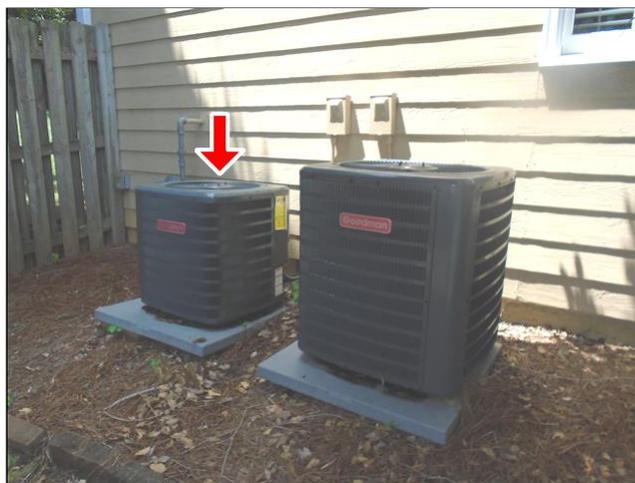
Left side of house

(1) An ambient air test was performed on the main floor cooling system by taking a temperature reading of both the output and return air to determine the temperature differential. A normal temperature differential is between 17 degrees and 22 degrees which indicates that the unit is cooling as intended. In this case the difference was only 13 degrees at best. Have further evaluated, checked for leaking, and repaired as needed by a qualified HVAC professional.

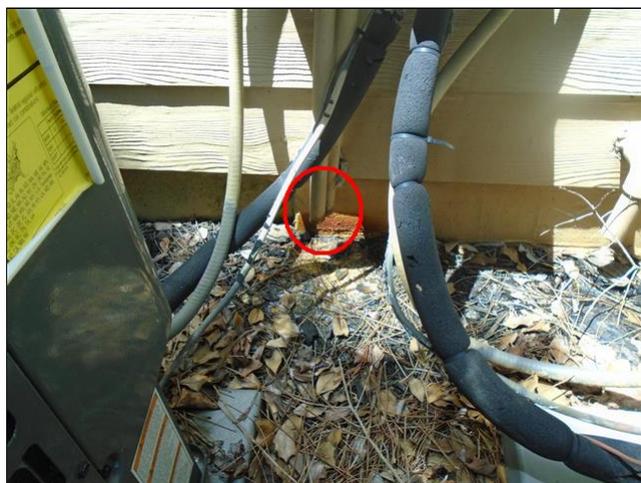
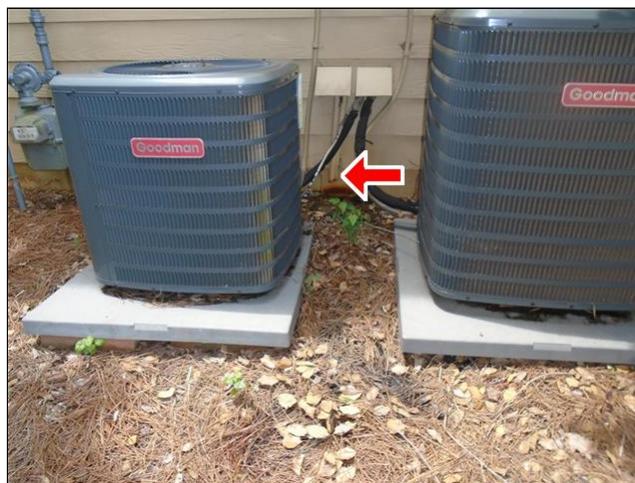
Left side of house

(2) Exterior condensate drains should be extended out to drain further away from the house.

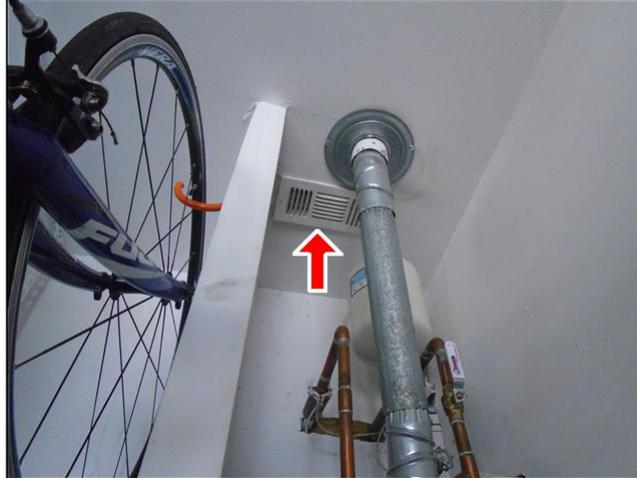
Garage

It is no longer recommended to have a HVAC supply vent inside garages as was seen. This may allow Carbon Monoxide cross contamination into the living space above. Have the vent sealed by a qualified HVAC professional.

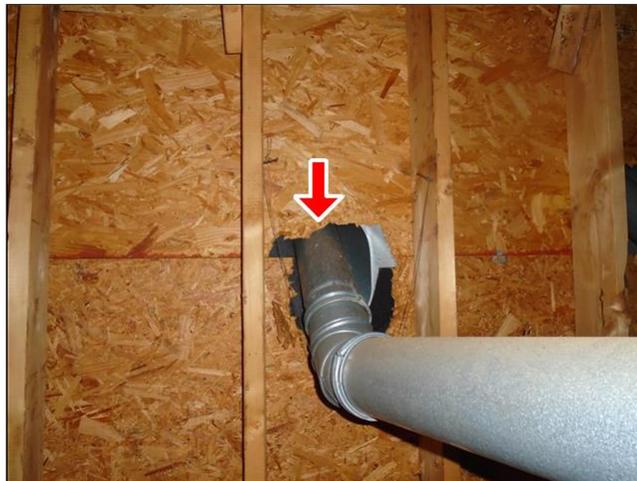
Attic roof

A furnace exhaust duct is in contact with the roof decking inside attic, which is considered a fire hazard. Have repaired to have at least a 1" gap created.

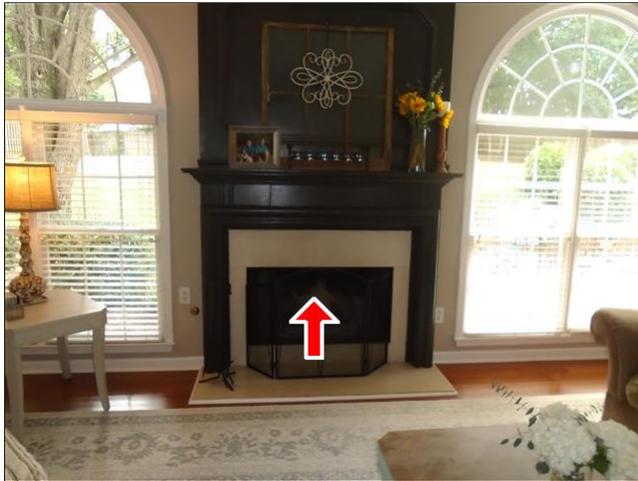
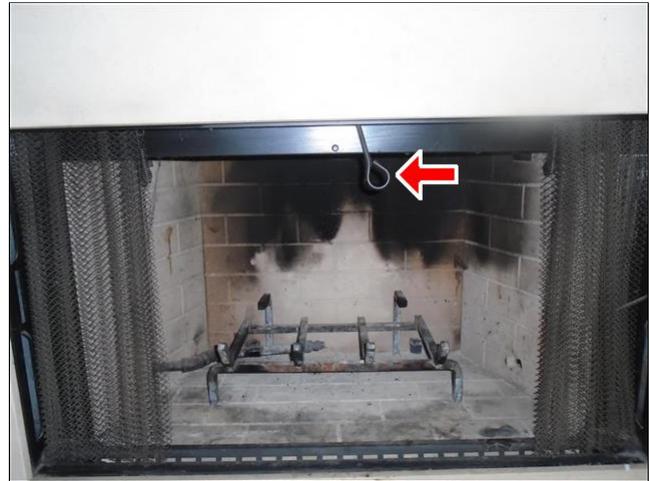
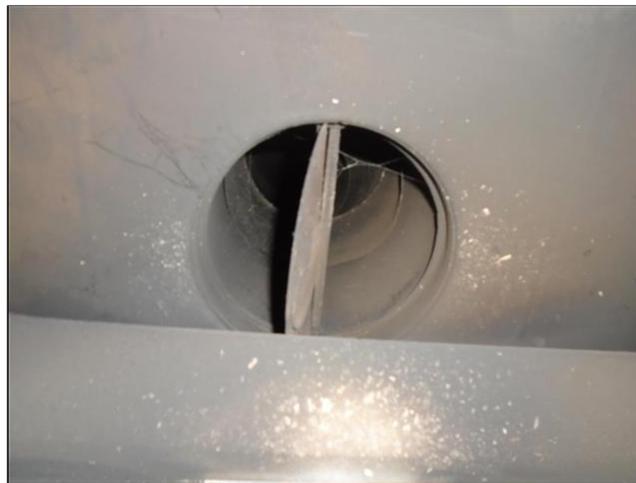
(1) The flue damper at the fireplace is not connected to the handle to OPEN/CLOSE the unit. Recommend further evaluation by a qualified fireplace professional for repairs as needed.

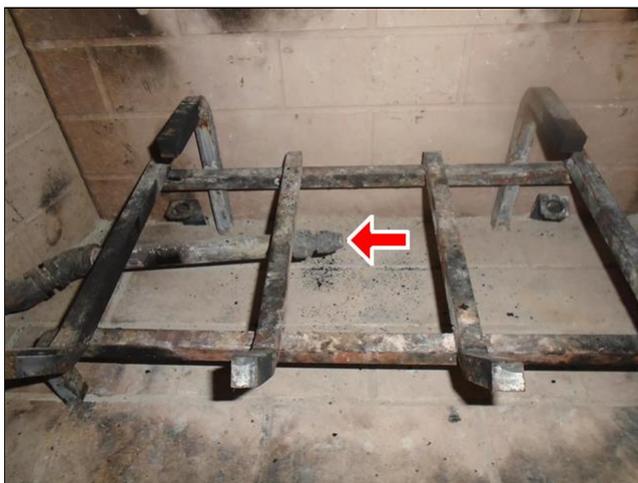
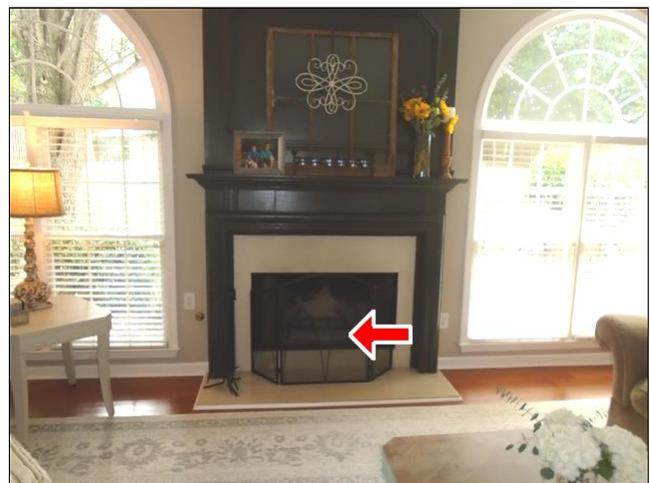
(2) The gas supply piping in the fireplace for the log lighter is missing a diffuser for proper operation.

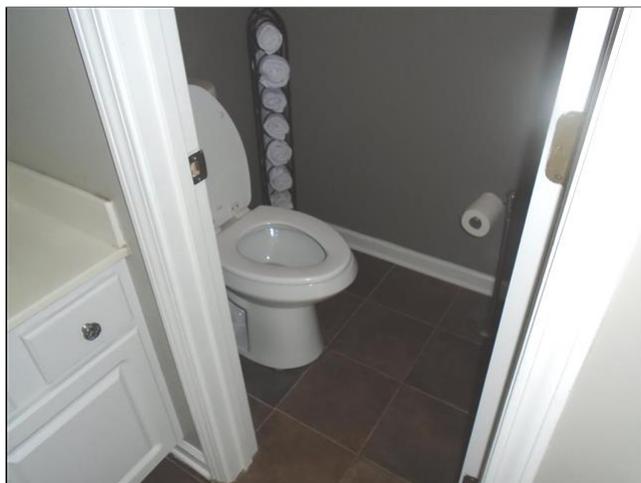
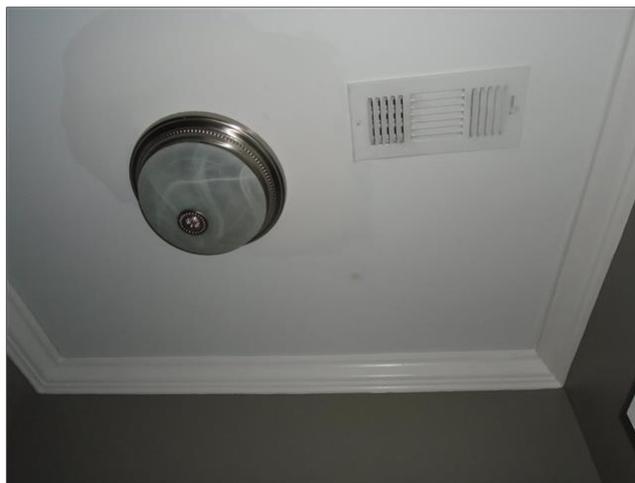
Master bathroom

There is no ceiling vent fan present in the master bathroom water closet. The electrical switch appears to be installed.

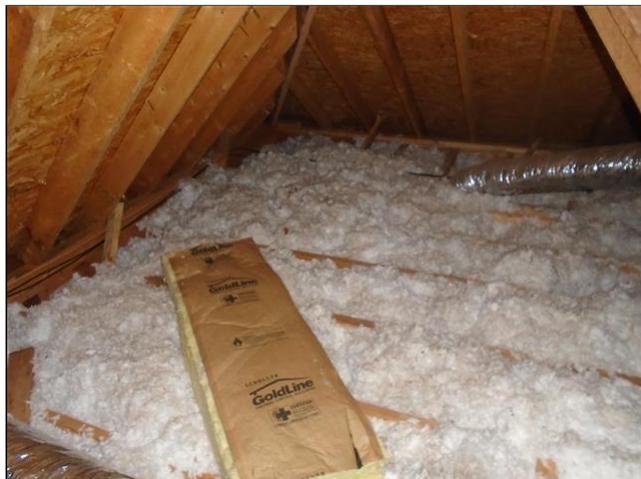
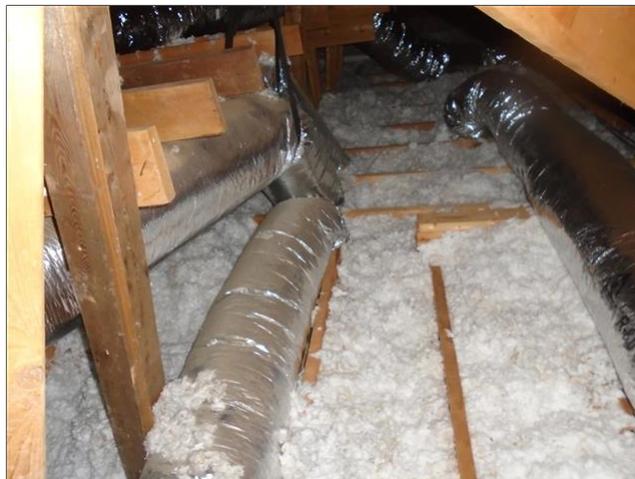
Signs of rodent burrowing were observed inside the attic insulation. Although a common problem, this should be further evaluated and treated by a qualified exterminator or wildlife control professional. The best fix for this would be having the exterior of the house sealed, which is called Exclusion.

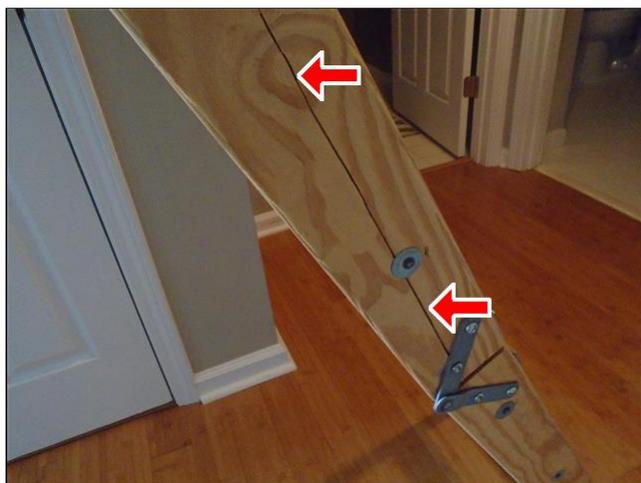
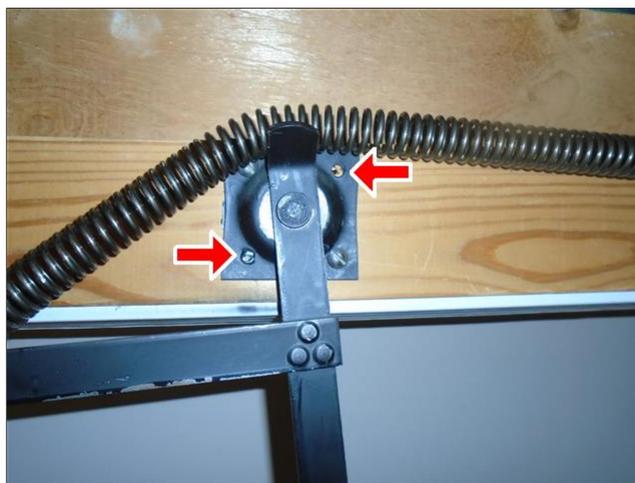
A stringer on the attic ladder was observed to have a large longitudinal split which may compromise the safety of the ladder. Nails are missing at the attic ladder hinge pivot hardware. Recommend repairs as needed by a qualified contractor.

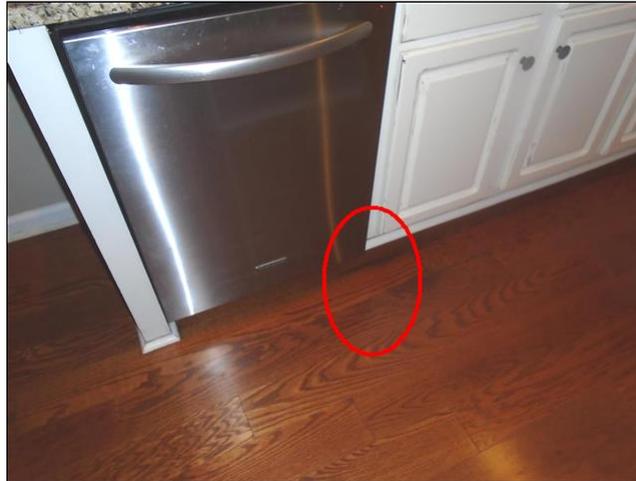
Kitchen

(1) The dishwasher door does not appear to close tightly. A puddle of water was found on the floor after running the appliance through a cycle. Recommend further evaluation by a qualified appliance repair professional for repairs as needed.

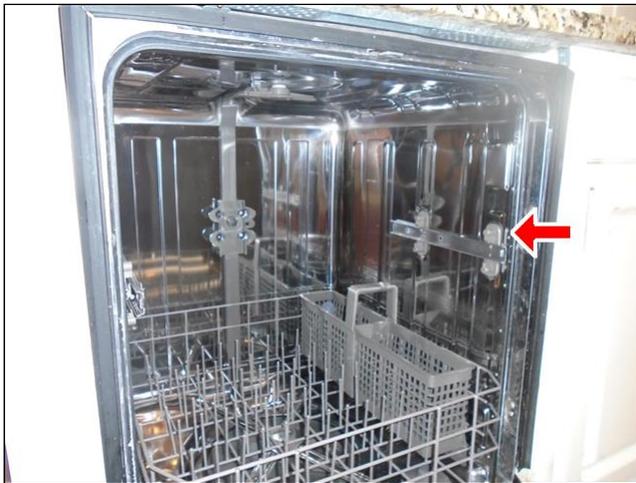
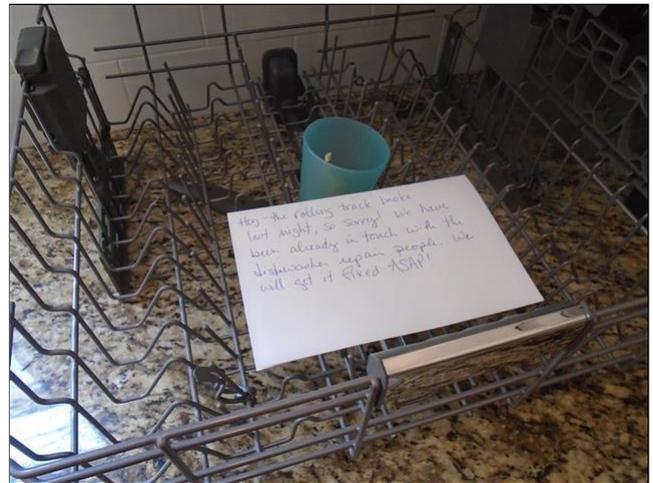
(2) The top drawer inside the dishwasher is damaged/not installed. Recommend further evaluation by a qualified appliance repair professional for repairs as needed.

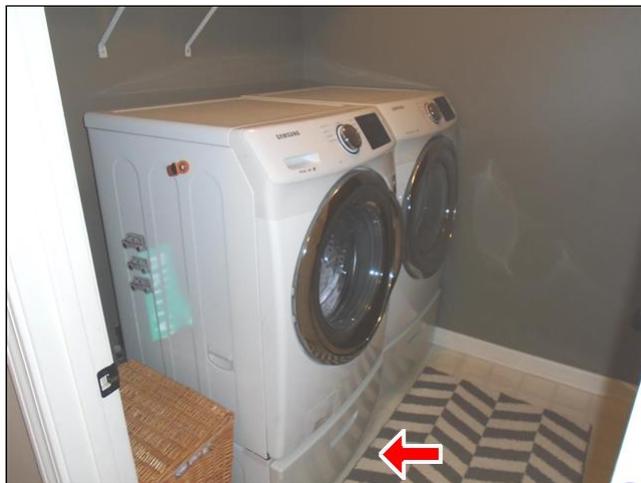
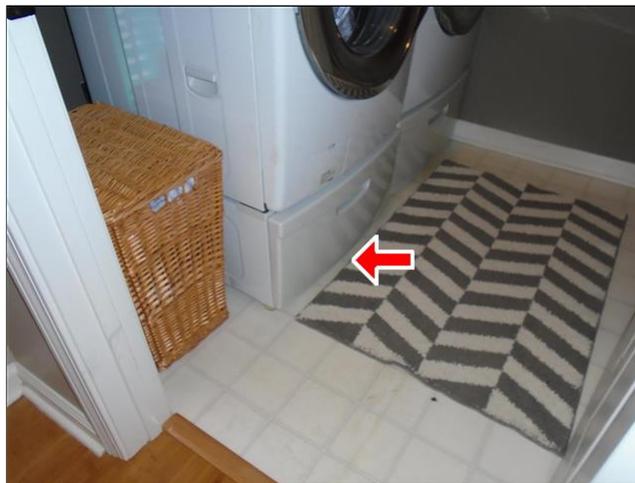
A drip pan with an exterior drain line is recommended under the clothes washer, as it is installed at a 2nd floor above finished living space.
