Property Inspection Report

Property address: 4065 Hopewell Springs Dr
Milton GA 30004-1705

Inspection date: Friday, August 7, 2020

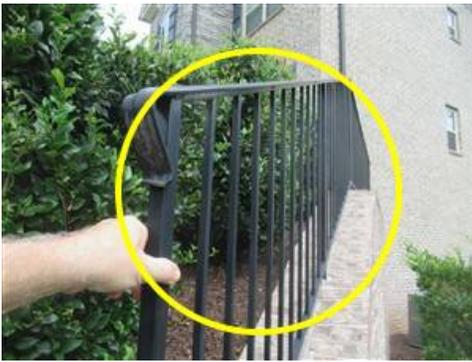
Photo 5-1

Guardrails on the front right side retaining wall, are loose and/or wobbly in one or more areas. This is a safety hazard. A qualified contractor should evaluate and make repairs as necessary, such as installing new fasteners or hardware, installing additional fasteners and/or installing additional railing components as necessary so they are securely attached.

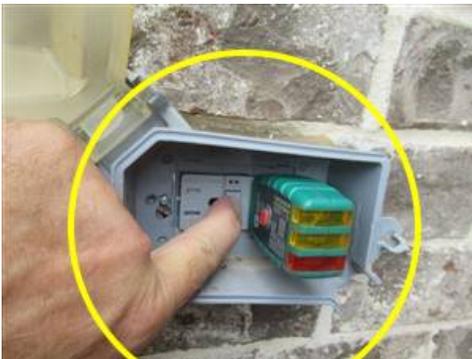
Photo 6-1

One front ground fault circuit interrupter (GFCI) electric receptacles are tripped and will not reset. This is a safety hazard due to the risk of fire and/or shock. A qualified electrician should evaluate and make repairs as necessary.

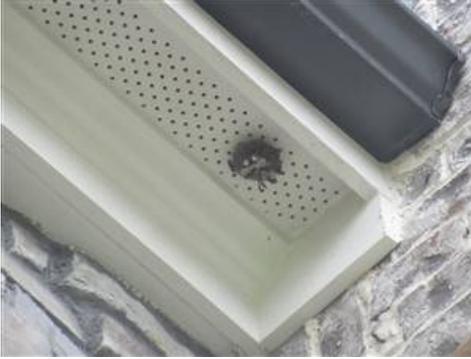
Photo 7-1

One or more hornet, bee and/or wasp nests were found. These can pose a safety hazard. Nest(s) should be removed as necessary.

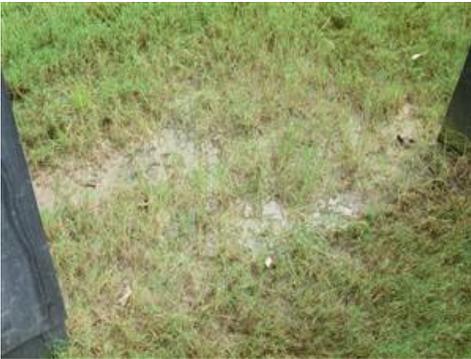
Photo 8-1

One area at the gate on the right side of the structure has significantly soggy soil, standing water or indications of accumulated water at times (sediment, dead grass, etc.). Recommend consulting with a qualified contractor who specializes in drainage, to determine if or what repairs are needed to provide adequate drainage. Possible repairs may involve grading soil, or installing, repairing and/or replacing underground drains.

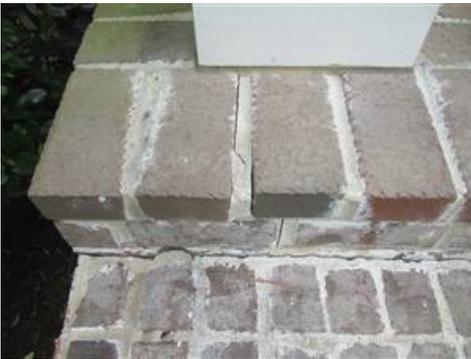
Photo 9-1

Minor cracks were found in one or more sections of brick veneer at the left side stairs. A qualified contractor should evaluate and make repairs as necessary, such as repointing mortar to prevent water intrusion and further deterioration in the future.

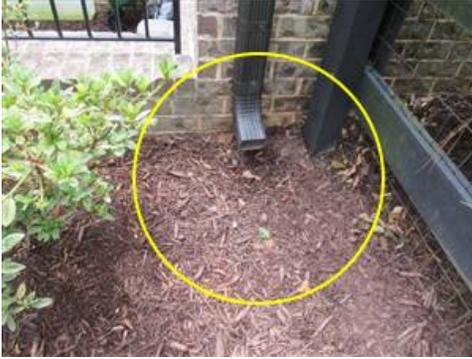
Photo 10-1

One or more downspouts have no extensions, or have extensions that are ineffective. This can result in water accumulating around the structure's foundation, or in basements and crawl spaces if they exist. Accumulated water is a conducive condition to wood destroying insects and organisms, and may also cause the foundation to settle and possibly fail over time. Repairs should be made as necessary, such as installing or repositioning splash blocks, or installing and/or repairing tie-ins to underground drain lines, so rain water is carried at least several feet away from the structure to soil that slopes down and away from the structure.

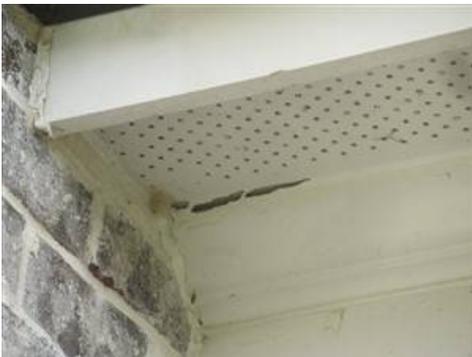
Photo 11-1

Caulk is missing or deteriorated in some areas and should be replaced and/or applied where necessary. For more information on caulking, visit [The Ins and Outs of Caulking](#).

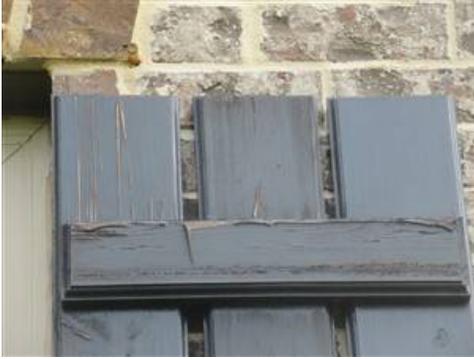
Photo 12-1

The exterior finish in some areas is failing. A qualified contractor should prep (pressure wash, scrape, sand, prime caulk, etc.) and repaint or restain areas as needed and as per standard building practices.

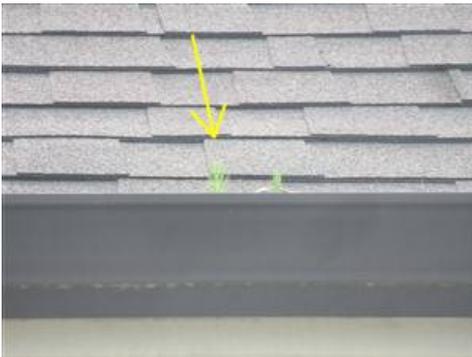
Photo 14-1

Debris has accumulated in one or more gutters. This is a conducive condition for wood destroying insects since gutters may overflow and cause water to come in contact with the structure's exterior or make water accumulate around the foundation. Gutters should be cleaned now and as necessary in the future.

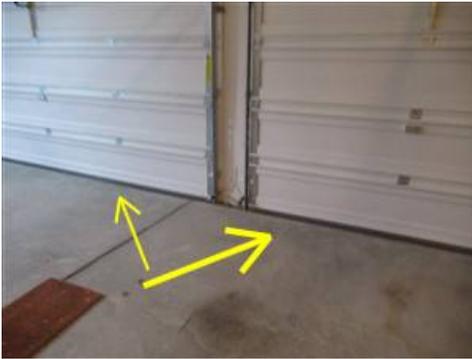
Photo 16-1

The auto-reverse mechanism or pressure safety, on the vehicle door openers are inoperable or requires too much force to activate. This is a safety hazard, especially for small children. A qualified contractor should evaluate and repair as necessary.

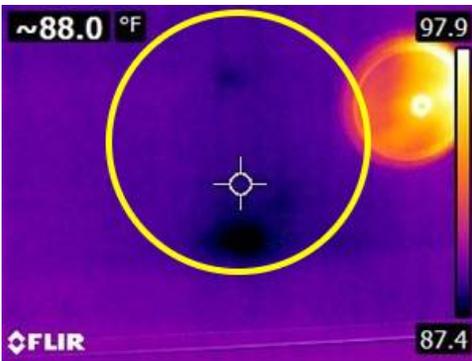
Stains and elevated levels of moisture were found in one or more ceiling areas. The stain(s) appear to be due to plumbing leaks. A qualified contractor should evaluate and repair as necessary.

Photo 17-1 This infrared scan and moisture meter showed signs of moisture at this ceiling stain. This is below the master bathroom.

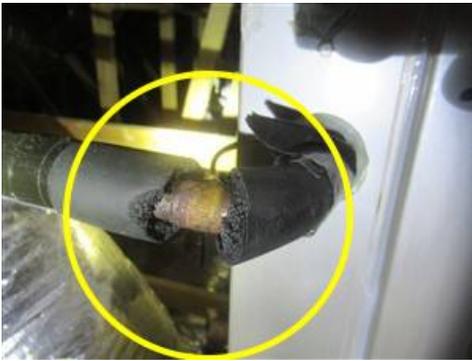
Photo 20-1

While inspecting the attic, the inspector noticed one or more sections of the insulated a/c refrigerant line, that is missing the insulation. This is allowing condensation to drip onto the unit below. Recommend having a qualified contractor evaluate and repair as necessary.

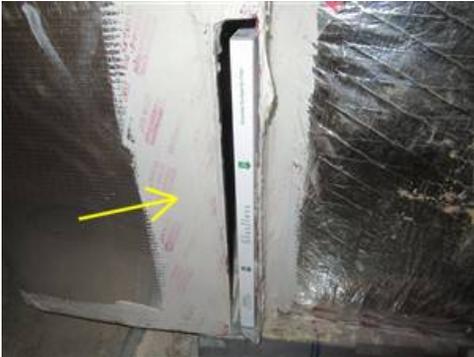
Photo 31-1

Air handler filter(s) should be checked monthly in the future and replaced or washed as necessary.

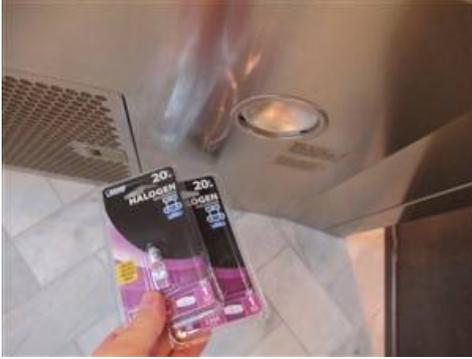
Photo 51-1

51) **i** One or more light bulbs are missing in the range hood light fixture. The inspector was unable to determine if the light fixture is fully operable.

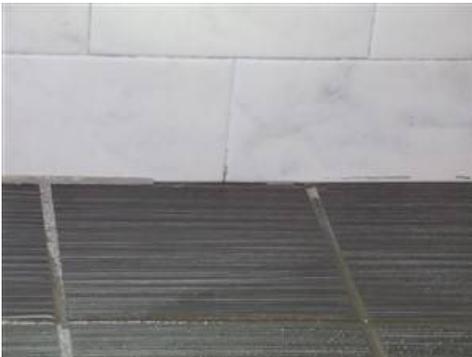
Photo 52-1

Grout or caulk in the master bedroom shower is damaged and/or deteriorated. For example, deteriorated or missing grout, cracked, missing or loose tiles, etc. A qualified contractor should evaluate and repair tile and/or grout as necessary.

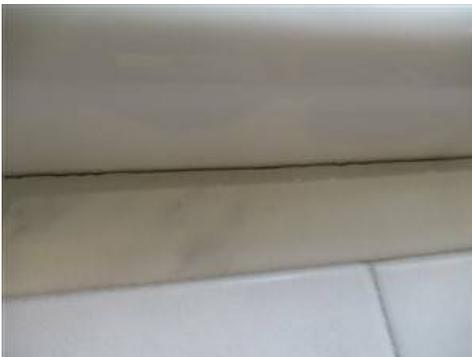
Photo 53-1

Caulk is missing or deteriorated above one or more bathtubs, where the tub surround meets the tub. It should be replaced where deteriorated and/or applied where missing to prevent water intrusion and damage to the wall structure.

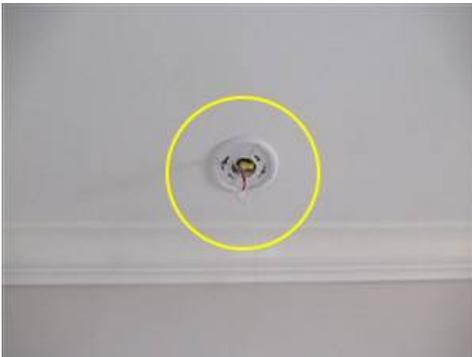
One or more smoke alarms are damaged, deteriorated and/or missing from their mounting brackets. Damaged and/or missing smoke alarms should be replaced as necessary so a functioning one exists in each hallway leading to bedrooms, and in each bedroom.

Photo 55-1 Upstairs back bedroom.

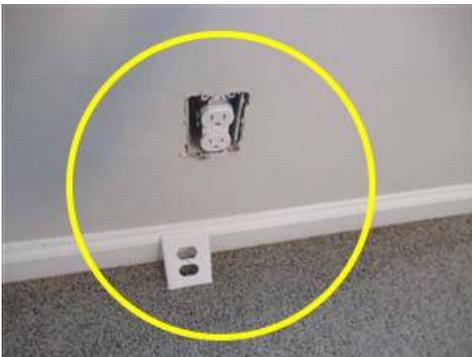
Cover plate(s) are missing from one or more electric boxes, such as for receptacles, switches and/or junction boxes. They are intended to contain fire and prevent electric shock from exposed wires. This is a safety hazard due to the risk of fire and shock. Cover plates should be installed where missing.

Photo 56-1 Upstairs back bedroom.

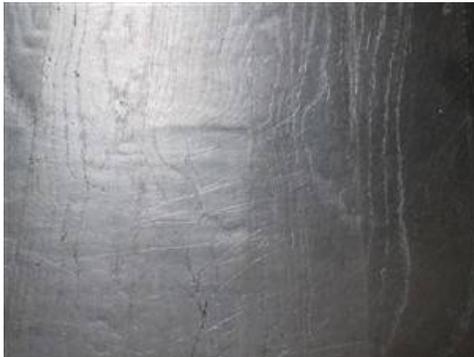
Photo 58-1

Wood flooring and stairs in one or more areas appears to be scratched. Recommend having a qualified contractor evaluate and refinish wood flooring as necessary.

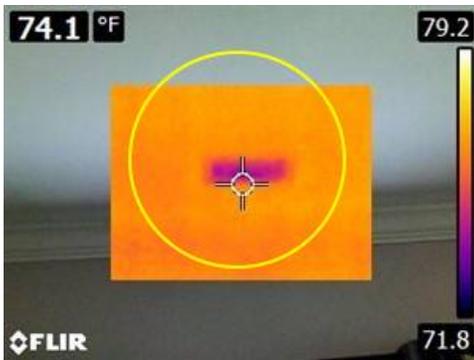
One master bedroom air supply registers has a weak air flow, or no apparent flow, and may result in an inadequate air supply for heating/cooling. Recommend asking the property owner(s) about this. Adjustable damper(s) in ducts may exist and be reducing the flow. If dampers exist, then they should be opened to attempt to improve the air flow. If the property owner(s) are unaware of such dampers, or if adjusting dampers does not improve the air flow, then a qualified heating/cooling contractor should evaluate and repair or make modifications as necessary.

Photo 59-1 This is the left side of the master bed.

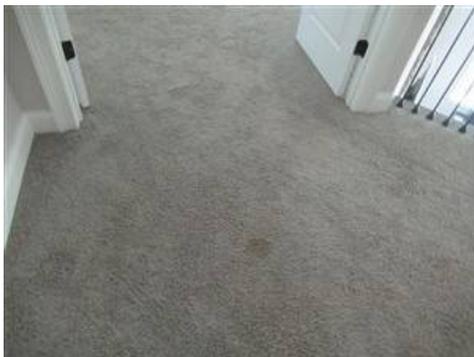
Photo 60-1

Carpeting in one or more rooms is soiled and/or stained. Recommend having carpeting professionally cleaned as necessary.

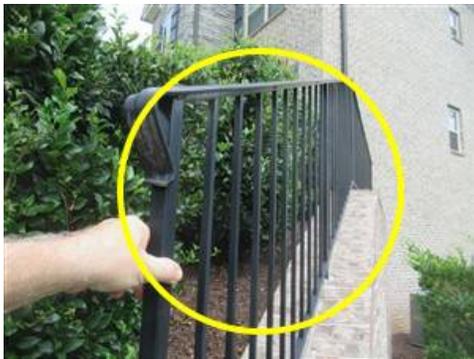
Photo 5-1

5) Guardrails on the front right side retaining wall, are loose and/or wobbly in one or more areas. This is a safety hazard. A qualified contractor should evaluate and make repairs as necessary, such as installing new fasteners or hardware, installing additional fasteners and/or installing additional railing components as necessary so they are securely attached.

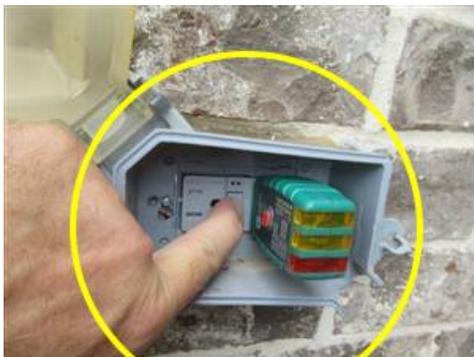
Photo 6-1

6) One front ground fault circuit interrupter (GFCI) electric receptacles are tripped and will not reset. This is a safety hazard due to the risk of fire and/or shock. A qualified electrician should evaluate and make repairs as necessary.

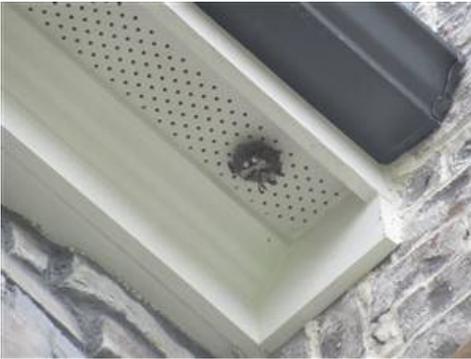
Photo 7-1

One or more hornet, bee and/or wasp nests were found. These can pose a safety hazard. Nest(s) should be removed as necessary.

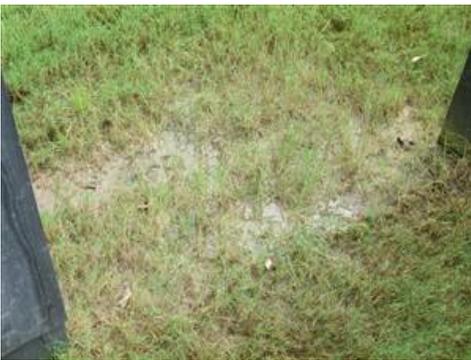
Photo 8-1

One area at the gate on the right side of the structure has significantly soggy soil, standing water or indications of accumulated water at times (sediment, dead grass, etc.). Recommend consulting with a qualified contractor who specializes in drainage, to determine if or what repairs are needed to provide adequate drainage. Possible repairs may involve grading soil, or installing, repairing and/or replacing underground drains.

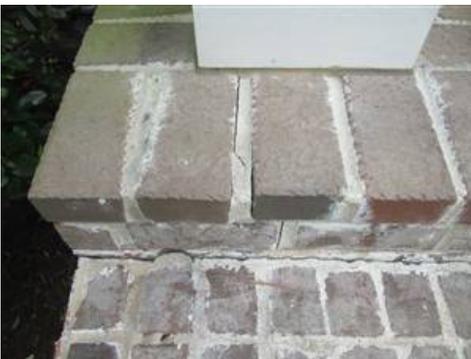
Photo 9-1

Minor cracks were found in one or more sections of brick veneer at the left side stairs. A qualified contractor should evaluate and make repairs as necessary, such as repointing mortar to prevent water intrusion and further deterioration in the future.

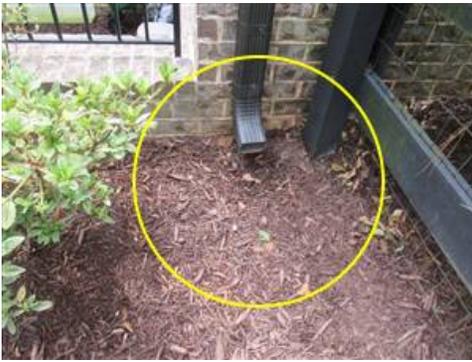
Photo 10-1

One or more downspouts have no extensions, or have extensions that are ineffective. This can result in water accumulating around the structure's foundation, or in basements and crawl spaces if they exist. Accumulated water is a conducive condition to wood destroying insects and organisms, and may also cause the foundation to settle and possibly fail over time. Repairs should be made as necessary, such as installing or repositioning splash blocks, or installing and/or repairing tie-ins to underground drain lines, so rain water is carried at least several feet away from the structure to soil that slopes down and away from the structure.

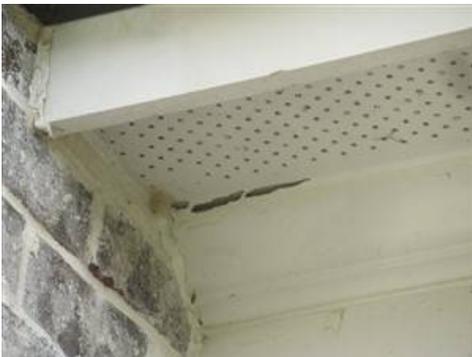
Photo 11-1

Caulk is missing or deteriorated in some areas and should be replaced and/or applied where necessary. For more information on caulking, visit [The Ins and Outs of Caulking](#).

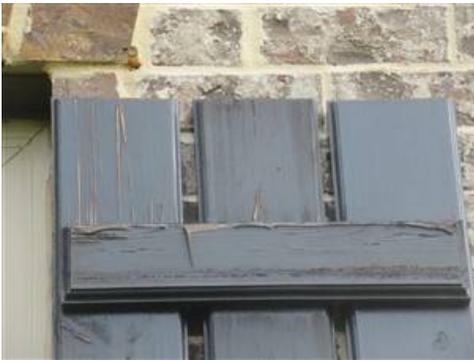
Photo 12-1

The exterior finish in some areas is failing. A qualified contractor should prep (pressure wash, scrape, sand, prime caulk, etc.) and repaint or restain areas as needed and as per standard building practices.

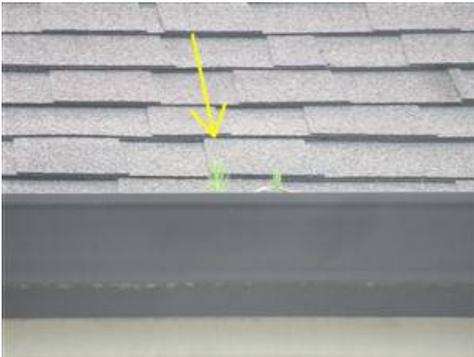
Photo 14-1

14) 🗑️💧 Debris has accumulated in one or more gutters. This is a conducive condition for wood destroying insects since gutters may overflow and cause water to come in contact with the structure's exterior or make water accumulate around the foundation. Gutters should be cleaned now and as necessary in the future.

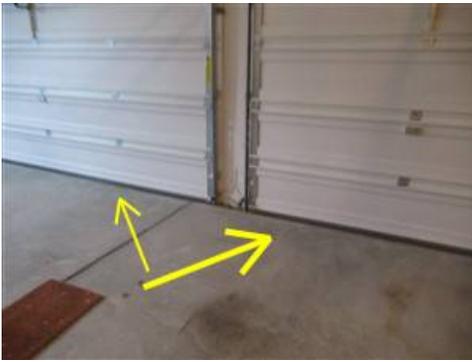
Photo 16-1

16) 🛠️🔍 The auto-reverse mechanism or pressure safety, on the vehicle door openers are inoperable or requires too much force to activate. This is a safety hazard, especially for small children. A qualified contractor should evaluate and repair as necessary.

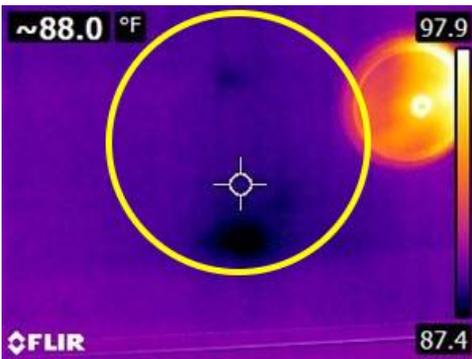
Stains and elevated levels of moisture were found in one or more ceiling areas. The stain(s) appear to be due to plumbing leaks. A qualified contractor should evaluate and repair as necessary.

Photo 17-1 This infrared scan and moisture meter showed signs of moisture at this ceiling stain. This is below the master bathroom.

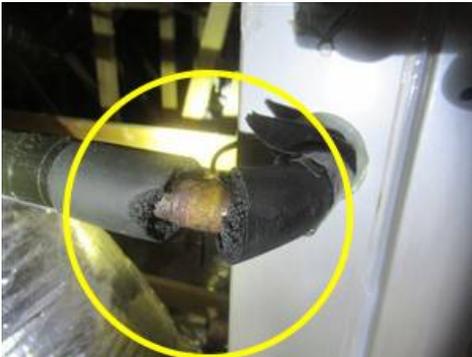
Photo 20-1

20) 🔧🔍🌡️ While inspecting the attic, the inspector noticed one or more sections of the insulated a/c refrigerant line, that is missing the insulation. This is allowing condensation to drip onto the unit below. Recommend having a qualified contractor evaluate and repair as necessary.

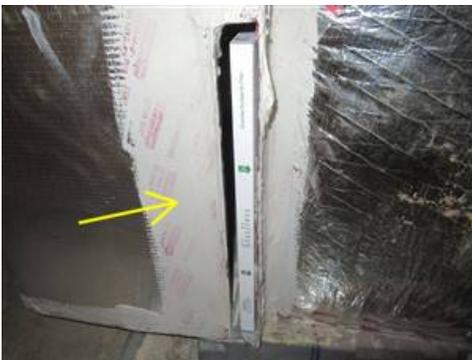
Photo 31-1

31) 🔧🔍🌡️ Air handler filter(s) should be checked monthly in the future and replaced or washed as necessary.

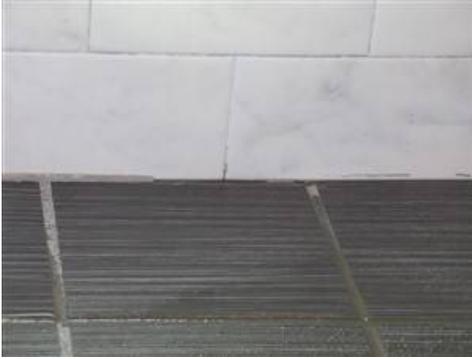
Photo 52-1

52) 🔧🔍💧 Grout or caulk in the master bedroom shower is damaged and/or deteriorated. For example, deteriorated or missing grout, cracked, missing or loose tiles, etc. A qualified contractor should evaluate and repair tile and/or grout as necessary.

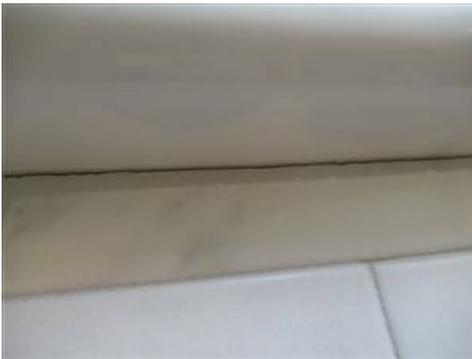
Photo 53-1

Caulk is missing or deteriorated above one or more bathtubs, where the tub surround meets the tub. It should be replaced where deteriorated and/or applied where missing to prevent water intrusion and damage to the wall structure.

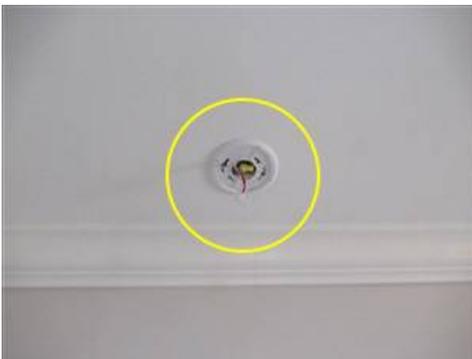
One or more smoke alarms are damaged, deteriorated and/or missing from their mounting brackets. Damaged and/or missing smoke alarms should be replaced as necessary so a functioning one exists in each hallway leading to bedrooms, and in each bedroom.

Photo 55-1 Upstairs back bedroom.

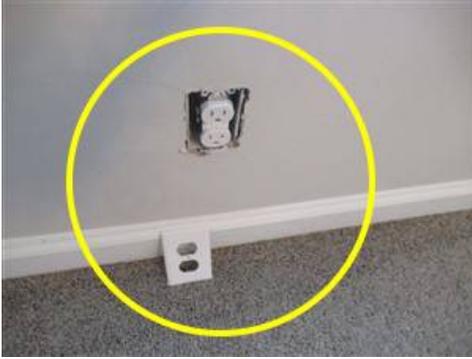
Cover plate(s) are missing from one or more electric boxes, such as for receptacles, switches and/or junction boxes. They are intended to contain fire and prevent electric shock from exposed wires. This is a safety hazard due to the risk of fire and shock. Cover plates should be installed where missing.

Photo 56-1 Upstairs back bedroom.

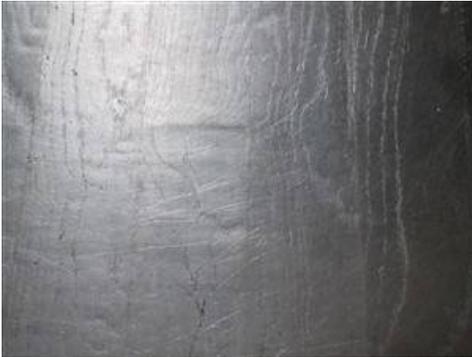
Photo 58-1

58) Wood flooring and stairs in one or more areas appears to be scratched. Recommend having a qualified contractor evaluate and refinish wood flooring as necessary.

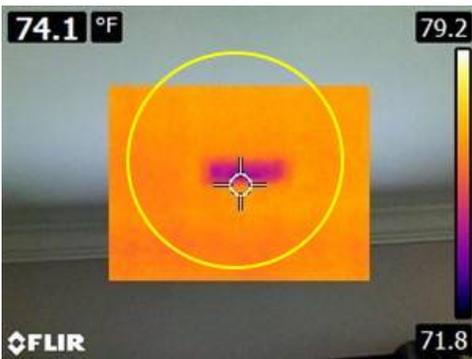
59) One master bedroom air supply registers has a weak air flow, or no apparent flow, and may result in an inadequate air supply for heating/cooling. Recommend asking the property owner(s) about this. Adjustable damper(s) in ducts may exist and be reducing the flow. If dampers exist, then they should be opened to attempt to improve the air flow. If the property owner(s) are unaware of such dampers, or if adjusting dampers does not improve the air flow, then a qualified heating/cooling contractor should evaluate and repair or make modifications as necessary.

Photo 59-1 This is the left side of the master bed.

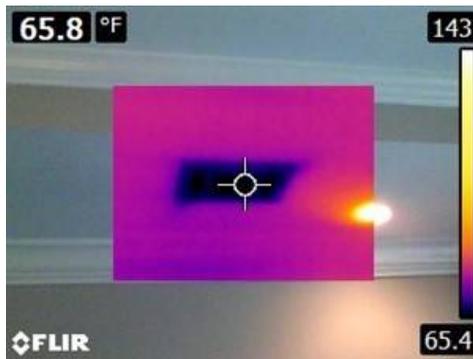
Photo 59-2 This is the right side of the master bedroom bed.

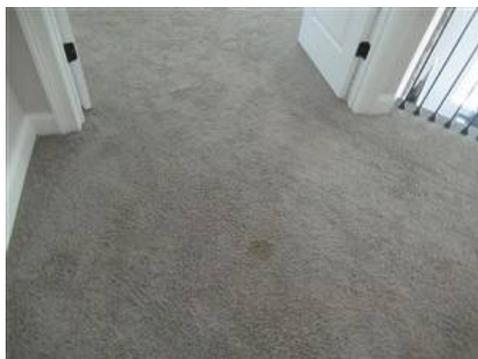
Photo 60-1

60) Carpeting in one or more rooms is soiled and/or stained. Recommend having carpeting professionally cleaned as necessary.
