Property Inspection Report

3089 Del Monico Dr , Decatur, GA 30032
Inspection prepared for: Ronald & Lauren Carlson
Real Estate Agent: Angie Leberte - Justin Landis Group

Date of Inspection: 6/3/2020 Time: 9 AM
Age of Home: 1978 | Size: 2,472 SF est.
Weather: 84°, partly cloudy

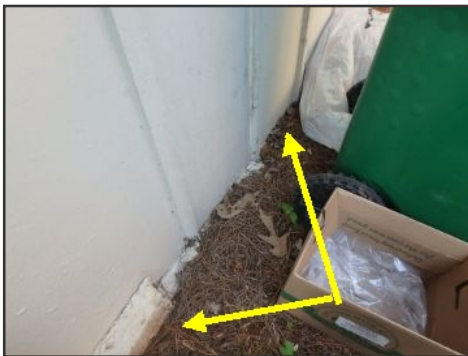
1.2. GRADING--TOO CLOSE TO BOTTOM EDGE OF SIDING: The Inspector observed that the finished grading is too high at side D (right) of the home. The grade should be no higher than 6" below the bottom edge of siding. When the grade is too high, water seepage can cause damage to the wood framing of the home. It can also create a conduit for termites. The Inspector advises the Client to arrange to have a professional landscape contractor further evaluate and address as necessary. Repair any damaged siding that is discovered.

grading too close to siding at side D

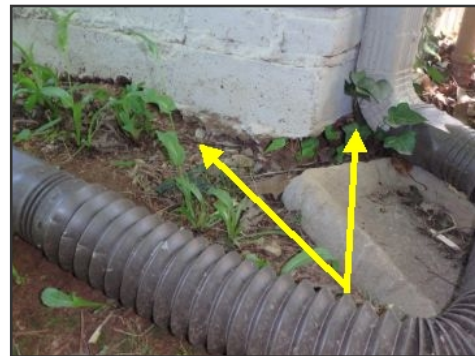
1.3. EROSION NEAR FOUNDATION: The Inspector observed areas of erosion near the foundation of the house at rear left corner. It is important to protect the foundation and surrounding soil to prevent differential settlement. The Inspector advises the Client to arrange to have a professional contractor further evaluate and address as necessary.

erosion near rear left corner

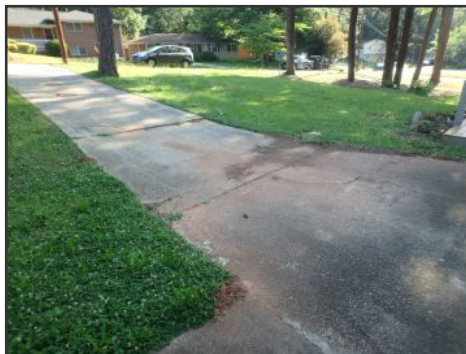
2.2. CRACKING WITH UNEVEN AREAS--DRIVEWAY: The Inspector observed typical cracking at the driveway. Uneven areas at cracks could be a trip hazard. The Client is advised to consider repairing uneven areas to mitigate fall hazards. Additionally, it appears that storm water pools at the driveway near the walkway; re-grade as needed. The Inspector advises the Client to arrange to have a professional contractor further evaluate and address as necessary.

general image of driveway

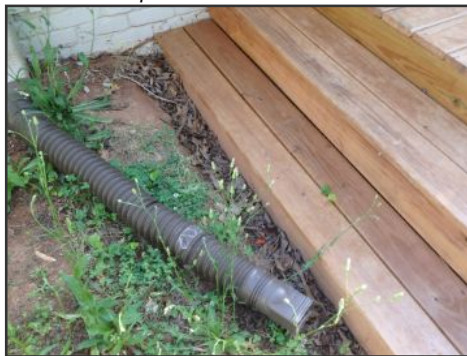
4.2. WOOD TO EARTH CONTACT--REAR DECK STEPS: Wood-to-earth contact of the deck was observed; this area may prematurely deteriorate. Except for posts, most types of preservative-treated wood should be kept 6" above ground (note some premium types of treated wood are permitted for contact, but the Inspector cannot determine type without seeing wood labels). The Inspector advises the Client to arrange to have a professional contractor further evaluate and address as necessary.

wood to earth contact

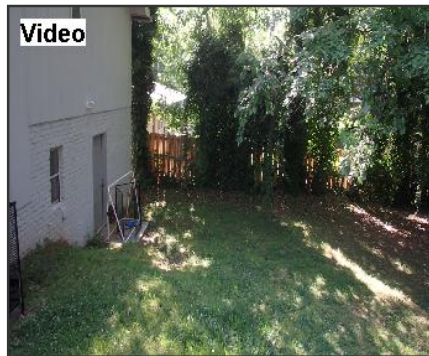
8.3. FENCE--CHAIN LINK--MAJOR REPAIRS NEEDED: The metal fence needs general repairs to address loose and misaligned areas. Some sections are missing or need major repairs, mostly at side B. The fence does not connect to the house at the rear left. The Inspector advises the Client to arrange to have a professional contractor further evaluate and address as necessary.

VIDEO--fence

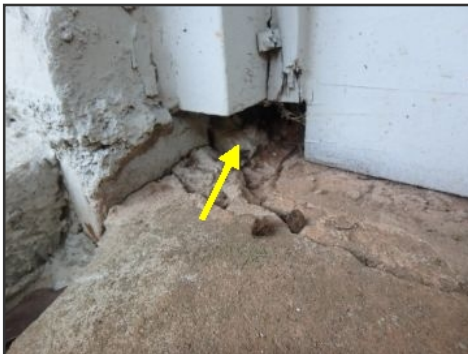
3.2. CONSTRUCTION GAPS: The Inspector observed an opening/gap at side A (front) and at side B (left). See images. They should be closed to prevent water or pest entry. The Inspector advises the Client to arrange to have a professional contractor further evaluate and address as necessary.

construction gap at side A

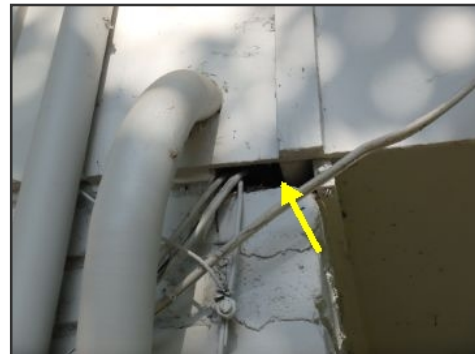
construction gap at side B

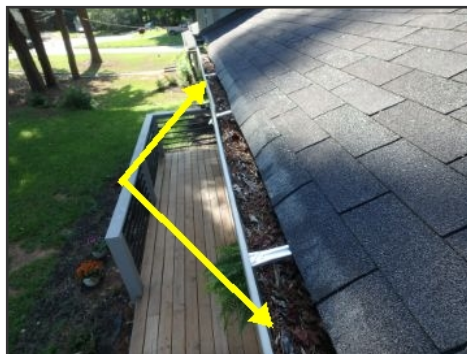
4.1. DEBRIS IN GUTTERS: The Inspector observed that the gutters and downspouts have debris/leaves/pine needles in them. Have gutter company clean and service. Consider installing micromesh screens to reduce maintenance. The Inspector advises the Client to arrange to have a professional roofing contractor further evaluate and address as necessary.

example gutter condition

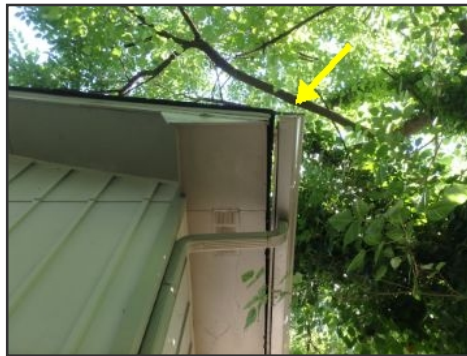
7.2. DETACHING FASCIA: The Inspector observed detaching fascia board at side B (left). It should be repaired to prevent water and pest entry. Include gutter repair as needed. The Inspector advises the Client to arrange to have a professional contractor further evaluate and address as necessary.

detaching fascia and gutter at side B

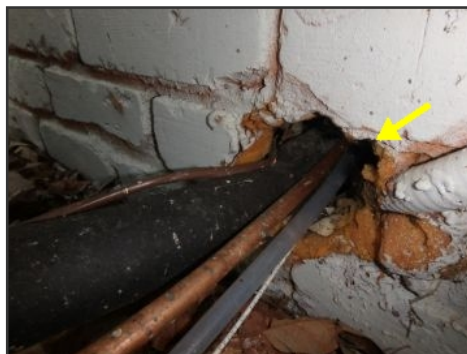
9.2. GAP AT FOUNDATION WALL AT PIPE: The Inspector observed an opening around HVAC line penetration at side C (rear) of the home. The gap should be sealed to prevent rodent entry into the crawl space. The Inspector advises the Client to arrange to have a professional contractor further evaluate and address as necessary.

gap should be sealed

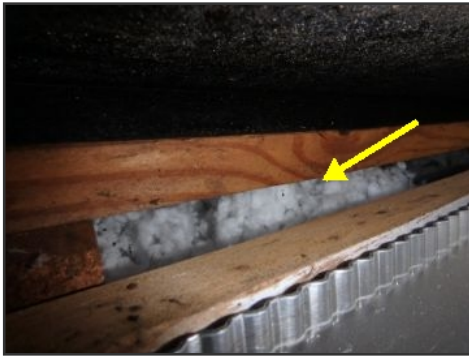
2.2. DRIP EDGE FLASHING: No drip edge flashing was observed at the roof edge. Drip edge flashing closes the gap at the fascia and roof deck intersection helping to prevent water from damaging the fascia and roof decking edge. It has a secondary function of helping to prevent rodents from entering the attic at the gaps. The Inspector advises the Client to arrange to have a professional contractor further evaluate and address as necessary. (IRC: R905.2.8.5)

example missing drip cap

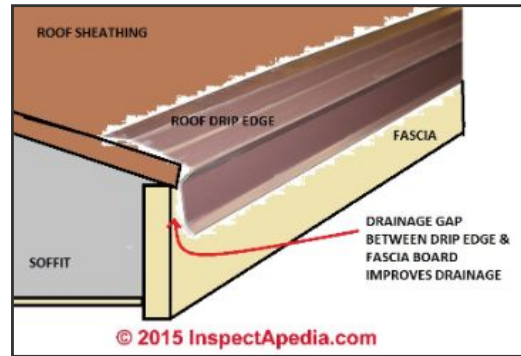
drip edge flashing

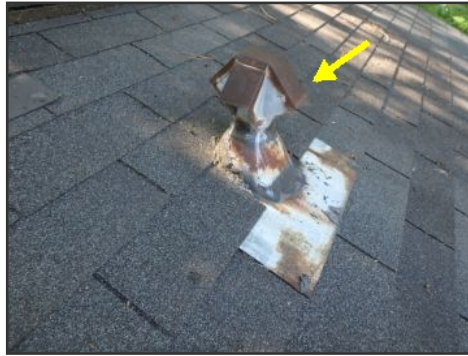
3.2. RUST AT APPLIANCE VENT: The Inspector observed a appliance vent pipe that is significantly rusted at the right side of the upper roof of the home. It should be replaced soon. The Inspector advises the Client to arrange to have a professional contractor further evaluate and address as necessary.

rusted vent

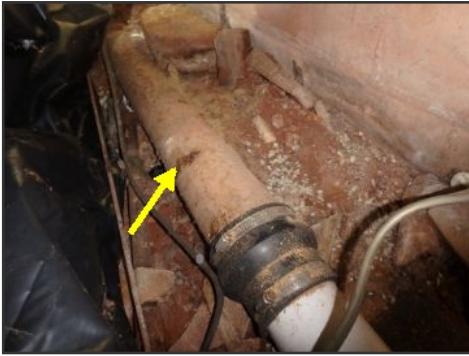
4.2. CAST IRON PIPE--AGED--SEWER LATERAL: The home has an aged cast iron sewer later (underground pipe from home to street that runs underground. While the system still appears to be serviceable, there may be concealed deterioration inside the pipe and underground. The Inspector cannot predict the remaining useful lifespan of the pipes. The pipes should be monitored in the meantime. HUD (US Dept. of Housing and Urban Development) estimates cast iron pipes last 50 years on average.

cast iron sewer lateral

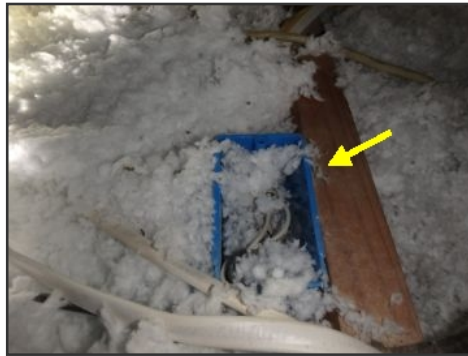
7.1. Appears normal at most sections. See exceptions.
 7.2. OPEN JUNCTION BOX--ATTIC: The Inspector observed at least 1 open junction box at the attic. A cover plate should be installed. This is a minor concern and can be easily addressed. The Inspector advises the Client to arrange to have a professional, licensed electrician further evaluate and address as necessary.

open junction box

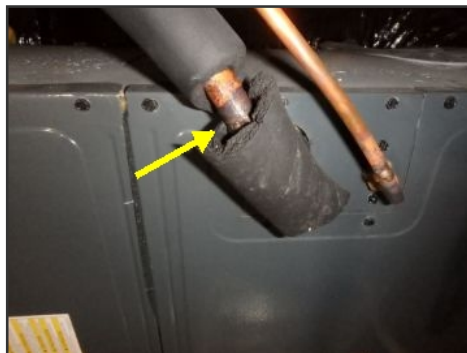
4.2. GAP--REFRIGERANT LINE INSULATION--NEAR COIL BOX--MAIN: The Inspector observed a gap at the insulation at the coil box. It should be replaced/sealed to prevent moisture damage from dripping condensation. This is an easy correction. The Inspector advises the Client to arrange to have a professional, NATE certified HVAC contractor further evaluate and address as necessary.

insulation damage

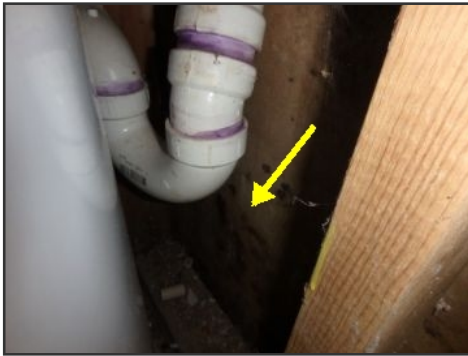
8.3. POSSIBLE MINOR MOLD--BASEMENT DRYWALL: The Inspector observed possible mold growth at the drywall and wood trim at the basement inside the water heater closet. The damaged material should be removed and area properly cleaned. The Inspector advises the Client to arrange to have a professional contractor further evaluate and address as necessary. Note that mold testing was not conducted as part of this inspection; mold is visually accessed. Seek additional testing as desired.

possible minor amount of mold at basement drywall

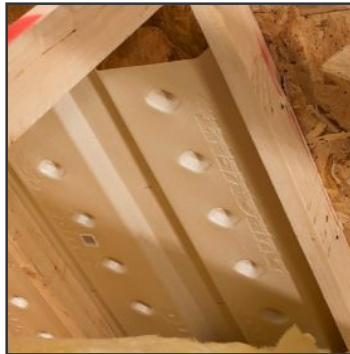
- 2.1. Appears normal.
 2.2. BAFFLES--MISSING AT EAVES: The Inspector did not observe baffles installed for venting as required for the eaves (sections where rafters meet exterior walls). Baffles help prevent the loose insulation from blocking the vents in the soffits. The Inspector advises the Client to arrange to have a professional contractor further evaluate and address as necessary.

stock photo--baffle

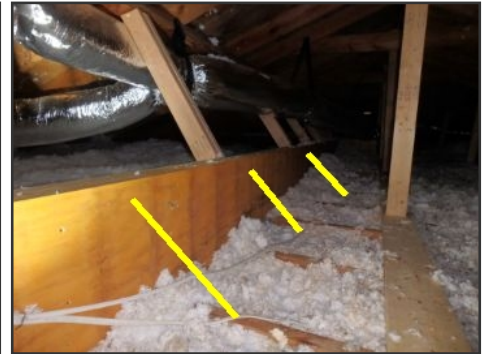
4.4. BEAM AT ROOF--DIAGONAL BRACES NEEDED: There is a newly installed laminated beam above the kitchen. Rafter struts are mounted on the upper side at an angle. The beam needs diagonal braces installed at the opposite side to prevent rotation. The Inspector advises the Client to arrange to have a professional contractor further evaluate and address as necessary.

beam needs diagonal braces
