Your Inspection Report

1817 West Wesley Road
Atlanta, GA 30327

INSPECTION DATE:
Monday, August 10, 2020

RE: Report No. 35122
1817 West Wesley Road
Atlanta, GA
30327

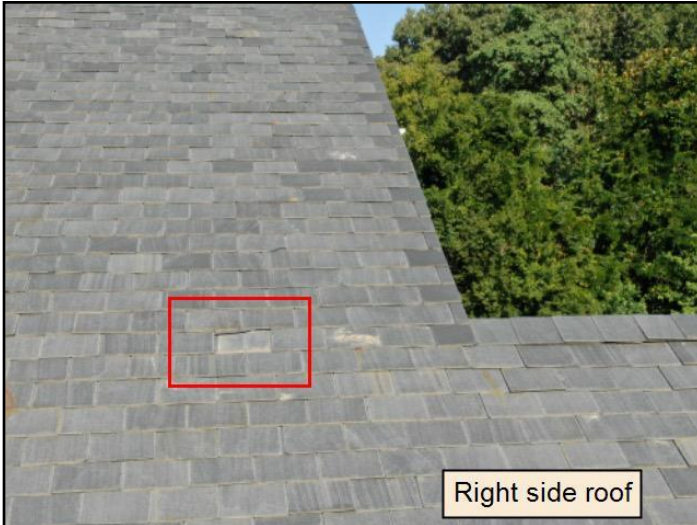
1. Condition: • Damage, missing, loose, torn

1. Damage, missing, loose, torn

Time: As Soon As Possible

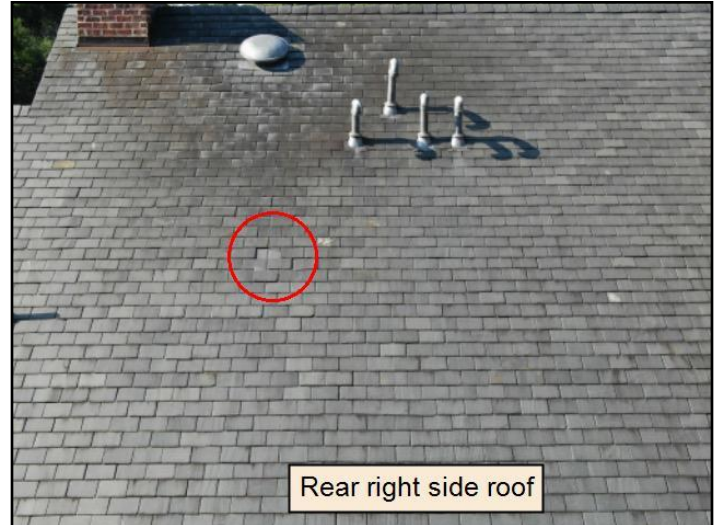
2. Damage, missing, loose, torn

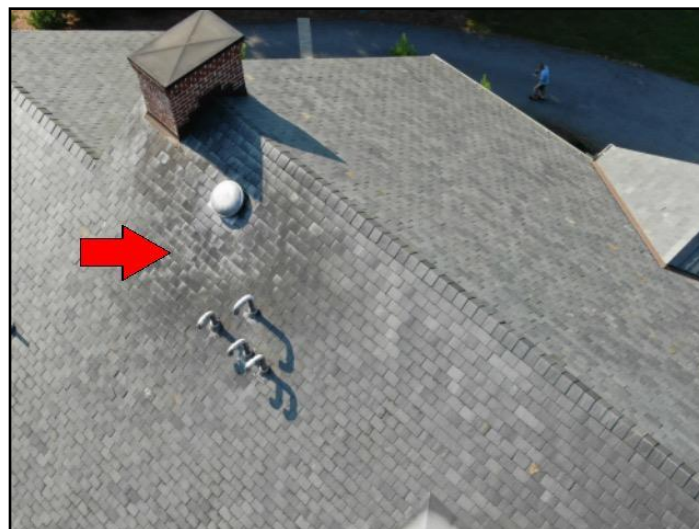
3.

2. Condition: • Staining or glazing around the power vent termination points on roof are most likely from the changes of temperature and humidity when air is expelled from attic space. No action needed.

Task: Be Advised

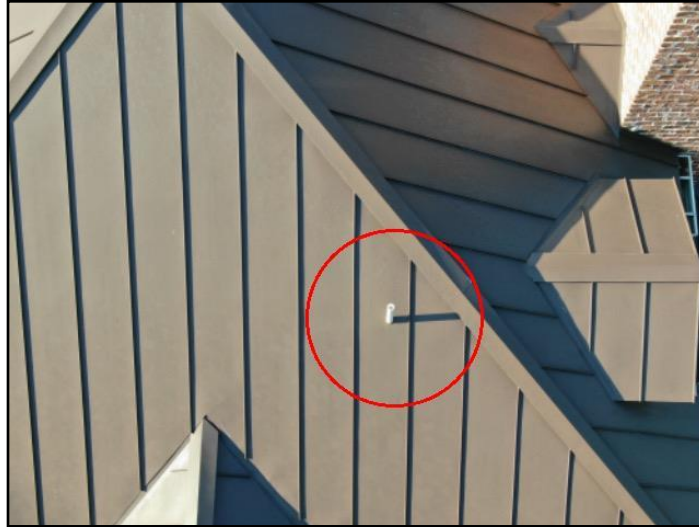
3. Condition: • Damage, loose, rusted or missing

Plumbing stack missing boot / flashing.

4. Damage, loose, rusted or missing

Task: Repair or correct

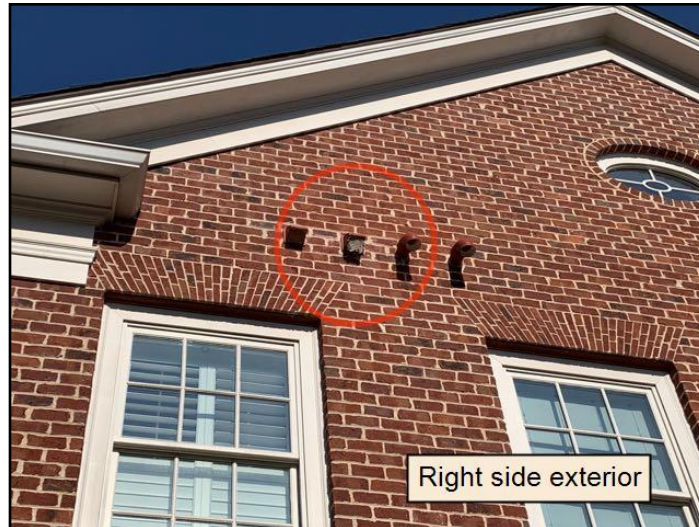
4. Condition: • Screen on dryer vent

14. Screen on dryer vent

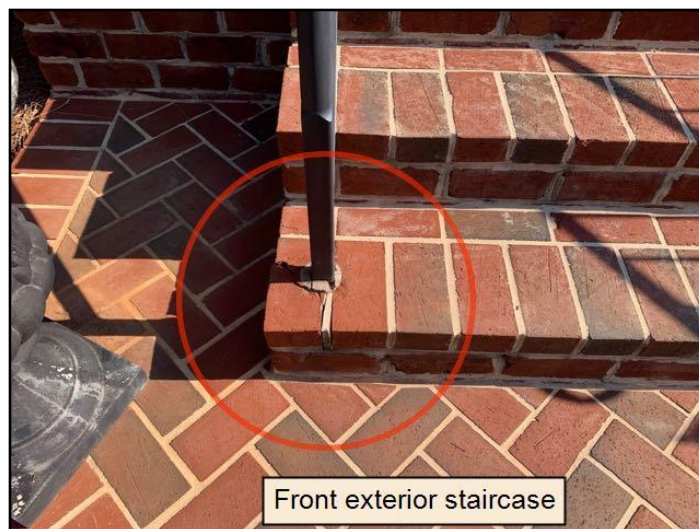
5. Condition: • Masonry or concrete deterioration

15. Masonry or concrete deterioration

Task: Repair As Needed

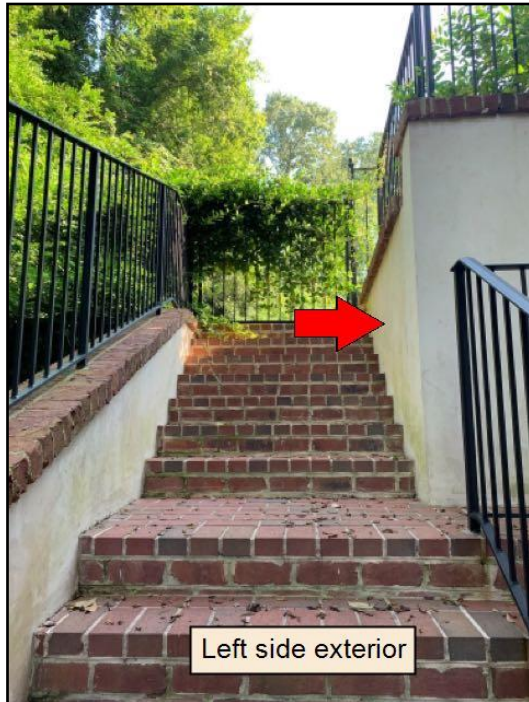
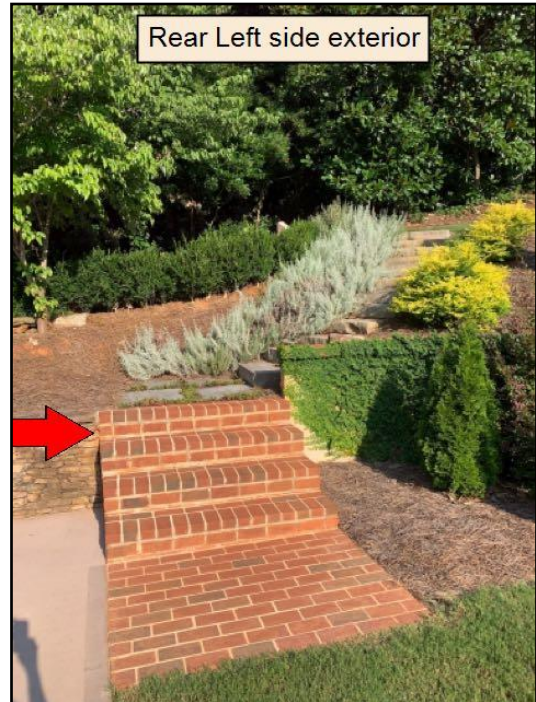
6. Condition: • Graspable Handrail Missing

16. Graspable Handrail Missing

17. Graspable Handrail Missing

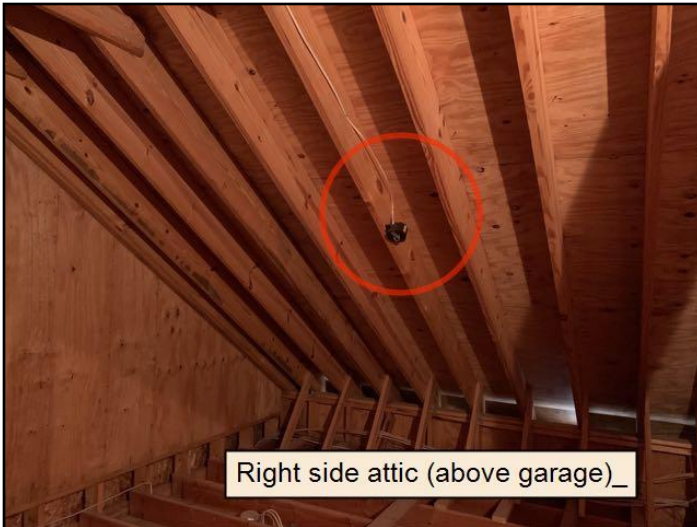
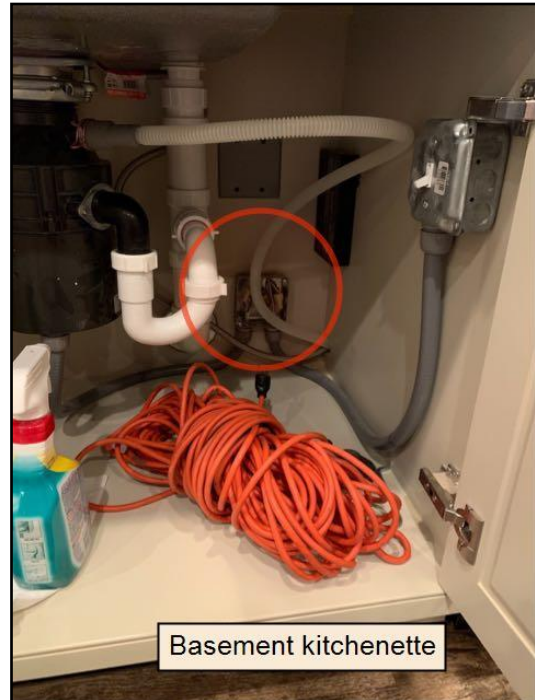
7. Condition: • Cover loose or missing

18. Cover loose or missing

19. Cover loose or missing

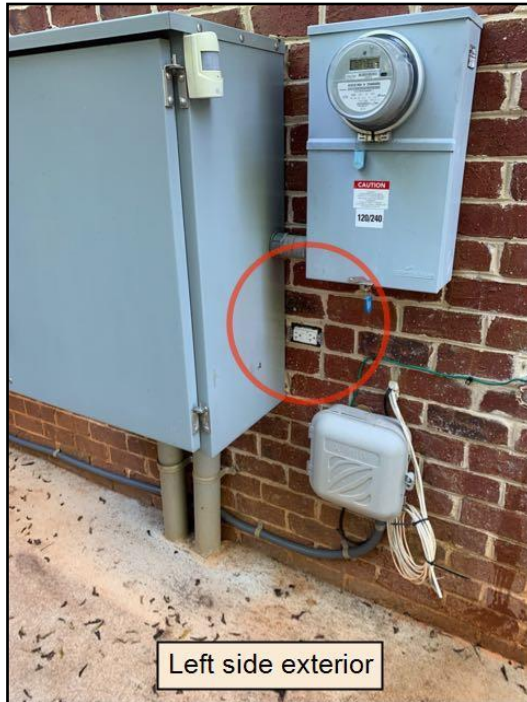
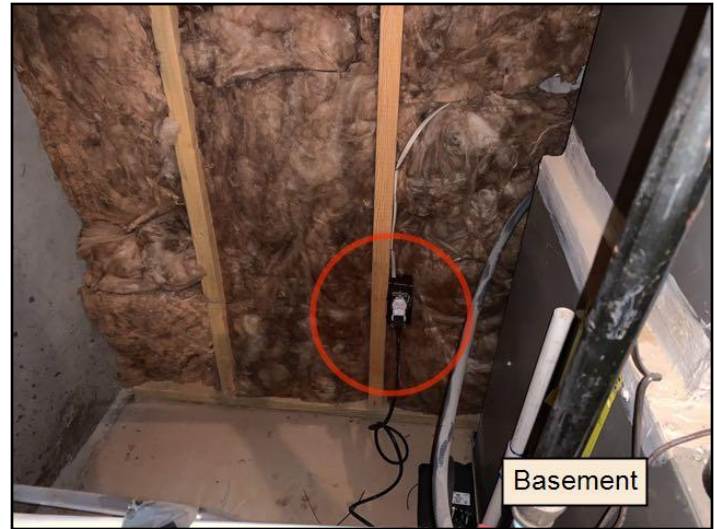
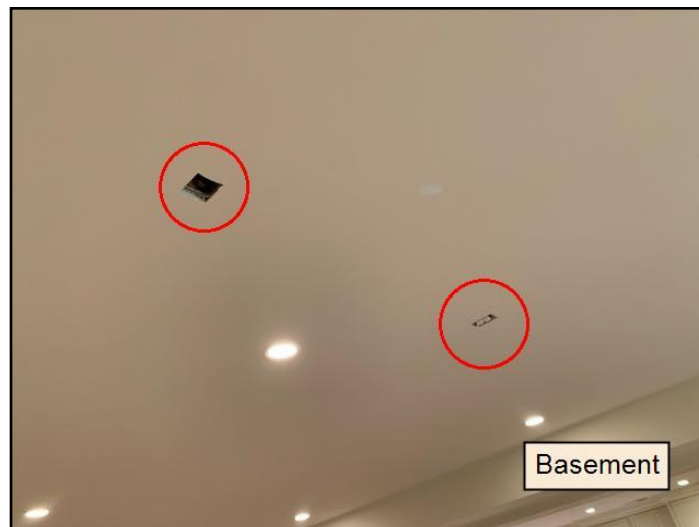
8. Condition: • Loose, missing, broken cover plate

20. Loose, missing, broken cover plate

21. Loose, missing, broken cover plate

22. Loose, missing, broken cover plate

Task: Replace

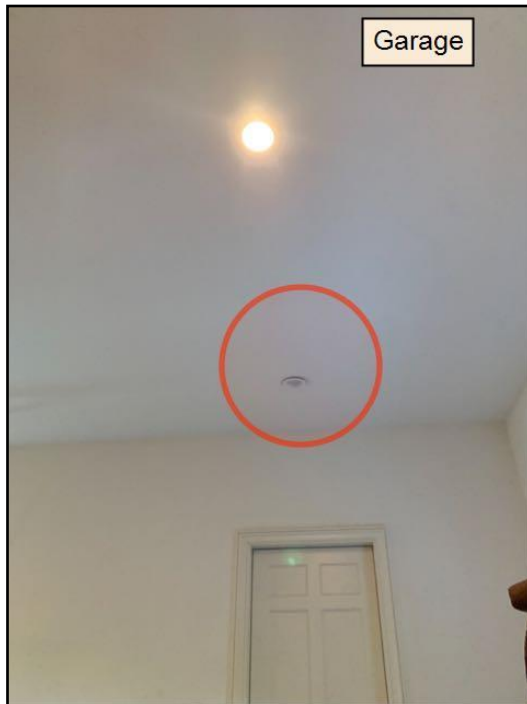
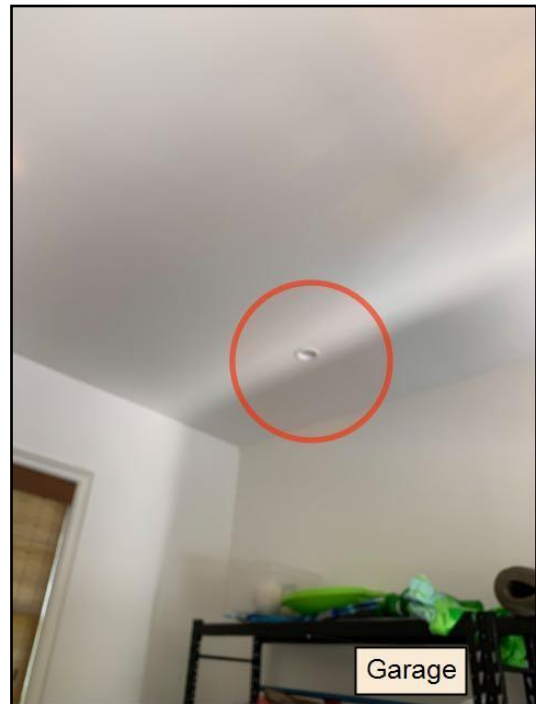
Garage

9. Condition: • Inoperative

This is most likely blown bulbs and recommend confirming operation from the seller.

23. Inoperative

24. Inoperative

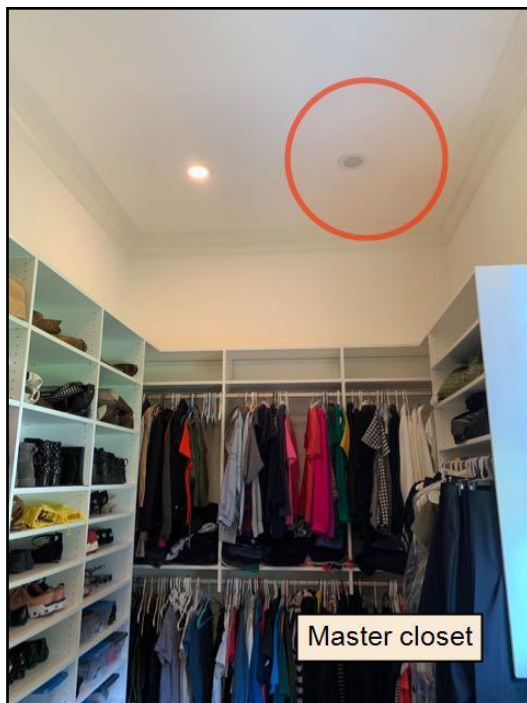
Master closet

25. Inoperative

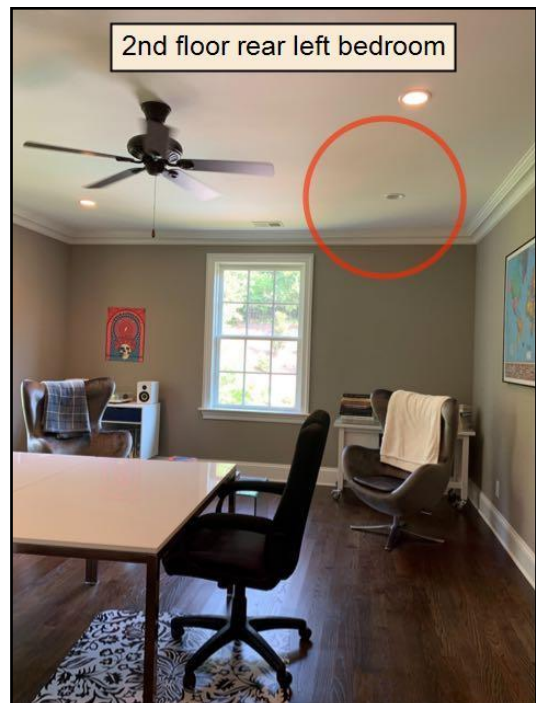
2nd floor rear left bedroom

26. Inoperative

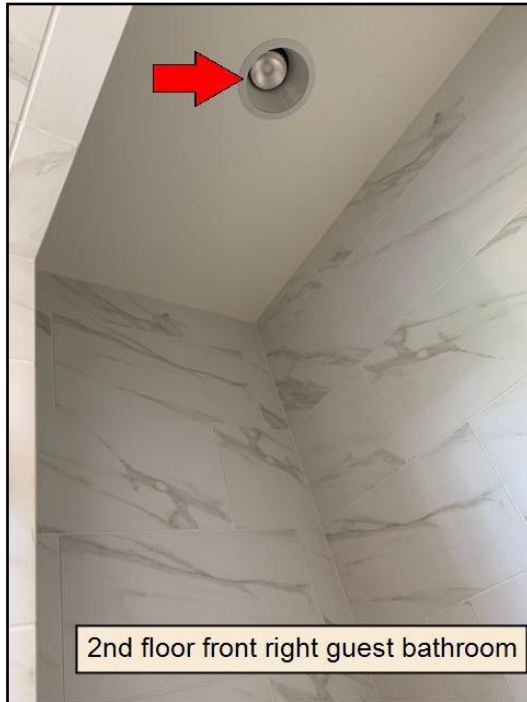
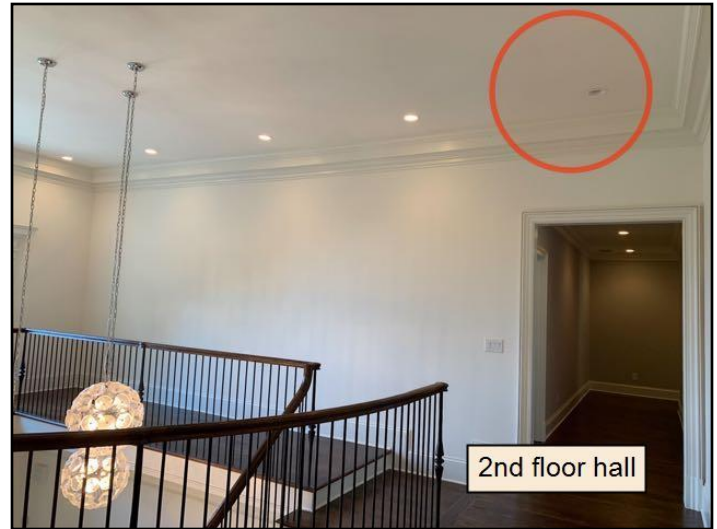
27. Inoperative

28. Inoperative

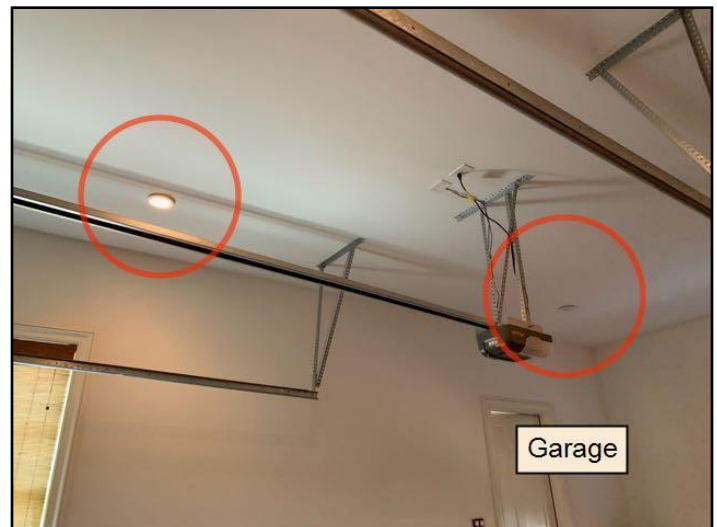
30.

10. Condition: • Loose fixtures

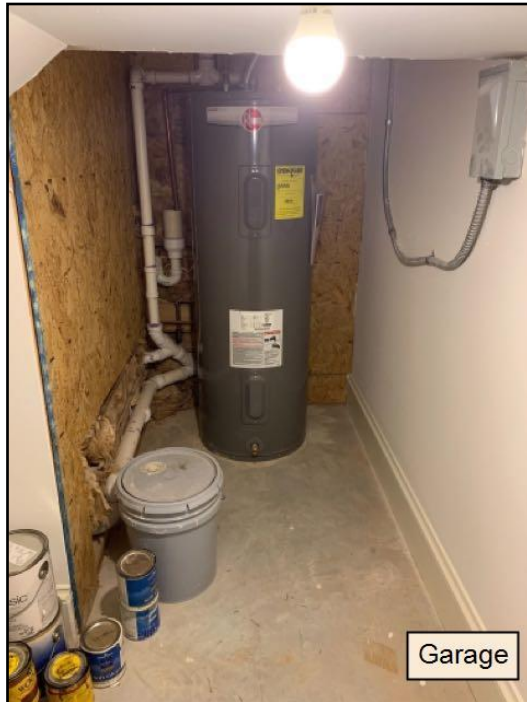
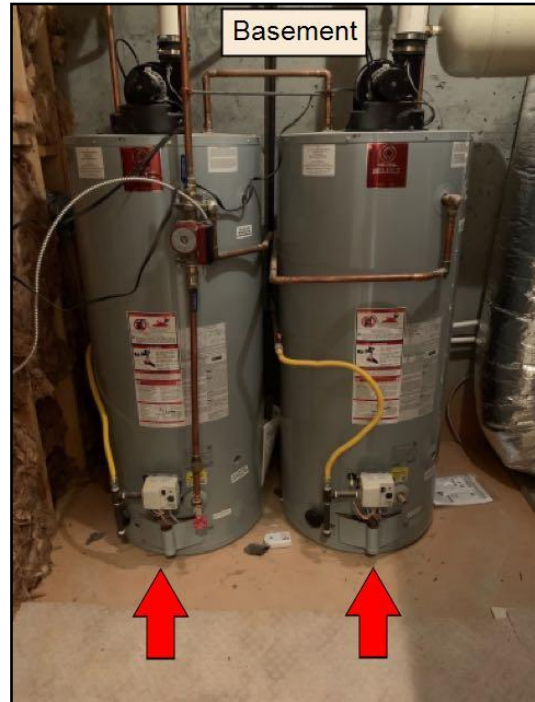
14. Condition: • Drain pan missing

60. Drain pan missing

61. Drain pan missing

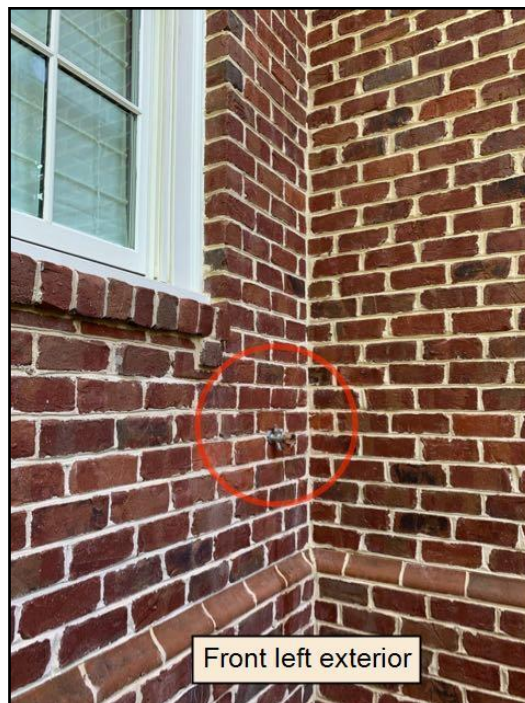
15. Condition: • [Loose](#)

62. Loose

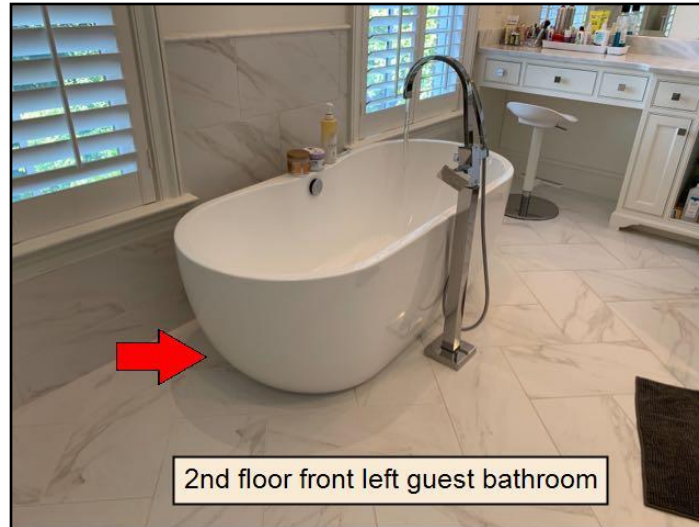
16. Condition: • [Loose or unstable](#)

63. Loose or unstable

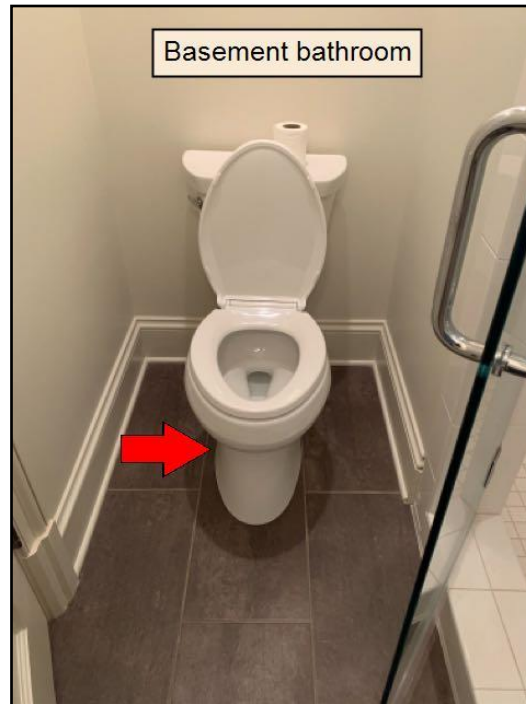
17. Condition: • [Loose](#)

64. Loose
