Property Address: 101 Manor N Dr Alpharetta GA 30004

Residential Inspector of America

General Info

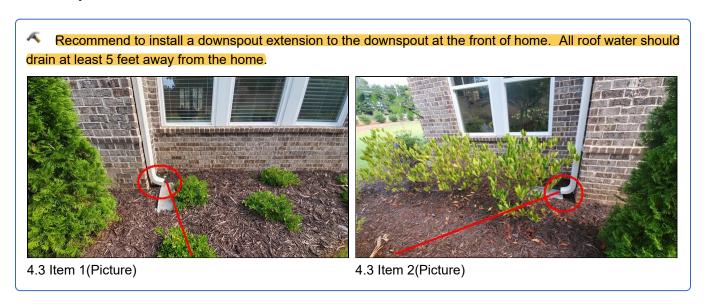
Comments: Inspected, Repair or Replace

Recommend to install a downspout extension to the downspout at the front of home. All roof water should drain at least 5 feet away from the home.
