## Summary Only

### Shamecca Grays

**Property Address:**  
1445 Richards Cir  
Alpharetta GA 30009

**Safe & Sound Home Inspections  
Tyrus Parrish  
P.O. Box 161696  
Atlanta, GA 30321**

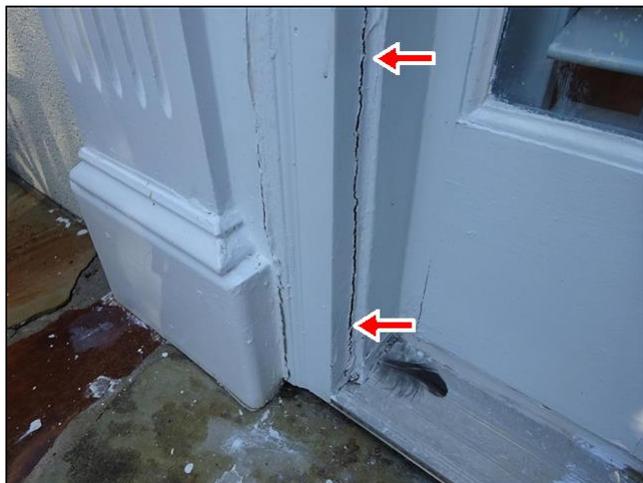
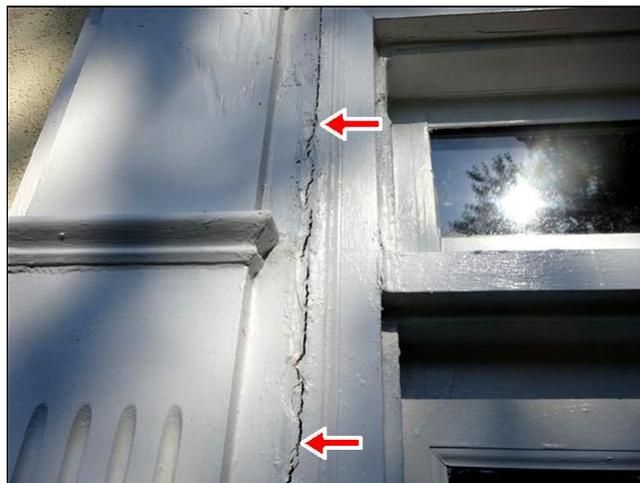
There's loose caulk in the trim around the front door. The trim should be caulked to help prevent any further separation and moisture penetration.

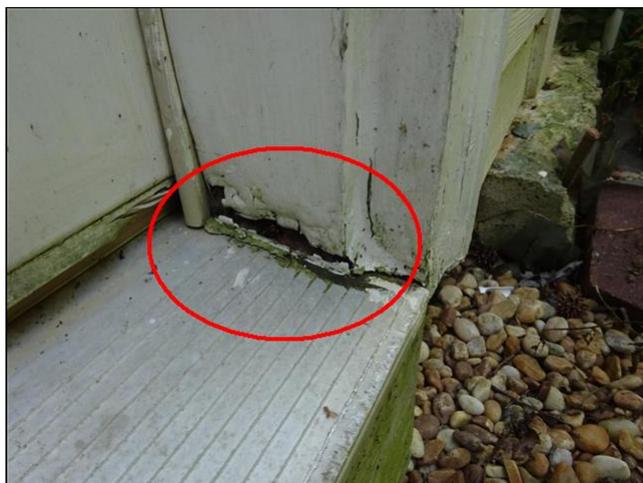
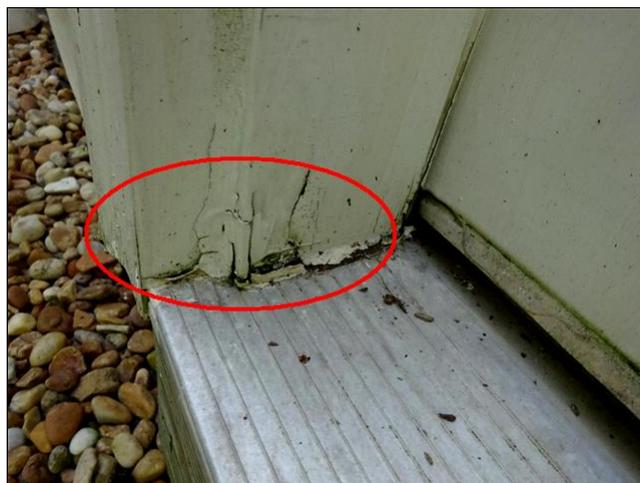
There's rot noted around the bottom of the rear exit door. This should be repaired to prevent moisture penetration and further damage.

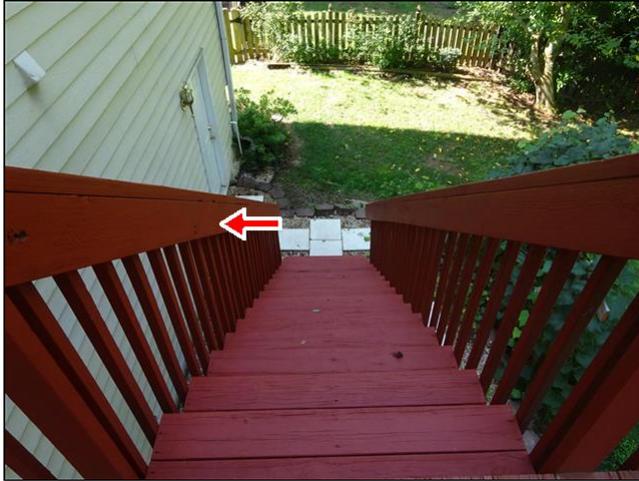
2.3 Item 1(Picture)

(1) The deck does not have graspable handrails installed. Handrails should be installed wherever there are more than 3 steps and/or the landing is more than 30 inches above grade.

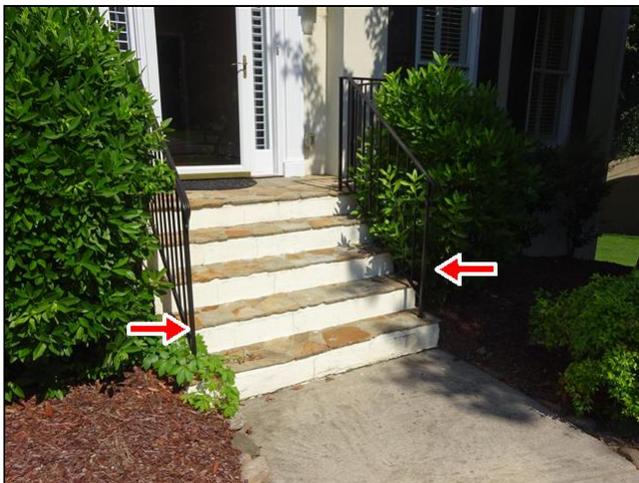
2.3 Item 2(Picture)

(2) The handrails on the front porch are loose. These should be secured to prevent injury to occupants.

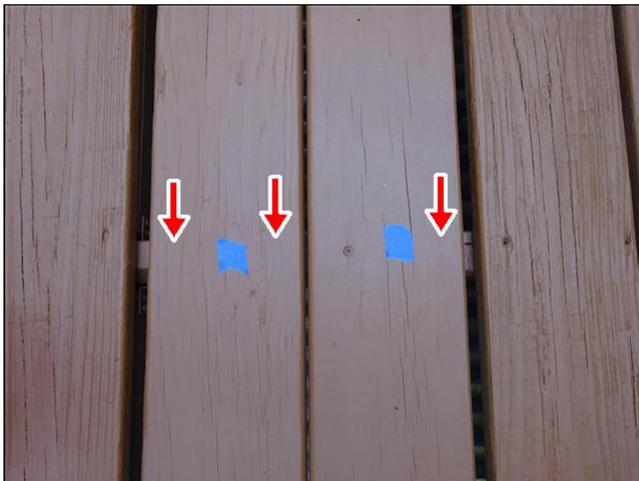
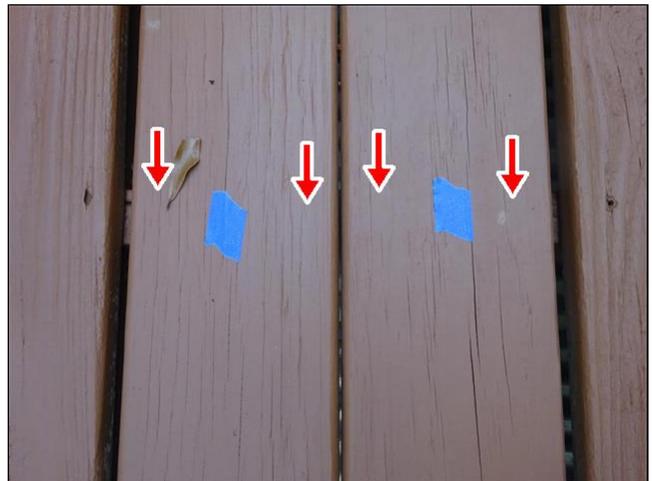
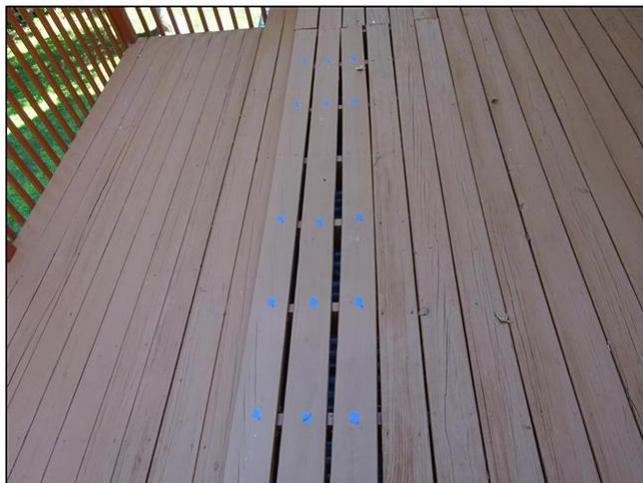
(3) There are 48 missing nails in the deck's floorboards. There should be two nails where each board intersects with a joist below. This helps to prevent cupping and warping.

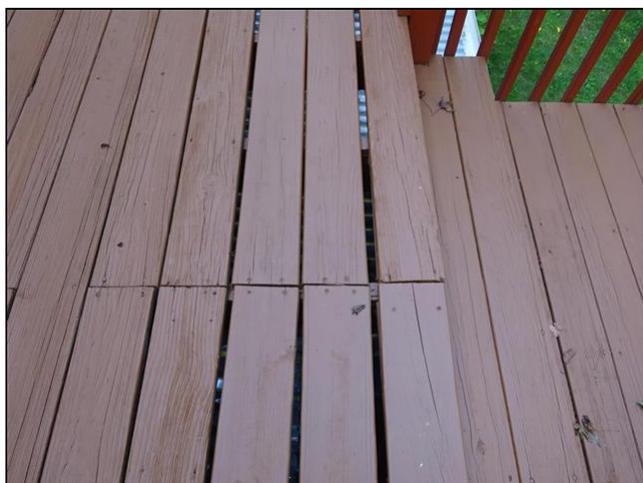
2.3 Item 6(Picture)

(4) There are loose floorboards with wide spacing between them noted on the deck. The boards should be properly secured and not spaced more than 1/4 inch apart to help prevent injury to occupants.

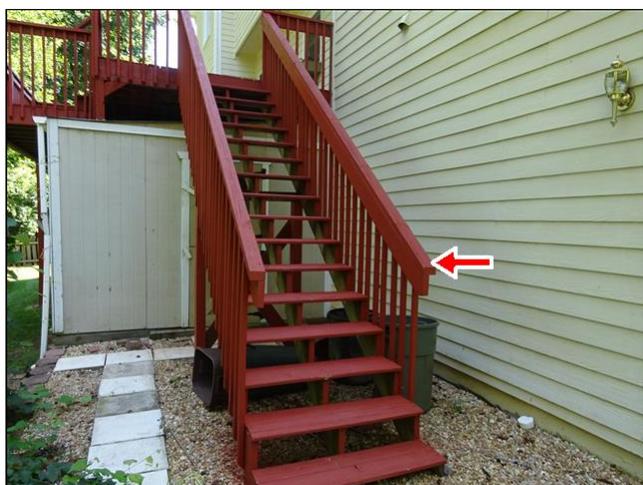
2.3 Item 7(Picture)

(5) The deck stairs are loose and need to be repaired to help keep them from swaying side to side when weight is applied.

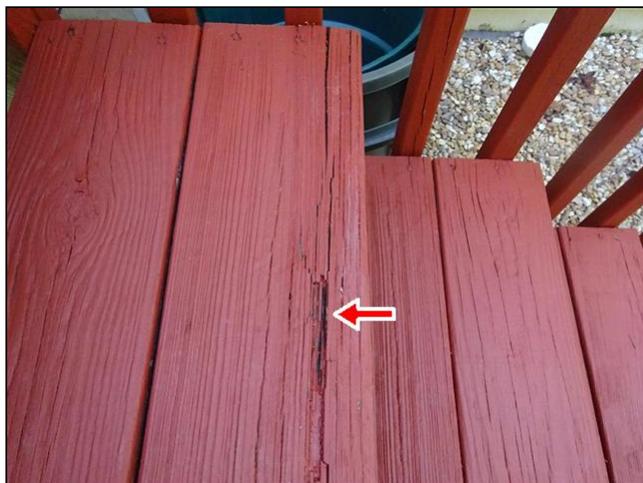
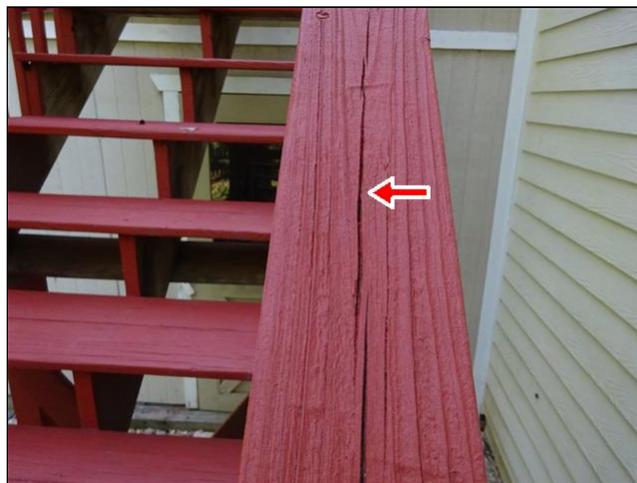
(6) The floorboards and railings are splitting. This is the result of age and weathering. Repairs and replacements should be made to maintain the integrity of the deck.

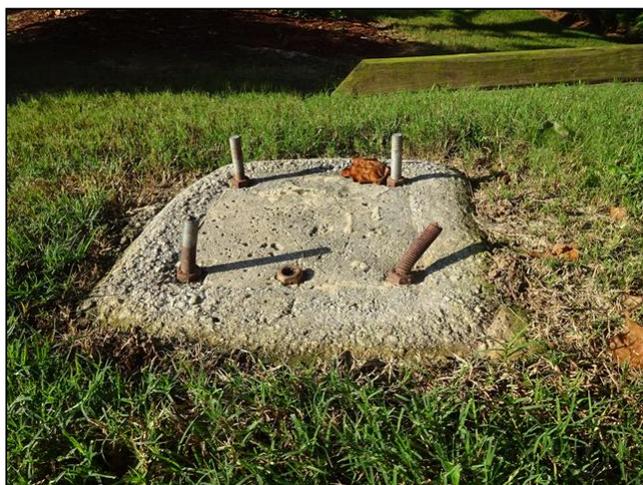
2.4 Item 1(Picture)

(1) There's a concrete pad on the left side of the driveway that has large bolts protruding from it. The bolts should be cut off or removed to eliminate the present safety hazard.

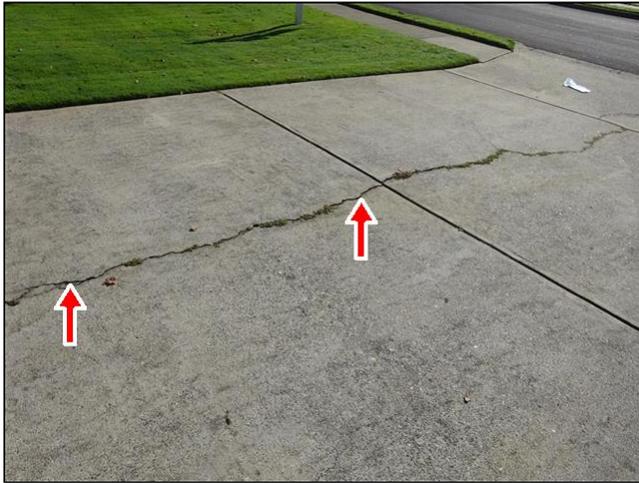
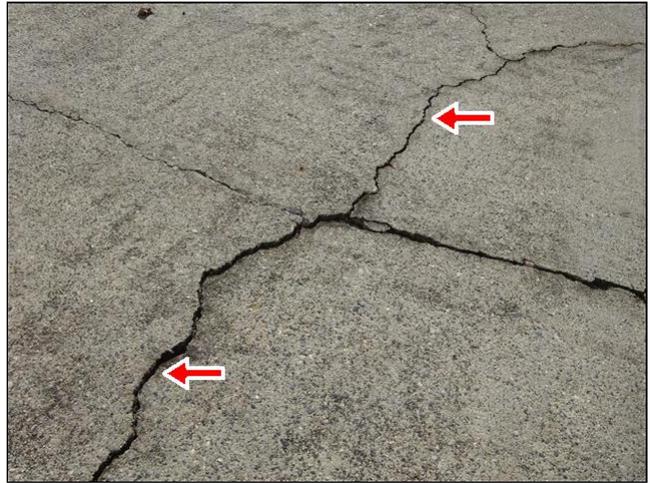
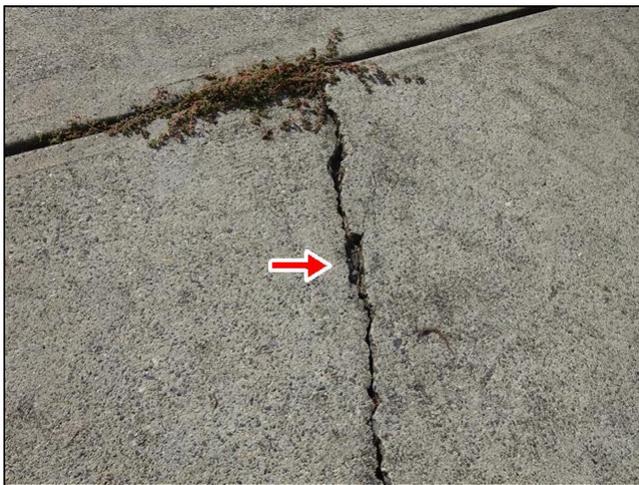
(2) The driveway has wide cracks and shifted sections. Repairs should be made to remove the current trip hazards and help prevent any erosion issues below the slab.

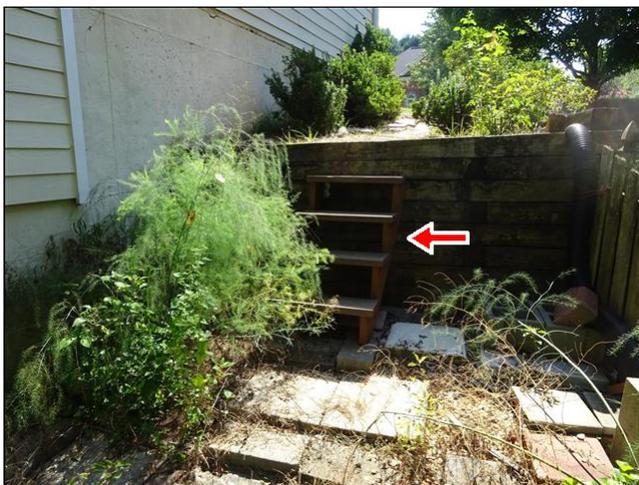
2.4 Item 5(Picture)

(3) The stairs in the left yard do not have a graspable handrail installed. All steps (interior and exterior) that are three steps or more require a handrail to allow safe access up and down the stairs.

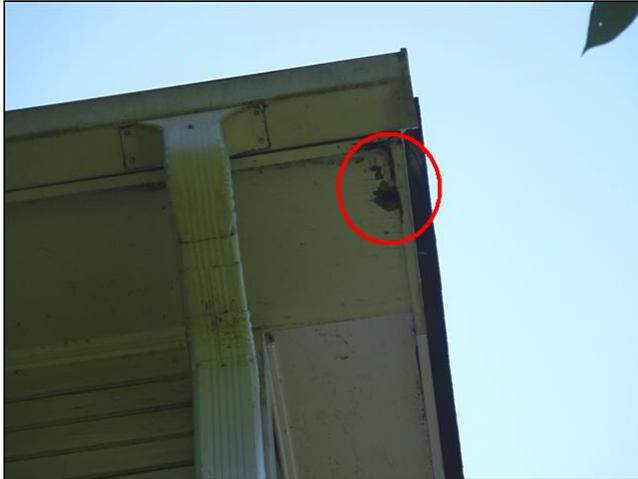
There are holes and rot in the soffits on the rear left corner and front side of home. These areas should be repaired to help prevent any further damage.

2.5 Item 1(Picture) Rear left corner

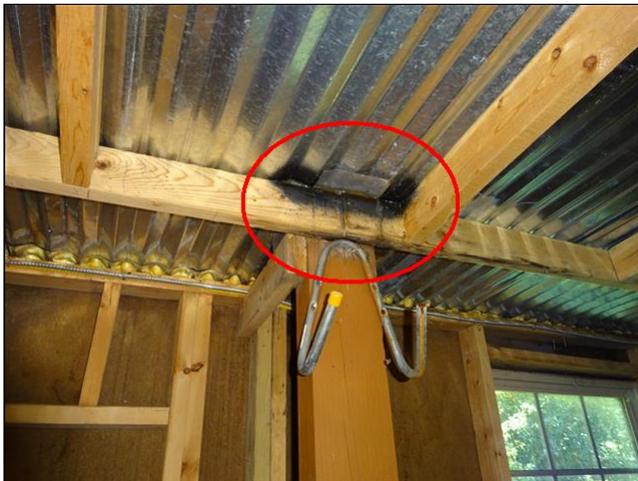
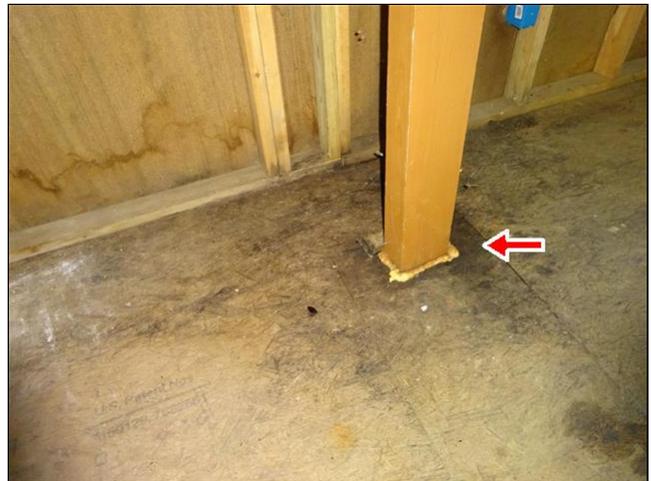
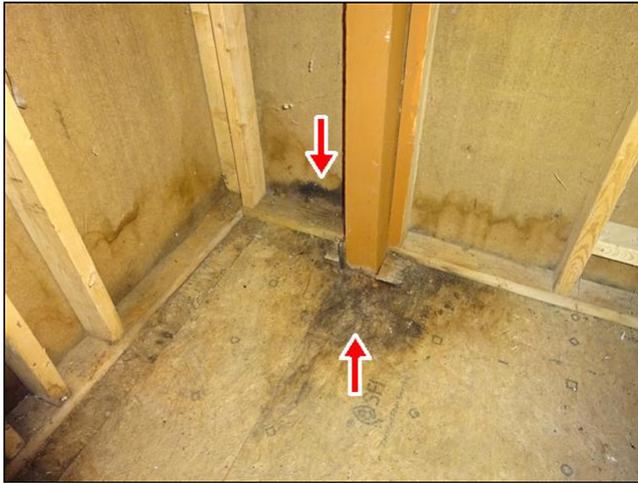
(1) There are water stains on the floor and ceiling along the posts in the workshop. The posts should be sealed to help keep water from seeping in from the deck.

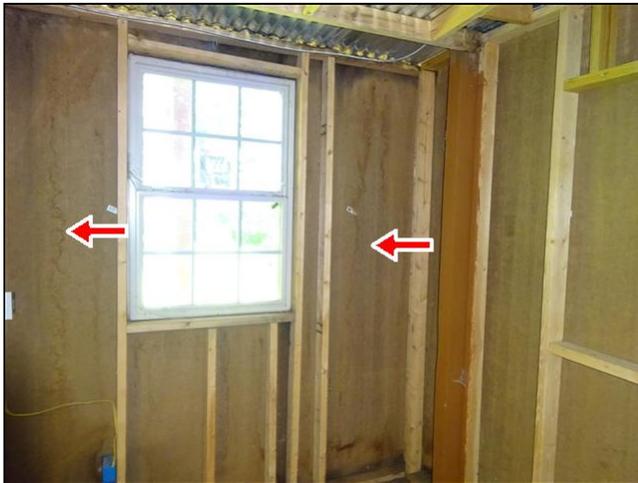
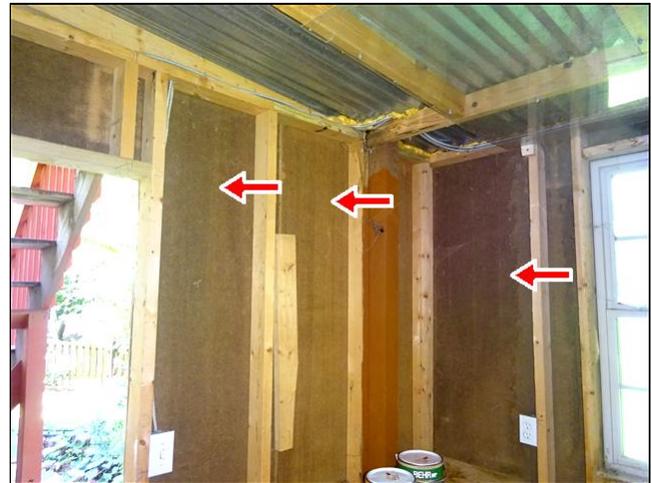
(2) Some of the studs in the workshop's walls are spaced too far apart. The studs should not be more than 24 inches apart to help support the framing above.

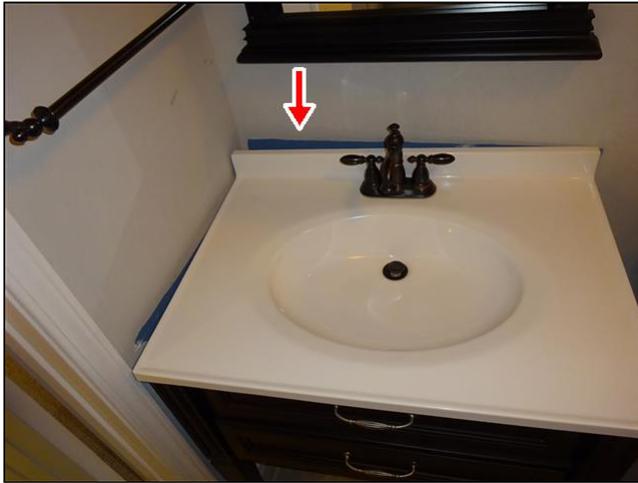
4.4 Item 1(Picture)

(1) The counter/sink in the basement bathroom is loose and needs to be properly secured to prevent damage to the plumbing below.

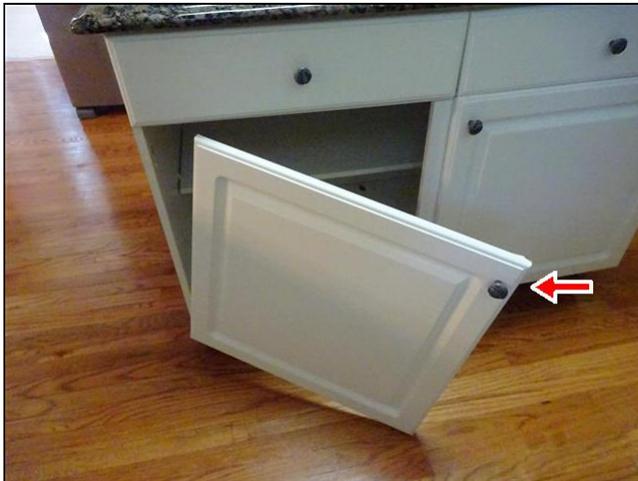
(2) The cabinet door(s) in the following location(s) is/are loose and need to be properly secured to help prevent injury to occupants: kitchen island, right side of the kitchen sink and upper cabinet next to laundry room door.

4.4 Item 2(Picture) Kitchen island

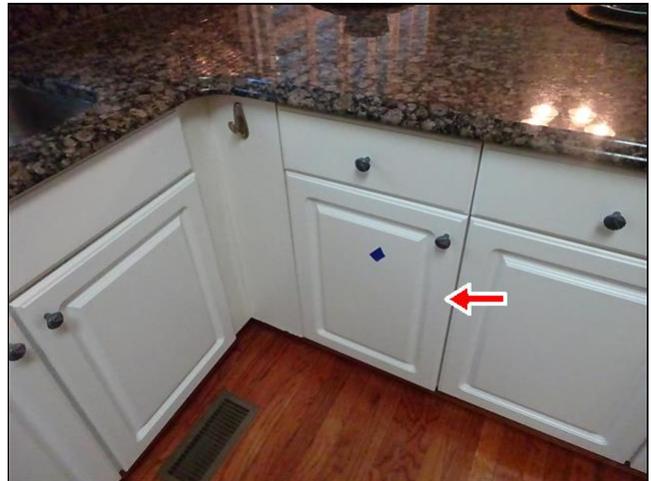
4.4 Item 3(Picture) Right side of kitchen sink

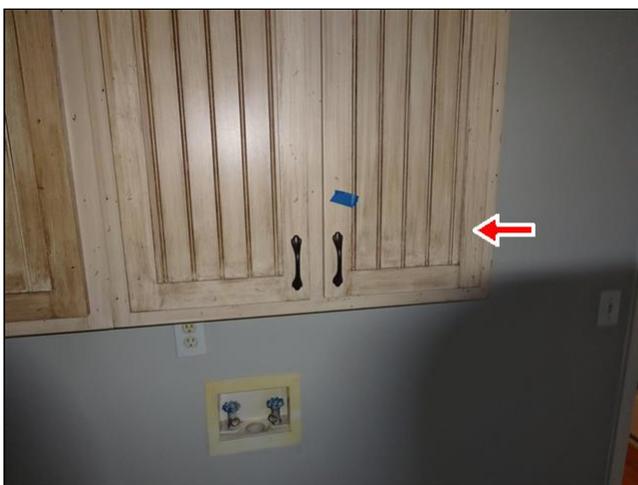
4.4 Item 4(Picture) Laundry room

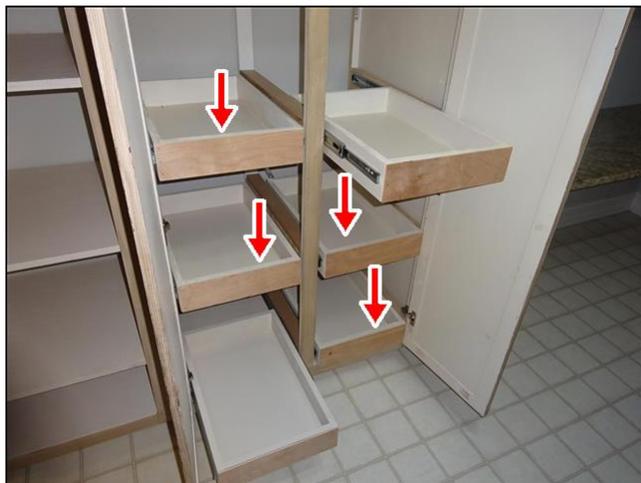
4.4 Item 5(Picture)

(3) Four of the drawers in the laundry room's cabinet can't be pulled out. The drawers hit against the cabinet doors. Repairs should be made to allow the drawers to function as designed.

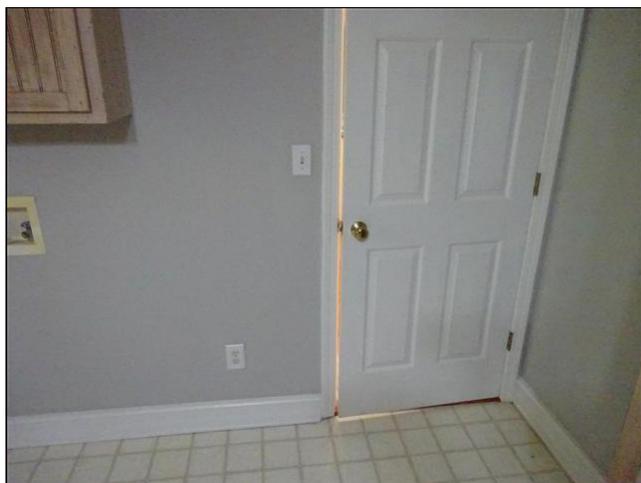
4.5 Item 1(Picture) Laundry room

(1) The door(s) in the following location(s) are not latching: laundry room, master closet, and master bedroom. Repairs should be made to allow the door(s) to be properly secured.

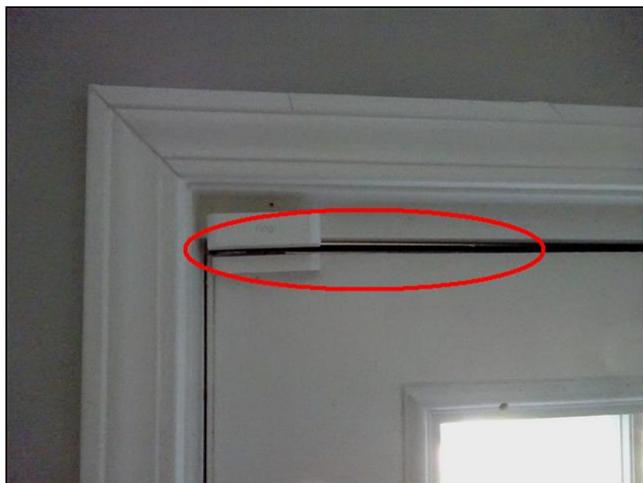
4.5 Item 4(Picture)

(2) There's an air gap around the basement exterior door. The door(s) should be sealed to help prevent energy loss and pest infestation.

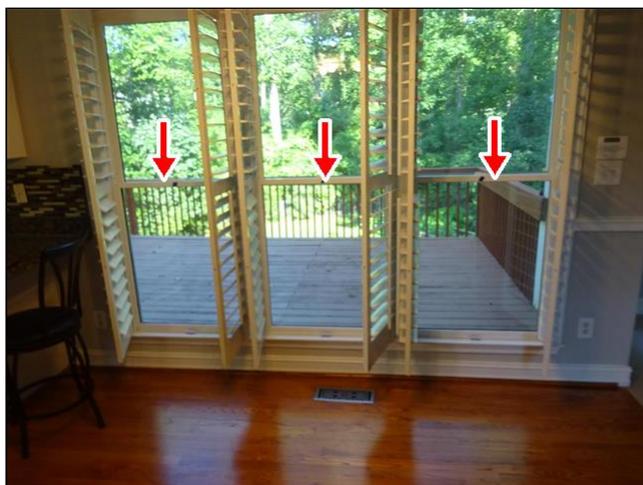
4.6 Item 1(Picture)

(1) The windows in the following locations are stuck shut: breakfast area. The windows should be pried free to allow safe operation. Wooden windows should be opened periodically to prevent them from swelling shut. This is especially true in the bedrooms, where an emergency exit might be required.

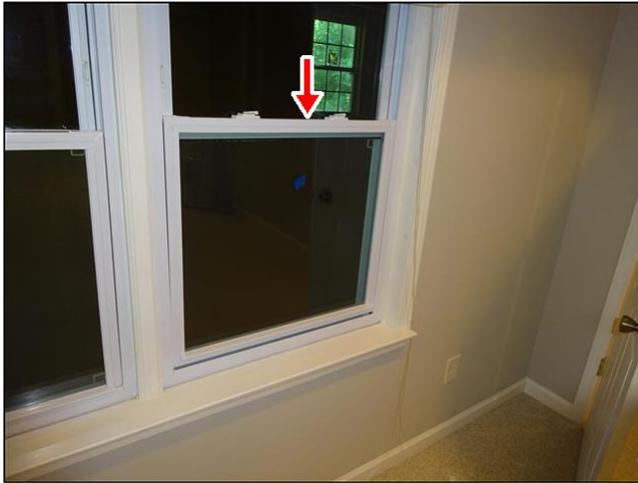
4.6 Item 2(Picture)

(2) The window(s) in the following location(s) has/have faulty lift system(s), which causes them to drop/slam down when opened: basement window facing workshop. The window(s) should be repaired to allow safe operation and help prevent injury to occupants.

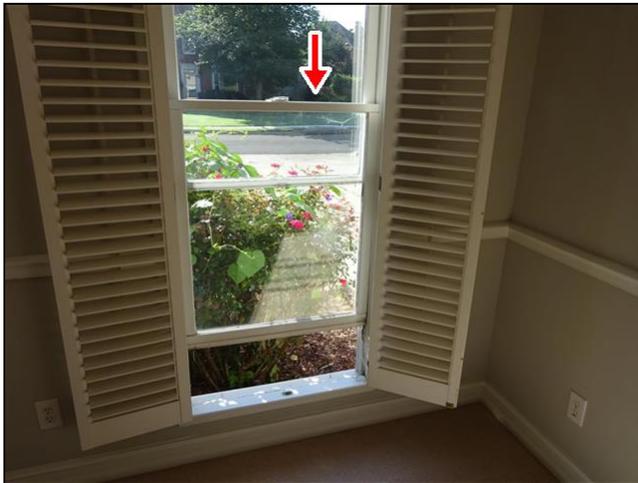
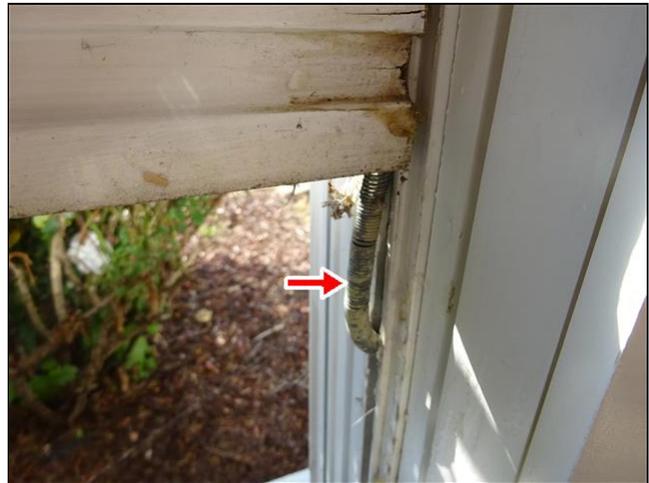
(3) The spring in the side of the right dining room window is separating. The spring should be replaced to allow the window to open and close as designed.

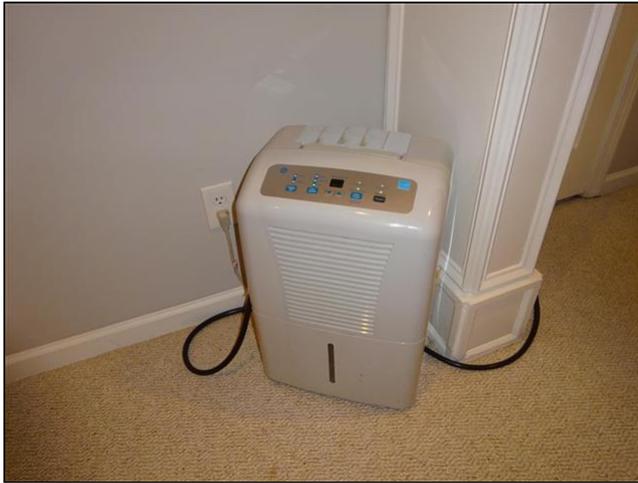
There's moisture noted in the front basement wall and floor. A dehumidifier is installed in this room to help keep the moisture in the air below 50%. The source of the moisture could not be determined since the front wall is finished. The only way to determine if this is a plumbing or foundation issue is to cut open the wall to see where the moisture is coming from. Once this is done, a plumber or foundation specialist should be contacted to further evaluate the issue and make the necessary repairs.

5.0 Item 1(Picture) Dehumidifier

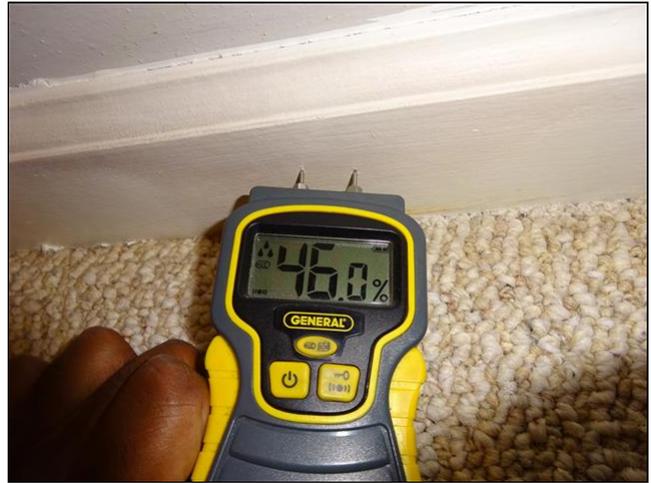
5.0 Item 2(Picture) Moisture in baseboard

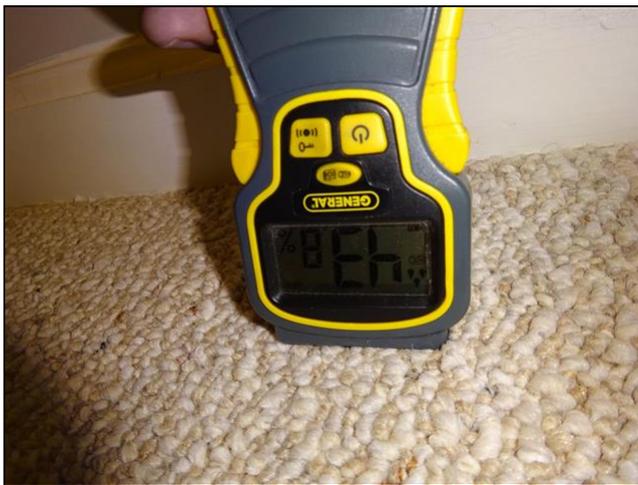
5.0 Item 3(Picture) Moisture in floor

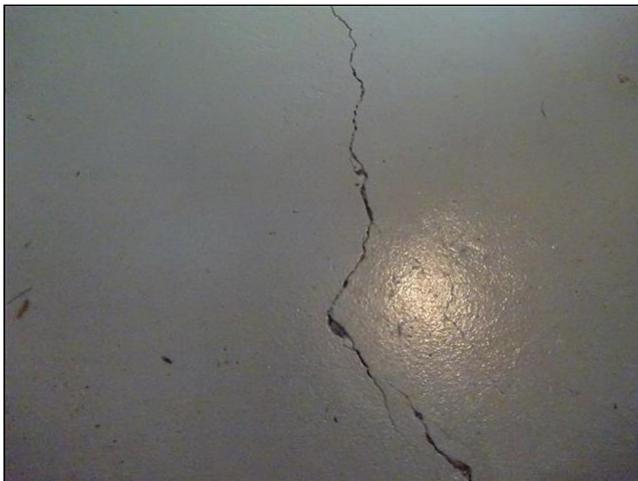
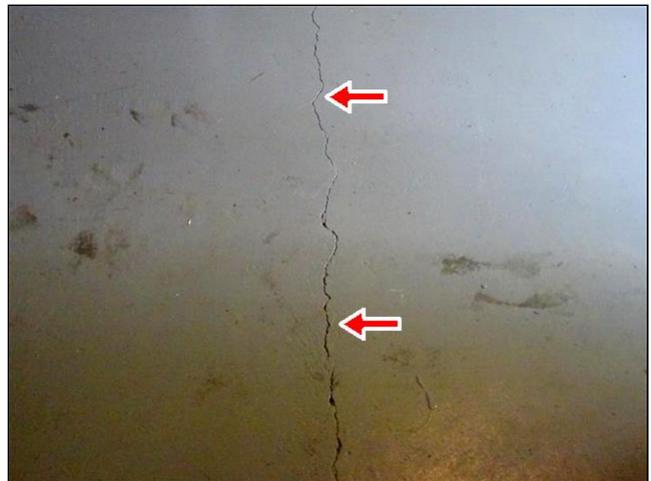
There are cracks noted in the basement floor, which are normal for the age of the home. However, these areas should be monitored for any spreading. If spreading is noted, then a foundation specialist should be contacted to make any necessary repairs.

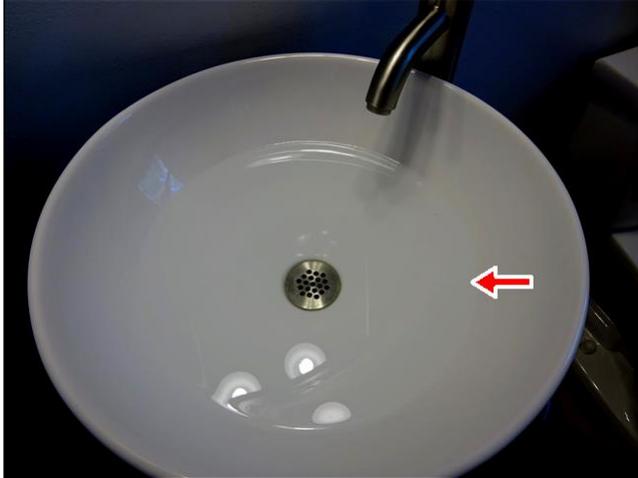
6.0 Item 1(Picture)

(1) The drains in the following location(s) are clogged: powder room. Repairs should be made to allow proper drainage of water.

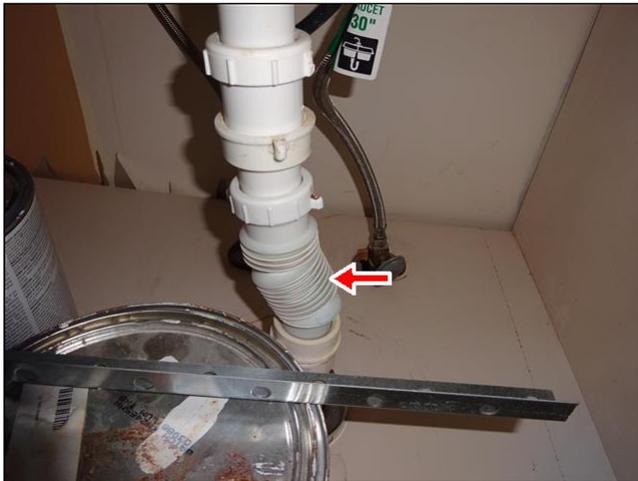
6.0 Item 2(Picture)

(2) There's an accordion style drain pipe below the laundry room's sink. This is not the approved material for drain pipe and should be replaced with the appropriate piping.

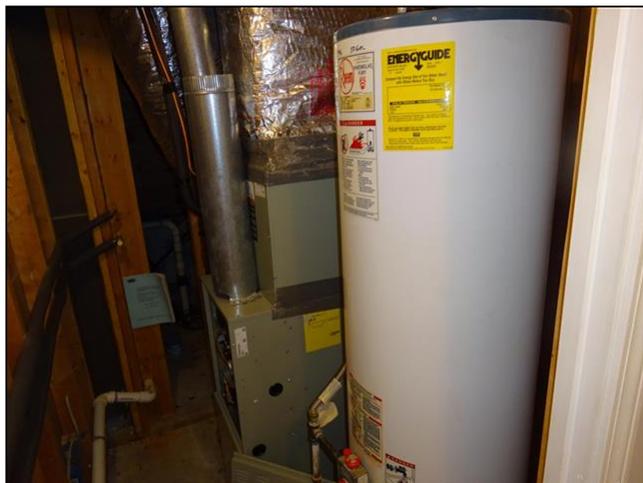
6.1 Item 1(Picture)

(1) The water heater is working fine at the time of inspection but has exceeded its service life. The service life for water heaters is 8-12 years. The client should budget for replacement in the near future.

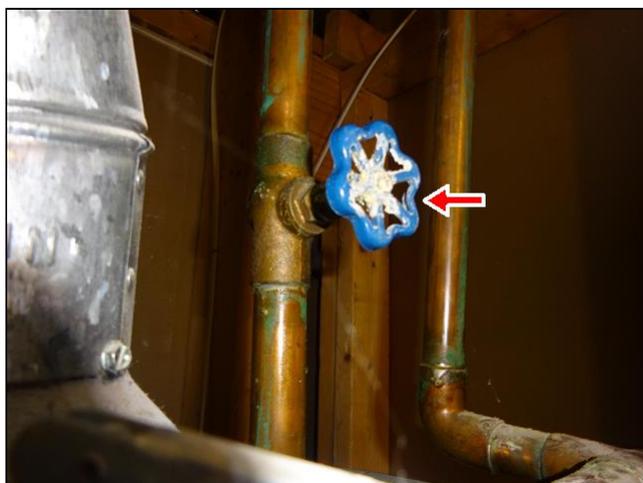
6.1 Item 2(Picture)

(2) The water heater's cold water shut off valve is rusting and leaking. The valve and other affected connections should be further evaluated and repaired as needed to prevent any further damage.

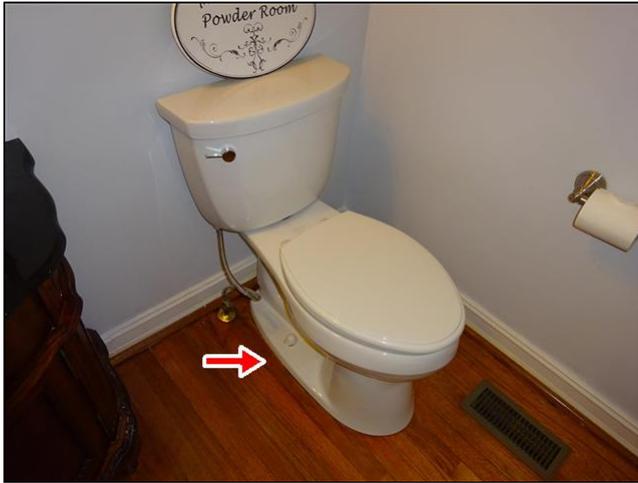
6.2 Item 1(Picture)

(1) The toilet in the powder room has a loose base. This should be repaired to keep the seal from breaking, which could lead to water leaks.

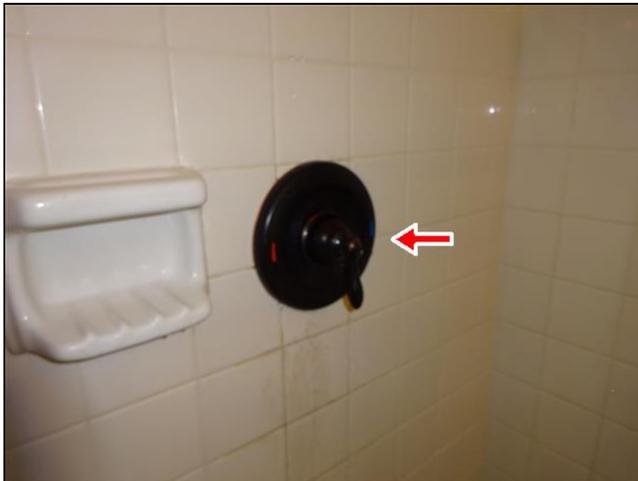
6.2 Item 2(Picture)

(2) The temperature knob in the master shower is free spinning. Which makes it difficult to determine where the "off" setting is. This should be repaired to prevent water waste and high utility bills.

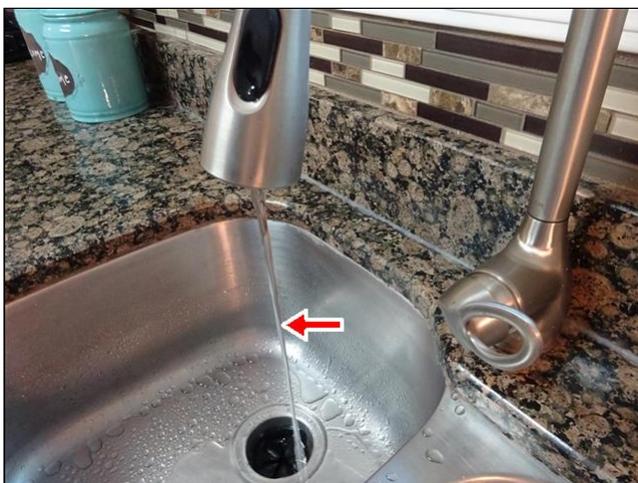
6.2 Item 3(Picture)

(3) There's low water pressure noted throughout the home. The Pressure Regulator Valve (PRV) should be adjusted. If the valve does not correct the problem when adjusted, then the plumbing system should be further evaluated by a licensed plumber and the proper repair or replacement procedures should take place to allow proper functionality.

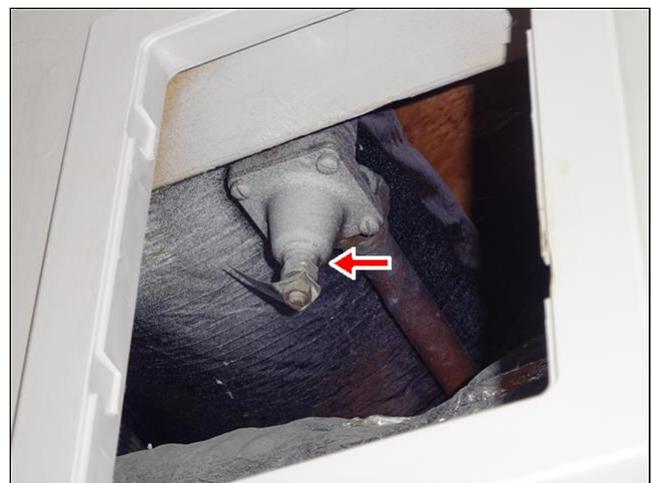
6.2 Item 4(Picture) Pressure regulator valve

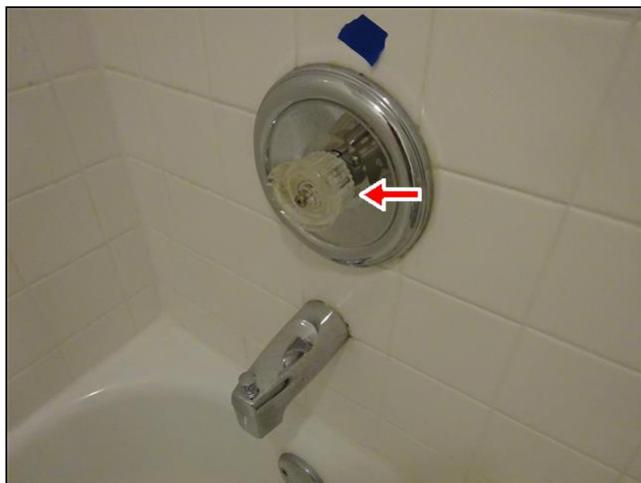
6.2 Item 5(Picture)

(4) The knob in the upper level hall bathroom's shower is loose and not turning on the water. The knob should be repaired to allow proper functionality.

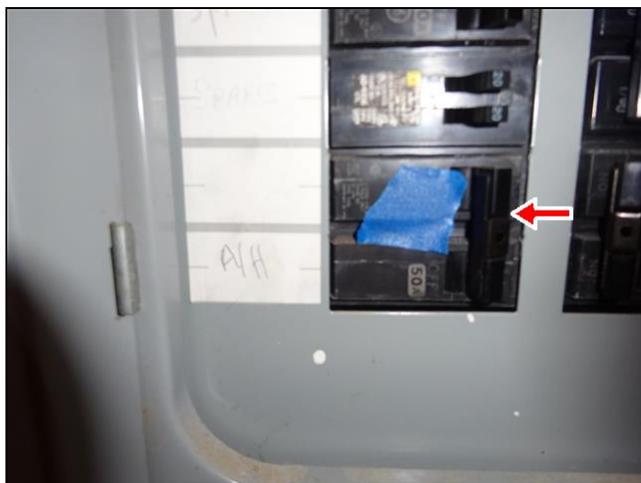
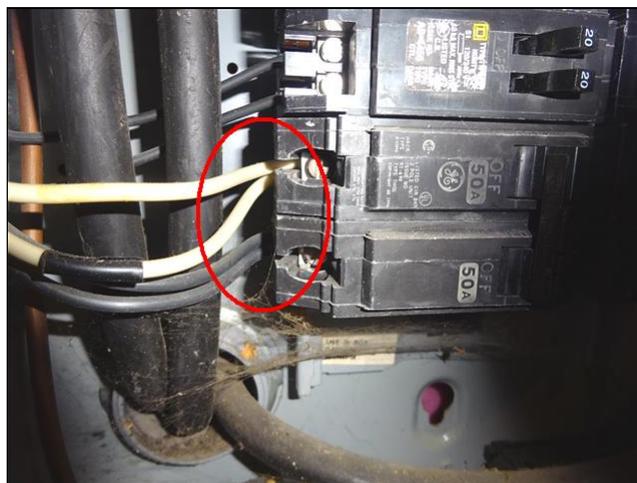
There's a double tapped breaker in the main panel box. Each circuit should be on its own breaker to prevent overloading.

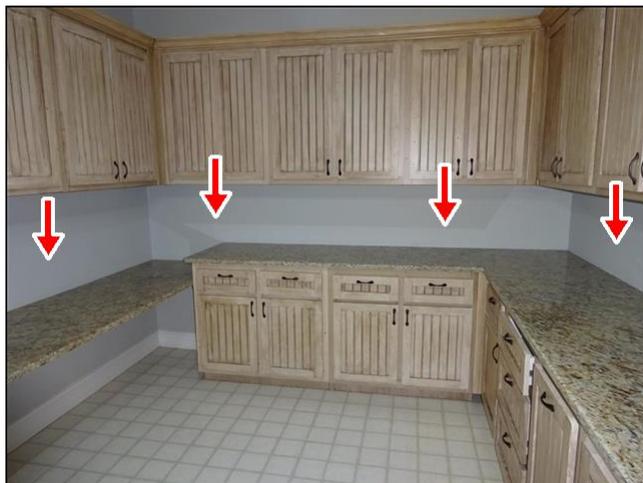
7.3 Item 1(Picture)

(1) There are missing outlets along the laundry room counter(s). There should not be more than 4 feet between outlets along a solid wall and all counters wider than 2 feet should have an outlet installed to allow safe connection of small appliances. All countertop outlets should be GFCI protected.

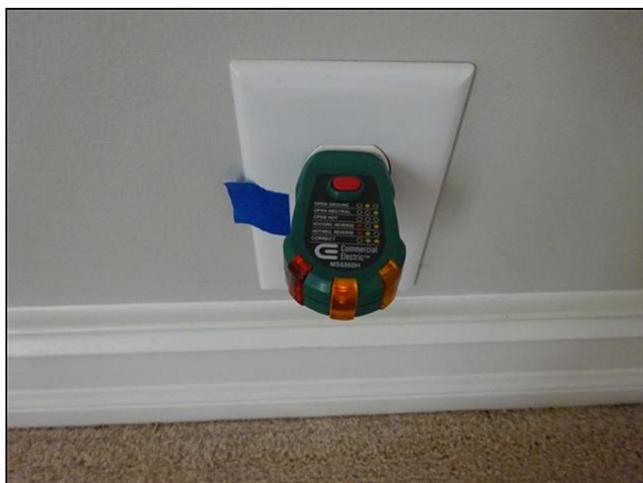
7.3 Item 2(Picture)

(2) The outlets in the following locations have their hot and neutral wires reversed: dining room on wall adjacent to garage. This should be properly wired to prevent damage to appliances and injury to occupants.

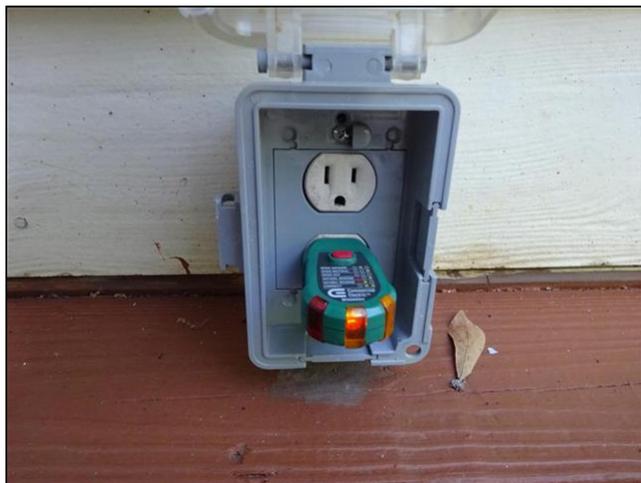
7.5 Item 1(Picture)

(1) The exterior GFCI outlets are not tripping off when tested. The outlets should be repaired or replaced to allow proper functionality.

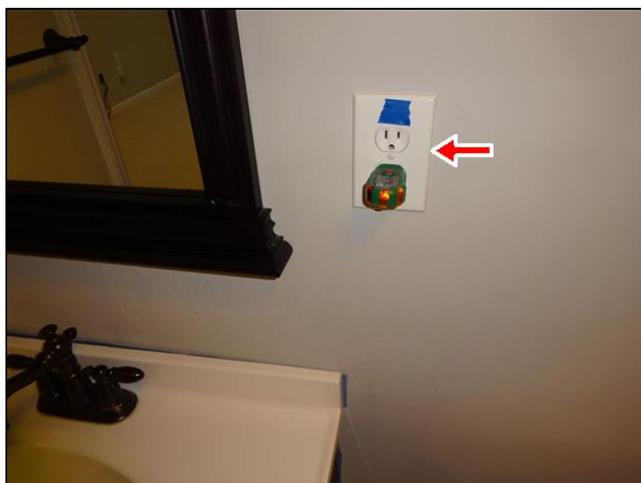
7.5 Item 2(Picture)

(2) The outlet next to the basement bathroom sink is not GFCI protected. All outlets within 30 inches of a wet location are required to be GFCI protected to help prevent any damage to the circuit or injury to occupants.

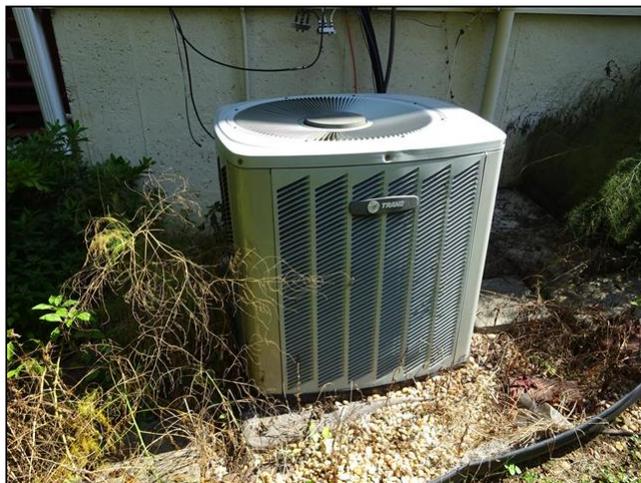
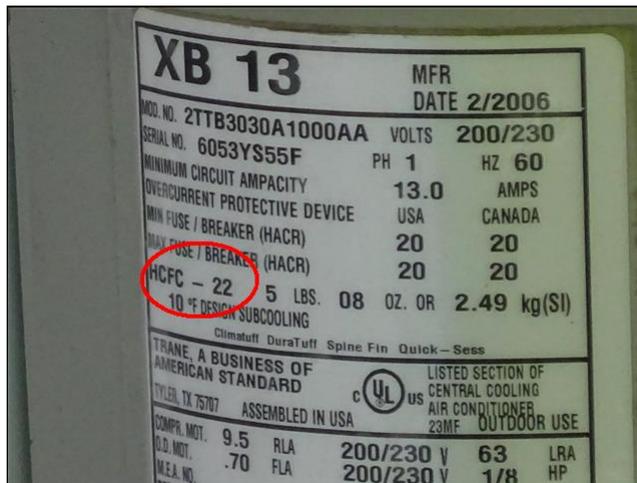
(1) One of the HVAC systems is currently using R22 refrigerant which was phased out as of January 2020. This will make it impossible or expensive to repair some units after this time. Some units can be modified to the new R410a refrigerant while others will need to be replaced if they run into refrigerant issues. This is being mentioned so that the buyer can search out home warranties that will cover R22 appliance replacements or repairs.

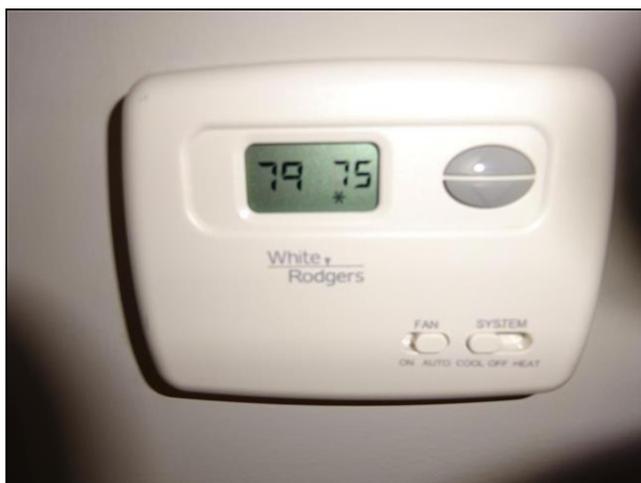
8.8 Item 3(Picture)

(2) The air conditioner did operate but failed to produce air cold enough to provide the proper temperature drop. The thermostat was set to 75 degrees for over an hour and the ambient temperature only dropped to around 79 degrees after the unit has been operating for all of this time. The HVAC system should be further evaluated and repaired as needed by a licensed HVAC technician.

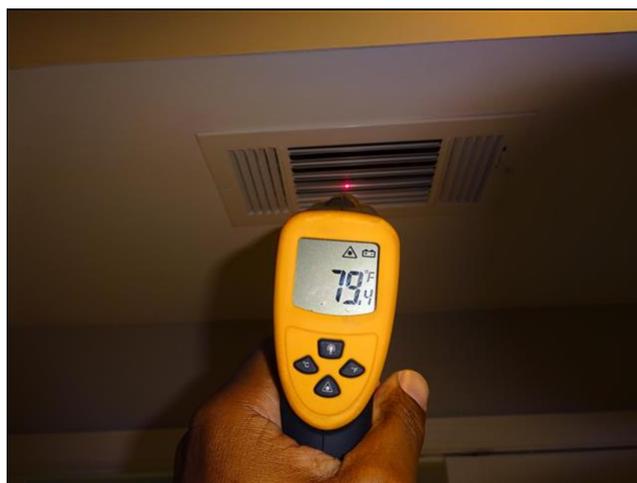
8.8 Item 4(Picture) Temperature of air coming out of the vents

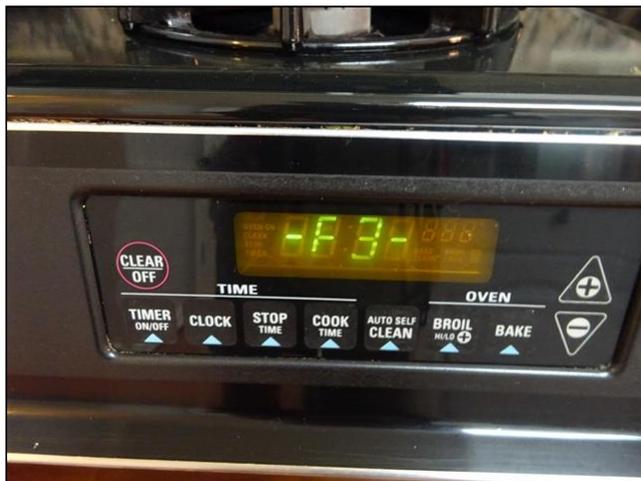
10.1 Item 1(Picture)

The oven is not coming on when tested. An error of F3 pops up on the display when attempting to use the oven. The appliance should be further evaluated and repaired as needed by a licensed appliance technician.
