Defective Summary

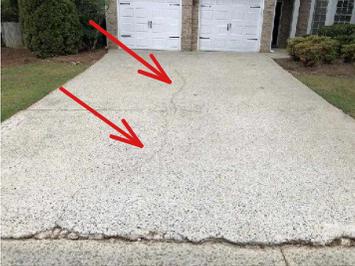
1. Driveway: Concrete - Cracks present. A qualified contractor is recommended to evaluate and estimate repairs.

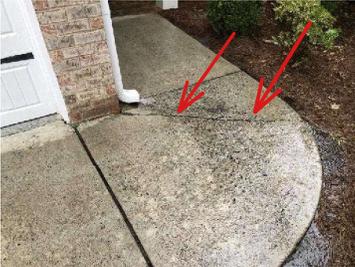
2. Walks: Concrete - Cracks present. A qualified contractor is recommended to evaluate and estimate repairs.

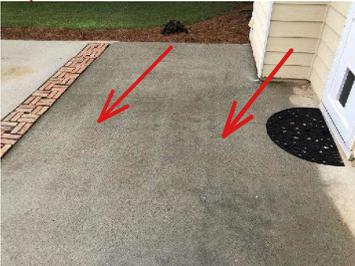
3. Patio: Concrete - Hairline crack present. A qualified contractor is recommended to evaluate and estimate repairs.

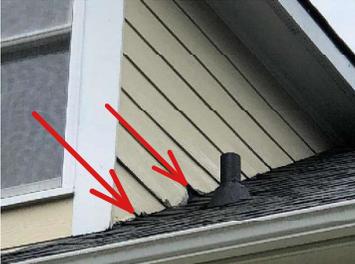
4. North Exterior Surface Type: Brick and siding - Damaged siding. A qualified contractor is recommended to evaluate and estimate repairs.

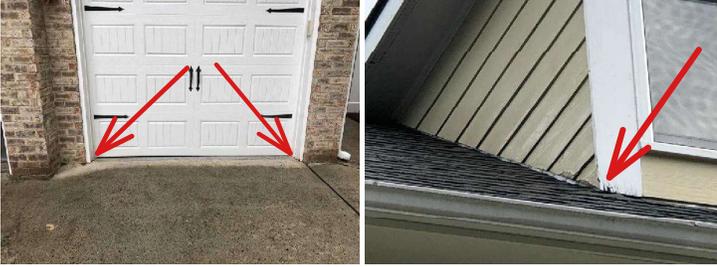
5. Trim: Wood - Wood rot present. A qualified contractor is recommended to evaluate and estimate repairs

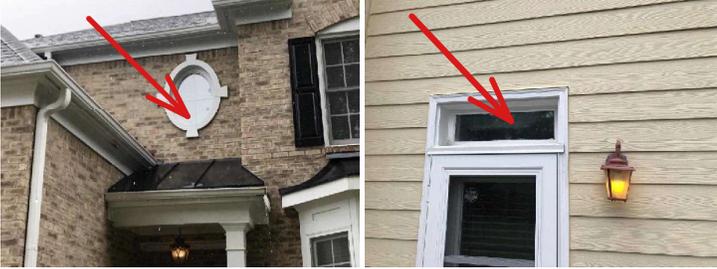
6. Windows: Wood double hung and casement - Wood rot present. Fogging present between the layers of glass. A qualified contractor is recommended to evaluate and estimate repairs.

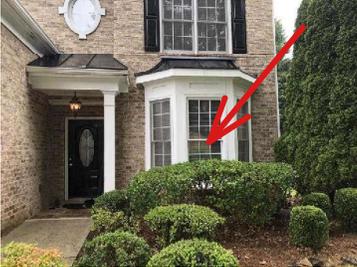
7. Window Screens: Vinyl mesh - Missing screen in front. Recommend screen be installed.

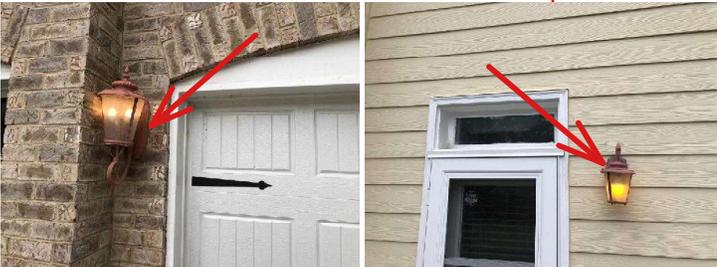
8. Exterior Lighting: Surface mount - Missing caulking around light fixtures. A qualified contractor is recommended to evaluate and estimate repairs.

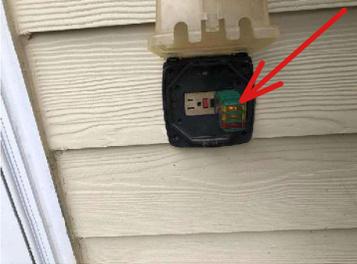
Exterior Electric Outlets: (continued)

9. Exterior Electric Outlets: 120 VAC GFCI - Open or missing ground present. A qualified contractor is recommended to evaluate and estimate repairs.

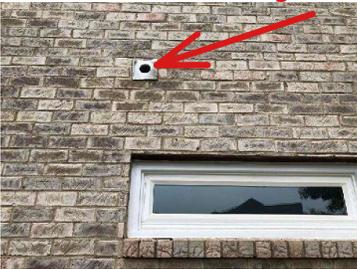
10. Vent: Plastic - Damaged vent. Recommend vent be repaired or replaced.

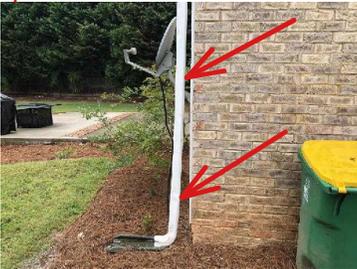
11. Downspouts: Aluminum - Loose downspout. A qualified contractor is recommended to evaluate and estimate repairs.

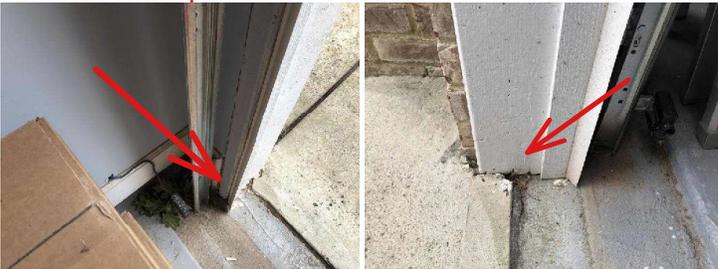
12. Front Garage Walls: Paint - Evidence of Termite present. A qualified contractor is recommended to evaluate and estimate repairs.

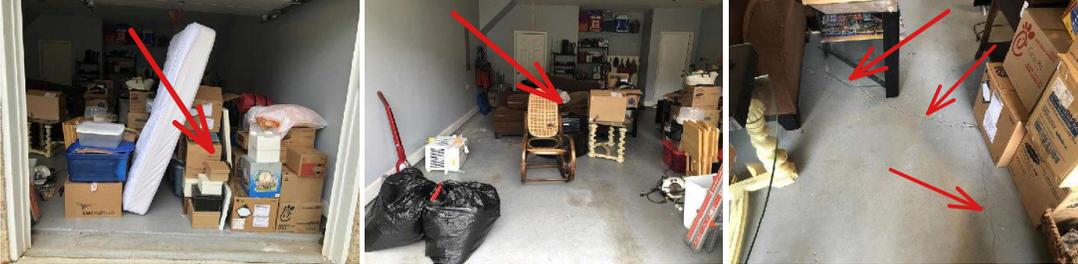
Floor/Foundation: (continued)

13. Front Garage Floor/Foundation: Poured slab - Items in garage covering floor and walls. Cracks present. A qualified contractor is recommended to evaluate and estimate repairs.

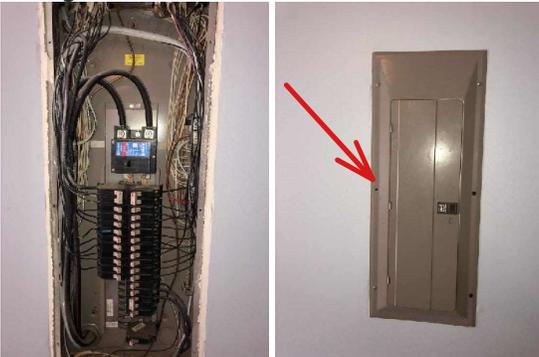
14. Garage Electric Panel Manufacturer: Cutler-Hammer - **Missing cover screw. Recommend screw be installed.**

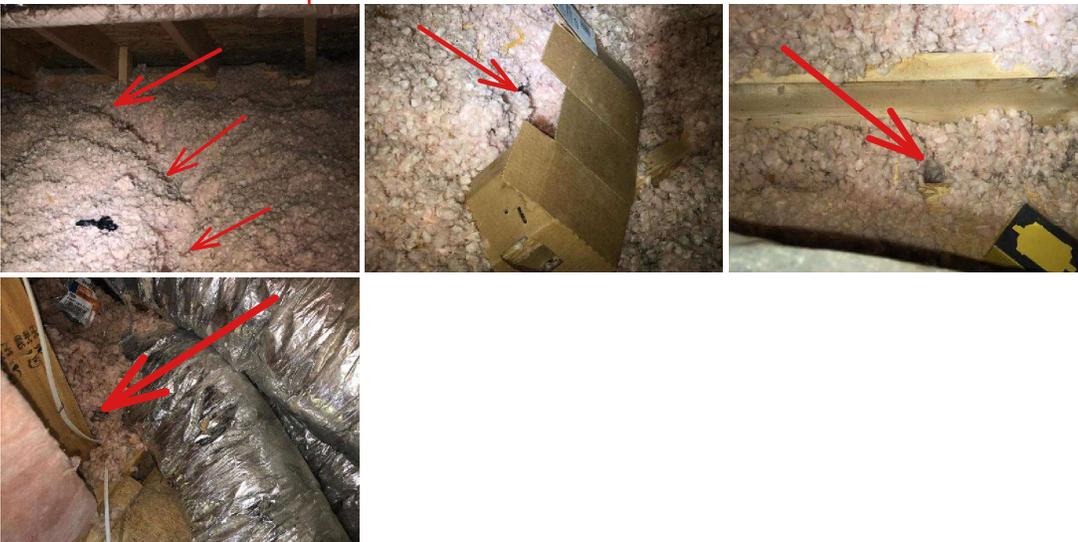
15. 3rd Floor Attic Unable to Inspect: 20% - **Evidence of pest present. A qualified contractor is recommended to evaluate and estimate repairs.**

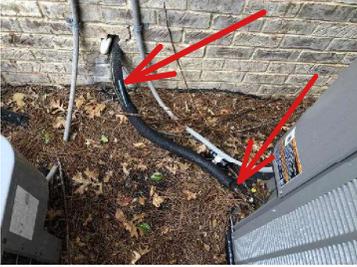
16. Left side of house AC System Refrigerant Lines: Low pressure and high pressure - Torn insulation at exterior unit. A qualified air conditioning contractor is recommended to evaluate and estimate repairs.

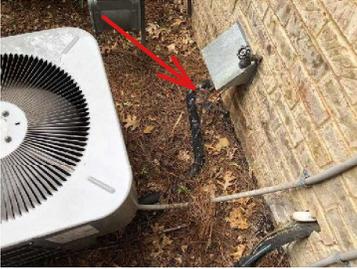
17. Left side of house AC System A/C System Operation: Functional at time of Inspection - A/C unit existing beyond it's design life. A qualified contractor is recommended to evaluate and estimate repairs.
18. Left side of house AC System Refrigerant Lines: Low pressure and high pressure - Torn insulation at exterior unit. A qualified air conditioning contractor is recommended to evaluate and estimate repairs.

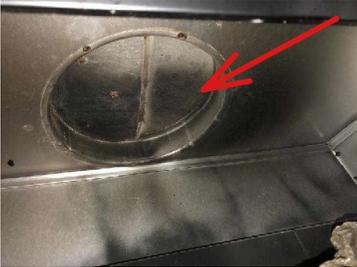
19. Family Room Fireplace Damper: Metal - Missing damper clamp. Recommend clamp be installed.

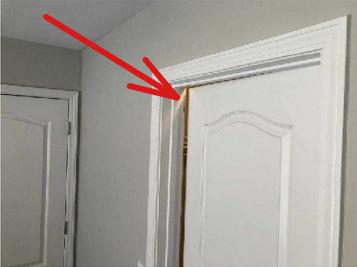
22. 2nd Floor Rear Bedroom Closet: Walk In - Closet door sticks. A qualified contractor is recommended to evaluate and estimate repairs.

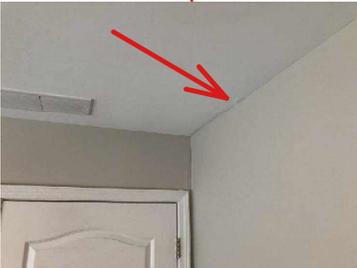
23. 2nd Floor Rear Bedroom Ceiling: Paint - Cracks present. A qualified contractor is recommended to evaluate and estimate repairs.

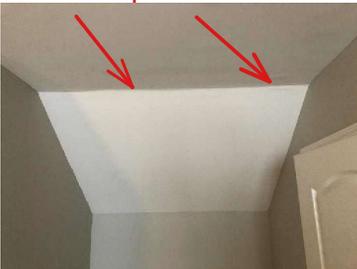
24. 3rd Floor Bedroom Ceiling: Paint - Cracks present. A qualified contractor is recommended to evaluate and estimate repairs.

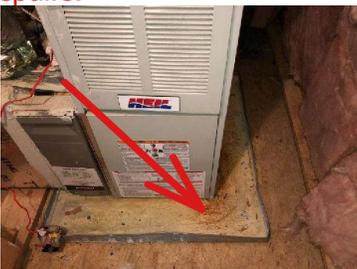
26. Garage Utility Closet Heating System Heating System Operation: Functional at time of Inspection - Furnace existing beyond it's design life. A qualified contractor is recommended to evaluate and estimate repairs.
27. 3rd Floor Attic Heating System Heating System Operation: Functional at time of Inspection - Furnace existing beyond it's design life. Rust present in pan. A qualified contractor is recommended to evaluate and estimate repairs.

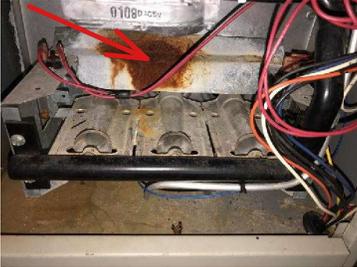
28. 3rd Floor Attic Heating System Heat Exchanger: 3 Burner - **Rust present on burners. A qualified contractor is recommended to evaluate and estimate repairs.**

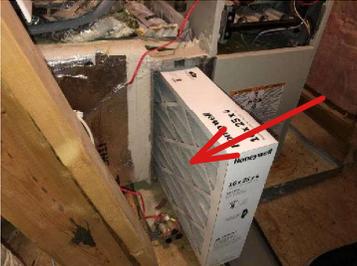
29. 3rd Floor Attic Heating System Blower Fan/Filter: Direct drive with disposable filter - **Filter size 16 X 25 X 4. Filter is dirty. Recommend filter be replaced.**

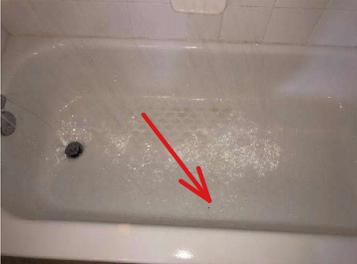
30. 1st Floor Bathroom Tub/Surround: Porcelain tub and tile surround - **Chipped tub. A qualified contractor is recommended to evaluate and estimate repairs.**

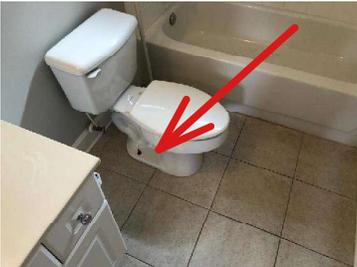
31. 1st Floor Bathroom Toilets: Universal-Rundle - **The toilet is loose at the floor. A qualified contractor is recommended to evaluate and estimate repairs.**

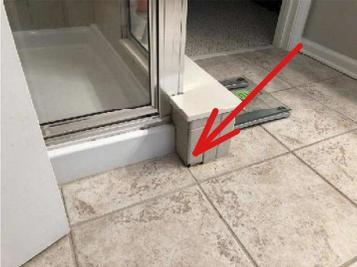
32. 2nd Floor Master Bathroom Floor: Tile - **Damaged flooring. A qualified contractor is recommended to evaluate and estimate repairs.**

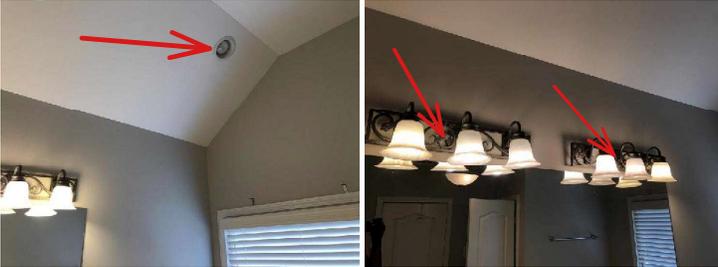
34. 2nd Floor Master Bathroom Electrical: 120 VAC GFCI - **Inoperable light fixture above spa tub. Missing screws in light fixtures. A qualified contractor is recommended to evaluate and estimate repairs.**

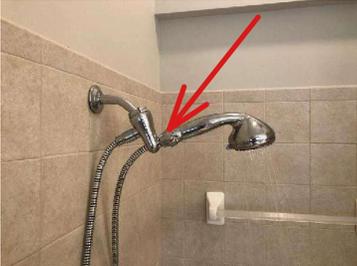
35. 2nd Floor Master Bathroom Faucets/Traps: Moen fixture with a PVC trap - **Leaking around shower head. A qualified contractor is recommended to evaluate and estimate repairs.**

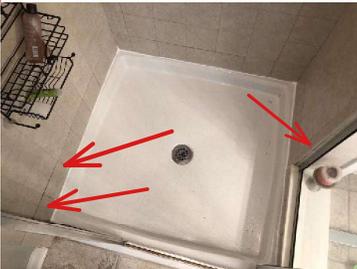
36. 2nd Floor Master Bathroom Shower/Surround: Fiberglass pan and tile surround - **Gap present in tile. A qualified contractor is recommended to evaluate and estimate repairs.**

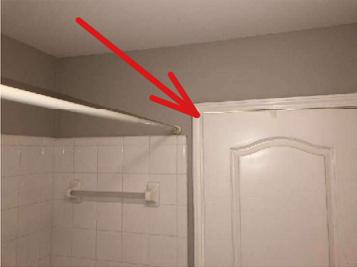
37. 2nd Floor Jack and Jill Bathroom Doors: Hollow wood - The door is sticking. A qualified contractor is recommended to evaluate and estimate repairs.

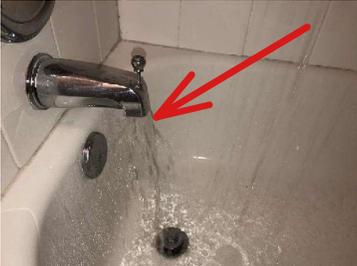
38. 2nd Floor Jack and Jill Bathroom Faucets/Traps: Moen fixture with a PVC trap - Inoperable diverter tub faucet. A qualified contractor is recommended to evaluate and estimate repairs.

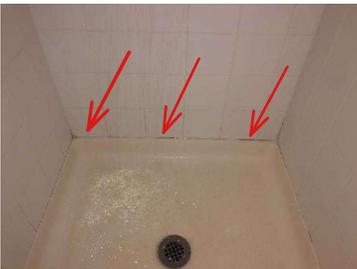
39. 3rd Floor Bathroom Closet: Small - Damaged closet door frame. A qualified contractor is recommended to evaluate and estimate repairs.
40. 3rd Floor Bathroom Doors: Not present - Missing doors. Recommend doors be installed.
41. 3rd Floor Bathroom Electrical: 120 VAC GFCI - Inoperable bulbs in light fixture. A qualified contractor is recommended to evaluate and estimate repairs.
42. 3rd Floor Bathroom Shower/Surround: Tile pan and surround - Missing grout. A qualified contractor is recommended to evaluate and estimate repairs.

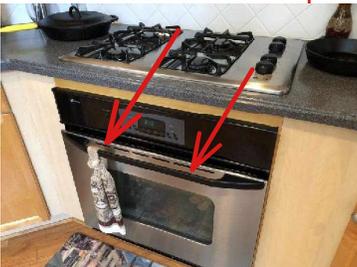
43. Center Kitchen Cooking Appliances: Maytag - Loose oven handle. A qualified contractor is recommended to evaluate and estimate repairs.

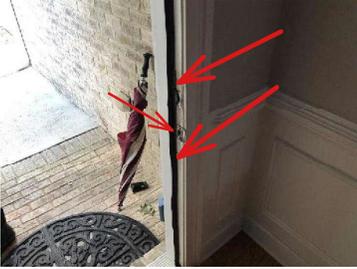
44. Foyer Living Space Doors: Metal entry - **Damaged door frame. Missing screw in door catch. A qualified contractor is recommended to evaluate and estimate repairs.**

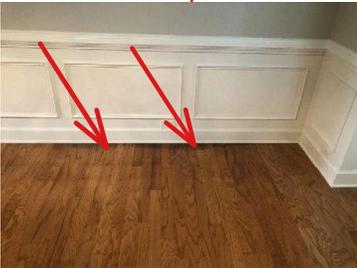
46. Dining Room Living Space Floor: Wood - **Stains present. A qualified contractor is recommended to evaluate and estimate repairs.**

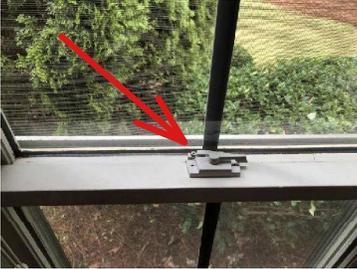
47. Dining Room Living Space Windows: Wood double hung - **Loose window latch. A qualified contractor is recommended to evaluate and estimate repairs.**

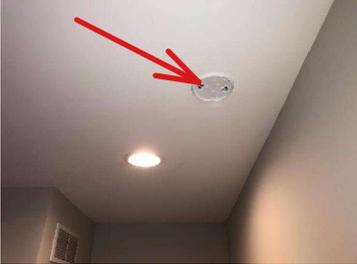
Smoke Detector: (continued)

50. 1st Floor Hall Living Space Smoke Detector: Battery operated - **Missing smoke detector. Recommend smoke detector be replaced.**

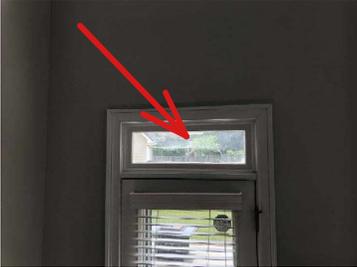
51. Family Living Space Windows: Wood double hung and casement - Fogging present inside the layers of glass. A qualified contractor is recommended to evaluate and estimate repairs.

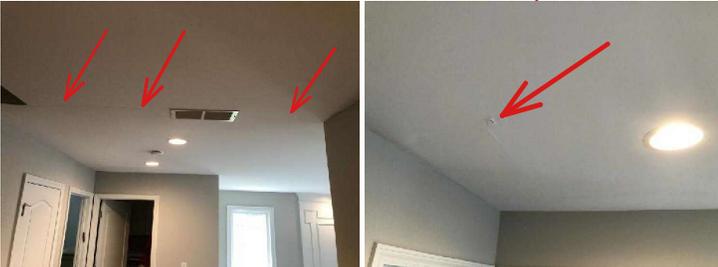
52. 2nd Floor Hall Living Space Ceiling: Paint - Cracks and damage present. A qualified contractor is recommended to evaluate and estimate repairs.

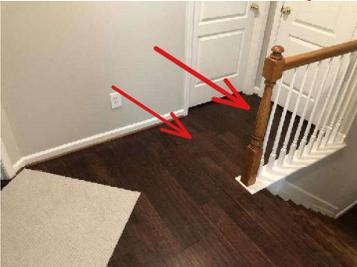
53. 2nd Floor Hall Living Space Floor: Wood - The floor is Not level. A qualified contractor is recommended to evaluate and estimate repairs.

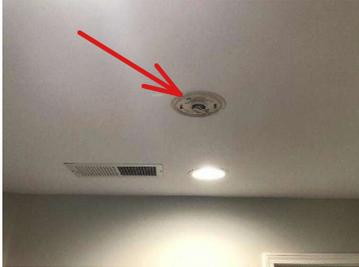
54. 2nd Floor Hall Living Space Smoke Detector: Hard wired with battery back up - **Missing smoke detector.**
Recommend smoke detector be replaced.

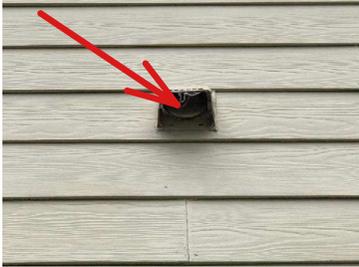
55. 2nd Floor Laundry Room/Area Doors: Hollow wood - **Missing door stop. Recommend door stop be installed.**
The door is sticking. A qualified contractor is recommended to evaluate and estimate repairs.
56. 2nd Floor Laundry Room/Area Dryer Vent: Metal, Plastic - **Needs cleaning. Recommend vent be cleaned.**
