Home Inspection Report

1539 Brompton Ct
Dunwoody, GA 30338

Hunter Home Inspections LLC.
4651 Woodstock Road, Suite 208
Roswell, GA 30075
678-822-2600

August 12, 2020

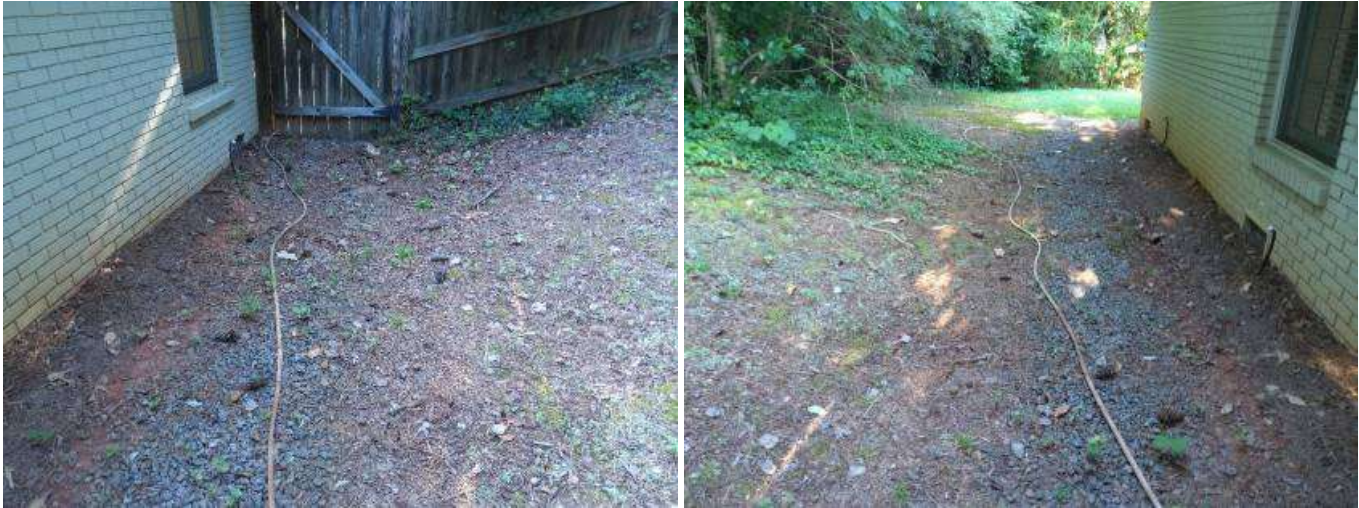
Action - The grade of the soil on the left side of the home slopes toward the foundation.
- The grade of the soil on the front of the home does not have sufficient slope to keep water away from the foundation. Water is entering the crawlspace.
Re-grading or a drain system is recommended to help prevent settlement of the foundation and water from entering the crawlspace.

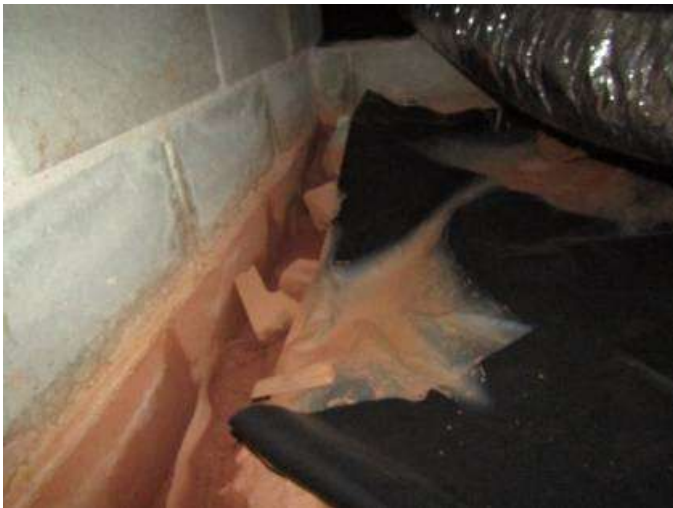
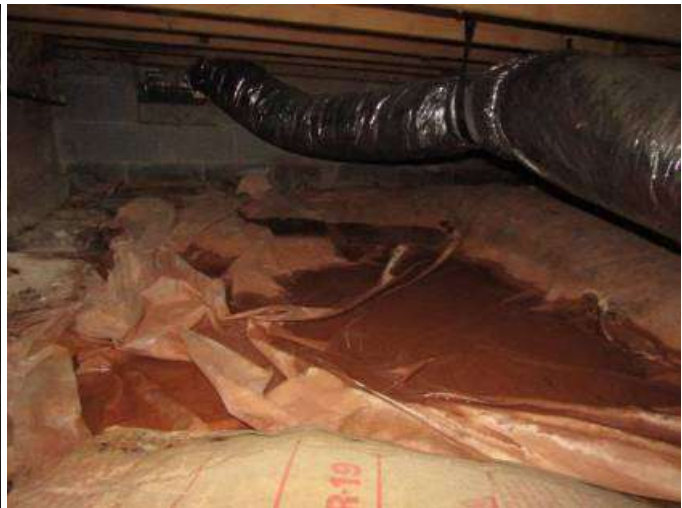
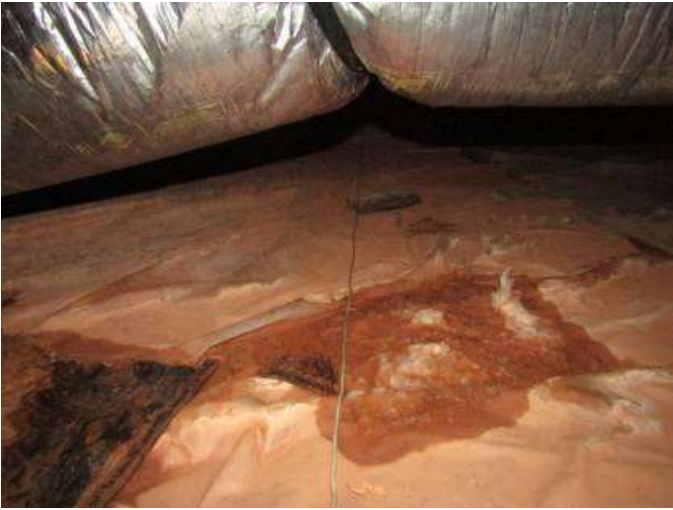
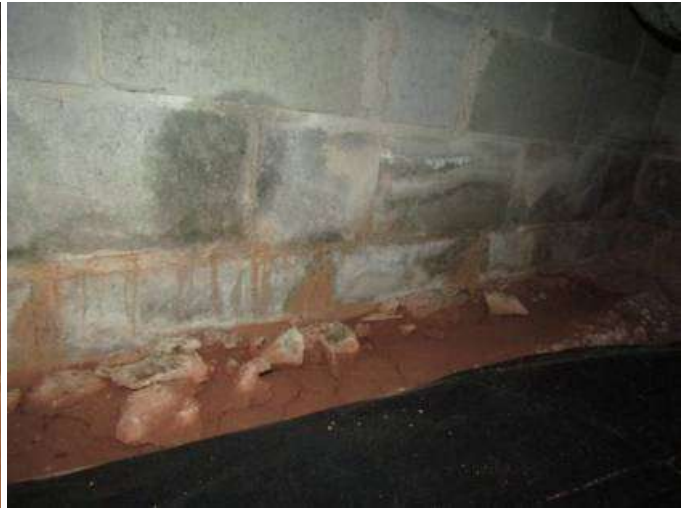
Evidence of Water: **Action** - At the time of the inspection the soil was wet at several locations of the crawlspace. Repairs by a water proofing contractor are recommended to stop water entry and to help keep the crawlspace dry. Not all locations are shown below.

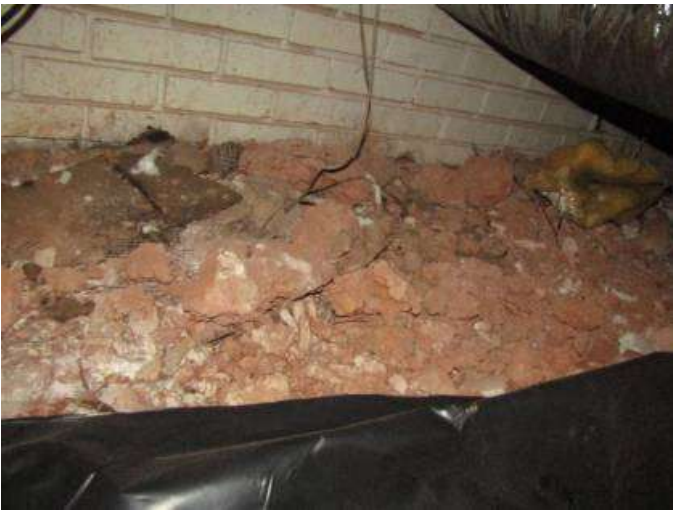
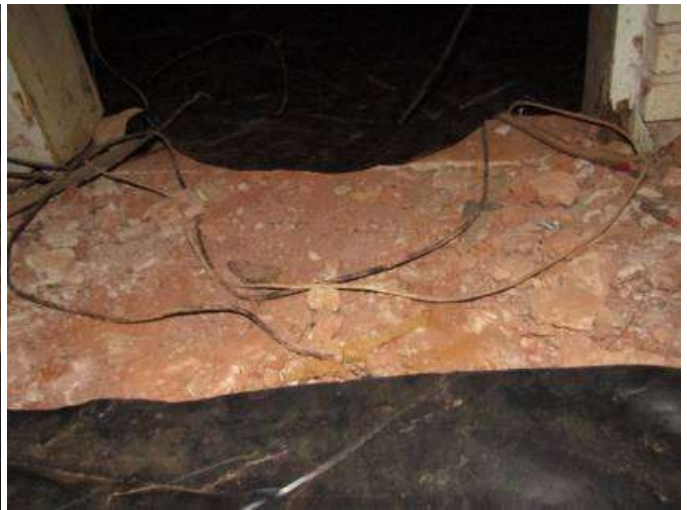
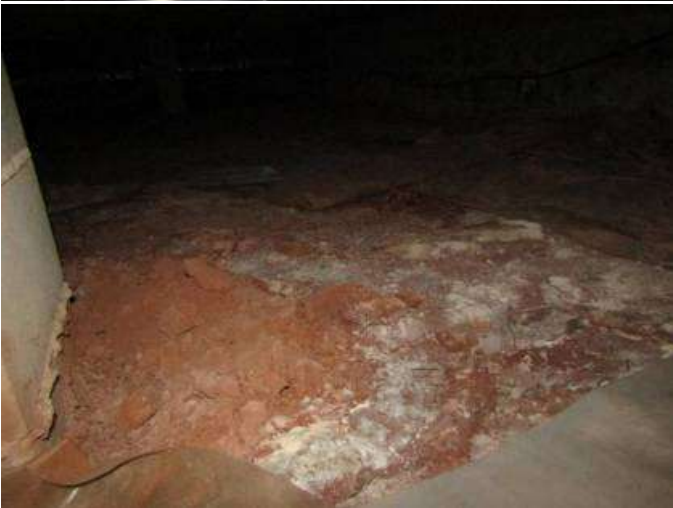
Vapor Barrier: **Action** - Some areas of the ground in the crawlspace are not covered with plastic. Not all locations are shown below. Recommend installing plastic where missing so that the entire area is completely covered to help reduce the moisture level.

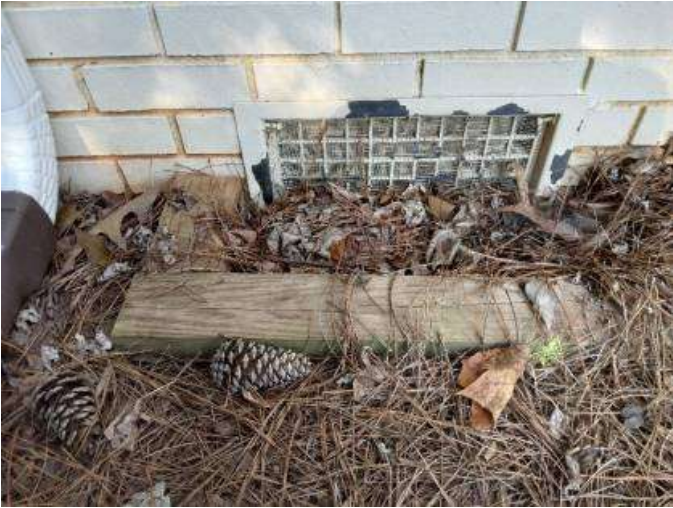
Ventilation: **Action** - The crawlspace vents on the left front of the home are below grade and the wood around them will allow water entry into the crawlspace.
Repair is recommended to prevent water entry into the crawlspace and help keep it dry.

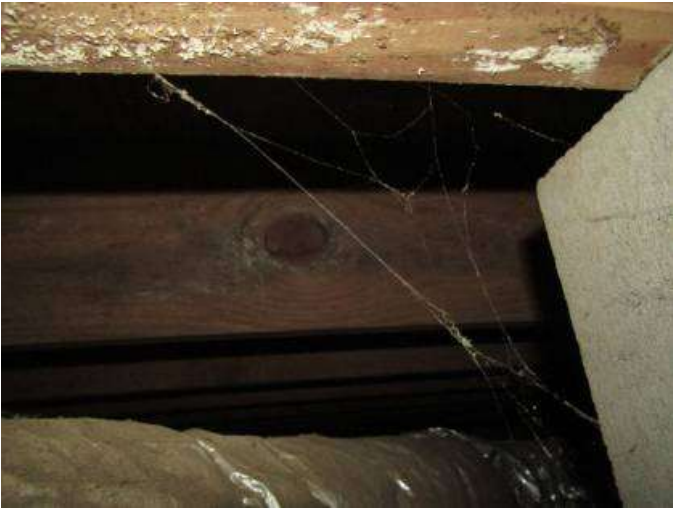
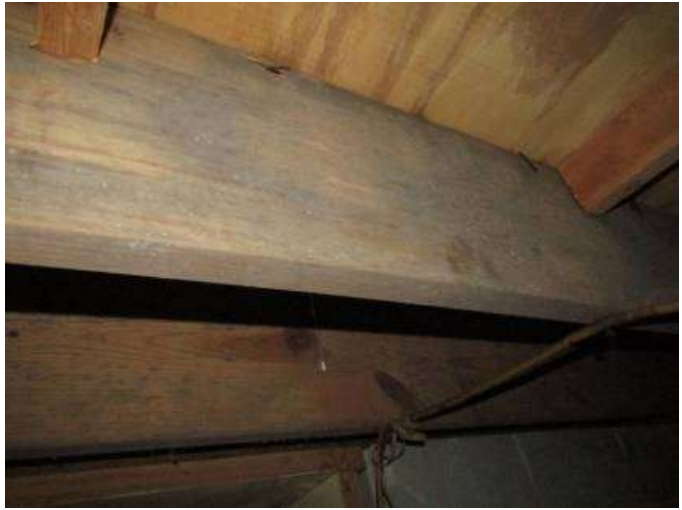
Evidence of Fungus: **Action** - There is a fungus or mold like substance on the floor joists and subfloor in the crawlspace. Not all locations are shown below. This inspection does not include testing for mold. Recommend having mold testing or remediation completed by a by a licensed mold remediation company.

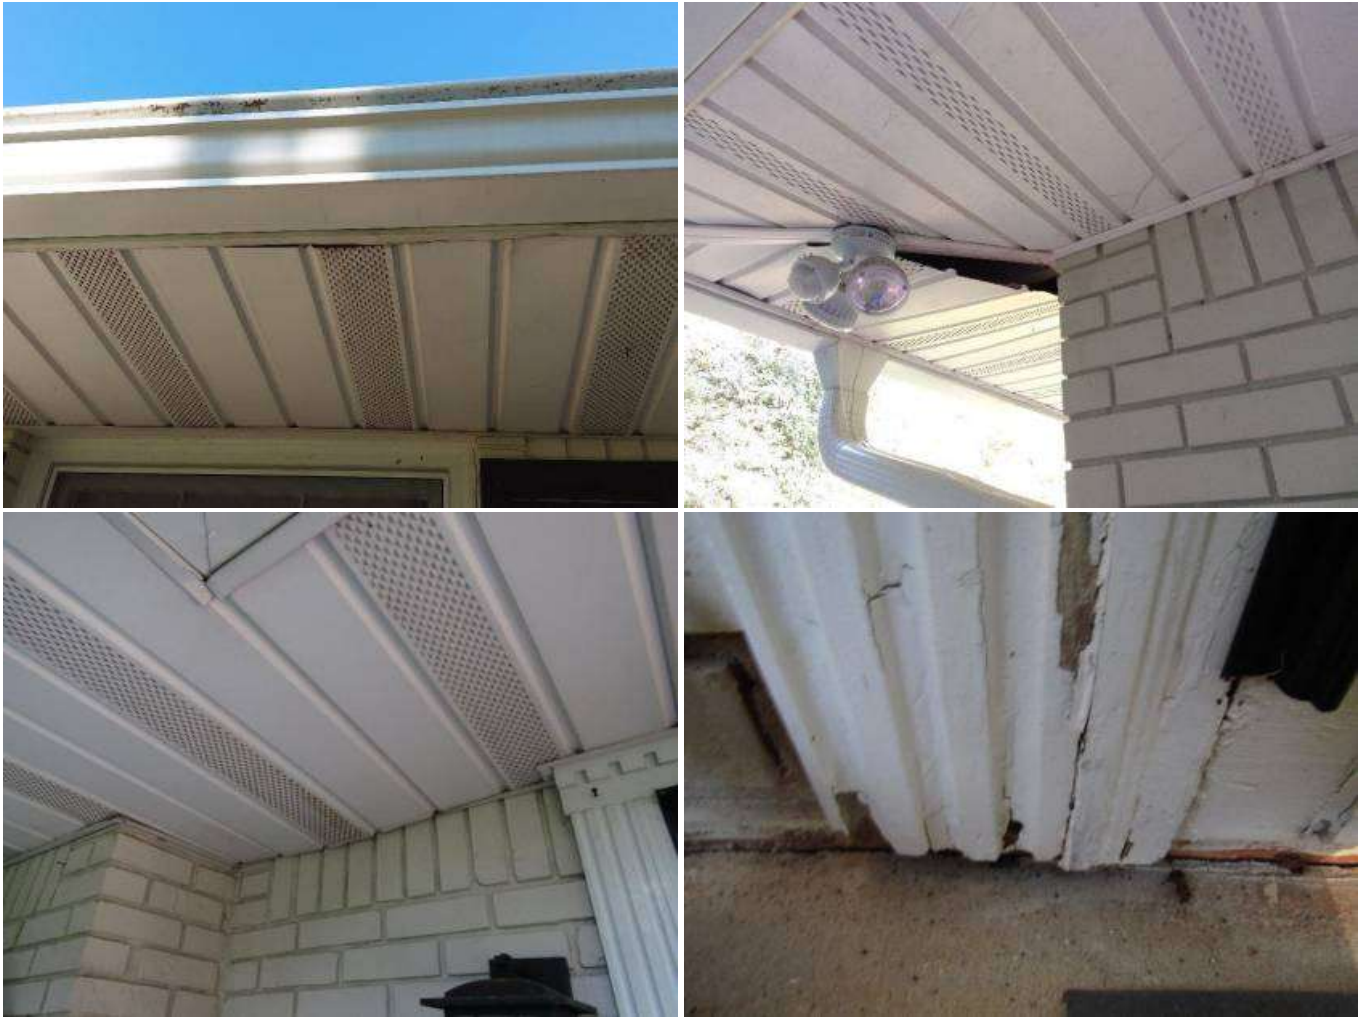
Trim Condition: **Action** - Some of the soffits on the front and rear of the home are loose.
- Wood rot was noted at the front door.
Recommend having a contractor repair as needed.

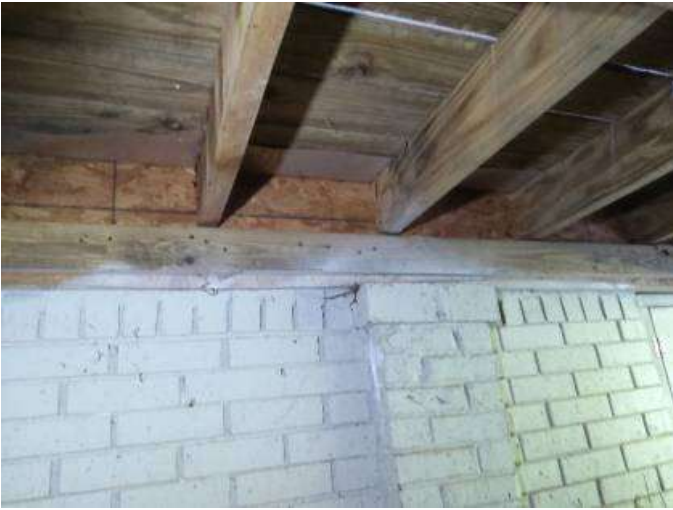
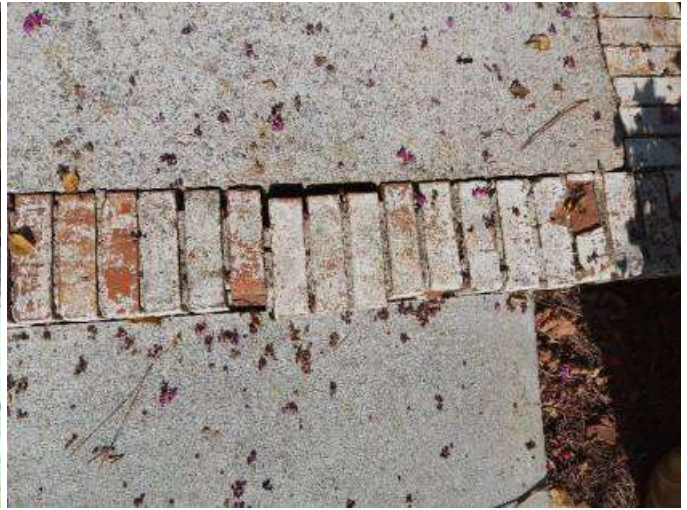
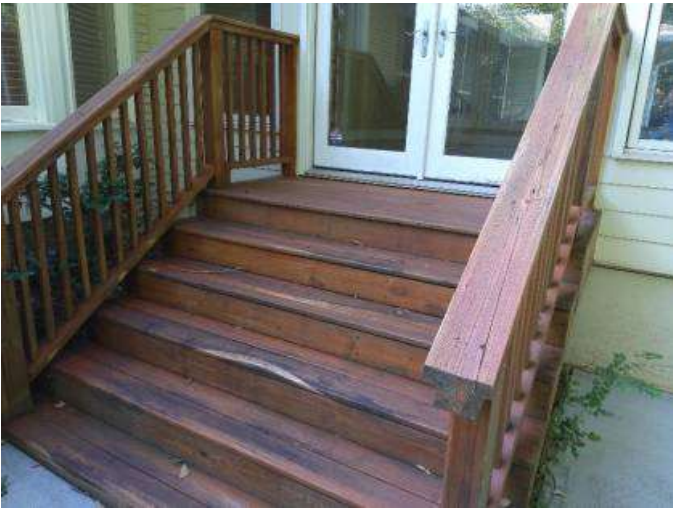
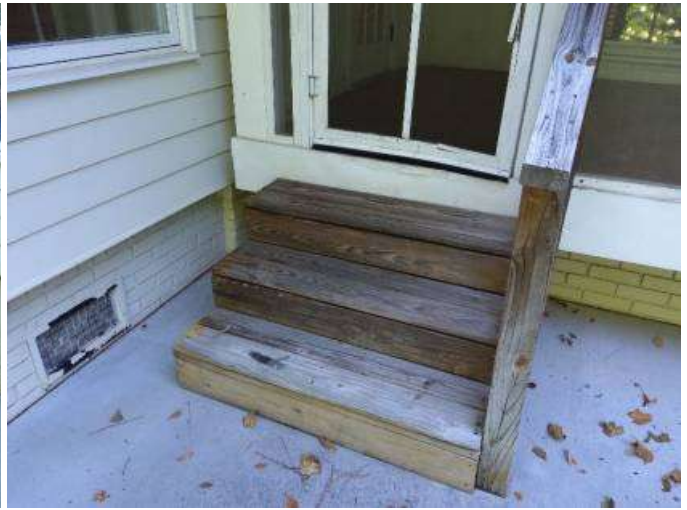
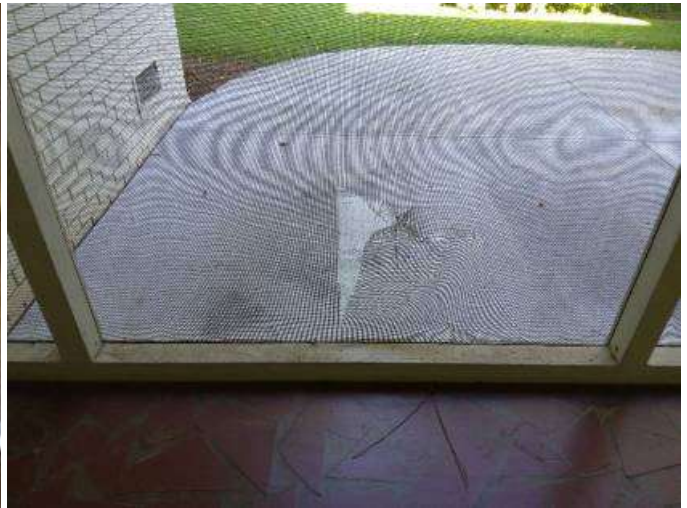
Condition: **Action** - There are loose bricks at the step of the front porch.
- The sunroom porch is not bolted to the home. This can allow it to pull away from the home.
- There is not a railing on one side of the screen porch stairway.
- There is not a graspable railing on the sunroom stairs. A graspable railing is required on at least one side for safety.
- The screen porch door is deteriorated.
- One of the screens is torn.
Recommend having a qualified contractor make necessary repairs.

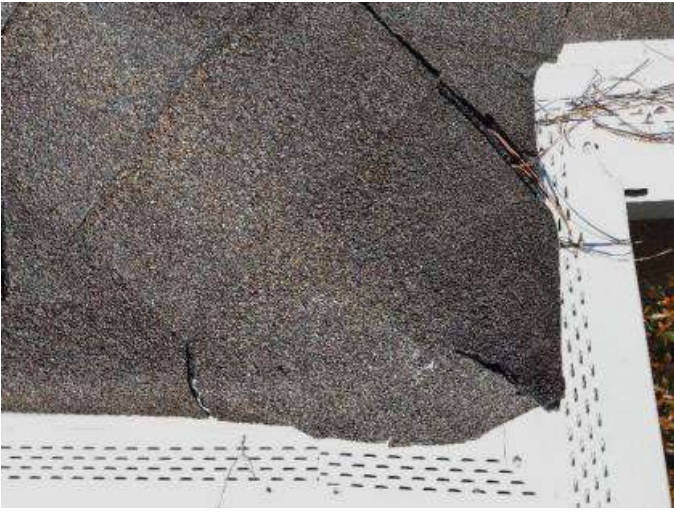
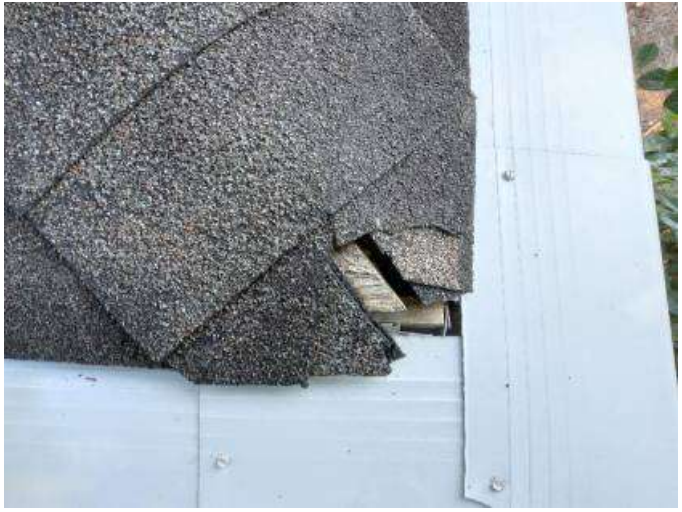
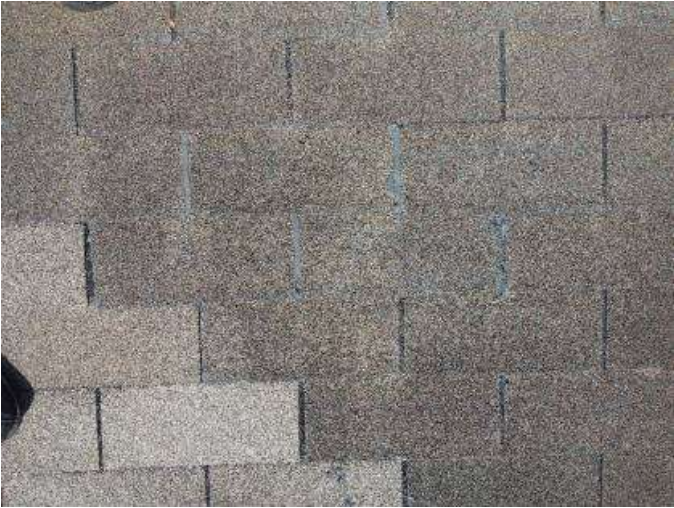
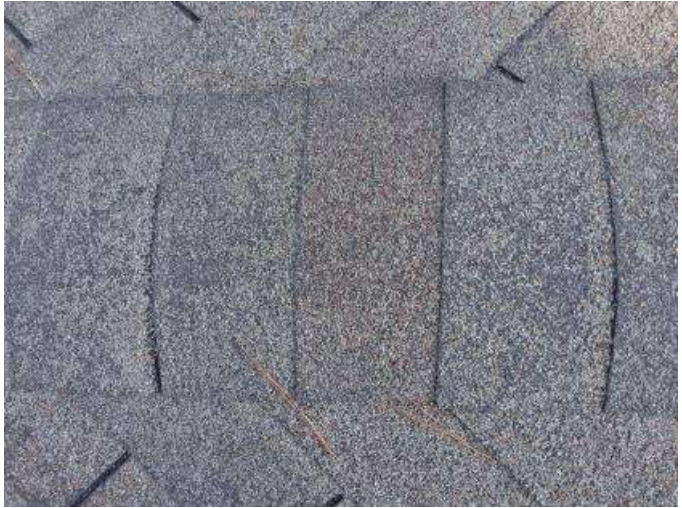
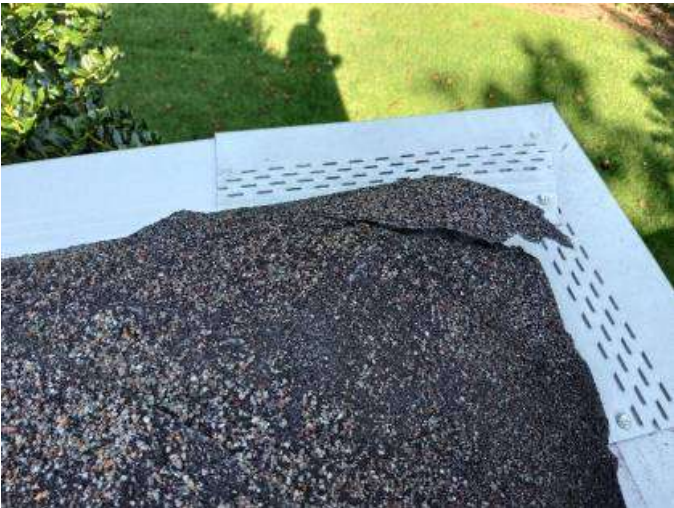
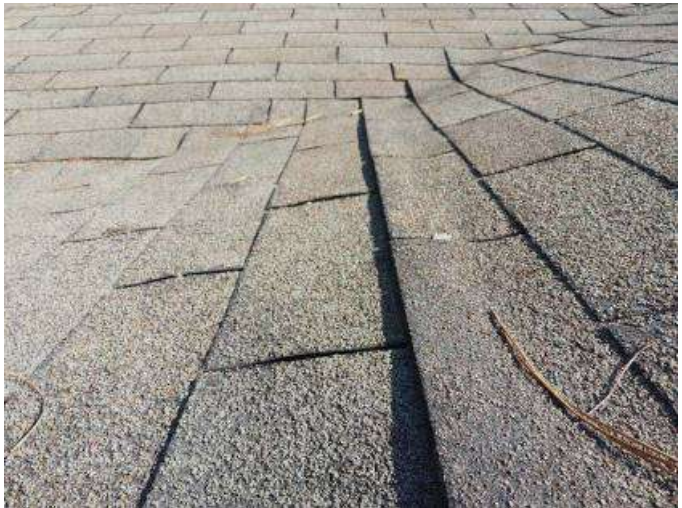
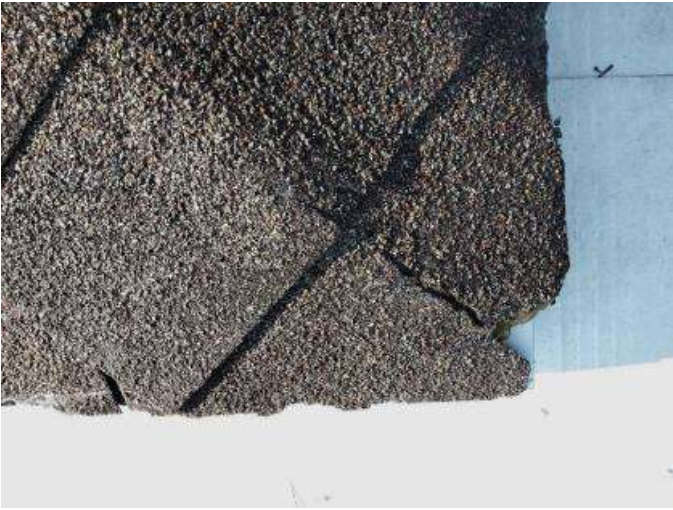
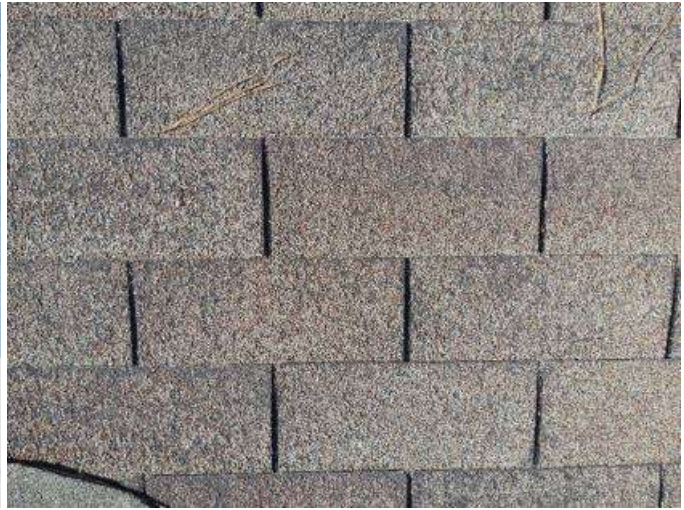
- Damaged shingles were noted at several locations.
- Some of the shingles on the rear of the home turn upward. This can allow water entry.
- There is evidence of a roof leak above the garage.
- The shingles have excessive granular loss.

Recommend having a licensed roofing contractor evaluate the roofing system and repair or replace as needed.

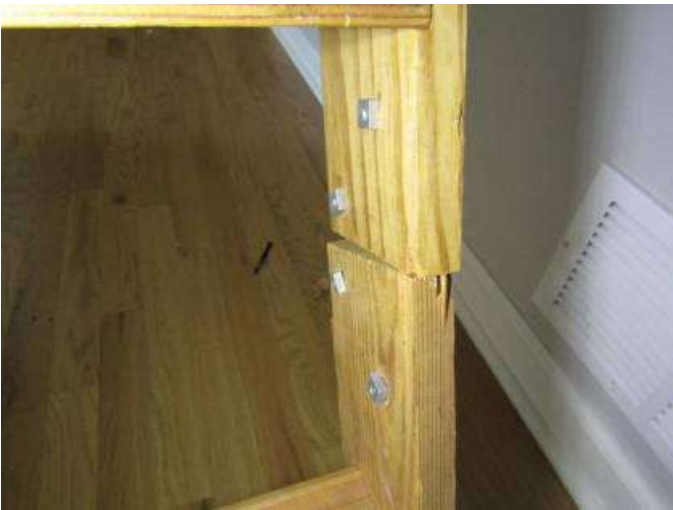
Condition of Access: **Action** - The hardware on the attic pull down stairs is loose. This can cause collapse of the stairs. Repair is recommended for safety.

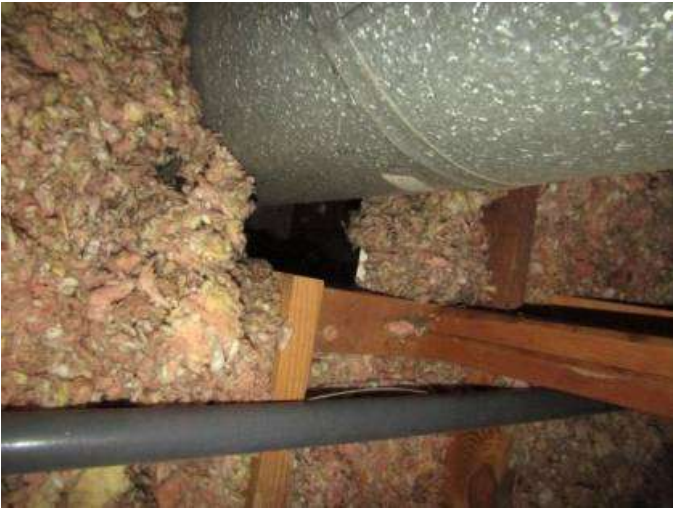
Attic Floor: **Attention** - There is an open chase in the attic at the chimney. This was allowed at time of construction. For safety, recommend closing off the opening for fire draft and fire spread prevention and because the walls below are not insulated which will allow hot or cold air directly against the interior walls, wasting energy. Plywood, drywall or sheet metal can be used to close the opening.

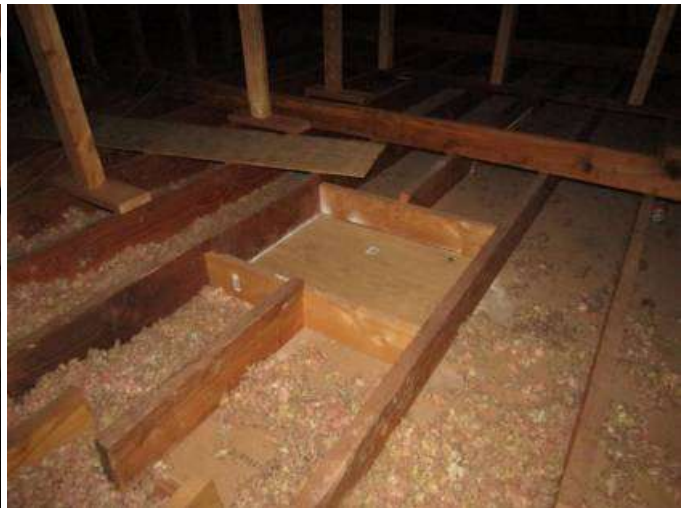
Action - One of the roof rafters above the fireplace was cut to install the flue, and one ceiling joist above the garage was cut to install the access panel. Recommend a qualified framing contractor repair as needed.

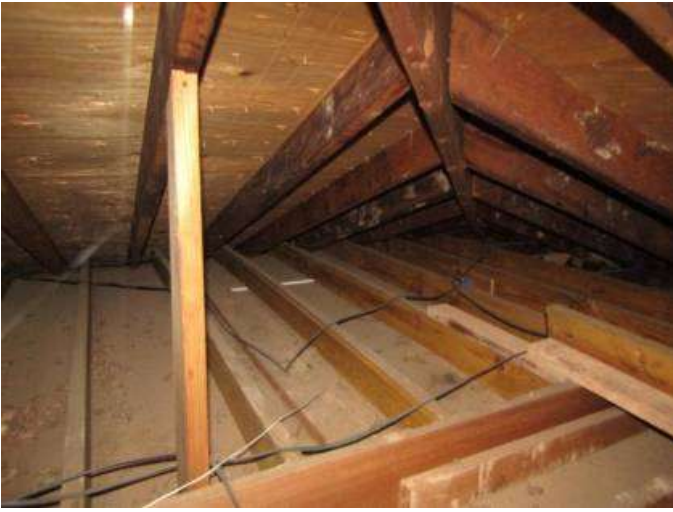
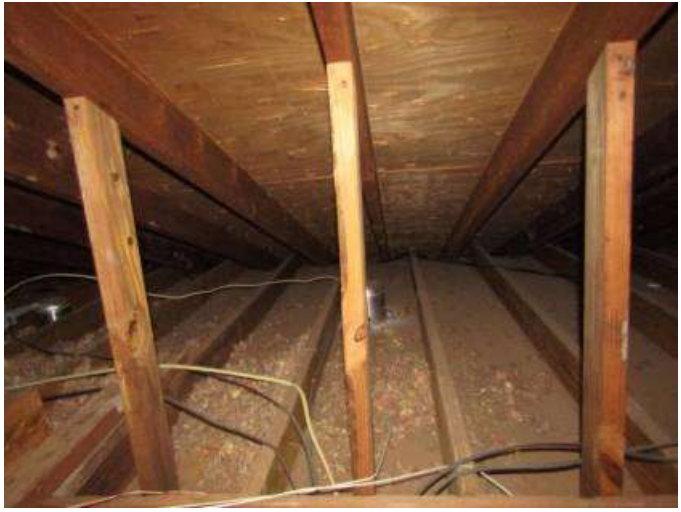
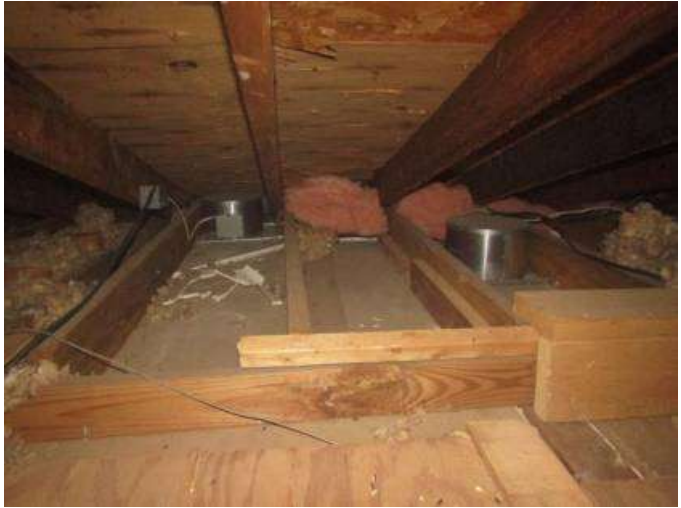
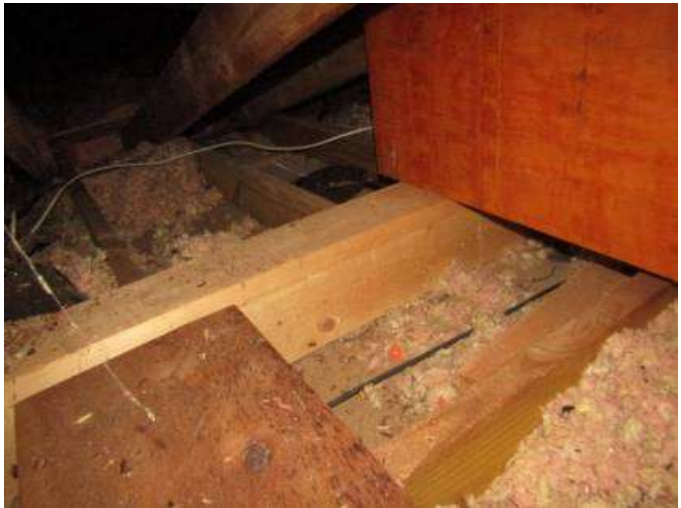
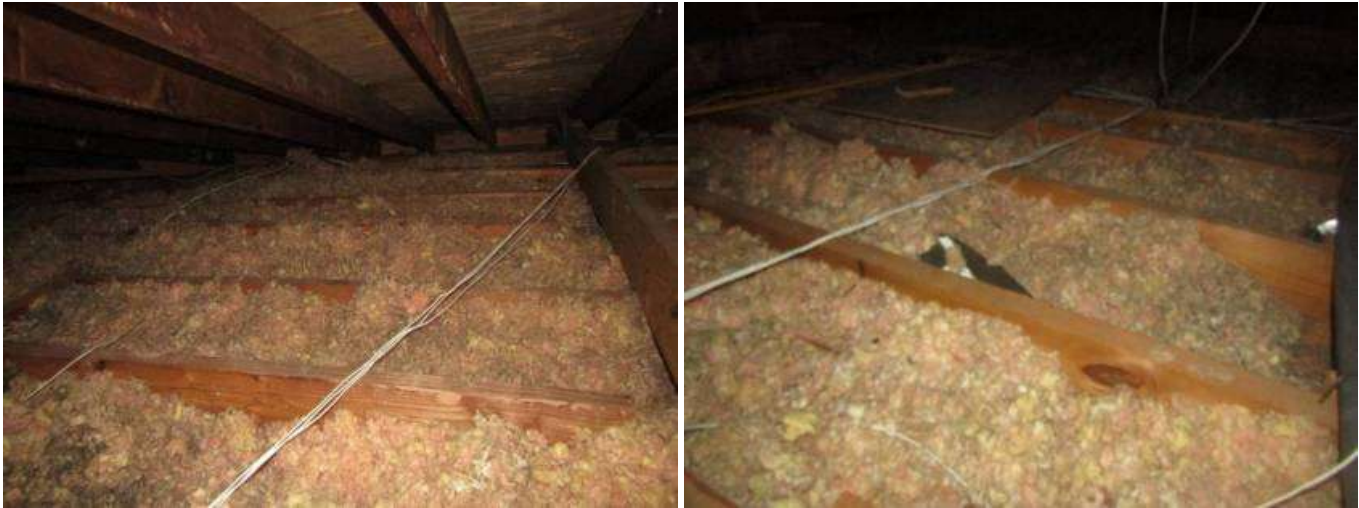
Condition of Insulation: **Action** - There is no insulation above the laundry room, above half of the kitchen, and above a section of the hallway. The insulation in the rest of the attic is low, it is approximately 5 inch thick.

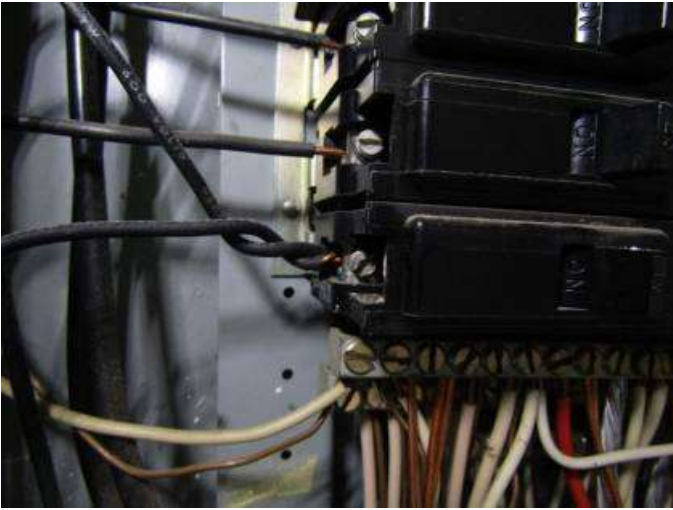
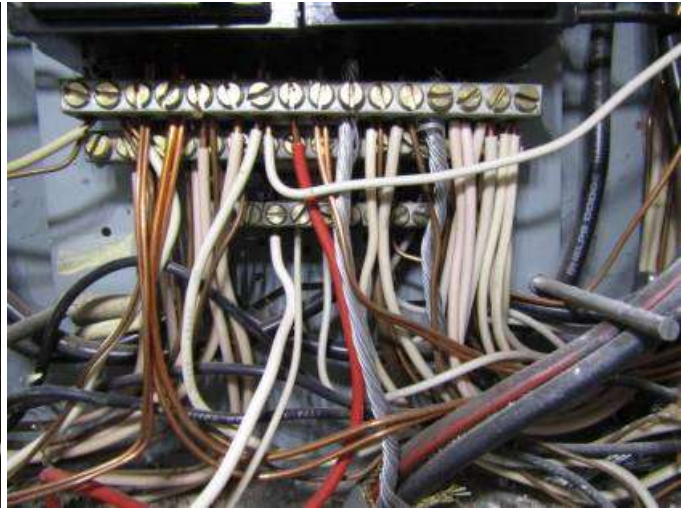
Electric Service:	The electrical service to the home is 150 amps, 120/240 volts.
Service Condition:	The overhead electrical service lines to the home are in satisfactory condition.
System Ground:	The grounding conductor for the electrical system is connected to the water piping and is satisfactory.
Service Cable to Panel:	Stranded aluminum wire. The visible portion of the cable is in satisfactory condition.
Distribution Panel:	Circuit breaker type, 150 amp. It is located in the store room off the garage. Split Buss type distribution panel. This is an older style electrical breaker panel. Instead of one main breaker, there is a series of main breakers in the panel. The top six breakers must be turned off to shut off all power in the panel box.
Panel Condition:	Action - One of the breakers in the electrical panel is double tapped. This is when two wires are connected to one breaker. These need to be separated so that each circuit will have its own breaker. - There is more than one wire installed in the terminals on the neutral bar in the panel box. - The electrical panel is not installed in a manner to allow for safe access for operation, repair, or inspection as required by industry standards. The clear space in front of a panel box is required to be a minimum of 30" wide, 36" deep and 80" high. Repair by an electrician is recommended.

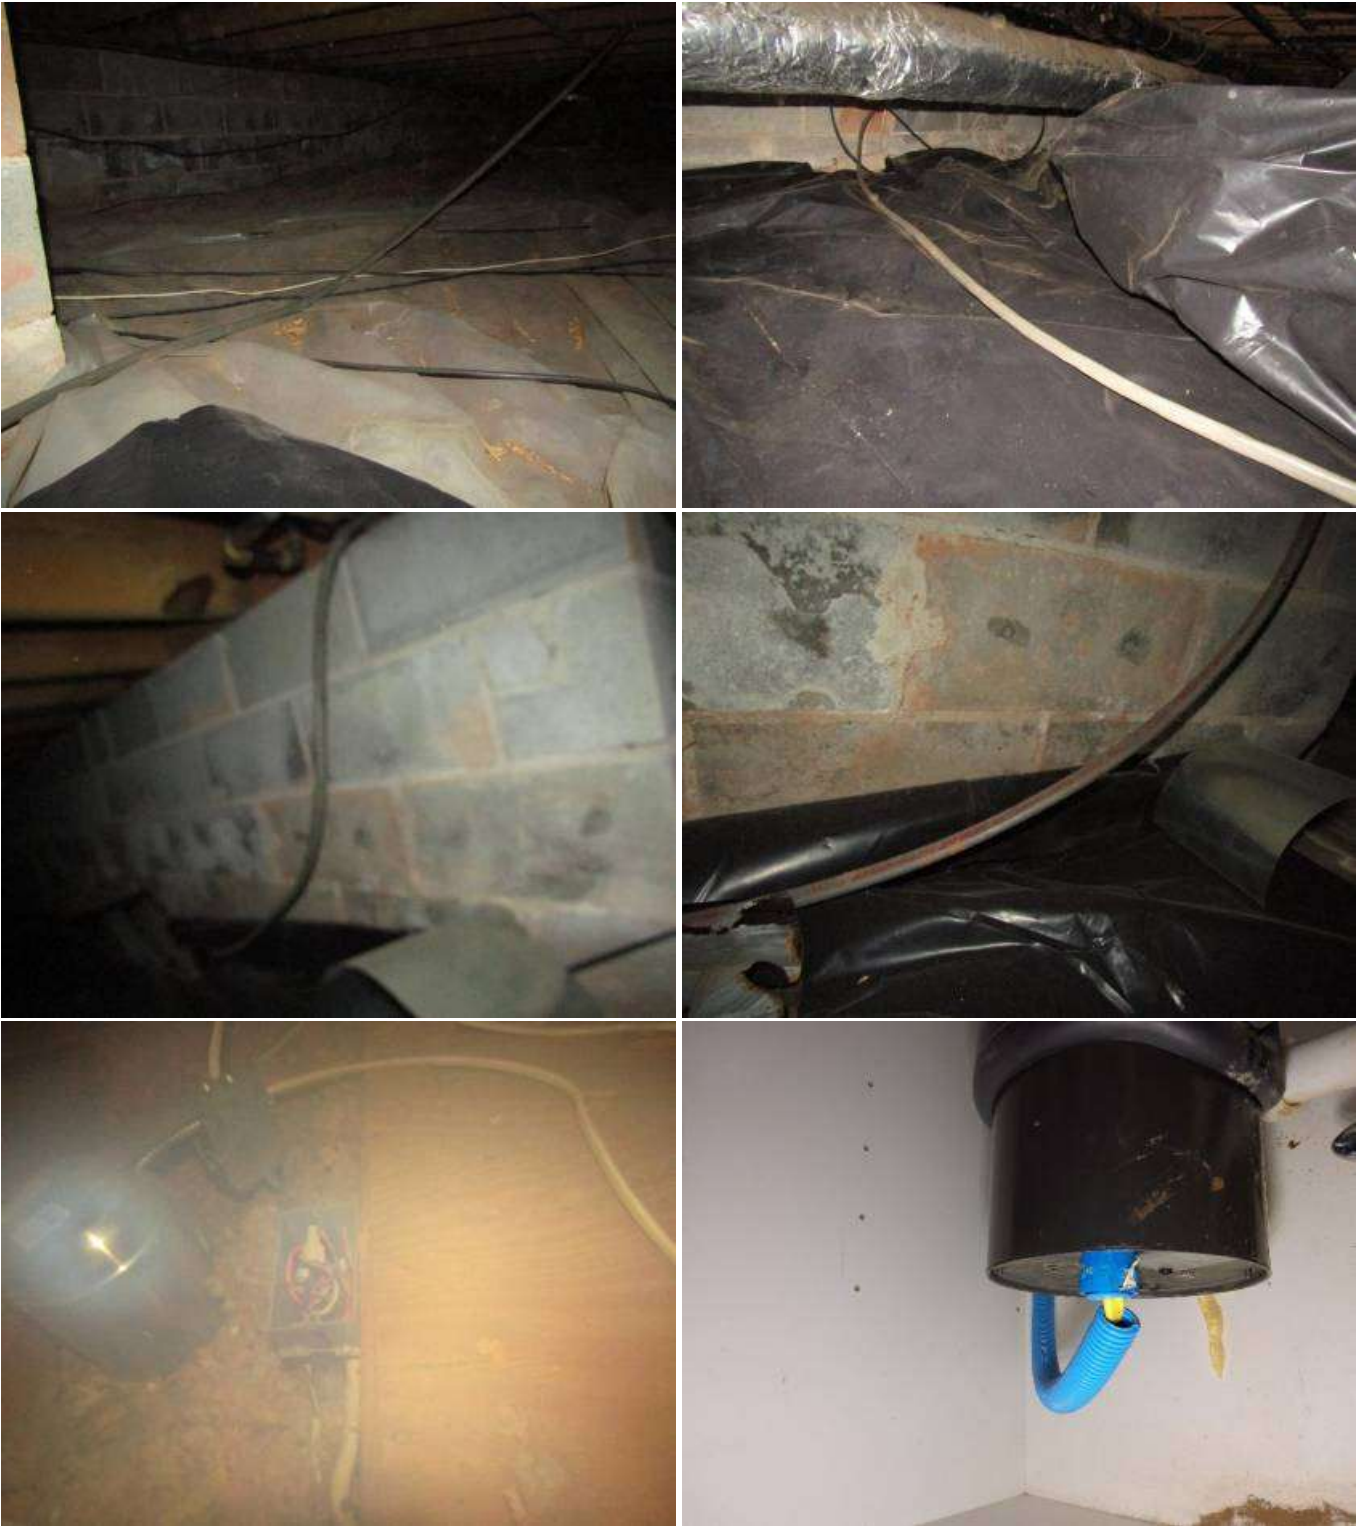
Action - Some of the wiring in the crawlspace is loose and laying on the ground.
 - There is an open junction box in the attic. This is a fire hazard.
 - The conduit on the electrical wire to the kitchen sink disposer is loose, this leaves the wires exposed.
 Repair by an electrician is recommended.

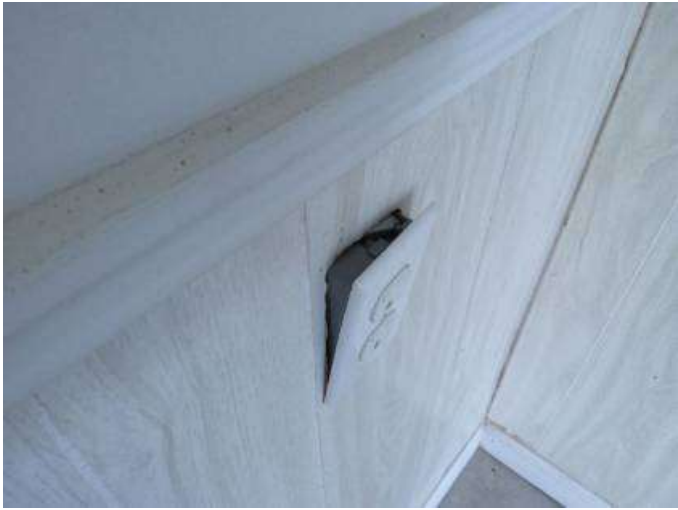
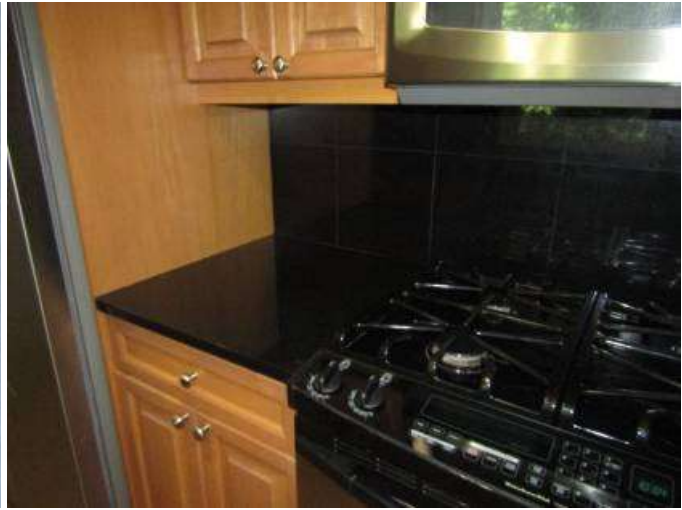
Receptacles: **Action** - Ungrounded receptacles were noted at the deck, in the screen porch, and in the garage.

- There is a loose receptacle in the garage.
- There is not an electrical receptacle to the left of the range. This was required at the time the kitchen was remodeled.

Repair by an electrician is recommended.

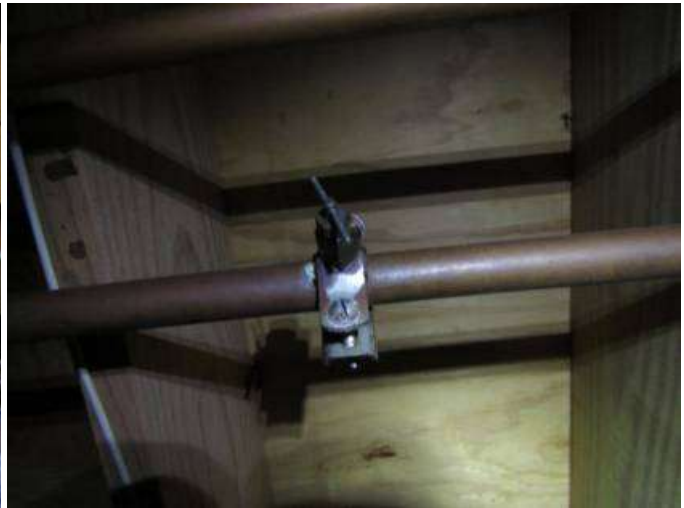
Action - There is a leak on the water pipe in the crawlspace under the kitchen.
 - The saddle valve in the crawlspace under the kitchen is rusted.
 Repair by a plumber is recommended.

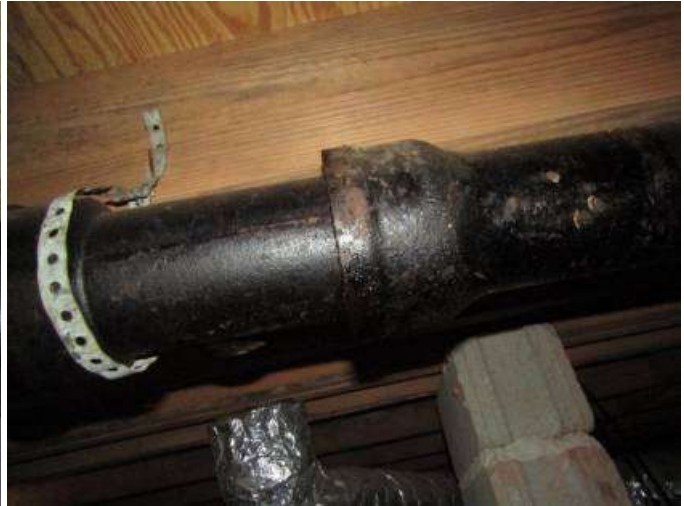
Action - There are leaks in the drain piping in the crawlspace.
Recommend having the waste piping evaluated and repaired as needed by a licensed plumber.

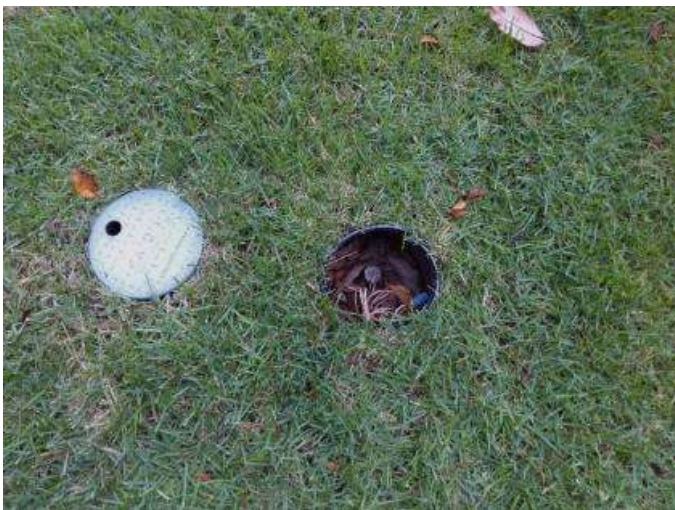
Attention - The cover is missing from one of the sprinkler system valve boxes in the front yard.
- The lawn irrigation system was turned off. Recommend having the homeowner confirm the condition of the system and demonstrate the operation.

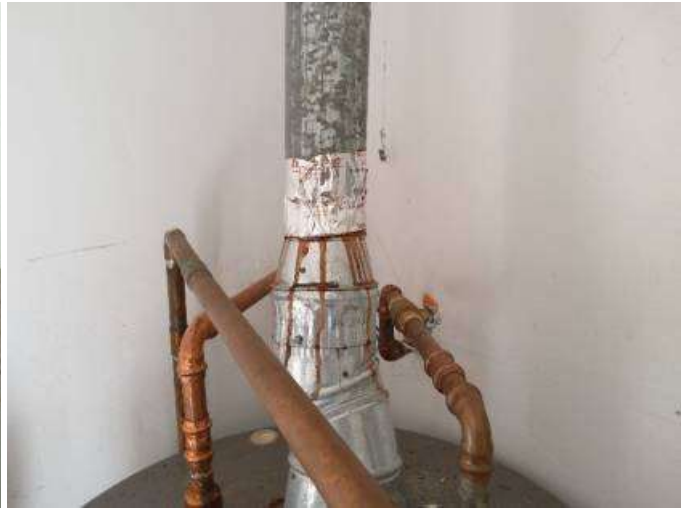
Flue Pipe: **Action** - The water heater flue collar is not properly installed and centered over the exhaust pipe on the tank.
- The flue pipe for the water heater was reduced from 4 inches down to 3 inches. This is too small for a 75 gallon water heater.
This can allow carbon monoxide to spill into the home. Recommend having a licensed plumber make all necessary repairs.

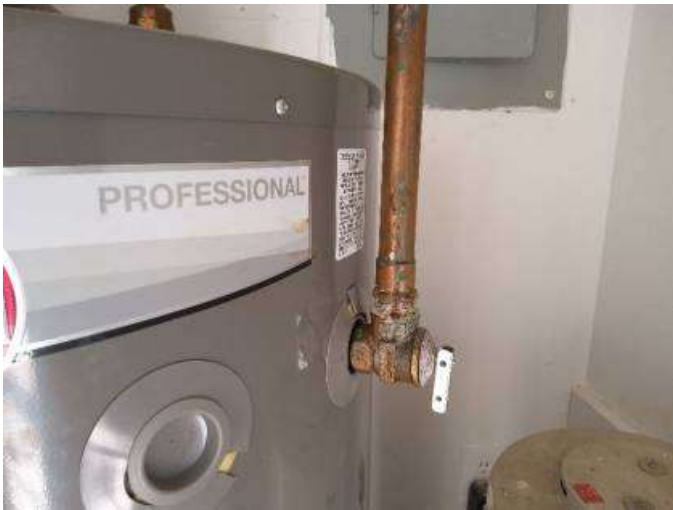
Relief Valve: **Action** - The Temperature & Pressure relief valve on the water heater is turned upward, the discharge pipe runs uphill and there is not a drain valve installed. Manufacturers and plumbing standards require the valve to be turned downward and require a drain installed before the pipe goes up after leaving the T&P valve. Water trapped in the discharge pipe can cause back-pressure and damage.
Recommend having a licensed plumber correctly install the T&P valve and install a drain on the lowest point of the pipe before it goes up.

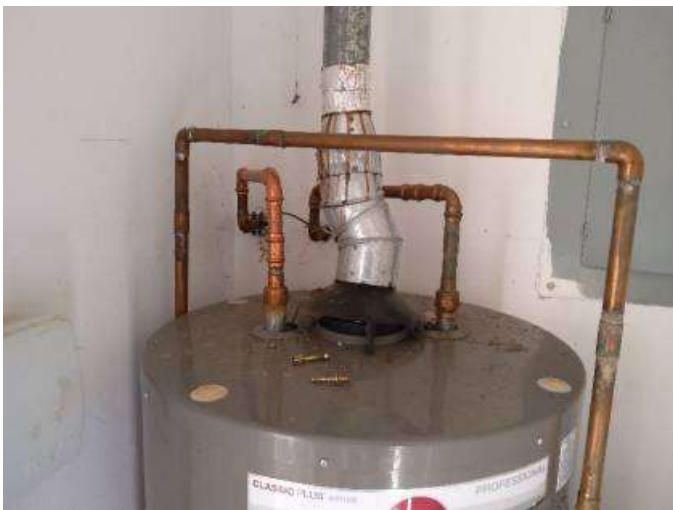
Action - I could not locate a thermal expansion tank or thermal expansion valve. This was required when the water heater was replaced. Recommend having a plumber install a thermal expansion tank for safety.

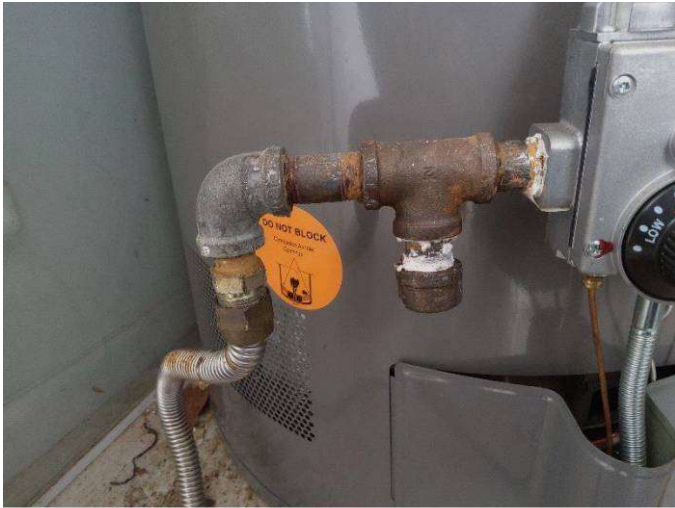
Action - The sediment trap on the gas line for the water heater is not properly installed.
 - I could not locate a sediment trap for the master suite furnace.
 - The gas line for the water heater is laying on the floor. The pipe is exposed to damage and leaks.
 - The gas piping at the furnace on the exterior of the home is rusted.
 Recommend having the gas piping evaluated and repaired by a licensed plumber.

improper trap at the water heater

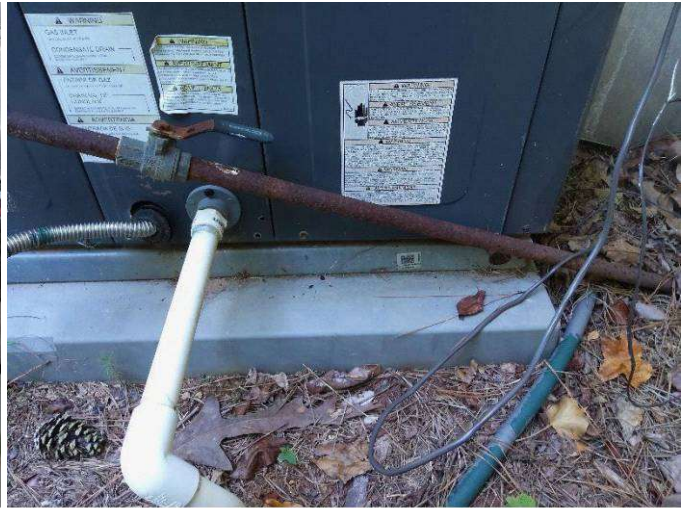
rustied piping outside at the furnace

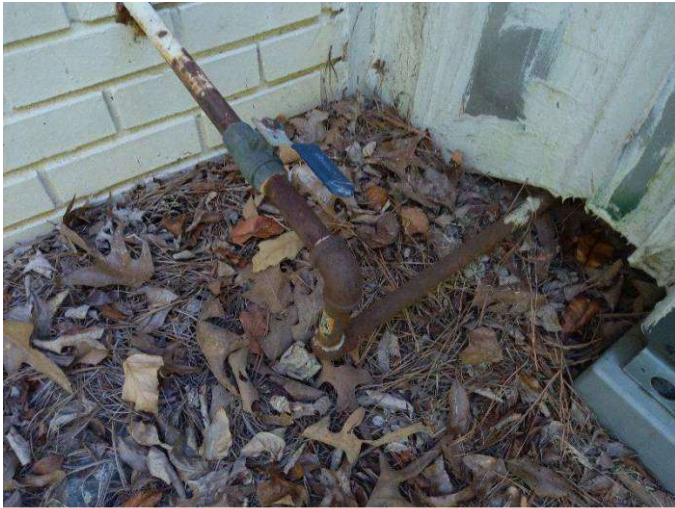
rustied piping outside at the furnace

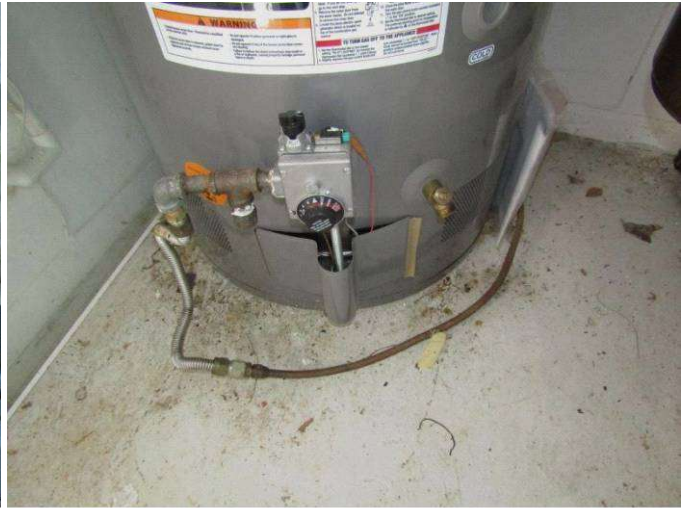
copper gas tubing laying on the floor

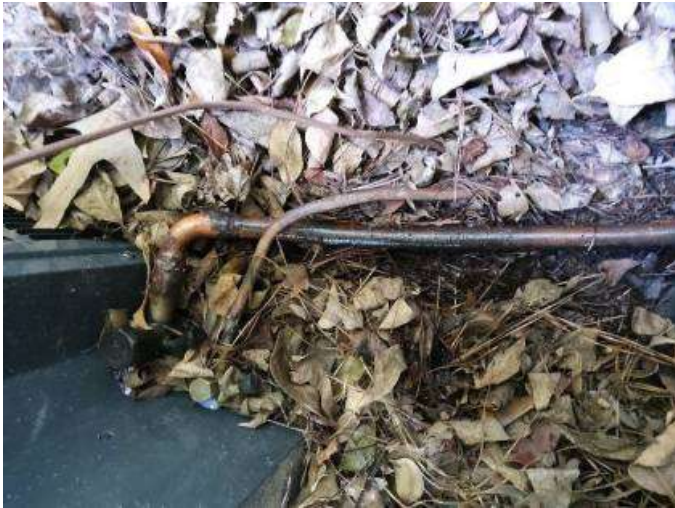
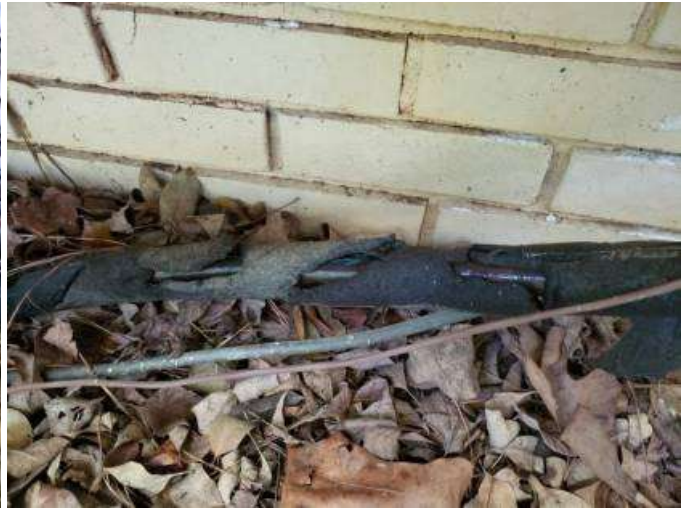
Refrigerant Lines: **Attention** - Missing insulation was noted on the refrigerant line at the outside condenser unit. Replacement will help with the energy efficiency of the system.
