Home Inspection Report

1539 Brompton Ct
Dunwoody, GA 30338

Hunter Home Inspections LLC.
4651 Woodstock Road, Suite 208
Roswell, GA 30075
678-822-2600

August 12, 2020

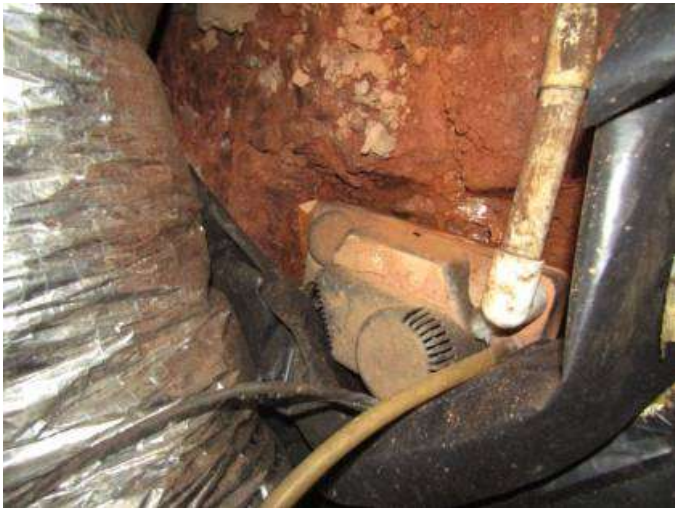
Condensate Drain: **Action** - The A/C condensate pump is not operating properly to remove the water. Recommend replacing the pump.

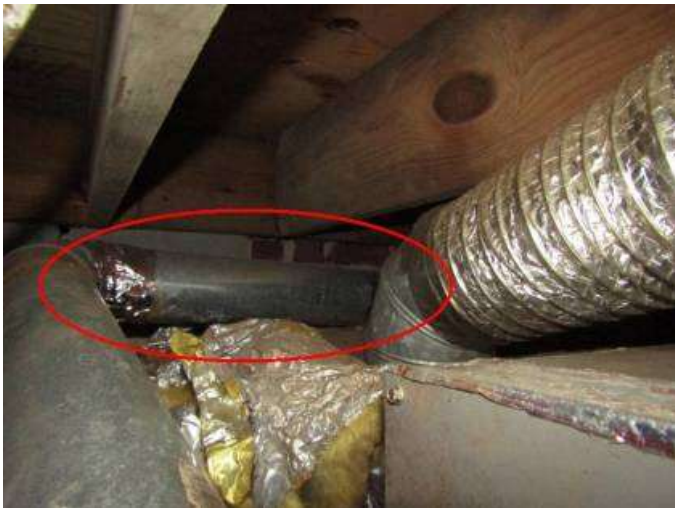
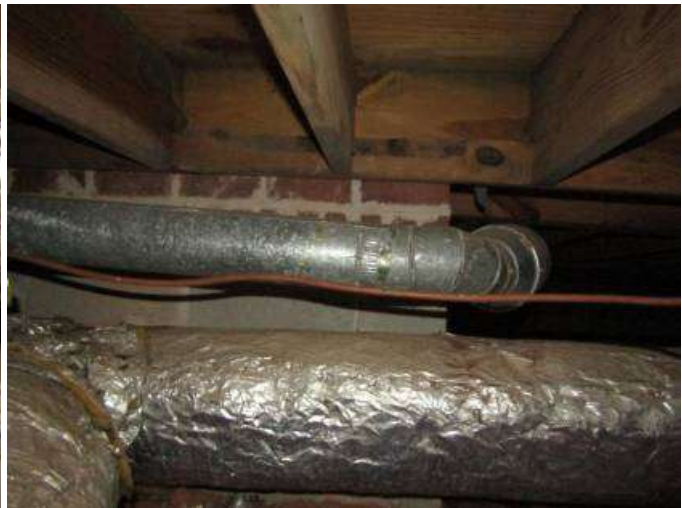
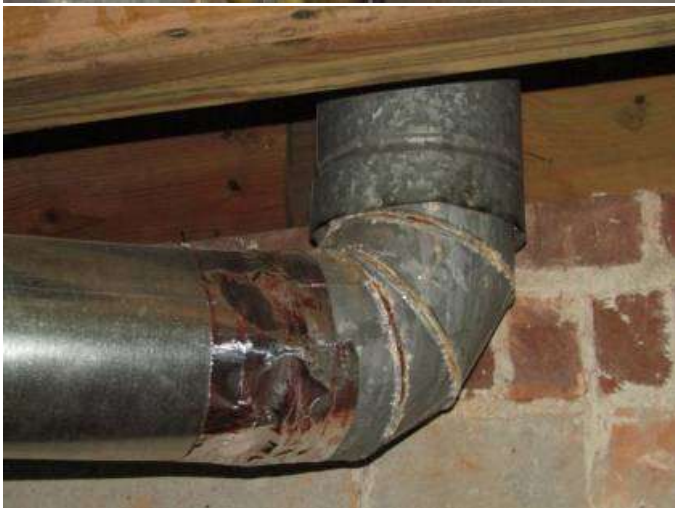
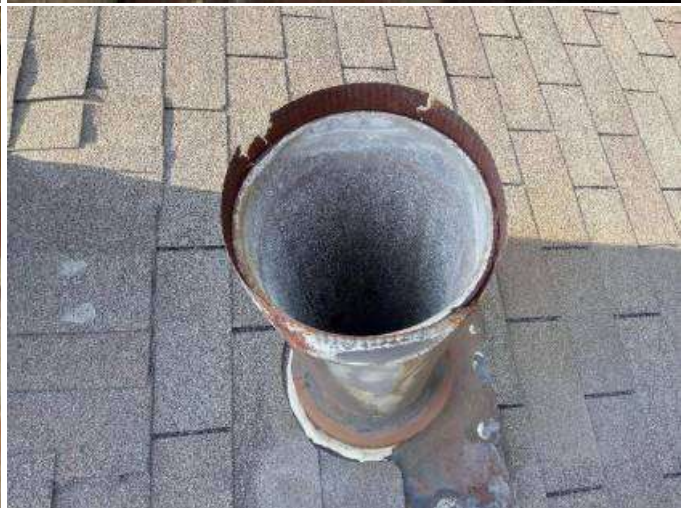
Flue: **Action** - The furnace flue pipe in the crawlspace does not have a continuous slope upward and is rusted. This is an unsafe condition. Flue piping must have a constant rise of at least 1/4" per foot. This can result in carbon monoxide gases entering the home.
- The flue pipe above the roof is rusted and the cap is missing. Recommend having a licensed HVAC contractor check the entire flue system and make all necessary repairs.

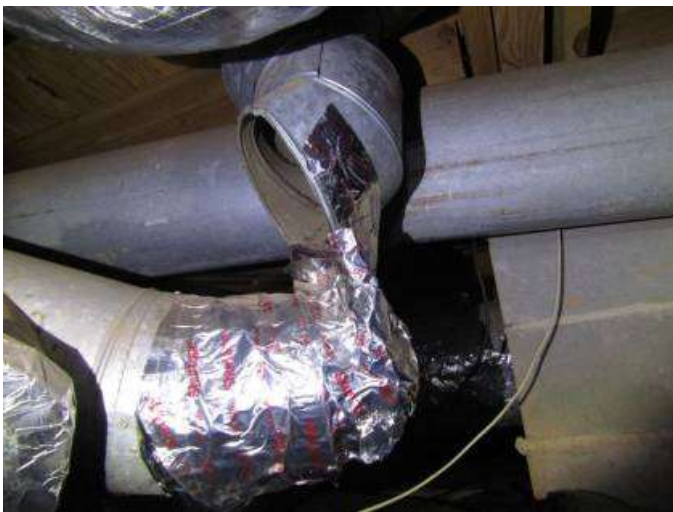
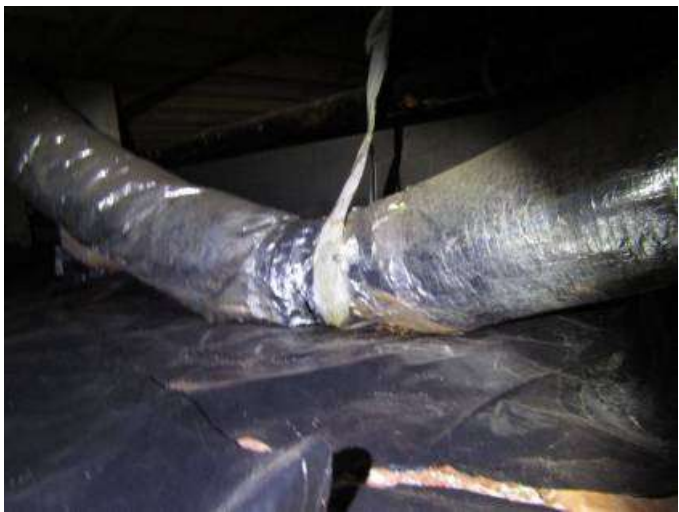
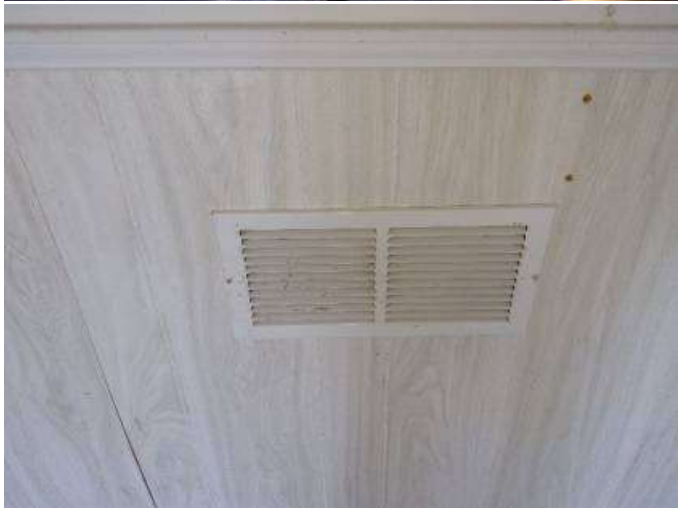
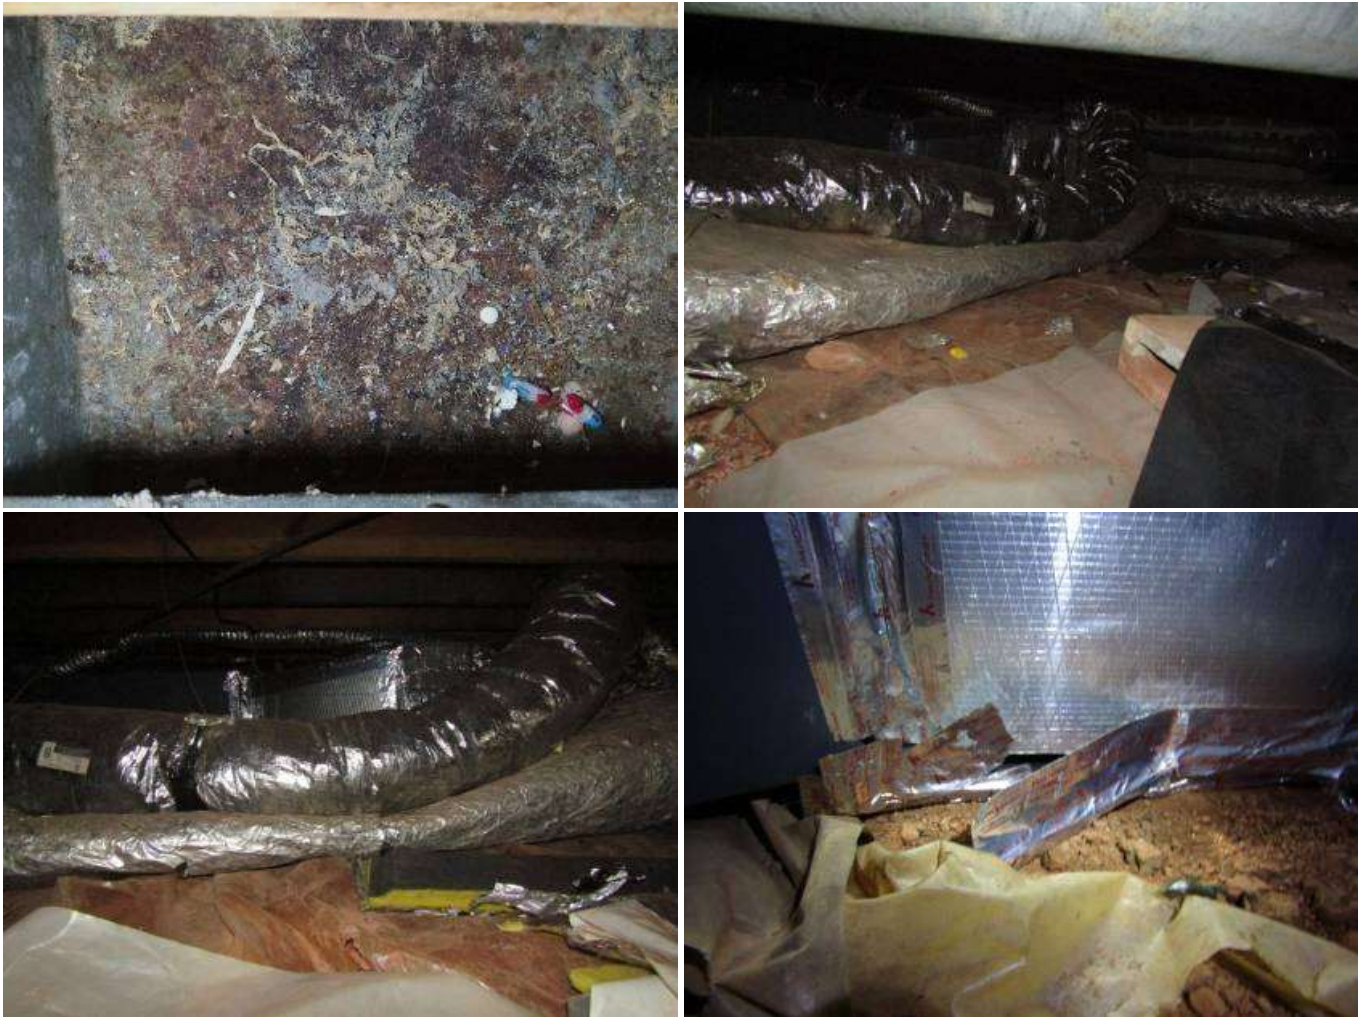
Action - One of the ducts in the crawlspace is disconnected, one of the ducts is crushed and several are laying on the ground.
- There are gaps and air leaks at the plenum.
- Some of the ducts in the crawlspace are not insulated.
- Current building standards do not allow HVAC return vents in garages because of concern of carbon monoxide entering the home.
- The ducts are dirty, professional cleaning of the ducts is recommended.
Recommend having a HVAC contractor evaluate the ducts and repair as needed.

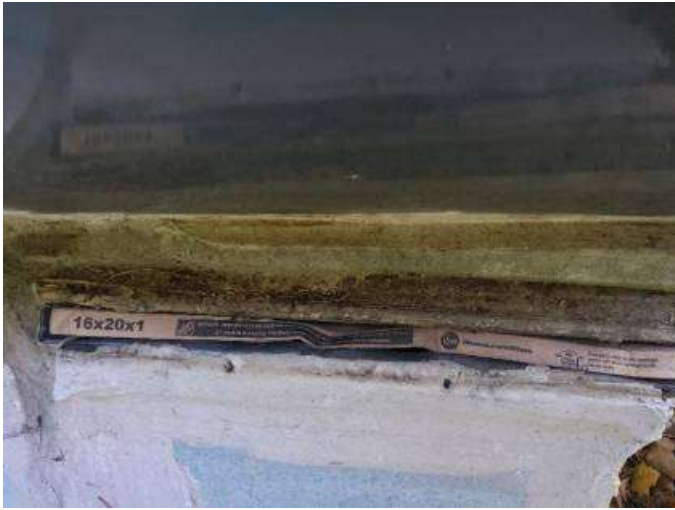
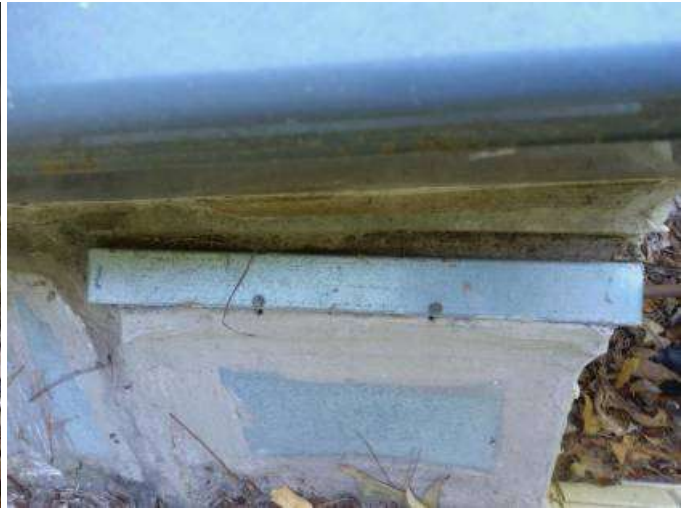
- Description:** Gas fired forced air furnace, 60,000 BTU. Manufactured: 3/2016.
- Condition:** The heating system was turned on and appeared to be operating normally.
- Combustion Air:** Availability of secondary air for combustion and flue draft is adequate.
- Filter:** The air filter is a disposable type. 16" X 20" X 1" It is recommended that the filter be changed every 90 to 120 days for best performance.
- Attention** - The furnace filter is dirty. Replacement is recommended.
- The cover over the filter opening does not keep the rain water out. Repair by a HVAC technician is recommended.

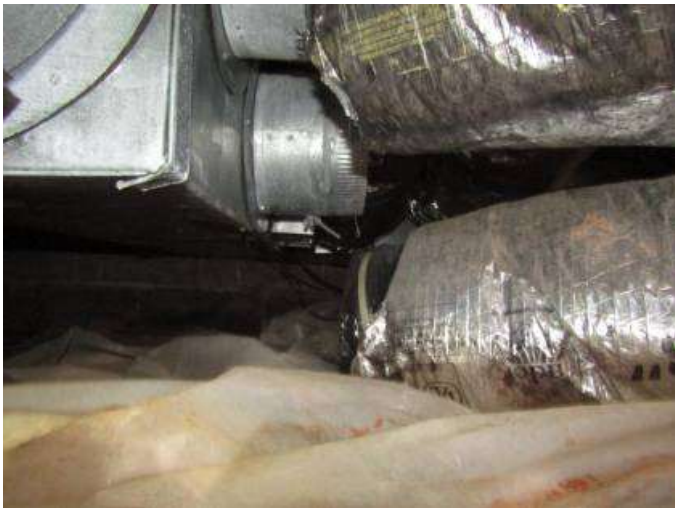
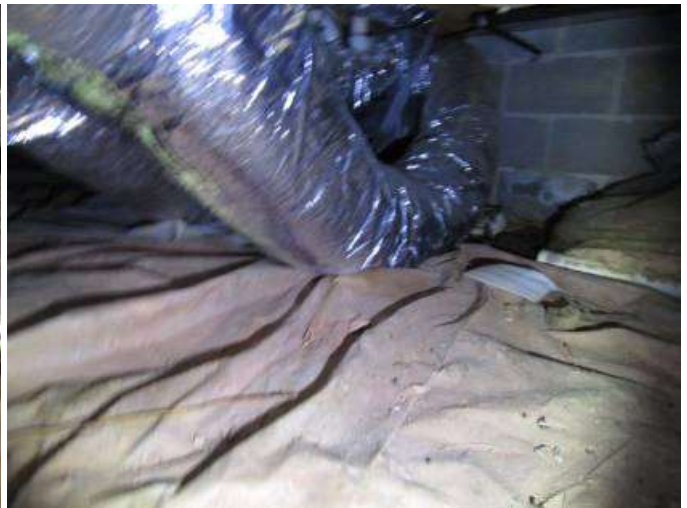
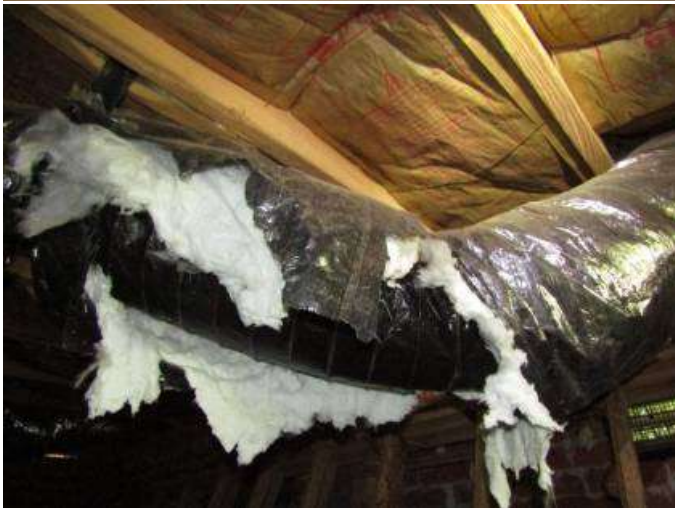
Action - One of the ducts in the crawlspace is disconnected.
- Some of the ducts in the crawlspace are damaged and some are laying on the ground. Repair by a qualified HVAC contractor is recommended.

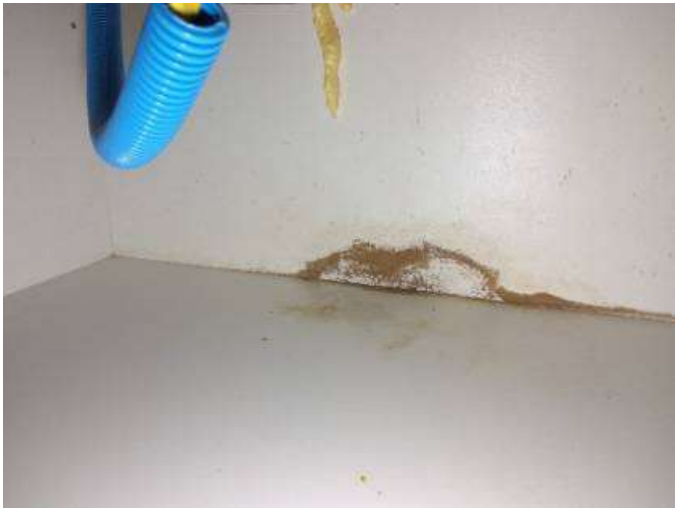
Cabinets: **Attention** - The cabinet underneath the kitchen sink has minor damage from a previous leak.

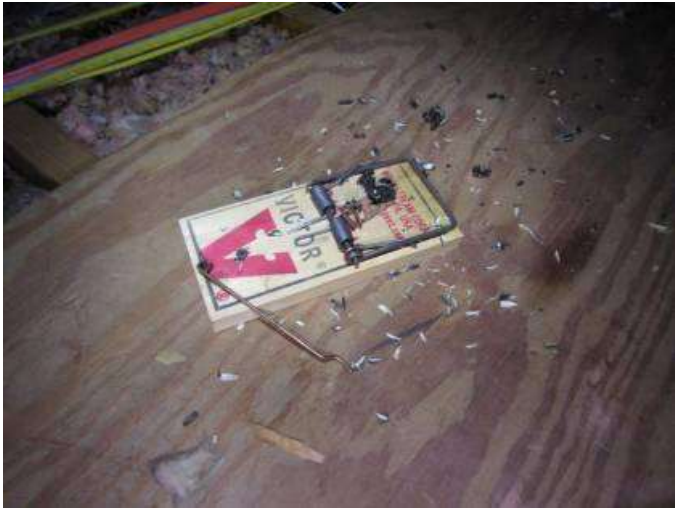
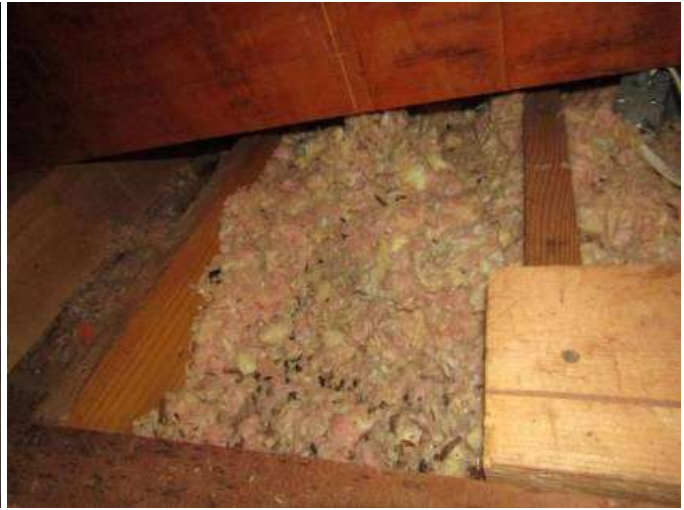
Animals or Insects: **Action** - Rodent droppings and traps were found in the attic and crawlspace. Recommend having the owner or a pest control company verify that the rodents have been removed and all entry points have been closed off. Remove all feces from the home.

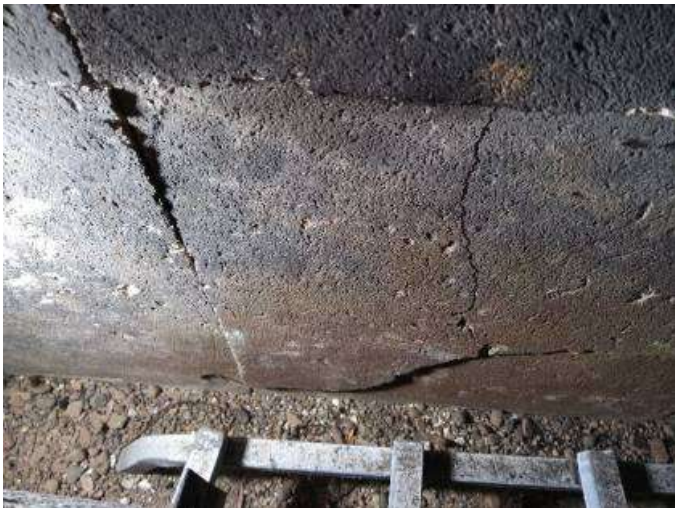
Firebox: **Action** - The heat reflector panel in the rear of the fireplace is cracked. Repair by a chimney sweep is recommended.

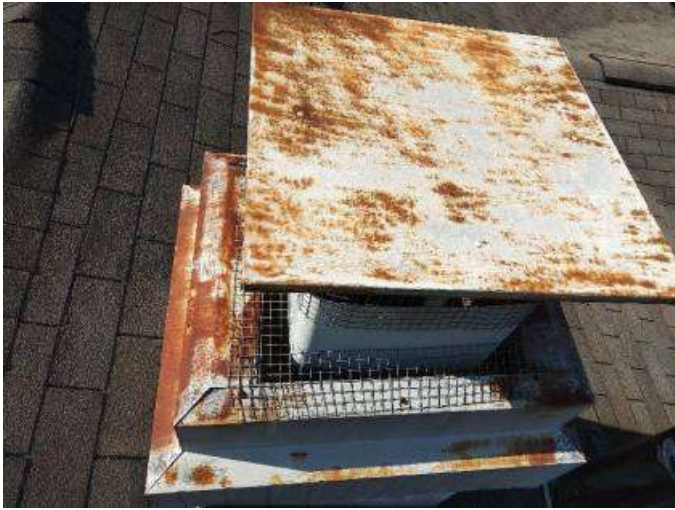
Chimney Cap: **Action** - The cap on the top of the chimney is rusted. Recommend having the cap evaluated by a chimney sweep and painted or replaced as needed to prevent water damage.
