Inspection Report

Property Address:
8980 Moor Park Run
Duluth GA 30097

Residential Inspector of America, Inc.

Date: 8/1/2020	Time: 01:00:00 PM	Report ID: 080120LQ1092
Property: 8980 Moor Park Run Duluth GA 30097	Customer: Adam Zola	Real Estate Professional: Mike Ross Weichert Realty (Atlanta)

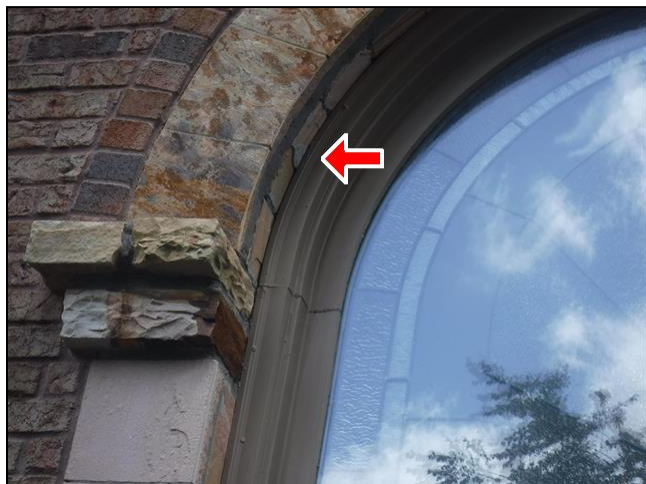
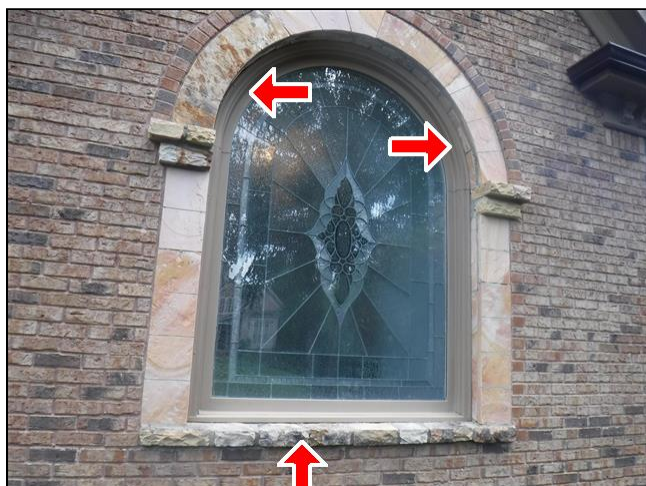
Seal the window trim to the stone siding around the house to prevent water entry into the wall cavity and fixture box. See photo(s) for location(s).

🔧 Seal the window trim to the stone siding around the house to prevent water entry into the wall cavity and fixture box. See photo(s) for location(s).

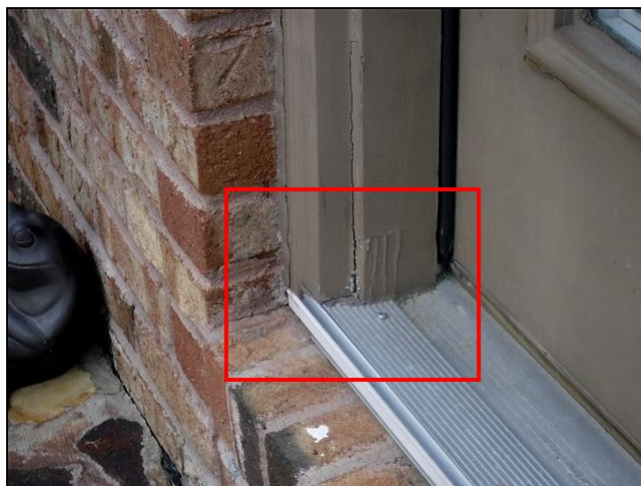
1.2 Item 1(Picture)

Minor rot damage on lower part of the side door(s). Repair or replace damaged wood. It is possible that there have been repairs made to this area in the past, and it can be expected that more damage will occur in the future. This area may be prone to future damage. See photo(s) for example(s).

🔧 Minor rot damage on lower part of the side door(s). Repair or replace damaged wood. It is possible that there have been repairs made to this area in the past, and it can be expected that more damage will occur in the future. This area may be prone to future damage. See photo(s) for example(s).

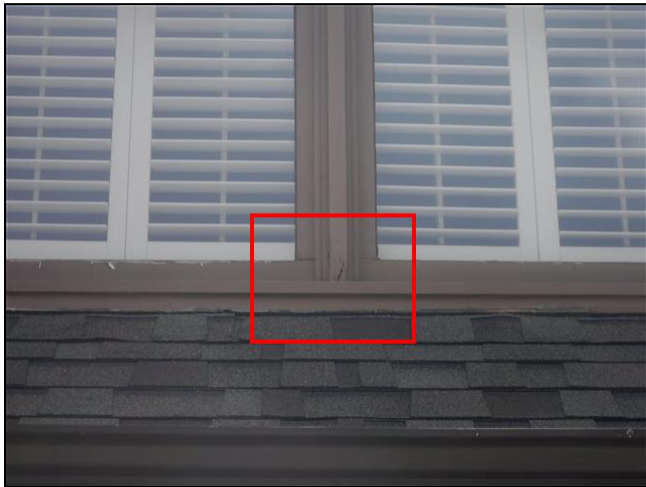
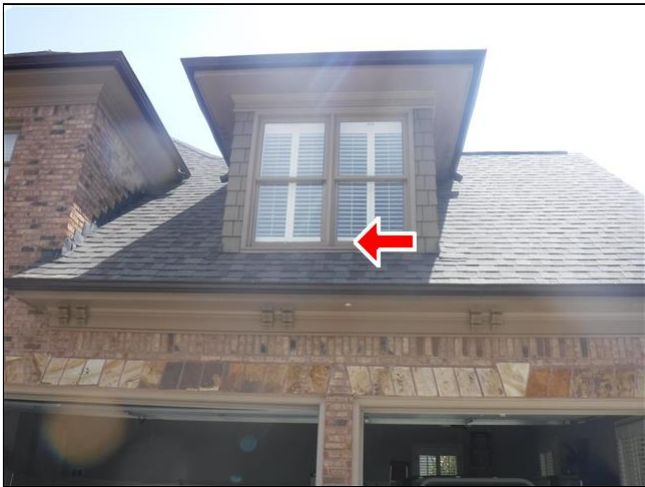
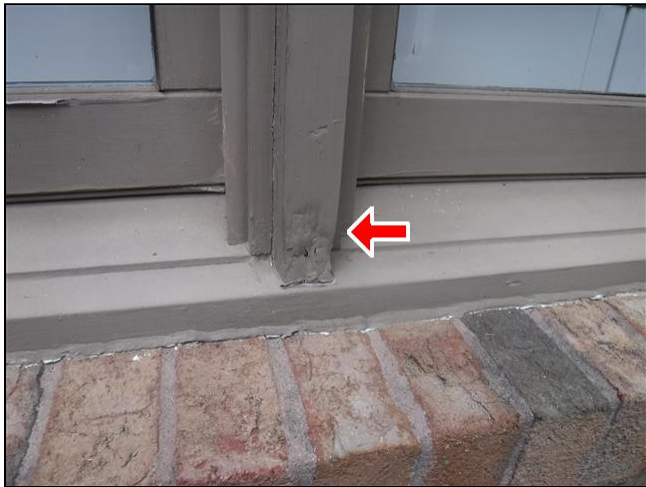
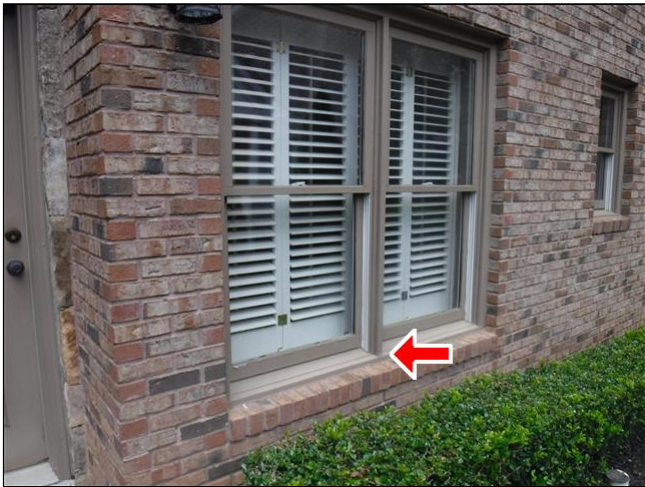
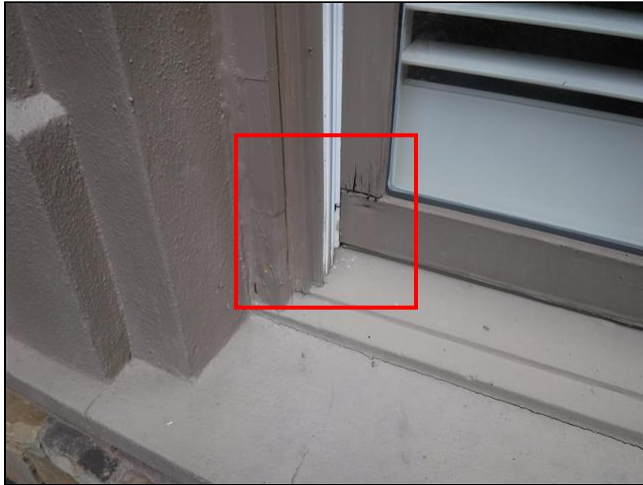
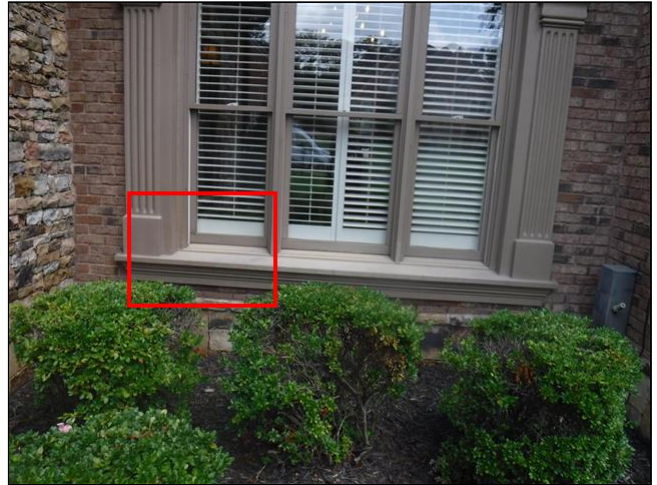
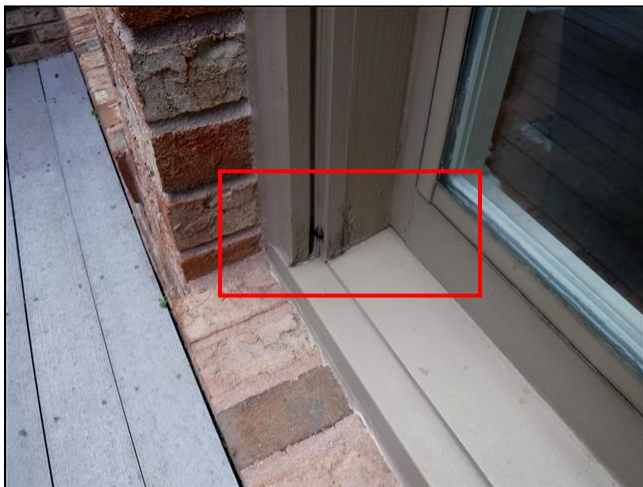
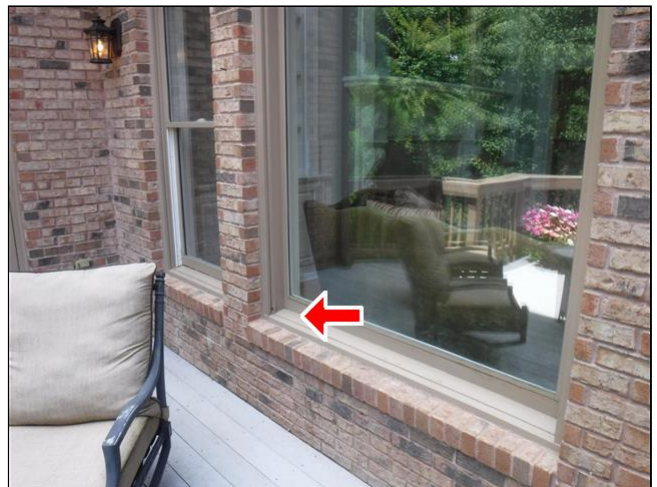
Water damage found on the exterior casing and other wood trim on a few windows. This is common for a house of this type and more should be expected in the future. Have damaged wood repaired or replaced as needed. Extent of any water damage or entry into wall cavity under or around window is not visible and is not known. See photos for locations of damaged trim on windows. Contractor should evaluate trim on house and replace all as needed.

🔧 Water damage found on the exterior casing and other wood trim on a few windows. This is common for a house of this type and more should be expected in the future. Have damaged wood repaired or replaced as needed. Extent of any water damage or entry into wall cavity under or around window is not visible and is not known. See photos for locations of damaged trim on windows. Contractor should evaluate trim on house and replace all as needed.

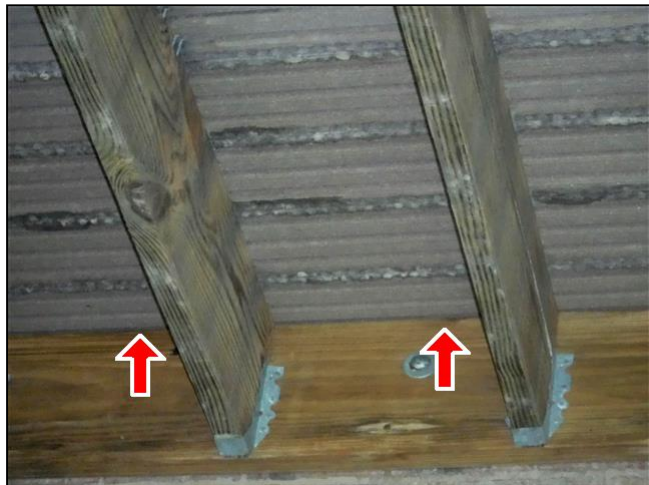
1.4 Item 1(Picture)

(1) No metal flashing could be seen between the rear deck and the rear wall. This was not often enforced or required in older homes, but flashing makes a better seal between the deck and house. Condition of framing between deck and house is not known.

🔧 (1) No metal flashing could be seen between the rear deck and the rear wall. This was not often enforced or required in older homes, but flashing makes a better seal between the deck and house. Condition of framing between deck and house is not known.

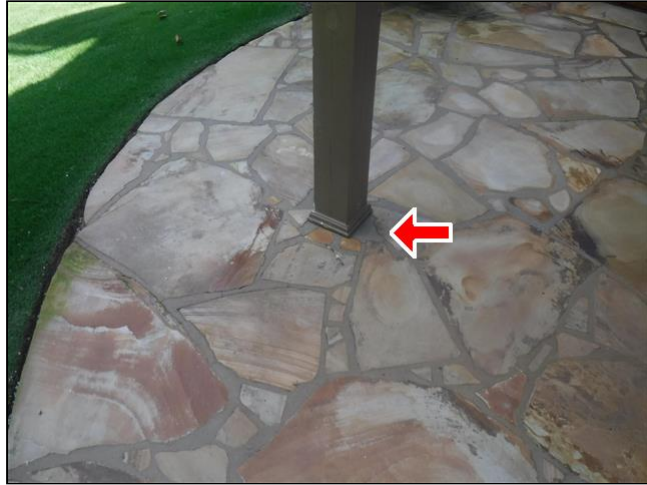
1.4 Item 2(Picture)

(2) It cannot be determined if the rear deck columns are on adequate footings. Columns are sitting on a patio slab that is likely a few inches deep. Footings under columns are intended to be at least 12 inches below the soil and wide enough to prevent movement of columns.

🔧 (2) It cannot be determined if the rear deck columns are on adequate footings. Columns are sitting on a patio slab that is likely a few inches deep. Footings under columns are intended to be at least 12 inches below the soil and wide enough to prevent movement of columns.

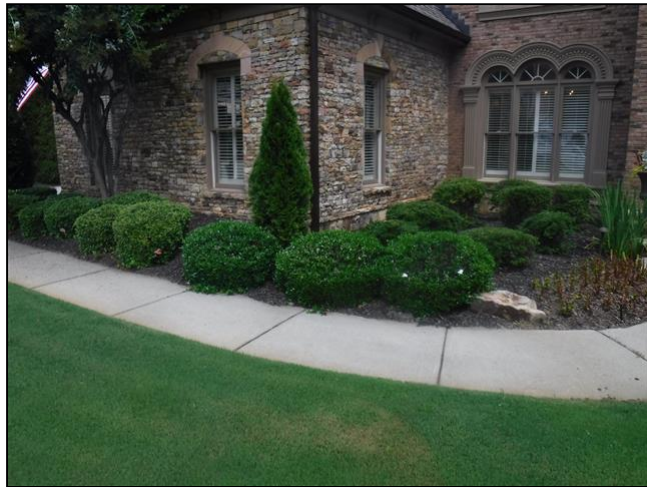
1.5 Item 1(Picture)

(1) The garden area formed by the front wall of the house, and the side walk from the driveway to the front landing, may prohibit quick drainage of run off water. These garden areas often are slow to drain and can cause water entry in the basement. See photo(s) for example(s).

🔧 (1) The garden area formed by the front wall of the house, and the side walk from the driveway to the front landing, may prohibit quick drainage of run off water. These garden areas often are slow to drain and can cause water entry in the basement. See photo(s) for example(s).

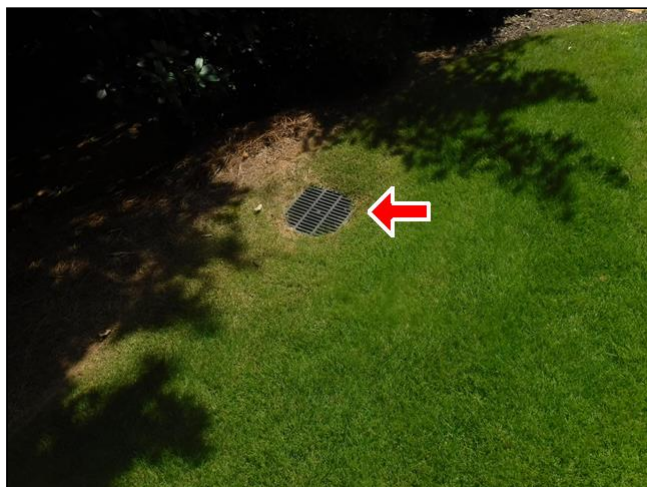
1.5 Item 2(Picture)

(2) Surface drain(s) located at the rear side will need periodical cleaning and maintenance. Drain outlets not found. Have owner point out location of all drain outlets. It cannot be determined if all underground drain tubes are free from obstruction. It will be critical to keep all drain basin grates clear of debris. Flooding may occur if drains are clogged.

🔧 (2) Surface drain(s) located at the rear side will need periodical cleaning and maintenance. Drain outlets not found. Have owner point out location of all drain outlets. It cannot be determined if all underground drain tubes are free from obstruction. It will be critical to keep all drain basin grates clear of debris. Flooding may occur if drains are clogged.

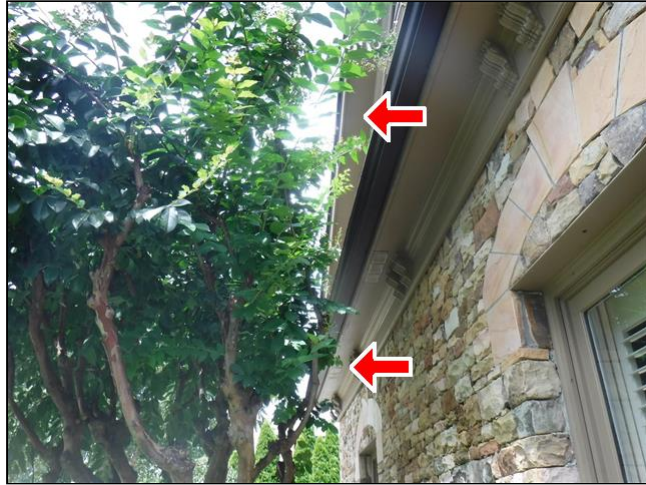
1.5 Item 3(Picture)

(3) Trim vegetation away from siding. It is best to have a clear path around the house so periodic inspections can be made to prevent vines/branches from damaging siding. See photo(s) for example(s).

🦋 (3) Trim vegetation away from siding. It is best to have a clear path around the house so periodic inspections can be made to prevent vines/branches from damaging siding. See photo(s) for example(s).

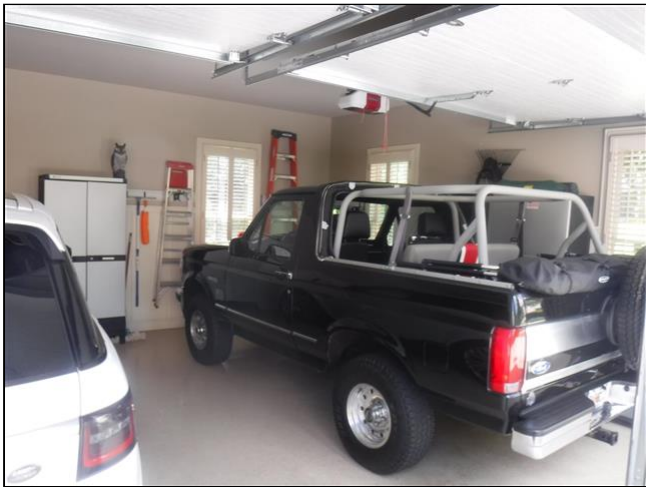
2.1 Item 1(Picture)

Garage inspection was limited due to the amount of stored items being in the garage at the time of the inspection. See photo(s) for example(s). Buyer should resolve all concerns prior to closing.

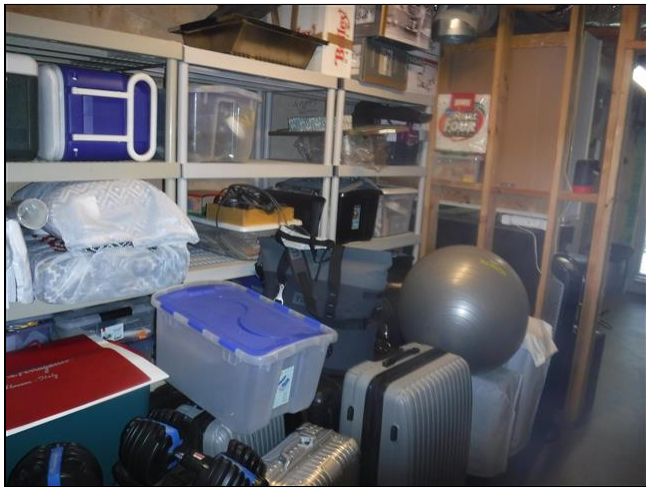
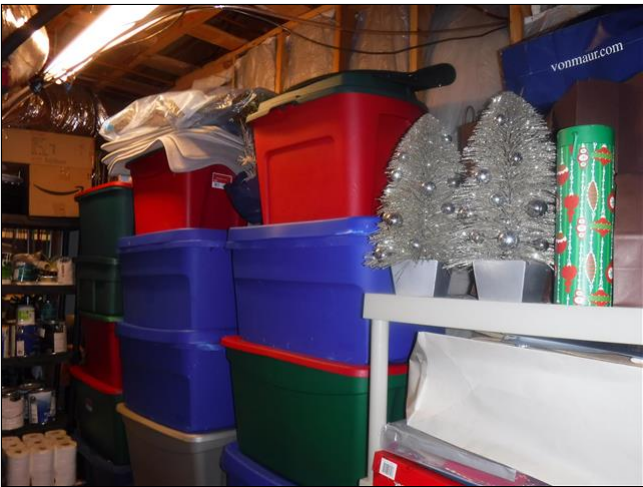
(1) Many stored items in the basement limiting visual inspection of the floor and walls. Insulation was not removed from between all floor and rim joist. It is possible that some concealed defects may be revealed when stored items are removed.

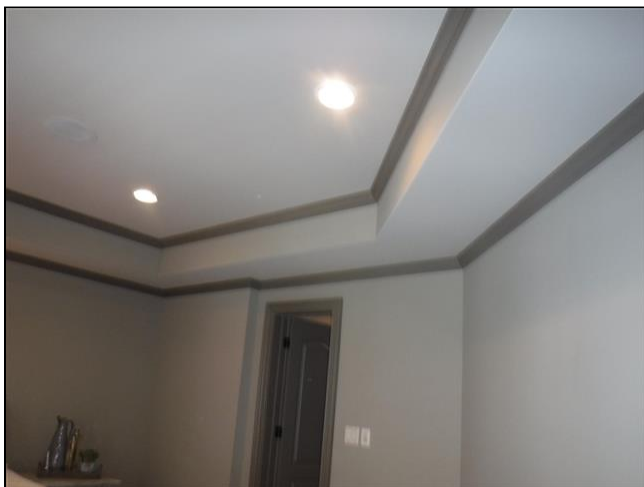
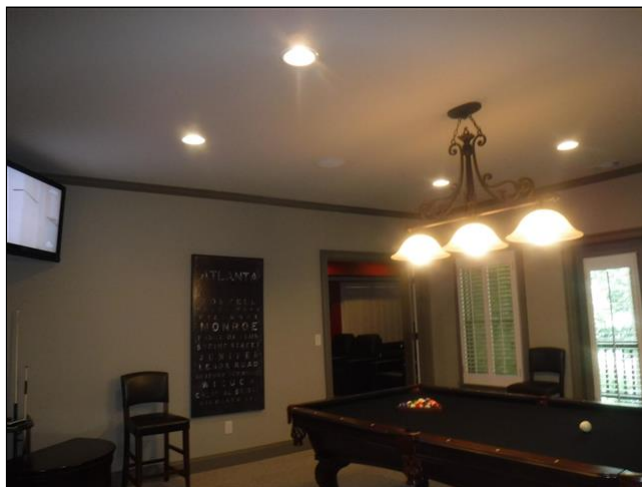
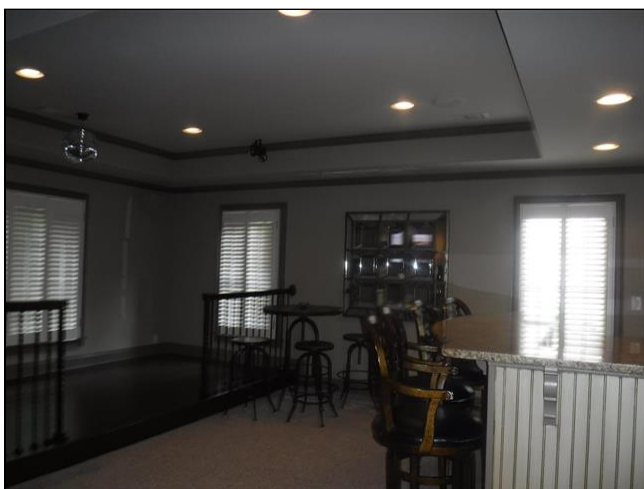
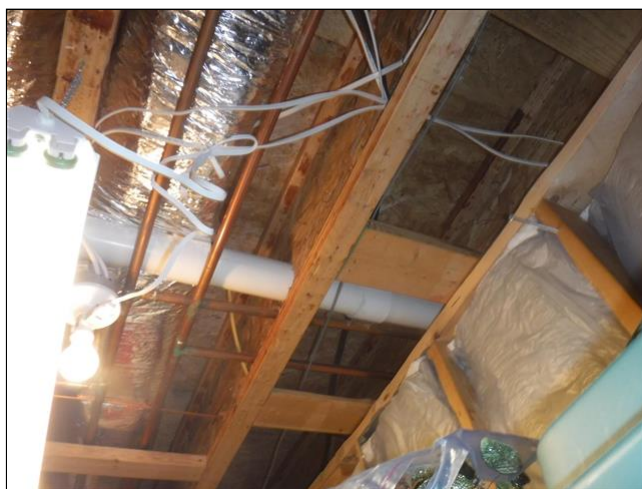
(2) Basement is mostly finished limiting visual inspection of the floor, walls and ceiling areas. Not all insulation was removed from between floor joist and along rim joist. A few unfinished areas were available for inspection of space between drop ceiling and floor frame.

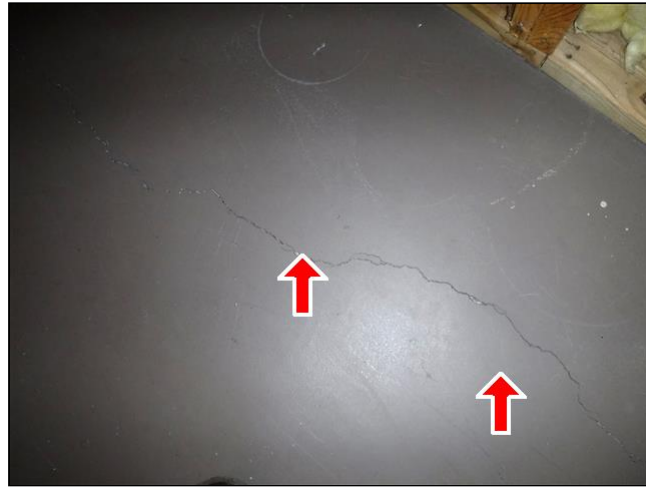
3.3 Item 1(Picture)

Cracks in concrete basement floor are not wide enough to be a structural concern and are likely due to settlement. See photos. Have patched as needed.

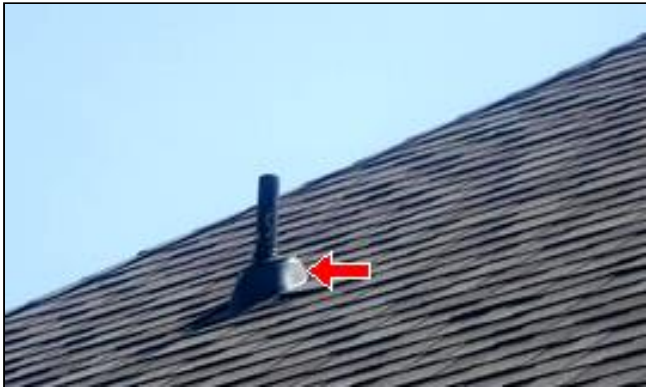
4.2 Item 1(Picture)

Boot flashing around plumbing vents on the roof are ok now, but these last about 5-7 years before needing replacement. They crack and split and allow rain water to leak into attic.

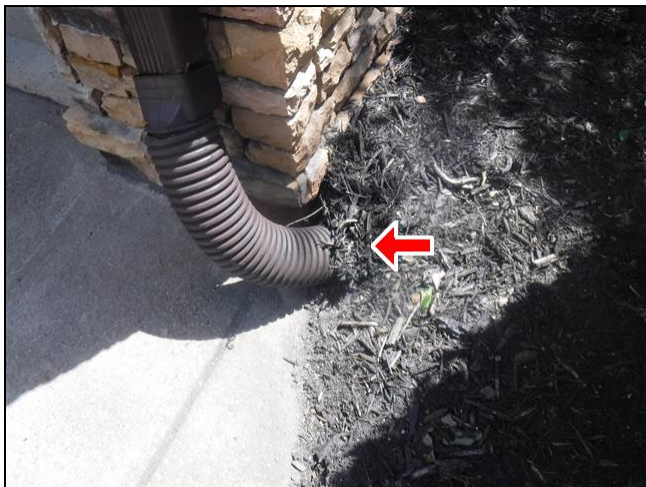
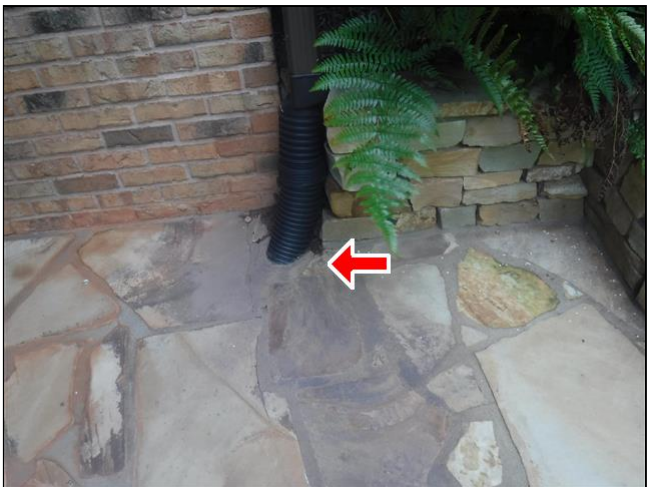
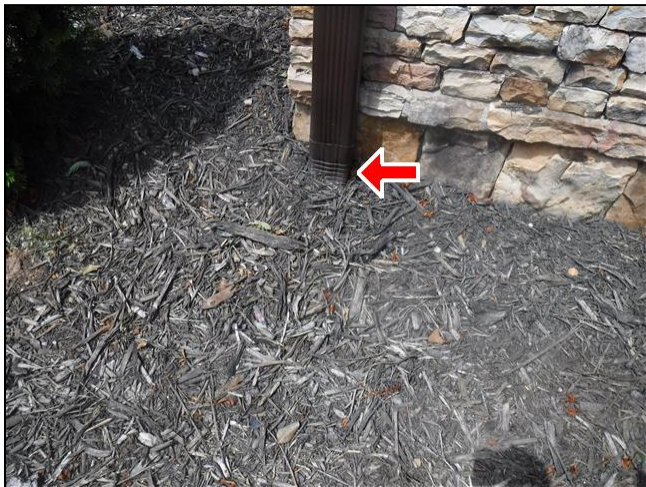
Have owner point out location of the outlets of the buried down spout extensions. They should come to daylight and the ends were not found.

🔧 Have owner point out location of the outlets of the buried down spout extensions. They should come to daylight and the ends were not found.

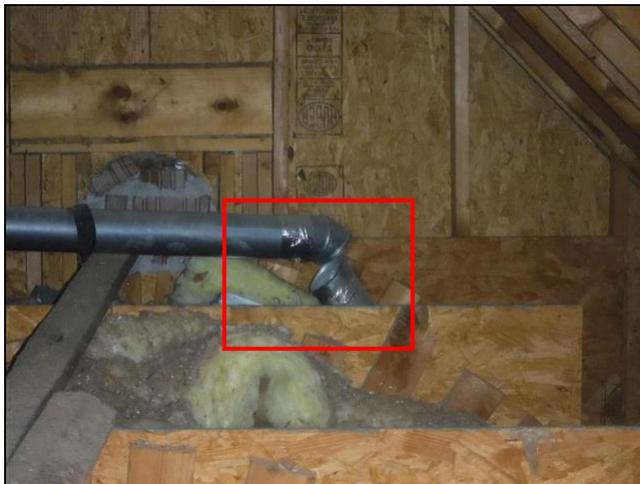
5.3 Item 1(Picture)

The master bathroom vent fan pipe is disconnected and venting into attic space. Have vent pipe reconnected.

🔧 The master bathroom vent fan pipe is disconnected and venting into attic space. Have vent pipe reconnected.

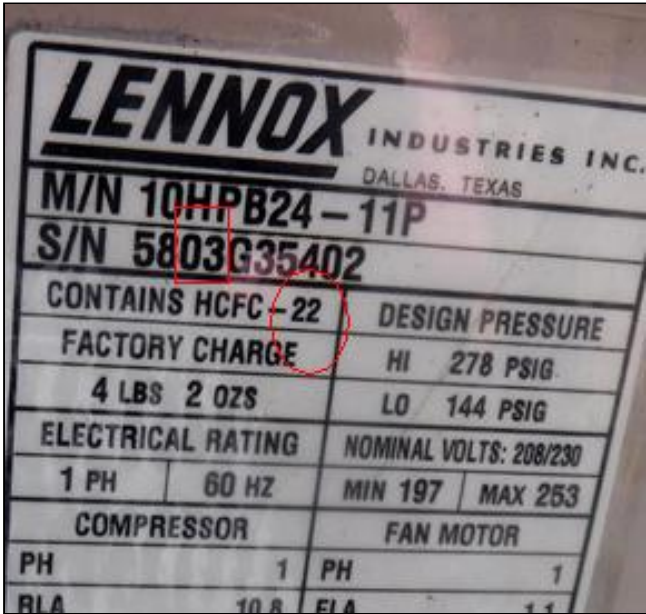
6.6 Item 2(Picture)

(3) A/c unit(s) is the older R-22 type of refrigerant gas (freon) that is being phased out of production and will likely be expensive and difficult to find in the near future. The newer type of freon does not mix with the older type.

A/c unit(s) usually last about 15 years, and it is likely that the unit(s) in this home will need replacement in the near future.

🔧 (3) A/c unit(s) is the older R-22 type of refrigerant gas (freon) that is being phased out of production and will likely be expensive and difficult to find in the near future. The newer type of freon does not mix with the older type.

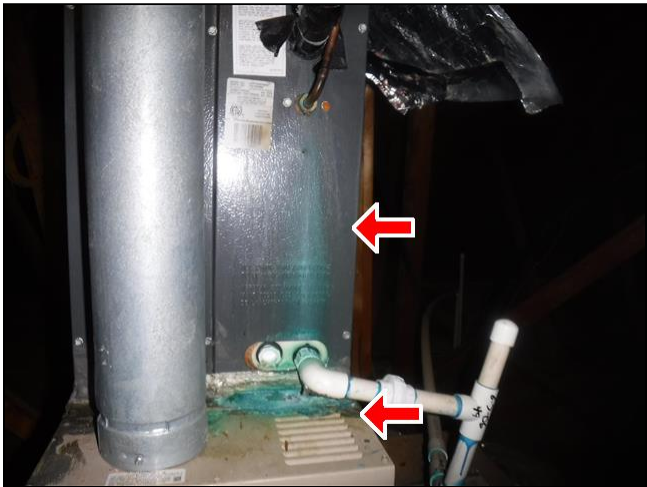
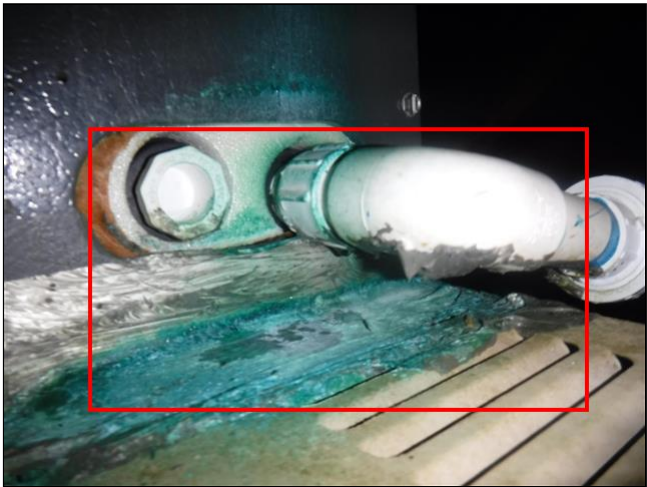
(4) Evidence of condensation leaks were noted at the top of the attic unit (green stains). These leaks caused minor rust inside the unit. There is a note on the evaporator coils indicating that there was a leak at this area. Have the seller ascertain that any leaks were properly repaired or have an HVAC contractor evaluate this situation to make repairs as needed.

🔧 (4) Evidence of condensation leaks were noted at the top of the attic unit (green stains). These leaks caused minor rust inside the unit. There is a note on the evaporator coils indicating that there was a leak at this area. Have the seller ascertain that any leaks were properly repaired or have an HVAC contractor evaluate this situation to make repairs as needed.

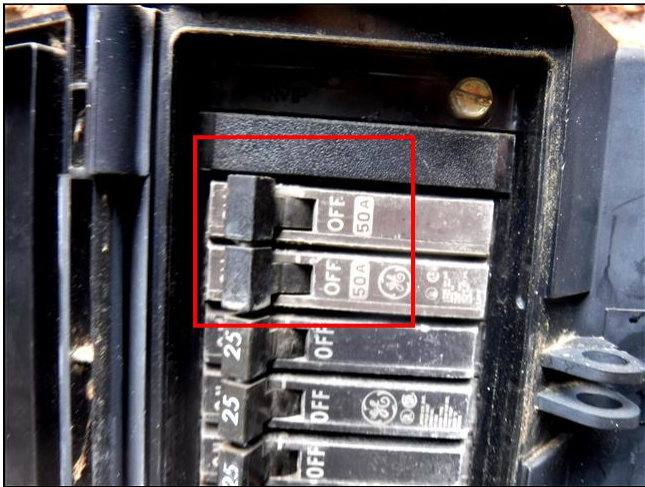
7.3 Item 1(Picture)

(1) Breaker in the electrical panel for the a/c unit is the 50 amp type. Info tag on the a/c unit outside calls for a 35 amp breaker to be the max size. Breaker in panel is 15 amps over sized. Have electrician change breaker to the required size.

🔧 (1) Breaker in the electrical panel for the a/c unit is the 50 amp type. Info tag on the a/c unit outside calls for a 35 amp breaker to be the max size. Breaker in panel is 15 amps over sized. Have electrician change breaker to the required size.

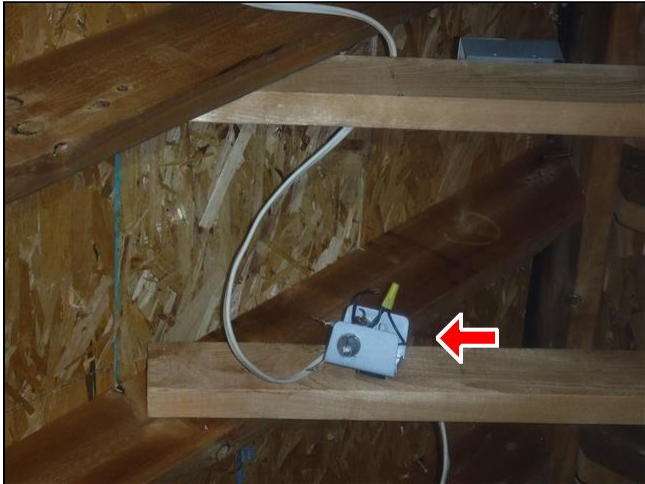
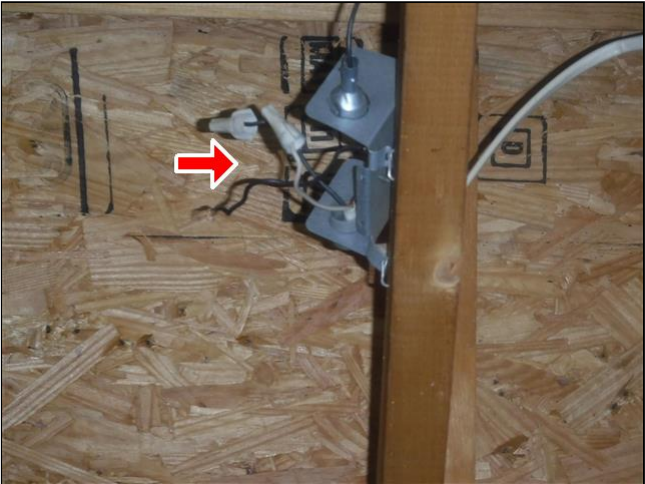
(2) Cover needed on the open junction box in the attic (front part) area. Covers are used to control sparking.

🔧 (2) Cover needed on the open junction box in the attic (front part) area. Covers are used to control sparking.

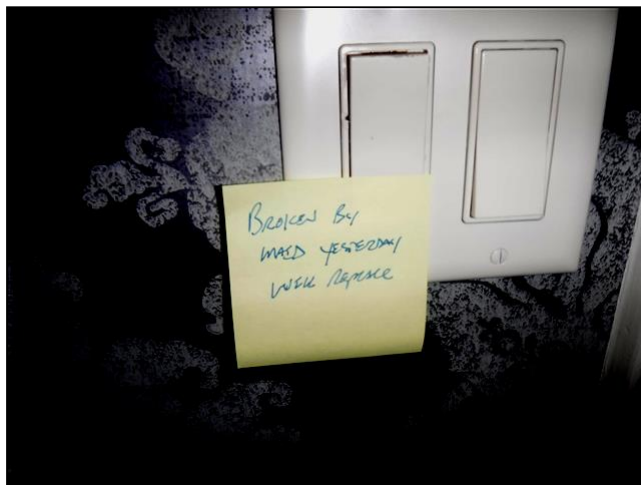
7.4 Item 1(Picture)

Half bath fan switch broken, have repaired or replaced as needed.

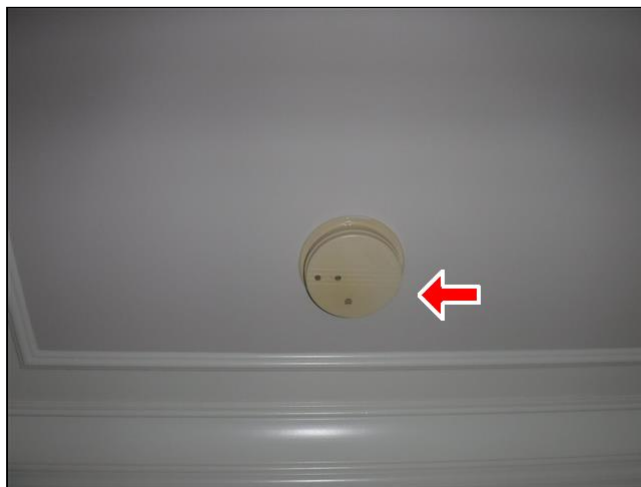
7.7 Item 1(Picture)

Smoke detectors can last 10 years before needing replacement. Smoke detectors in this house work, but it is recommended that they be replaced. See photo(s) for example(s).

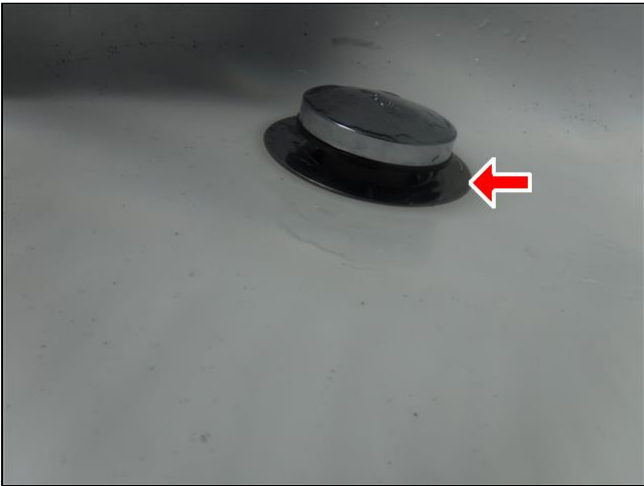
8.2 Item 1(Picture)

(1) Master bath tub stopper does not engage fully. Water continues to drain when in the closed position. Adjust or replace as needed.

🔧 (1) Master bath tub stopper does not engage fully. Water continues to drain when in the closed position. Adjust or replace as needed.

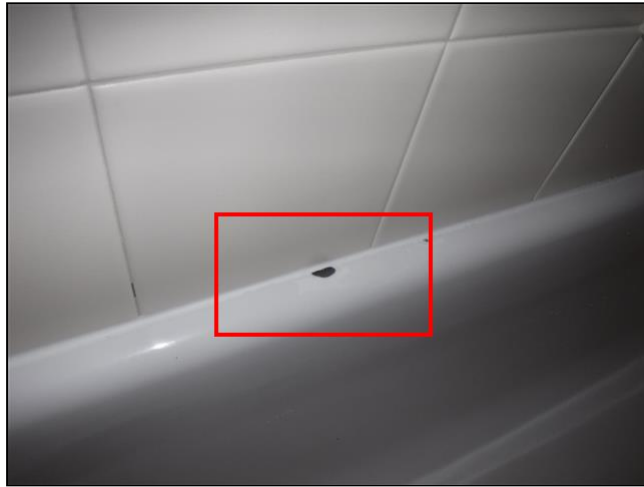
8.2 Item 2(Picture)

(2) Tub in upstairs bath has chip on the top. Have repaired to prevent rust and further damage to finish.

🔧 (2) Tub in upstairs bath has chip on the top. Have repaired to prevent rust and further damage to finish.

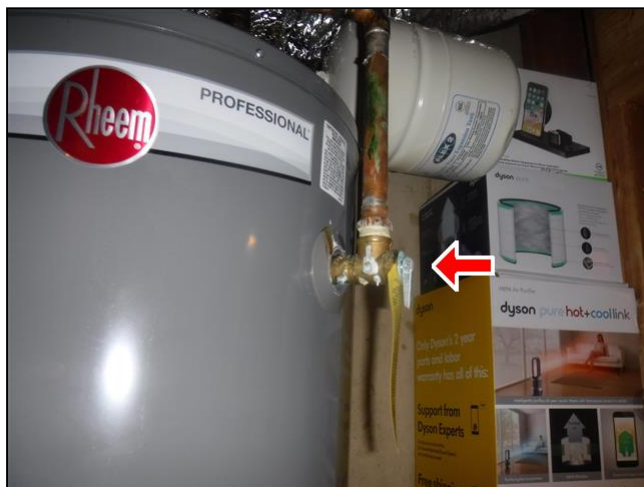
8.3 Item 2(Picture)

🔧 (2) Bleeder valve needed on the drain pipe from the temperature pressure relief valve since the drain pipe is routed in an up position. See photo(s) for example(s).

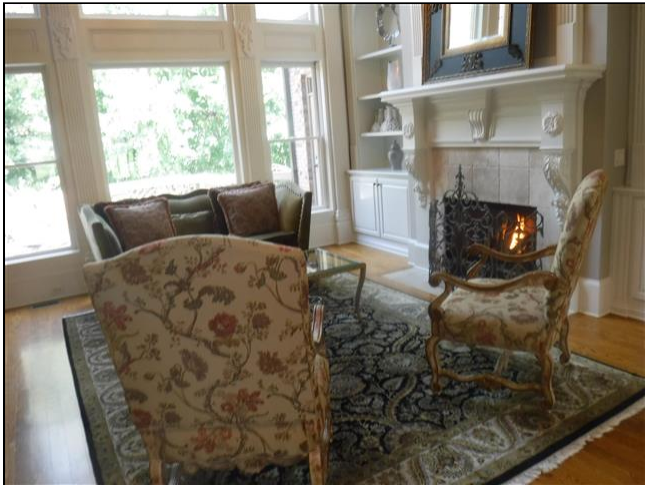
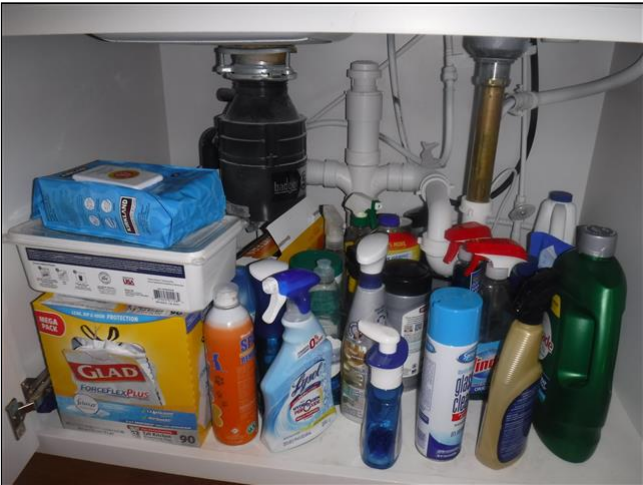
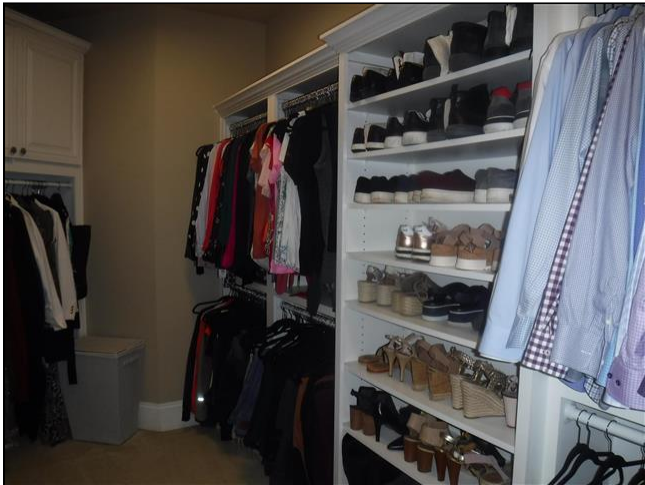
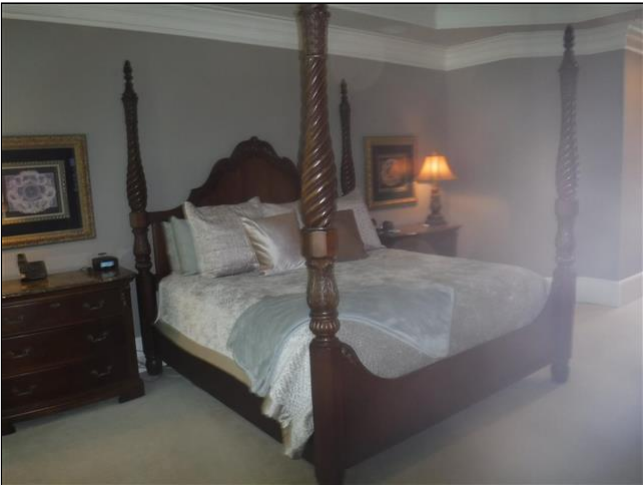
Many stored items were in the house during the inspection, somewhat limiting visual inspection of walls, windows, floors, closets, areas under sinks, ect... It is possible that some defect issues may be concealed in areas not accessible or visible during this inspection.

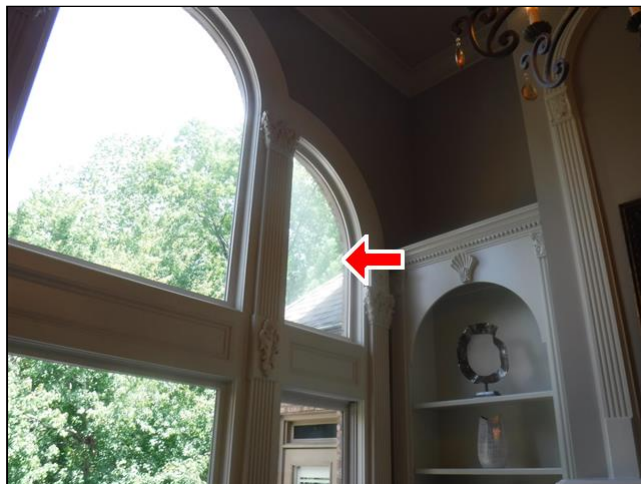
9.5 Item 1(Picture)

Replace all "fogged" windows. The seal between the panes of glass has failed allowing moisture to enter between the panes. It is possible that more may fog in the future. Have window contractor evaluate all windows because it is highly likely that if one window has had a seal failure, that more seal failures in different windows will occur. See photos for examples. It is difficult to identify seal failure in windows when the weather is rainy, over cast, foggy or the glass is wet from recent rains or condensation. Buyer should resolve all concerns prior to closing.

🔧 Replace all "fogged" windows. The seal between the panes of glass has failed allowing moisture to enter between the panes. It is possible that more may fog in the future. Have window contractor evaluate all windows because it is highly likely that if one window has had a seal failure, that more seal failures in different windows will occur. See photos for examples. It is difficult to identify seal failure in windows when the weather is rainy, over cast, foggy or the glass is wet from recent rains or condensation. Buyer should resolve all concerns prior to closing.

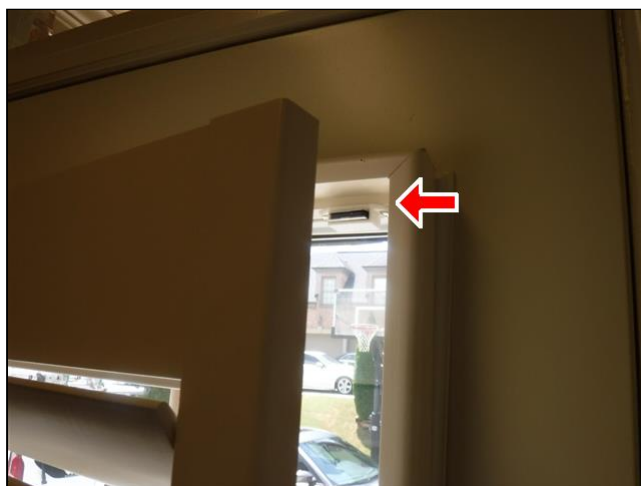
9.7 Item 1(Picture)

Plantation shutter at laundry egress door will not stay latched. Have adjusted or repaired as need to avoid damage to shutter, frame or surrounding area and items.

🔧 Plantation shutter at laundry egress door will not stay latched. Have adjusted or repaired as need to avoid damage to shutter, frame or surrounding area and items.

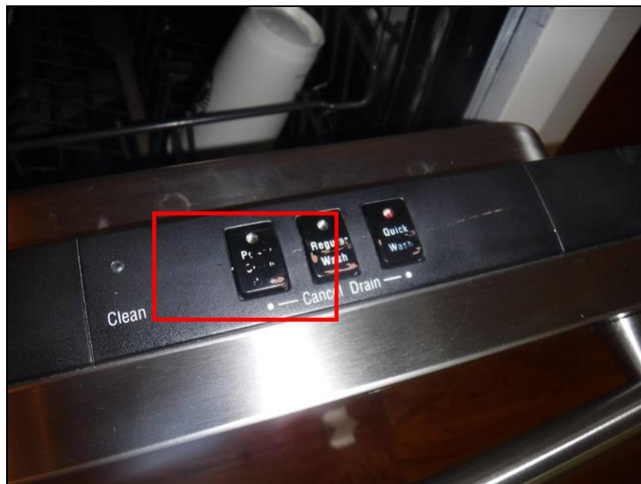
10.0 Item 1(Picture)

Worn out and damaged touch control panel on front of dishwasher. Unit works, but panel is worn out.

🔧 Worn out and damaged touch control panel on front of dishwasher. Unit works, but panel is worn out.

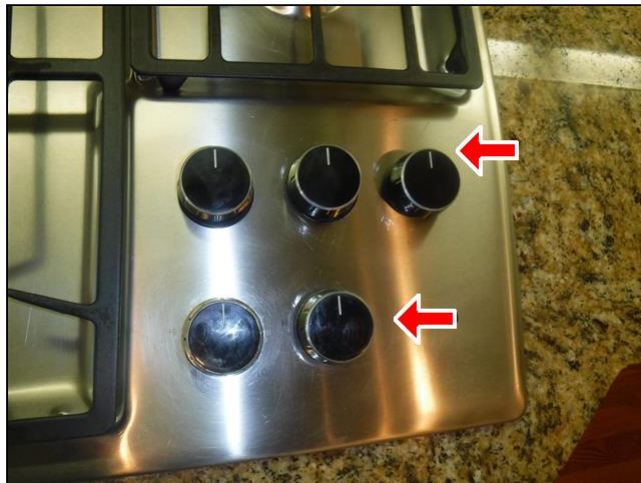
10.1 Item 1(Picture)

Dial indicators on stove top are worn and faded. Difficult to determine settings.

🔧 Dial indicators on stove top are worn and faded. Difficult to determine settings.
