Property Address: 1220 Primrose Dr, Roswell, GA 30076

Inspector: Ronnie McCaskill
Company: WIN Home Inspection- Roswell
dba
(770) 650-1601
rmccaskill@wini.com

Standard Full Home Inspection

Service Date: 8/19/2020

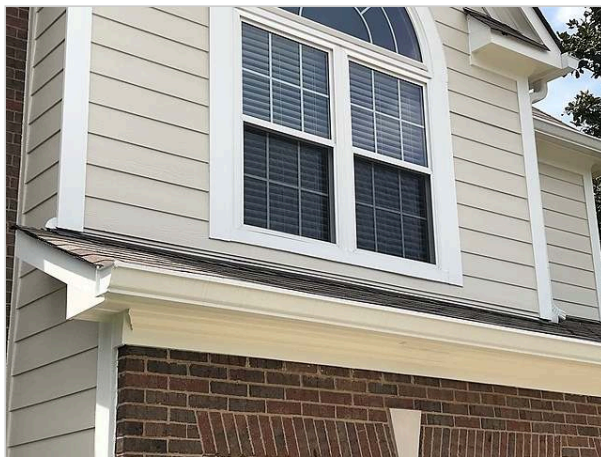
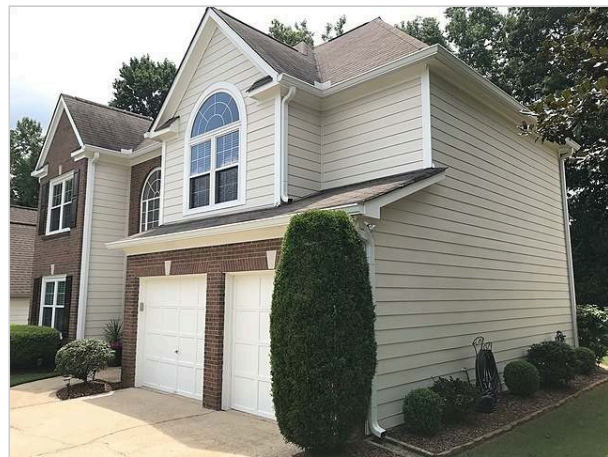
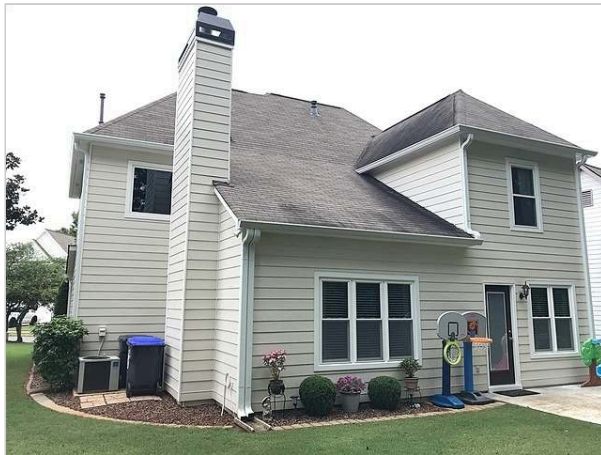
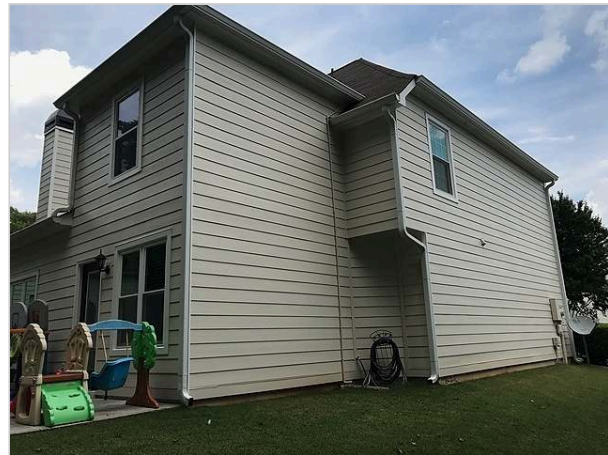
1. Structure - Repairs Evident

The inspector noted that the home has undergone renovations to include replacing of the siding, exterior trim, and windows. These items appear to be correctly installed and should provide long service life. We recommend questioning the Seller as to why the siding was replaced, who did the work, and whether there are any warranties for material or workmanship.

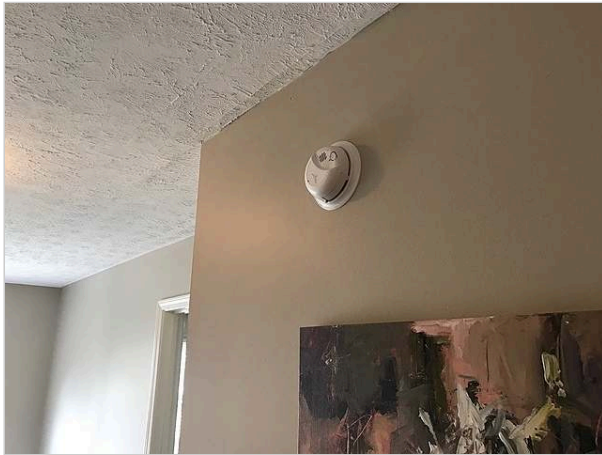
2. Structure - Carbon Monoxide Detector(s)

The inspector could not verify that there are any functional hard-wired carbon monoxide (CO) detectors in the home. We do not recommend using plug-in or battery powered CO detectors where possible due to the risk of these not working when needed. Fire safety officials recommend that a CO detector be placed on each floor of the home and outside of sleeping areas. We recommend installing CO detectors that are hardwired to power with a battery back-up as directed by the manufacturer. Newer guidelines require that smoke/CO detectors be interlinked so that if one goes off they all alarm. The existing smoke detectors in the hallways could be changed to combination smoke/CO detectors to accomplish the above recommendation.

Appears to be smoke only

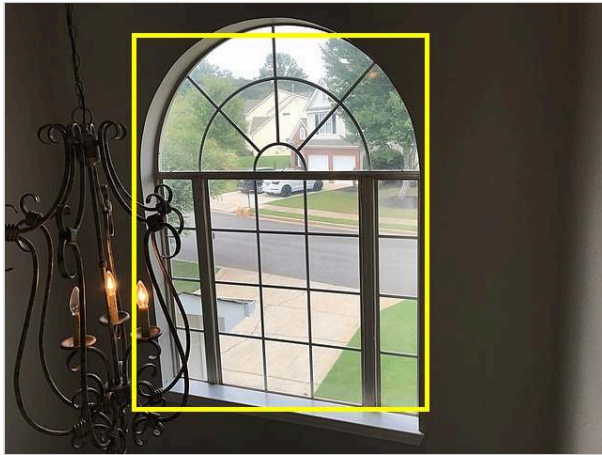
The inspector found double pane insulating windows that have defective seals as depicted in the photos below. These windows have a slightly reduced energy efficiency and may look hazy and/or have condensation visible under certain atmospheric conditions. Condensation is not always evident under differing weather conditions or exposures to the sun. The visibility through the glass may deteriorate over time and we only recommend replacing these windows should the Buyer deem the hazy appearance unacceptable.

Double pane seal has failed

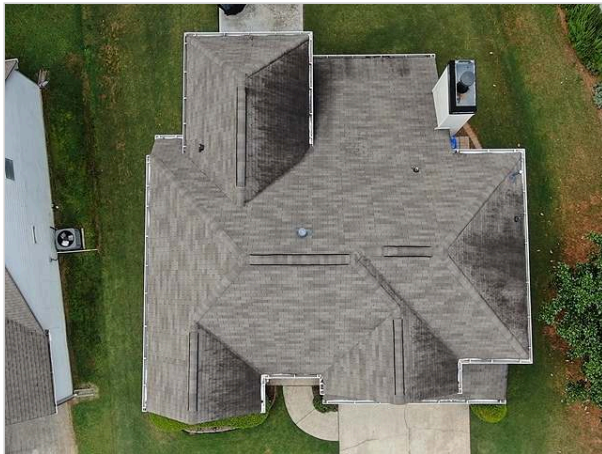
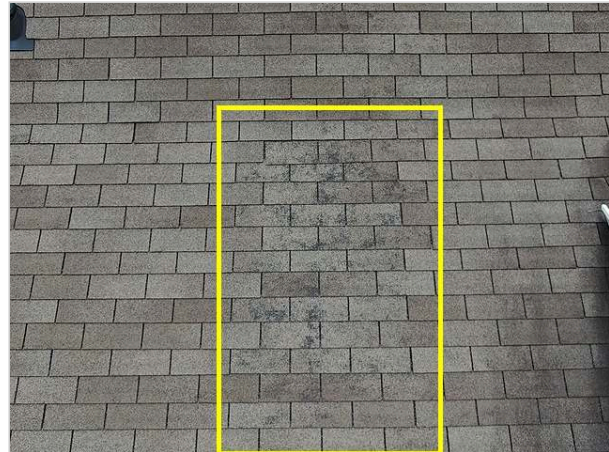
7. Roof - Cover Material Condition

The roofing shingles were inspected and we found some localized moderate granule loss that may be due to workers on the roof when the siding was replaced. Periodic inspection and maintenance of the shingles, vents/ chimneys, and flashing is recommended to prevent leaks and address deficiencies early.

Localized granule loss

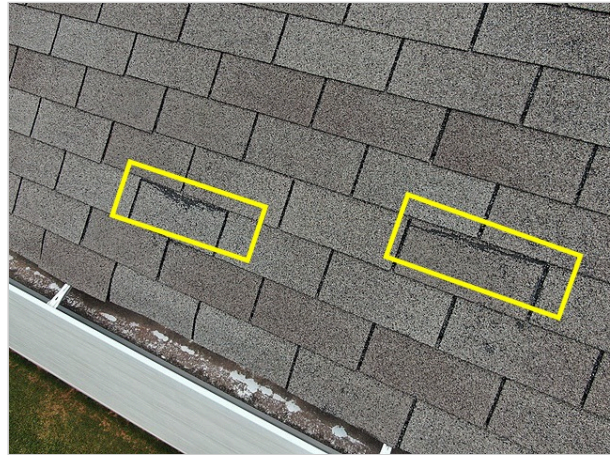
Possible wind damage

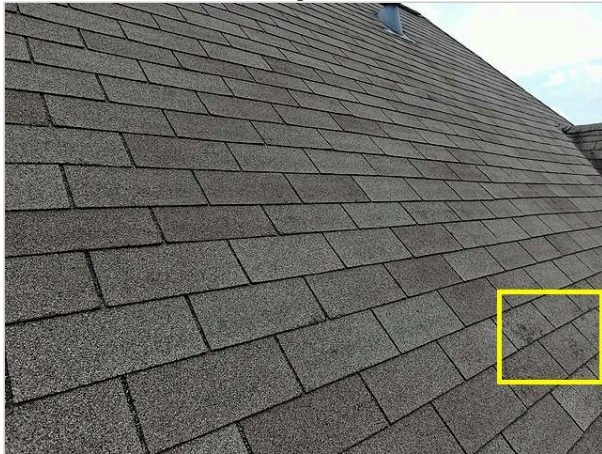
Localized granule loss

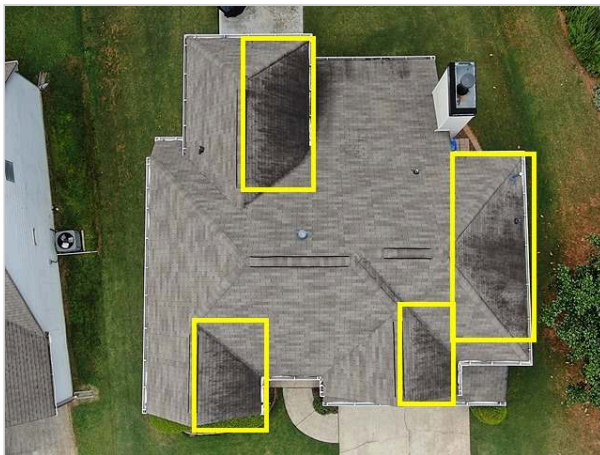
Discoloration of the asphalt shingle roof appeared to be the result of algae growth, indicated by areas of reduced growth on shingles located downhill from metal roof flashing. Zinc in galvanized metal-based flashing inhibits algae growth. Algae growth is a cosmetic issue and will have little effect on shingle roof performance. Improper efforts to remove algae can damage shingles. Any efforts to remove algae should be made by a qualified contractor.

Black Algae

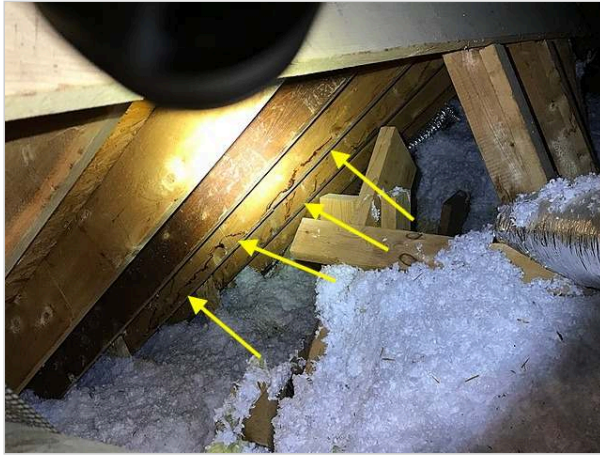
The Inspector noted a moisture stains at the attic framing above the second floor hall bathroom as noted in the photos below that may be due a current or past roof leak. The area could not be tested with a moisture meter due to their not being a safe walk path. We recommend questioning the Seller as to the history of the stains and any leaks that may have been repaired. Leaks into the structure of a home can result in mold, hidden structural damage, and may attract insects like termites. Additional damage may not be evident to the inspector or may be hidden and we recommend that the area of the leaks be fully evaluated for any of these concerns during the Buyers due diligence period.

Moisture stains on attic framing

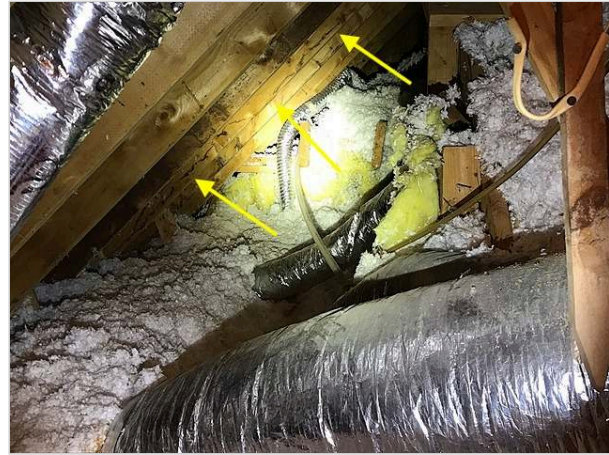
Moisture stains on attic framing

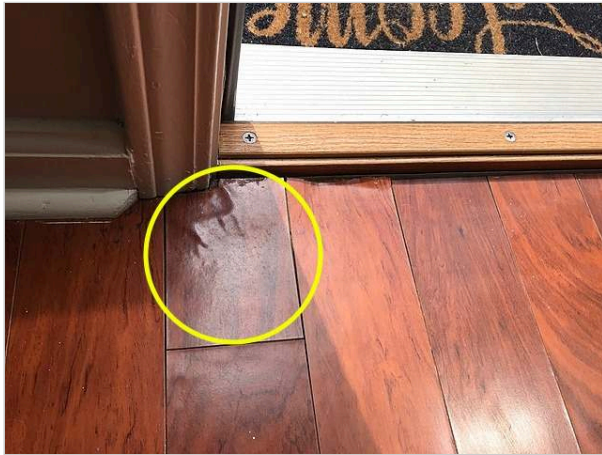
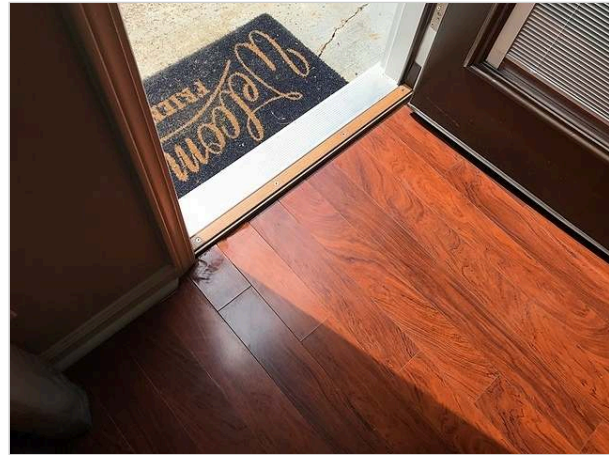
The inspector noted some damage to the flooring near the exterior patio door that is likely due to wind driven rain. The weather stripping at the door is satisfactory and we recommend the Buyer monitor the area during periods of rain to determine if moisture is still entering the home.

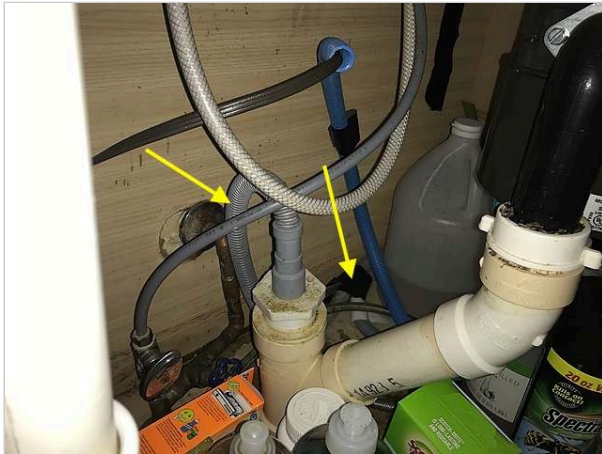
The Inspector noted that the dishwasher drain tube does not loop up to the level of the countertop. There may be enough slack in the line to accomplish this with the current line. We recommend having a qualified handyman or homeowner adjust the drain tube so that a potential backup in the plumbing does not contaminate the dishwasher with bacteria.

Dishwasher drain tube does not attach near
countertop level

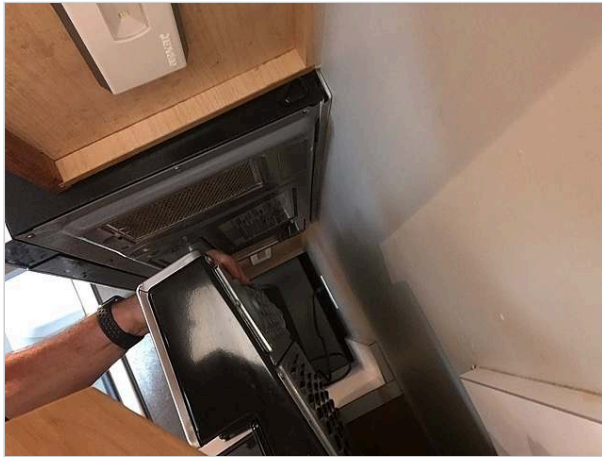
The oven does not have an anti-tip device that would keep it from rocking forward should pressure be applied to the door while it's open. We recommend having a qualified handyman add an anti-tip device for safety especially when there are small children in the home.

No anti-tip bracket

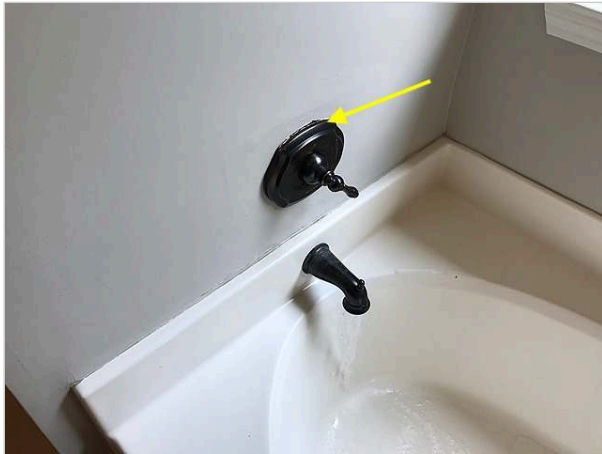
The primary bathroom tub fixture is loose and there is a gap around the escutcheon that may allow water into the wall. We recommend having a qualified individual repair the fixture and seal it to the wall to prevent moisture intrusion behind the fixture.

Fixture loose and not sealed to wall

Note - leaks into the structure can lead to conditions conducive to mold growth, structural damage, and termite infestation. We recommend that during repairs the area be checked for these concerns as they may not be evident to the inspector.

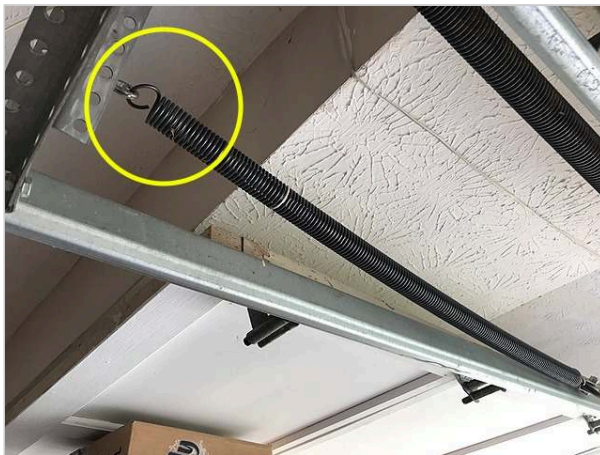
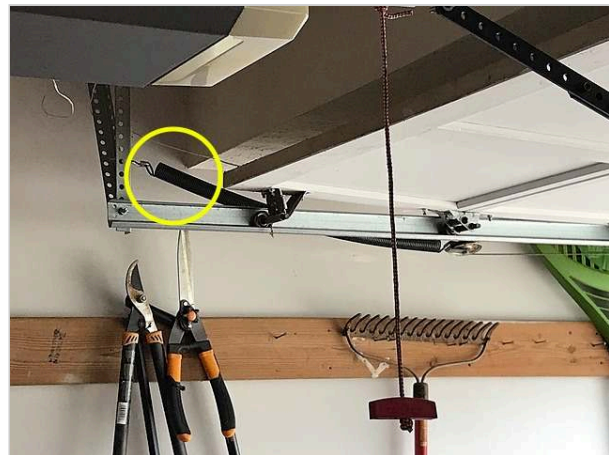
19. Attached Garage - Springs/Mount

The springs installed at a garage door on the left side (looking out) did not have containment cables installed. Extension springs should have containment cables installed to help prevent injury or death if a spring should break. The Inspector recommends having a qualified garage door installer add a containment cable to properly tether the springs.

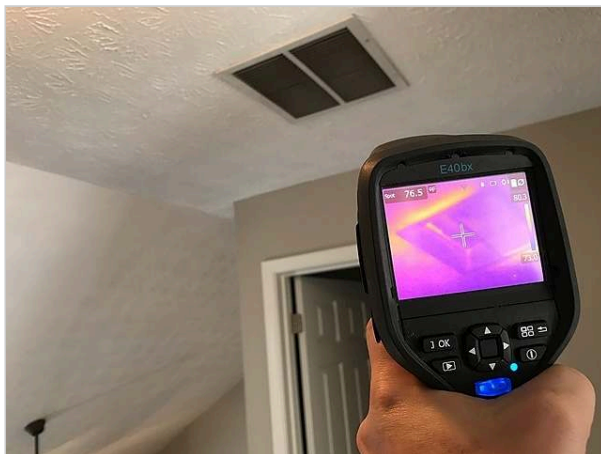
The thermostat controls were used to test the Air Conditioning and we found that the unit servicing the home did not cool effectively on the day of the inspection and is nearing or has exceeded the design life for residential systems. We recommend the Buyer have the Air Conditioning system evaluated by a qualified technician during the Due Diligence period to determine whether repairs or replacement is warranted. The inspector took temperature readings at the supply and return vents. While there may be some cooling capacity to the system (approximately 11 degrees on the day of the inspection), the unit did not maintain a temperature drop of 14-22 degrees between the supply and return vents. The design life of residential Air Conditioning units is 10-15yrs and this unit is 28yrs old.

76.5 at return (2nd floor)

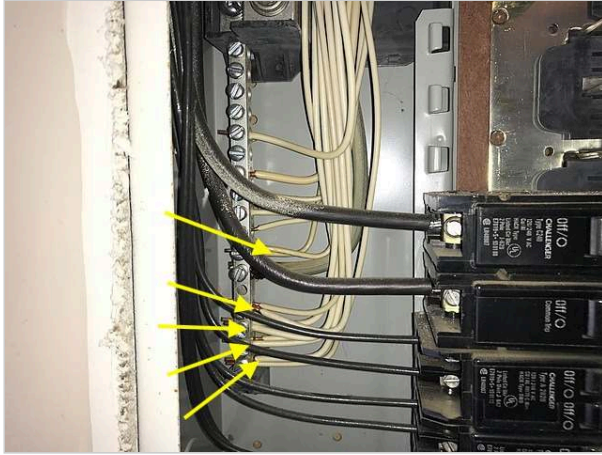
The panel cover was removed and the inspector found current carrying neutral wires double tapped with other neutrals and/or grounds at the bus bar. This condition does not allow for circuits to be isolated when work is being done to the electrical system. Also, panel manufacturers design bus bars to hold only 1 neutral per screw and securing more than one wire may not allow for a positive connection which can lead to a fire hazard. While it was common practice prior to 2002 for electricians to secure multiple neutrals under the same lug it was never allowed. We recommend providing for single lugging of all neutrals at the bus bar.

Double lugged neutrals

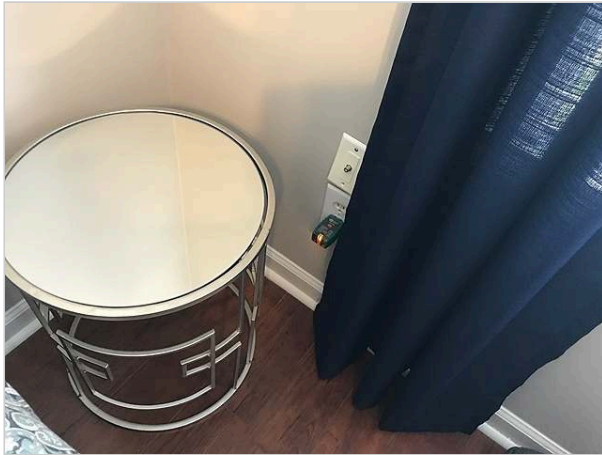
The outlets pictured below are not wired correctly or are defective. These outlets may represent an electrical shock and/or fire hazard and they may not provide safe service. We recommend having a qualified electrician evaluate and repair or replace as necessary.

Open ground second floor NE bedroom

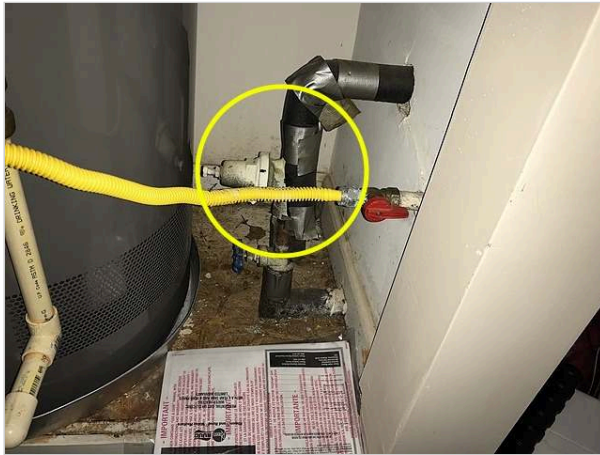
The Inspector noted that there are no bonding jumpers over the pressure reducing valve or at the hot and cold water piping above the water heater. Bonding jumpers should be installed at these locations by a qualified electrician since grounding of the piping and electrical systems could be rendered ineffective by the presence of these fittings and equipment or should a plumber ever be required to remove them for maintenance.

No bonding jumper

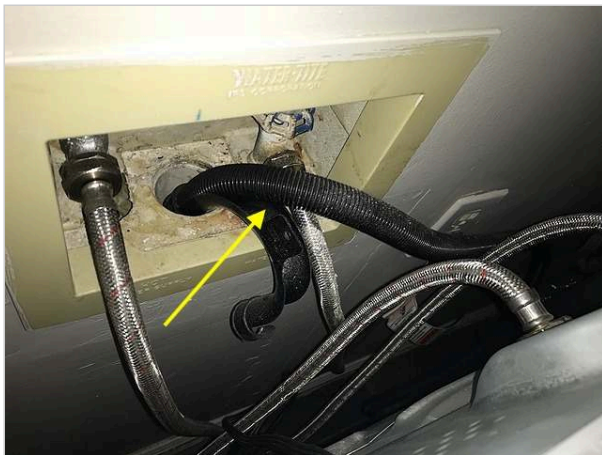
Clip/attach drain pipe to prevent it from backing out

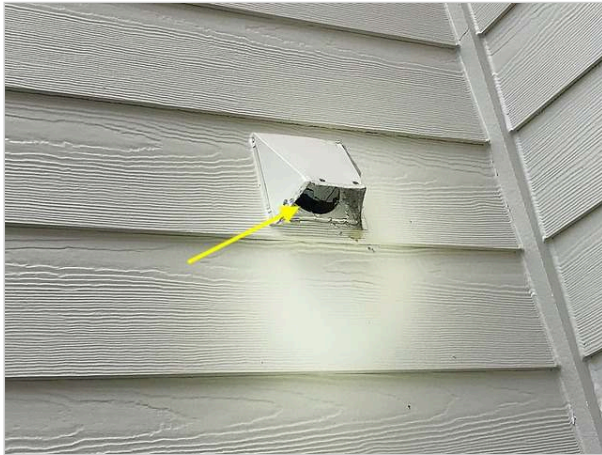
Missing rodent/insect flap at dryer vent

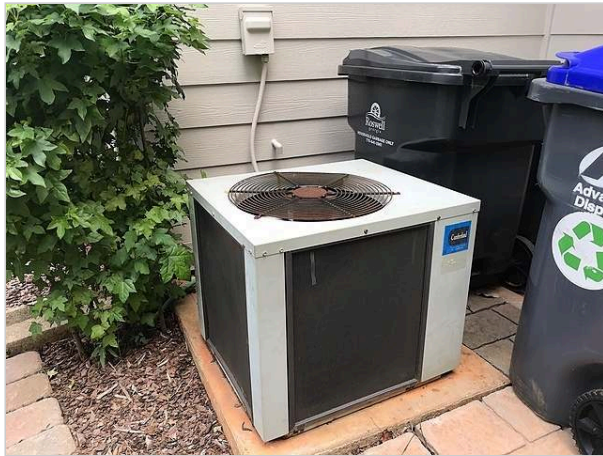
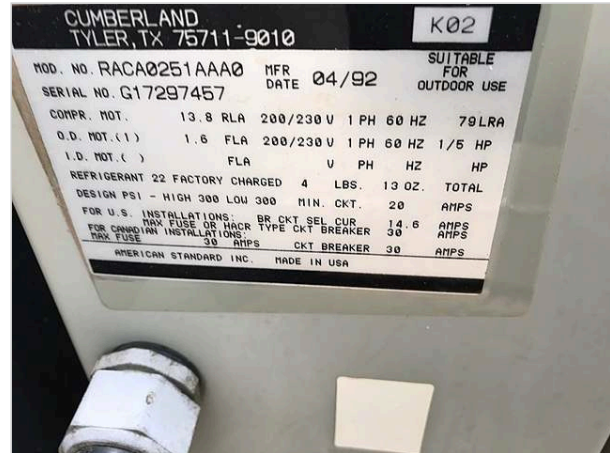
Residential Air Conditioners have an expected design life of 10 - 15yrs but there are exceptions on both sides. The units in this home were manufactured in 1992

1992 Cumberland A/C
