Inspection Report

Property Address:
3434 Winborn Walk NW
Kennesaw GA 30152

Dana Inspection Services, Inc.

Date: 8/17/2020**Property:**3434 Winborn Walk NW
Kennesaw GA 30152**Customer:**

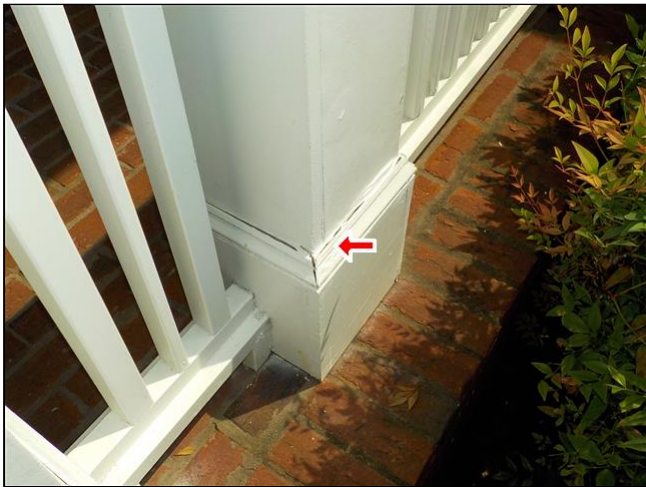
(1) Paint and seal repair is needed around the front porch post trim.

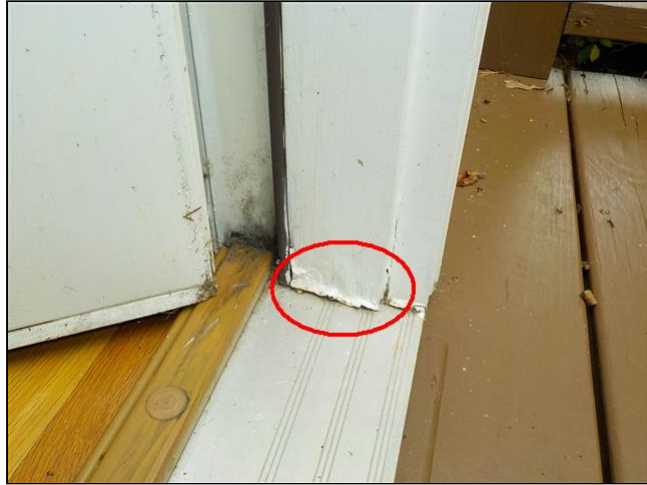
(2) A small area of wood rot was observed at the back deck door trim.

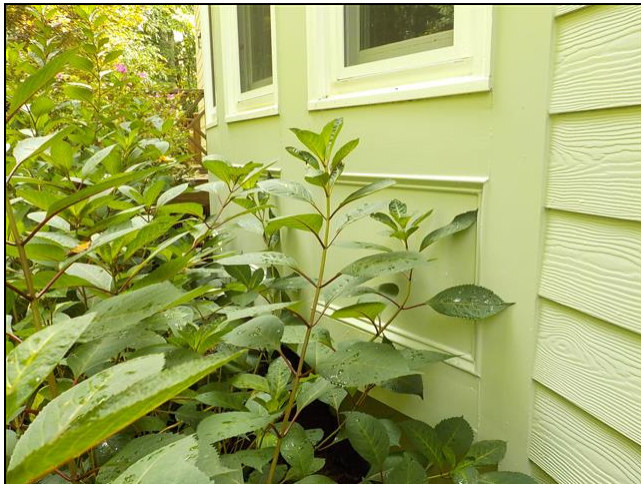
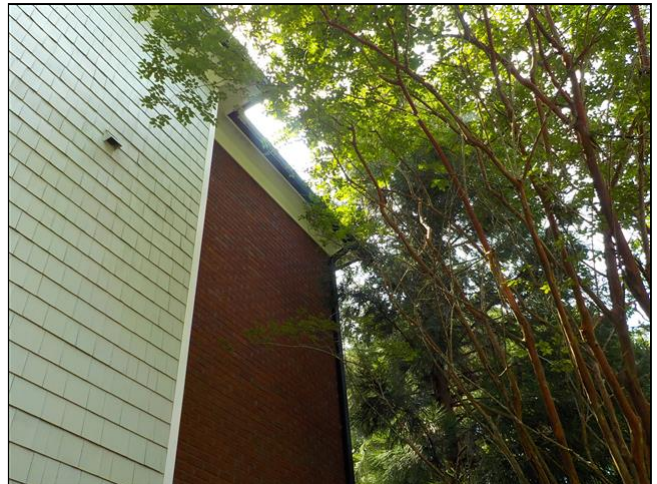
(1) All vegetation in contact with the house or roof should be cut back or removed.

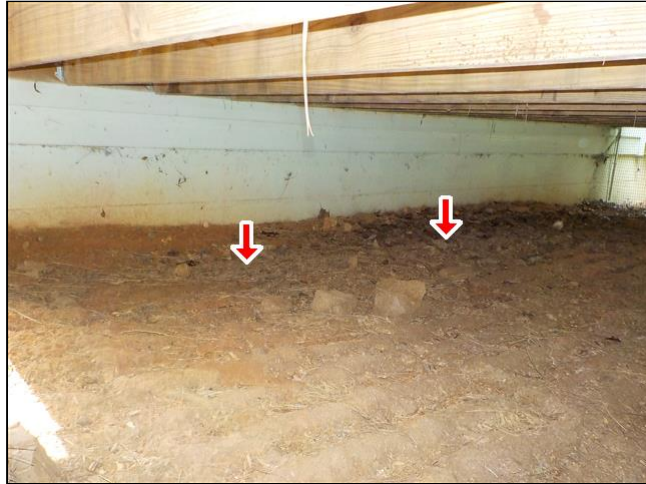
(3) There is a neutral to negative grade under the deck that may place excessive amounts of moisture up against the foundation. It is recommended to modify the grading to create a positive slope away from the house and foundation.

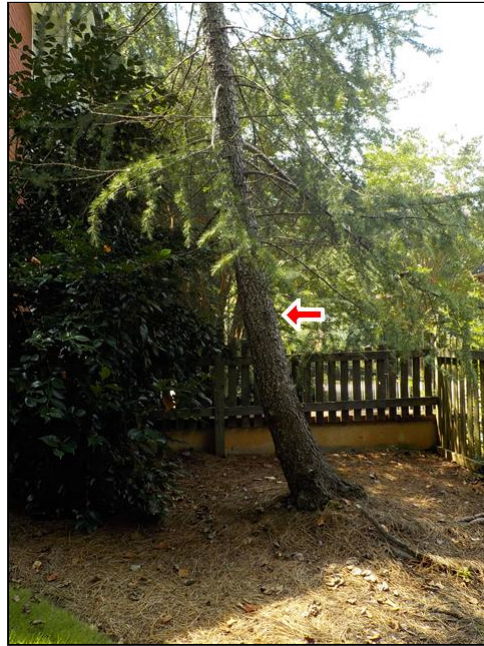
(4) A tree is leaning toward the house at one of the back corners and should be evaluated by a qualified tree person for removal.

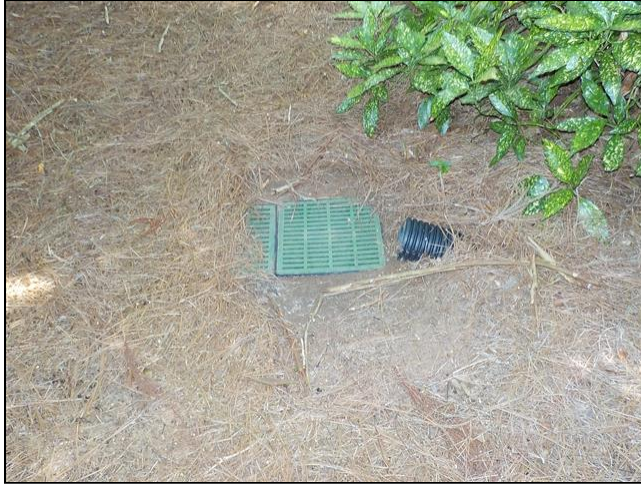
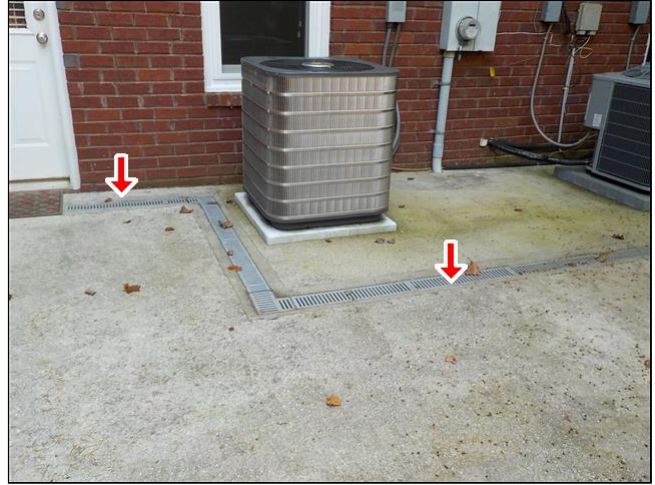
(5) In-ground yard drains were observed but are not tested as part of the inspection.

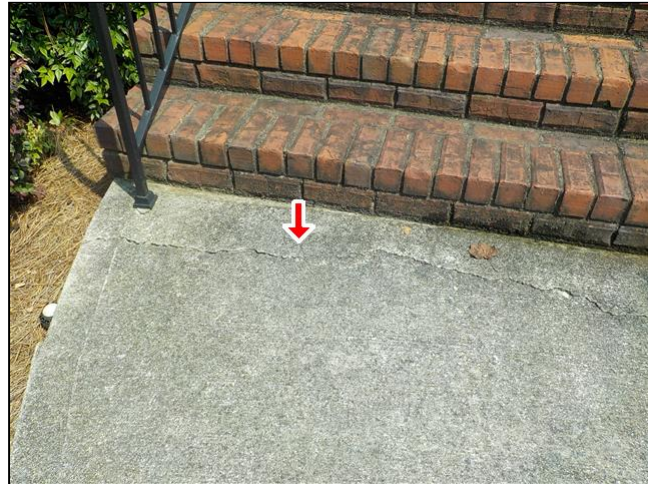
(6) A common settling crack was observed on the front walkway.

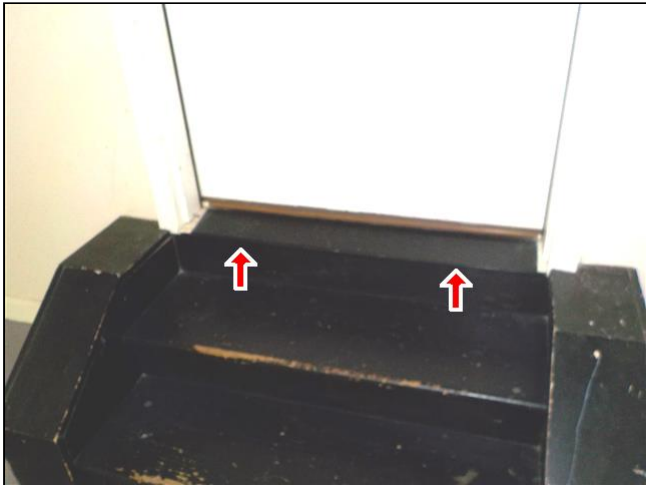
A support block is needed at the garage entrance door threshold to prevent the threshold from flexing when stepped on.

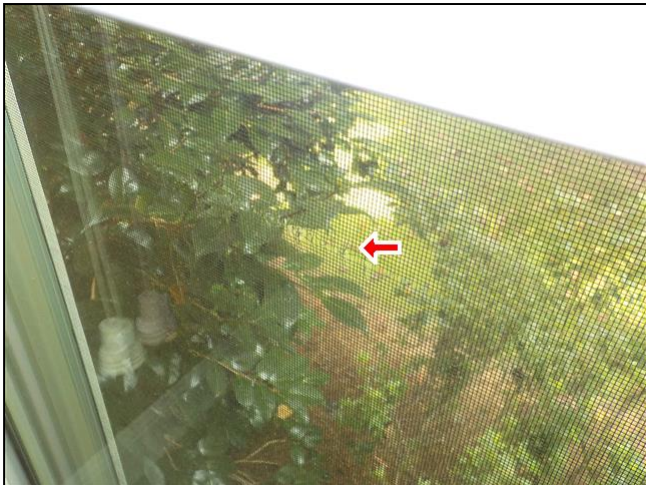
One of the 1st floor bedroom window screens is torn.

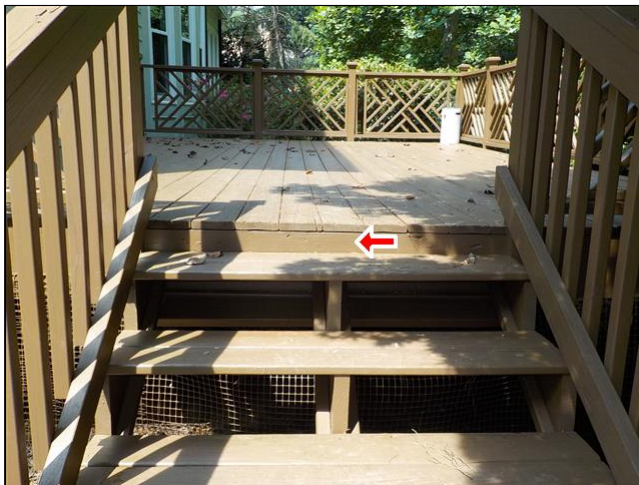
(1) The short step, compared with the other steps, at the top of the deck steps creates a trip hazard.

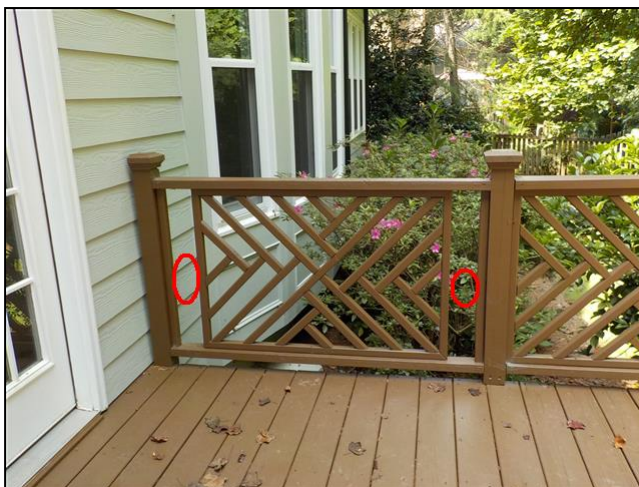
(2) The spacing between some of the deck balusters is over 4" and considered a safety hazard for children.

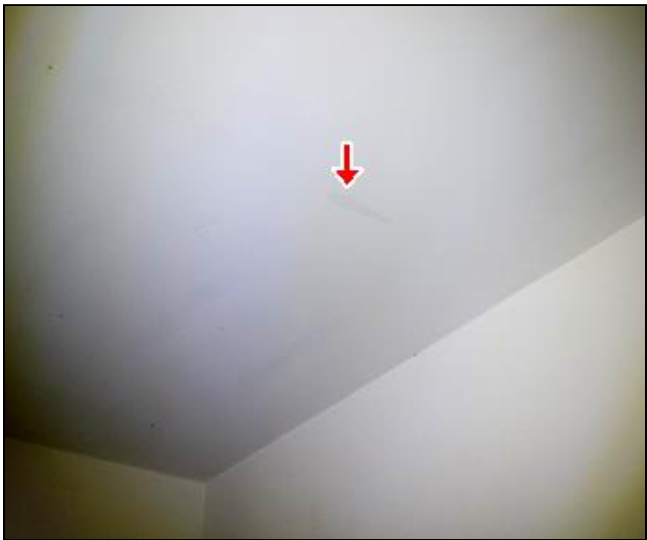
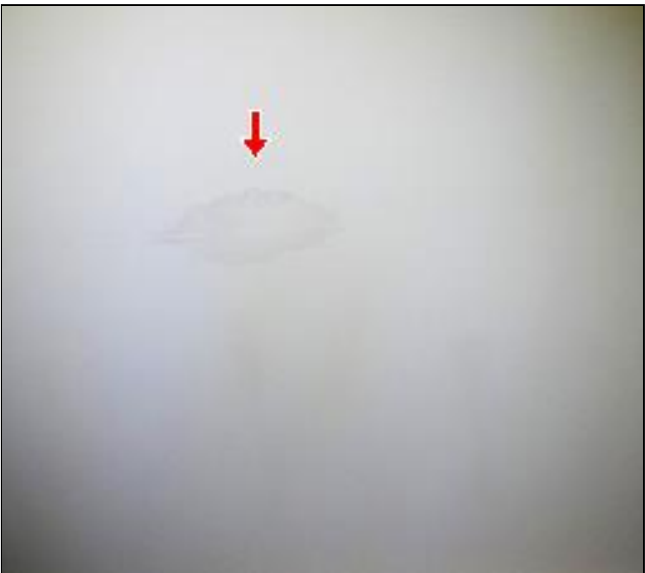
Two moisture stains were observed on the garage ceiling. After running the upstairs plumbing fixtures and viewing with an infrared camera, these did not show signs of active moisture and appear to be old stains. Recommend cosmetic repairs and monitor for changes.

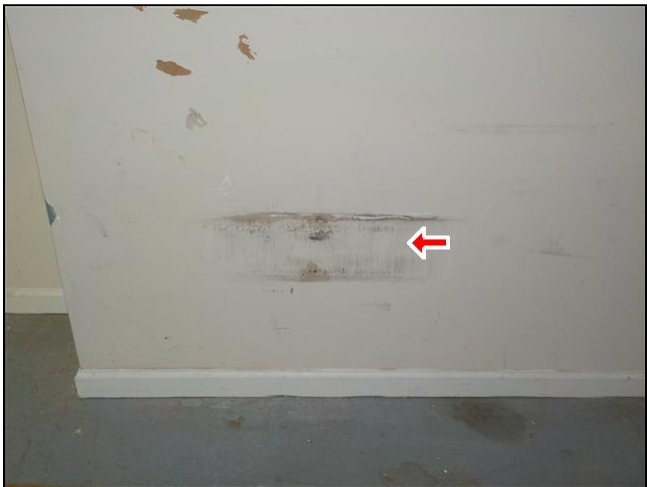
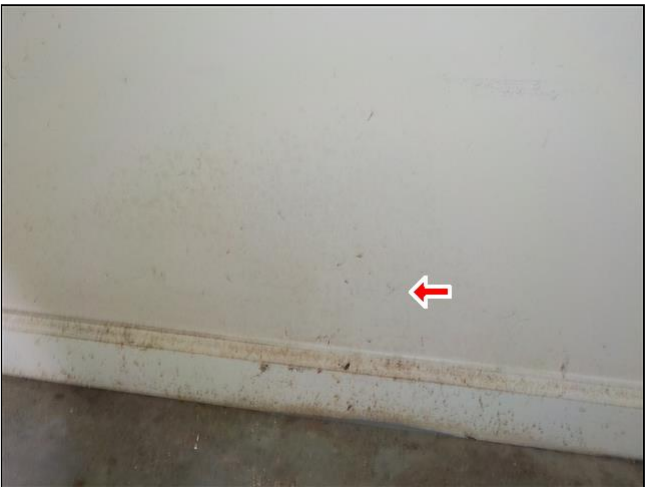
Mold-like growth was observed on two areas of the back wall in the garage. This is likely from items having been stored against the wall. A little drywall damage was observed at one of the areas. Have these areas further evaluated and cleaned/repared as needed.

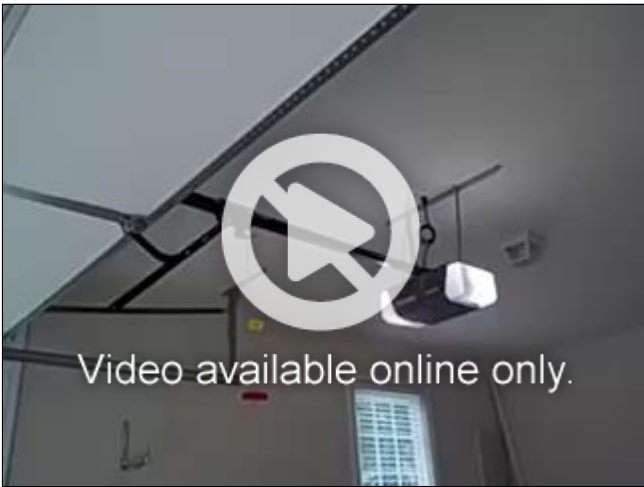
(1) The far overhead garage door needs to be adjusted as it is banging into the back stop when opened.

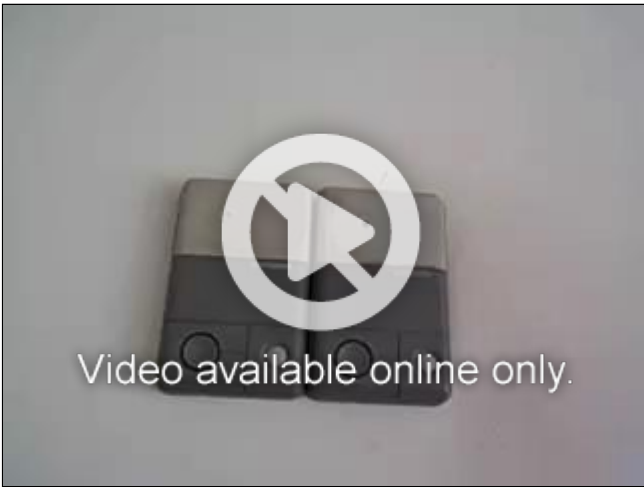
(2) One of the overhead garage door operator buttons is blinking. Consult the manufacturer instructions.

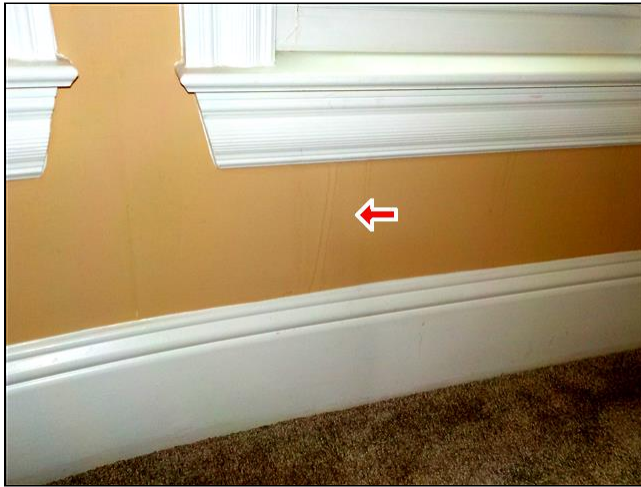
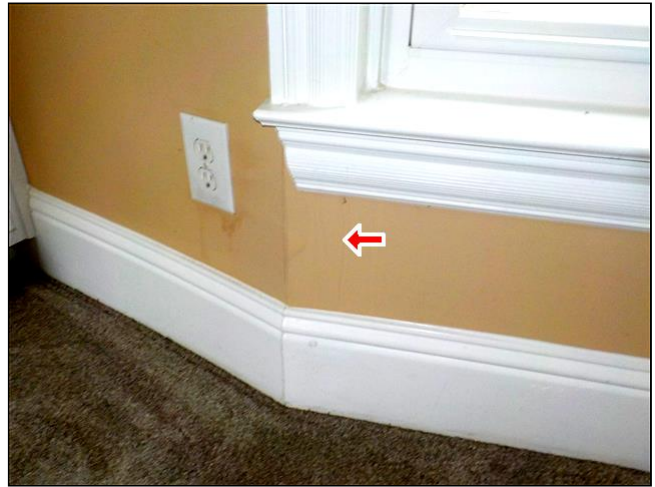
Water stains were observed under some of the family room bottom windows. No active leaking was observed.

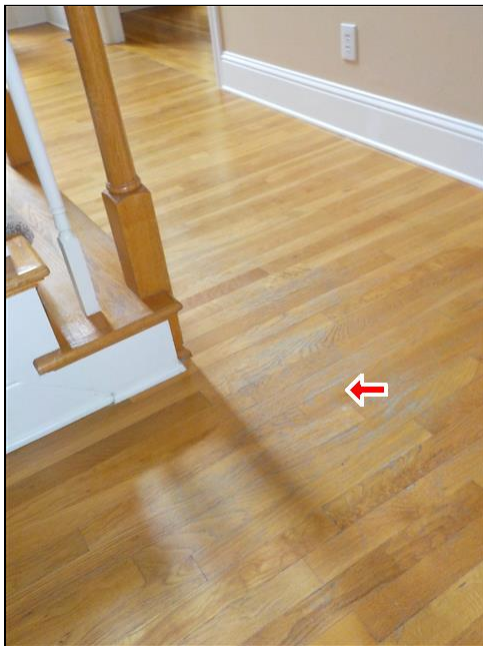
There are areas of wear and gaps on the hardwood floors. Have evaluated and resurfaced as needed.

Wear

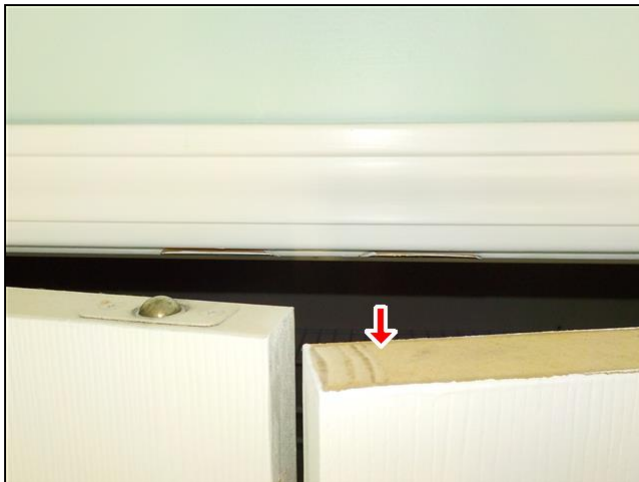
(1) One of the closet doors in the 2nd floor front middle guest bedroom is missing the ball catch.

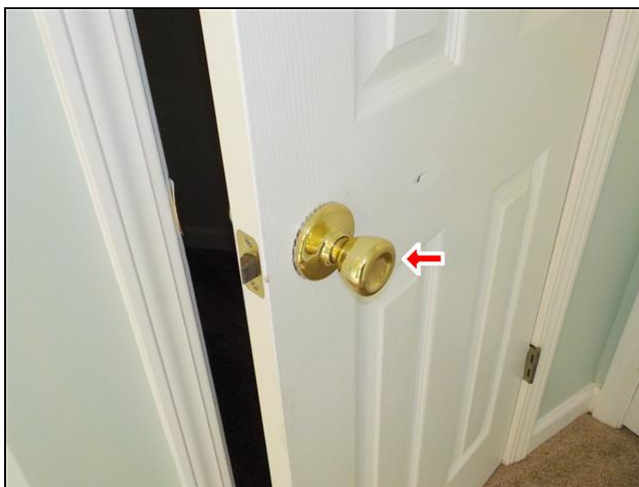
(2) The front Jack & Jill bedroom closet door knob is a little loose.

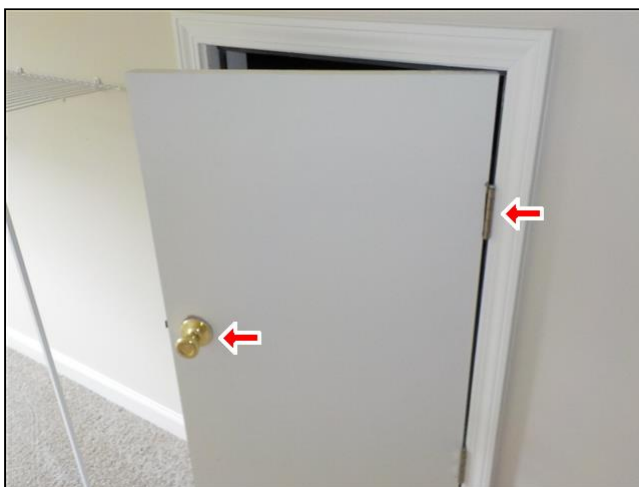
(3) One of the attic doors in the master closet has a loose hinge and door knob.

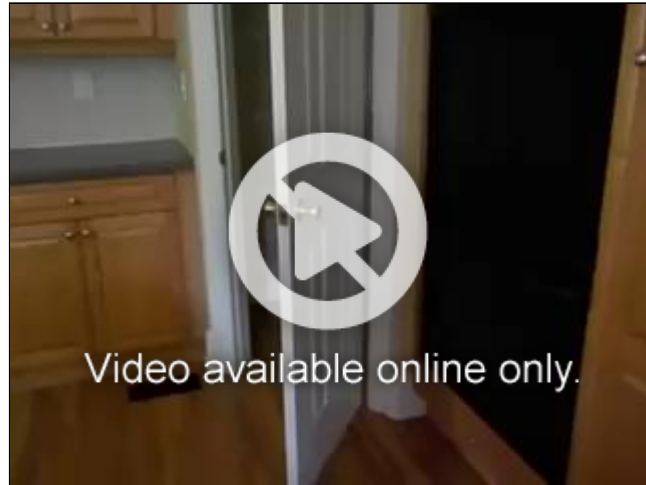
(4) The pantry door swings open on its own.

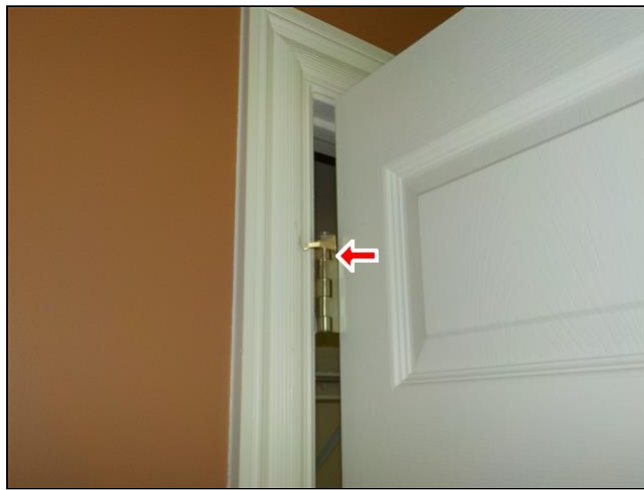
(5) One of the basement bedroom closet door hinges is broken.

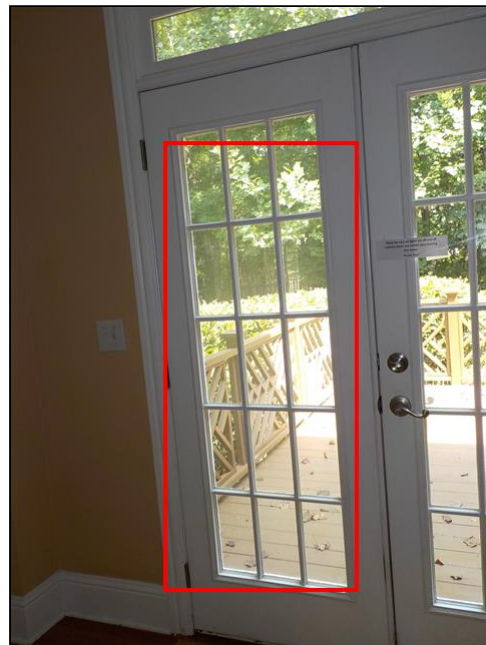
(1) One or more of the double-pane windows that are part of the back door to the deck appear to be fogging over due to a bad seal between the panes of glass. Have evaluated and replaced where needed.

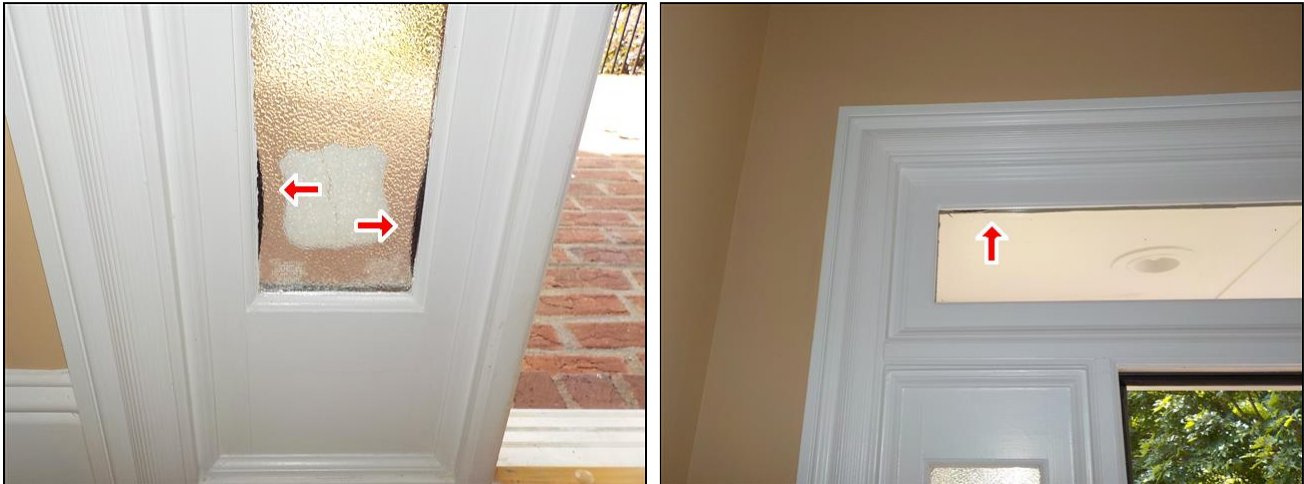
(2) The transom and sidelite windows at the front door have rubber seals that are loosening due to expansion and contraction. This does not affect the window other than being unsightly. Replacement is needed.

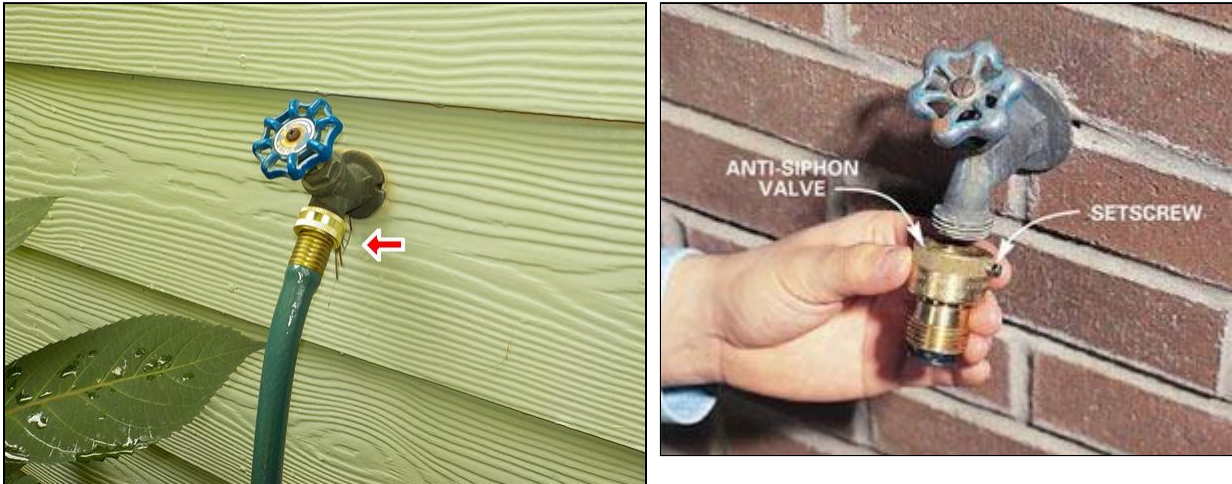
(1) Anti-siphon valves are missing at the exterior hose bibbs. These help prevent backflow into the potable water system.

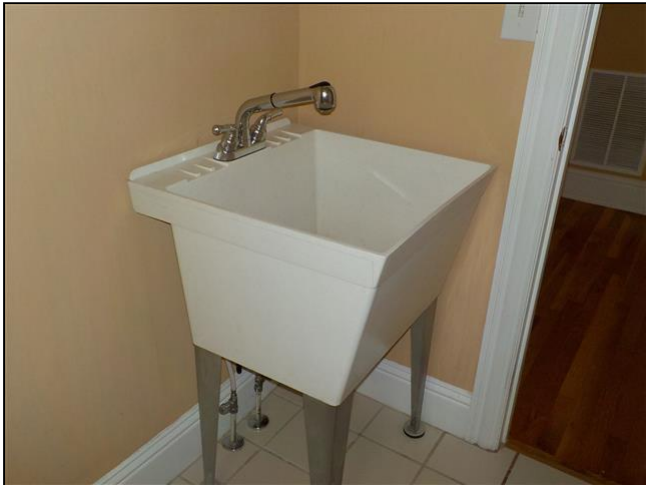
(2) The laundry room utility sink should be secured to prevent accidental movement that can damage plumbing components.

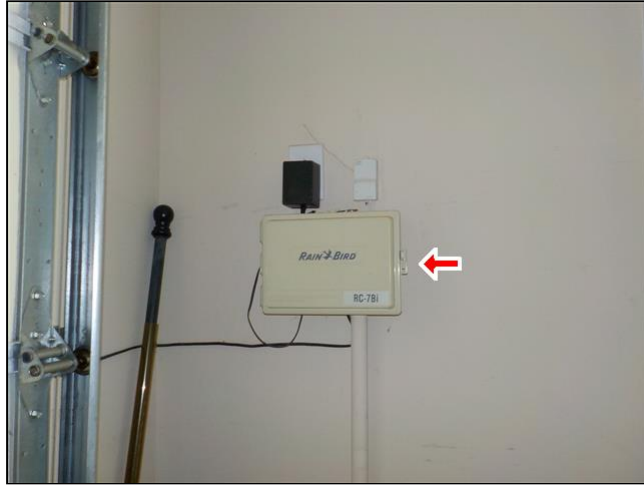
(3) A irrigation system control panel was observed in the garage but is a specialized component that was not tested. Contact the seller to provide information on how it operates or have evaluated by a qualified irrigation professional.

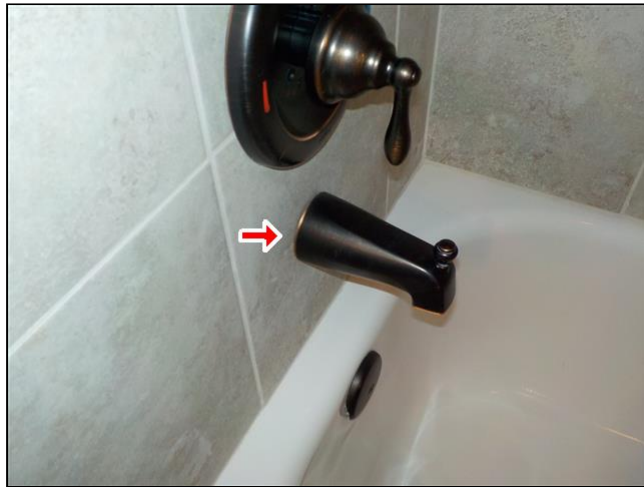
(4) Bathtub spouts should be caulked at the wall tile to prevent moisture penetration.

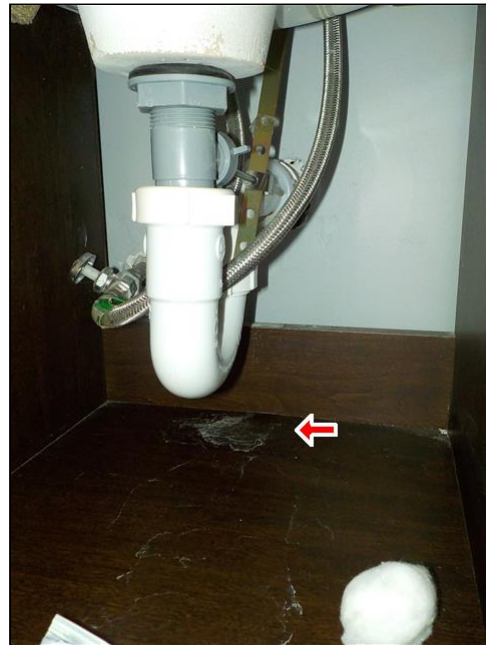
(5) A very small leak (one drip) was seen inside the 1st floor bathroom sink cabinet after running the water for several minutes. Have evaluated and repaired as needed.

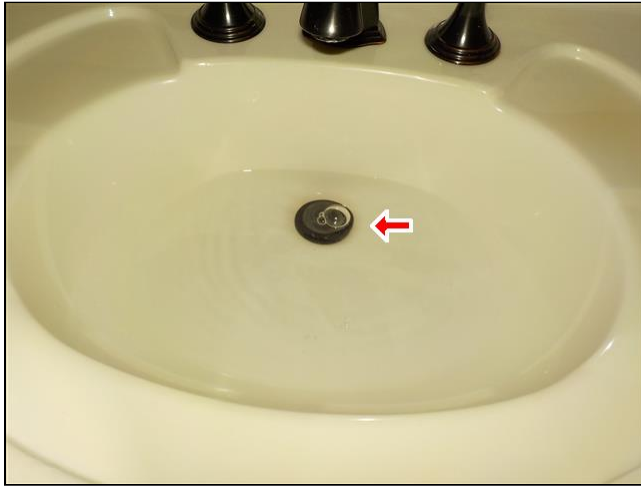
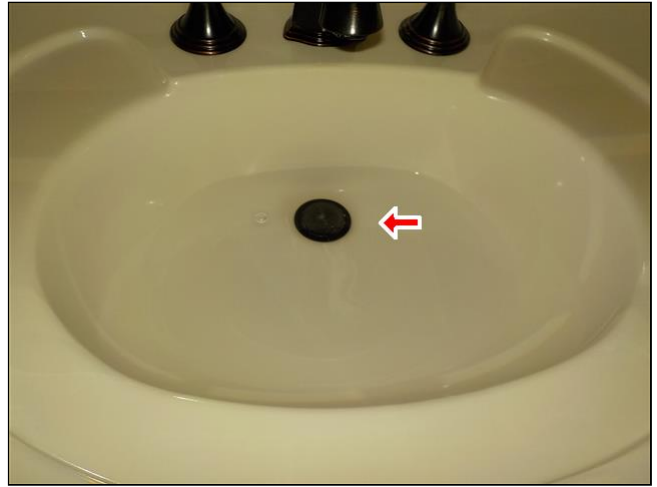
(6) Both master sinks are draining slowly.

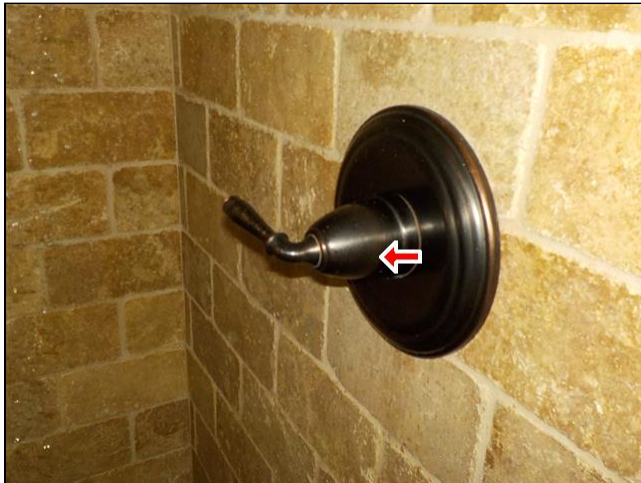
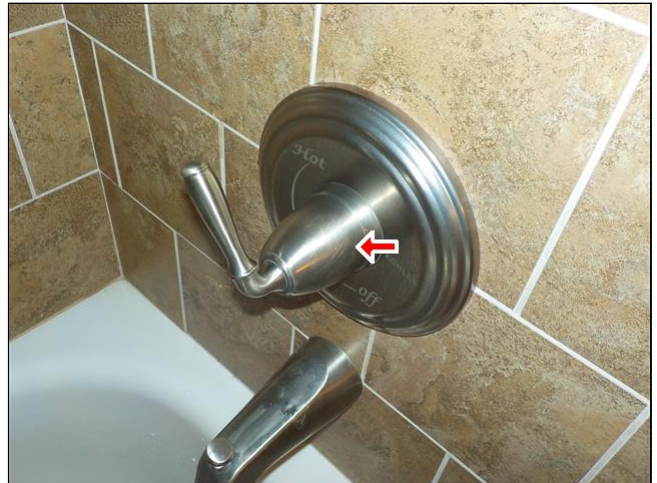
(7) The master shower valve and Jack & Jill tub valve both have the hot and cold not installed properly. Cold should be in the first position, and hot in the last. Currently it is reversed.

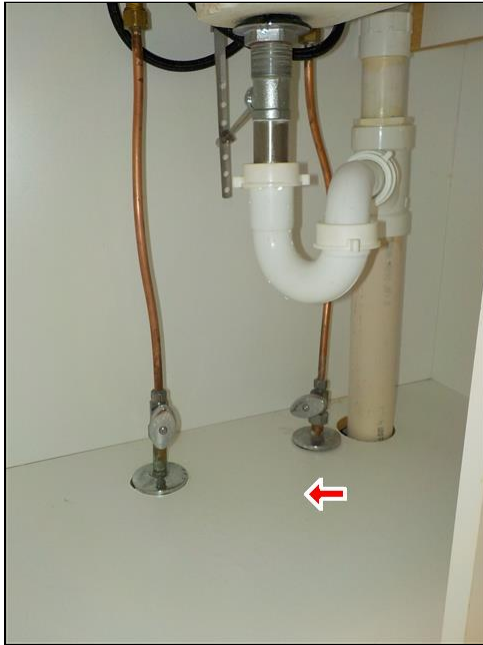
(8) A small leak was observed inside the back Jack & Jill sink cabinet. The sink is also draining slowly.

Water in cabinet

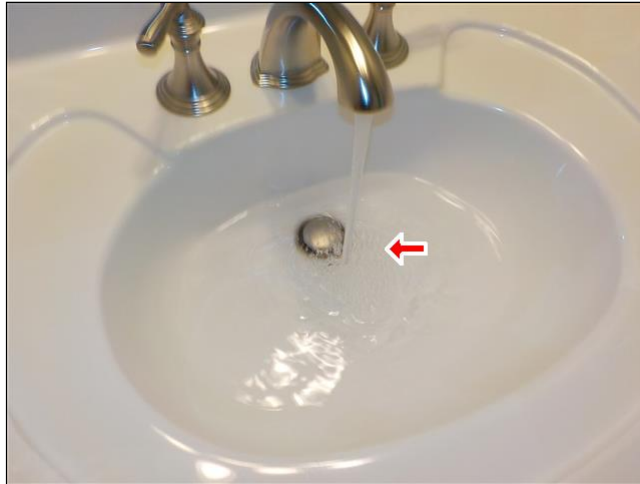
Slow drain

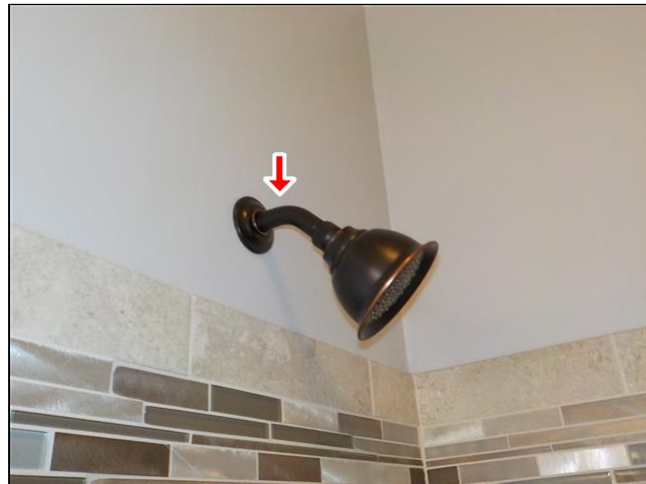
(9) The 1st floor basement showerhead pipe is a little loose.

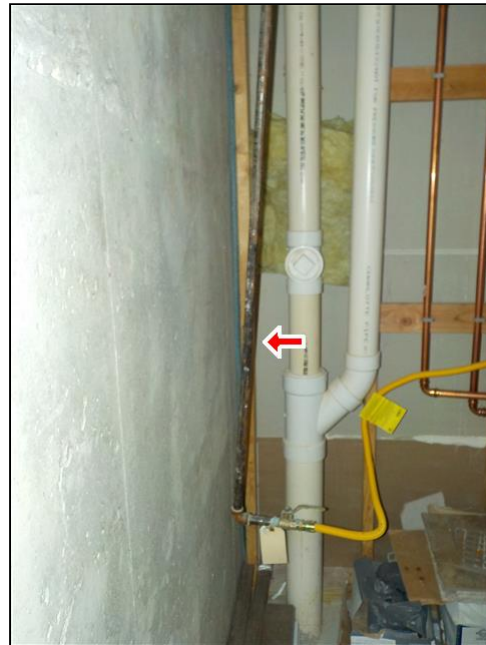
The rigid gas line serving the tankless water heater is inadequately secured/strapped.

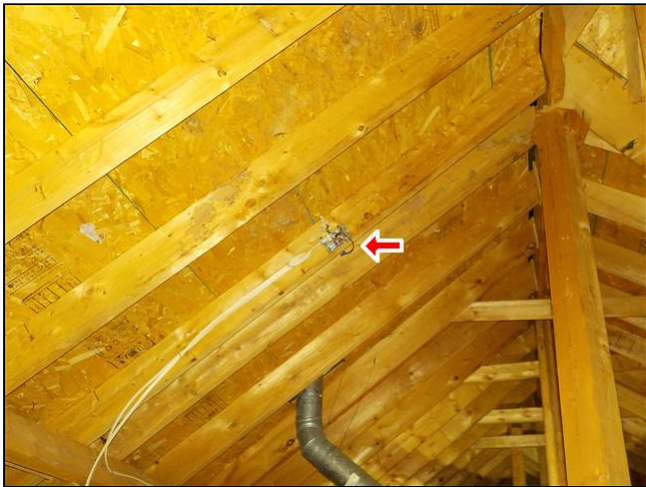
(1) Exposed wires from a previously installed attic fan were observed in the attic.

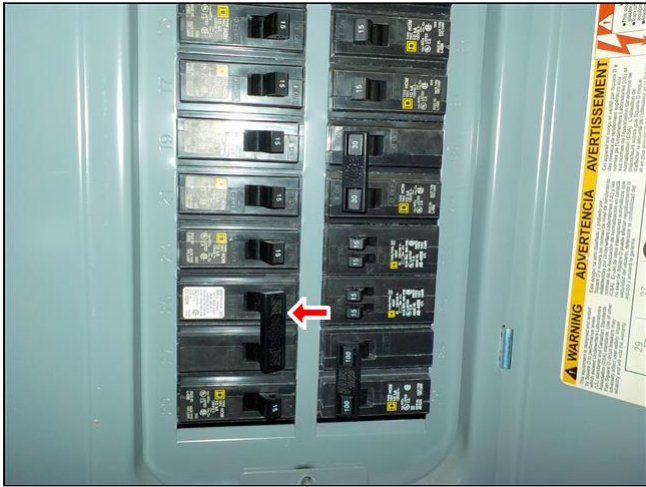
(2) One of the A/C condensing units appears to be over-amped. There is a 55 amp breaker in the panel labelled for an A/C unit, but all of the cooling systems take only 30 or 25 amp max. Have evaluated and repaired by a qualified electrician.

55 amp breaker in panel

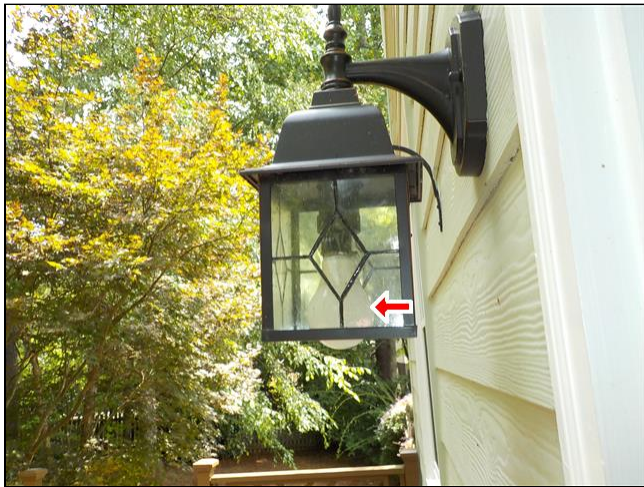
Example, back deck

(1) Have all burnt out or missing light bulbs in and around the house replaced where needed.

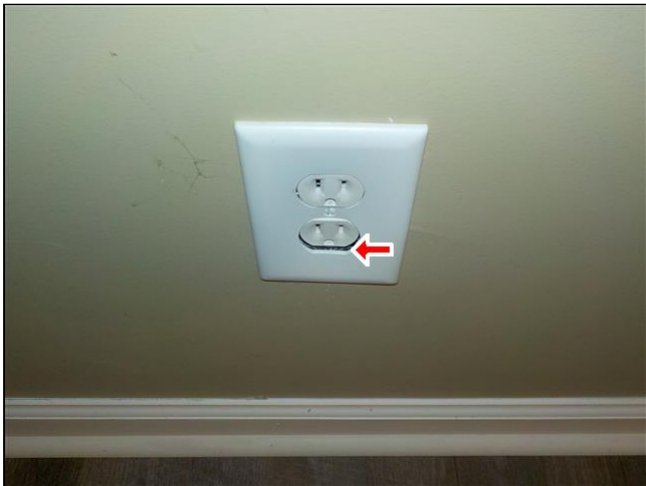
(2) One of the basement bedroom outlets is recessed in the wall.

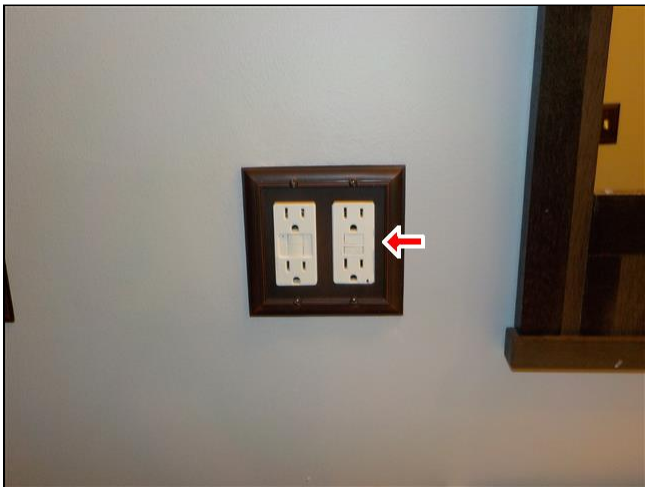
The basement bathroom GFCI outlets were not installed correctly as the circuit already has GFCI protection being controlled by the GFCI outlet inside the air handler closet in the basement. However, an additional problem is that the basement air handler's condensate pump is connected to the GFCI outlet in that closet. Thus, if the GFCI outlet does a nuisance trip, it will turn off the condensate pump and may cause water damage. It is recommended to have these issues further evaluated by a qualified electrician and repaired as needed.

GFCI outlets in basement bath

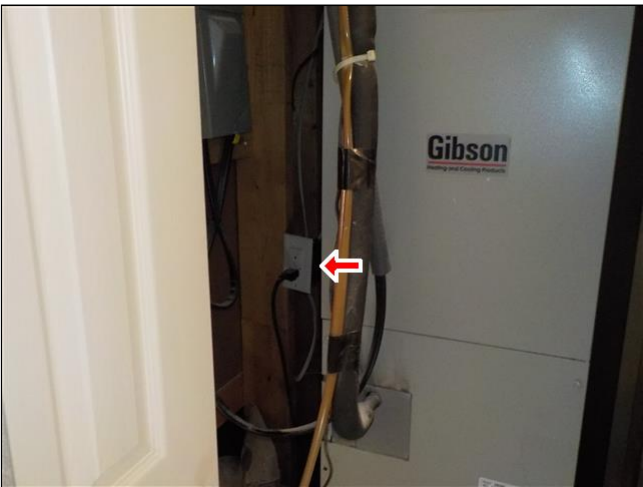
GFCI outlet next to air handler

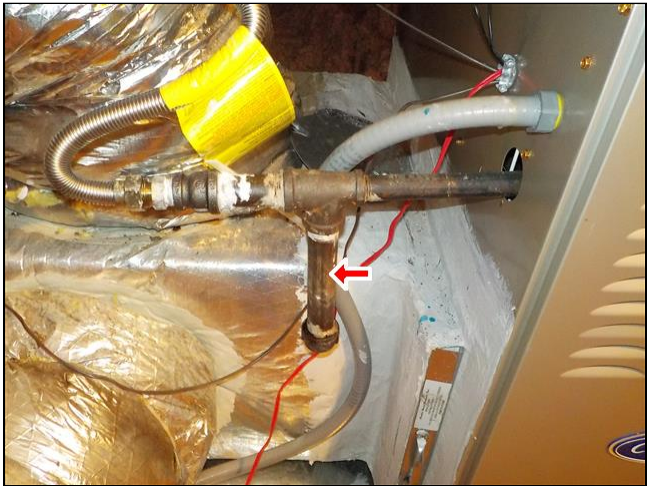
(2) The sediment trap in the attic for the furnace is not the correct style and should have been updated when the furnace was replaced.

Existing, improper sediment trap

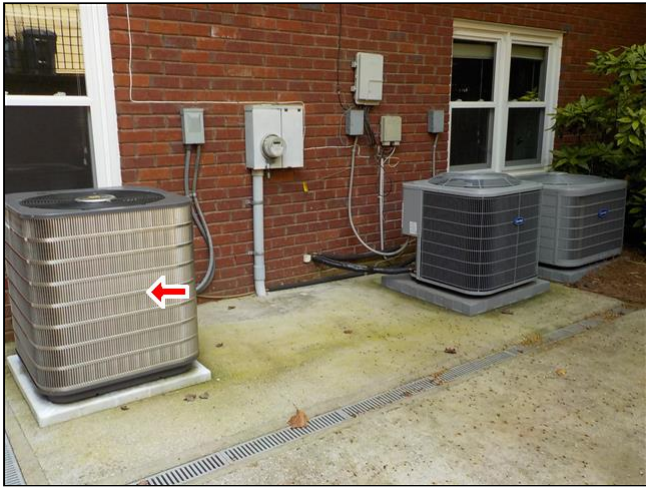
The Heat Pump is 15 years old and at the end of its useful life. This may require repair or replacement within the next few years.

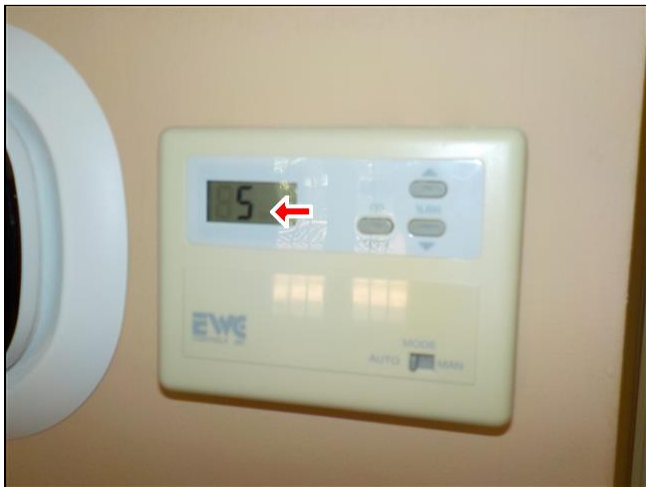
Humidistat

The humidistat on the 1st floor did not appear to be functioning properly as the display was not showing a proper humidity level ("5"). Have evaluated and repaired as needed.

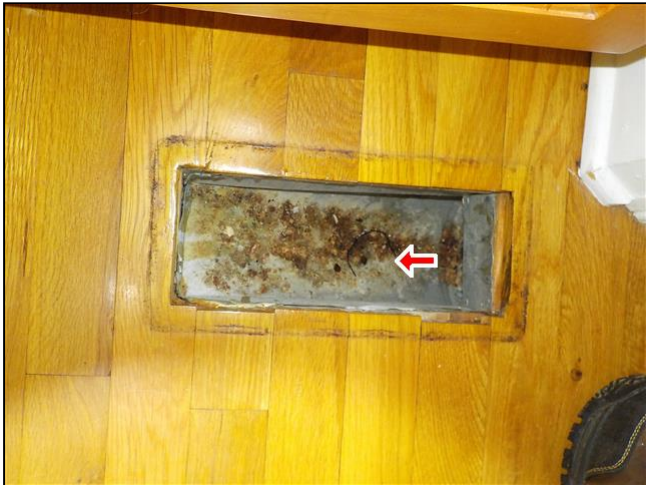
Example, kitchen

The interior of some of the ductwork is dirty. It is recommended to have the ductwork further evaluated and cleaned by a qualified duct cleaning company.

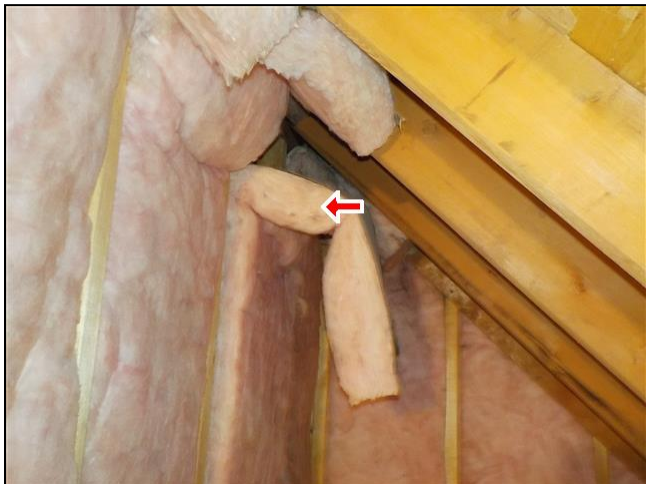
(1) Minor insulation repairs are needed in the two small attic spaces off the master closet. Some small areas are missing and loose. One is also backwards.

Loose

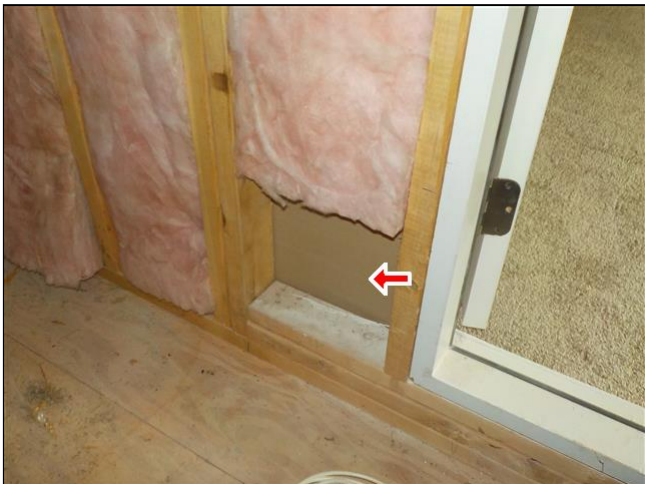
Missing

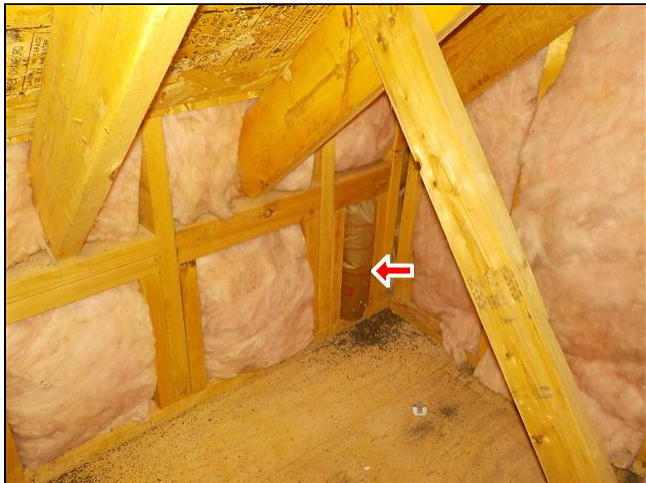
Backwards

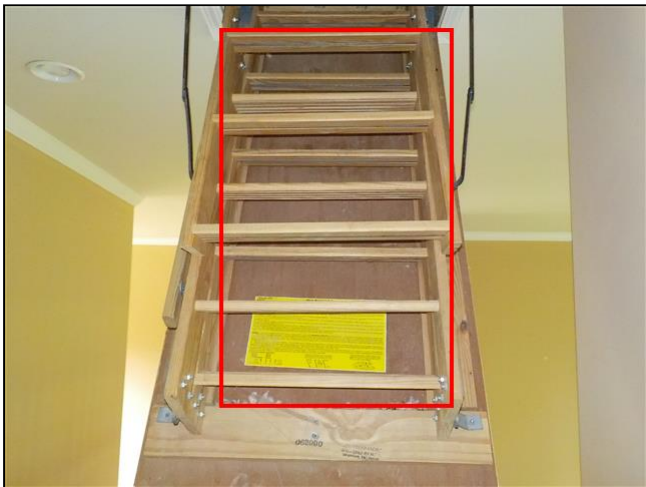
(2) Insulation and weather stripping should be added to the attic pulldown ladder or the attic opening should be insulated with a cover.

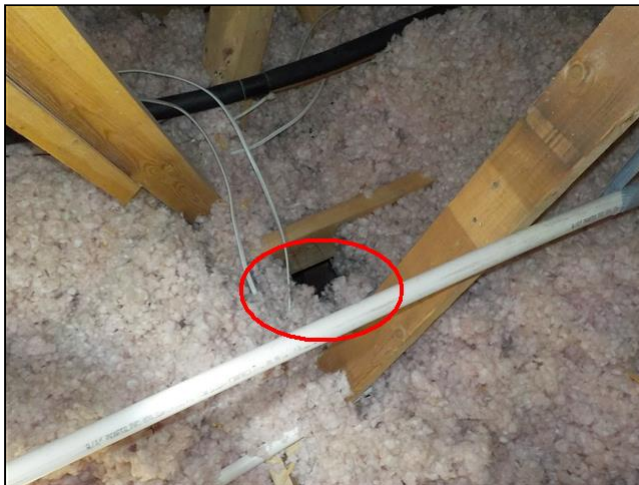
(3) An uninsulated chase opening was observed on the attic floor near the Jack & Jill bedrooms.

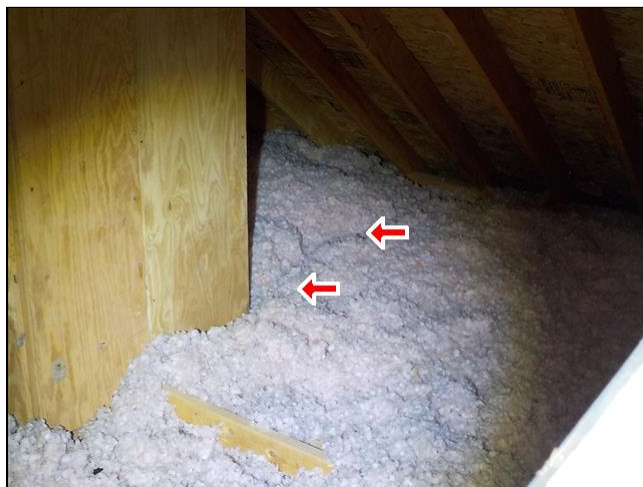
Evidence of wildlife intrusion was observed in the attic in the form of burrowing inside the insulation and one bait station. However, there are signs that the seller may have had an "Exclusion" service done. Contact them for more info or have further evaluated by a qualified pest company.

Trails

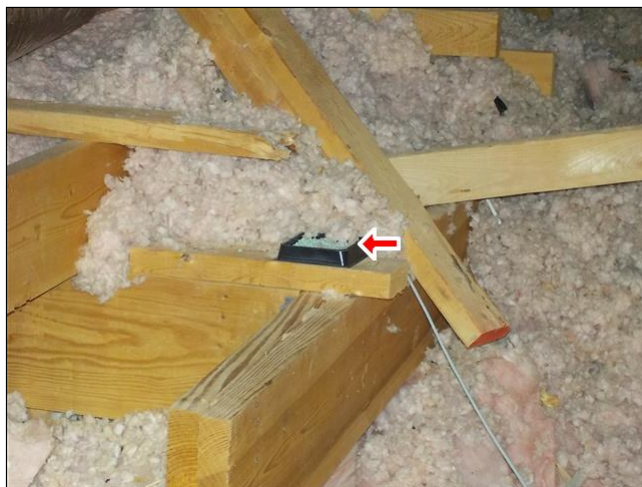
Bait station

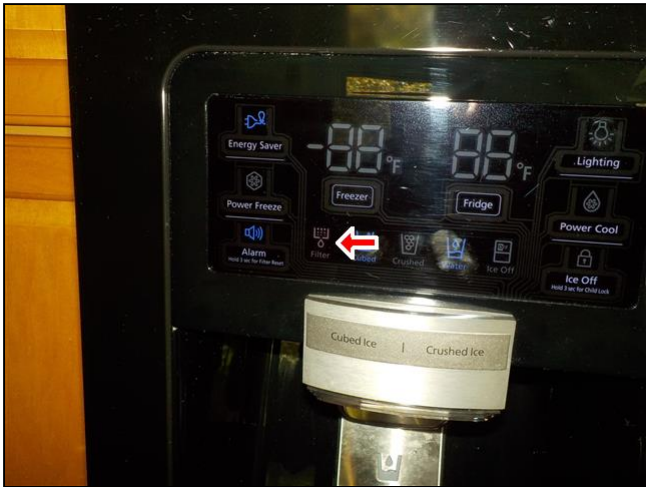
The water filter replacement indicator is lit at the refrigerator.
