BPG Inspection Services

**1357 Westminster Walk Northwest
Atlanta GA 30327**

Client(s): Hamza
Inspection Date: 8/13/2020
Inspector: Kevin Carey ,

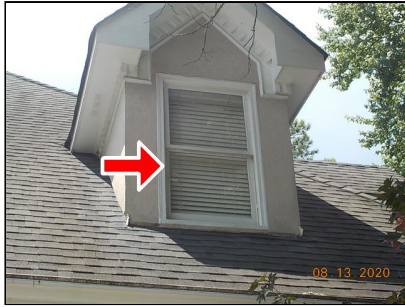
SERVICE / REPAIR: Missing screens noted. Many owners choose to remove screens to enhance the views from the window. Verification of possession by the owner is recommended. Location: **Basement, right side dormer**

Missing screens noted.

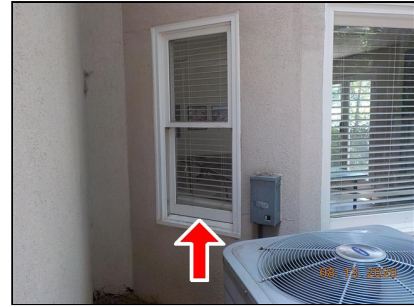
Missing screens noted.

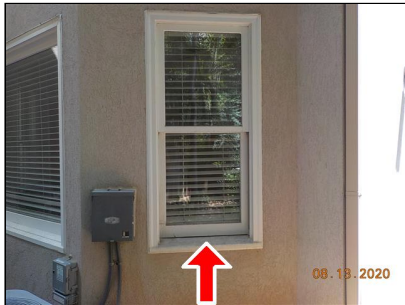
Missing screens noted.

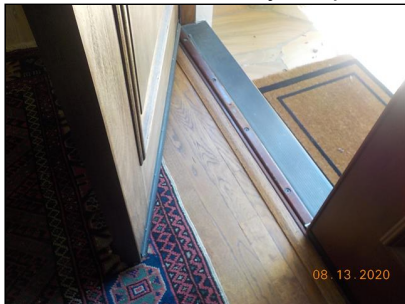
- ❌ 4. **SERVICE / REPAIR:** The exterior door sticks and makes a loud noise when opened/closed. Modify or repair the threshold as necessary to operate normally. Location: **Front door**

The exterior door sticks and makes a loud noise when opened/closed.

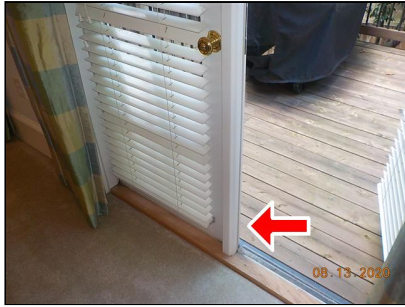
- ❌ 5. **SERVICE / REPAIR:** Exterior door is stuck and will not open as designed. Recommend further evaluation and repairs made by a qualified contractor. Location: **Owner's bedroom deck door**

Exterior door is stuck and will not open as designed.

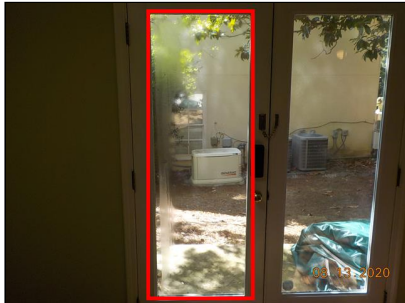
- ❌ 6. **MAJOR DEFECT:** Condensation and / or hazing was noted between insulated window panes in glass door. The thermopane insulated glass has lost its vacuum seal and may eventually completely cloud over. Broken seals also reduce the insulation value of the window. (Dirty glass should be cleaned to verify if damage exists in other units). All insulated glass should be reviewed by a glass replacement company and windows replaced to the extent found. Location: **Basement exterior door**

Condensation and / or hazing was noted between insulated window panes in glass door

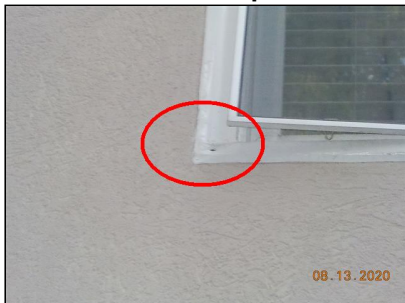
- ❌ 7. **SERVICE / REPAIR:** Wood rot and deterioration are present. Evaluate all areas and replace/repair all wood rot to the extent found to prevent further damage to any area. All replacement wood should be primed on all sides, caulked and painted as required. Any damage on the exterior wall or trim that allows openings into the wall cavity or interior can cause significant water damage over time if not repaired. Location: **Rear window trim/frames.** **Recommend a complete review of all the wood trim elements on the house.**

Wood rot and deterioration are present.

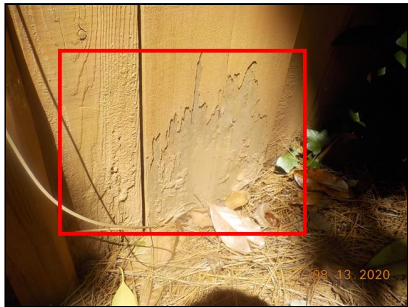
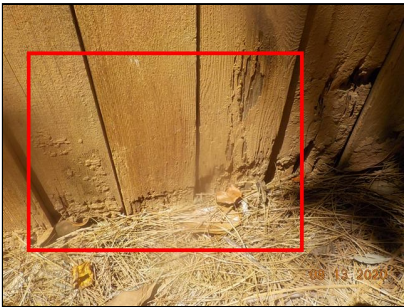
- ❌ 8. **SERVICE / REPAIR:** Termite damage noted. Unable to determine if this is active. Recommend further evaluation by a qualified exterminator.

Termite damage noted.

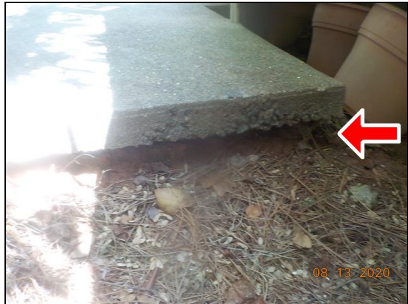
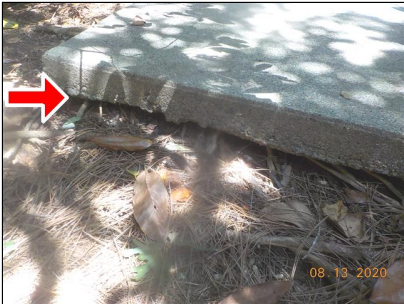
9. **SERVICE / REPAIR:** Voids noted below patio/pool decking. Advise filling and compacting areas with fill dirt or concrete to prevent nesting of animals or damage to patio from settling.

Voids noted below patio/pool decking.

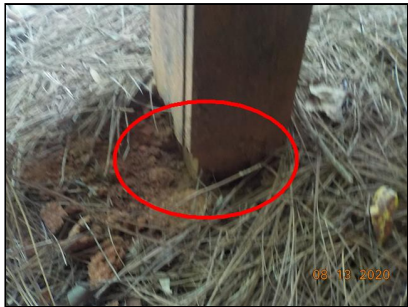
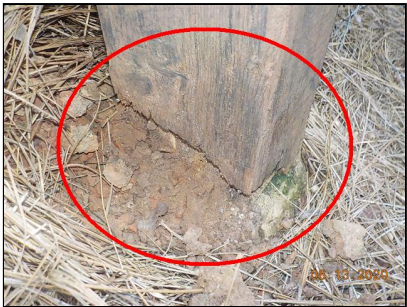
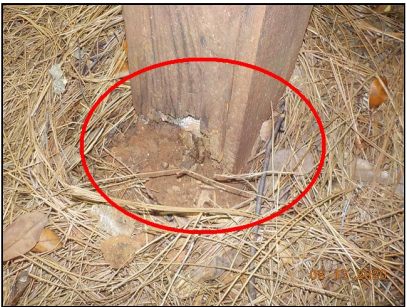
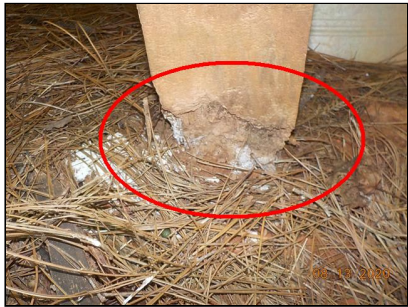
10. **SERVICE / REPAIR:** Deck posts are wrapped in a material that is not intended for ground contact. Wood rot noted at the base of the posts. Have the wrap material removed and concrete or gravel added at the base of the posts to prevent ground contact. Recommend further evaluation and repairs made by a qualified contractor.

Wood rot noted at the base of the posts.

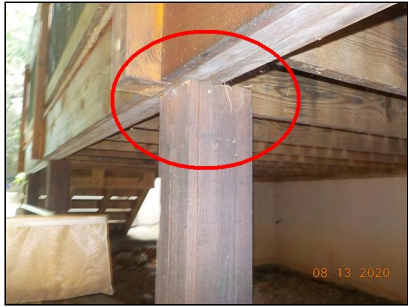
- ❌ 11. **SERVICE / REPAIR:** Support columns/posts are only toe nailed to the deck frame at the top of the posts. To minimize the chance of displacing posts/columns supporting beams or girders, a means of mechanically anchoring support post/columns to the beams is required. Bolts and/or prefabricated metal wood connectors are preferred methods. Positive connections shall be provided to prevent uplift and lateral displacement. After initial construction, some counties do approve a repair alternative that uses 2 - 45 degree (2 x 6) Y sized wood braces per support post/column.

Support columns/posts are only toe nailed to the deck frame

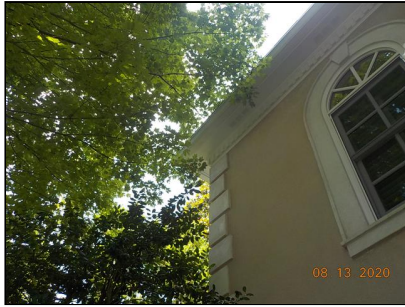
- ❌ 12. **SERVICE / REPAIR:** Trees overhanging or near roof area. Recommend having kept trimmed back to reduce possible damage from wind and to reduce access avenues for climbing pests to roof level. Location: **Front left**

Trees overhanging or near roof area.

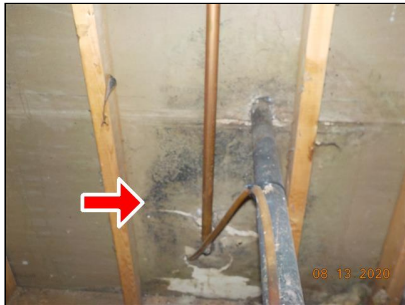
- ❌ 13. **SERVICE / REPAIR:** Mildew noted on the drywall. Signs of moisture at some point. Have the walls cleaned and monitor for any reoccurrence. Location: **Front left corner of the basement.**

Mildew noted on the drywall.

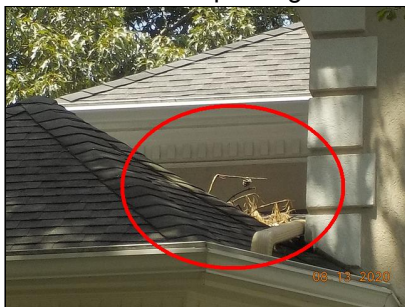
- ❌ 14. **SERVICE / REPAIR:** Organic debris (leaves, sticks, etc) is present on the roof covering. Removal of all debris is recommended to prolong the life of the roof. Location: **Front left**

Organic debris (leaves, sticks, etc) is present on the roof covering.

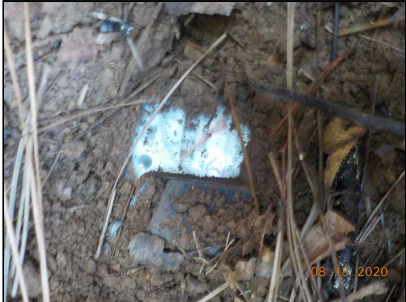
16. **SERVICE / REPAIR:** Upon arrival, found the water service meter and monitored all dials and indicators for water usage. There was indication of a leak. Slight movement noted and we were unable to determine the source. Recommend further evaluation and repairs made by a qualified plumber.

Slight movement noted at the water meter.

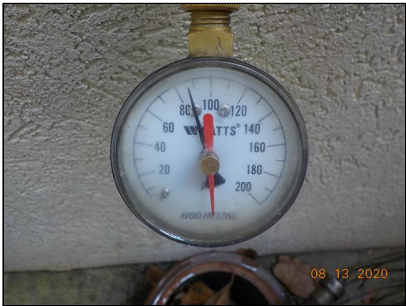
17. **SERVICE / REPAIR:** The water pressure tested at over 80 PSI. This is considered excessive. Adjustment/ replacement of the pressure regulator valve (PRV) is necessary. Correct to have between 40 and 80 PSI. The water pressure was recorded at 88 PSI

The water pressure was recorded at 88 PSI

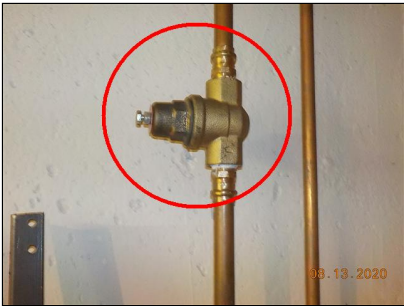
Adjustment/replacement of the pressure regulator valve (PRV) is necessary.

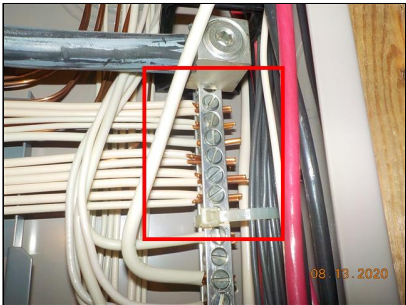
18. **SAFETY / HEALTH:** The neutral (white) wires are doubled under the same lugs inside the electrical panel. Although the manufacturer of this panel may allow the doubling of ground wires, the doubling of neutral wires is prohibited in most cases due to potential for loose contact. Would recommend having reviewed and corrected by an electrician for safety.

The neutral (white) wires are doubled under the same lugs

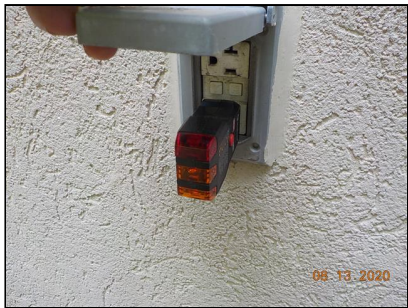
19. **SAFETY / HEALTH:** GFCI device failed to trip when tested with pocket tester or when test button was used. While it will still appear to function, it does not provide the required level of safety. Required to be GFCI protected at this location. Replacement with a functional GFCI is necessary by qualified electrician. Location: **Exterior-rear at the deck**

GFCI device failed to trip when tested

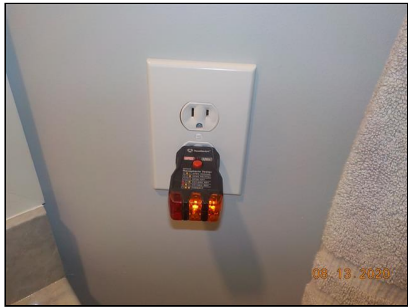
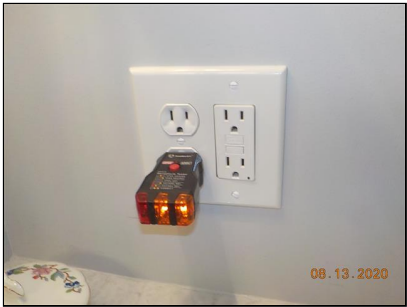
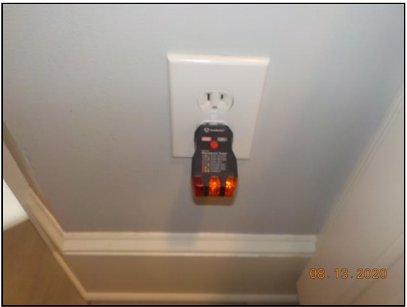
20. **SAFETY / HEALTH:** GFCI protection is missing. GFCI (ground fault circuit interrupter) protected devices are required to be installed at this location for protection from electrical shock. Have corrected by qualified electrician. Locations: **Owner's bathroom (3), laundry room, kitchen island**

GFCI protection is missing.

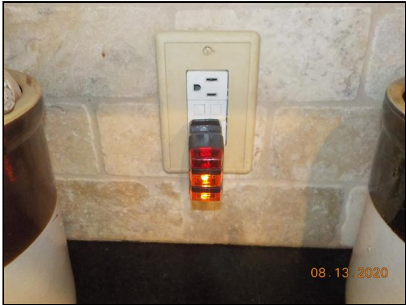
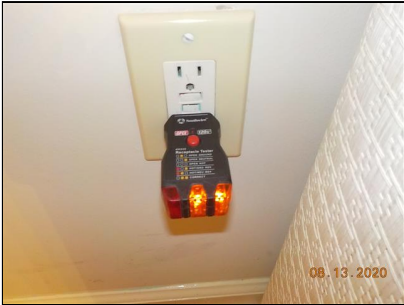
21. **SAFETY / HEALTH:** GFCI device failed to trip when tested with pocket tester or when test button was used. While it will still appear to function, it does not provide the required level of safety. Required to be GFCI protected at this location. Replacement with a functional GFCI is necessary by qualified electrician. Location: **Kitchen counters, basement bathroom**

GFCI device failed to trip when tested

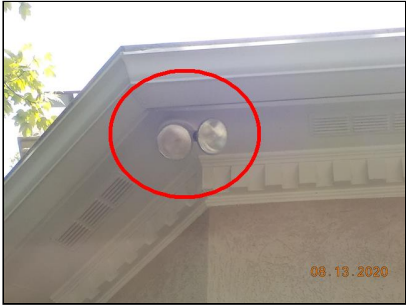
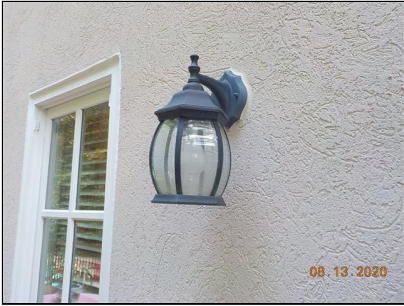
22. **SERVICE / REPAIR:** Inoperable lights noted. Replace bulbs and verify that the fixture is operational. If not, consult an electrician for repairs. Location: **Exterior-front left flood lights, deck**

Inoperable lights noted.

Inoperable light noted.

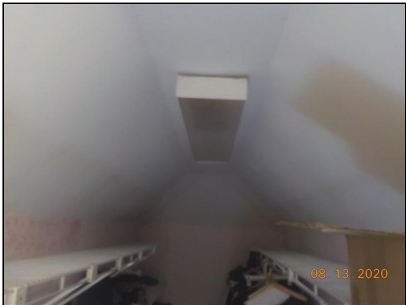
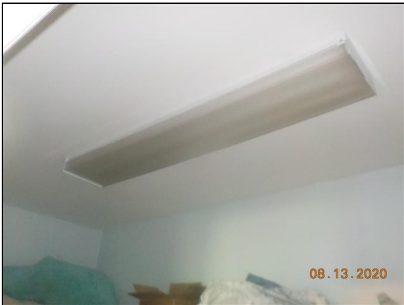
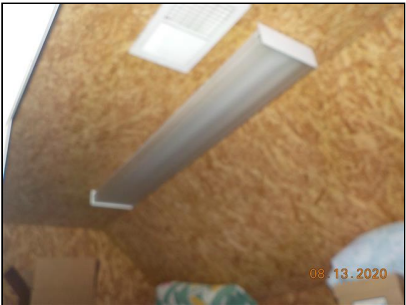
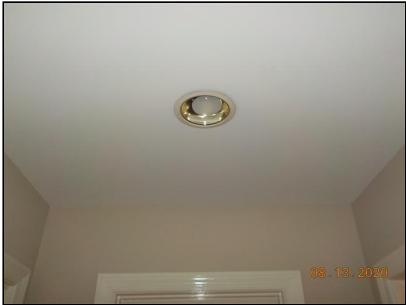
23. **SERVICE / REPAIR:** Inoperable lights noted. Replace bulbs and verify that the fixture is operational. If not, consult an electrician for repairs. Locations: **Left bedroom closet, rear middle bedroom closet, cedar closet, 2nd floor hallway**

Inoperable light noted.

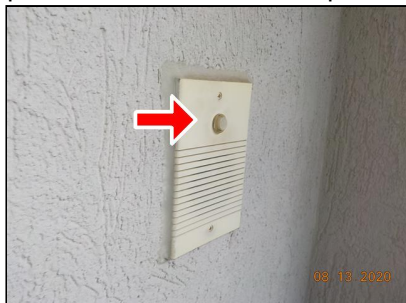
- ❌ 24. **SERVICE / REPAIR:** Door bell did not sound when tested. System should be evaluated to determine where the problem exists and have repaired as necessary.

Door bell did not sound when tested.

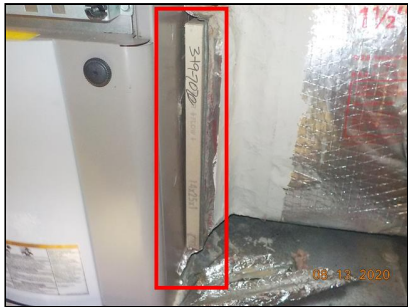
- ❌ 28. **SERVICE / REPAIR:** The filter access cover is missing. All filters should have a cover to prevent combustion gases from being drawn into the distribution air and to maximize the efficiency of the HVAC system. Have a cover installed for proper function. Location: **Upper floor-left side system**

The filter access cover is missing.

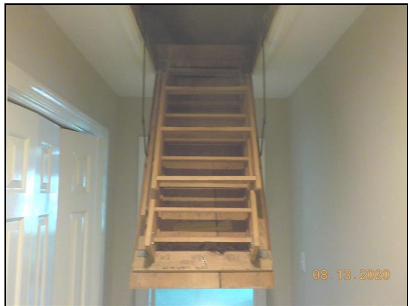
29. **SERVICE / REPAIR:** Attic pull down stair is not substantially weather tight when closed. Have the unit modified (weather stripped / insulated) as necessary to control energy loss. One option is to provide an insulated cover that fits over the stairs when retracted to reduce heat loss in the winter.

Attic pull down stair is not substantially weather tight when closed.

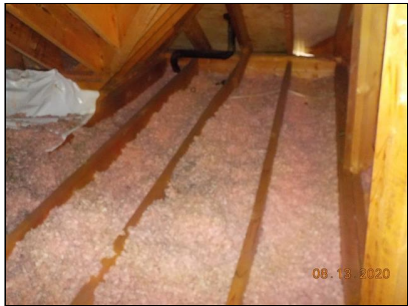
30. **SERVICE / REPAIR:** Visible ceiling joists means that thickness is less than 7 1/4 inches. Have insulation added at thin and missing areas to achieve R-30 minimum required (12-14 inches).

Visible ceiling joists means that thickness is less than 7 1/4 inches.

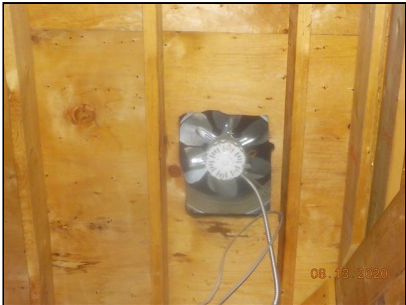
31. **SERVICE / REPAIR:** The attic roof power exhaust fan is not operating. The unit is too high up to reach for testing. The thermostatically controlled fan usually operates from 50-120 degrees attic temperature. As a general rule, roof

power ventilators quite often fail after several years of operation. Have a technician evaluate and repair/replace as required. **This is the only source of ventilation and is required.**

The attic roof power exhaust fan is not operating.

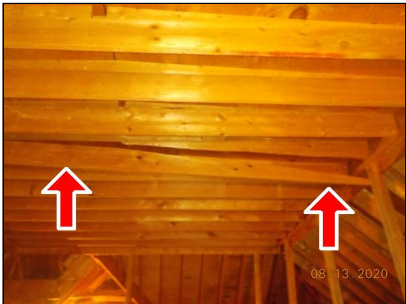
- ❌ 33. **SERVICE / REPAIR:** Split rafter noted. Recommend further evaluation and repairs made by a qualified contractor.

Split rafter noted.

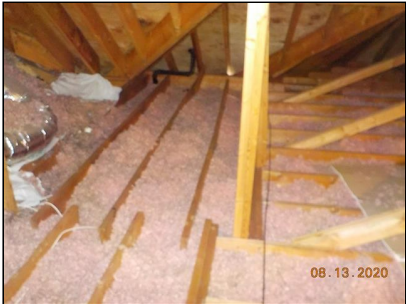
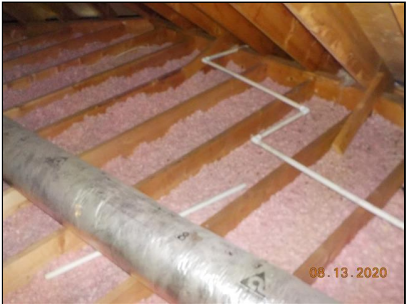
- ❌ 34. **SERVICE / REPAIR:** Signs of past rodent activity noted. Matted insulation and trails noted. Seek disclosure from the seller regarding any efforts taken to eliminate the pests. If none, recommend a complete evaluation and service performed by a qualified pest control contractor.

Matted insulation and trails noted.

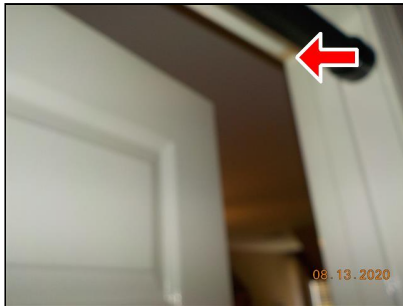
- ❌ 35. **SERVICE / REPAIR:** The door sticks when closed. Evaluate and correct for proper operation. Verify latching when after corrected. Possibly a result in improper installation, settling or misaligned hardware. Location: **Right rear bedroom**

The door sticks when closed.

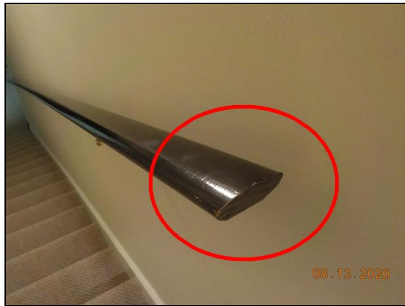
- ✘ 39. **SAFETY / HEALTH:** No return noted at the top and bottom of the stairway hand rail. All hand rails should terminate back to a wall for safety, to keep from catching on clothes or purses. Location: **Basement stairway**

All hand rails should terminate back to a wall for safety

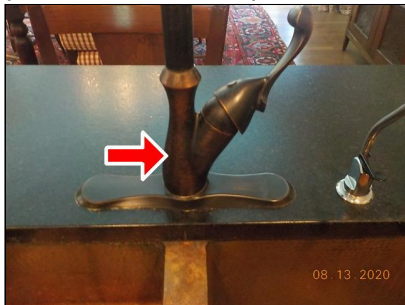
- ✘ 40. **SERVICE / REPAIR:** Loose faucet fixture noted. Secure the fixture assembly to the sink/counter as required to prevent rotation and potential wear on parts. Location: **Kitchen sink**

Loose faucet fixture noted.

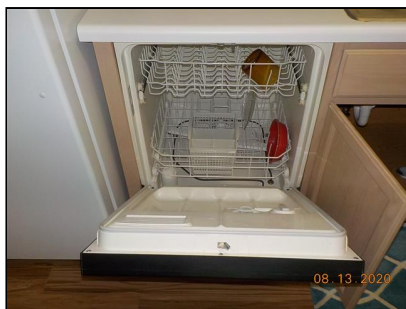
- ✘ 41. **SERVICE / REPAIR:** Dishwasher was noisy at start up and failed to fill with water. Recommend further evaluation and repair/replacement made by a qualified appliance repair contractor. Location; **Basement.**

Dishwasher was noisy at start up and failed to fill with water.

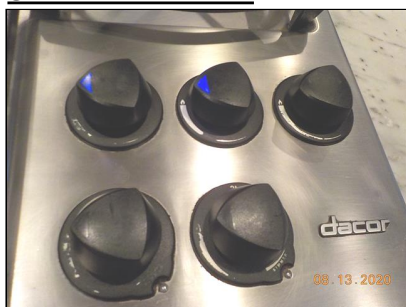
- ✘ 42. **SERVICE / REPAIR:** Knobs do not illuminate when the burner is on. 2 knobs are correct 3 are not.

Knobs do not illuminate when the burner is on.

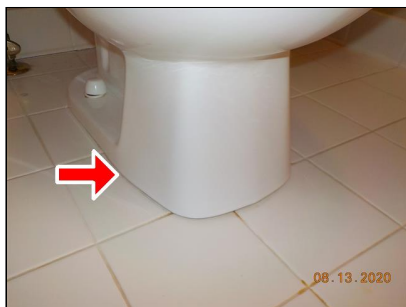
- ✘ 43. **SERVICE / REPAIR:** Toilet should be sealed between the base and floor as required. This helps protect below the unit from contaminants and better holds the unit in place to avoid rotating. The plumbing code also requires caulking fixtures to their mounted surfaces. Location: **All toilets** Note: Recommend using clear caulk on darker floor surfaces

Toilet should be sealed between the base and floor

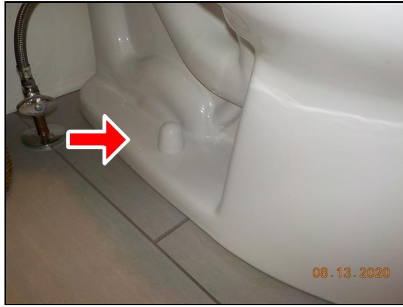
- ✘ 44. **SERVICE / REPAIR:** The toilet is loose at the base. Either the bolts holding the toilet to the floor need to be tightened or the wax ring needs to be replaced. Recommend a licensed plumber inspect further and repair as necessary. Location: **Owner's bathroom**

The toilet is loose at the base.

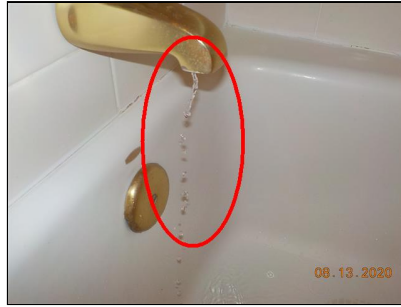
- ❌ 47. **SERVICE / REPAIR:** Shower diverter does not seal completely when engaged. This will result in a weaker flow to the shower head. Recommend correct to prevent water loss and allow normal use of shower. Locations: **Left bathroom, right rear bathroom,**

Shower diverter does not seal completely when engaged.

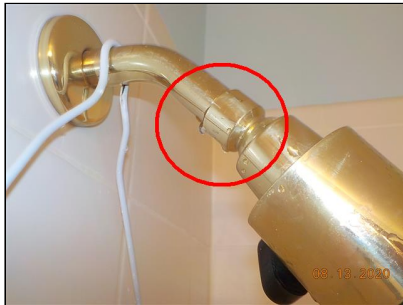
- ❌ 48. **SERVICE / REPAIR:** Leaking noted at the shower head connection. Location: **Right rear bathroom**

Leaking noted at the shower head connection

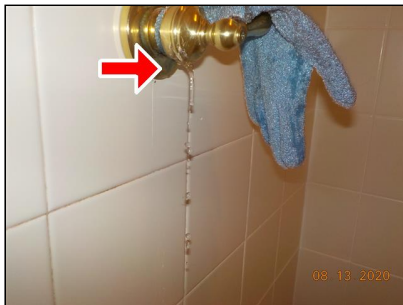
- ❌ 49. **SERVICE / REPAIR:** Faucet control valve stem leaks during operation at the shower. This may cause moisture damage behind wall. Recommend a licensed plumber inspect further and repair as necessary. Location: **Front bathroom**

Faucet control valve stem leaks

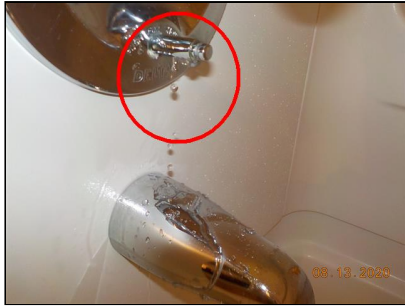
- ❌ 50. **SERVICE / REPAIR:** Shower diverter leaks when engaged. Recommend further evaluation and repairs made by a qualified plumber. Location: **Basement bathroom**

Shower diverter leaks when engaged.

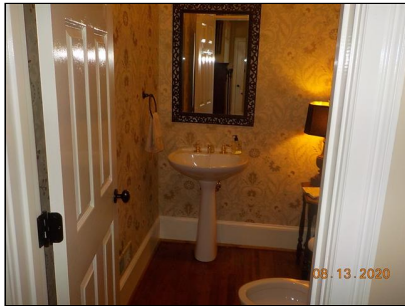
- ✗ 51. **SERVICE / REPAIR:** All bathrooms should have either a window or a fan installed. In this case of the **half bathroom**, neither is present. Recommend the installation of a vent fan.

Missing vent fan noted.

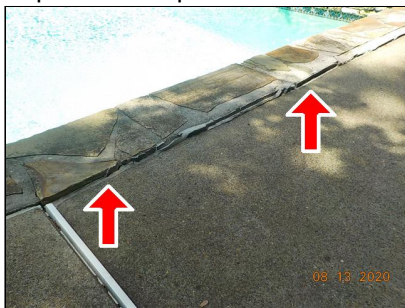
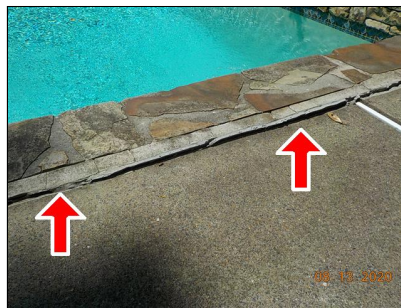
- ✗ 53. **SERVICE / REPAIR:** Areas of settled pool decking noted. Repairs are necessary to allow for proper drainage and to prevent a trip hazard.

Areas of settled pool decking noted.

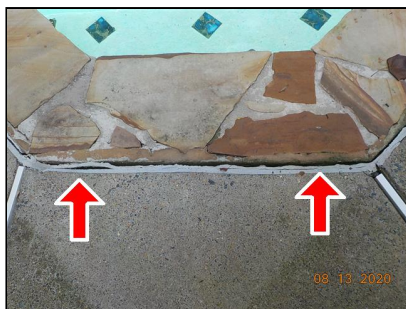
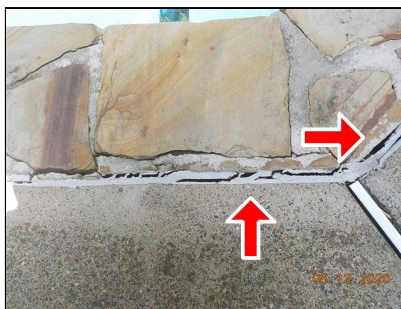
- ✗ 54. **SERVICE / REPAIR:** Separation noted. Have the gaps evaluated and corrected/filled by a qualified contractor.

Separation noted

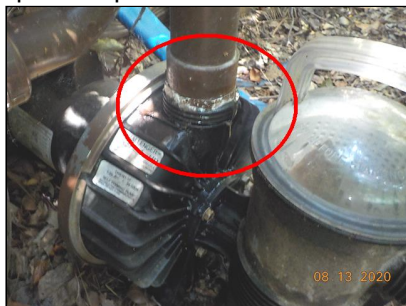
- ❌ 55. **SERVICE / REPAIR:** Leaking noted at the pool pump. Recommend further evaluation and repairs made by a qualified pool service contractor.

Leaking noted at the pool pump.

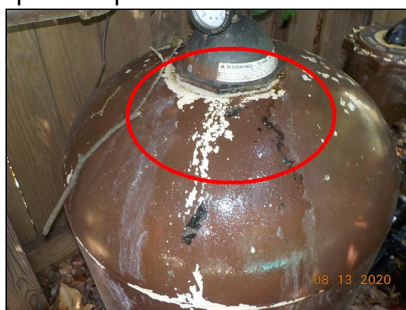
- ❌ 56. **SERVICE / REPAIR:** Leaking noted at the top of the filter. Recommend further evaluation and repairs made by a qualified pool service contractor.

Leaking noted at the top of the filter.

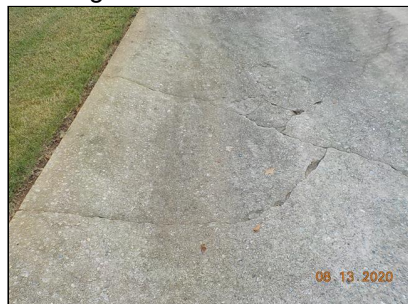
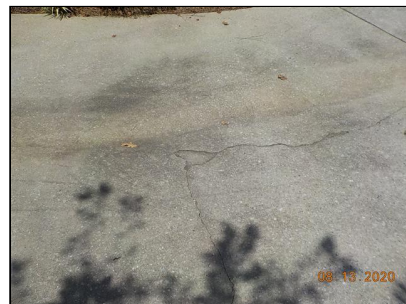
61. **GENERAL NOTE:** Cracks present in driveway surfaces. This is an indication of settling. We are unable to determine if it is a past problem or an ongoing one. This area should be monitored as repairs may be necessary in the future. Recommended to seal all open cracks to reduce rain water subsurface erosion and damage from freezing.

Recommended to seal all open cracks

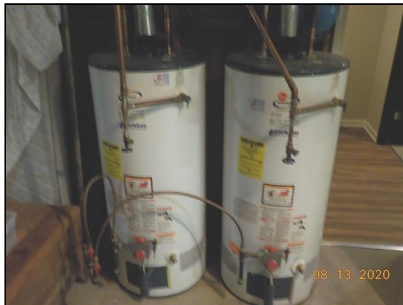
65. **GENERAL NOTE:** Average life expectancy for a water heater is approx. 8 to 12 years in the Atlanta area. Units manufactured in 2004. Budget for replacement or have a warranty program established.

Units manufactured in 2004.

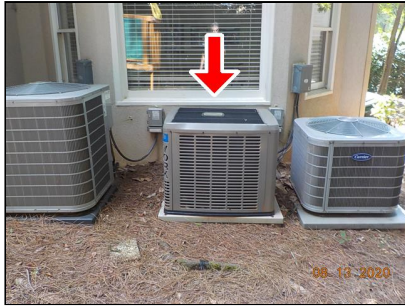
69. **GENERAL NOTE:** A/C compressors have an average life expectancy of 12 -15 years. The compressor for the **upstairs-left** is 15 years old. Advise to budget for future replacement or recommend that warranty program be set up.

The compressor for the upstairs-left is 15 years old.
