Inspection Report

Property Address:
382 Lofton Rd NW
Atlanta GA 30309

Avalon Home Inspections Inc.

Date: 7/21/2020	Time: 09:30:00 AM	Report ID: 31236JK
Property: 382 Lofton Rd NW Atlanta GA 30309	Customer: Bethany Seewoester	Real Estate Professional: Cathryn Weldon Keller Williams (Atlanta) InTown

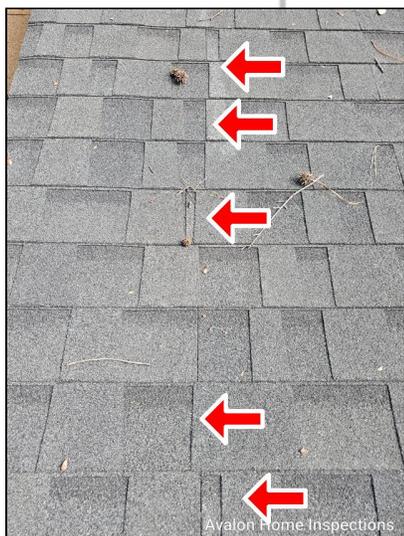
1.0 Item 12(Picture)

Racking can be an improper installation method for many shingle types. It is acceptable for some shingle types, and it is the required method for a few shingle types.

The inspector recommends that, before the expiration of your Inspection Objection Deadline, you have the roof examined by a qualified roofing contractor to determine whether the shingles on your roof have been improperly installed.

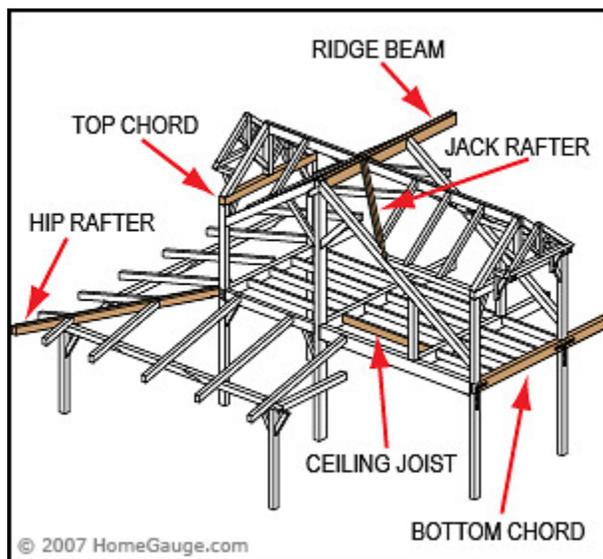
1.5 Item 1(Picture)

i (1) Diagram of roof system.

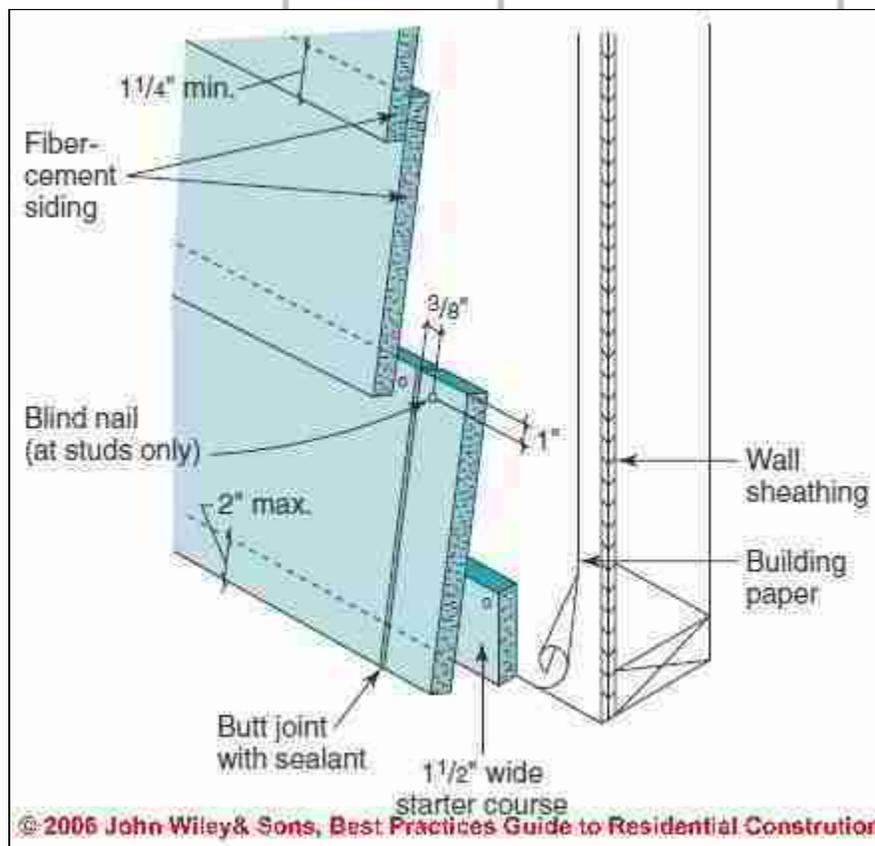
2.0 Item 1(Picture)

- 🔨** (2) This property was clad with cedar, redwood or white pine wood. It is prone to deteriorate and/or fail prematurely due to moisture penetration, especially when the paint coating is substandard or has not been maintained. Failure is typically visible in the form of cracking, splitting, buckling and fungal growth.

Some areas of siding on this structure showed symptoms described above and need replacement and/or maintenance.

Pictures shown do not represent all deficiencies, recommend that a qualified contractor evaluate and replace siding as necessary, and/or seal and repaint as necessary.

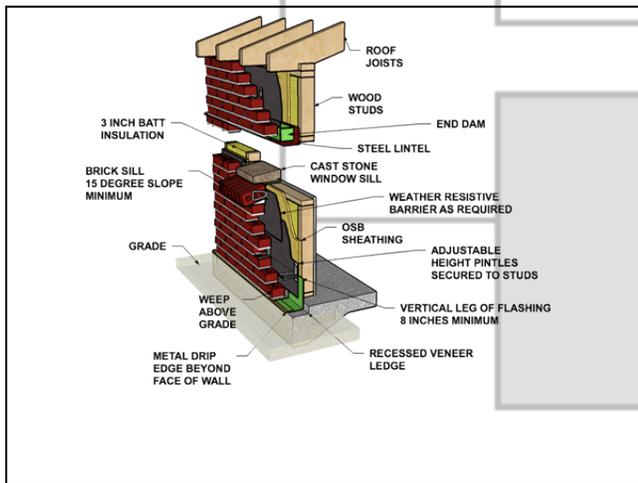
2.0 Item 3(Picture)

- (5) The wood trim at the front, rear and sides of home is beginning to deteriorate along bottom edge. Further deterioration can occur if not corrected. A qualified contractor should inspect and repair as needed.

Pictures shown do not represent all deficiencies, recommend that a qualified contractor evaluate and replace siding as necessary, and/or seal and repaint as necessary.

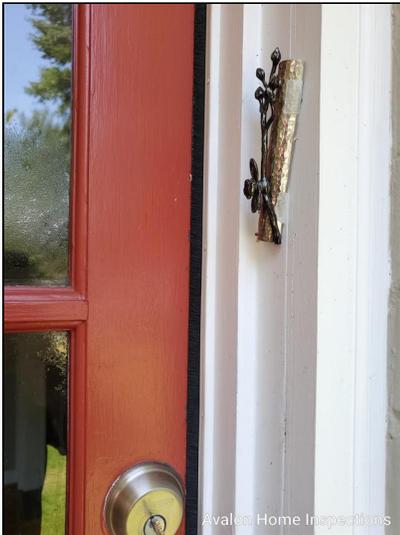
2.1 Item 1(Picture)

✂ (2) The entry door at the front of home rubs at jamb when closing. This is a small repair. A qualified contractor should inspect and repair as needed.

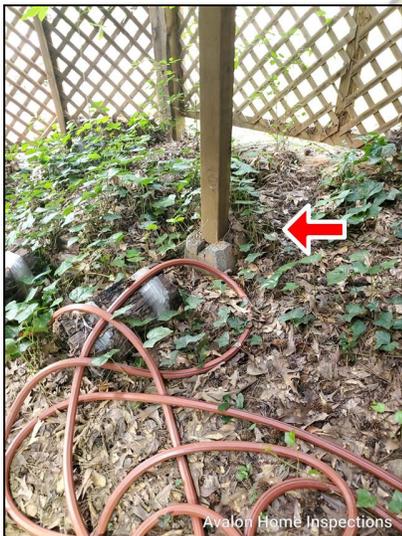
2.3 Item 4(Picture)

- 🔨 (4) The support post(s) for the deck at the rear of home are not sitting on proper footers. Repairs are needed. A qualified contractor should repair or replace as needed.

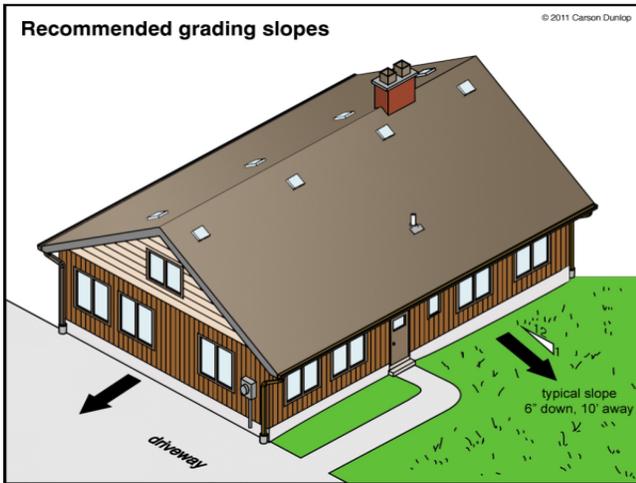
2.4 Item 1(Picture)

The grounds in contact with the home were inspected to determine that they were graded in a manner to allow rainwater to adequately drain away from the structure. The soil is recommended to slope away from the home, with a 6 inch drop in elevation, in the first 10 feet away from the structure (5% grade). When the 5% grade can not be achieved, swales or drains should be used as needed to properly divert rainwater runoff. Any flat or low areas around the home should be backfilled and sloped away from the foundation, to prevent potential moisture infiltration into areas below grade (if applicable). No significant grading deficiencies were observed at the time of inspection unless otherwise noted in this report.

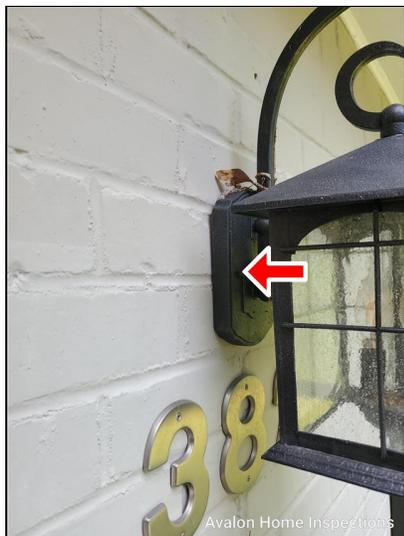
2.8 Item 1(Picture)

- 🔨 The light fixtures at the front, rear and right side of home are missing sealant to protect connections from corrosion. Electrical issues are considered a hazard until repaired. A qualified licensed electrical contractor should perform repairs that involve wiring.

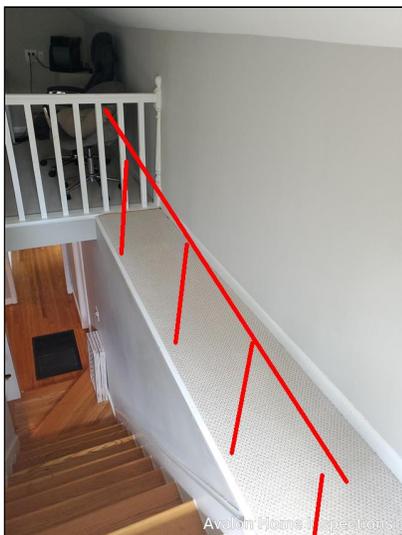
4.3.D Item 1(Picture)

The guard rail is missing. A fall or injury could occur if not corrected. A qualified contractor should repair or replace as needed.

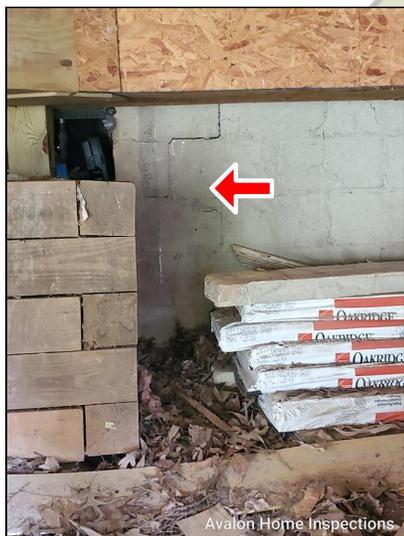
6.0 Item 1(Picture)

Typical shrinkage/expansion cracks at the foundation wall. Typical shrinkage/expansion cracks can be sealed and may need to be re-sealed periodically. This is FYI. Small cracks in masonry will sometimes appear as a house ages. These cracks are not structural in nature and are a result of shrinkage and/or settlement. Cracks should be sealed as a precaution to prevent rainwater penetration. During a prolonged or significant rain this can result in moisture intrusion over time and may not always be visible during the home inspection. Minor preventive maintenance can help to eliminate this.

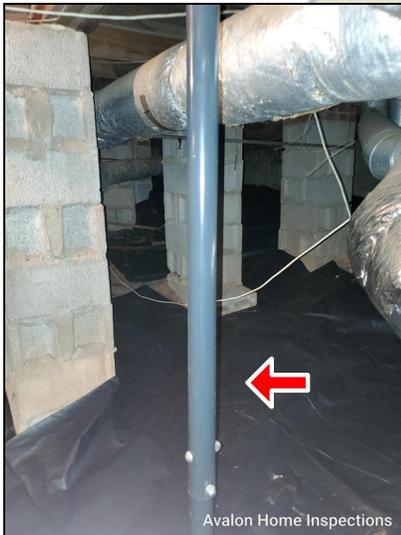
6.3 Item 1(Picture)

- 🔨 The steel jackpost(s) appears to work but are considered temporary supports in the crawlspace. Repairs are needed. A qualified licensed general contractor should inspect further and repair as needed.

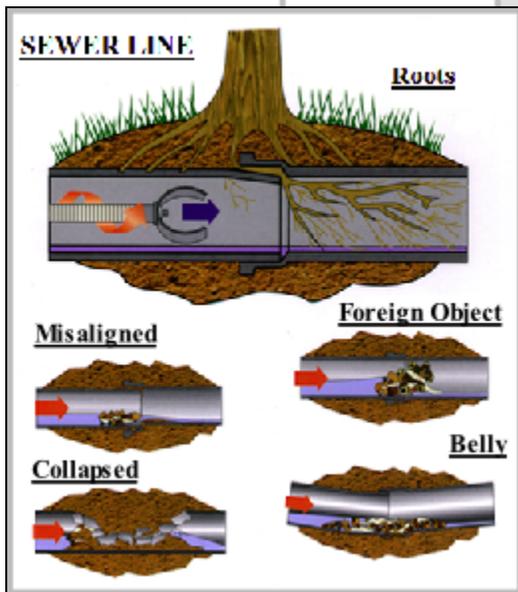
7.0 Item 2(Picture)

🔨 (2) The main soil pipe(waste line) for the home is cast iron. Typical lifespan of this material is 40-50 Years. These pipes rust from the inside out, most of the time with little or no warning. No obstructions or leaks were noted at the time of inspection; however, when solid waste or large volumes of waste are introduced pipes could clog or begin to leak. Recommend a qualified plumber scope waste lines for further inspection to determine the integrity of system. Buyer should budget for replacement.

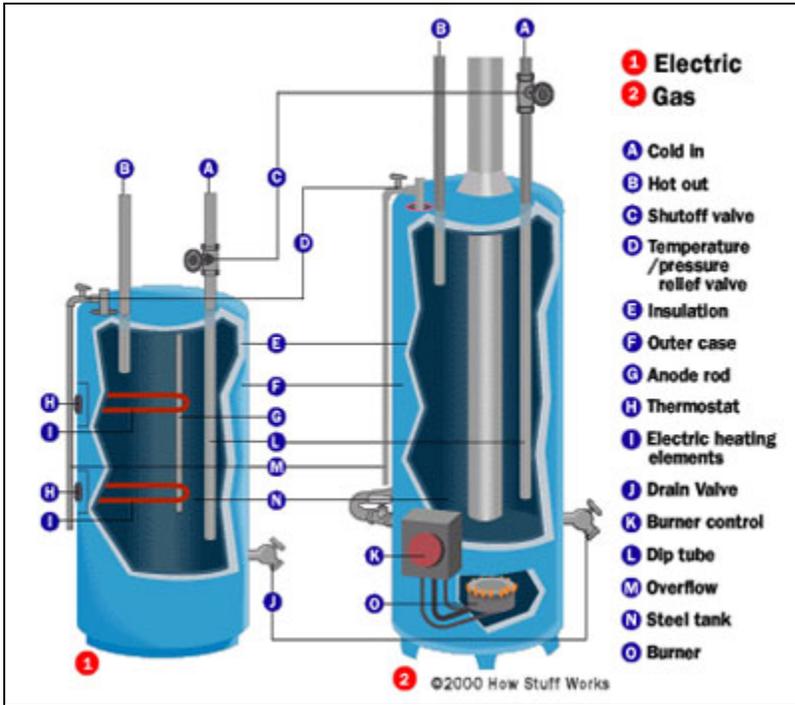
7.2 Item 1(Picture)

(1) Average useful lifespan of water heater in Georgia is 14 Years. If water heater is over this age, buyer should budget for replacement. This is FYI.

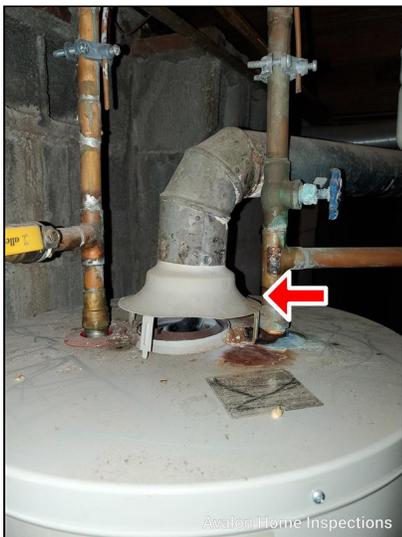
7.2 Item 5(Picture)

(4) The draft hood for water heater is loose or not secured. This is a safety issue and should be repaired. I recommend a qualified licensed heat contractor inspect further and repair as needed.

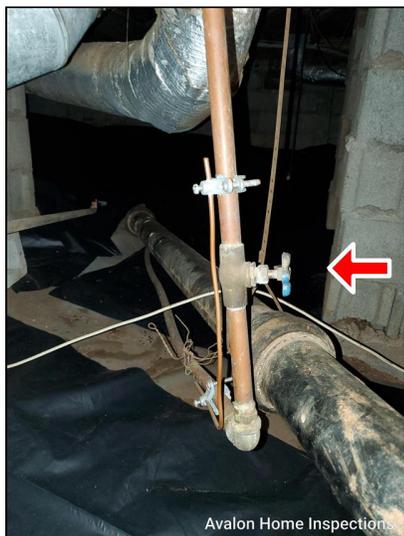
7.3 Item 1(Picture)

i The main shut off is the blue knob/lever located in the crawlspace. This is for your information.

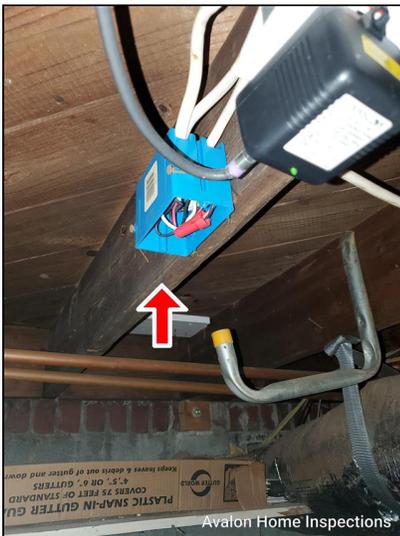
8.3 Item 1(Picture)

✂ Several junction boxes in the crawlspace need cover plates. This is a small repair.

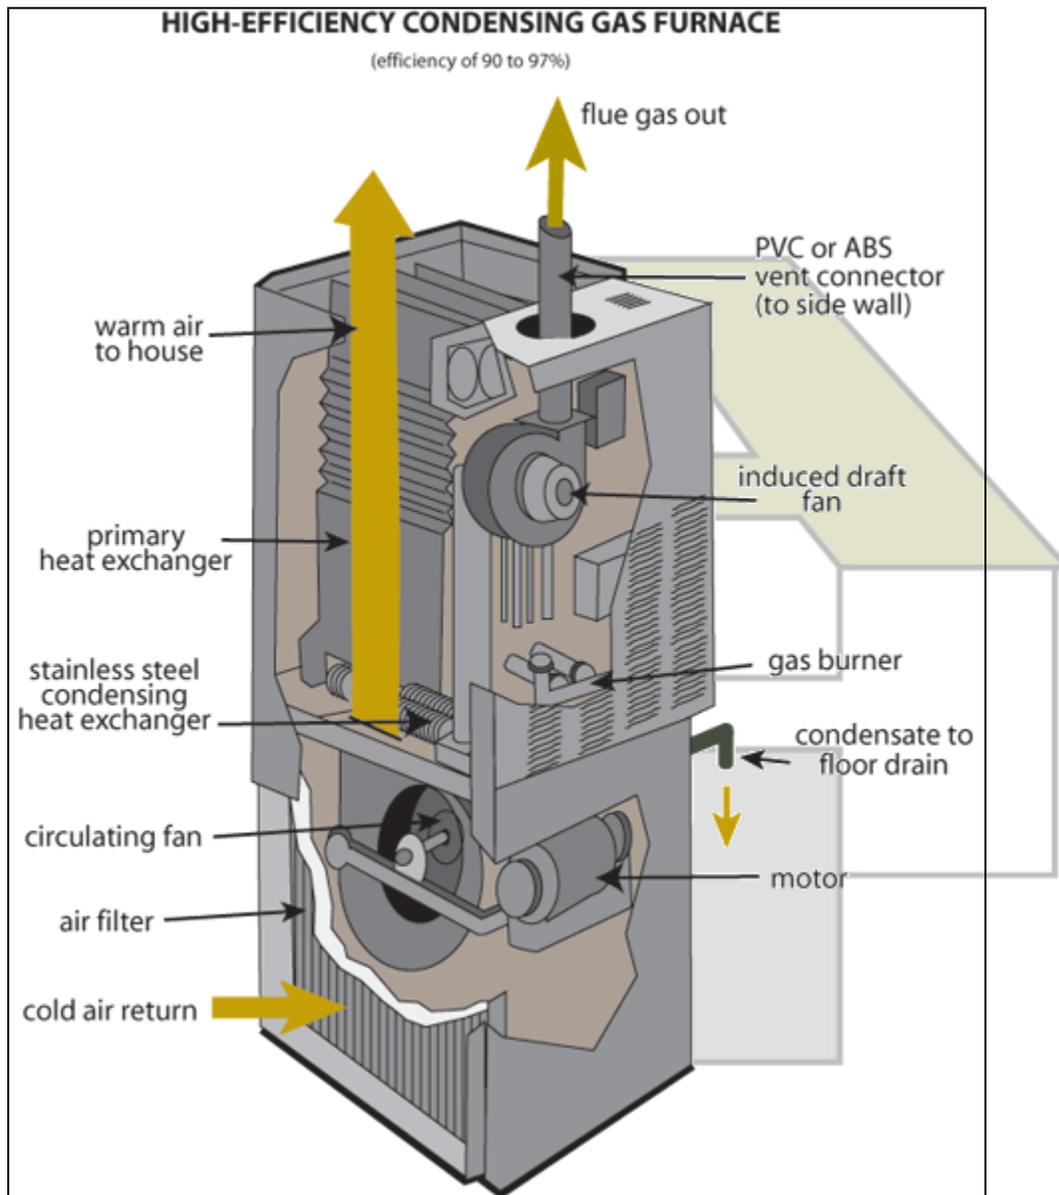
9.0 Item 1(Picture)

(1) Average lifespan of gas furnace in Georgia is 25 Years. If unit is above this age, buyer should budget for replacement. This is FYI.

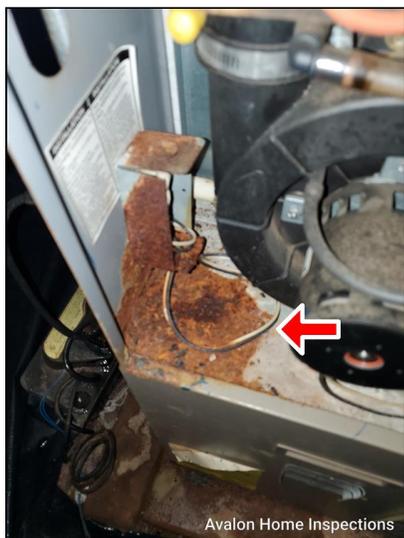
9.0 Item 2(Picture)

- 🔧 (2) The gas furnace will fire, but carbon deposits on burners or jets and rust within furnace indicate the need to service. A more thorough inspection by a qualified contractor is needed. A qualified HVAC person should inspect further and repair or replace as needed.

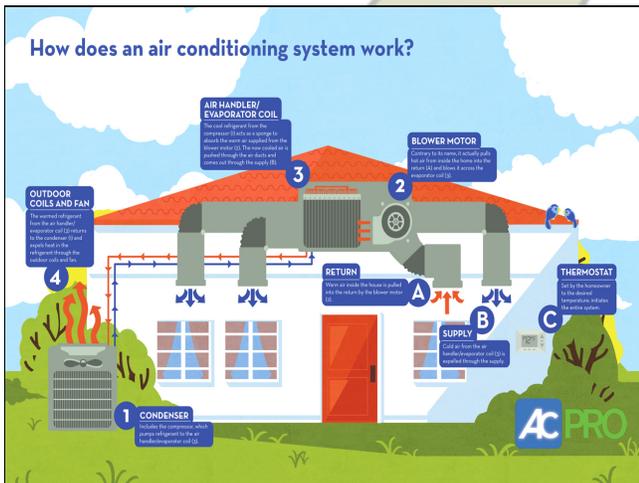
9.10 Item 1(Picture)

(1) Average lifespan of Air Conditioner in Georgia is 15 Years.If unit is above this age, buyer should budget for replacement. This is FYI.

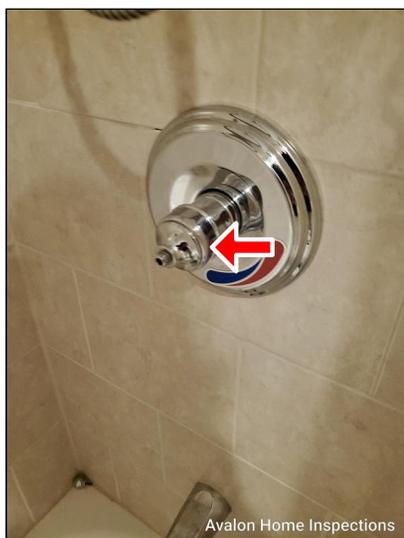
5.5.B Item 1(Picture)

The control knob for shower is missing at the hall bath. Repairs are needed. A qualified licensed plumber should repair or correct as needed.

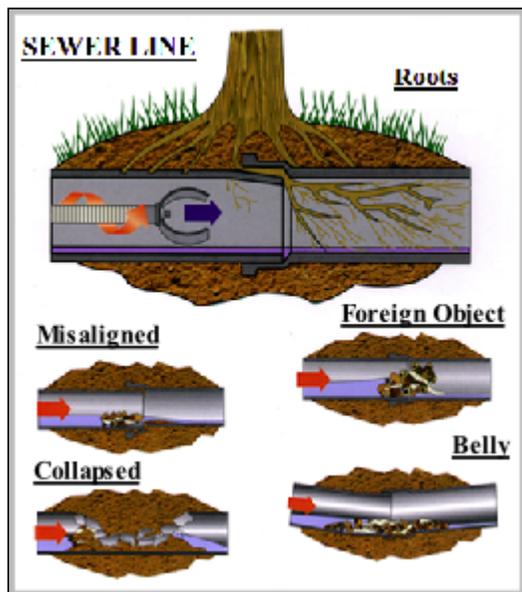
7.0 Item 3(Picture)

(2) The main soil pipe(waste line) for the home is cast iron. Typical lifespan of this material is 40-50 Years. These pipes rust from the inside out, most of the time with little or no warning. No obstructions or leaks were noted at the time of inspection; however, when solid waste or large volumes of waste are introduced pipes could clog or begin to leak. Recommend a qualified plumber scope waste lines for further inspection to determine the integrity of system. Buyer should budget for replacement.

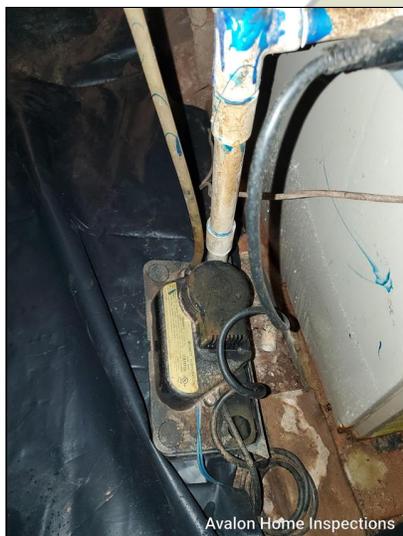
9.10 Item 2(Picture)

(3) The condensation pump's float switch is not connected to HVAC unit. Leaks can cause damage to unit or home. A qualified HVAC person should inspect further and repair or replace as needed.

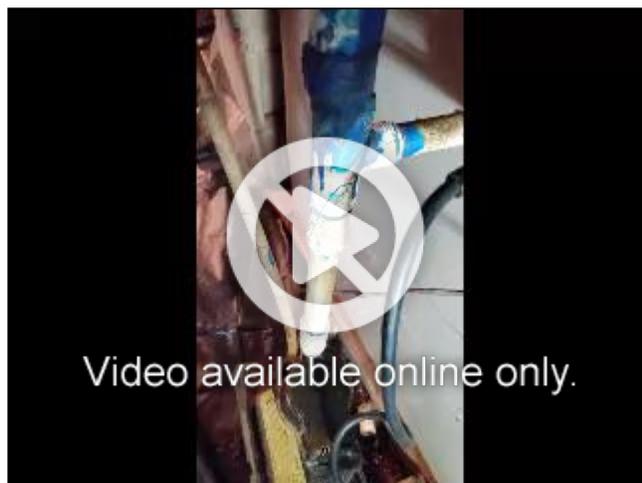
9.10 Item 4(Video)

(5) The evaporator coil is leaking in the crawlspace at air handler and should not as this can lead to fungi growth and water damage. This can be an indication that the evaporator coil pan has rusted through. Leaks can cause damage to unit or home. A qualified HVAC person should inspect further and repair or replace as needed.
