Inspection Report

Brian & Ilissa Feiler

Property Address: 4805 Lafayette Court Sandy Springs, GA 30327

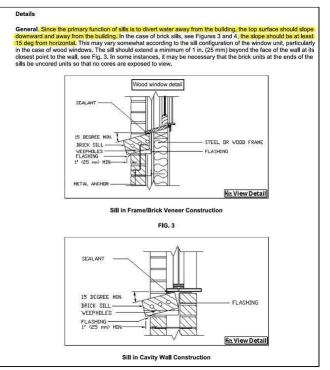
2.1 Item 1(Picture)

2.1 (1) Brick veneer window sills and ledges are pitched less than 15 degrees. Pitching the top row of bricks will help direct rain water away from the home. See a requirement when the home was built. 2006 International Residential Code Section R703.7. Stone and masonry veneer, general. Stone and masonry veneer shall be installed in accordance with this chapter, Table R703.4 and Figure R703.7. For more information, see the attached pictures.

Brick veneer window sills and ledges are pitched less than 15 degrees. Pitching the top row of bricks will help direct rain water away from the home. See a requirement when the home was built. 2006 International Residential Code Section R703.7. Stone and masonry veneer, general. Stone and masonry veneer shall be installed in accordance with this chapter, Table R703.4 and Figure R703.7. For more information, see the attached pictures.
There's a settlement crack in the brick veneer wall, at the basement entry door, roof. Is the roof improperly supported on the brick veneer wall? See a requirement when the home was built. 2006 International Residential Code Section 703.7.3. <u>Masonry veneer shall not support any vertical load other than the dead load of the veneer above</u>.

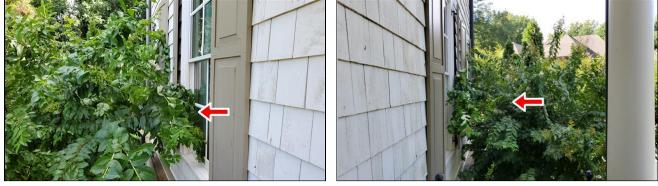
2.6 Item 1(Picture)

2.6 (1) Trees, shrubs, and/or vegetation should be properly trimmed back from the home.

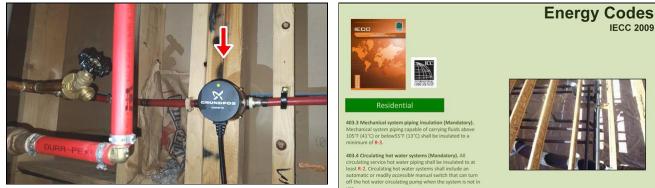
4.3 Item 1(Picture)

4.3 (1) The water circulation pump's pipes are not insulated. See a requirement when the home was built. 2009 international International Energy Conservation Code section R403.4. Piping insulation. Circulation hot water system's piping shall be insulated to at least R-2.

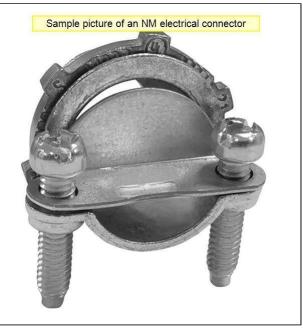
10.5 Item 1(Picture)

10.5 The food waste disposer's electrical connector and electrical cover-plate are missing.

The food waste disposer's electrical connector and electrical cover-plate are missing.
