Property Inspection Report
5068 Bright Hampton Dr SE
Smyrna, GA 30080

| 5068 Bright Hampton Dr SE Smyrna, GA 30080 | 2020-08-20 |

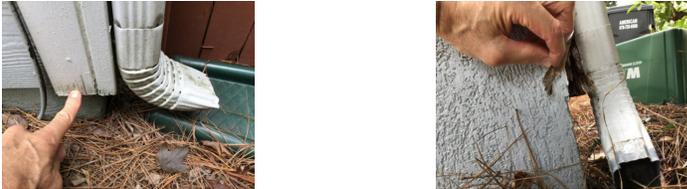
| Condition 16 | | |

| Condition 16 | | |
|---|---|--|
| Location | Right rear, right front | |
| Condition | Damaged corner boards | |
| Explanation | Damage was noted at corner boards near the ground | |

| Condition 16 | | |
|---|---|--|
| Suggested Action | Have a contract to replace all damaged components | |

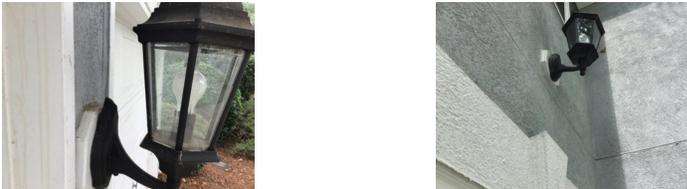
| Condition 16 | | |
|---|---|--|
| Condition 17 | | |

| Condition 16 | | |
|---|---|--|
| Location | All exterior fixtures | |
| Condition | Fixtures Not Sealed | |
| Explanation | Exterior light fixtures have not been properly sealed and may allow water into the electrical components. | |

| Condition 16 | | |
|---|---|--|
| Suggested Action | Properly secure all loose fixtures and seal with silicone caulk along the perimeter. | |

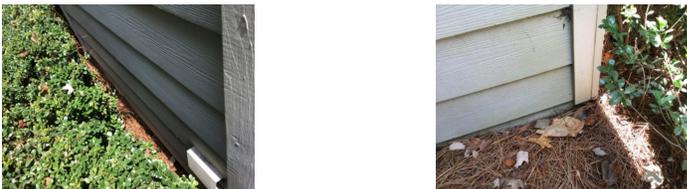
| Condition 16 | | |
|---|---|--|
| Condition 19 | | |

| Condition 16 | | |
|---|---|--|
| Location | Rear | |
| Condition | Earth to Siding Clearance Limited | |
| Explanation | A minimum of 6 inches should be provided between exterior siding/veneer material and the ground. | |

| Condition 16 | | |
|---|---|--|
| Suggested Action | Adjust the grade and the mulch to ensure minimum clearance. Also ensure proper slope away from the foundation (6 inches per 10 feet). | |

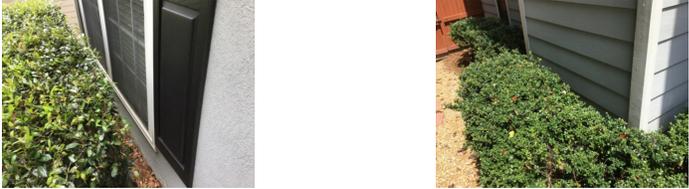
Condition 32

| Location | Front and rear | |
| Condition | Overgrown Vegetation | |
| Explanation | Vegetation close to walls, windows and trim traps moisture, especially in the summer humidity, and accelerates deterioration. This has likely contributed to the rear window frame damage | |
