Inspection Report

**565 Trowbrook Road
Atlanta, Georgia 30350**

Inspection Date August 21, 2020
Inspector Jay Cao
www.HouseChecked.com
jc@housechecked.com
(678)557-8958
interNACHI Certified Inspector, GA Registered Professional Engineer

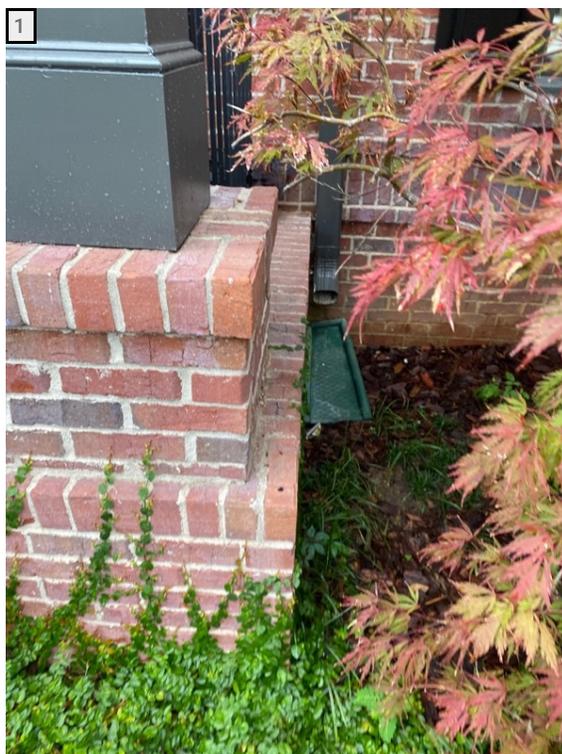
Location Exterior: Ground View

apply to all, too close to house foundation, need to add an extender to diver water at least 4 ft away from house.

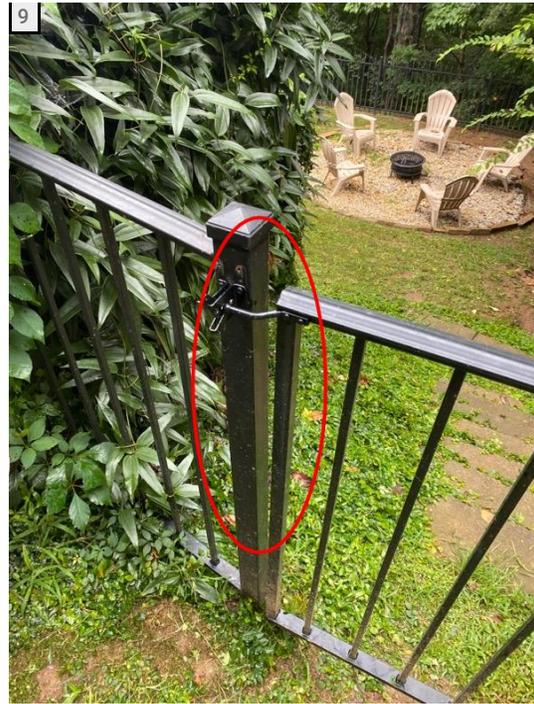
Location Exterior: Ground View

Misaligned

Impact The misalignment makes it difficult to open and close the gate

Suggested Action Have the fence repaired by a fence contractor

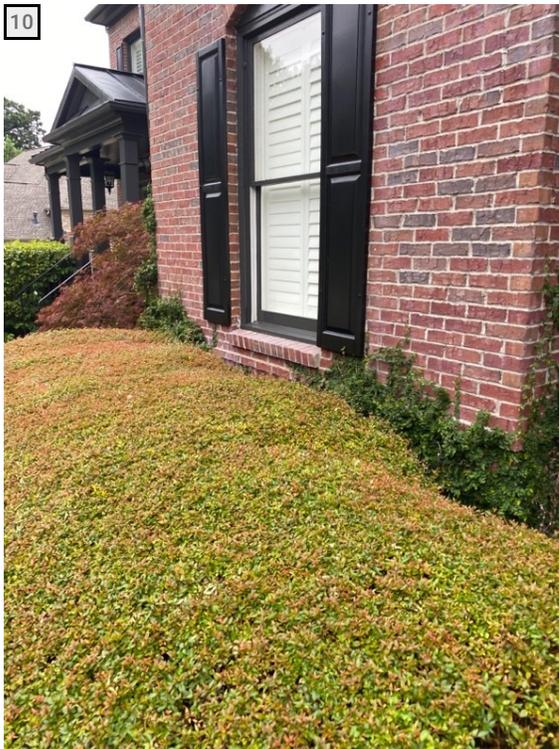
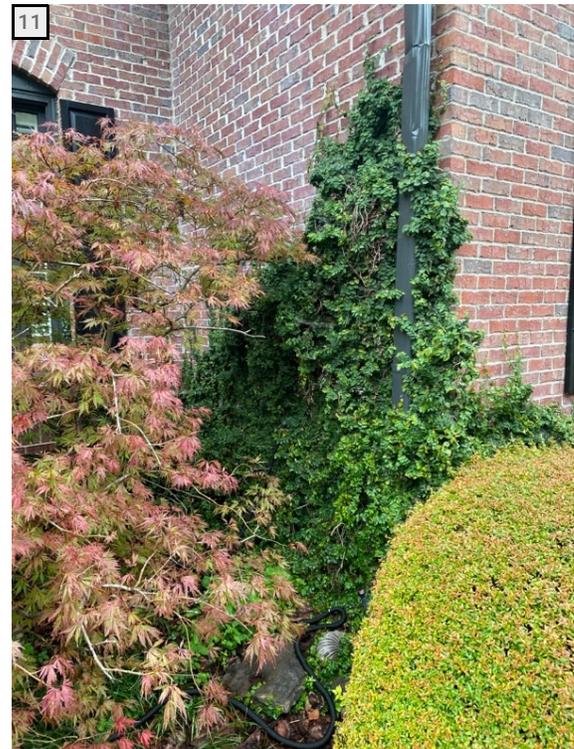
Location Exterior: Ground View

vegetation branches are in contact with building

Impact The tree branches provide an environment where moisture and/or insects could intrude and also may cause damage or excess wear to the siding or roofing material

Suggested Action Regularly trim the trees to achieve a clearance of at least 6 - 8 feet

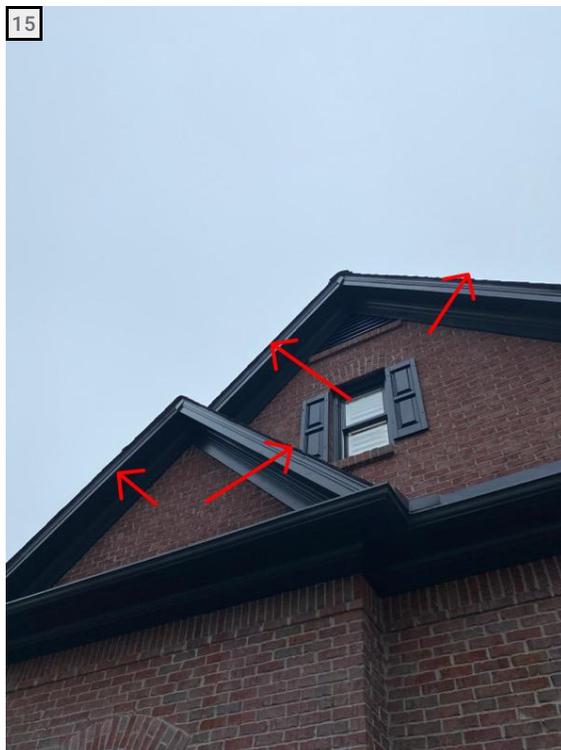
Location Exterior: Roof View

drip edge flashing is not installed, this may result water it moisture getting behind the shingles along the edge, recommend to have it installed per code

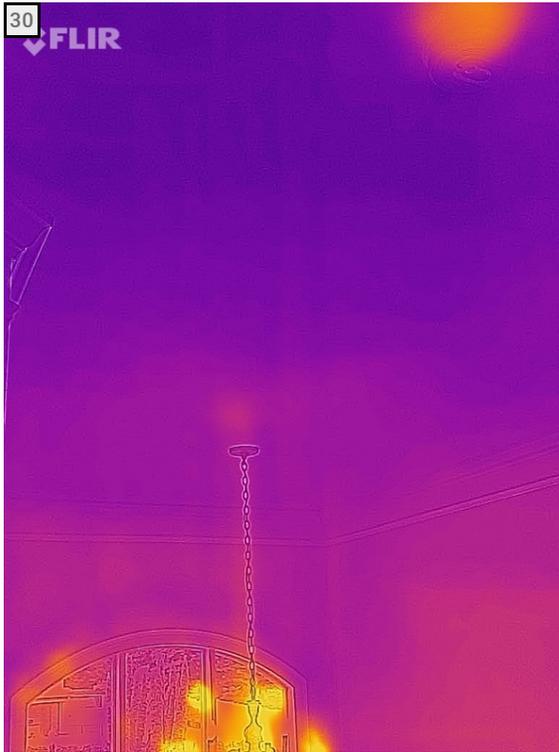
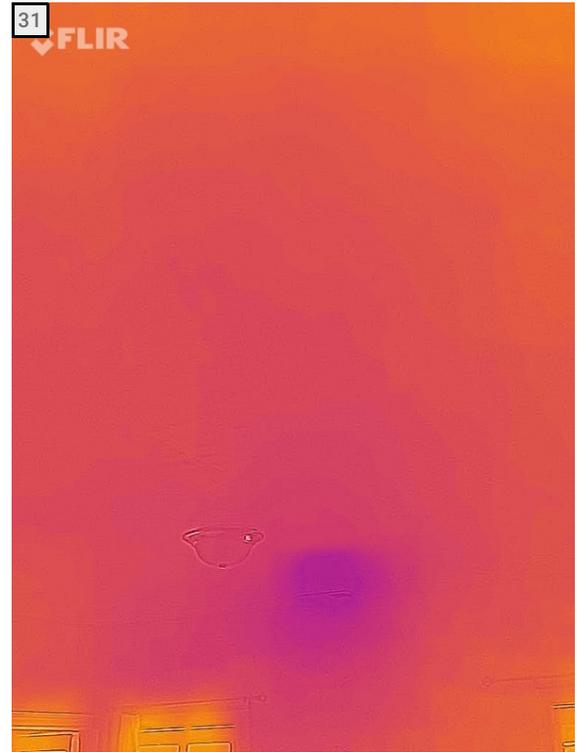
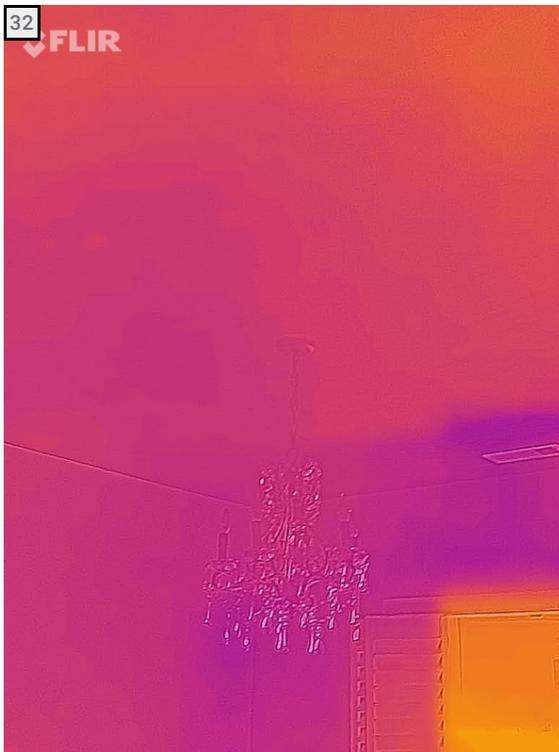
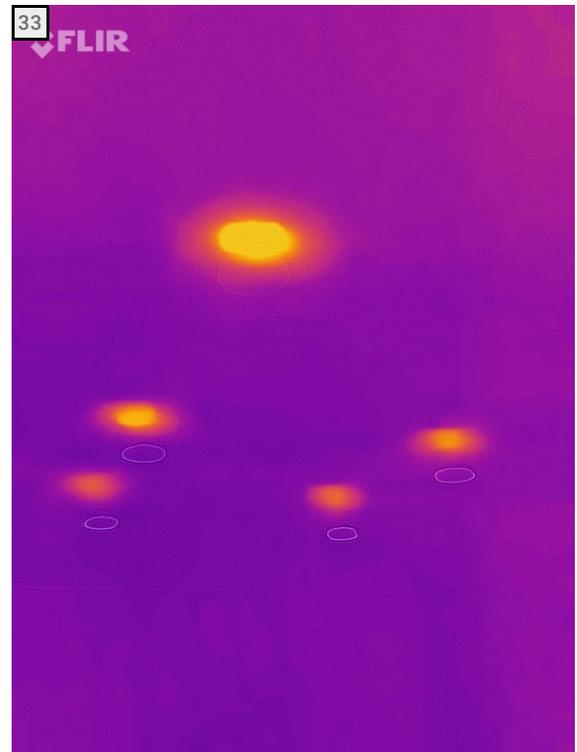
Location Living Room

thermal scan shows there is no active water leak for the area noted

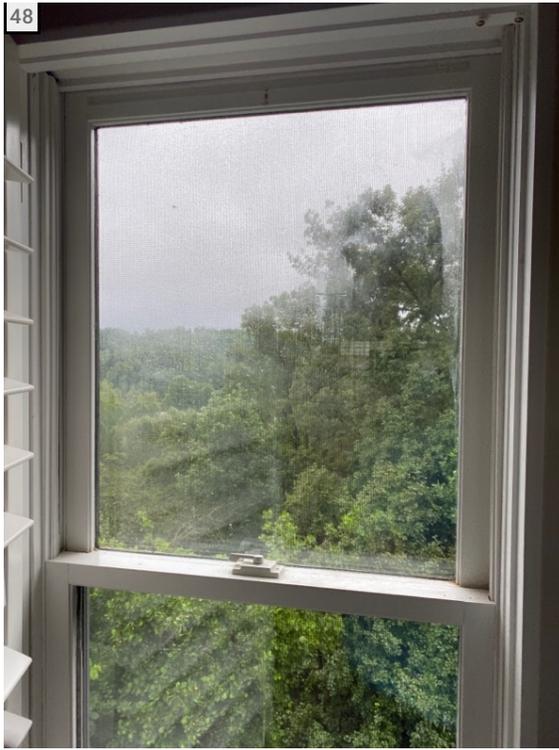
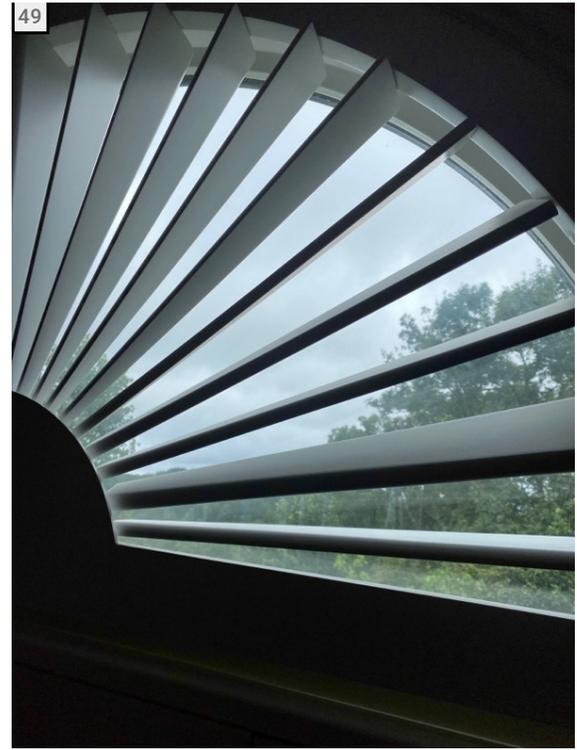
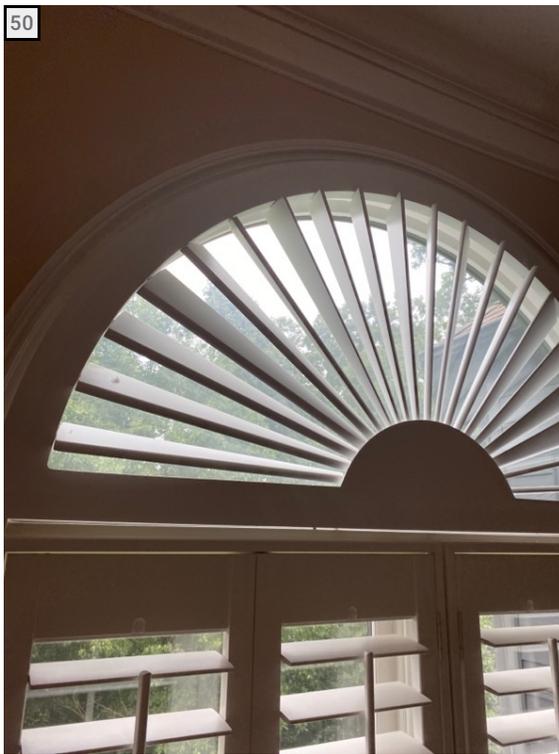
Fogging or sweating

Location	Family Room, 3rd Bathroom
Impact	Should it worsen, insulating value may be impacted
Suggested Action	Monitor or replace to improve appearance
Other Information	This is likely caused by a broken seal. Windows get their insulating value by trapping air between two well-sealed panes of glass. Some insulated windows are actually filled with argon gas which provides a higher insulating value. When the seals break, moist air enters the space. However, as long as there is minimal air movement in the space, the insulating value remains high. Broken seals are caused by buildup of water and other debris (pine needles, dust, etc.) in the window frame. Temperature differences between the indoors and outdoors also puts stress on the seals by causing them to expand and contract in cold weather

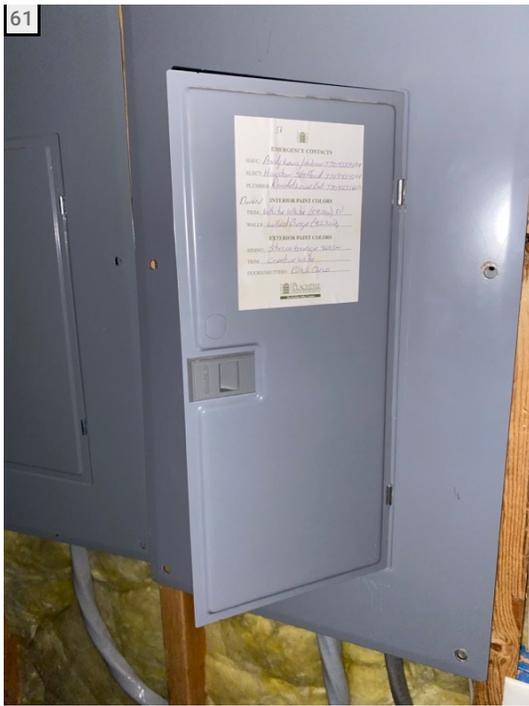
Cover panel is missing mounting screws

Location Basement
Impact A loose panel provides little protection from arcing
Suggested Action Install mounting screws in cover panel

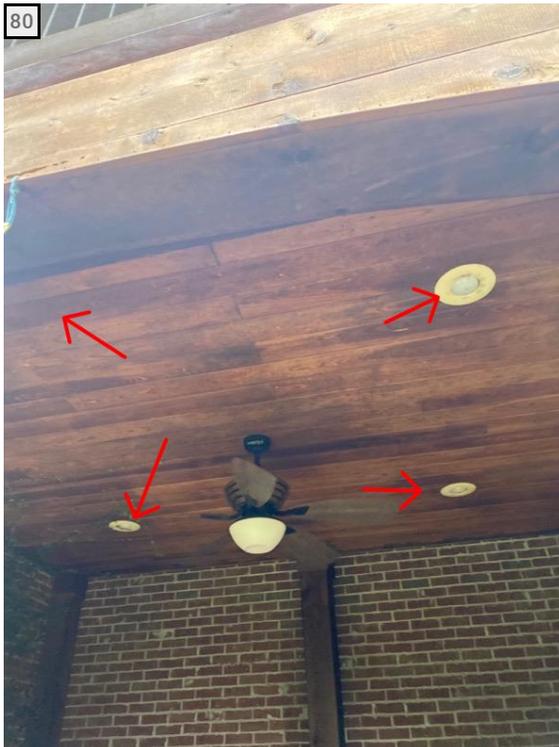
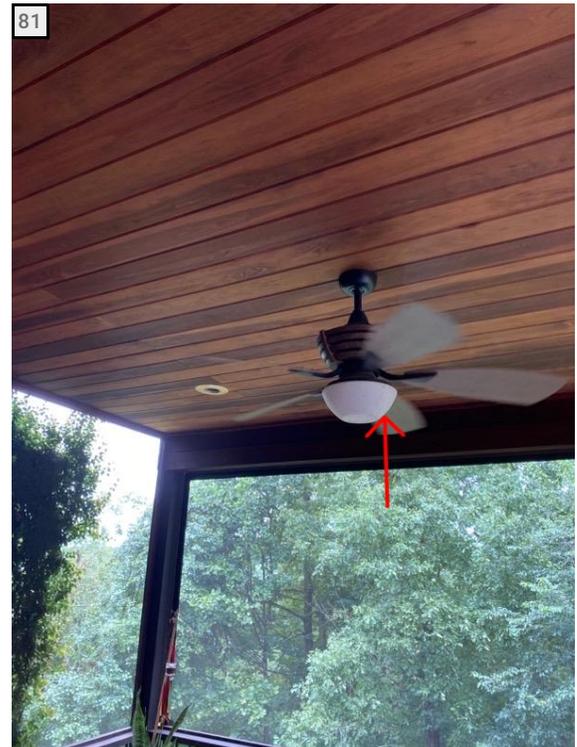
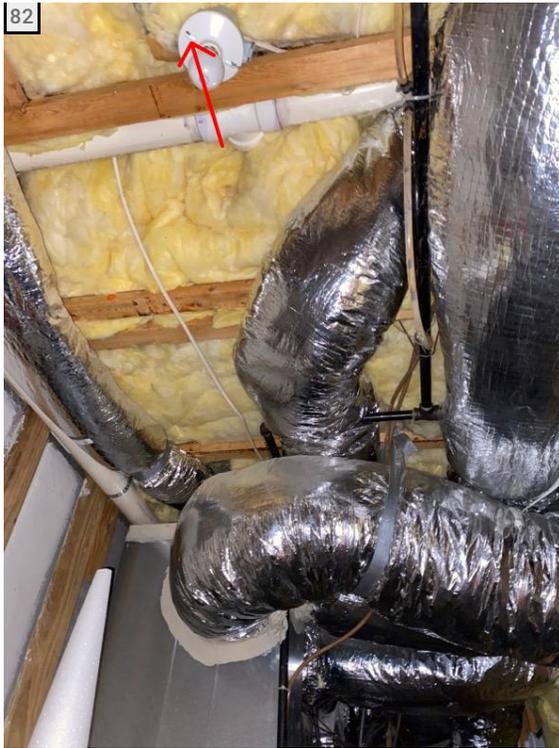
Location Basement, Exterior: Ground View

Not working

Suggested Action Replace the light fixture

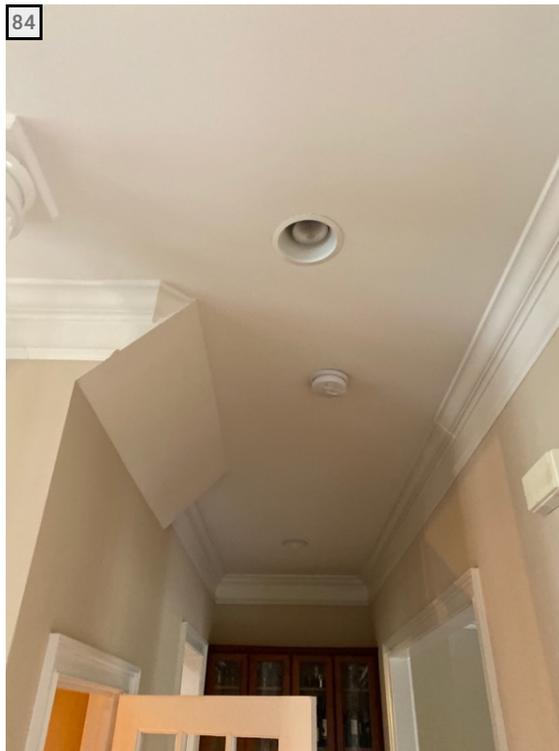
Location Hallway and Stairs

all the smoke alarms and CO alarms throughout the house shall be tested at the time of moving in, current code requires each bedroom shall have smoke detector, older house without major renovation doesn't need to meet this requirement but it is strongly recommended

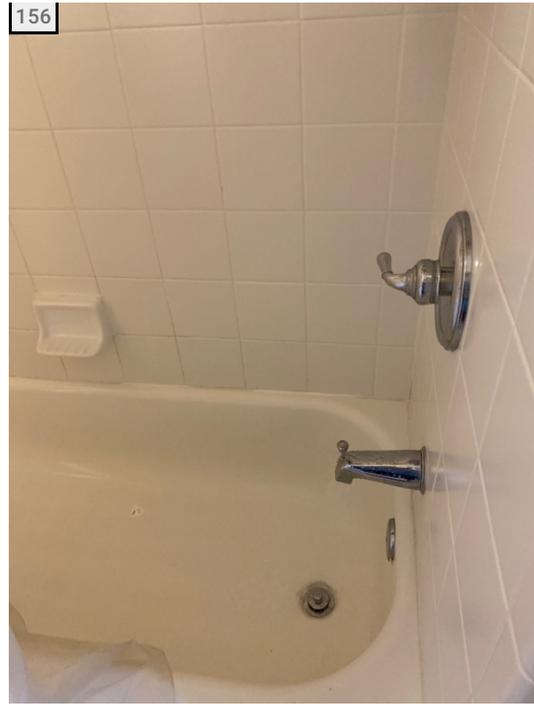
Moderate Concern**Spout diverter is leaking**

Impact The leak may become a nuisance. If not repaired, calcium deposits may form at the base of the valve and water flow to the shower head will be reduced

Suggested Action Replace the tub spout including the diverter

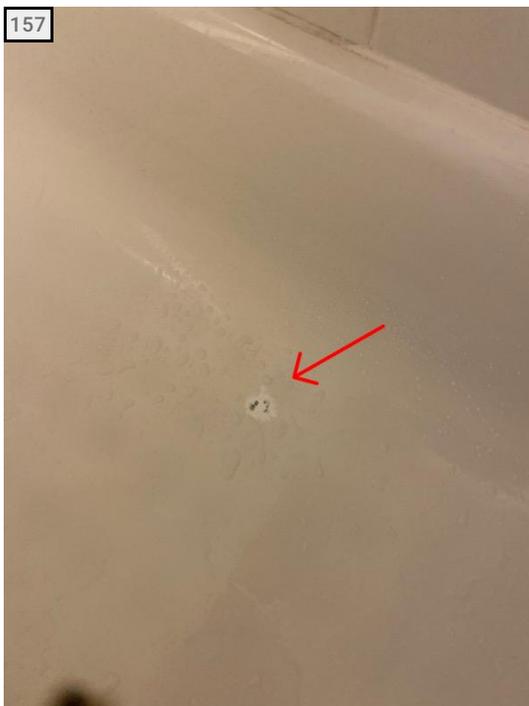
Location 3rd Bathroom

tub has minor damage

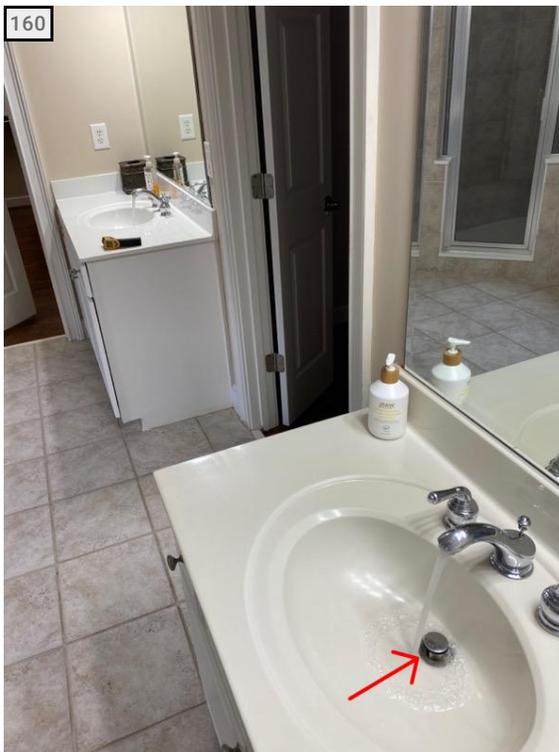
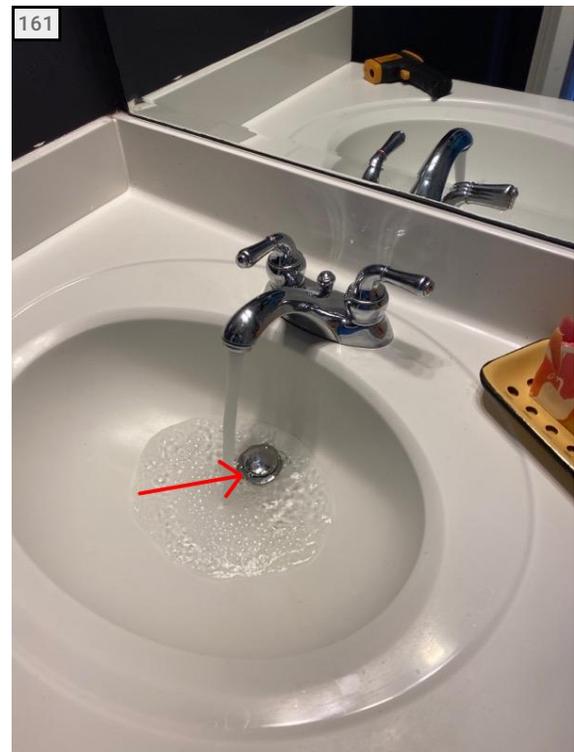
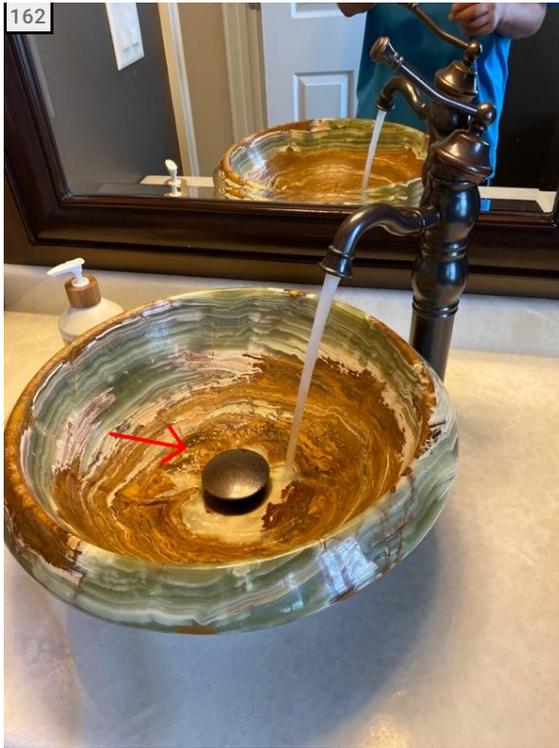
Drain stop is not working

Location Partial Bathroom, 1st Bathroom, 2nd Bathroom
Suggested Action Reconnect and/or readjust the drain stop. If the problem is not resolved, replace the drain stop
