HOME INSPECTION REPORT

300 Saddlebrook Drive, Roswell, GA 30075

Date of Inspection: 6/30/2020 Time: 1:30 PM

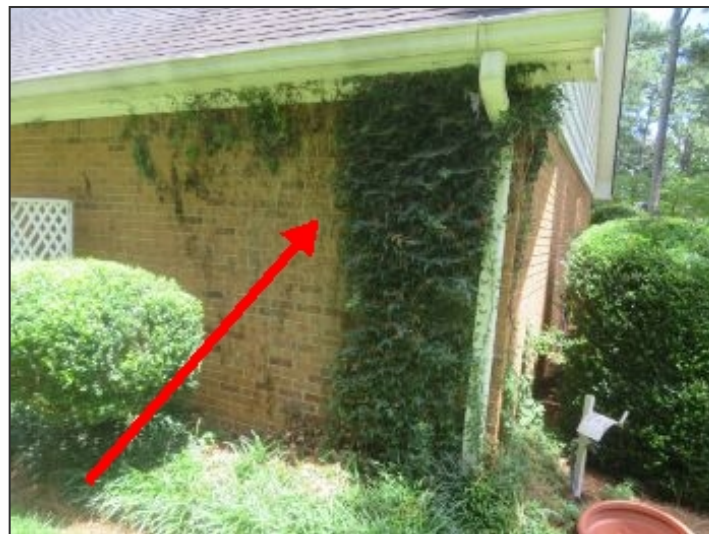
- Climbing vegetation / vines were observed on the exterior walls which is not recommended. Removal of all exterior wall climbing vegetation is suggested.

Climbing vegetation at rear right wall

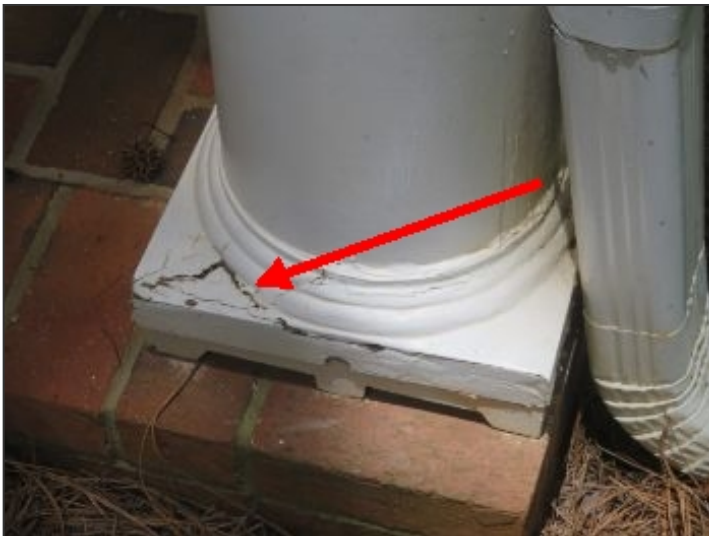
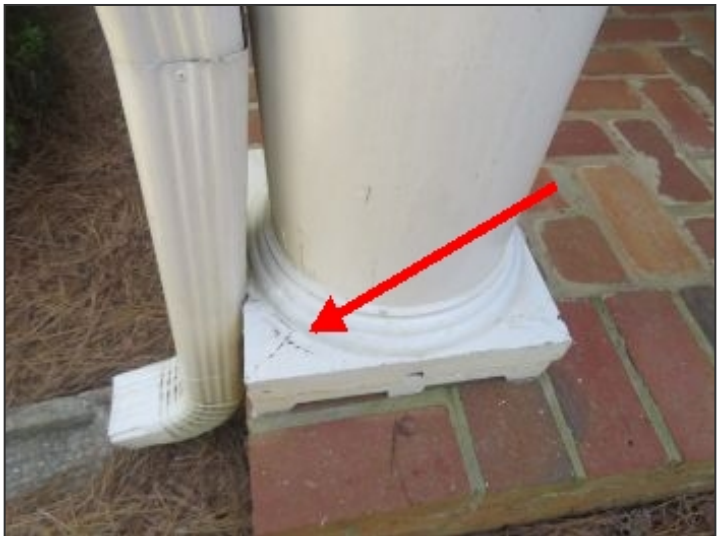
- Damaged wood trim was noted at the lower portions of the far left and far right front porch roof columns (see photo). Replacement of the affected wood trim is recommended.

Damaged trim at front porch roof column

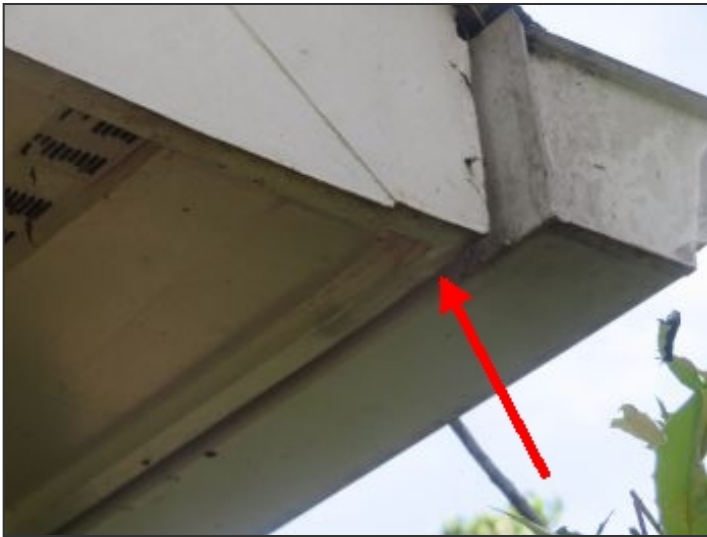
1. The fascia at the front left corner roof;
2. The fascia and soffit at the rear roof below the chimney;

Damaged fascia at front left corner roof

Replacement of the damaged wood is recommended; in addition, further evaluation is recommended to determine the source of the water damage and to make necessary repairs.

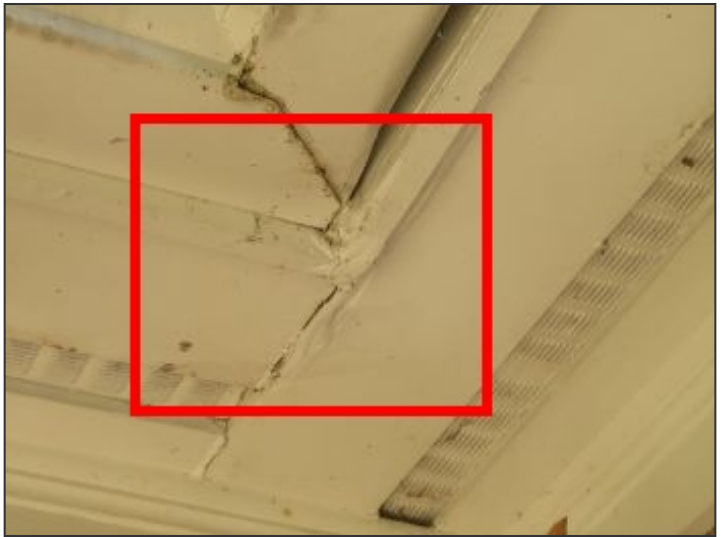
Damaged fascia and soffit at rear roof below chimney

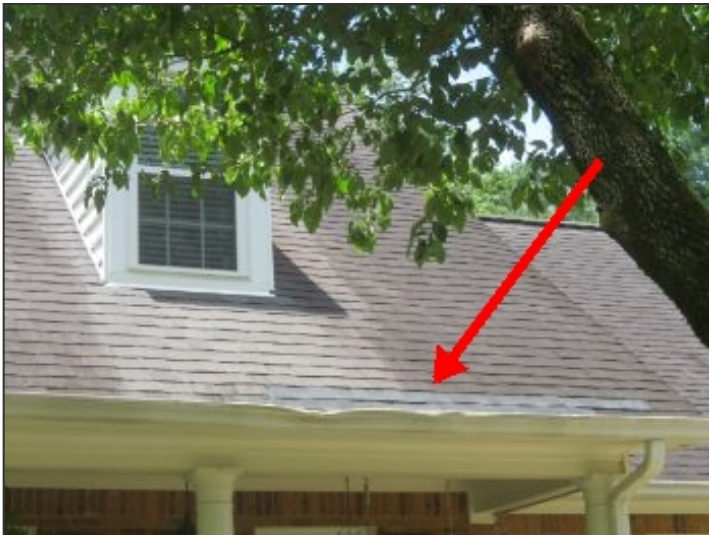
• Shingle replacement was observed on the roof at the right side of the front porch (see photo). The repairs appear to be adequate, continue to monitor. It is suggested that client ask seller for any available disclosure information regarding this repair.

Shingle replacement at front roof

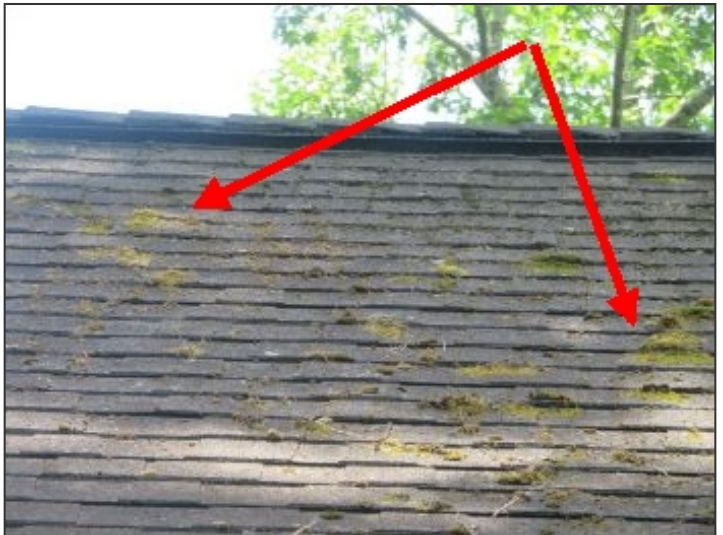
• The front left roof surface has an excessive amount of moss growth which is not recommended (see photo). Moss can have a negative effect on proper shingle drainage and can lead to roof leaks if not corrected. Removal of all moss growth is recommended to allow the roof to drain correctly.

Excessive moss growth at front left roof

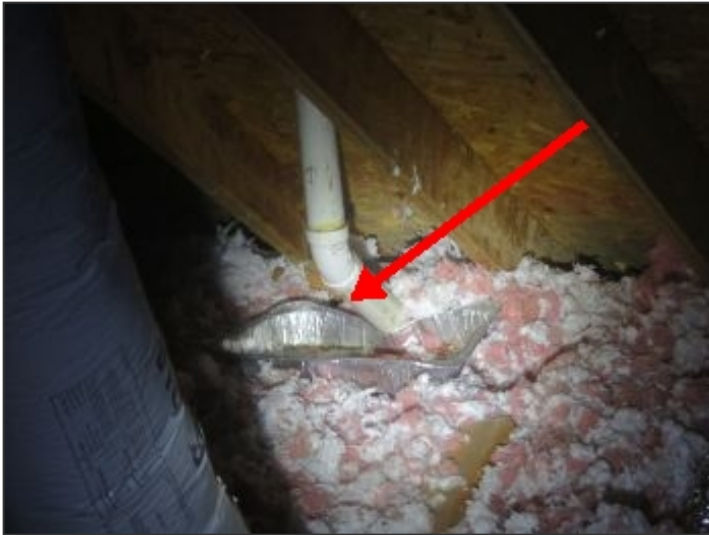
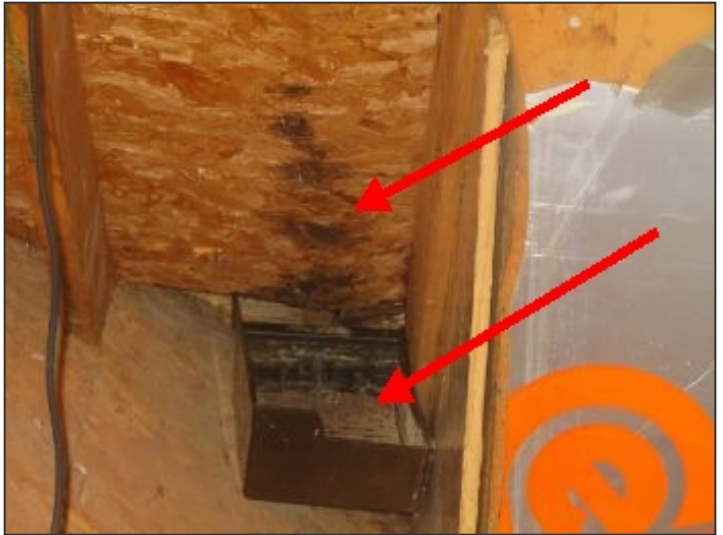
• Evidence of multiple roof leaks were observed in the attic at the chimney and at the plumbing vent penetration above the master bathroom - water stains were noted on the roof decking at these locations as well as containers to catch moisture (see photos). This condition is evidence of possible roof leaks but could not be verified during this limited visual inspection. The stained areas and containers appear to be dry after recent heavy rains. It is recommended that client ask seller for full disclosure information regarding these leaks and any repairs made. If no information is available, further evaluation is recommended by a professional roofer to determine the full scope of repair needs and costs.

Container to catch leaks below master bathroom plumbing vent

Water stains and container in attic at chimney

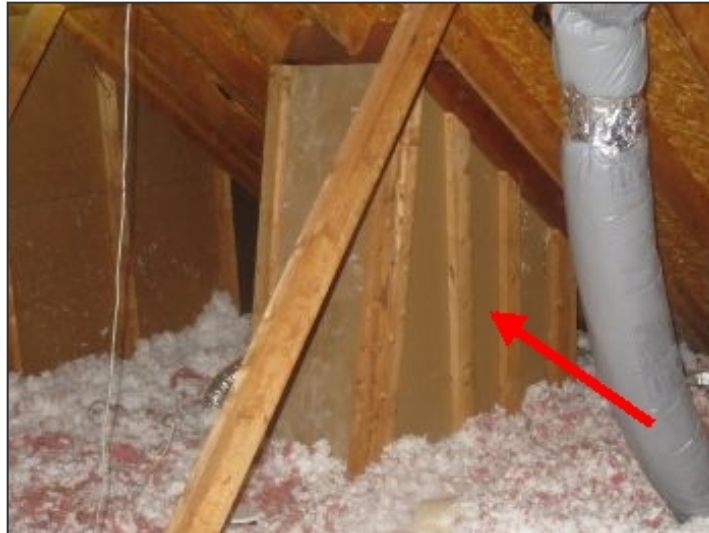
- Missing batt insulation was noted over portions of the vertical walls in the attic space. Bare sheetrock is present which will lead to an excessive amount of heat loss in winter and heat gain in the summer months. Correction is recommended.

Missing insulation at vertical walls of skylight

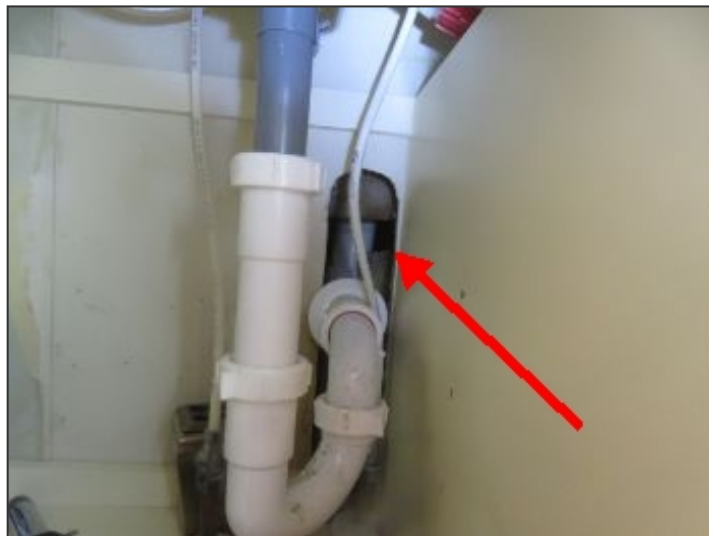
No fire separation is present at the wall opening below the second floor bathroom sink cabinet (see photo). Visibility into the attic is present. This condition does not meet current fire safety standards that call for this opening to be sealed or covered but was most likely not required when this home was originally constructed. As a fire safety upgrade, installation of a fire separation barrier is recommended and could include the use of wood, sheetrock, sheet metal, or in some cases 16" of unfaced insulation batts.

Opening into attic below second floor bathroom sink

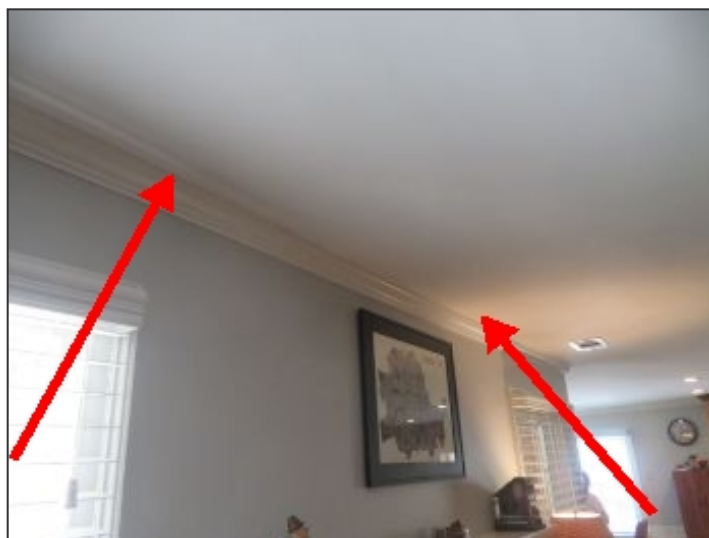
• **A sheetrock ceiling repair was noted at the family room above the fireplace. It is suggested that client ask the seller for more information regarding this repair.**

Ceiling repair in family room

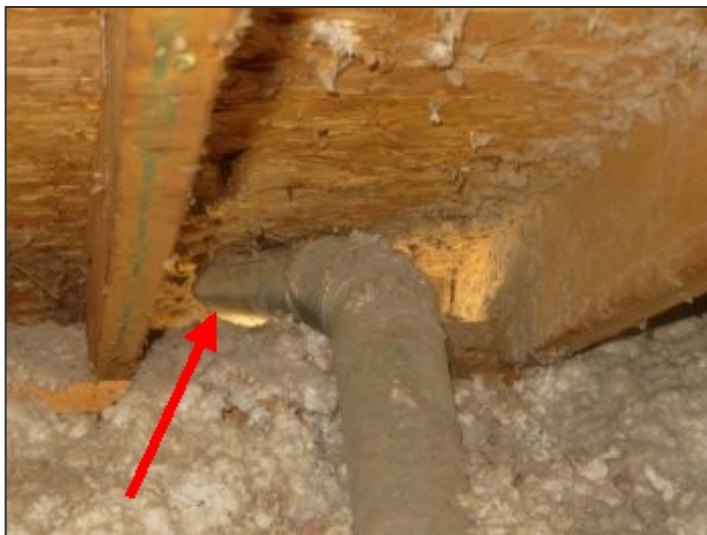
• Improper dryer ducting: The laundry dryer incorrectly terminates into the attic space above the exterior vent cover which is not advised. Dryer lint, which is highly flammable, is being distributed into the attic space. Correction is recommended so that the dryer vent correctly terminates outside or through the roof.

Dryer vent terminating in attic space

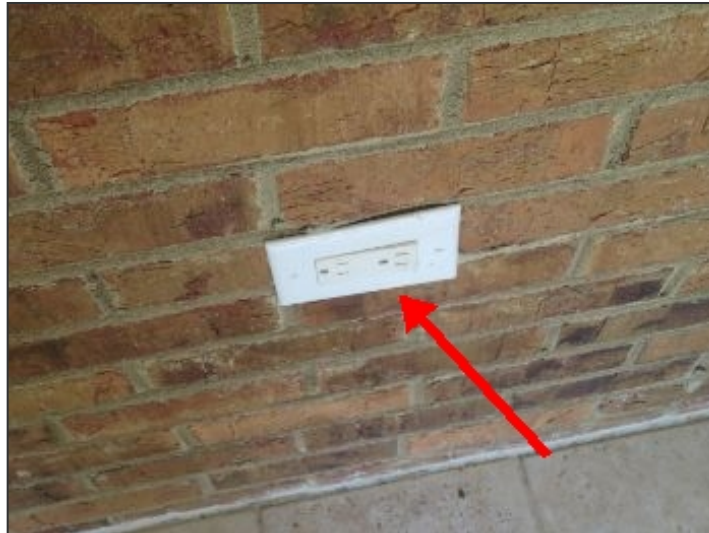
• Incorrect electrical, safety concern: The outlet located at the exterior screened patio is not the required weatherproof type. This condition is a safety concern and a violation of the National Electric Code (NEC). Correction is advised by a licensed electrician to meet the safety requirements of the NEC.

Screened patio outlet not weatherproof
