# Inspection Report

**Property Address:**  
8970 Ridgemont Dr NE  
Atlanta GA 30350

**Residential Inspector of America**

<b>Date:</b> 7/30/2020	<b>Time:</b> 09:00:00 AM	<b>Report ID:</b> 073020MG1051
<b>Property:</b> 8970 Ridgemont Dr NE Atlanta GA 30350	<b>Customer:</b> Mark Jagor	<b>Real Estate Professional:</b> Katie Brinkman

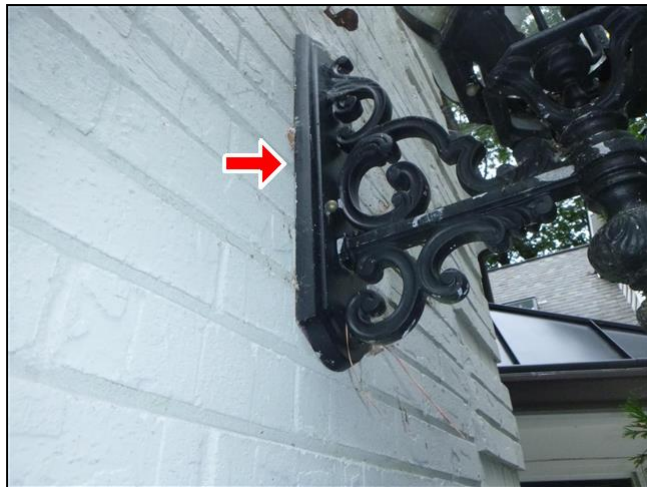
1.1 Item 1(Picture)

🔧 (2) Recommend to seal around all exterior light fixtures where they meet the siding of the home to prevent potential water entry.

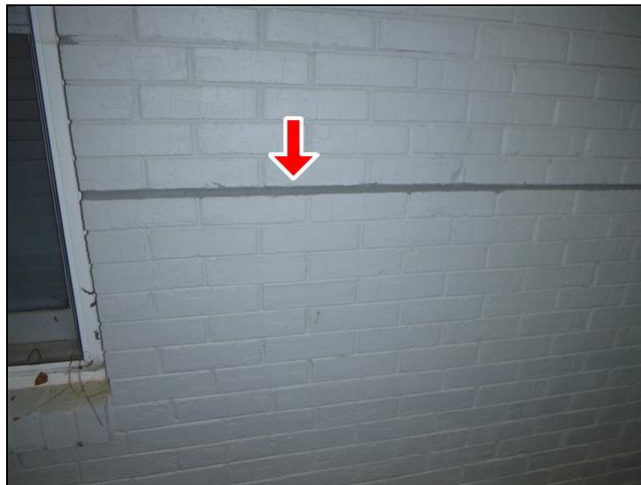
1.1 Item 2(Picture)

🔧 (3) There is a crack in the brick veneer behind the garage. This is not a structural concern. The crack has been sealed and should be monitored. See photo(s) for location.

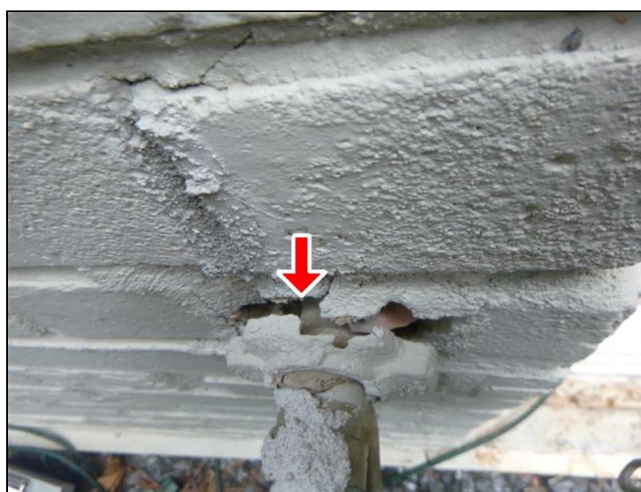
1.1 Item 3(Picture)

🔧 (4) Secure and seal the exterior hose faucets to the brick veneer.

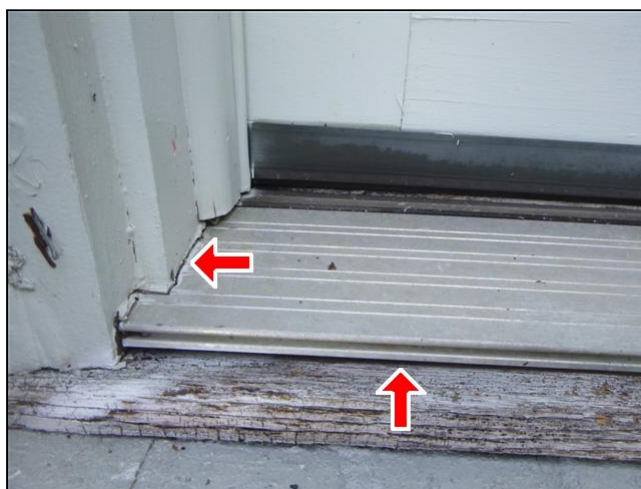
1.2 Item 1(Picture)

🔧 Recommend to seal the gap between the siding and the threshold of the exterior doors. Seal all miters where the brick mold meets the threshold to ensure that the area is water tight.

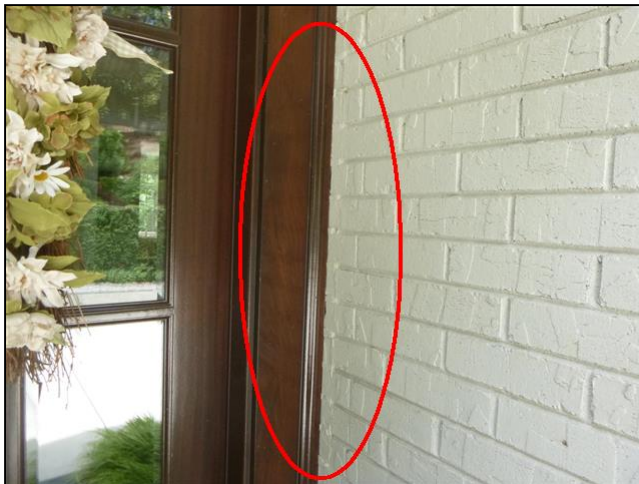
1.3 Item 1(Picture)

🔧 Recommend to seal the gaps between the brick siding and the front entry door. Make areas water tight. See photo(s).

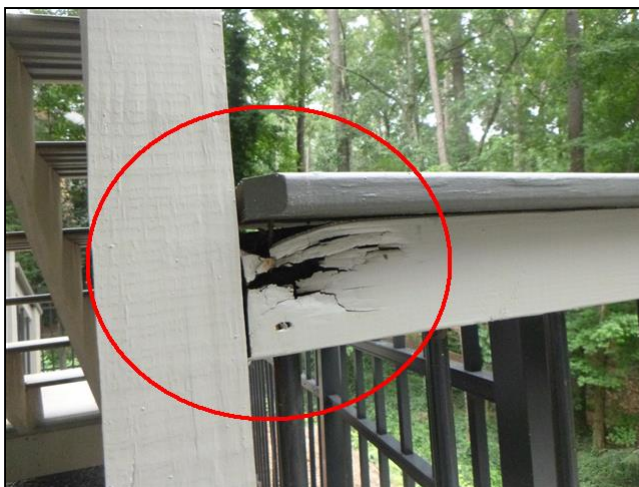
1.4 Item 1(Picture)

🔧 (1) An area of moisture damage was observed to the guardrail below the left sides deck stairs. Repair as needed.

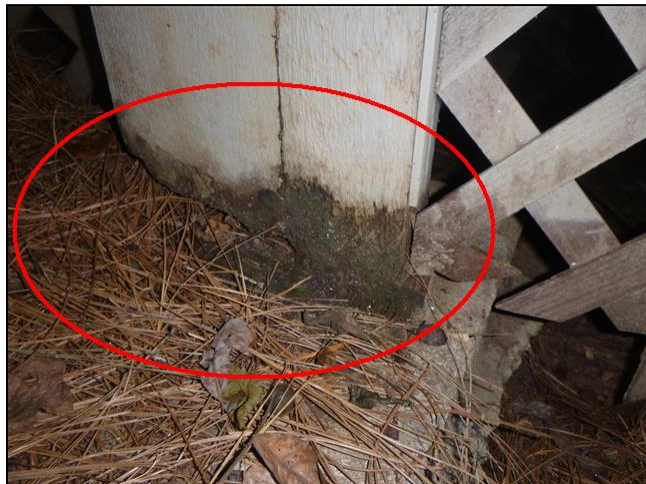
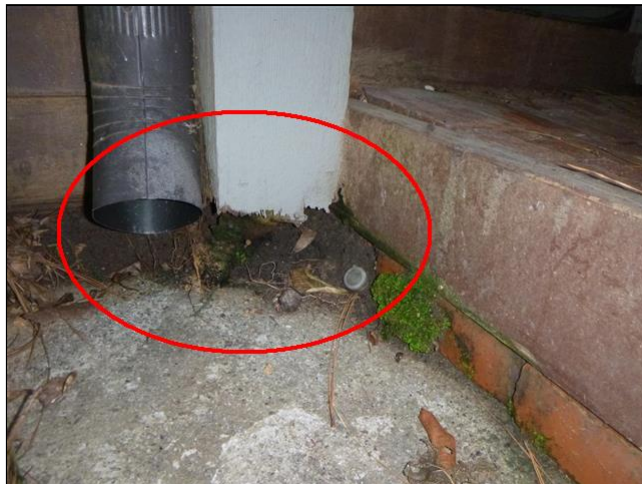
🔧 (2) Moisture damage and decay was observed at the base of several deck posts and the post supporting the rear right corner of the home. These posts should be replaced by a licensed contractor.

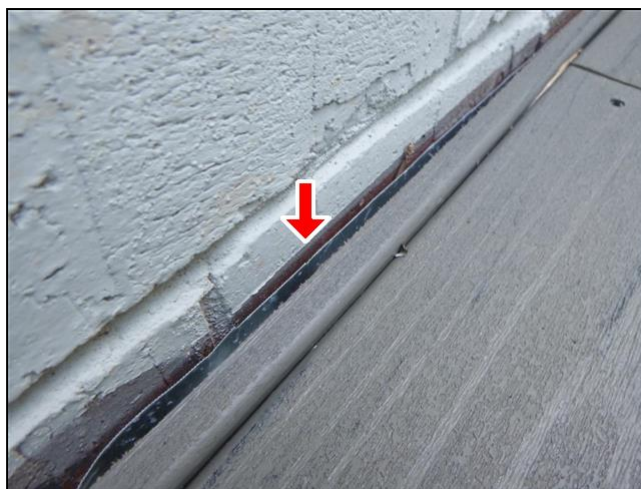
1.4 Item 4(Picture)

🔧 (4) The metal flashing between the rear deck and the home is not counter flashed or sealed. This flashing is intended to prevent water from entering behind the wall cavity. Recommend to have deck contractor inspect and make necessary repairs. See photo(s).

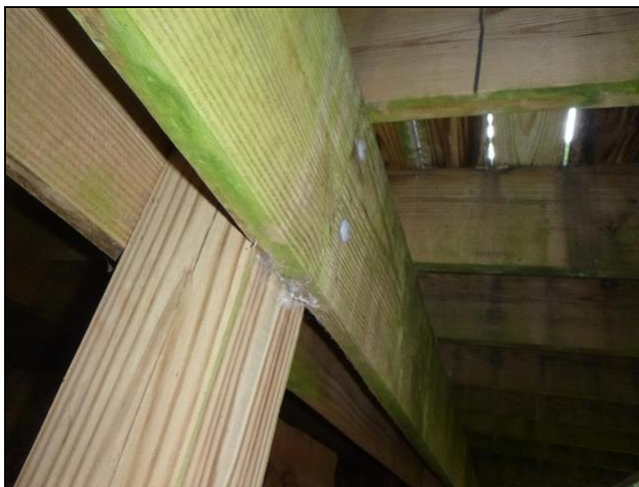
1.4 Item 5(Picture)

🔧 (6) The deck framing for the lower deck has been attached to its supports, fasteners can fail in sheer or withdrawal. Framing should always be resting on supports. Repair is needed by a deck construction professional.

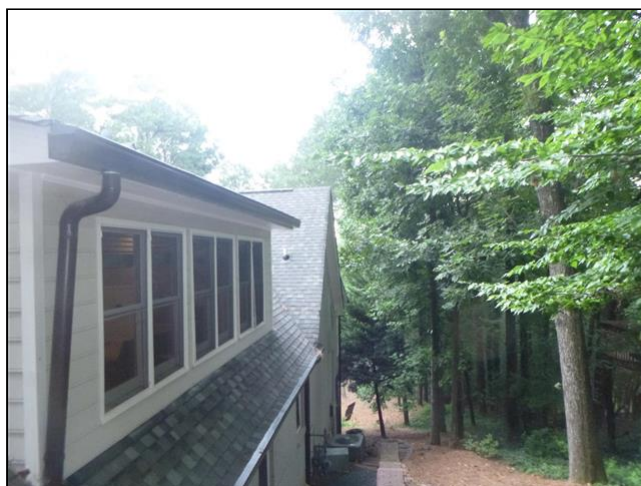
1.5 Item 5(Picture)

🔧 (2) The tree limbs that are in contact with roof or hanging near roof at the right side of home and should be trimmed away. This will help prevent against rodent entry into the attic. See elevation photos for location.

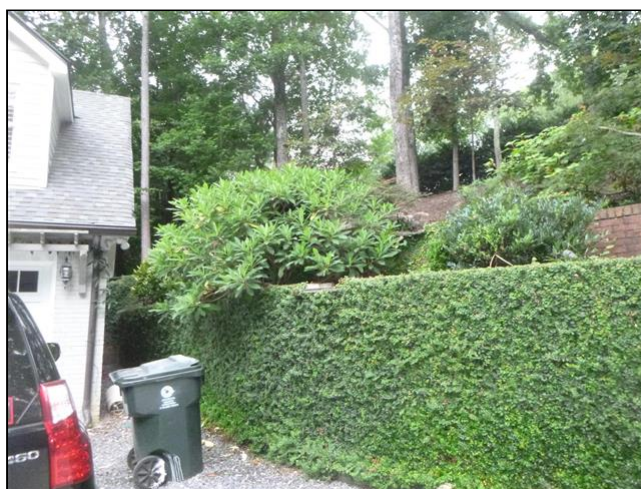
1.5 Item 6(Picture)

🔧 (3) A guardrail should be considered to prevent children from accidental fall predominantly at front of home. Any wall 30 inches or higher should have a guardrail.

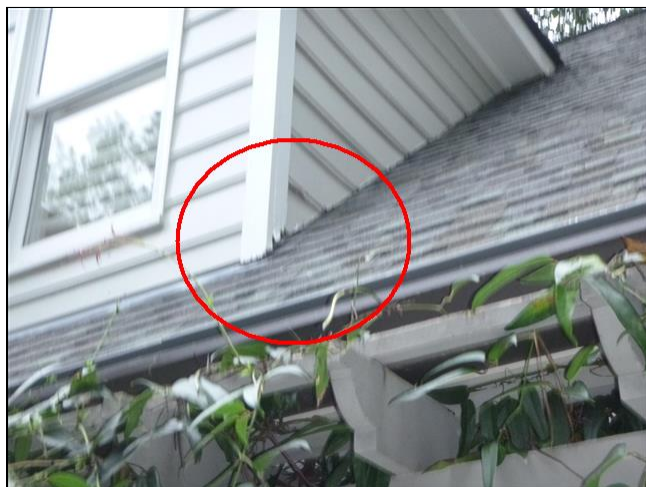
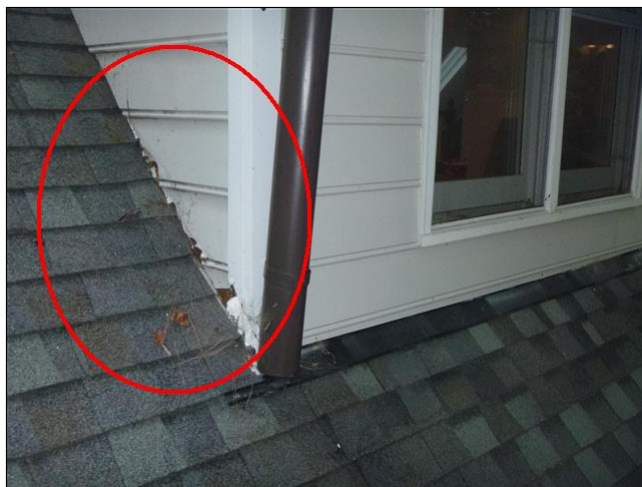
🔧 (1) Some siding and trim damage was observed at the bottom corners of the dormers over the front and rear of the garage. These areas should be repaired by a siding professional.

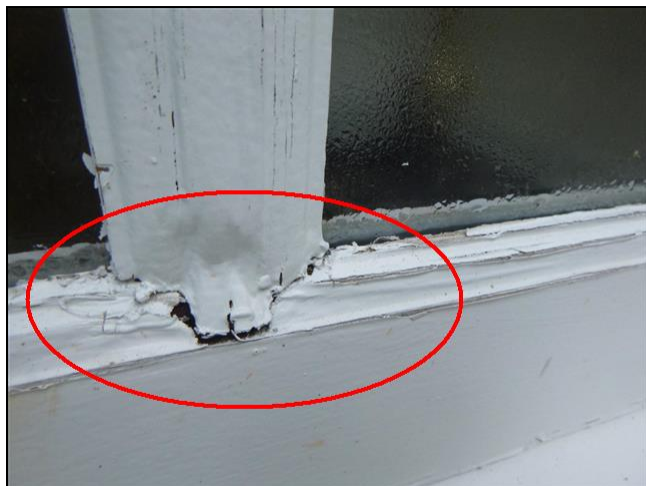
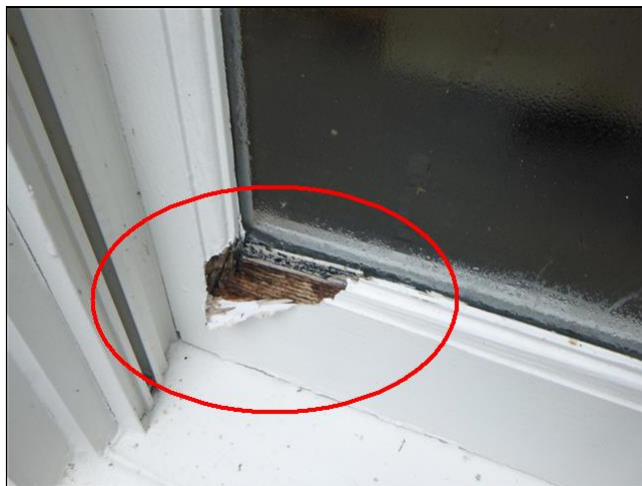
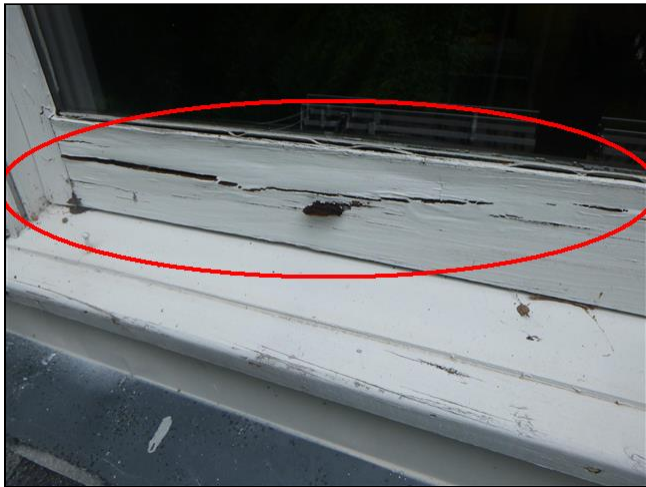
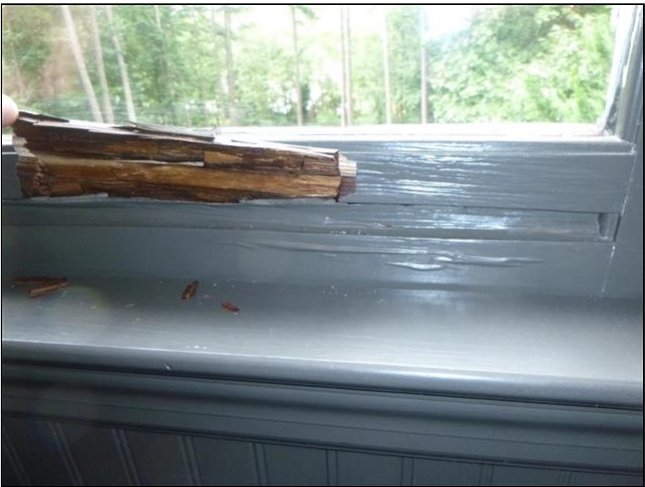
🔧 (2) Rot damage found on exterior wood trim in several areas predominantly Windows across the rear of the home. This damage has transferred to the interior of a window in the rear right bedroom. See photos for examples of these locations. Have all water damaged trim replaced or repaired. It should be understood that that more minor water damage may be present on other trim around the house. This is very common and more should be expected in the future. If water damage occurred in the past, it will occur again in the future.

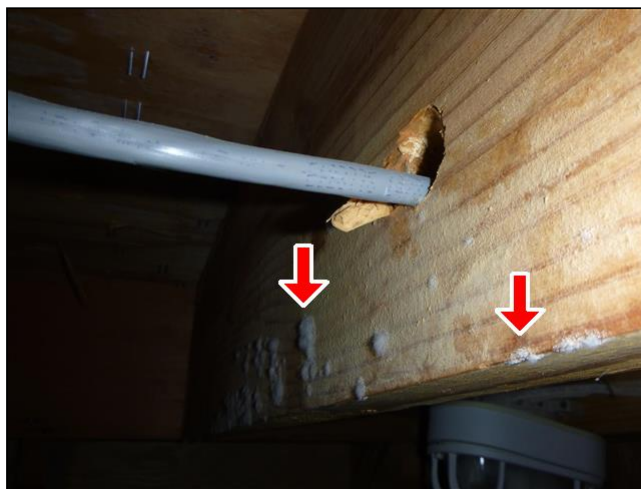
2.1 Item 1(Picture)

🔧 (2) Some mildew was observed in the storage area accessible from the garage. Have these areas cleaned as needed.

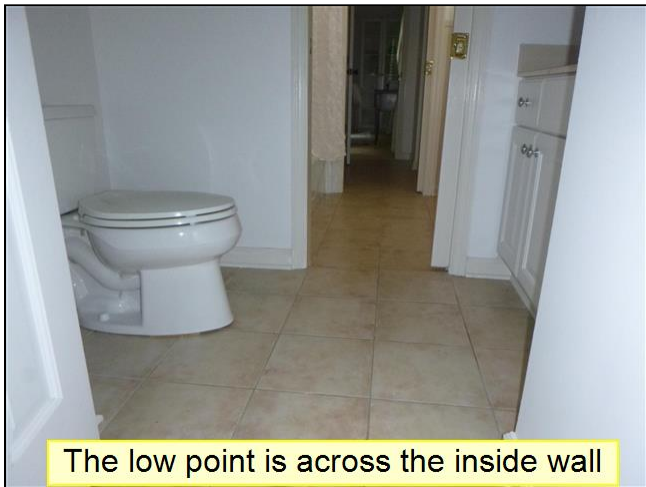
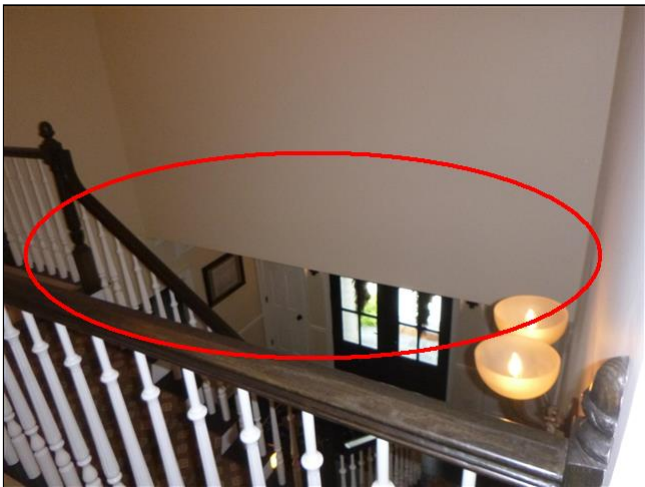
🔧 There is an excessive dip to the floor in the front shared bathroom. Due to the lack of cracking on the walls and floors this could have occurred at the time of construction. It is recommended to have this evaluated by licensed contractor.

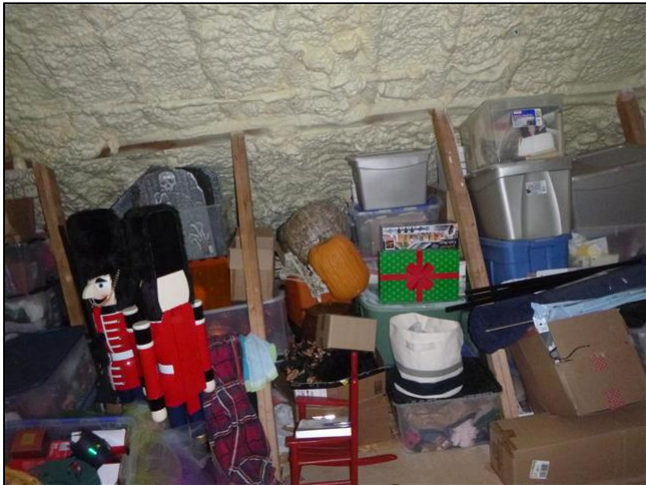
3.5 Item 1(Picture)

The attic inspection was limited due to stored items at the time of the inspection. See photo(s) for examples.

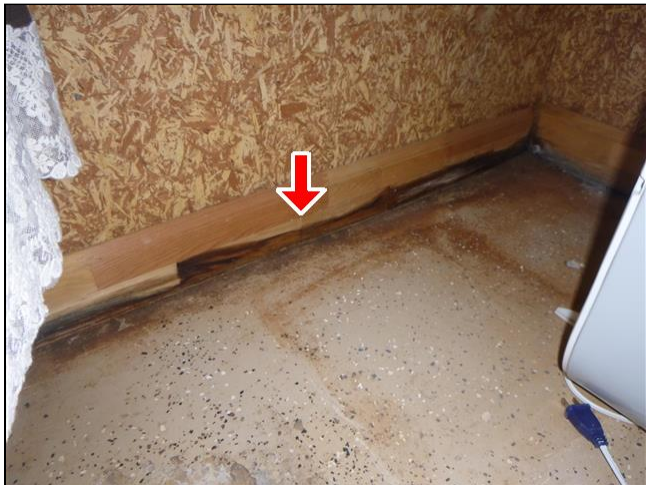
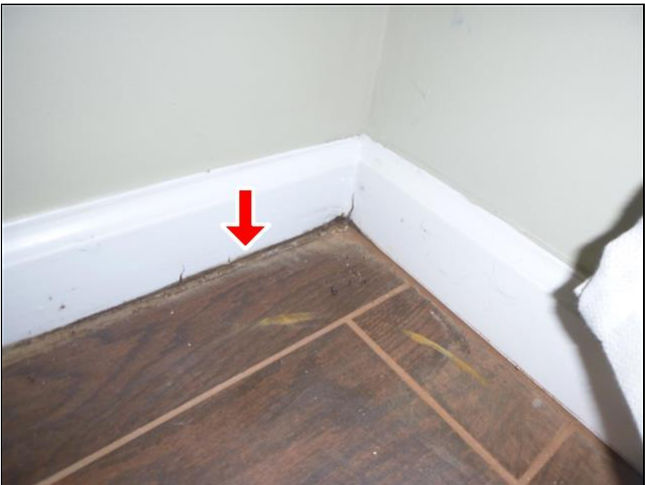
Evidence of water entry into the basement areas noted in the photo(s). Areas were dry at time of inspection but this could change due to several outside factors such as gutter drainage, grade, down spouts and weather conditions. It is possible that water may still be leaking into basement during certain conditions that were not present at time of inspection. Wet basement contractor should evaluate and ensure that the entire basement is water tight, because it is not unusual for water to enter different parts of the basement during certain weather conditions.

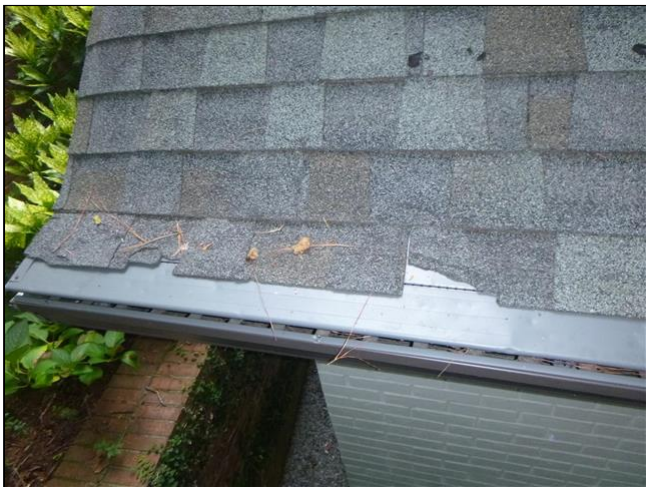
4.0 Item 1(Picture)

Damaged shingles were observed across the right edge of the roof. Recommend having the roof evaluated and shingles repaired by licensed roofing professional.

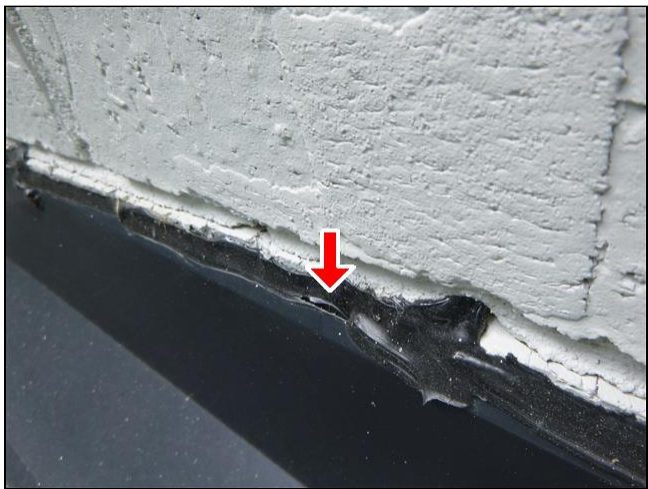
4.1 Item 1(Picture)

The small metal roofs over the front bay windows are not counter flashed. As caulk separation occurs leaks will develop. These areas should be properly flashed by a roofing professional.

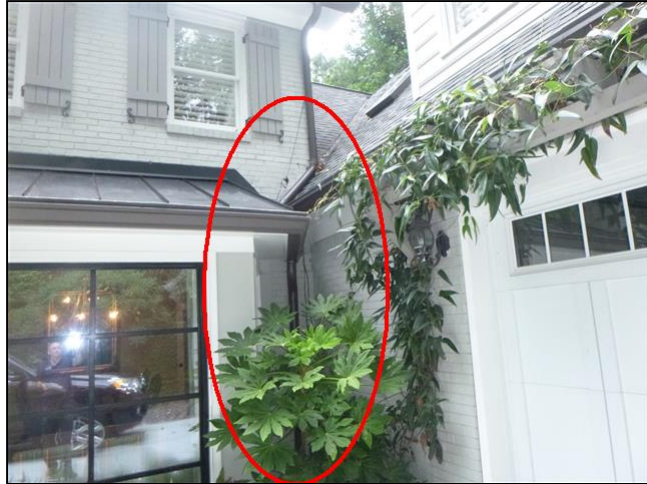
4.3 Item 1(Picture)

🔧 There are multiple gutters discharging at a single location at the corner where the house meets the garage. There will be a high volume of water discharge at this location. Recommend having these gutters reconfigured. Consult a gutter professional.

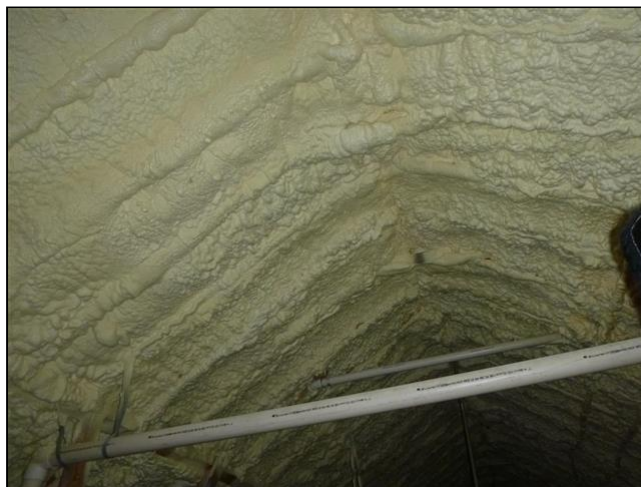
5.0 Item 1(Picture)

🔧 The attic framing was covered with spray foam insulation. Framing could not be inspected for potential issues. This is for your information.

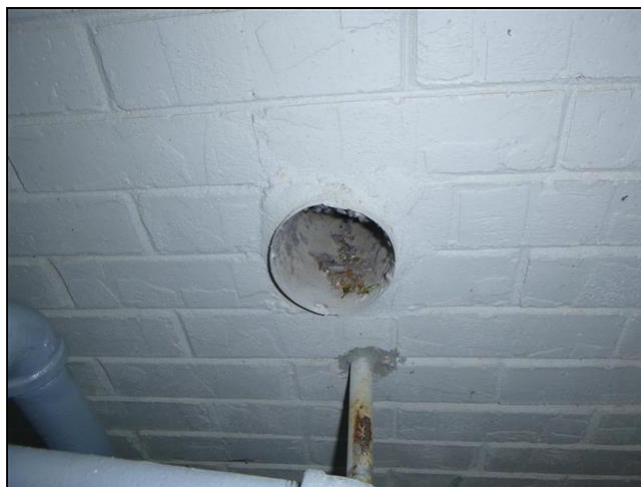
5.2 Item 1(Picture)

🔧 Vent hood is missing on the exterior of the dryer vent. Repair as needed.

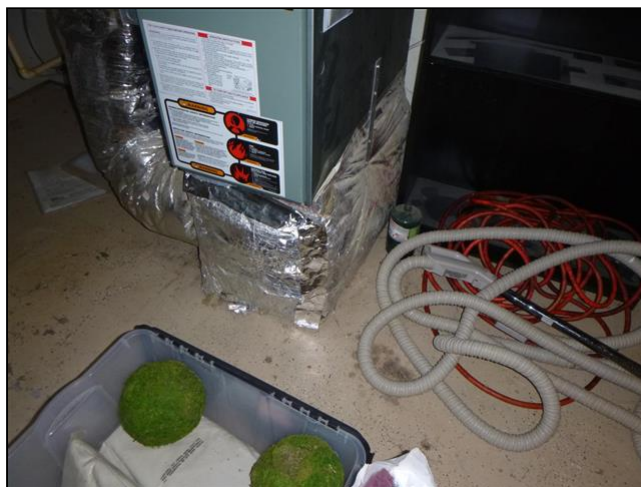
6.0 Item 1(Picture)

🔧 (3) Recommend to have drain pans or a water detection device installed under the units in the basement to prevent potential water damage. This was not required when the home was built since the basement was not finished then. See photo(s).

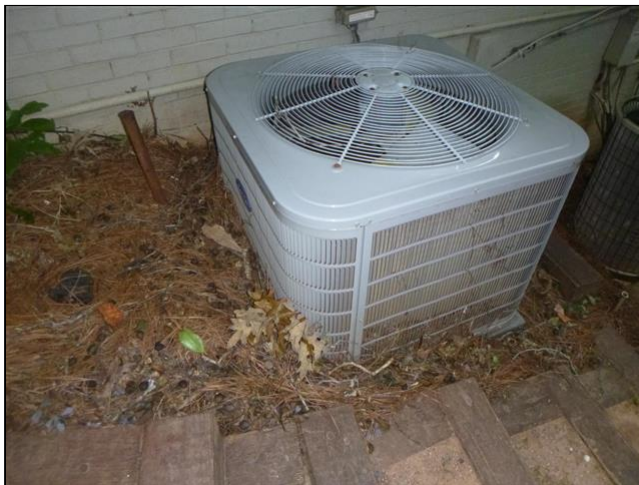
6.6 Item 1(Picture)

🔧 (2) All the debris around the condensers should be removed to prevent damage to the units.

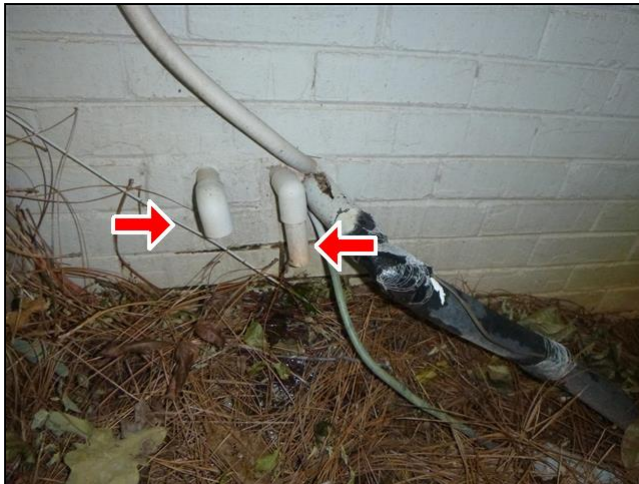
6.6 Item 2(Picture)

🔧 (3) Recommend to have the condensate drain lines and/or pump line(s) for the compressors extended out and away from the home. Water should drain at least 5 feet away from the home. This was not required in older homes.

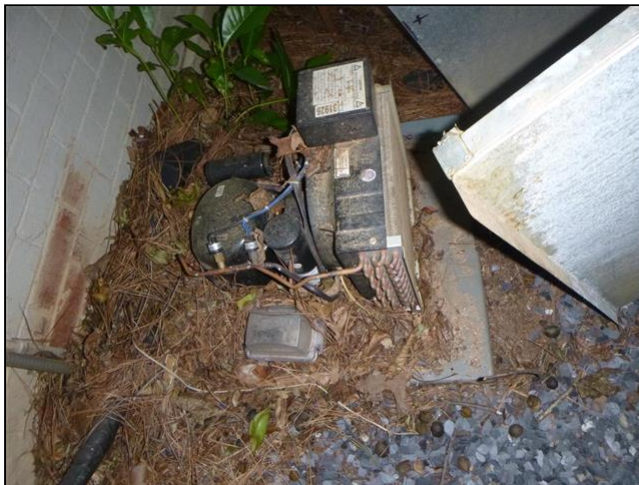
6.6 Item 3(Picture)

🔧 (4) The fourth air conditioner that appears to be for the wine cooler is in unsafe condition due to the amount of debris in the unit and the cover is not secure. Repair is needed by an HVAC professional.

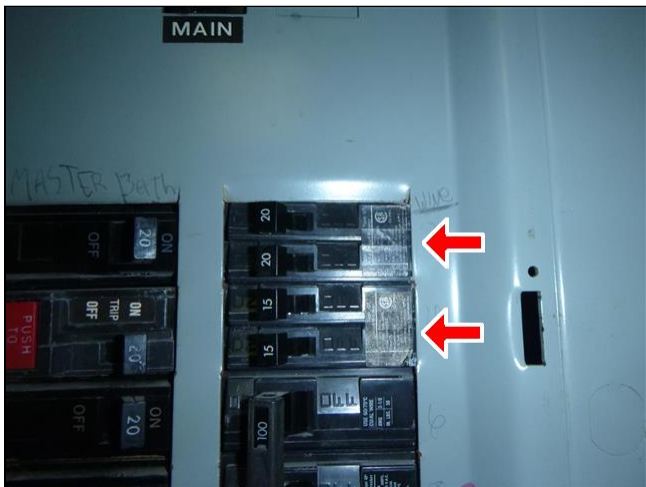
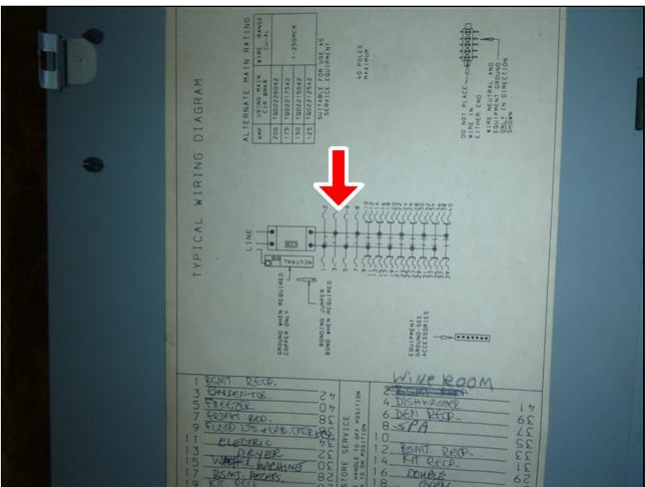
(1) There are tandem breakers in the main electrical panel that are in positions not labeled as allowed by the manufacturer. Consult a licensed electrical professional.

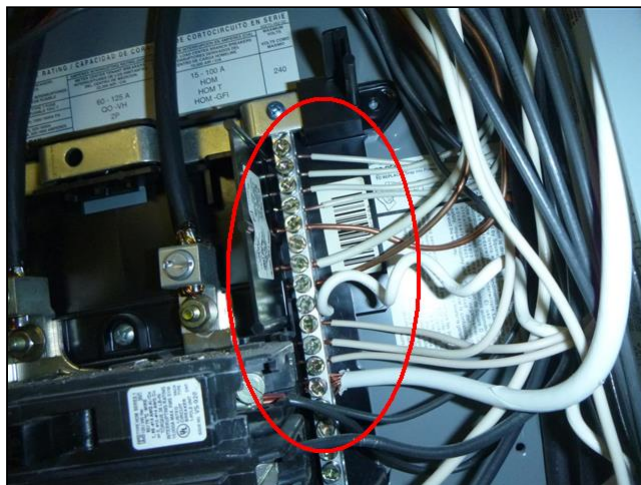
7.2 Item 3(Picture)

🔧 (2) The neutrals and grounds are on the same bus bar in the sub panel. They should be separated for safety. Recommend to have an electrician inspect for further evaluation and make necessary repairs. See photo(s).

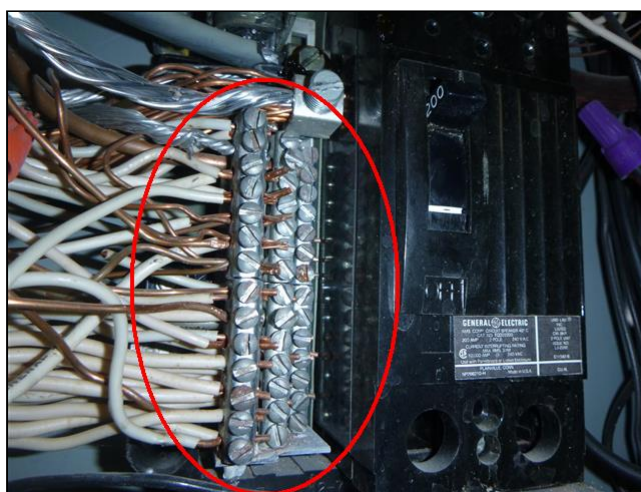
7.2 Item 4(Picture)

🔧 (3) There are multiple neutral wires on the same lug for the bus bar in the main panel. This does not meet current standards but was permitted at the time the home was built. Current standards suggest that neutral wires be placed on individual lugs on the bus bar. Recommend to have electrician inspect and repair as needed. See photo.

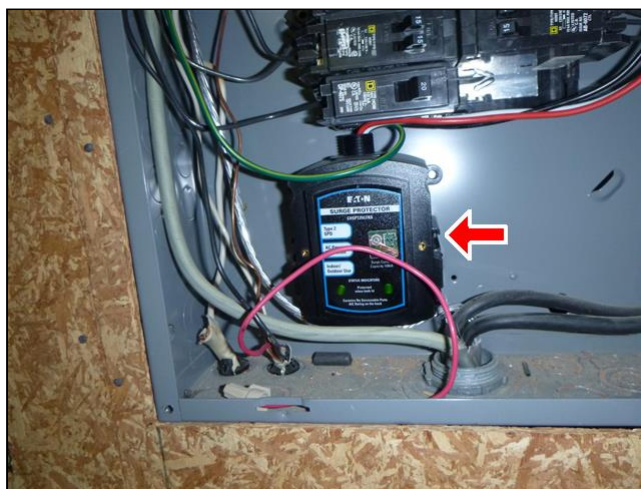
7.2 Item 5(Picture)

🔧 (4) There is a surge protector wired inside the subpanel. These types of devices should not be wired inside the panel. The search protector should be located on the exterior. Repair as needed by licensed electrical professional.

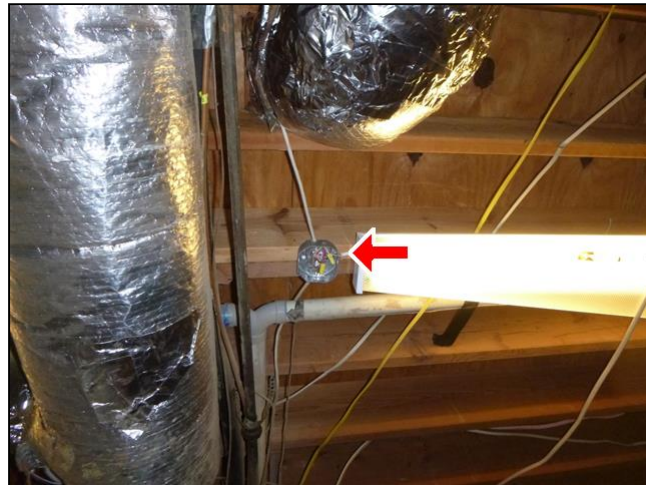
7.4 Item 1(Picture)

🔧 There is an open junction box on the ceiling in the unfinished area of the basement. A cover should be installed for safety.

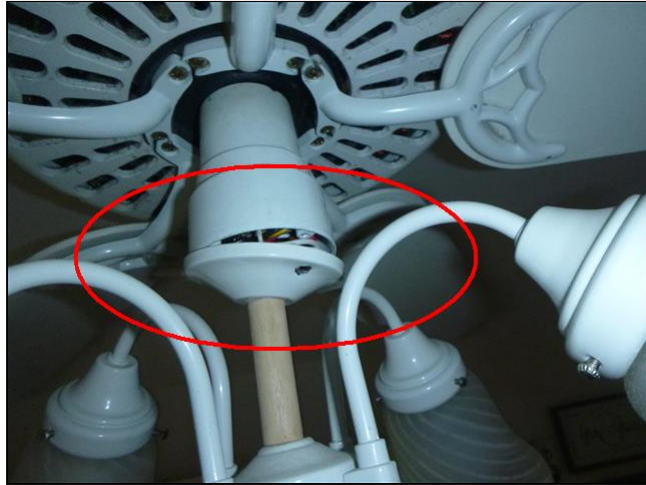
7.5 Item 1(Picture)

🔧 (3) The light kit for the ceiling fan in the front left bedroom is loose. Repair for safety.

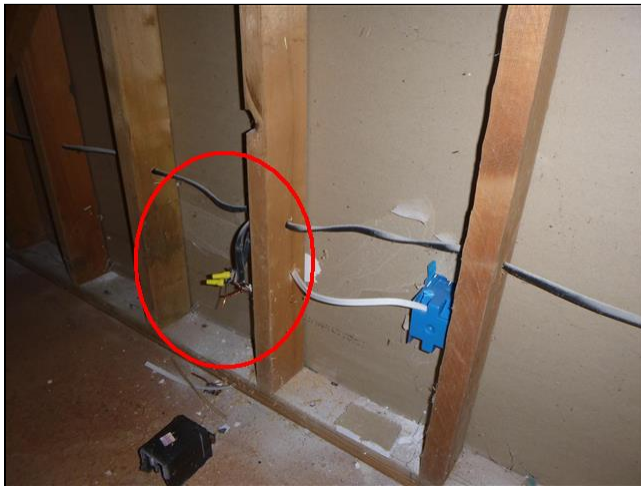
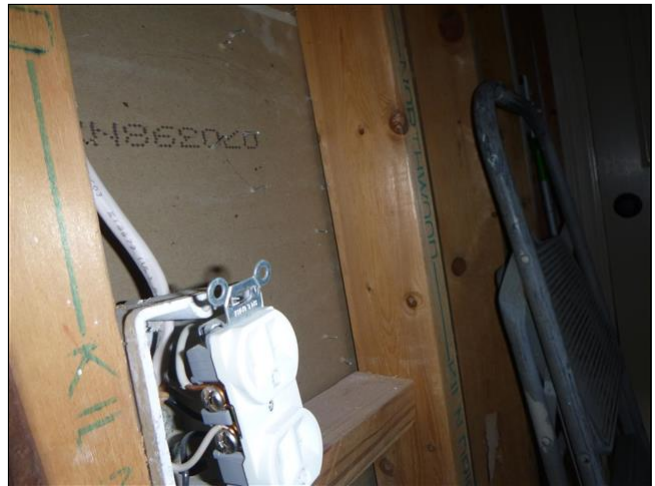
🔧 (4) There is an open splice that should be contained within a closed junction box and lose receptacles under the basement stairs. Repair as needed.

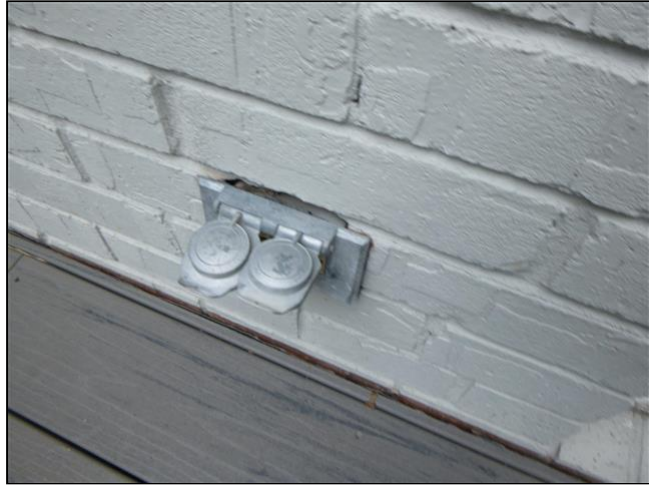
7.5 Item 4(Picture)

- 🔧 (5) The deck receptacle outside the master bedroom is loose. Repair as needed. Recommend caulking the receptacle to reduce moisture intrusion.

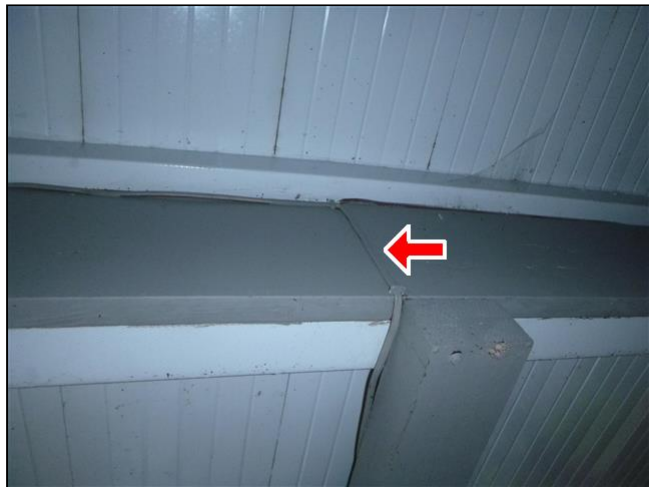
7.6 Item 1(Picture)

- 🔧 Currently, the exterior light fixture wiring at the rear deck is exposed. Recommend to have these wires placed in a protective conduit.

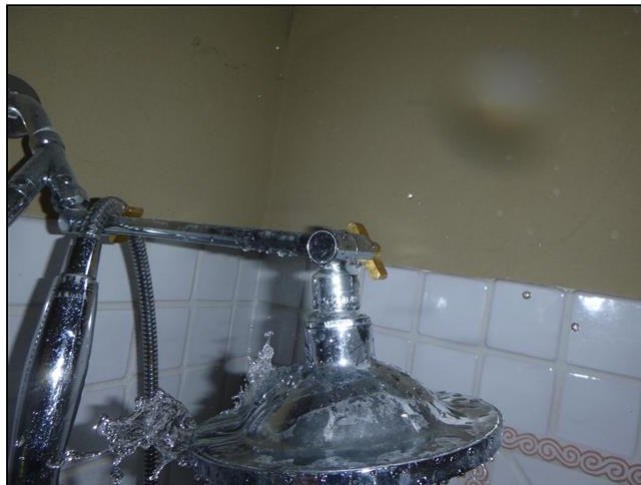
8.2 Item 1(Picture)

- 🔧 (1) Recommend to repair the leaking shower head in the basement bath. Have plumber inspect and make necessary repairs.

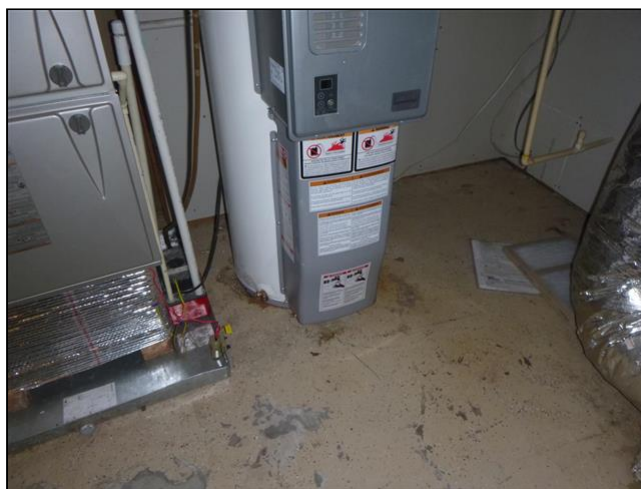
8.3 Item 1(Picture)

- 🔧 (1) Recommend to install a drain pan under the water heater to prevent water damage to the surrounding areas. This pan should be piped to a safe location or to the exterior.

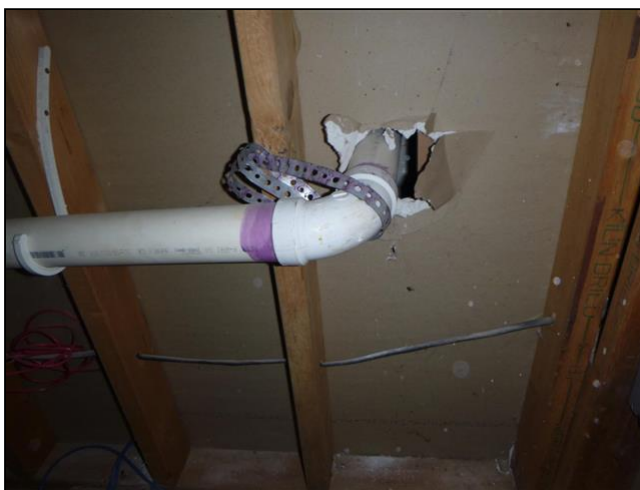
8.6 Item 1(Picture)

🔧 The sewage ejector pump for the basement bathroom is not accessible and could not be inspected. This pump should be readily accessible for service or replacement.

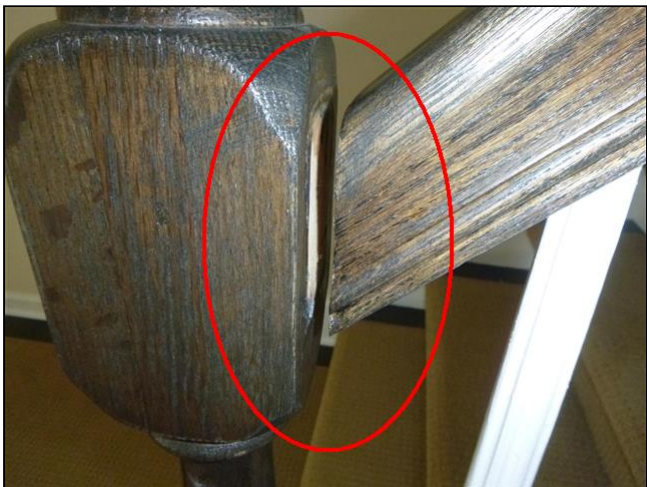
9.3 Item 1(Picture)

The guardrail is not attached to the newel post at the landing for the stairs by the kitchen. Repair as needed.

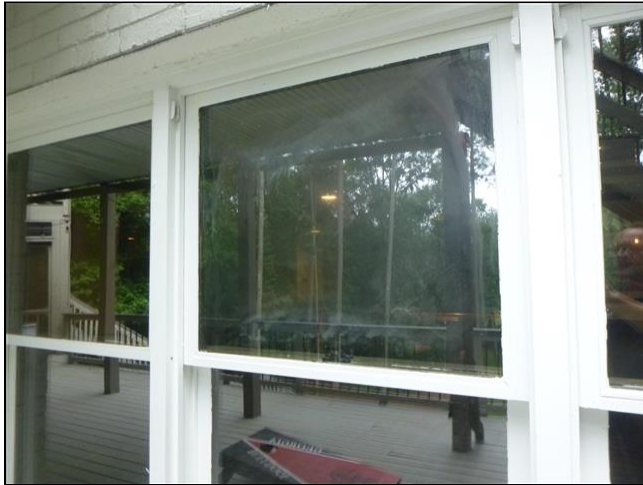
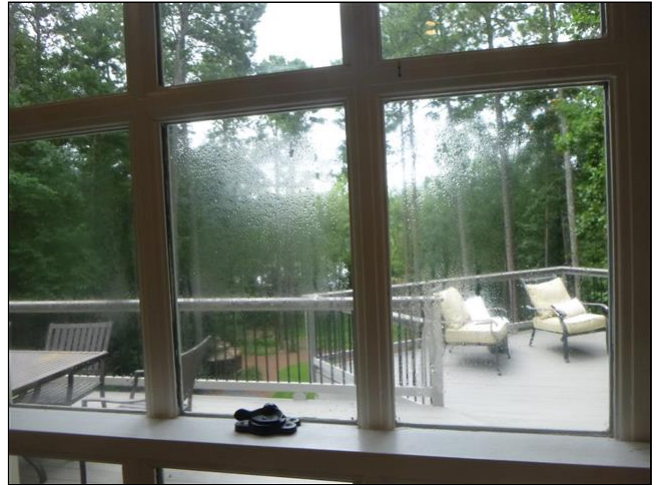
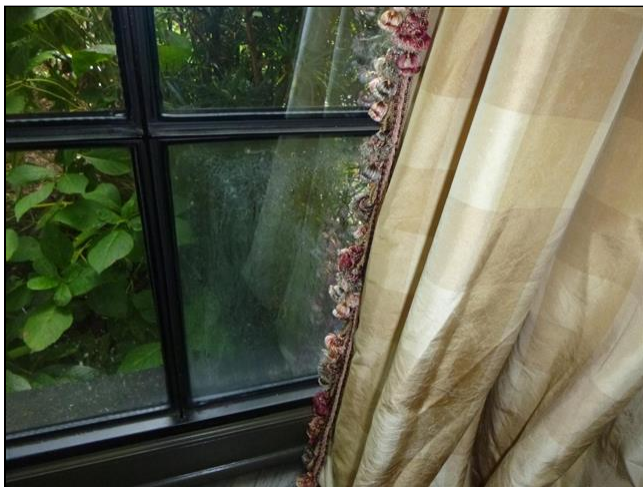
🔧 (2) Approximately nine fogged windows were counted. Recommend to replace all "fogged" windows. The seal between these panes of glass has failed allowing moisture to enter between the panes. It is possible that more may fog in the future. Have window contractor evaluate all windows since it is likely that if one window has had a seal failure, that more windows will also fail. See photos for examples. It is difficult to identify seal failure in windows when the weather is rainy, over cast, foggy or the glass is wet from recent rains or condensation. Buyer should resolve all concerns prior to closing.
