Trademark Home Inspection Co.

Property Inspection Report

4410 Beckwith Place, Cumming, GA 30041
Inspection prepared for: Tom Berger & Nancy Berger
Date of Inspection: 9/3/2020 Time: 9am
Age of Home: 1999 Size: 4815
Weather: Clear 85 degrees

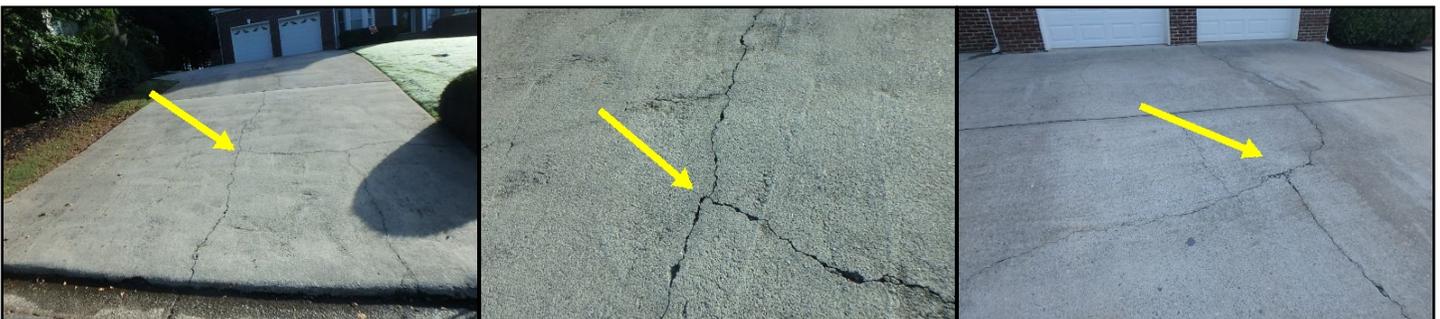
*Common crack in driveway, not a concern.**

Common cracks

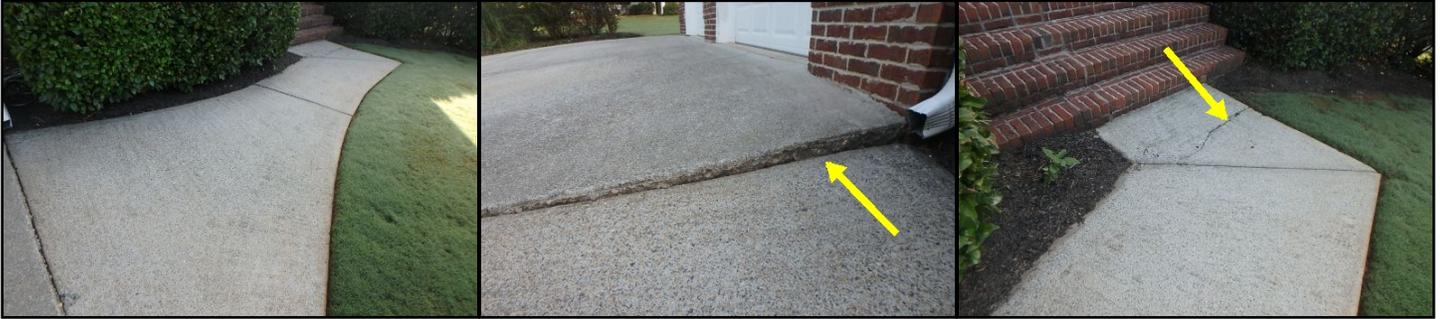
Raised areas are trip hazard.*

Common cracks

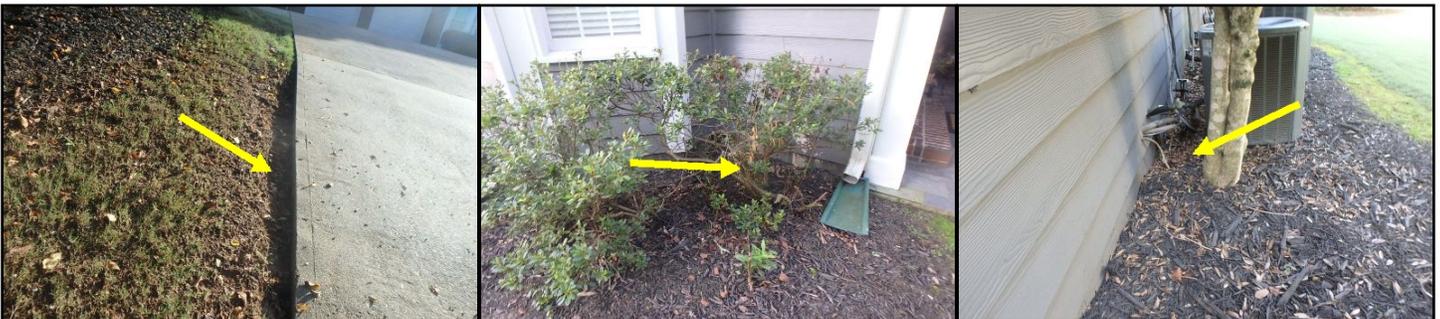
Erosion present by drive, needs correction.*

Improper slope at rear.*

Improper slope.*

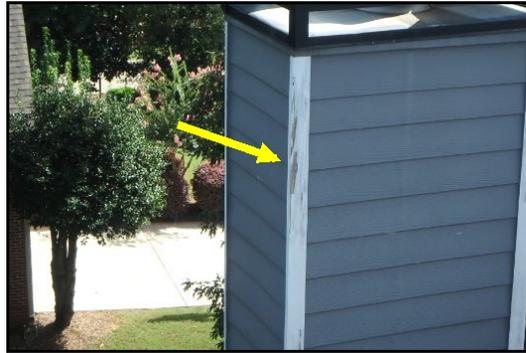
Peeling or missing paint, maintenance needed.*

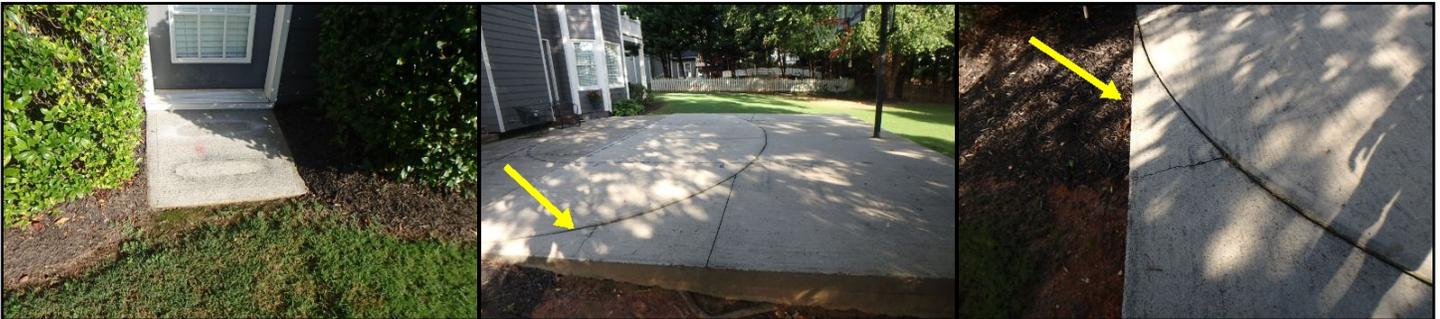
- Large cracks present, raised areas may be a trip hazard, should consider grinding down raised portions.*

settling cracks at patio

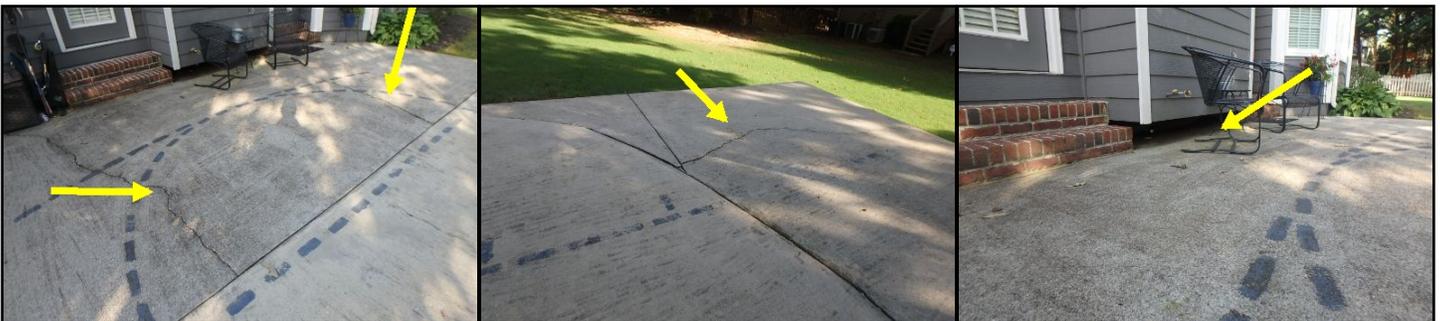
settling cracks at patio/court

settling cracks

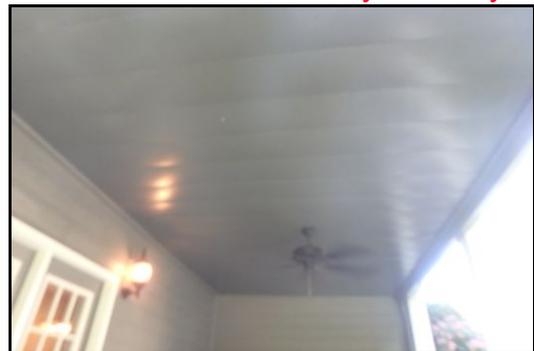
improper slope at patio, may hold water by chimney.*

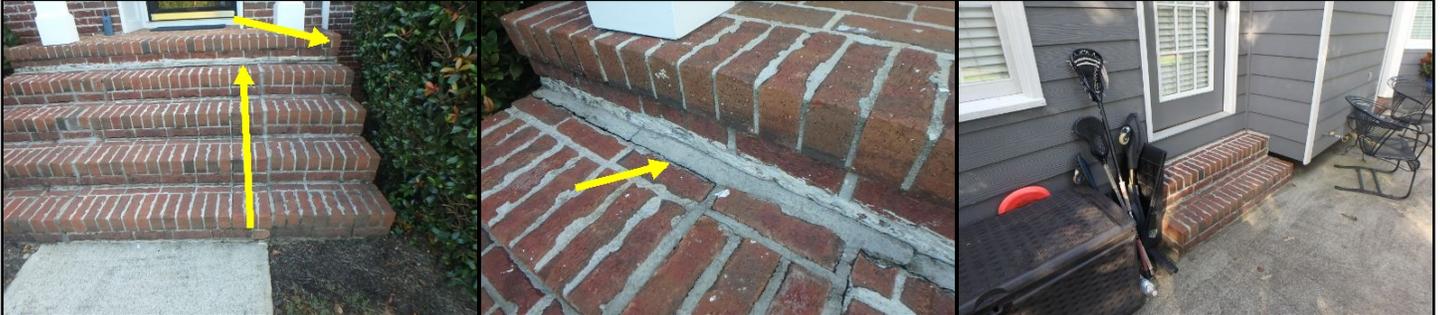
Settling and separation noted at entry steps, portion is out of level.*

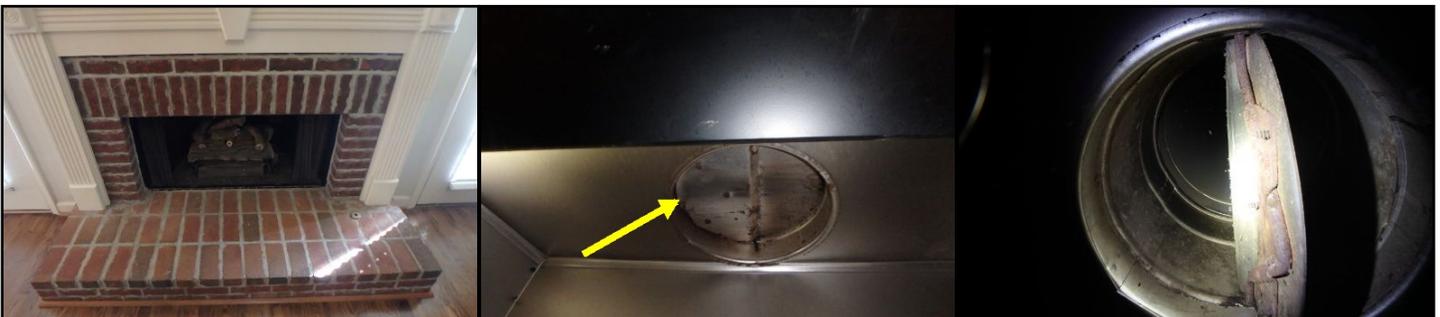
Damper should be blocked open with gas log use for safety.*

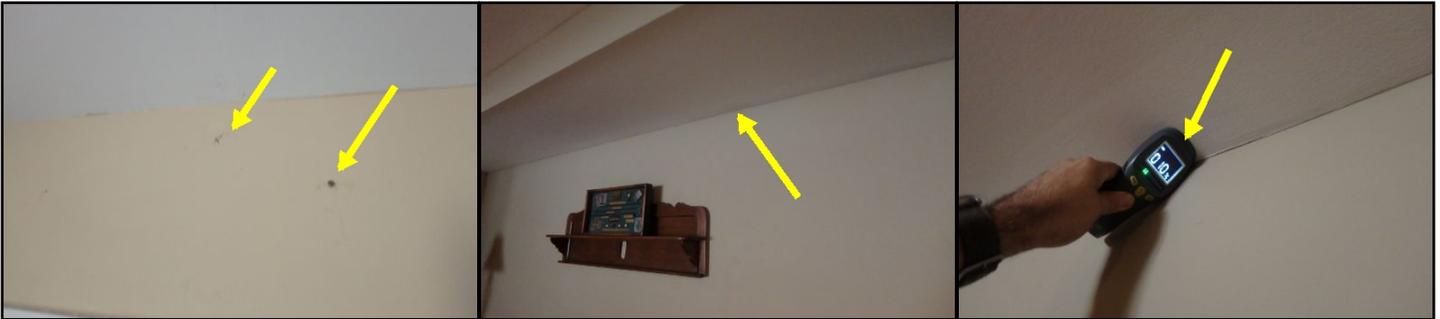
Nail pops noted.*

slight moisture present in basement ceiling under patio door.*

10% moisture reading

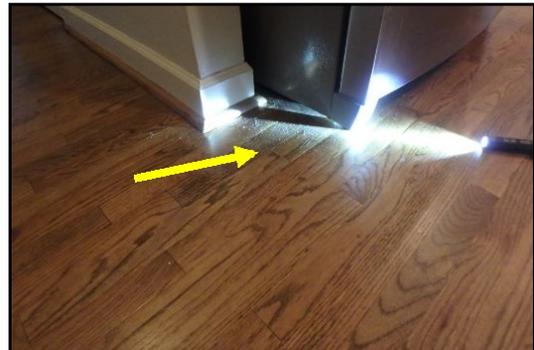
minor water damage by fridge.*

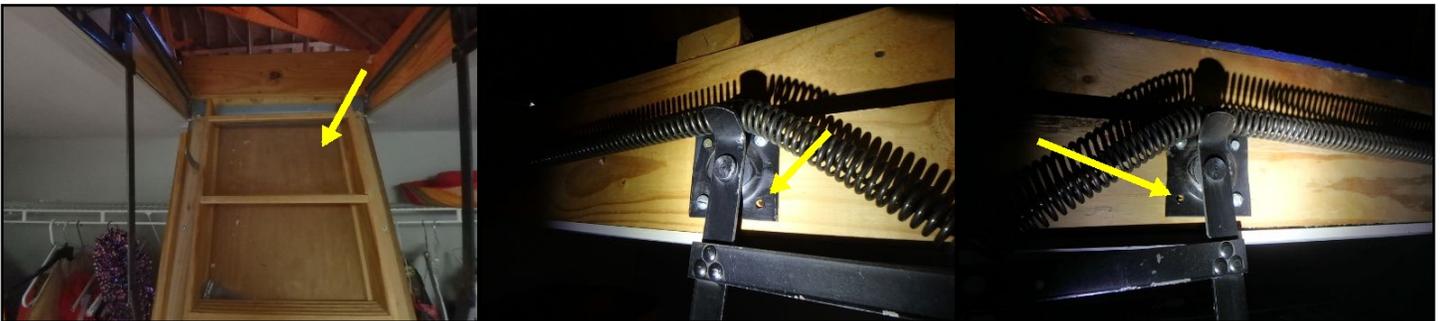
Attic cover not insulated to current standards.*

Lack nails in side hinge plates.*

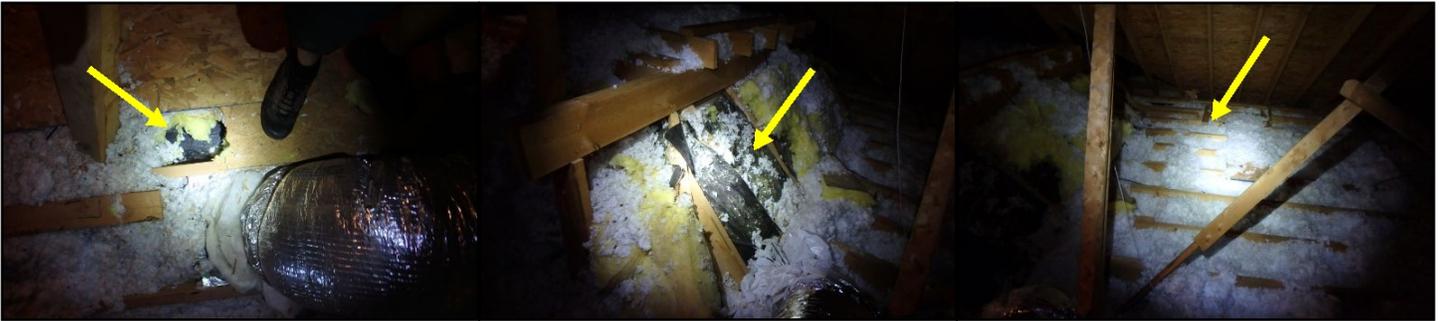
Rodent signs noted.*

missing insulation at master tray.*

low insualtion.*

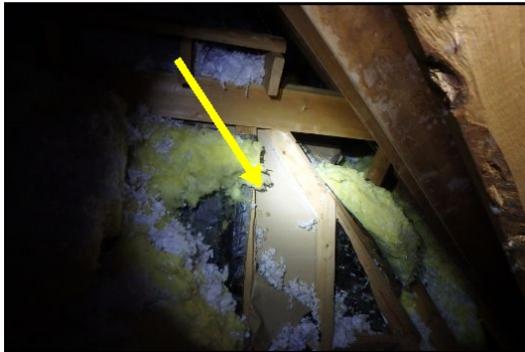
missing tray ceiling insulation.*

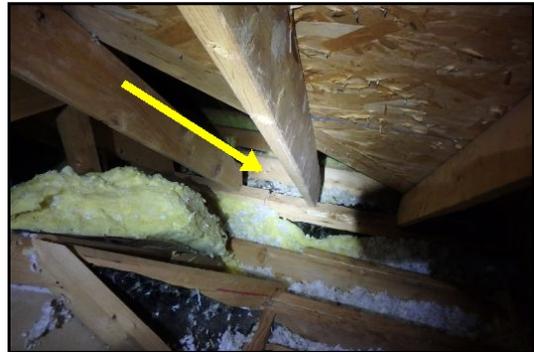
low insualtin in master.*

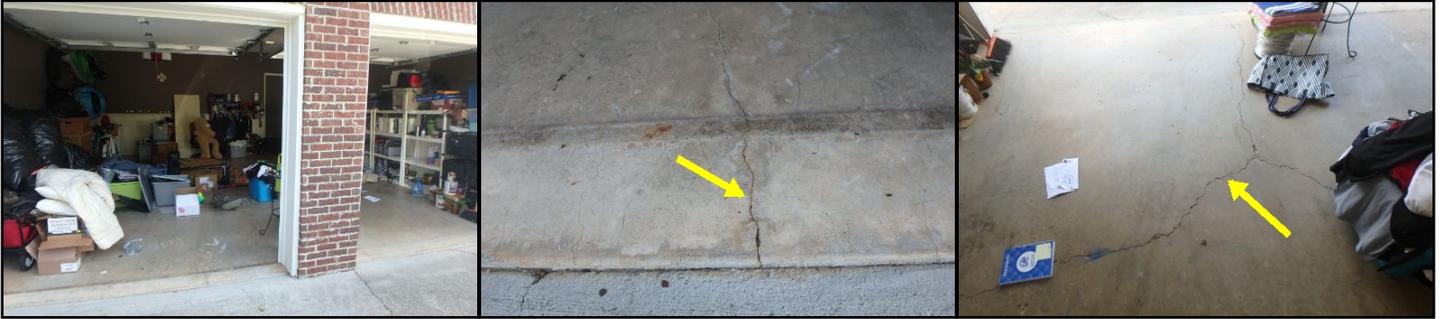
Common cracks not a concern

Settling cracks present but appeared to be within tolerance levels.*

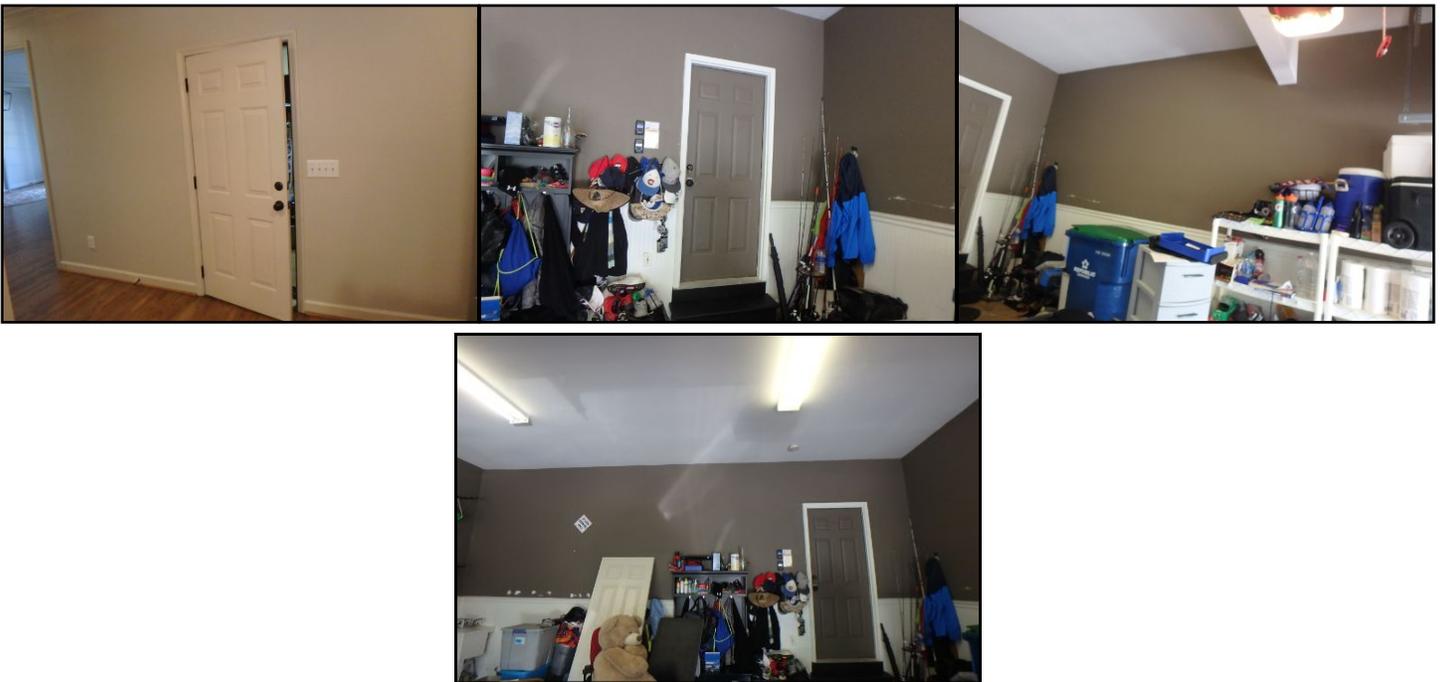
- *Dead bolt need deeper hole to close properly.**

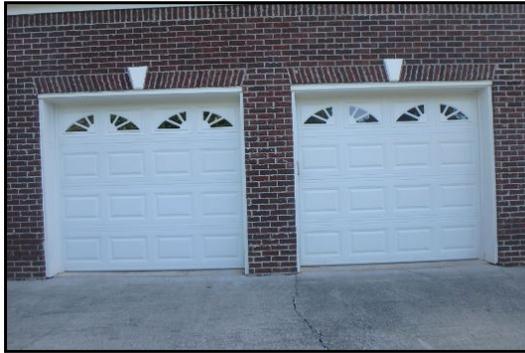
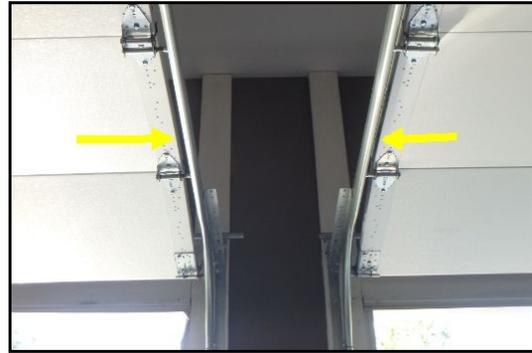
No manual lock present.*

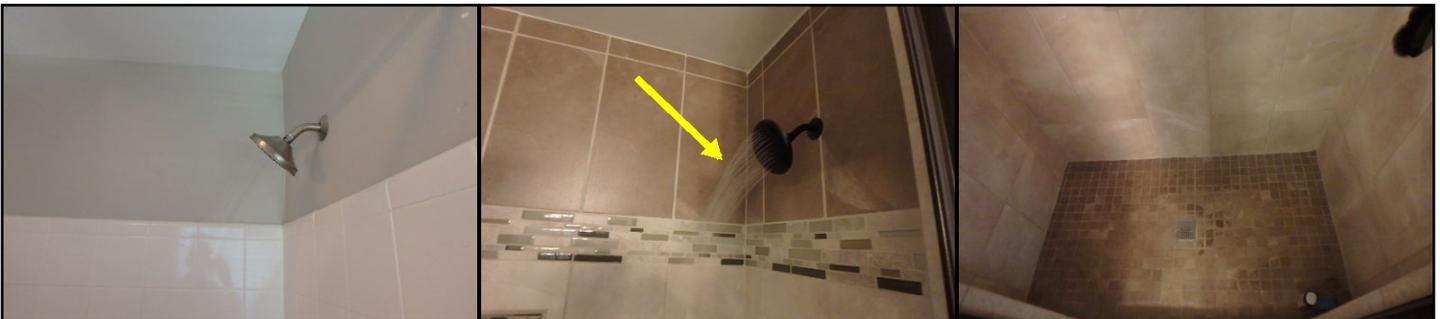
*Low water pressure noted in master shower or when multiple units running.**

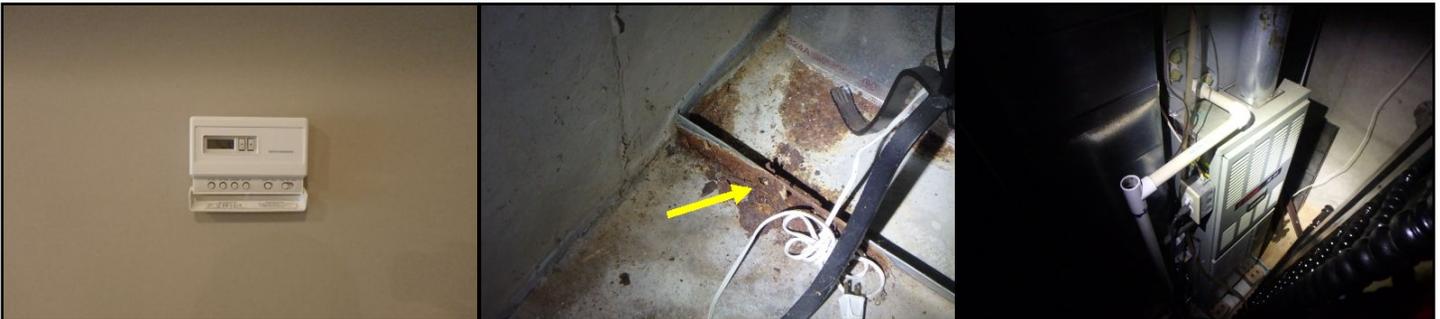
Pan for far basement unit is rusted through, needs to be replaced.*

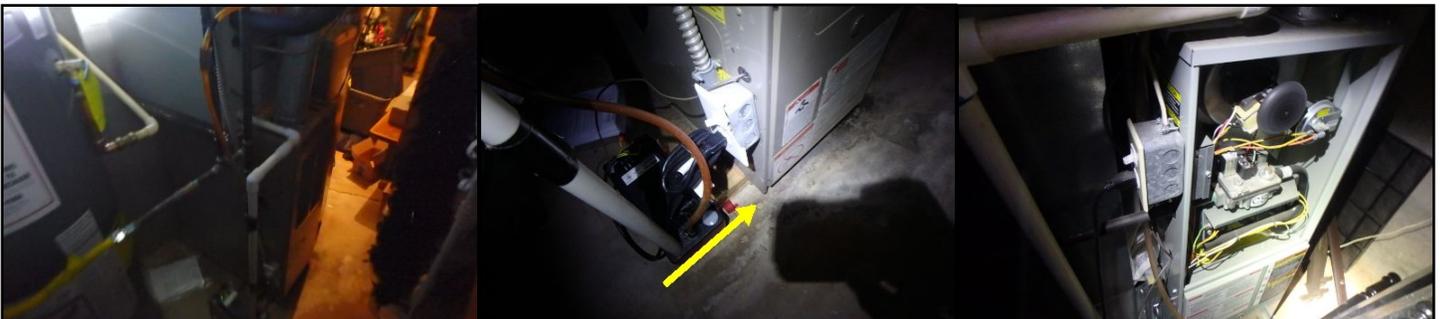
No emergency pan.*

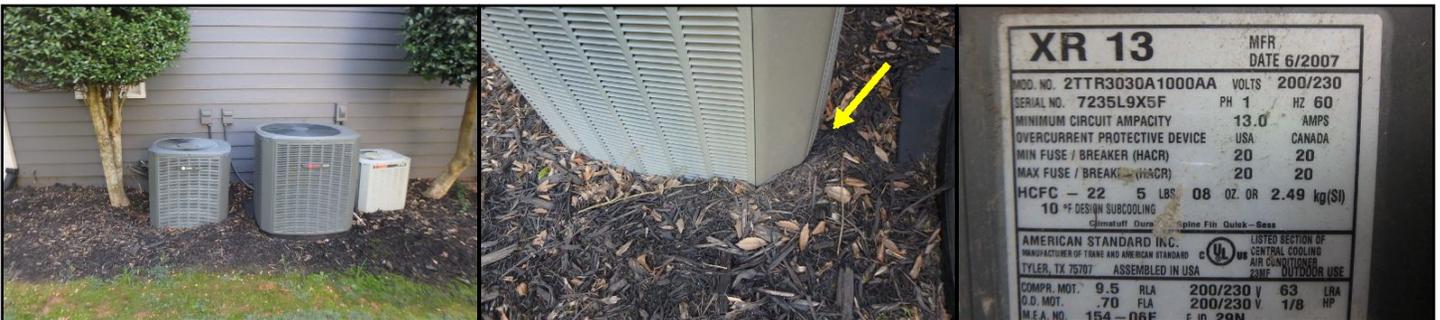
Recommend clearing debris at unit.*

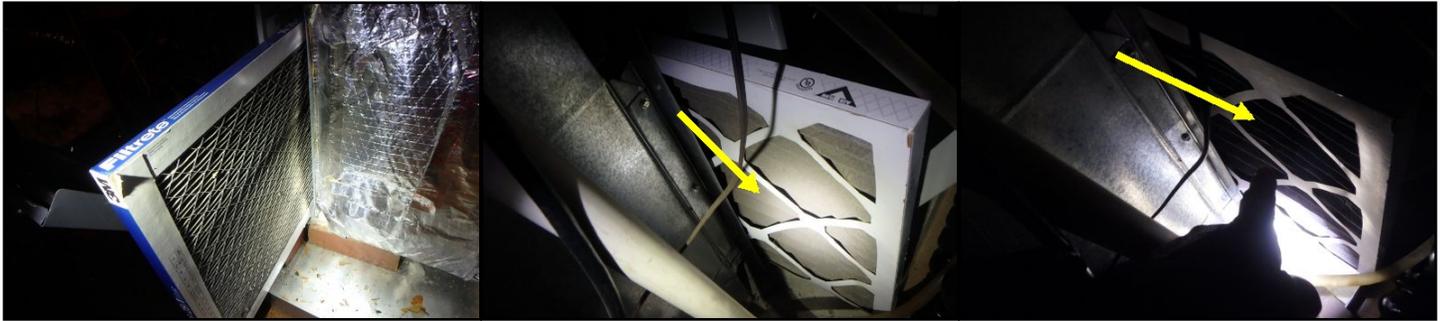
Filters need to be replaced in basement units.*

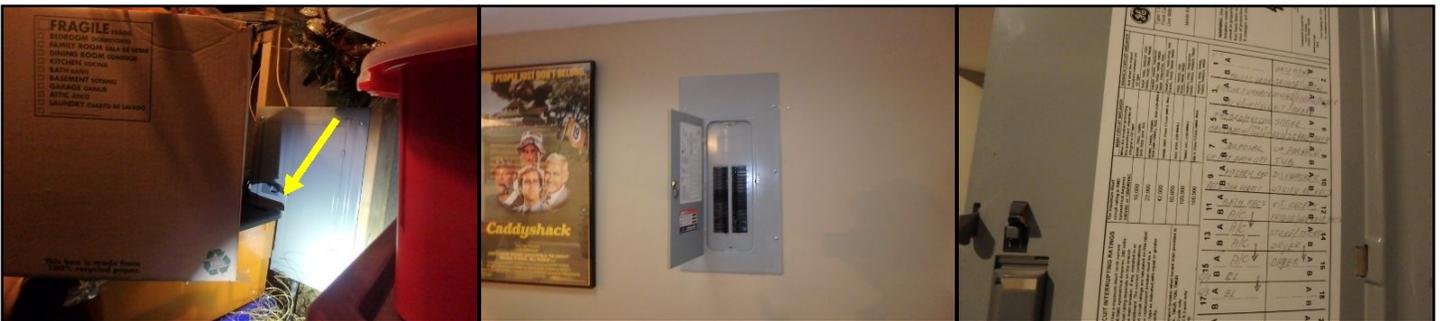
panel blocked by storage.*

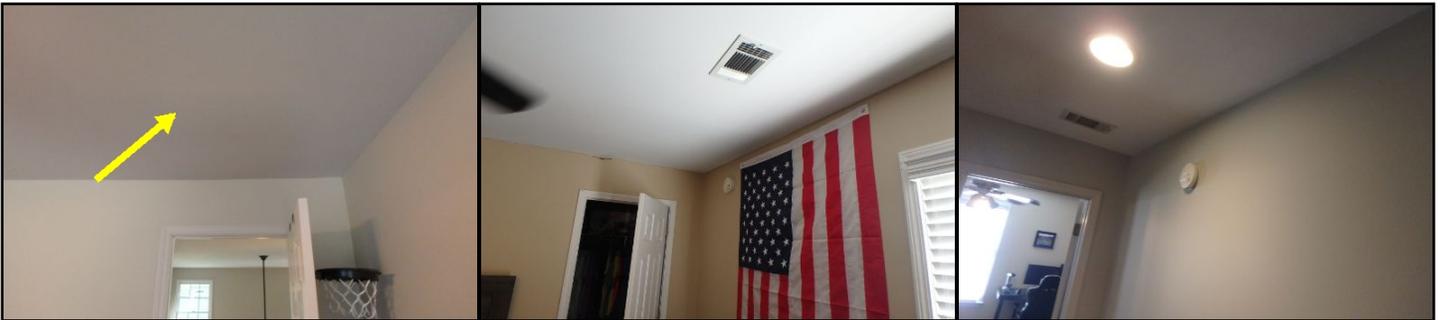
Recommend smoke detectors in all bedrooms.*

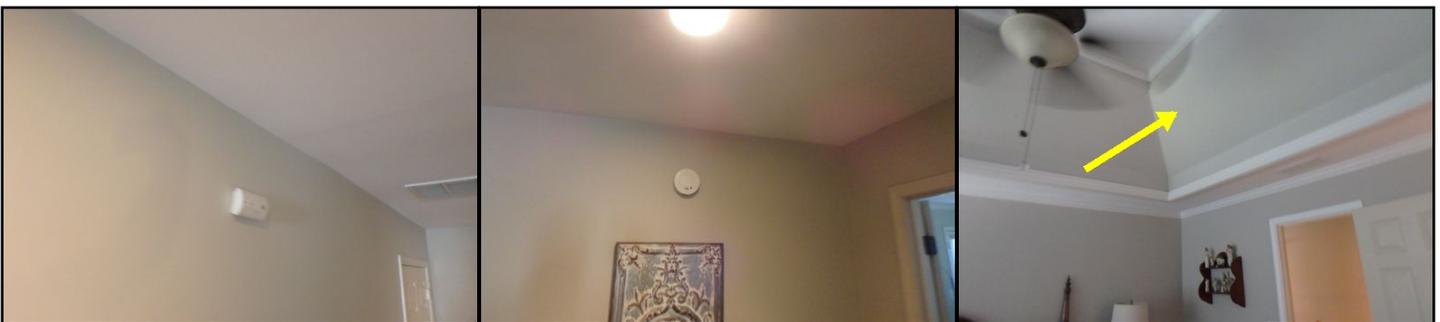
Recommend smoke detectors in all bedrooms.*

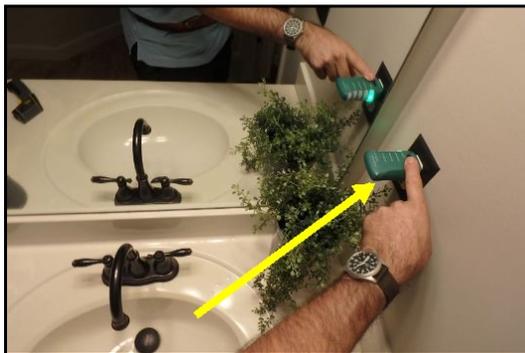
lack GFCI protection in main floor bath.*

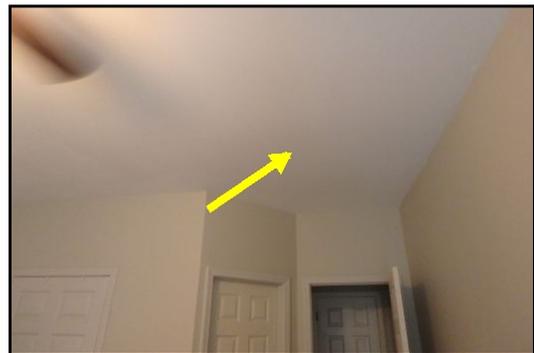
Recommend smoke detectors in all bedrooms.*
