Property Inspection Report

Property address: **820 Deerfield Township Way
Alpharetta GA 30004-0913**

Inspection date: **Thursday, September 3, 2020**

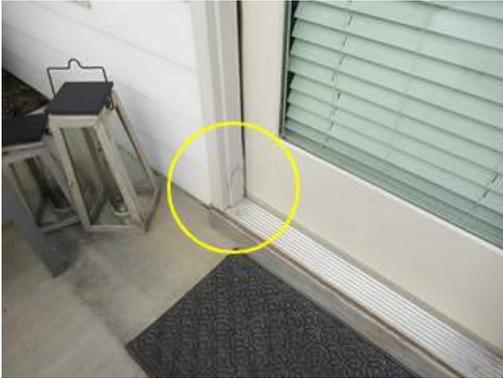
Photo 4-1

Exterior trim appears to be damaged in one or more areas. Recommend having a qualified contractor evaluate and make any necessary repairs.

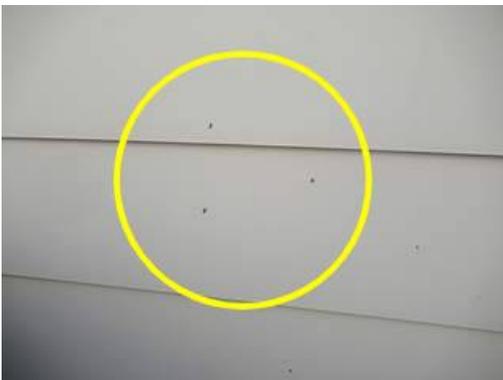
Photo 5-1

Siding is damaged and/or deteriorated in one or more areas. A qualified contractor should evaluate and make repairs and/or replace siding as necessary.

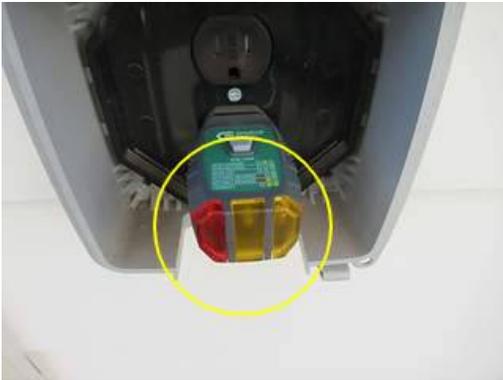
Photo 6-1

6) 🔧🔍 One or more electric receptacles appear to have no power. Recommend asking the property owner(s) about this. Switches may need to be operated to make some receptacles energized. If necessary, a qualified electrician should evaluate and make repairs as necessary.

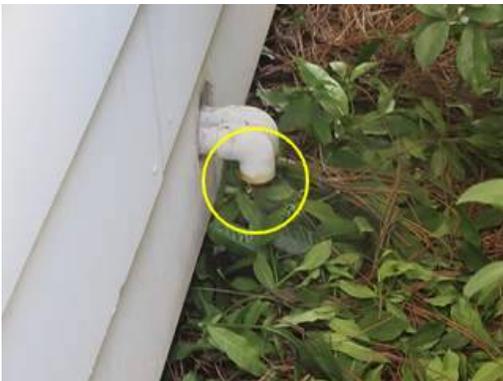
Photo 7-1

7) 🔧🔍📌 The HVAC condensation drainage lines are discharging too close to the foundation. This is a conducive condition for wood destroying organisms. Recommend that the drain pipes be extended so that condensation drains away from the foundation.

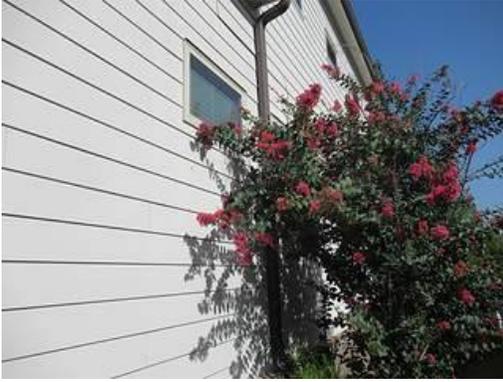
Photo 8-1

8) 🪓🔍 Vegetation such as trees, shrubs and/or vines are in contact with or less than one foot from the structure's exterior. Vegetation can serve as a conduit for wood destroying insects and may retain moisture against the exterior after it rains. Vegetation should be pruned and/or removed as necessary to maintain a one foot clearance between it and the structure's exterior.

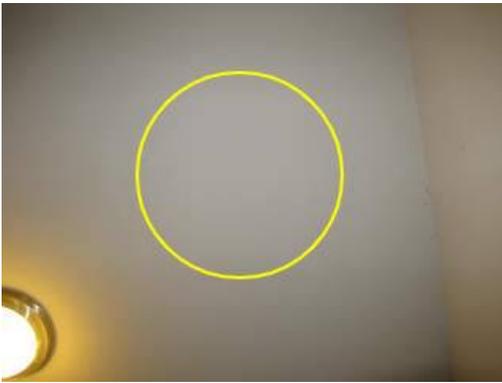
Photo 11-1

No smoke or carbon monoxide alarms are visible in the garage. This is a safety hazard. A qualified electrician should install smoke alarms as per standard building practices.

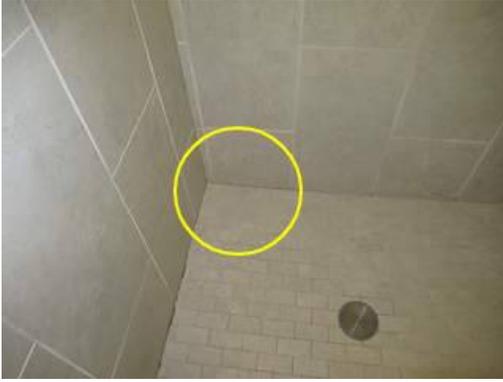
Tile and/or grout in one or more showers is damaged and/or deteriorated. For example, deteriorated or missing grout, cracked, missing or loose tiles, etc. A qualified contractor should evaluate and repair tile and/or grout as necessary.

Photo 42-1 Master shower

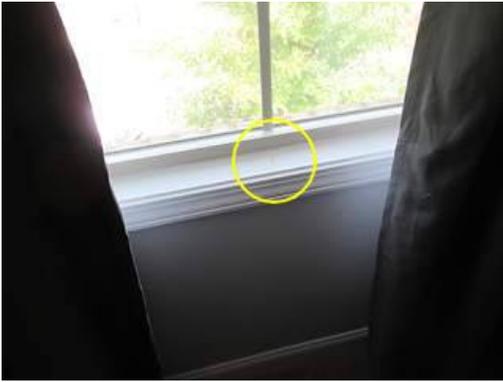
Photo 46-1

Trim is damaged and/or deteriorated in one or more areas. Recommend having a qualified contractor replace or repair trim as necessary.

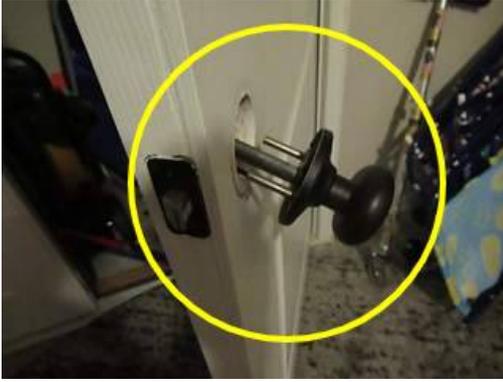
Photo 47-1

One or more locksets are loose and should be tightened, repaired and or replaced as necessary.

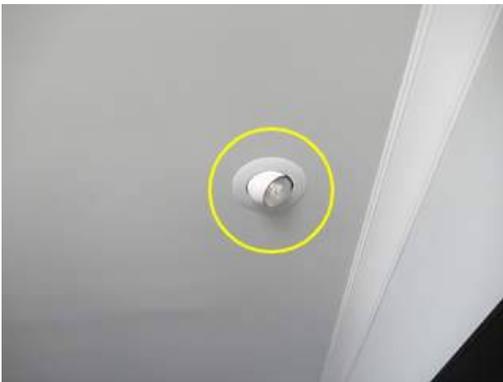
Photo 48-1

48) 🔍 One or more light fixtures appear to be inoperable. Recommend further evaluation by replacing bulb(s) and/or consulting with the property owner(s). Repairs or replacement of the light fixture(s) by a qualified electrician may be necessary.

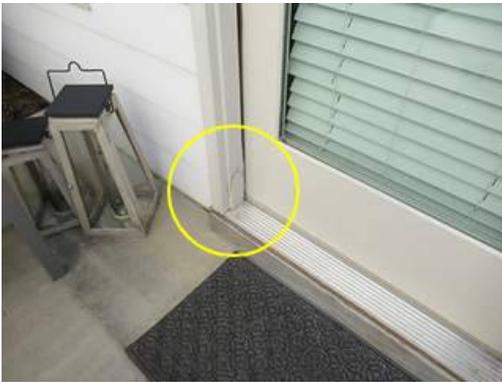
Photo 4-1

Exterior trim appears to be damaged in one or more areas. Recommend having a qualified contractor evaluate and make any necessary repairs.

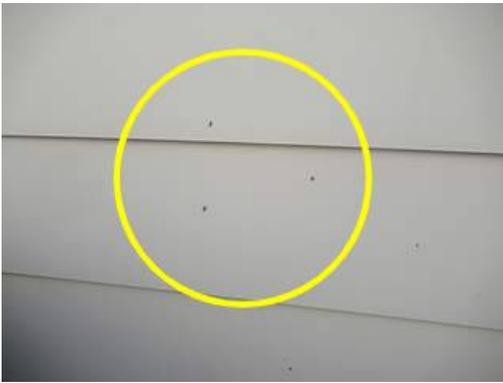
Photo 5-1

Siding is damaged and/or deteriorated in one or more areas. A qualified contractor should evaluate and make repairs and/or replace siding as necessary.

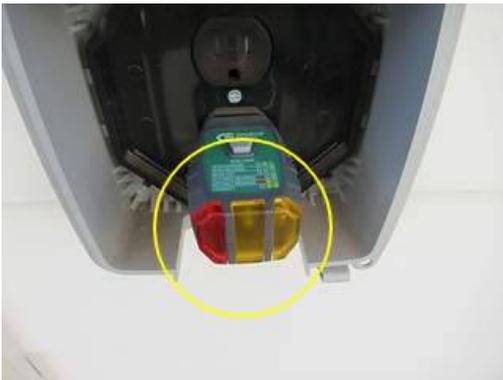
Photo 6-1

One or more electric receptacles appear to have no power. Recommend asking the property owner(s) about this. Switches may need to be operated to make some receptacles energized. If necessary, a qualified electrician should evaluate and make repairs as necessary.

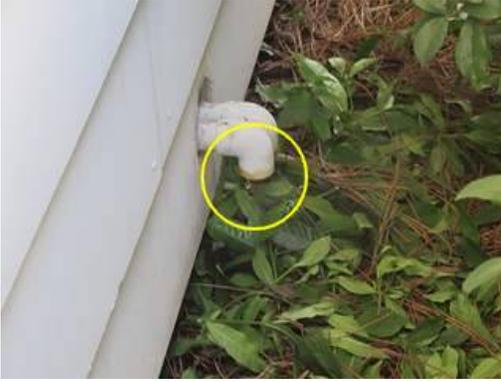
Photo 7-1

The HVAC condensation drainage lines are discharging too close to the foundation. This is a conducive condition for wood destroying organisms. Recommend that the drain pipes be extended so that condensation drains away from the foundation.

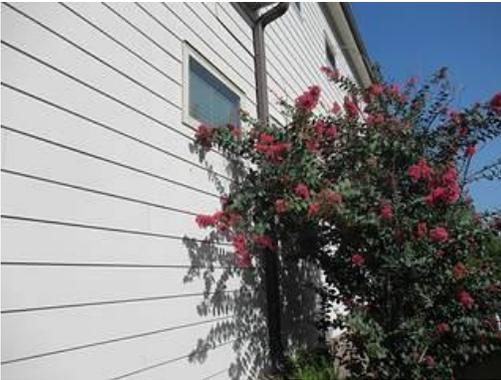
Photo 8-1

Vegetation such as trees, shrubs and/or vines are in contact with or less than one foot from the structure's exterior. Vegetation can serve as a conduit for wood destroying insects and may retain moisture against the exterior after it rains. Vegetation should be pruned and/or removed as necessary to maintain a one foot clearance between it and the structure's exterior.

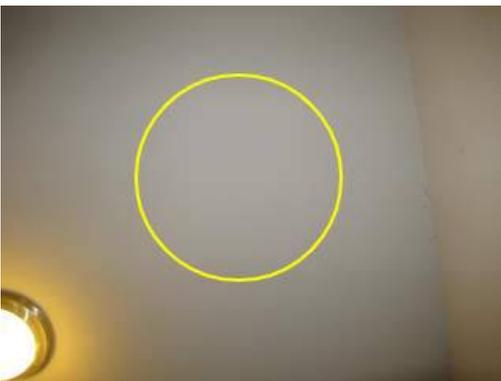
Photo 11-1

No smoke or carbon monoxide alarms are visible in the garage. This is a safety hazard. A qualified electrician should install smoke alarms as per standard building practices.

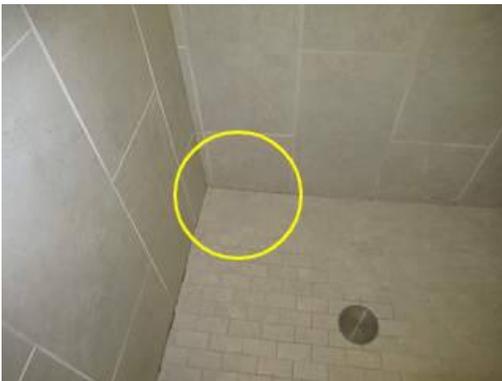
Tile and/or grout in one or more showers is damaged and/or deteriorated. For example, deteriorated or missing grout, cracked, missing or loose tiles, etc. A qualified contractor should evaluate and repair tile and/or grout as necessary.

Photo 42-1 Master shower

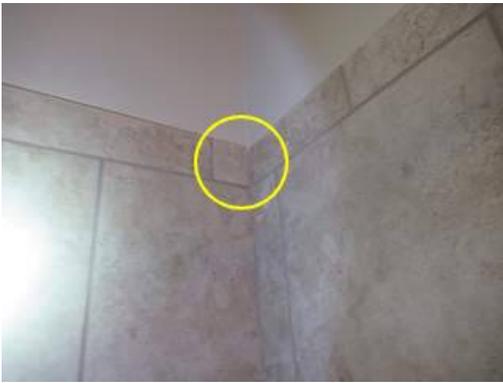
Photo 42-3 Upstairs attached bathroom

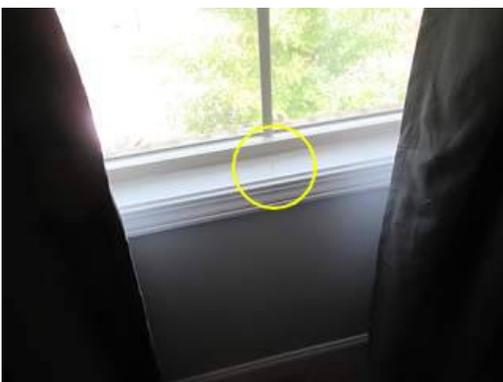
Photo 46-1

Trim is damaged and/or deteriorated in one or more areas. Recommend having a qualified contractor replace or repair trim as necessary.

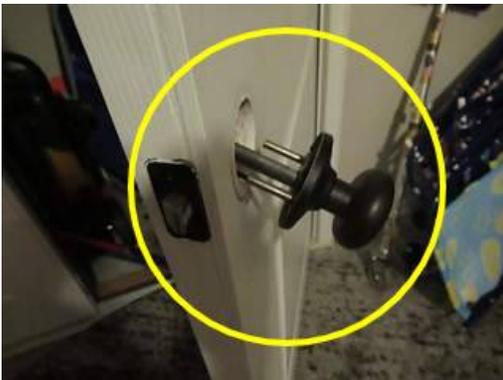
Photo 47-1

One or more locksets are loose and should be tightened, repaired and or replaced as necessary.
