Home Inspection
for
Christian Stanko
5535 Concord Downs Drive
Cumming, GA 30040

HOME INSPECTION REPORT

Brief Description of the Subject Structure

This two-story wood framed structure is a single-family residence, constructed in the year circa 2006. It has a two-car attached garage; an asphalt shingle roof; brick and fiber-cement cladding and a concrete slab foundation. The front of the home faces East.

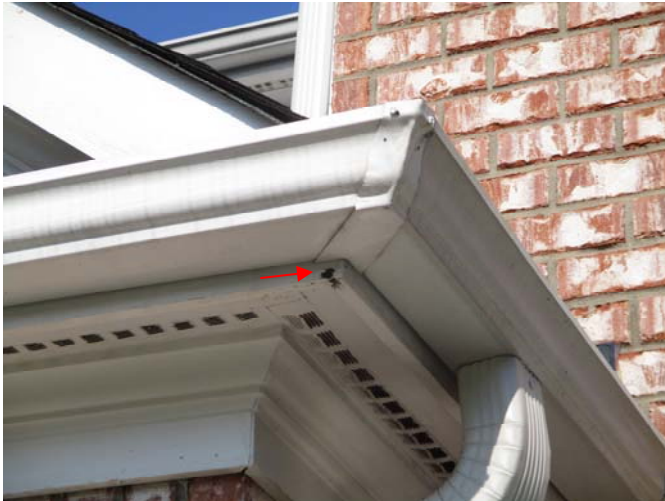
Moisture damage was present at the fascia boards below the corner joint in the gutter located above the right, front corner of the garage.

1. Moisture damage was present at the fascia boards below the corner joint in the gutter located above the right, front corner of the garage, at the fascia and soffit boards located above the left, corner of the front, center bedroom, at the wood trim located under the right side of the front porch roof, at the horizontal trim located above the right side of the front porch, at the fascia board located below the right and left sides of the upper gable on the front of the home, at the exterior trim located below the gable vent on the left side of the home, at the lower portion of the corner trim located at the back, right and left corners of the chimney chase, at the lower portion of the corner trim located above the small, shingled area on the right side of the chimney chase, at the bottom of the corner trim at the back, right corner of the home and at the bottom of the frame on the left side of the left, exterior French door in the rear wall of the breakfast area (see photos). A qualified contractor should evaluate the damaged wood and replace as needed.

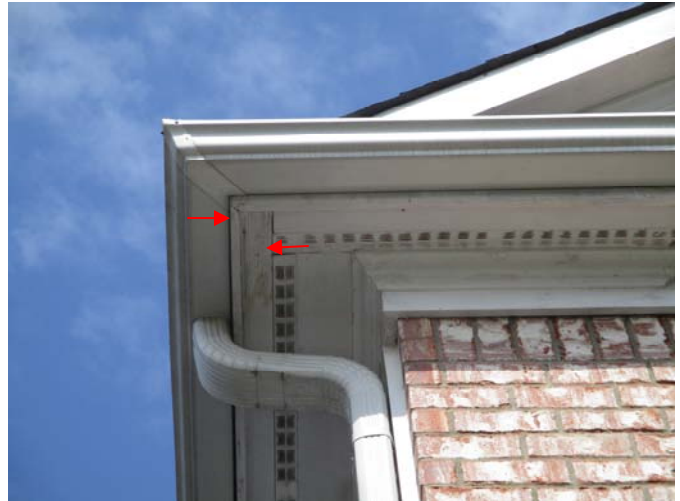
Moisture damage was present at the fascia and soffit boards located above the left, corner of the front, center bedroom.

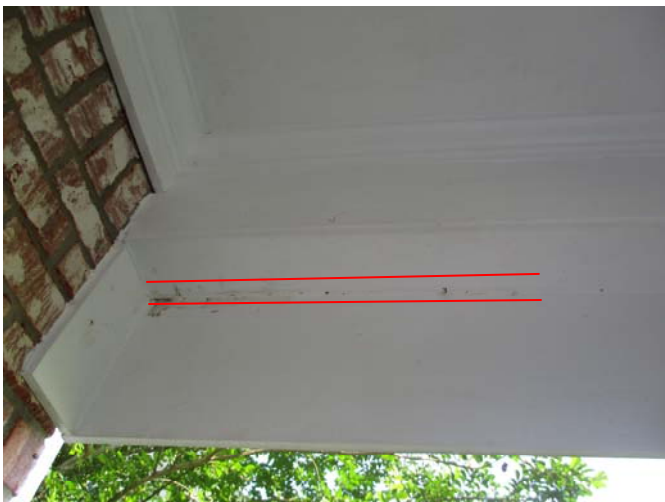
Moisture damage was present at the wood trim located under the right side of the front porch roof.

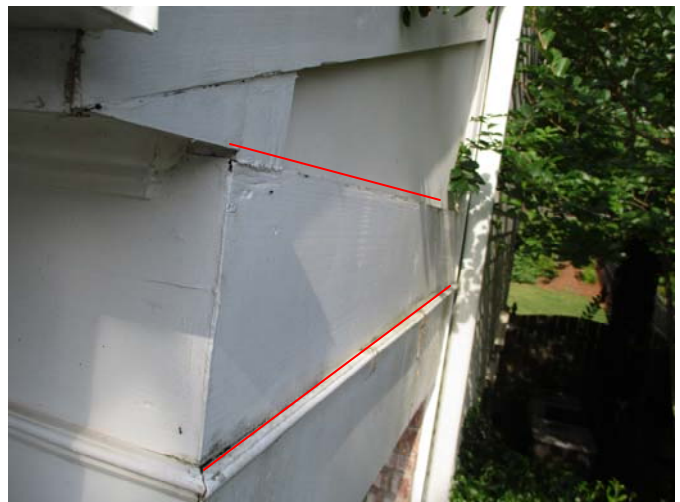
Moisture damage was present at the horizontal trim located above the right side of the front porch.

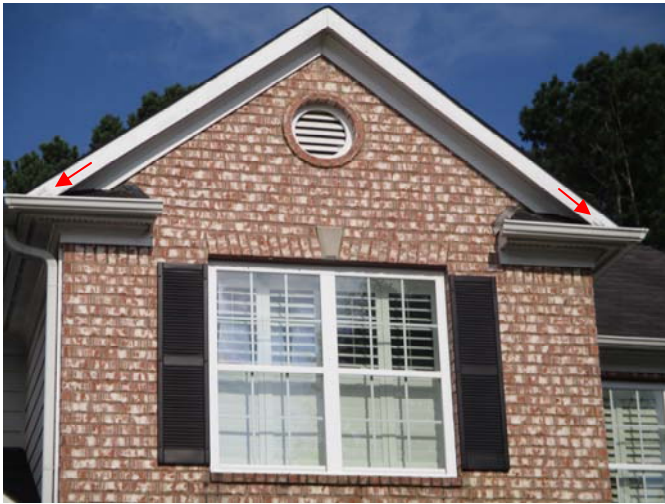
Moisture damage was present at the fascia board located below the right and left sides of the upper gable on the front of the home.

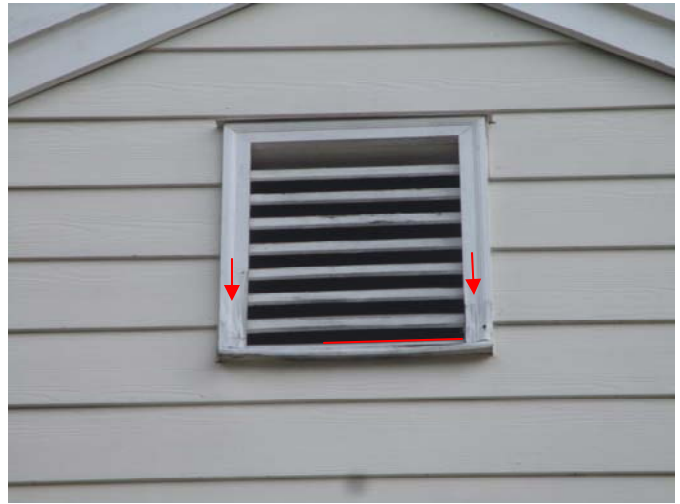
Moisture damage was present at the exterior trim located below the gable vent on the left side of the home.

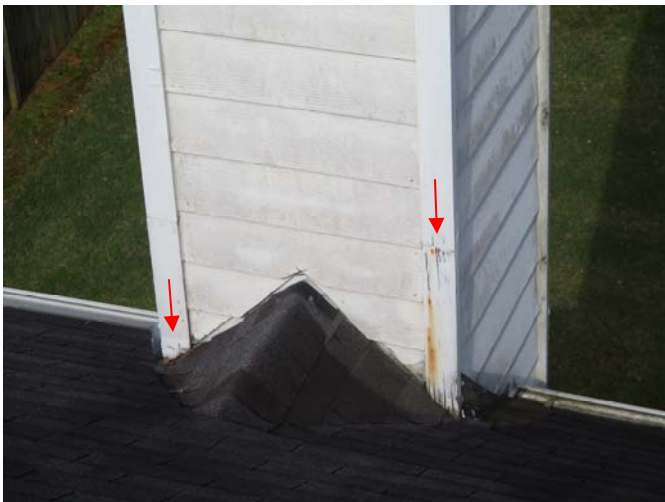
Moisture damage was present at the lower portion of the corner trim located at the back, right and left corners of the chimney chase.

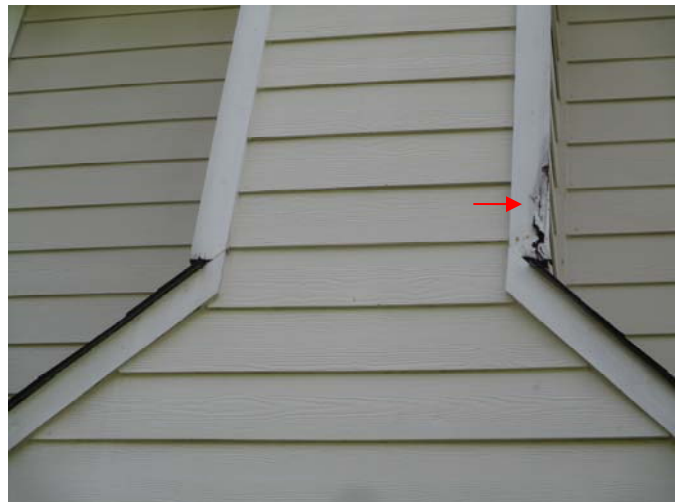
Moisture damage was present at the lower portion of the corner trim located above the small, shingled area on the right side of the chimney chase.

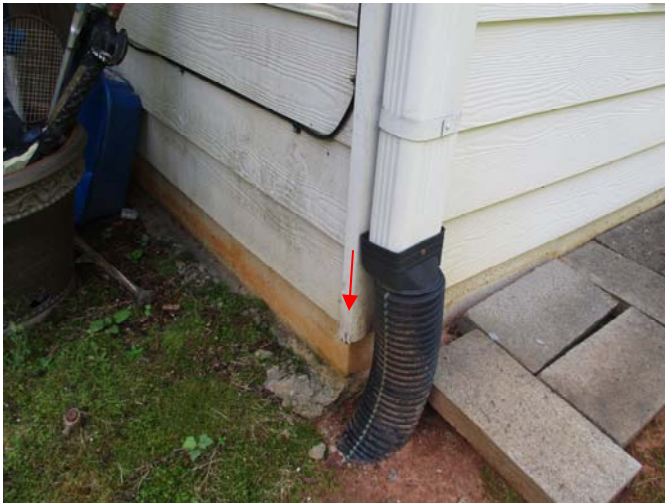
Moisture damage was present at the bottom of the corner trim at the back, right corner of the home.

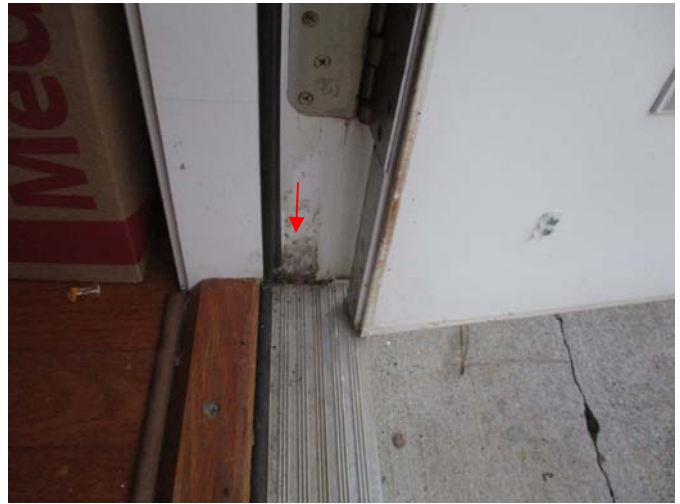
Moisture damage was present at the bottom of the frame on the left side of the left, exterior French door in the rear wall of the breakfast area.

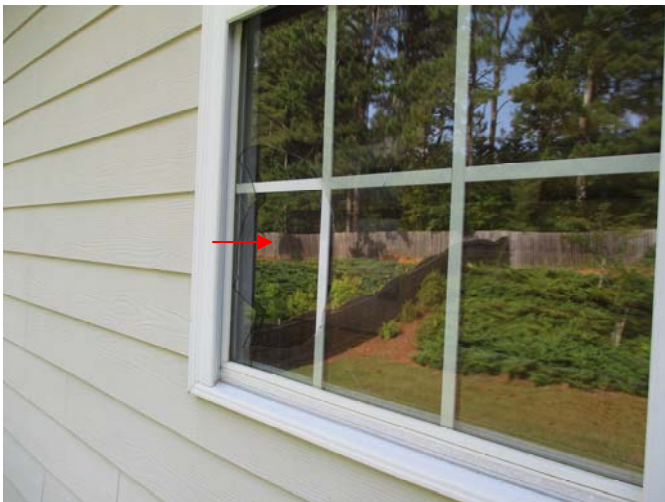
The lower piece of glass is cracked in the center window in the rear wall of the master bedroom.

2. The lower piece of glass is cracked in the center window in the rear wall of the master bedroom (see photo). The thermo seal appears to have failed inside the upper piece of glass in the window located on the right side of the fireplace in the family room (1) and inside the upper piece of glass in the left window in the front, center bedroom (1) – (the glass is fogged). A qualified contractor should replace the glass in these windows.

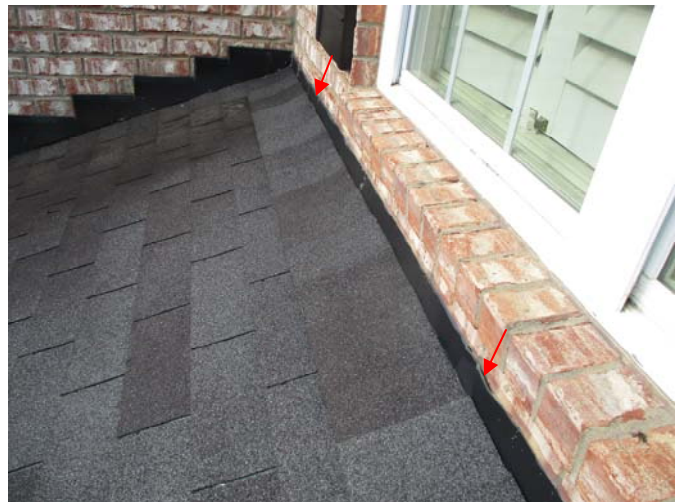
A qualified contractor should secure and re-apply the caulking along the top edge of the flashing located along the upper portion of the front porch roof to prevent future moisture entry.

3. A qualified contractor should secure and re-apply the caulking along the top edge of the flashing located along the upper portion of the front porch roof to prevent future moisture entry (see photo).

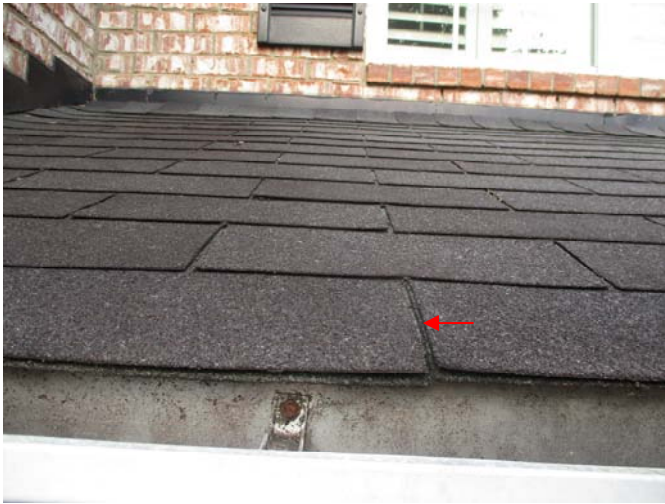
A qualified contractor should seal the open gap in the shingles located above the left side of the gutter on the front porch roof to prevent future moisture damage to the roof decking.

4. A qualified contractor should seal the open gap in the shingles located above the left side of the gutter on the front porch roof to prevent future moisture damage to the roof decking (see photo).

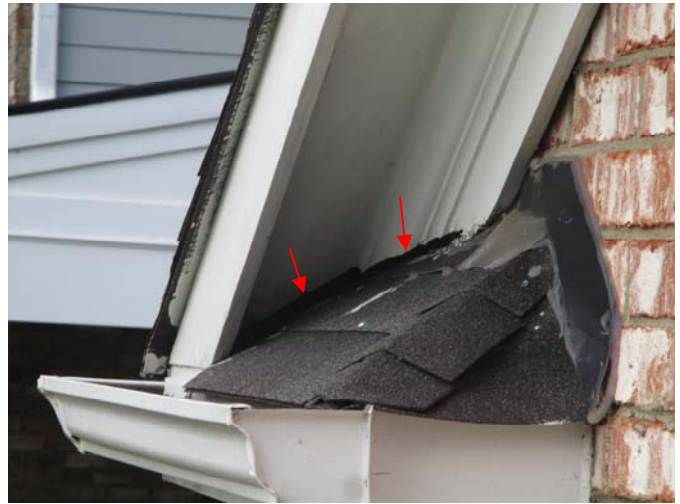
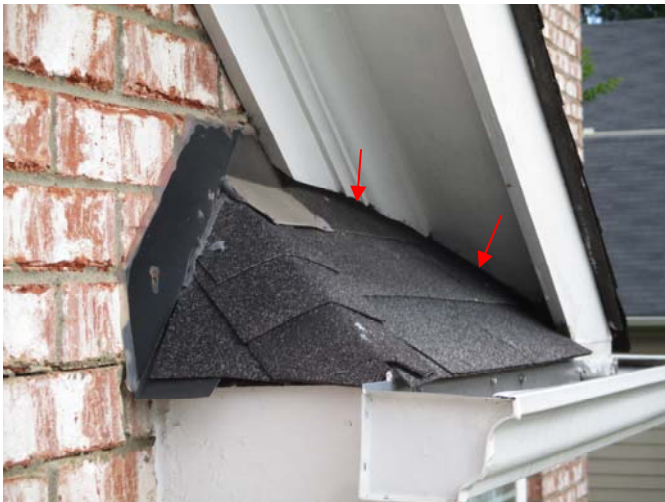
A qualified contractor should seal the construction gaps along the soffit and frieze boards above the gable returns on the front of the home to prevent future insect/rodent entry into the attic areas.

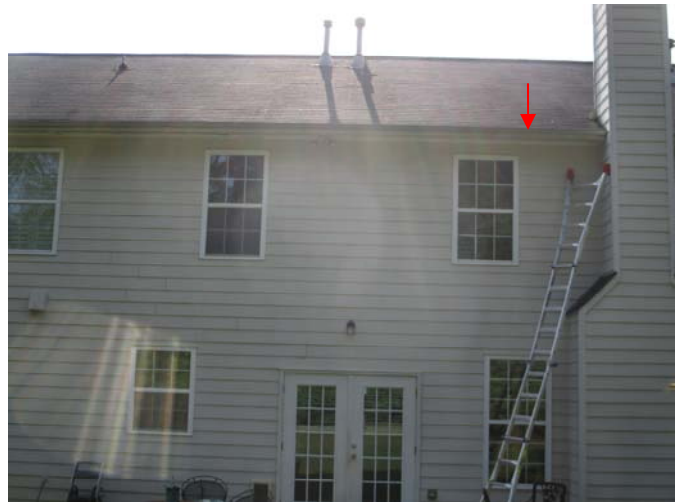
The gutter located on the right side of the chimney chase is pitched away from the downspout.

6. The gutter located on the right side of the chimney chase is pitched away from the downspout (see photo). A qualified contractor should evaluate and adjust as needed to prevent overflow during rains. Note: Several stains were present on the fascia board below this gutter.

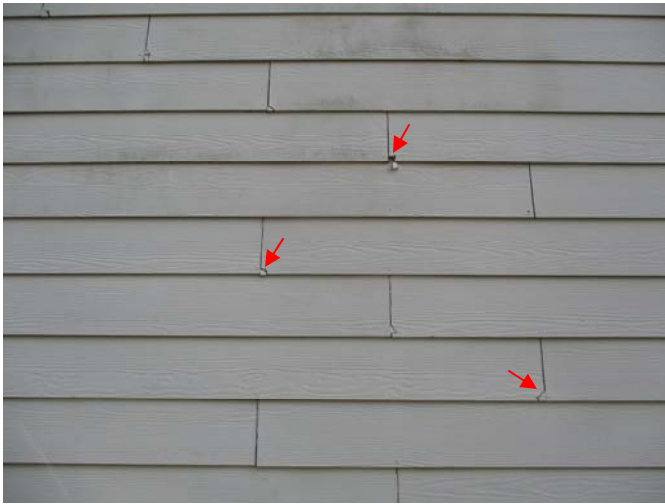
The bottom corners of several pieces of fiber-cement siding are cracked on the left side of the home.

7. The bottom corners of several pieces of fiber-cement siding are cracked on the left side of the home (see photo for example). A qualified contractor should evaluate the fiber-cement siding on the left side of the home and replace as needed.

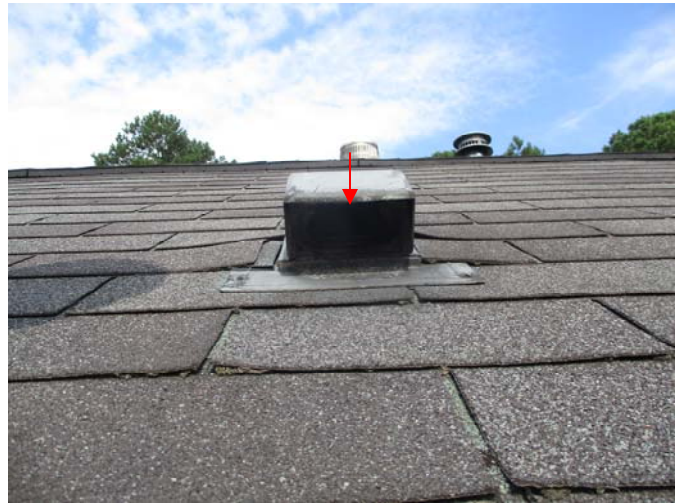
The dryer in the laundry room vents out through the shingles on the front of the home. The inside of the dryer vent and the venthood attached to the dryer vent located above the shingles should be cleaned by a qualified contractor.

1. The dryer in the laundry room vents out through the shingles on the front of the home. The inside of the dryer vent and the venthood attached to the dryer vent located above the shingles should be cleaned by a qualified contractor (see photo). Inactive moisture stains were present on the wall and ceiling above the backside of the dryer in the laundry room which appear to be related to condensation forming on the metal flue for the dryer vent located inside this wall cavity (see photos).

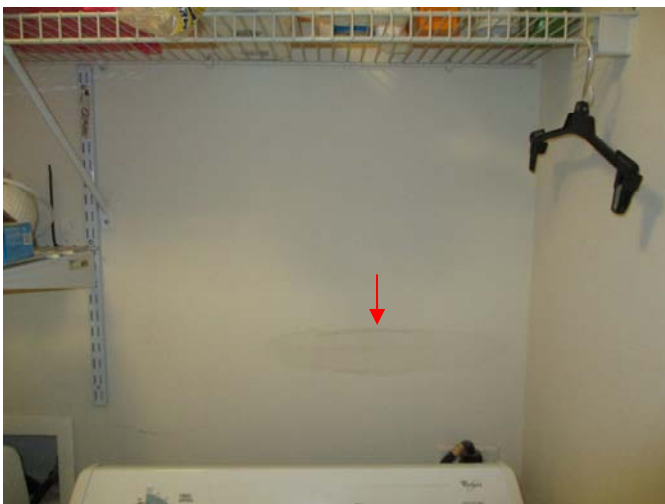
Inactive moisture stains were present on the wall above the backside of the dryer in the laundry room.

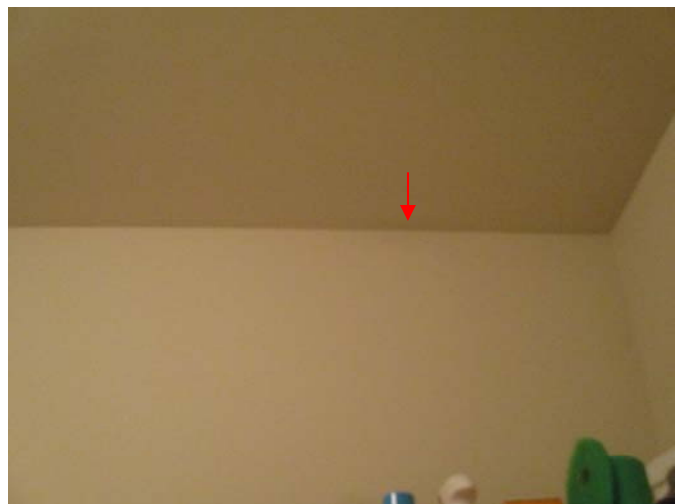
Inactive moisture stains were present on the ceiling above the backside of the dryer in the laundry room.

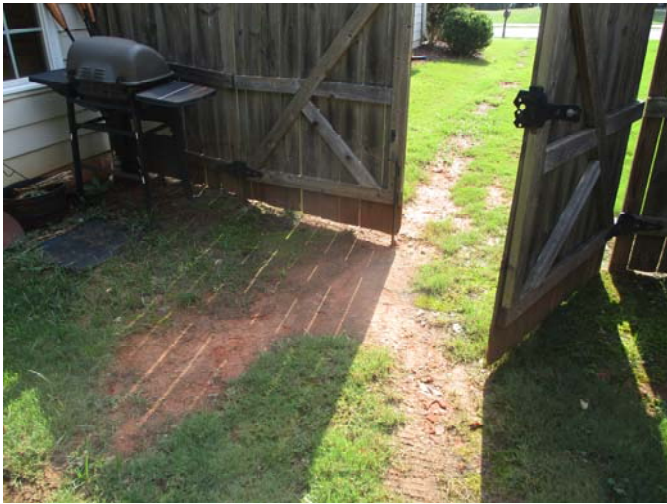
Water appears to pond in the soil near the gates in the fence at the back, left corner of the home during rains.

1. Water appears to pond in the soil near the gates in the fence at the back, left corner of the home during rains (see photo). Recommend having this area evaluated by a qualified landscaping contractor (i.e. install a catch basin in the soil).

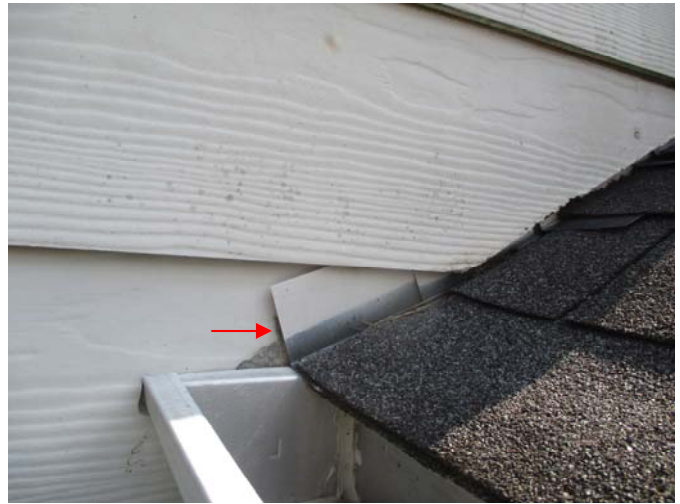
A licensed roofer or qualified contractor should install kick-out flashing under the last piece of roof flashing above the gutter on the right side of the chimney chase to prevent water from draining between the gutter and the siding during rains.

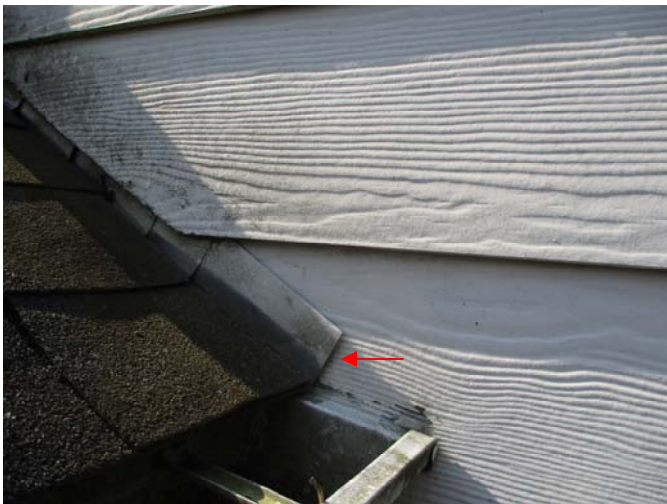
A licensed roofer or qualified contractor should install kick-out flashing under the last piece of roof flashing above the gutter on the left side of the chimney chase to prevent water from draining between the gutter and the siding during rains.

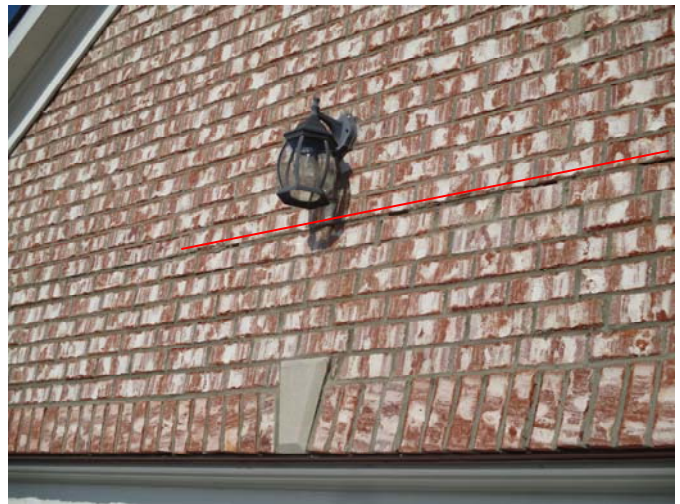
A qualified contractor should apply the missing mortar along the horizontal joint in the brick veneer cladding below the exterior light fixture located above the garage door.

4. A qualified contractor should apply the missing mortar along the horizontal joint in the brick veneer cladding below the exterior light fixture located above the garage door (see photo) – monitor in the future.

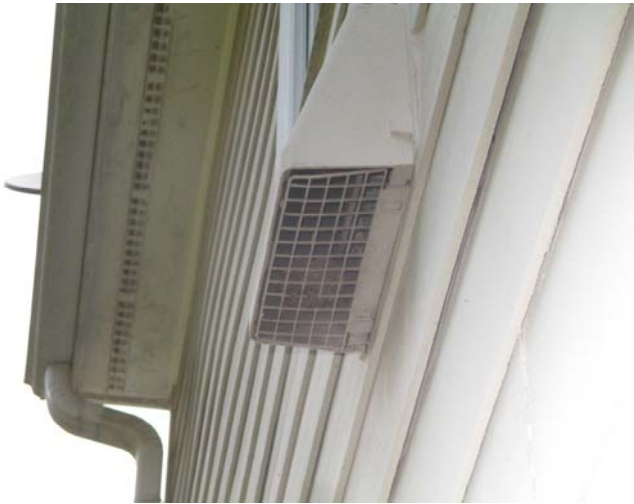
Remove the abandoned wasp nests inside the venthood located outside the back, right corner of the kitchen so that the damper inside this venthood can open properly (this venthood is attached to the flue for the exhaust fan above the microwave in the kitchen).

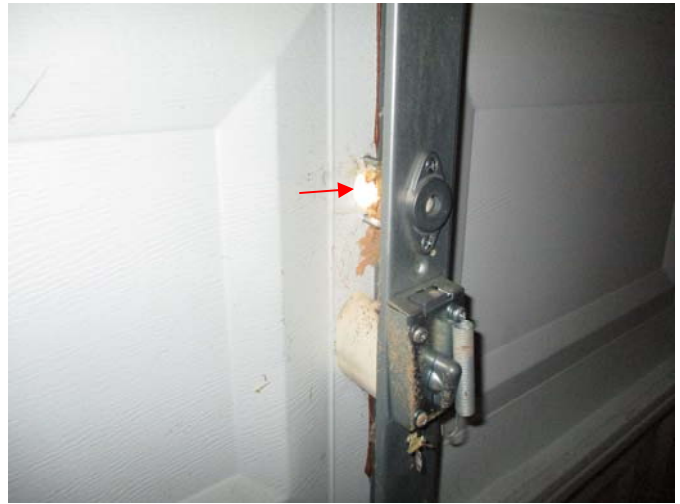
Recommend sealing the drilled hole in the center portion of the lower panel on the garage door to help prevent future insect entry and increase efficiency.

10. The lower portion of the screen is damaged on the window above the kitchen sink – replace as needed.
11. Recommend sealing the drilled hole in the center portion of the lower panel on the garage door to help prevent future insect entry and increase efficiency (see photo).

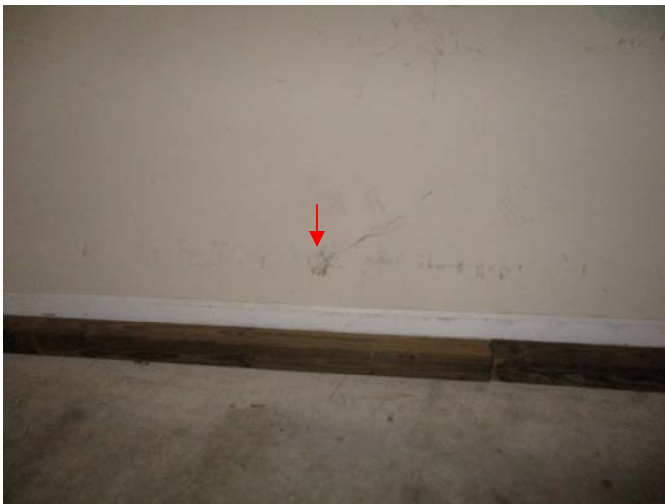
Impact damage was present in the lower portion of the sheetrock at the right wall of the garage, which is cosmetic in nature.

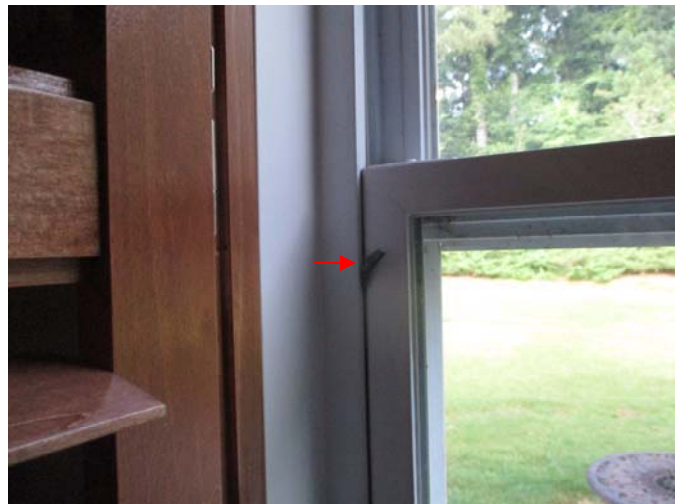
The weather-stripping is displaced along the left side of the window located on the right side of the fireplace in the family room.

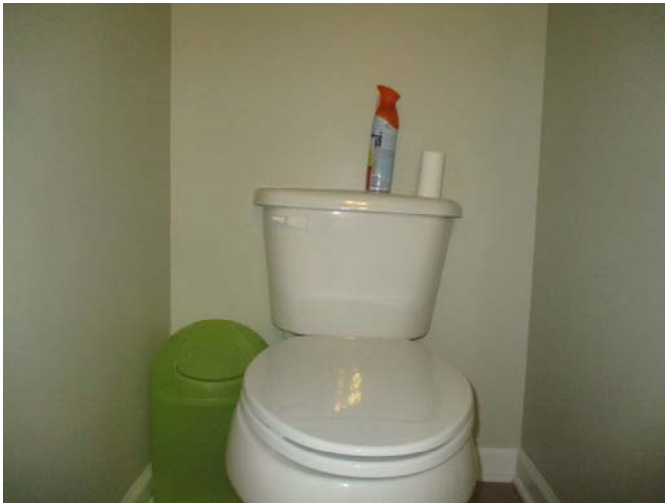
The tank on the commode in the master bathroom was installed at an angle, which is cosmetic in nature.
