Atlanta Property Inspections, Inc.

HOME INSPECTION REPORT

2977 Crosswycke Forest Drive, Atlanta, GA 30319
Inspection prepared for: Rachel Blanks
Date of Inspection: 8/28/2020 Time: 1:00 PM
Age of Home: 35 Years (1985) Size: 1400 SF
Weather: Overcast/ Rain, Wet Soil, 85 Degrees

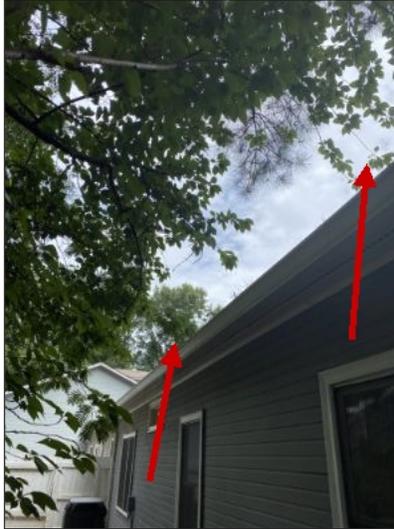
- **Tree limbs are in contact with the roof at the rear roof above the master bedroom (see photo). This condition can lead to damage to the roof coverings and an excessive amount of leaf and tree debris on the roof that can clog gutters and down spouts.**

In addition, squirrel activity on the roof and in the attic is common with tree limb proximity to the house and can be expensive to correct with professional wildlife exclusion services. Squirrel and rodent activity in the attic can also lead to rodent droppings and urine debris, disturbed insulation and chewed electrical wiring.

Tree limbs too close to the rear master bedroom roof

Due to these concerns it is recommended that the tree limbs be trimmed back away from the roof and exterior walls. In some cases it may be beneficial to remove the entire tree.

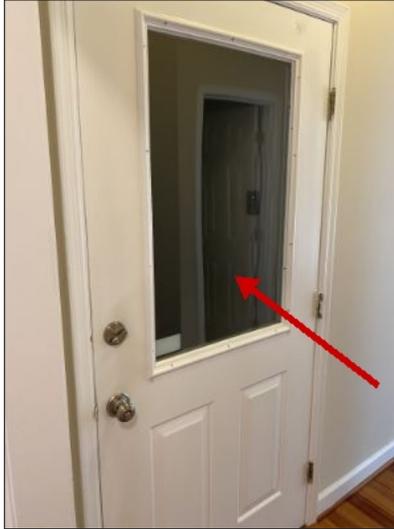
Because garages are one of the primary locations for residential house fires, fire rated doors are now required at this location to prevent the spread of fire from the garage into the home. Fire-rated doors can be solid wood or steel coated - with no glass.

Recommend fire rated door to the garage

As a fire safety upgrade, it is recommended that client consider replacement of this door with a fire-rated type door instead. A replacement door can also improve energy efficiency at this location and can be a better door for security.

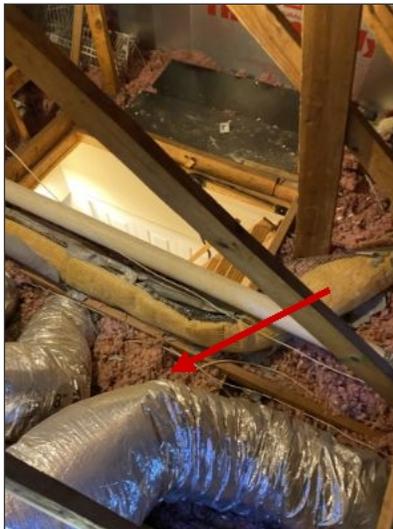
An inadequate or missing walkway was noted from the attic access area to the floored furnace service platform (see photo). This condition is a potential hazard. Correction is advised. Installation of a minimum 22 inch walkway is recommended to meet current attic access and safety standards.

Missing walkway flooring to the furnace platform in the attic

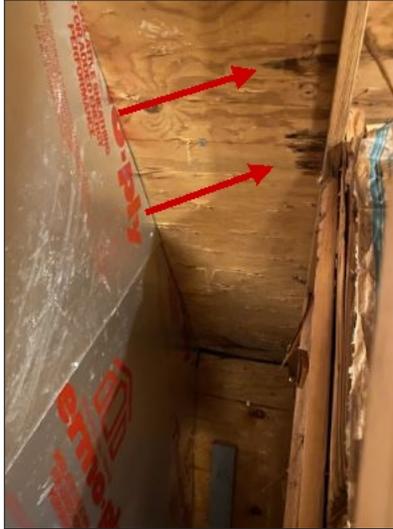
• **Water stains were noted in the attic above the attic ladder (see photo). This condition may be the result of previous roof leaks from the older roof that has since been replaced but this could not be verified during this limited visual inspection. Ask seller for disclosure information regarding any past roof leaks. Continue to monitor, future repair may be needed.**

Water stains in the attic above the attic ladder

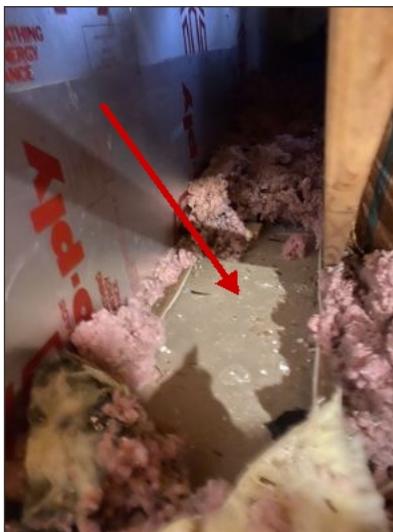
• Missing insulation was observed over portions of the ceiling above the master bedroom and the rear guest bedroom (see photo). Bare sheetrock is present which will lead to an excessive amount of heat loss in winter and heat gain in the summer months. Correction is recommended.

Missing insulation above rear guest bedroom in the attic

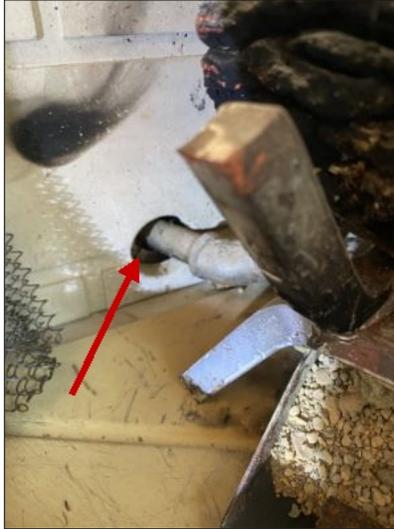
• The gas line penetration at the side wall of the fireplace panel is open and unsealed and could allow the possible passage of hot embers through this opening (see photo). It is recommended that this opening be filled with a fire-rated sealant to meet current fireplace safety standards, a minor repair is suggested.

Open wall at the fireplace gas pipe

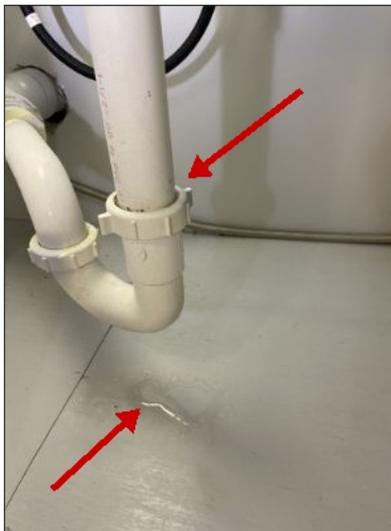
• **An active drain leak was observed below the kitchen sink (see photo). Further evaluation and correction is recommended by a professional plumber.**

Drain leak below the kitchen sink

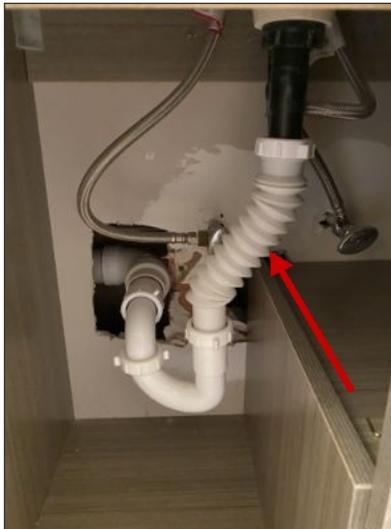
• The drain below both master bathroom sink is incorrectly using a flexible connector which is not approved by local plumbing codes (see photo). This type of drain pipe can allow debris collection, clogged drains and unsanitary waste buildup. Although the use of this type of drain is common and the drain may be working correctly at this time, replacement of the flexible connector is recommended with an approved rigid, smooth bore drain pipe instead.

Improper flex drains below the master bathroom sinks

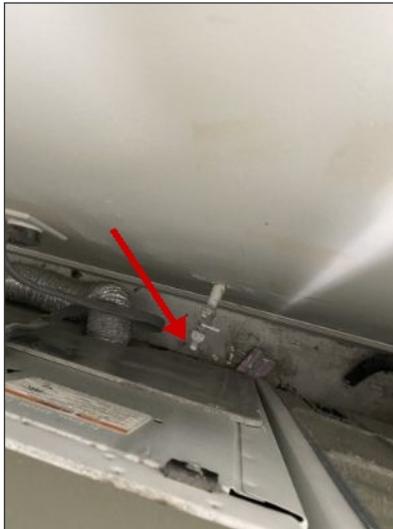
- An open gas line is present behind the dryer (see photo). This condition is a code violation (National Fuel and Gas Code, ANSI Z223.1/NFPA54) and a potential hazard. Repair is advised. The open gas line needs to be capped or plugged when not in use.

Open gas line behind the dryer

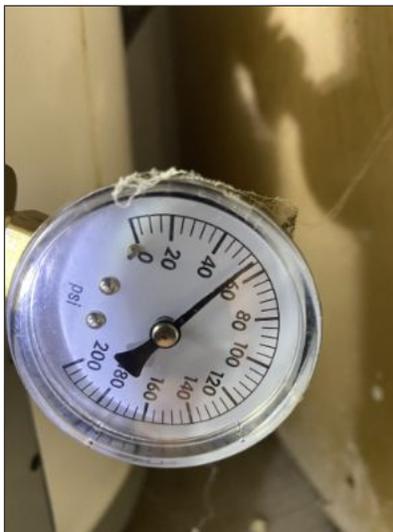
• The supply piping appears to be serviceable, no concerns were noted. A water pressure reading was taken at the rear hose bib and was found to be normal at (55) PSI.

Normal water pressure at 55 psi

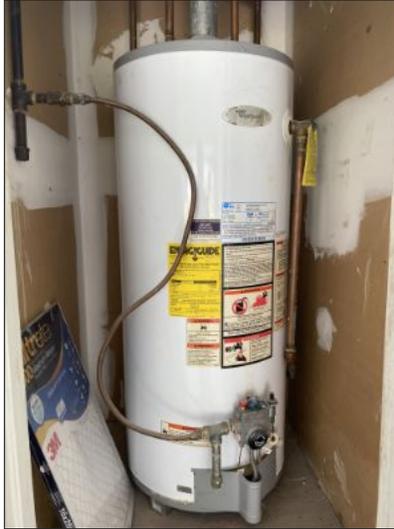
Due to the advanced age of this aging gas water heater, client should budget for replacement of the water heater tank soon. The water heater tank is at, or past, the normal expected lifespan of 10 years.

Water heater in the garage
