Property Inspection Report

210 N. Esplanade, Alpharetta GA

9/02/2020

31123

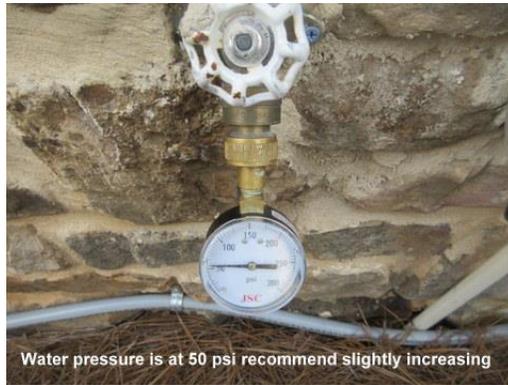
Water pressure is at 50 psi recommend slightly increasing

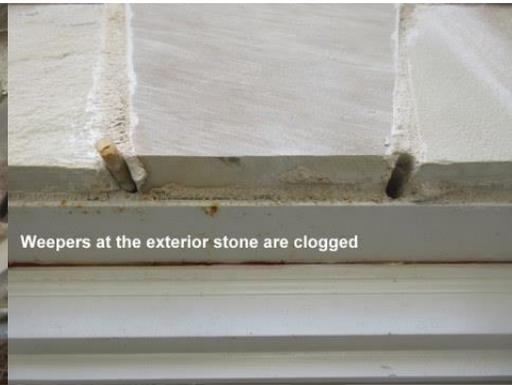
Weepers at the exterior stone are clogged

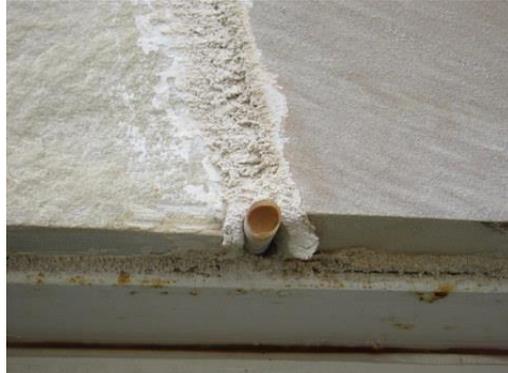
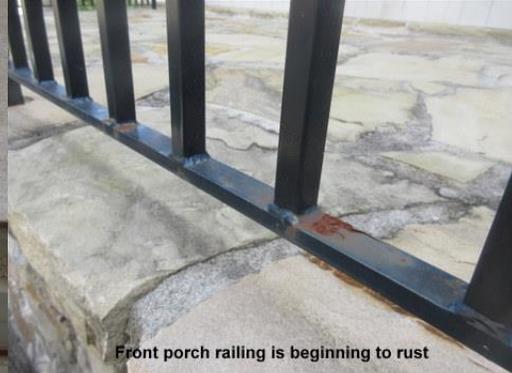
Front porch railing is beginning to rust

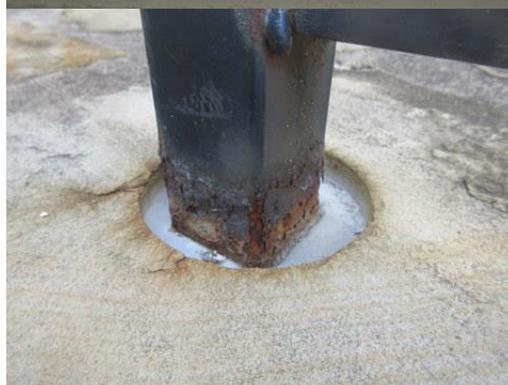
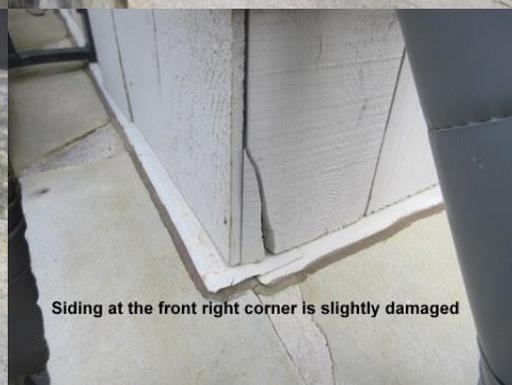
Siding at the front right corner is slightly damaged

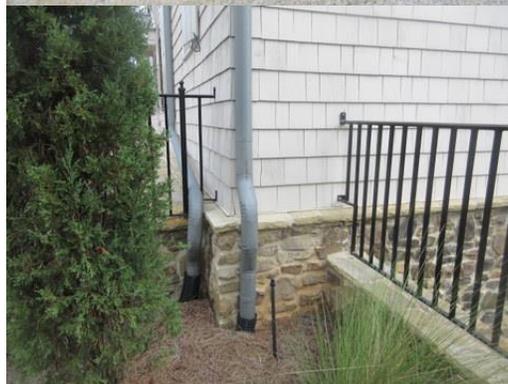
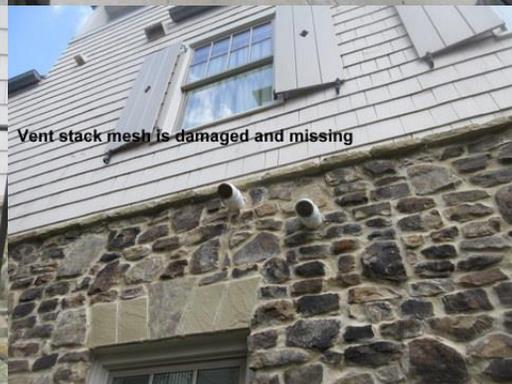
Vent stack mesh is damaged and missing

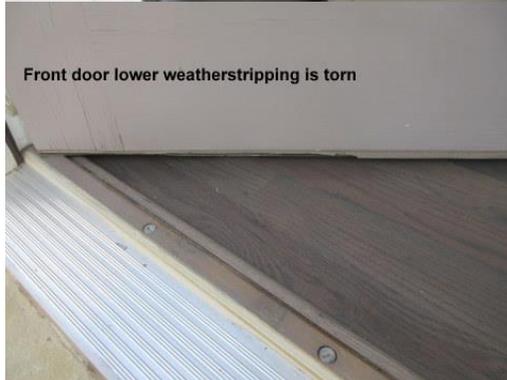
Front door lower weatherstripping is torn

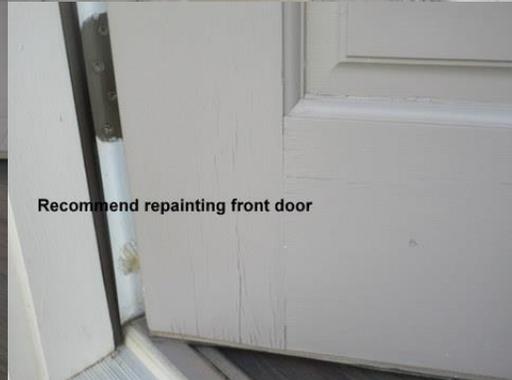
Recommend repainting front door

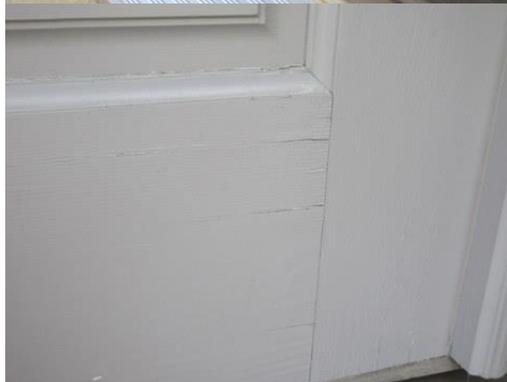
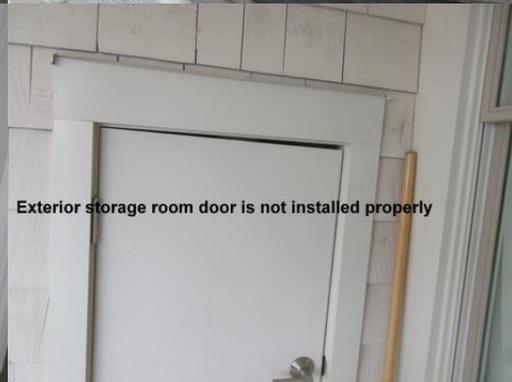
Exterior storage room door is not installed properly

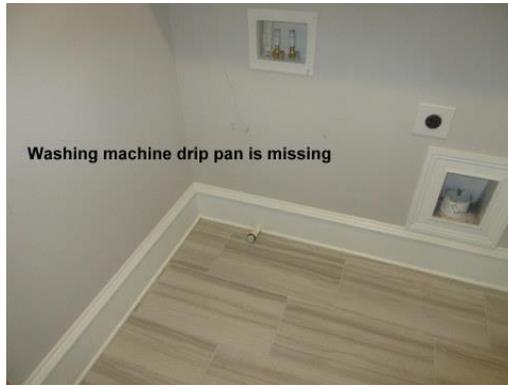
Washing machine drip pan is missing

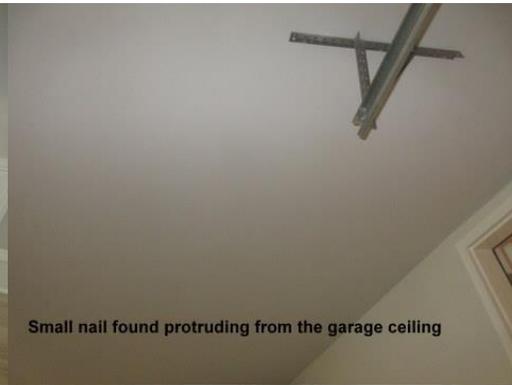
Small nail found protruding from the garage ceiling

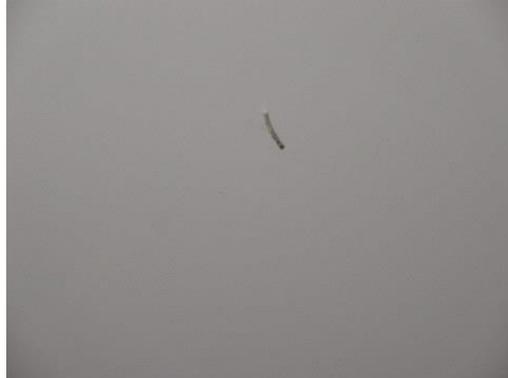
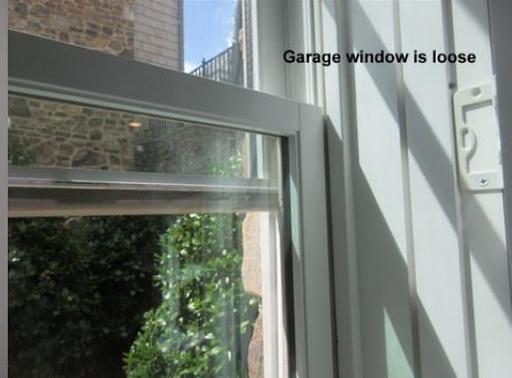
Garage window is loose

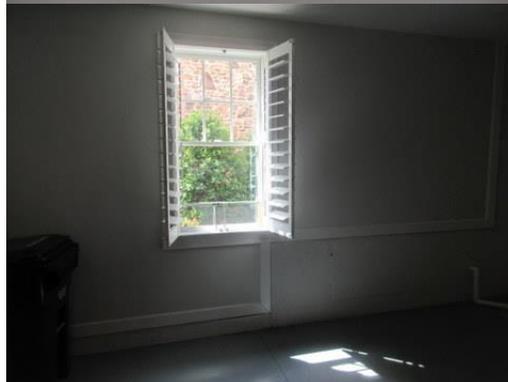
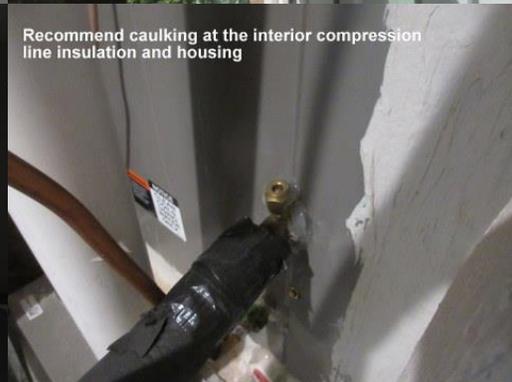
Recommend caulking at the interior compression line insulation and housing

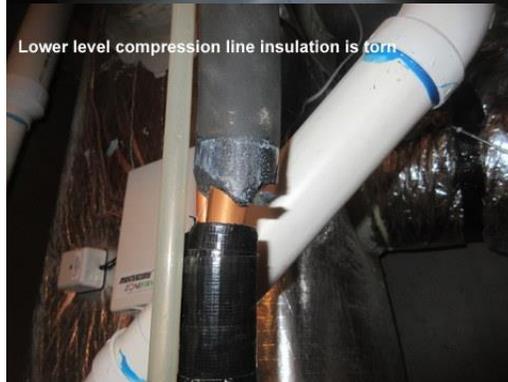
Lower level compression line insulation is torn

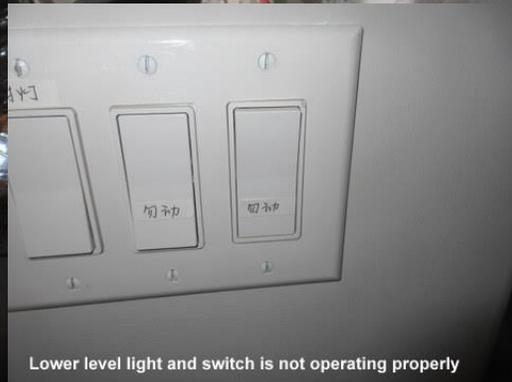
Lower level light and switch is not operating properly

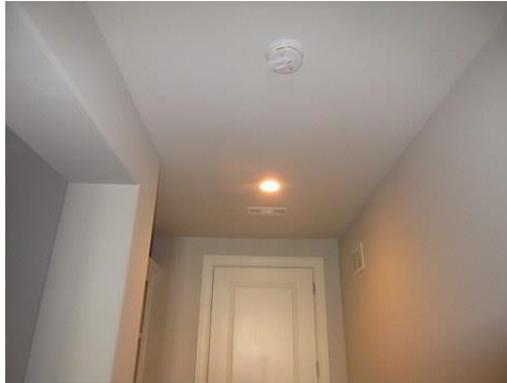
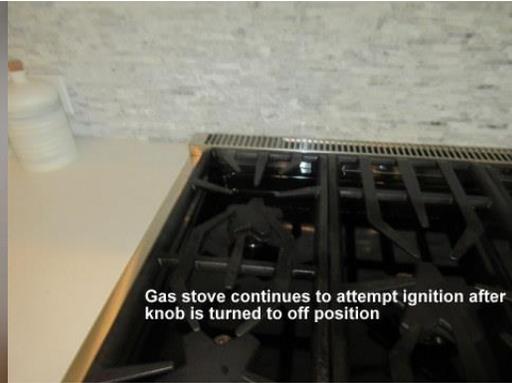
Gas stove continues to attempt ignition after knob is turned to off position

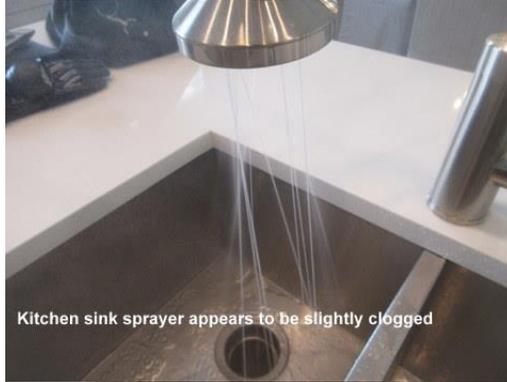
Kitchen sink sprayer appears to be slightly clogged

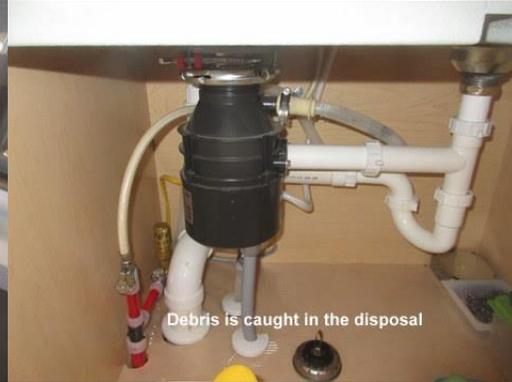
Debris is caught in the disposal

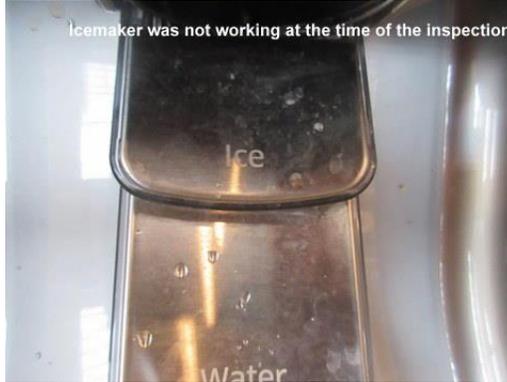
Icemaker was not working at the time of the inspection

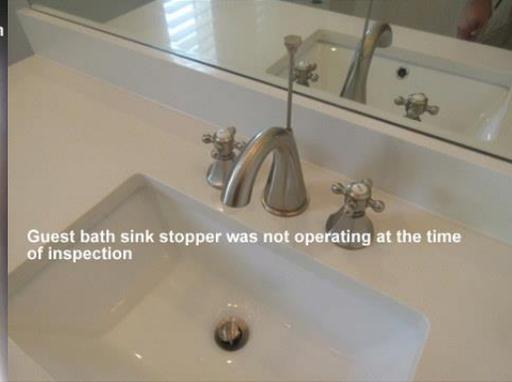
Guest bath sink stopper was not operating at the time of inspection

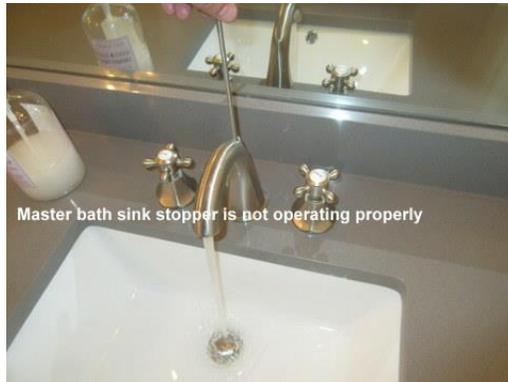
Master bath sink stopper is not operating properly

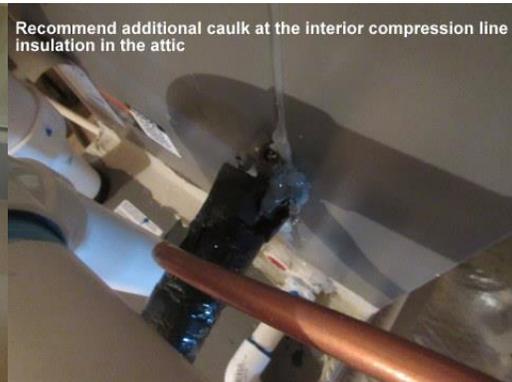
Recommend additional caulk at the interior compression line insulation in the attic

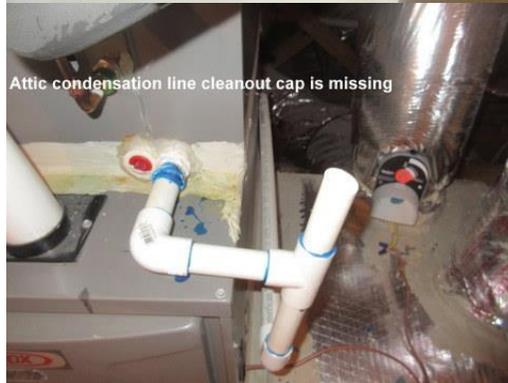
Attic condensation line cleanout cap is missing

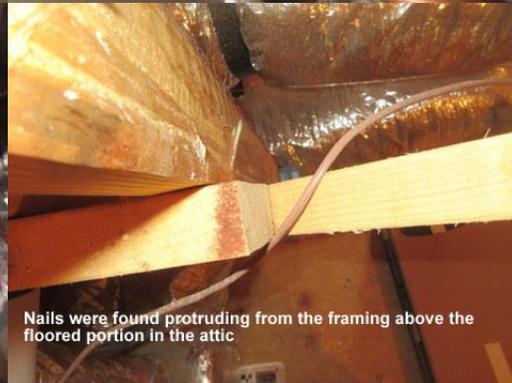
Nails were found protruding from the framing above the floored portion in the attic
