Inspection Report

Property Address:
881 Little Lost Landing NW
Suwanee GA 30024

Date: 9/1/2020	Time: 09:00:00 AM	Report ID: 090120MG1042
Property: 881 Little Lost Landing NW Suwanee GA 30024	Customer: Suzanne Lim	Real Estate Professional: Allison Kloster Harry Norman - 7855 North Point Parkway

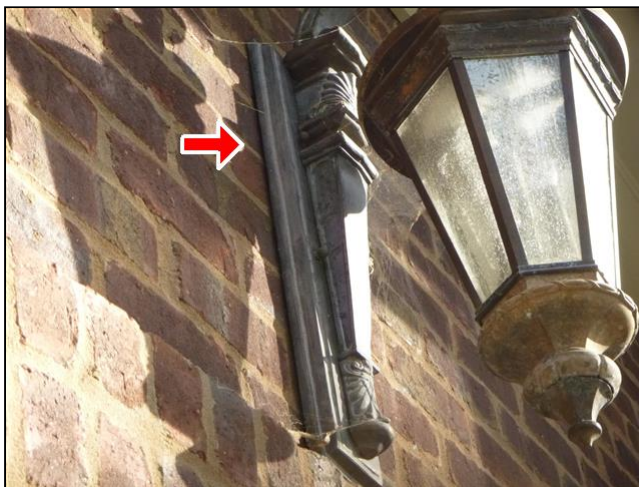
1.1 Item 1(Picture)

🔧 (1) Recommend to seal around all exterior light fixtures where they meet the siding of the home to prevent potential water entry.

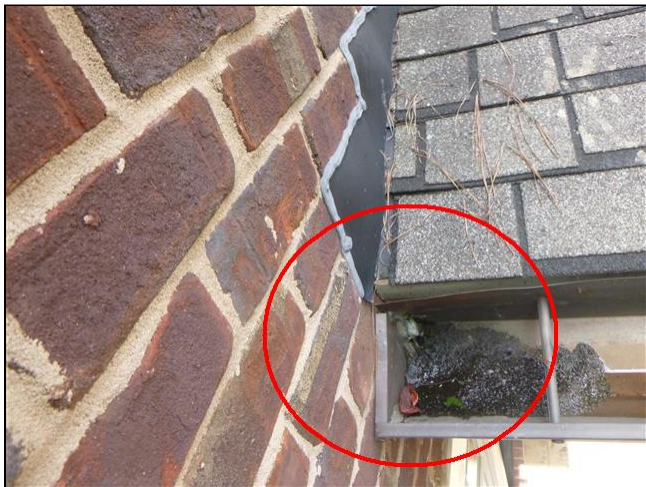
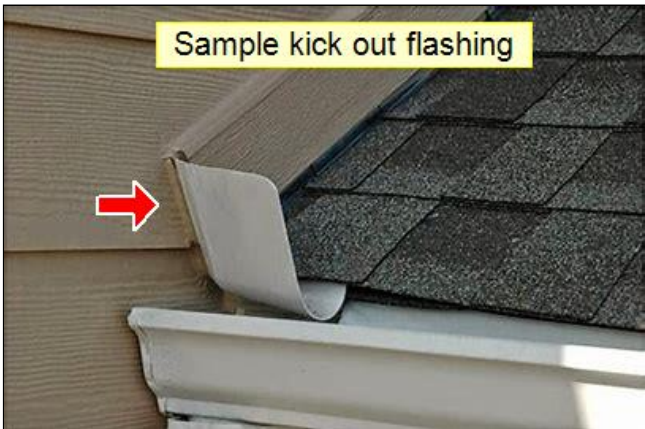
🔧 (2) Kick out flashing is needed were gutters terminate on siding. Kick out flashing directs water into the gutter preventing damage and staining to the siding below the gutters. Repair is needed by a siding professional.

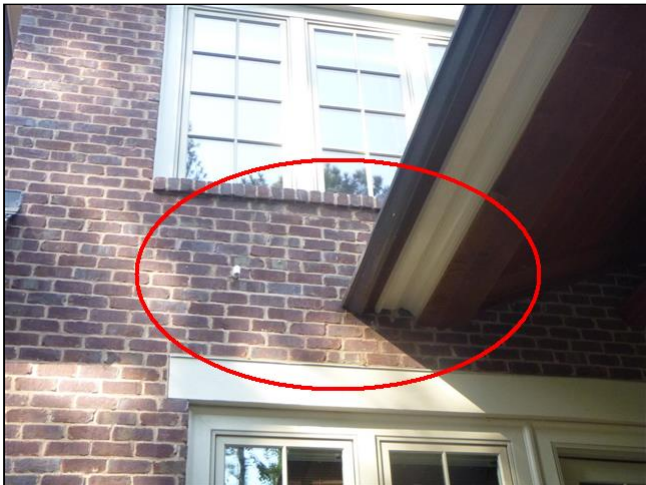
1.1 Item 4(Picture)

🔧 (3) There is a step crack in the brick veneer above the breakfast area window. This is not a structural concern. Recommend to have this area sealed as needed. See photo(s) for location.

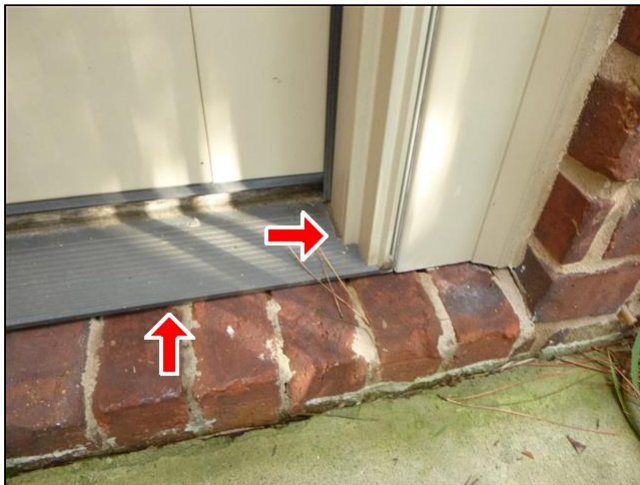
1.2 Item 1(Picture)

🔧 Recommend to seal the gap between the siding and the threshold of the exterior doors. Seal all miters where the brick mold meets the threshold to ensure that the area is water tight.

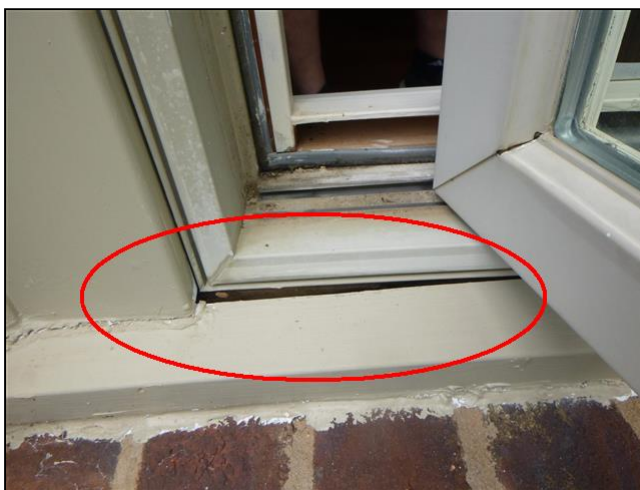
1.3 Item 1(Picture)

🔧 There is a loose trim piece along the bottom of the front window over the side entry. Repair as needed.

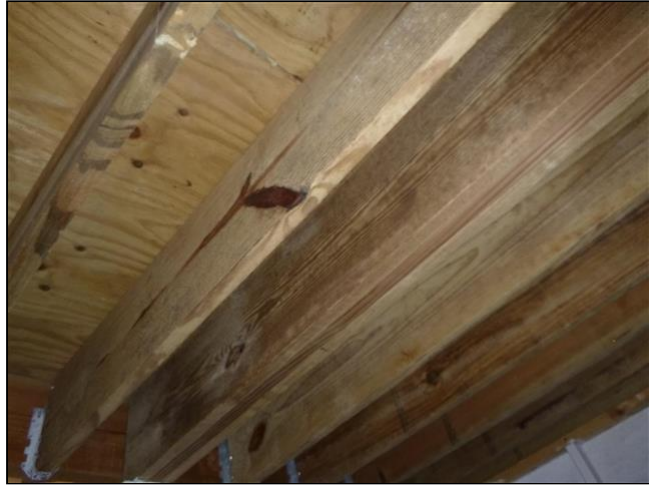
1.4 Item 1(Picture)

🔧 (1) Mold growth was observed in the storage room under the rear deck. This area should be cleaned by a mold abatement professional and ventilation improved.

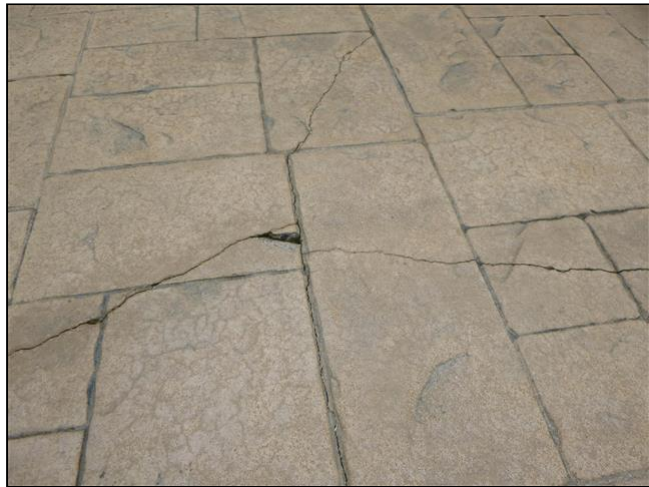
1.4 Item 2(Picture)

🔧 (2) Cracks on the rear deck slab are not wide enough to be considered a structural concern and are due to normal settlement and shrinkage of the concrete. Have patched as needed. This area should be periodically monitored to ensure that damage is not occurring to the surfaces underneath.

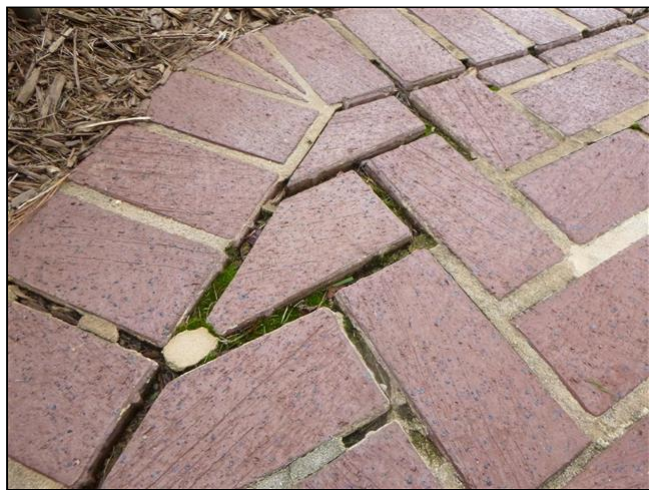
1.4 Item 3(Picture)

🔧 (3) Recommend to re-point all open mortar joints at the front walkway. This will help prevent further deterioration. See photo(s).

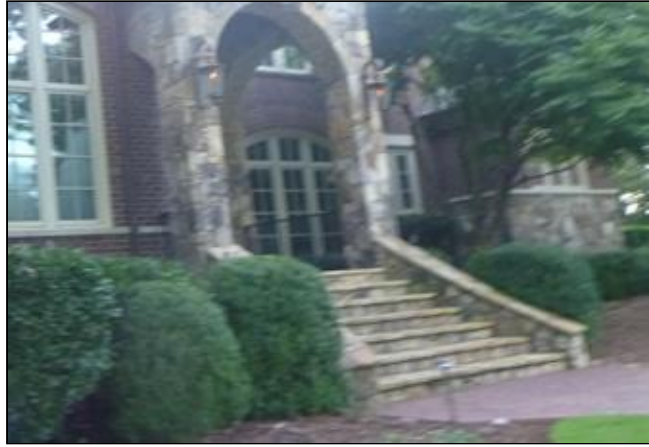
1.4 Item 4(Picture)

🔧 (4) Recommend to Install a handrail for the front porch steps. Hand rails are recommended for steps/landings that are 30 inches above the ground or with four or more risers.

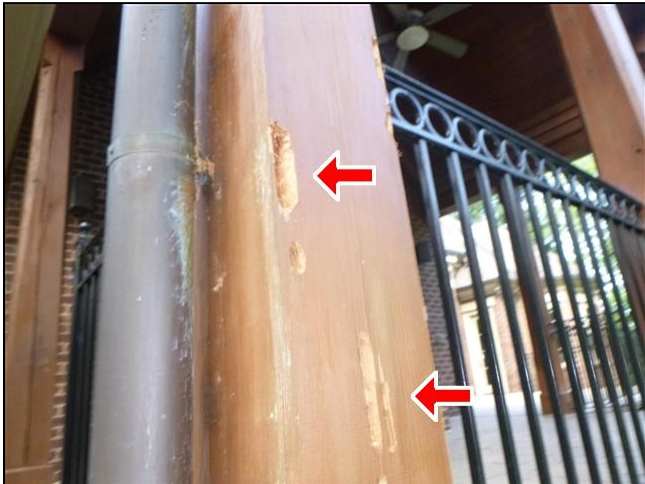
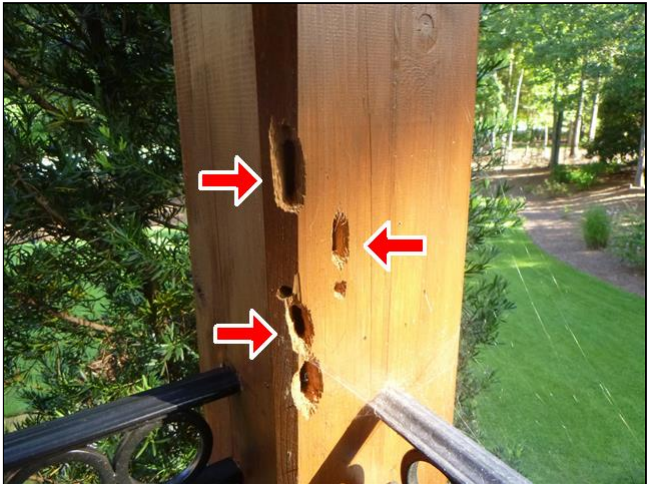
(7) Insect damage and some areas of moisture decay were observed on the rear deck columns. Repair is needed.

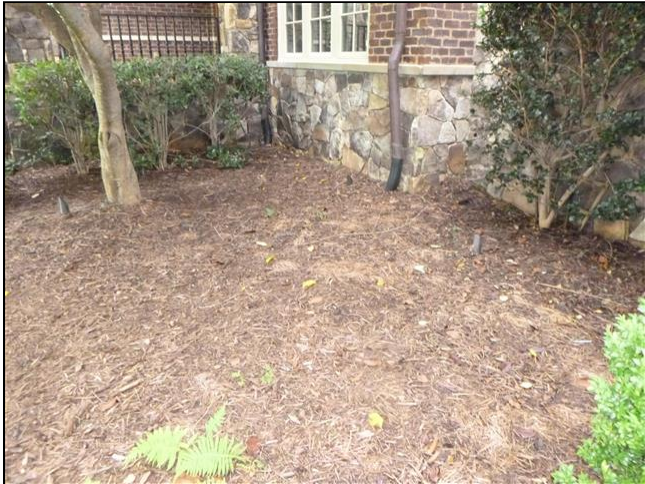
1.5 Item 1(Picture)

(1) There is a negative slope at the front of home and can cause or contribute to water intrusion or deterioration. Recommend correcting landscape to drain water away from home. Acceptable standards call for soil levels to drop a minimum of 6 inches in the first 10 feet away from the home.

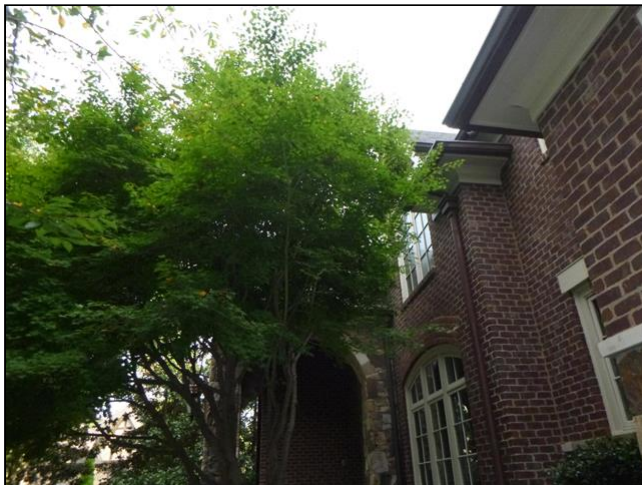
1.5 Item 3(Picture)

🔧 (2) The tree limbs that are in contact with roof or hanging near roof at the front of home and should be trimmed away. This will help prevent against rodent entry into the attic. See elevation photos for location.

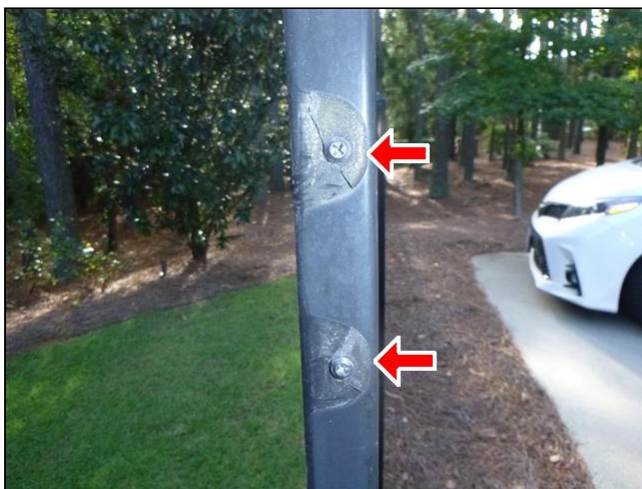
1.5 Item 4(Picture)

🔧 (3) The lock for the gate at the end of the driveway is damaged. Repair as needed.

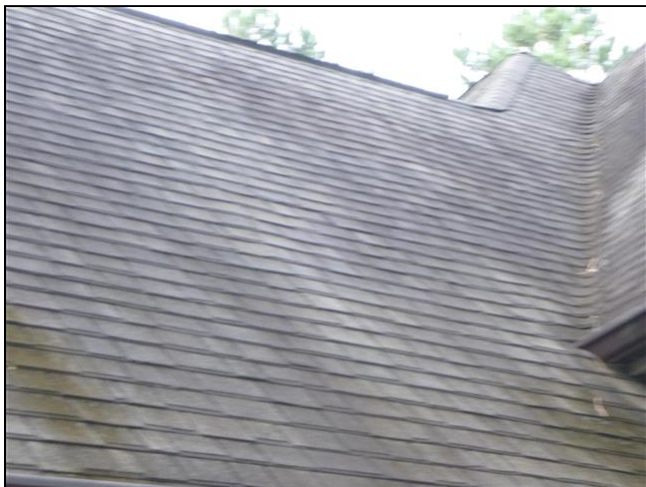
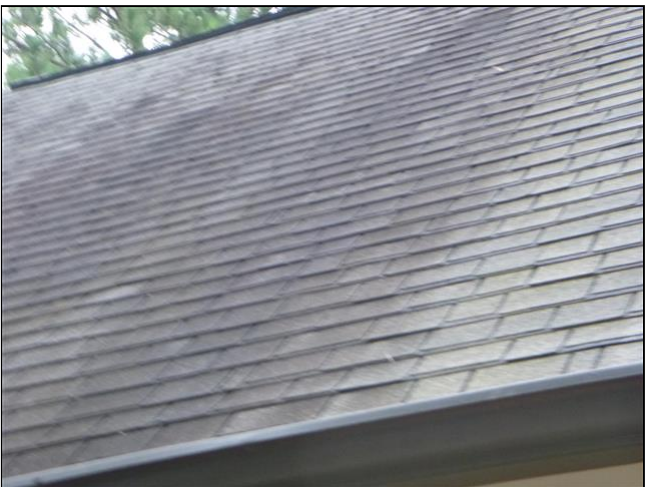
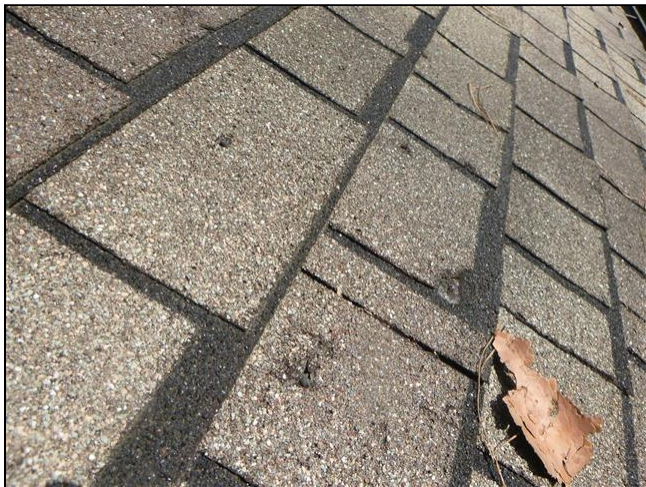
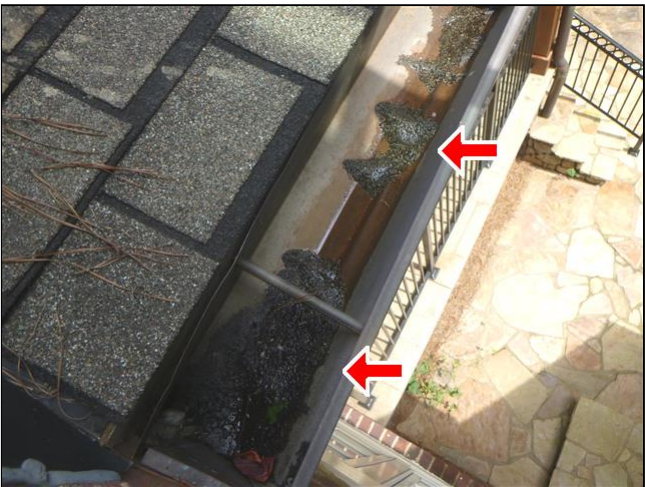
The shingles on the roof are showing signs of aging, damaged shingles were observed at the front and rear of the home, and there is an excess of granular material in the gutters. It is recommended that a roofing contractor further evaluate this situation.

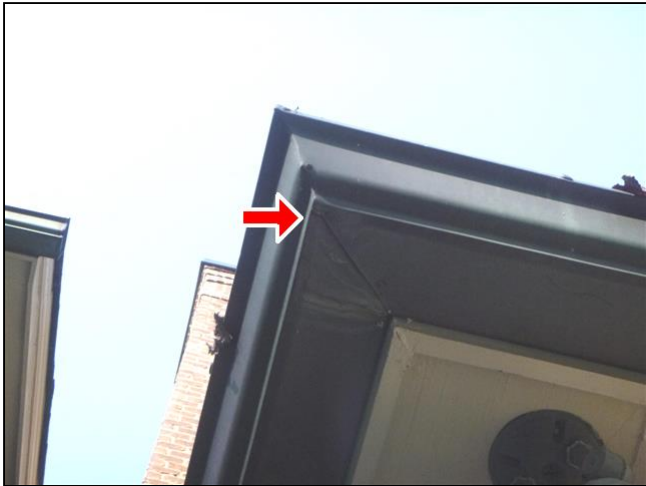
4.3 Item 1(Picture)

🔧 The gutter seam at the at several locations around the perimeter of the home were leaking at time of inspection. Recommend to have area properly sealed to help correct this issue. See photo(s) for location.

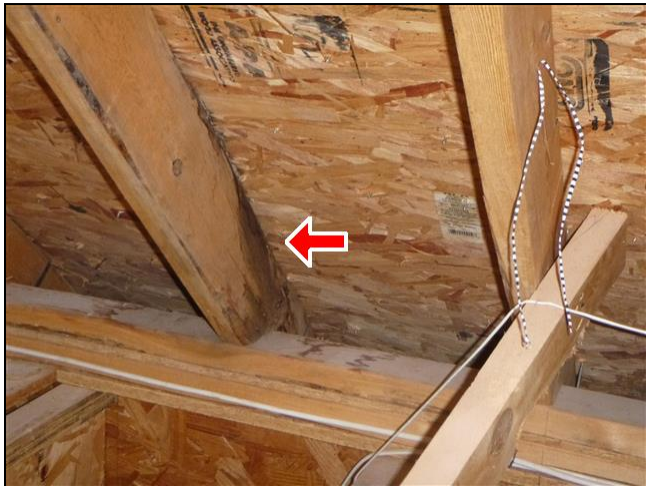
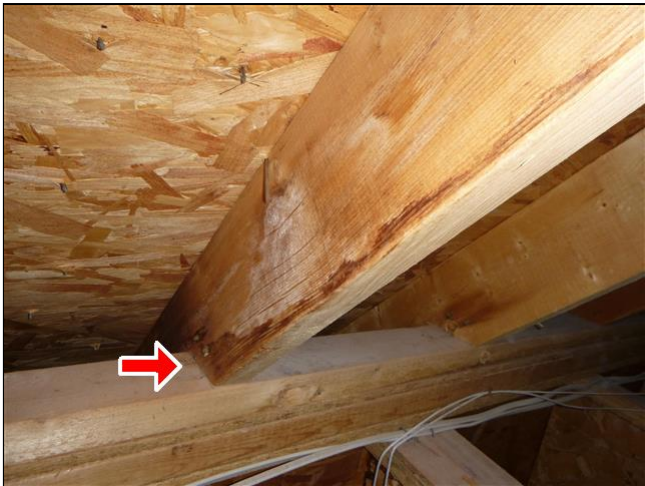
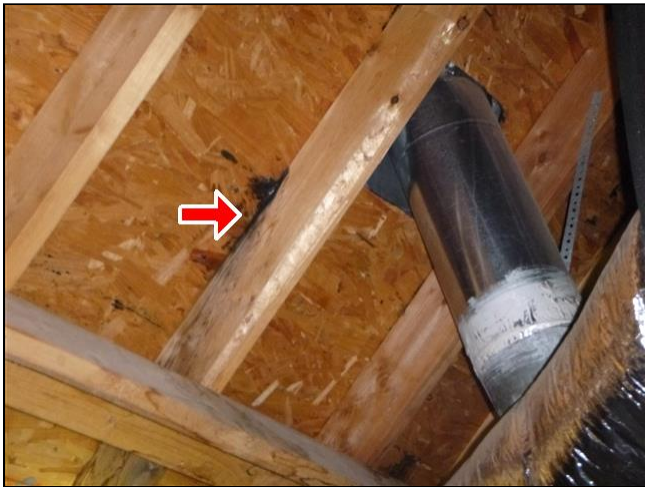
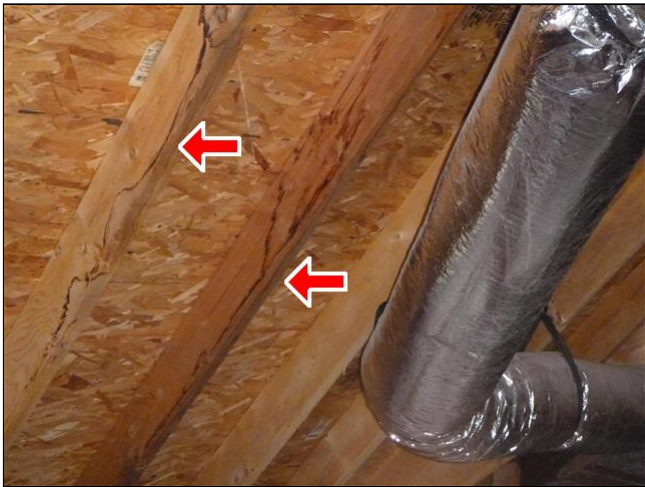
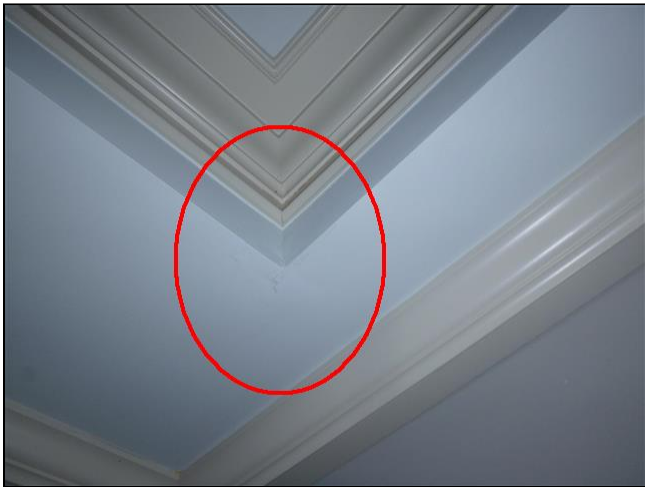
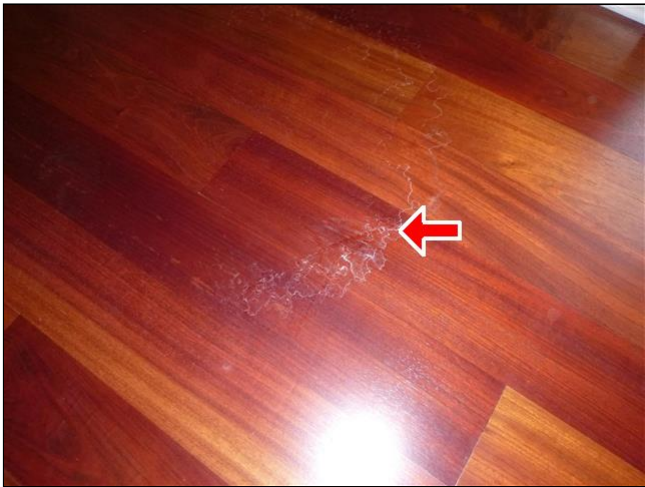
🔧 Water stains and possible slight damage noted on roof decking at multiple locations in the attic. Roofer will need to evaluate roof and ensure that the roof covering is water tight. Even though these areas may not have been wet during this inspection, it is possible that outdoor and weather conditions could change and cause leaks to become active again. See photo(s) for location(s). There are some stains in the front bedroom that could indicate roof leaks are current.

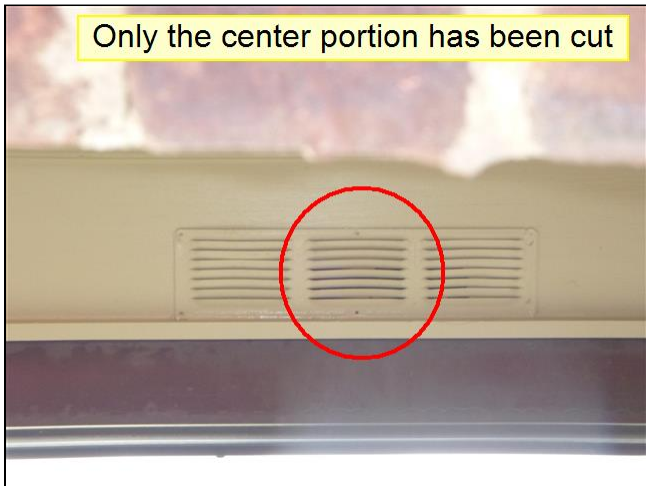
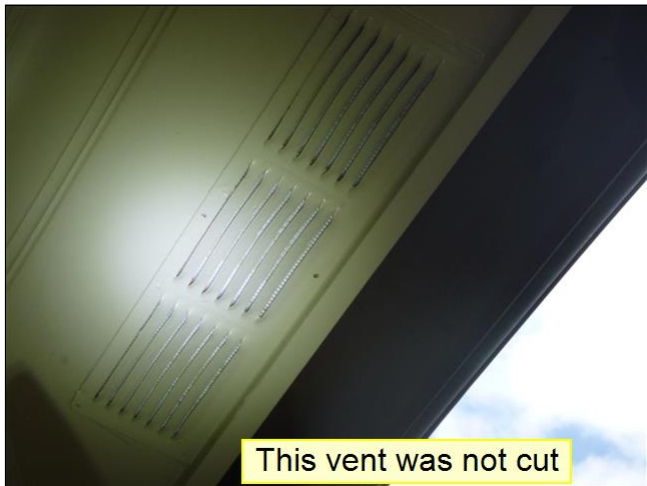
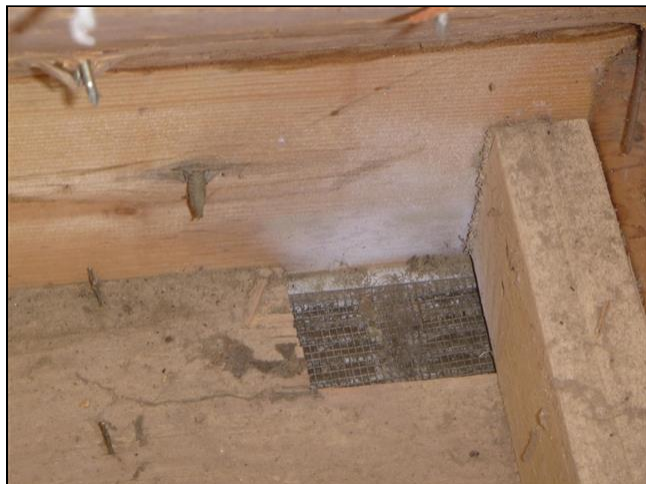
Many of the soffit vents have been undercut or were not cut at all creating inadequate ventilation for the attic. If the attic becomes too hot then the shingles may overheat prematurely. Increasing the ventilation to promote/maintain the life expectancy of the roof covering will be beneficial. Recommend to have roofing contractor inspect for further evaluation and make necessary repairs. See photo(s).

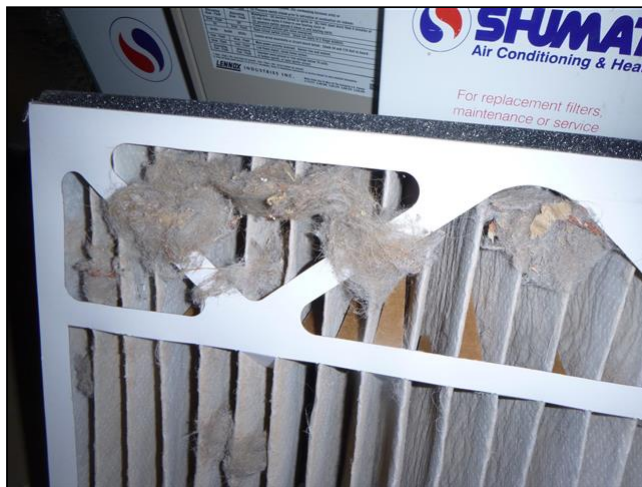
6.0 Item 1(Picture)

🔧 (1) Have an HVAC tech service the heating and cooling equipment to clean the blower motor, the evaporator coils, the condensing coils, the electrical contacts, check refrigerant levels, check size of units compared to size of home and ascertain that the heat exchangers are not cracked and the equipment is safe to operate and functioning properly. Most of internal parts of the HVAC system are concealed from view, and our inspection is visual and is intended to check the function of the systems. This inspection does not make any assessment of the internal parts of the air duct system, since it is not visible. Therefore, an HVAC tech should evaluate for any concealed defects or hazards in the system. Furthermore, manufacturers recommend annual maintenance and servicing to keep the system working at peak efficiency.

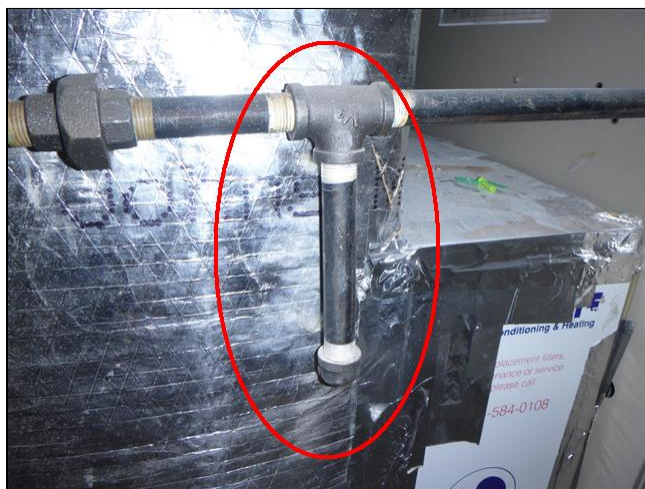
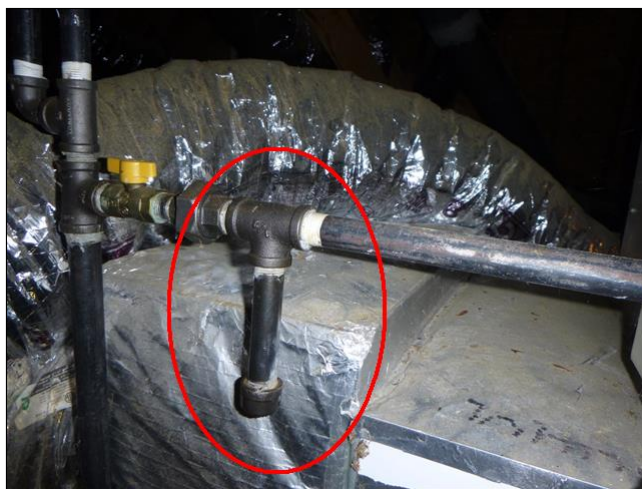
🔧 (3) The "T" connector for the furnace gas line is installed horizontally. This was permitted when the home was built, however, does not meet current standards and the gas company may not turn on the gas with the current gas line configuration. Recommend to have an HVAC contractor examine and repair as needed. See photo

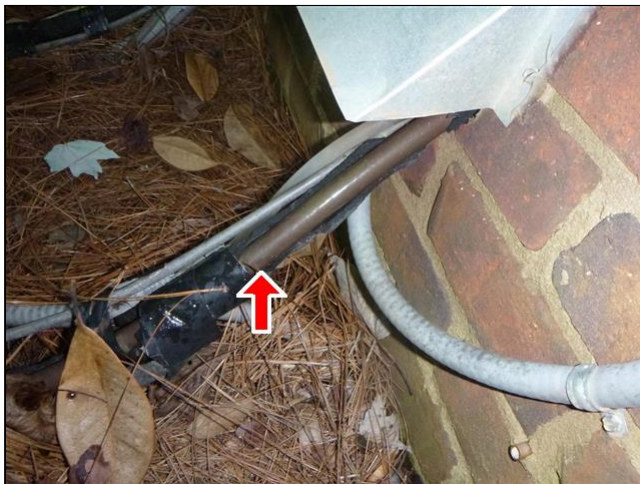
6.6 Item 1(Picture)

🔧 (3) Re-insulate the open portions of the A/C lines between the unit and the siding. This will help maintain energy efficiency.

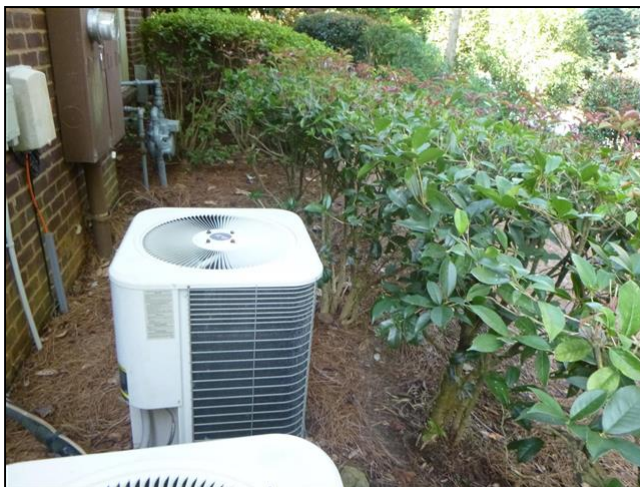
6.6 Item 2(Picture)

🔧 (4) All the vegetation around the air-conditioners should be trimmed back. Manufacturers recommend 2 feet of clearance for maximum efficiency.

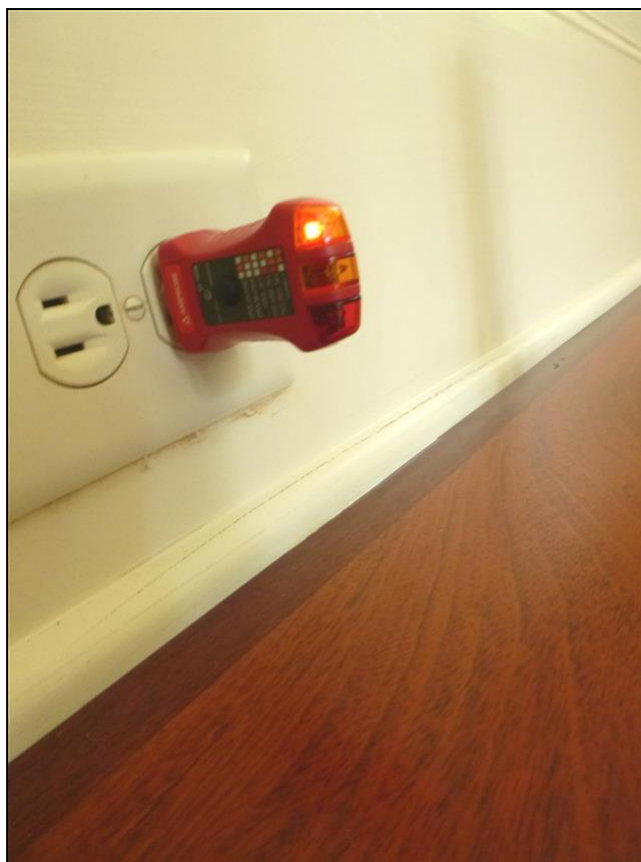
7.5 Item 1(Picture)

🔧 (1) All the receptacles in the master bedroom tested as having an open neutral. This condition needs to be repaired by a licensed electrical professional.

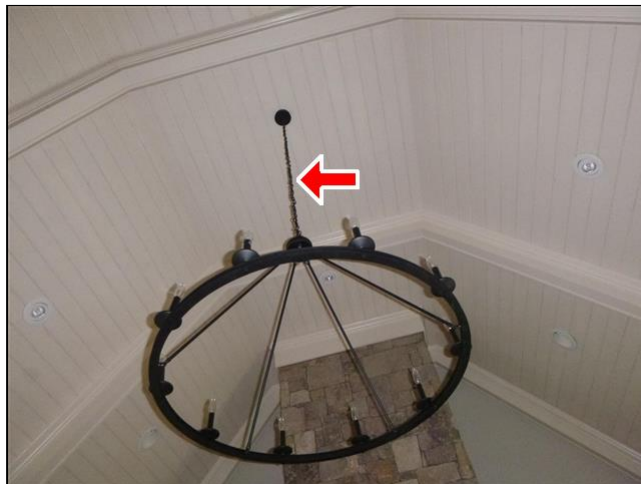
7.5 Item 2(Picture)

🔧 (4) The light fixture in the keeping room and in the master bathroom are being supported by the electrical wire. The chain should be shortened to avoid tension on the electrical wire.

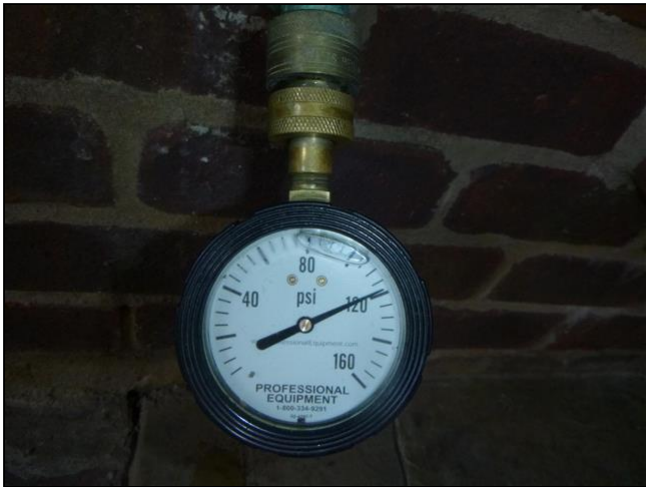
8.1 Item 1(Picture)

🔧 (1) The water pressure was tested at the rear exterior faucet and measured 120 Psi. Homes should maintain between 40-80 Psi. The current water pressure is elevated. The Pressure Reducing Valve (PRV) may need to be adjusted or replaced..

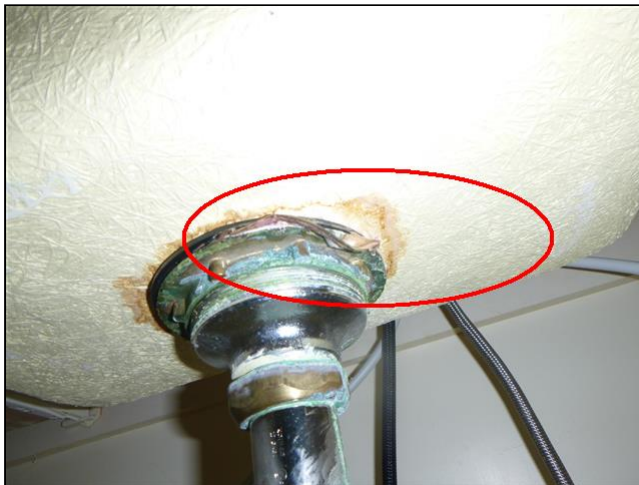
8.2 Item 1(Picture)

🔧 (1) The drain gasket under the laundry room sink is damaged. The area was dry, but indications are that it has leaked in the past. Repair as needed.

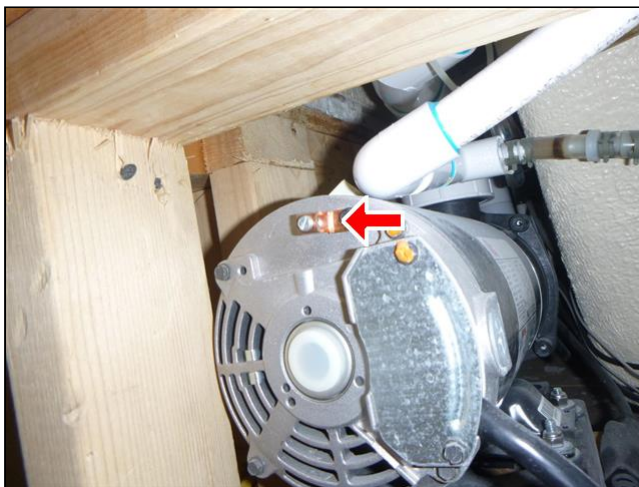
8.2 Item 2(Picture)

🔧 (4) The pump for the Jacuzzi is not grounded. When a grounding lug is provided by the manufacturer a ground wire should be installed. Recommend repair by licensed electrical professional.

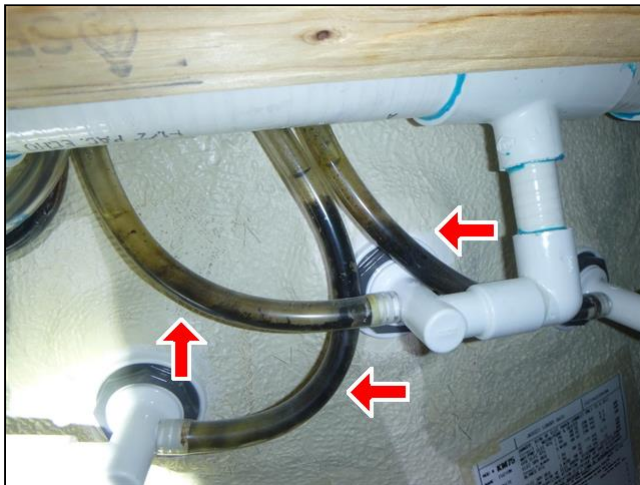
8.2 Item 3(Picture)

- 🔧 (5) The hoses for the Jacuzzi tub are visibly dirty. Recommend having the system cleaned as needed.

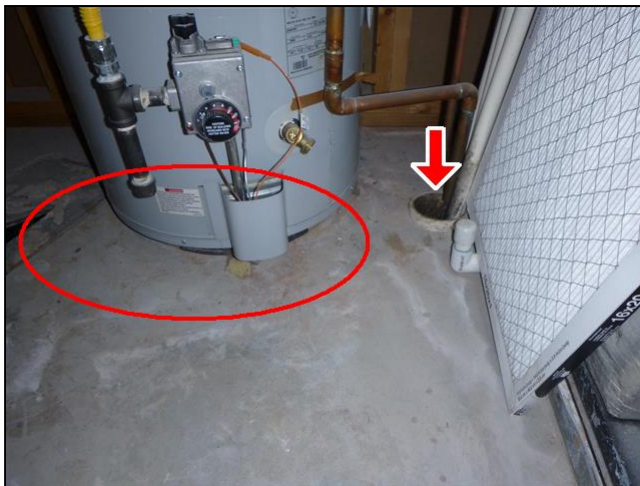
8.3 Item 1(Picture)

- 🔧 (2) Recommend to install a drain pan under the water heater to prevent water damage to the surrounding areas. This pan should be piped to a safe location or to the exterior. In this case the floor drains could be utilized.

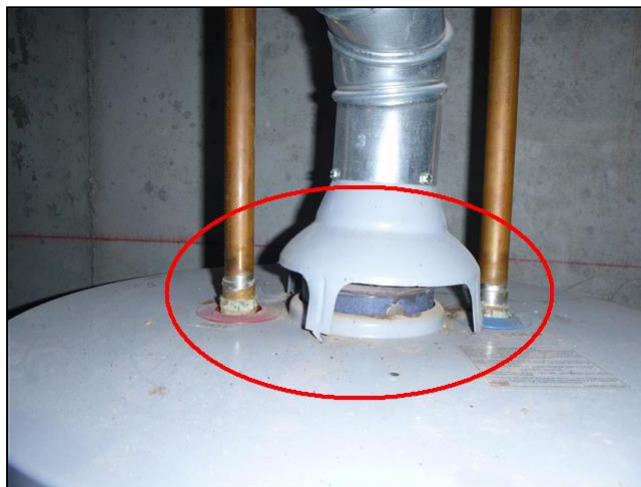
8.3 Item 2(Picture)

- 🔧 (3) Secure the loose hood vent to the water heater in the basement. This is necessary to prevent carbon monoxide from entering the home.

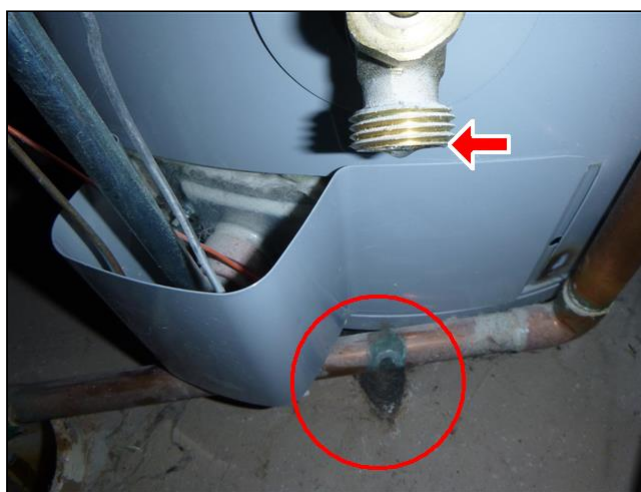
8.3 Item 3(Picture)

- 🔧 (4) The water heater on the right side of the basement is leaking at the drain. Repair as needed.

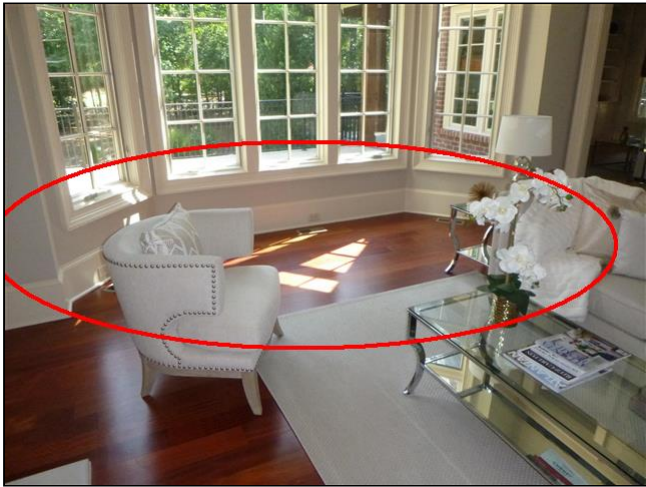
9.2 Item 1(Picture)

The rear bay area of the family room was excessively squeaky. Have this condition evaluated by flooring professional.

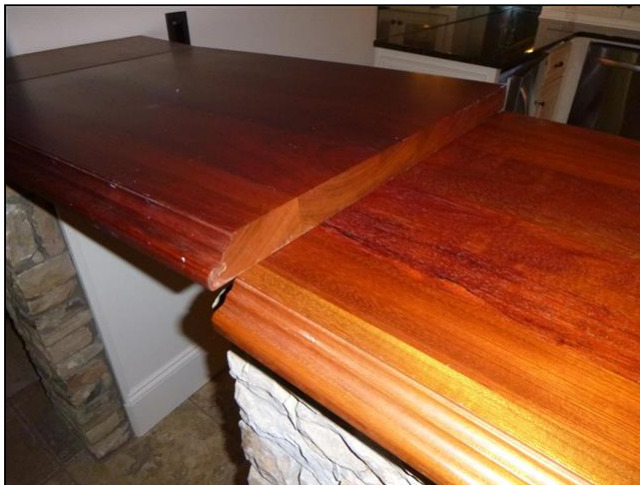
9.4 Item 1(Picture)

🔧 The flip top portion of the basement bar countertop is out of alignment. Adjust as needed.

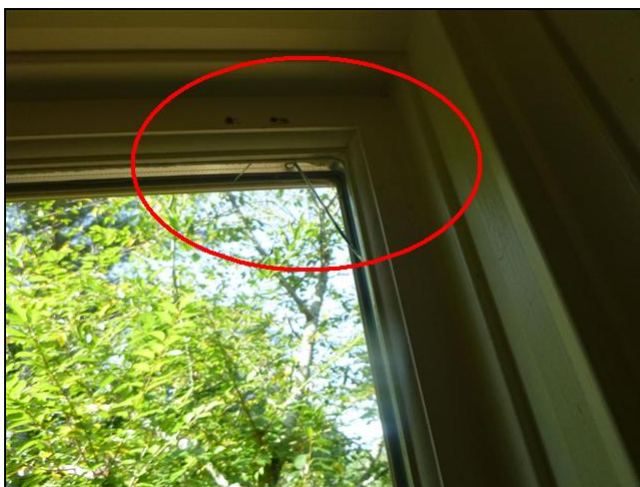
9.6 Item 1(Picture)

🔧 (1) Recommend to replace the cracked glass window in the Laundry room.

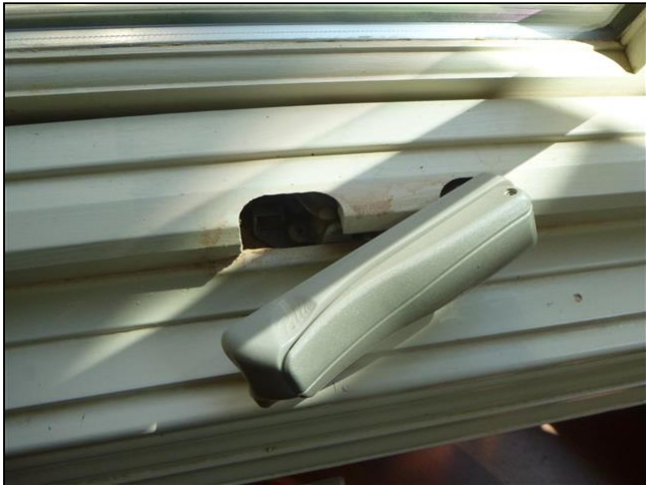
9.6 Item 2(Picture)

🔧 (2) The hand cranks on several windows were loose. Repair is needed.

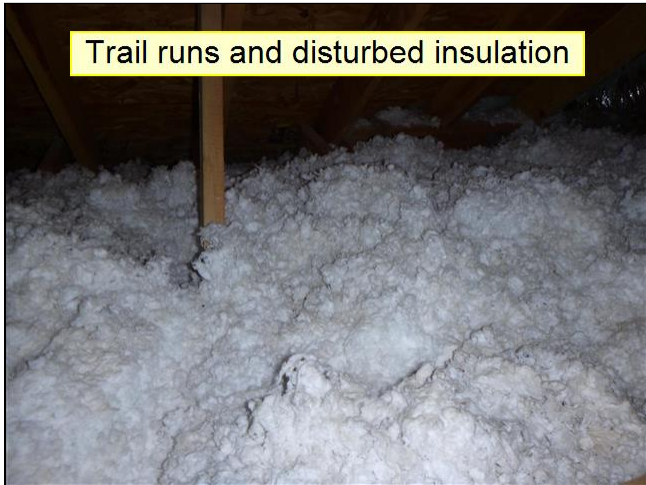
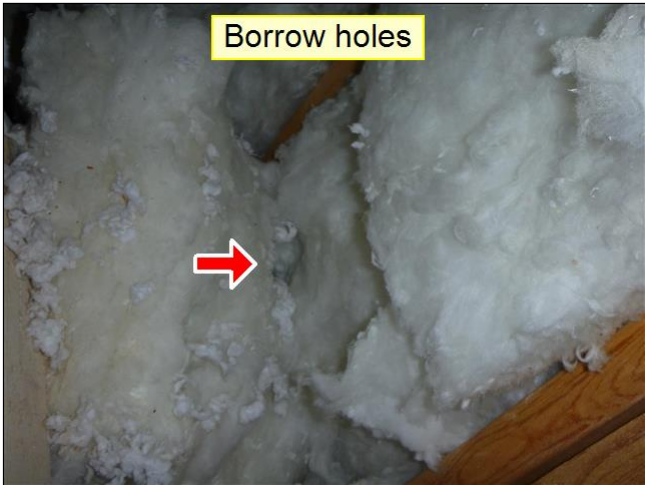
🔧 There is evidence of rodent activity in the attic. Have this situation further evaluated by nuisance wildlife control operator and have all areas of the home sealed off.

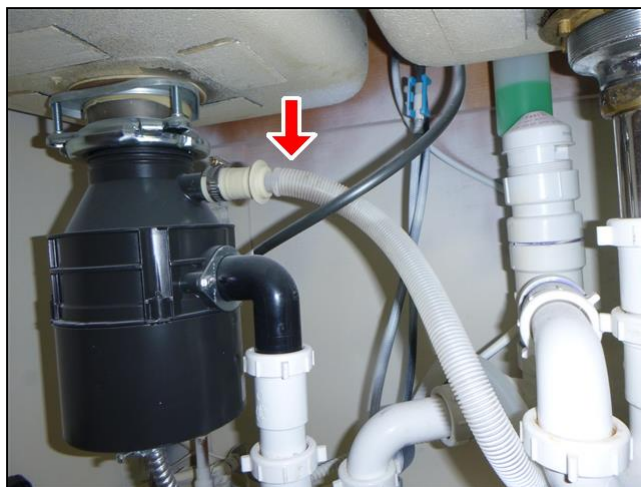
10.0 Item 1(Picture)

🔧 (2) The drain line for the dishwasher is not installed properly. This line should loop above the sink drain line to prevent potential garbage and debris from entering in to the dishwasher. Have appliance repair man inspect and make necessary repairs. See photo.

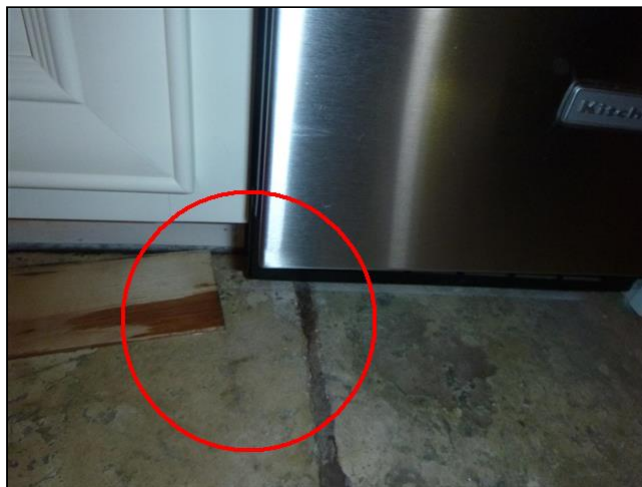
10.5 Item 1(Picture)

🔧 The icemaker in the basement was leaking at the time of inspection. Repair as needed.
