Home Inspection Report

Hiren Patel
1030 Patriot Trail Cumming, GA 30040

Inspection Date: 8/27/2020

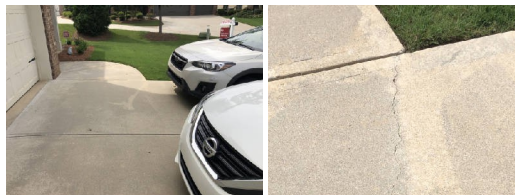
Driveway: | -

1. Various Surface Cracks: No visible concern noted, but it is recommended to monitor the observed conditions for changes.

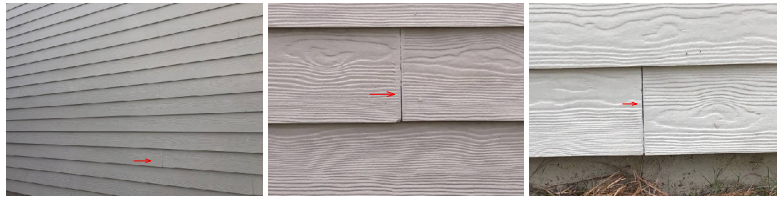
1. Gaps Between Panels: The cement fiber siding panels appeared to have gaps at the vertical seams. This is mostly cosmetic. However, these gaps should be sealed to prevent water intrusion.

It is recommended to have a qualified contractor evaluate all observed conditions and properly repair or replace as needed.

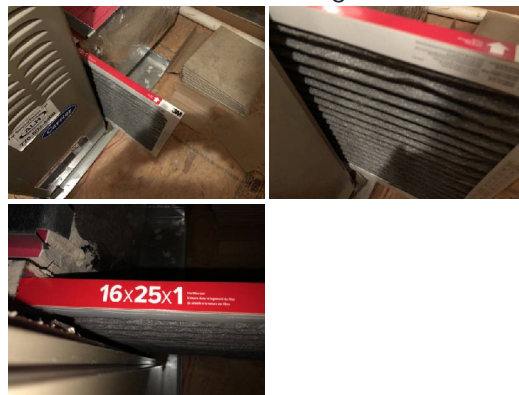
18. Repair/Replace/Maintain, Ongoing Maintenance Filter: | -

1. Change Filters: It appeared that the Filters were existing beyond useful life and should be replaced. It is recommended to change all Filters at least every three months or as recommended by the manufacturer of the individual filter being used.

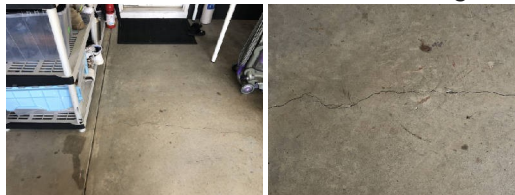
| 7. Cosmetic Defect | Floors: -

Cosmetic Defects:
1. The garage floor had various surface cracks. It is recommended to monitor the observed conditions for changes over time. |

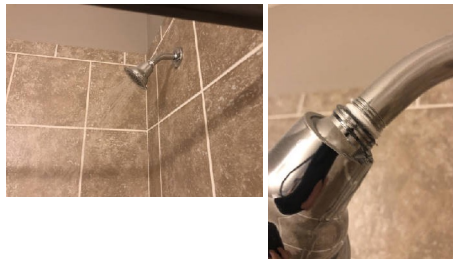
| 4. Repair/Replace/Maintain | Faucets/Drains: -

Repair/Replace/Maintain:
1. Active Drip When On: Various faucets had an active drip from joint connections when the water was turned on.
- 1st floor shower

2. Loose Faucet: Various faucets were loose at the time of the inspection.
- 2nd floor Jack & Jill bathroom |

It is recommended to have a qualified contractor evaluate all observed conditions and properly repair or replace as needed.
