Inspection Report

Property Address:
3336 Grand Villas Loop
Gainesville GA 30506

Dana Inspection Services, Inc.

Date: 8/11/2020		
Property: 3336 Grand Villas Loop Gainesville GA 30506	Customer: Carol Lowenthal	Real Estate Professional: Andrea Kenny Ansley Atlanta Real Estate

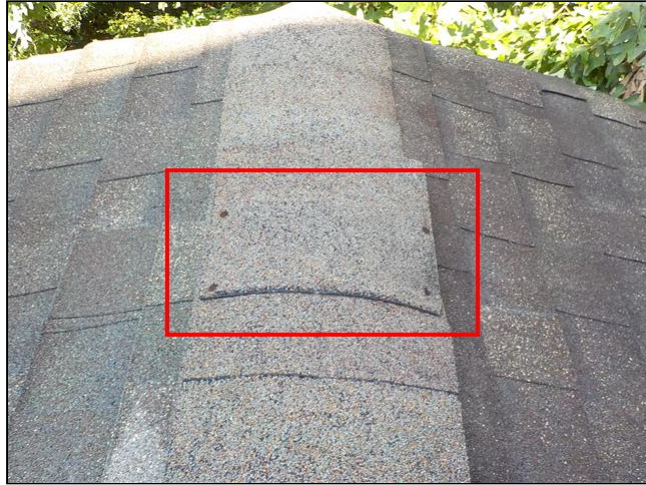
Exposed nail heads were observed on the covered porch shingles.

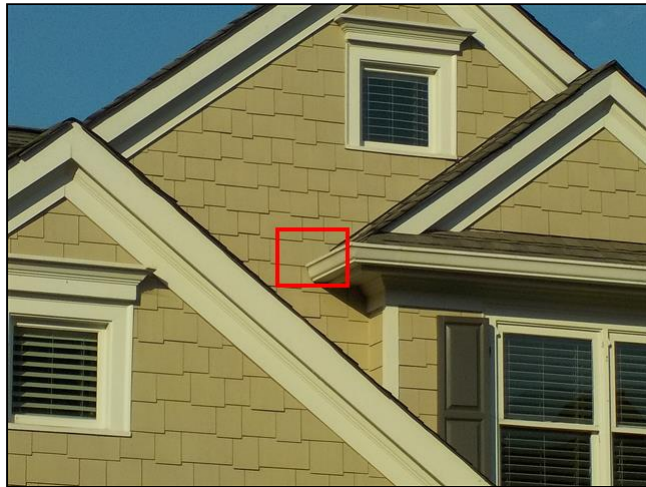
Kickout flashing is missing at the front roof/sidewall transitions. Have all similar areas further evaluated and repaired where needed by a qualified roofer.

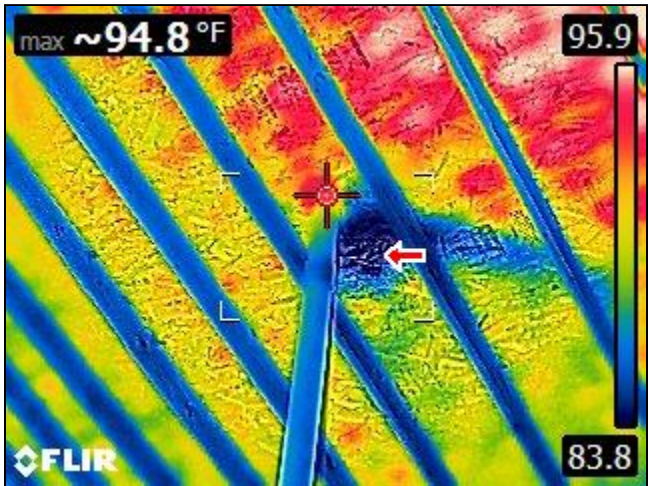
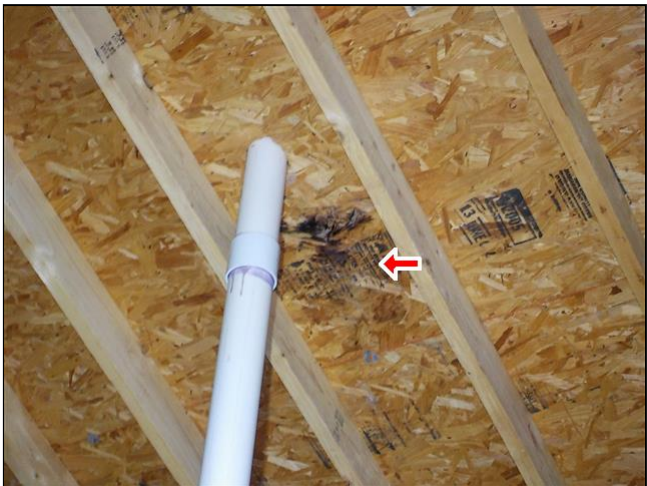
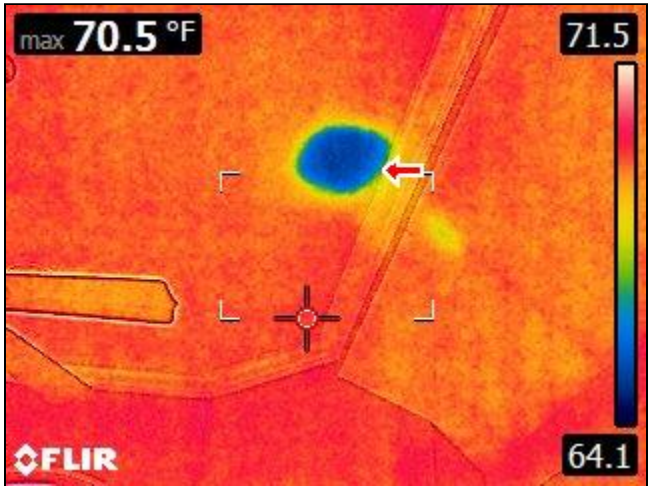
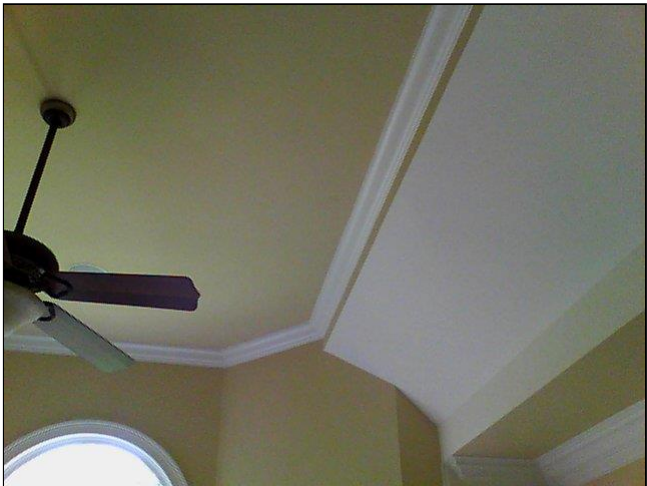
Active leaking was detected at the plumbing vent above the master attic. Have the roof further evaluated by a qualified roofer and repaired where needed.

Thermal image of wet roof decking

Thermal image of water dripping onto master ceiling from the leak

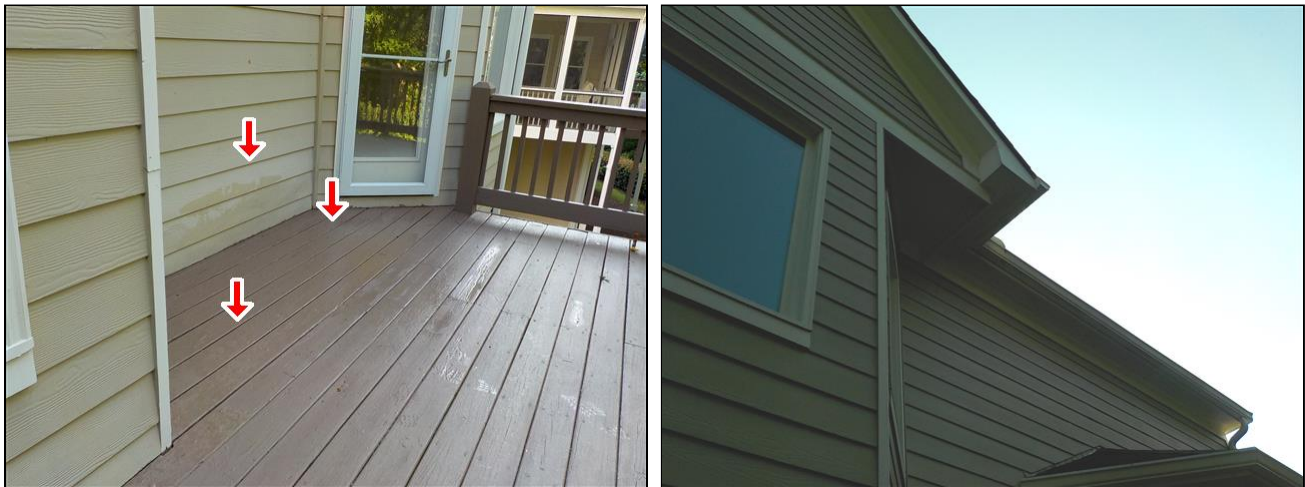
Excessive wetness was observed on the back deck against the house, which may indicate the gutters are not performing as expected. Have the gutter system further evaluated and repaired as needed by a qualified gutter company.

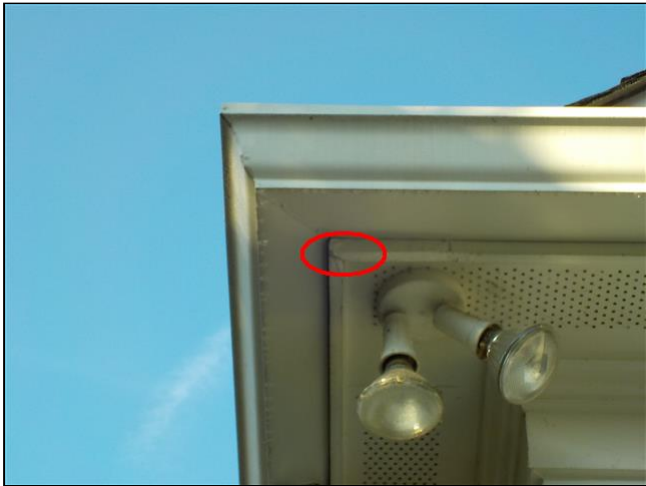
(1) Suspect wood rot was observed on the fascia board at the front left corner of the house.

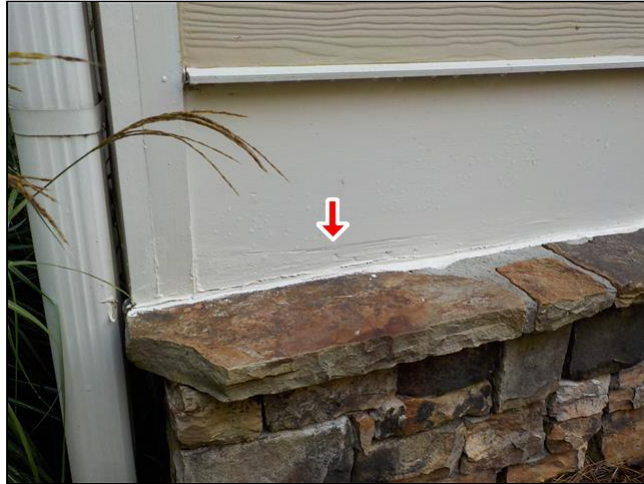
(3) A small area of wood rot was observed on the band board at the exterior left side of the house at the back corner.

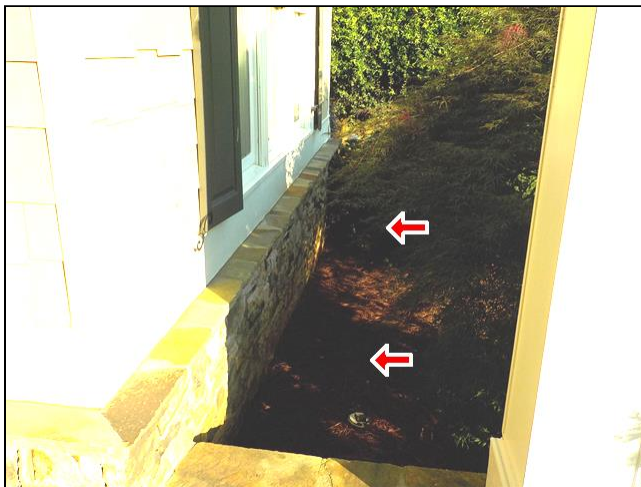
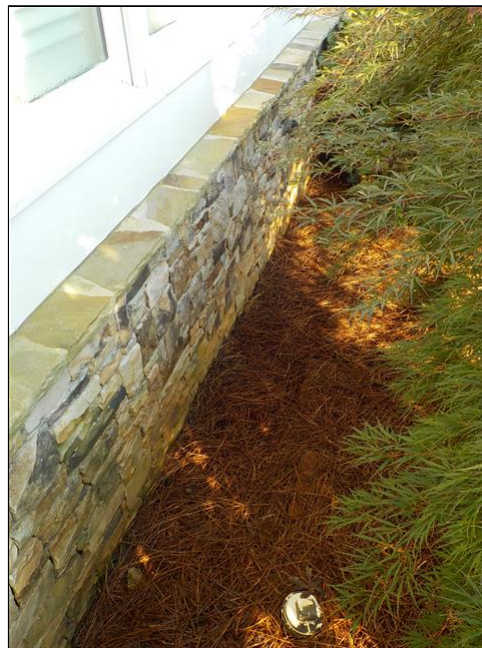
(1) There is a neutral to negative grade at the front right of the house that may place excessive amounts of moisture up against the foundation. It is recommended to modify the grading to create a positive slope away from the house and foundation.

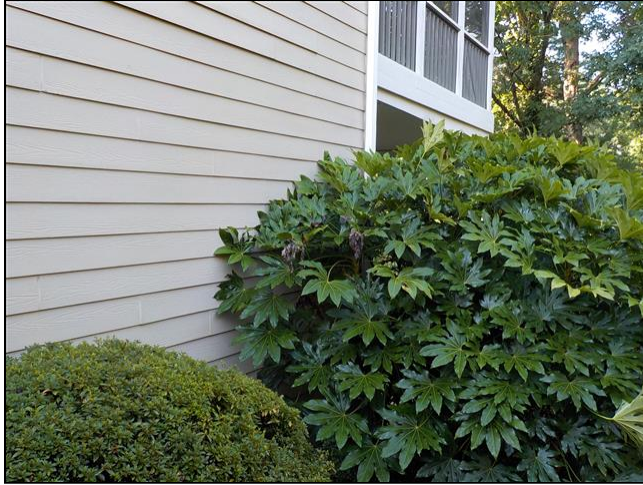
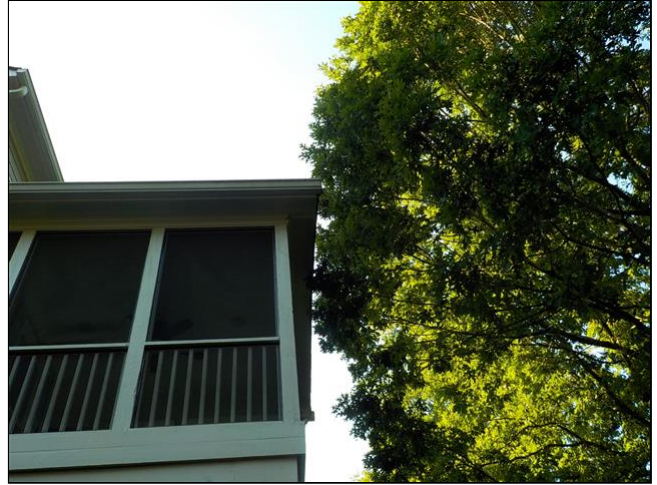
(2) All vegetation in contact with the house or roof should be cut back or removed.

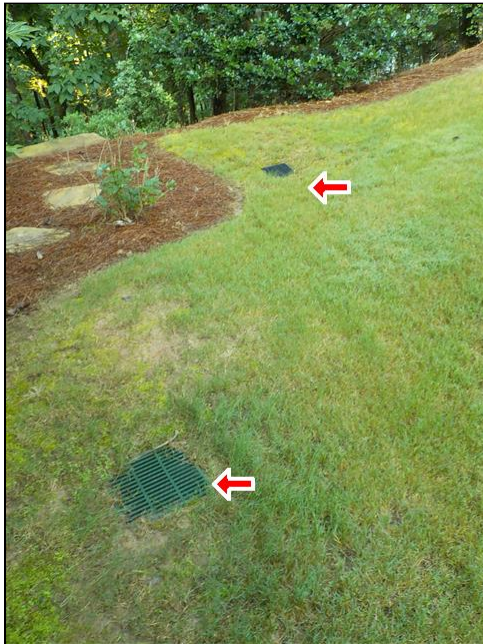
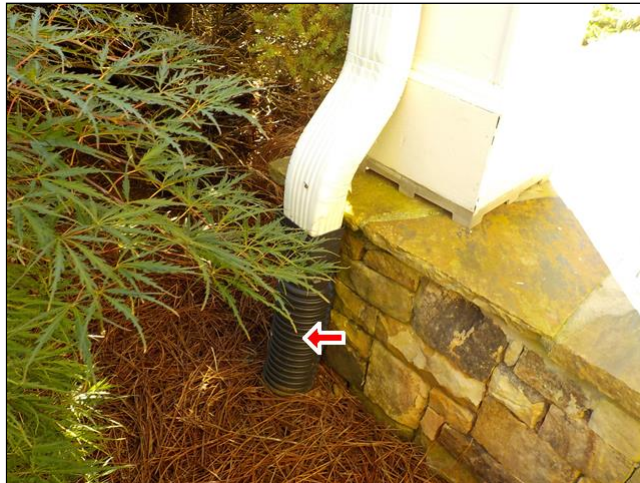
(3) In-ground downspouts and yard drains were observed around the house but are not tested as part of the inspection.

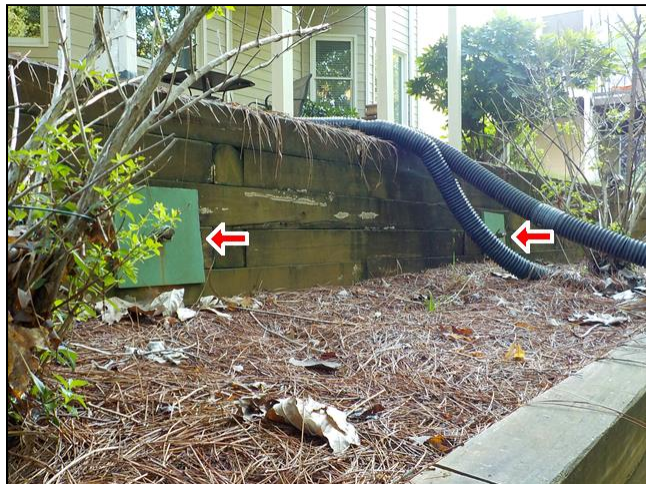
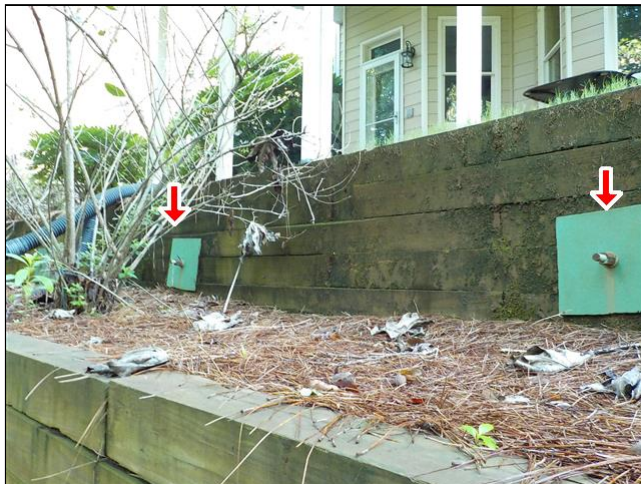
(4) Structural repairs are evident at the upper wooden retaining wall at the back of the house. Contact the seller for repair info and documentation.

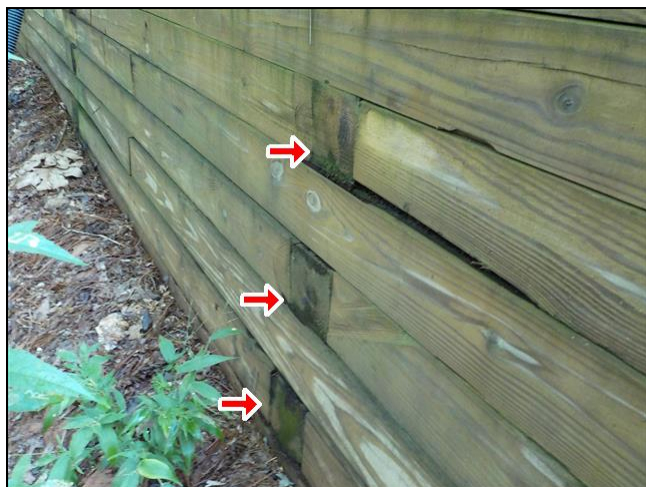
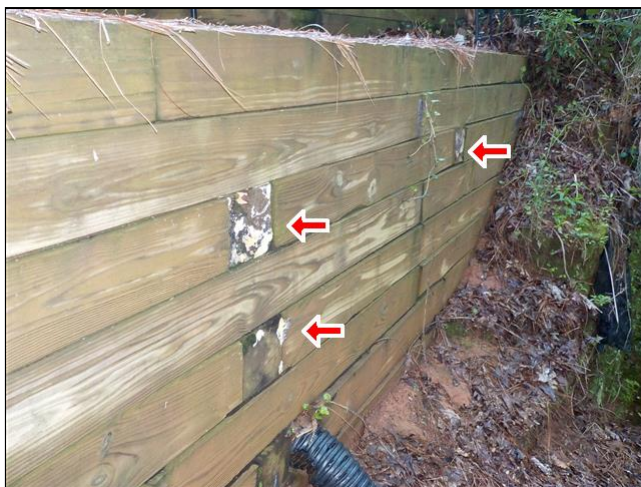
(5) The lower wooden retaining wall shows signs of deterioration at the "deadmen" but was in satisfactory condition in general.

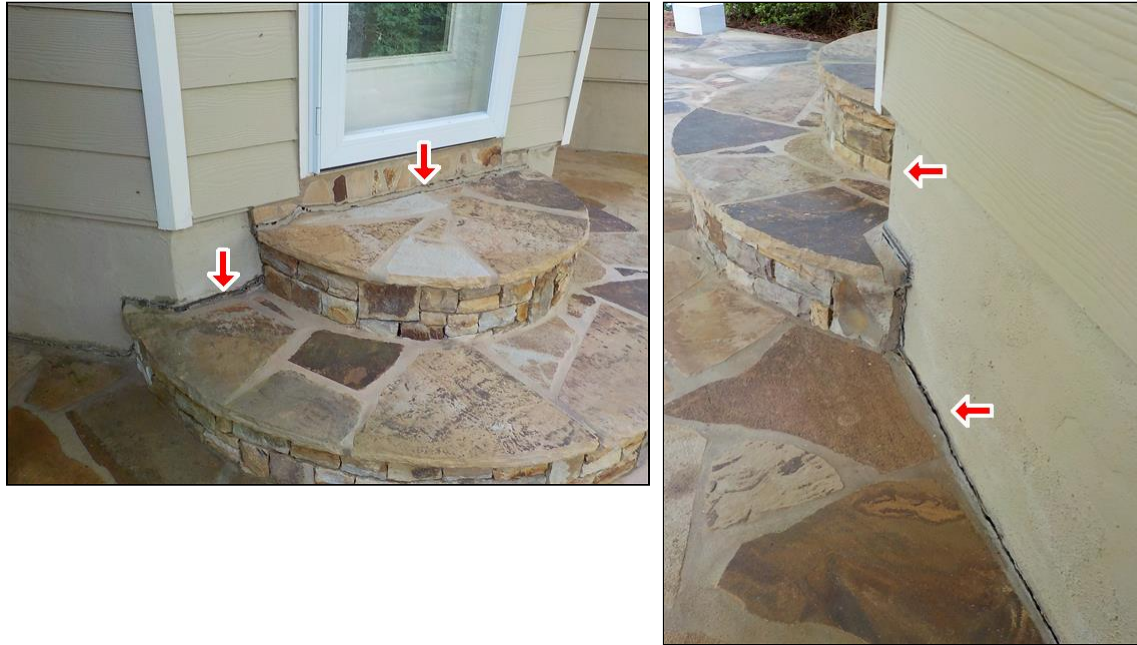
(6) The back patio and steps show signs of settling where a gap has developed between them and the house.

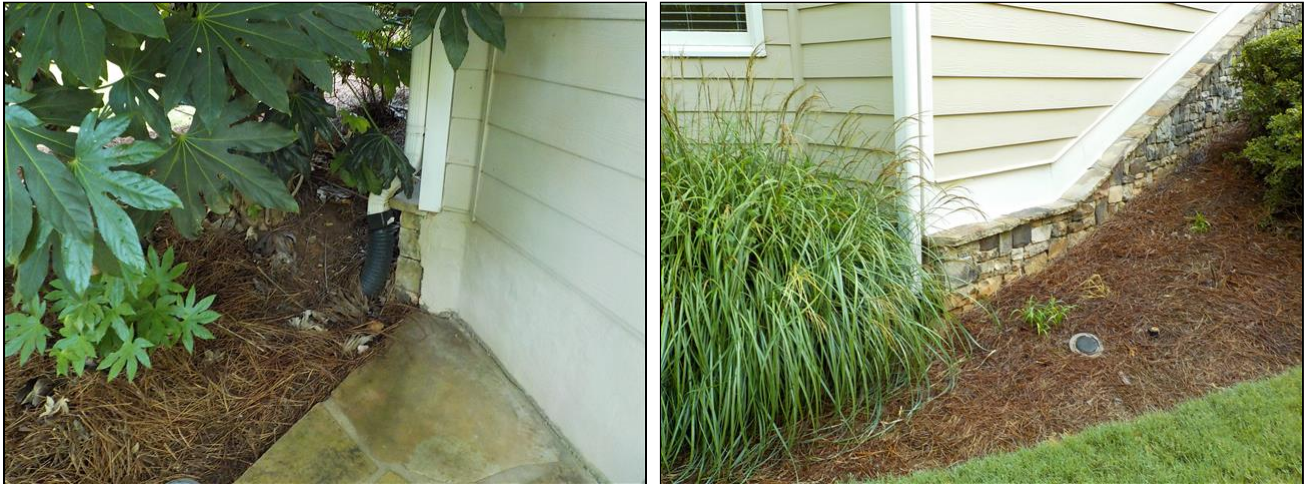
I was unable to locate where the foundation drains terminate at the back two corners of the house.

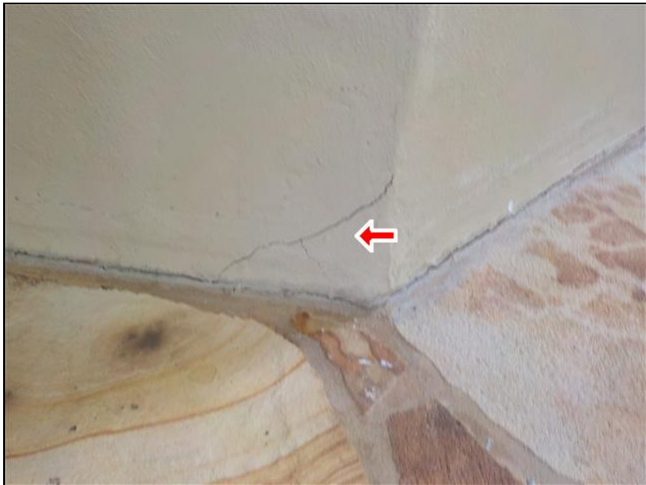
Cosmetic cracking of the parge coat was observed at the back patio on the foundation.

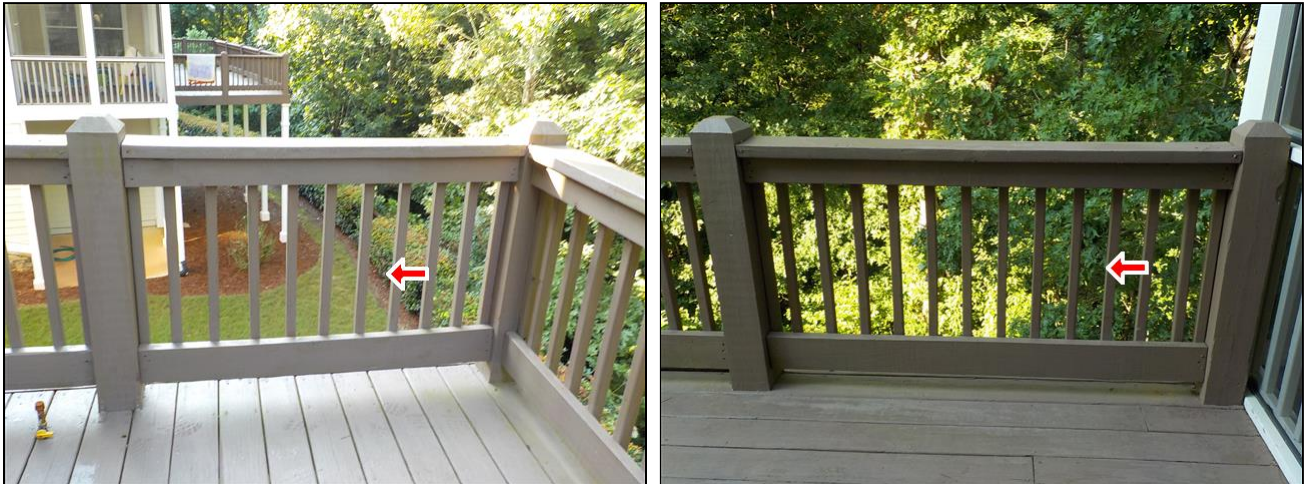
Many of the deck railing balusters are loose, creating an unsafe condition for children. Have the railing further evaluated and repaired where needed.

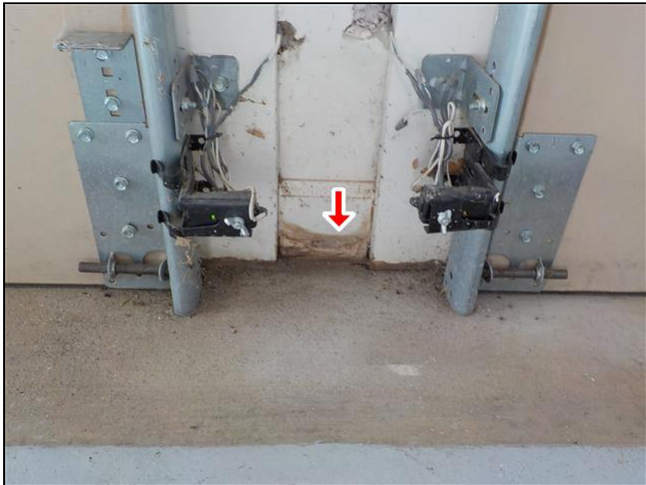
Common staining was observed on the wall between the garage openings. Monitor for any future water penetration.

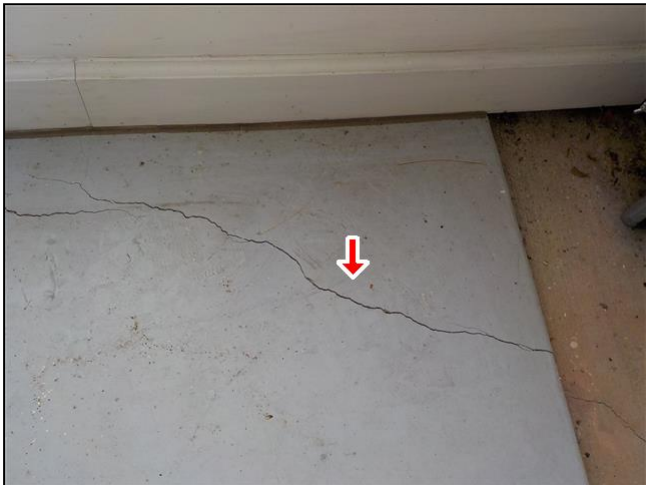
Common curing or settling cracks were observed on the garage floor.

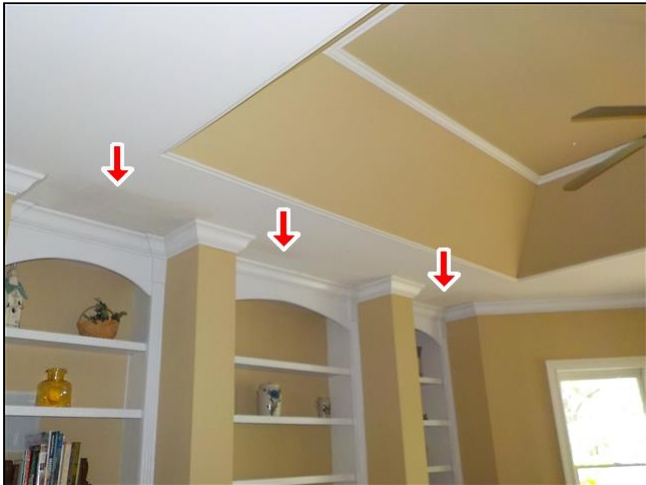
Repairs are evident in the basement family room under the fireplace. No active leaking was observed. Contact the seller for more info.

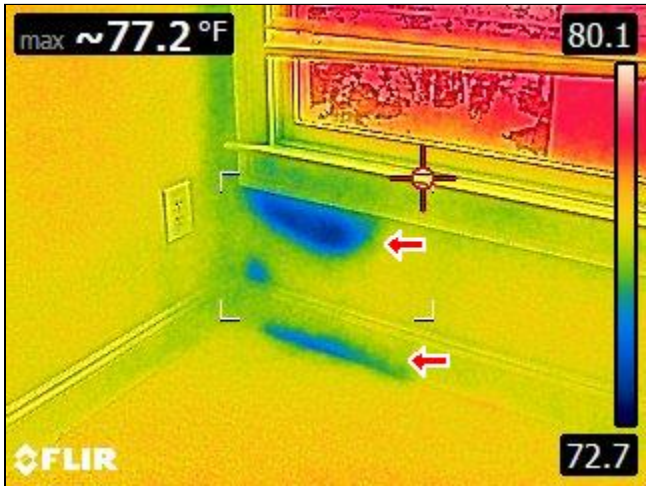
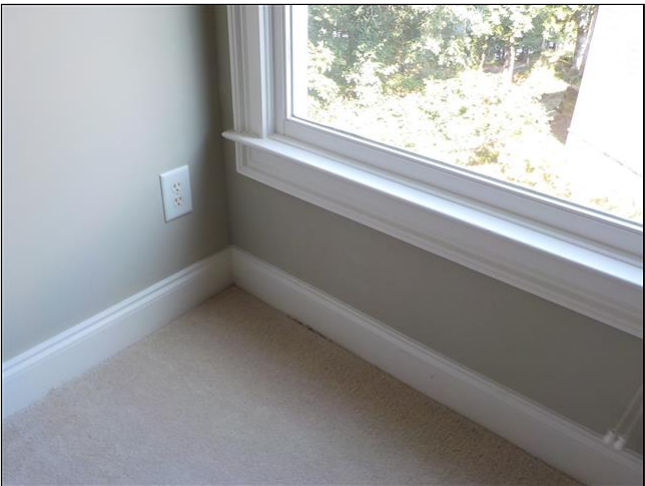
(1) Using an infrared camera, active water penetration was detected through the wall and window area of the 2nd floor back guest bedroom. The dark colors in the thermal image tested positive for high levels of water. Have the exterior further evaluated and repaired as needed. Other stains were also seen below the back windows, but these areas were dry.

Thermal image of wet area

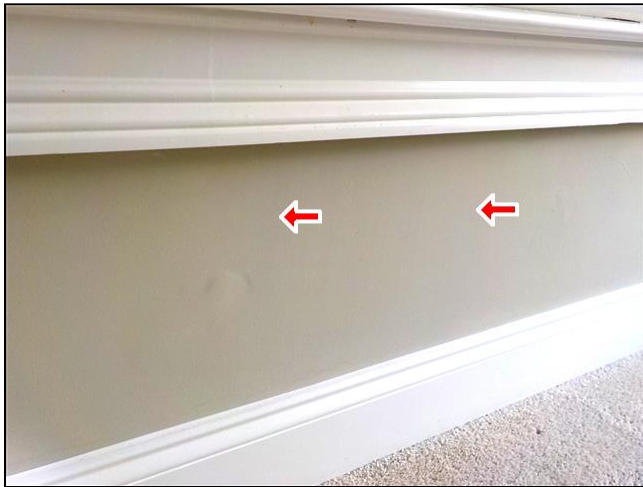
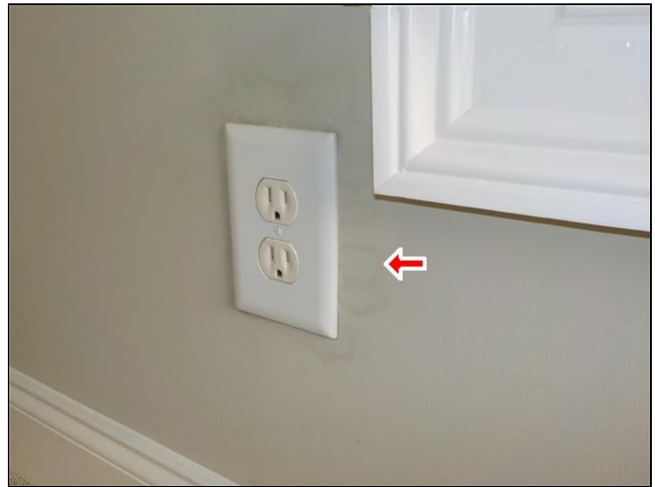
Other stains (dry)

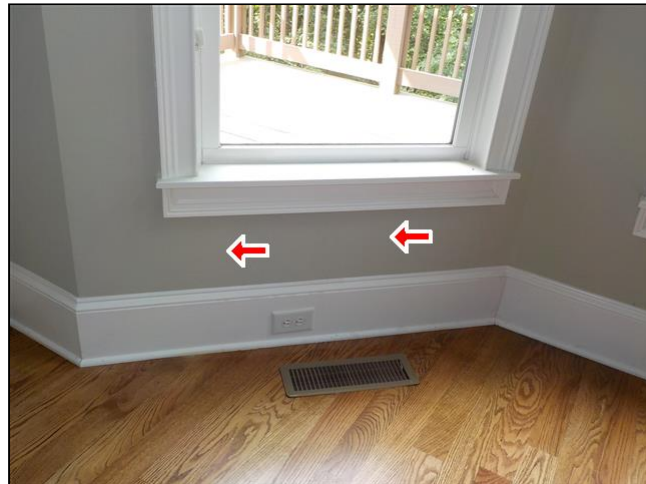
(2) Water stains were observed on the wall under the family room window but they were dry at the time of the inspection.

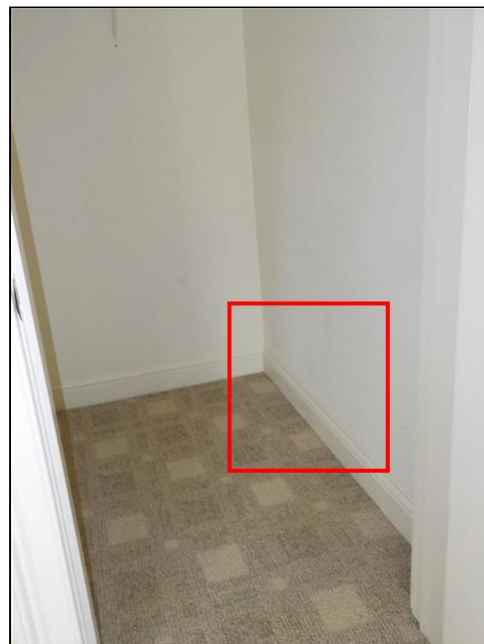
(3) Mold-like substances were observed on the wall in the basement closet. This area is being swab tested, and the basement is having an air sample test being done. Refer to that report for more info.

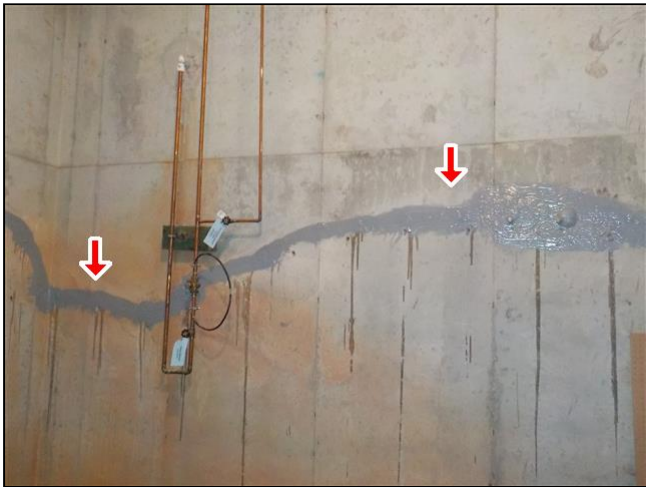
Professional-looking repairs were observed on the foundation wall in the basement.

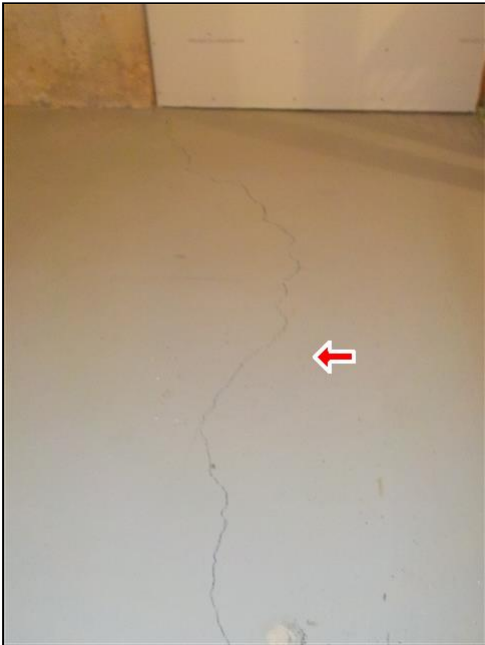
Common settling or curing cracks were observed on the basement floor. Monitor for changes.

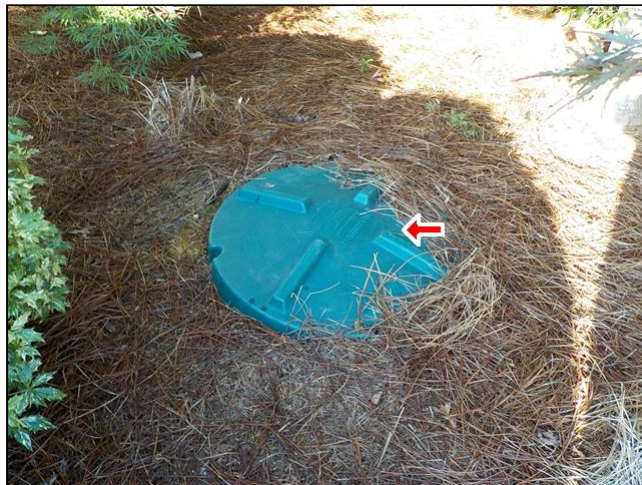
There is a septic-like component in the front yard that is beyond the scope of the inspection. Have further evaluated by a qualified septic professional.

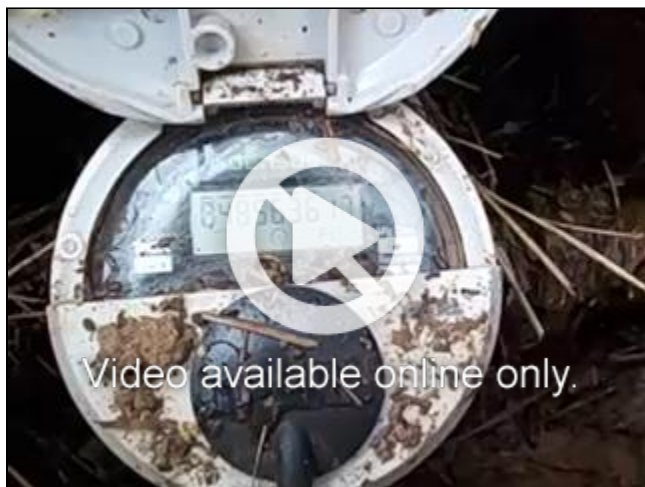
(1) A draw was observed on the water meter when first arriving at the inspection. Later, when evaluating the main water shut off valve in the basement, there was the sound of water flow despite no known fixtures running. When the main water shut off valve was then turned off, the water flow sound continued. This indicates a problem and should be further evaluated and repaired by a qualified plumber.

Water meter running

Sound of water flow at main line

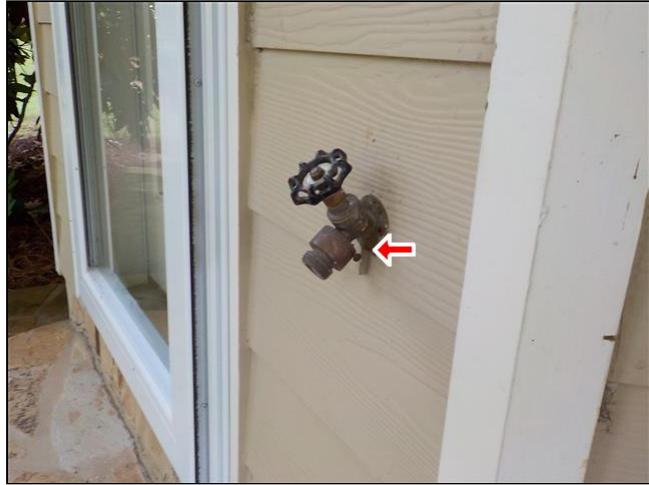
(2) The exterior back hose bibb appears to be winterized as there was no water flow.

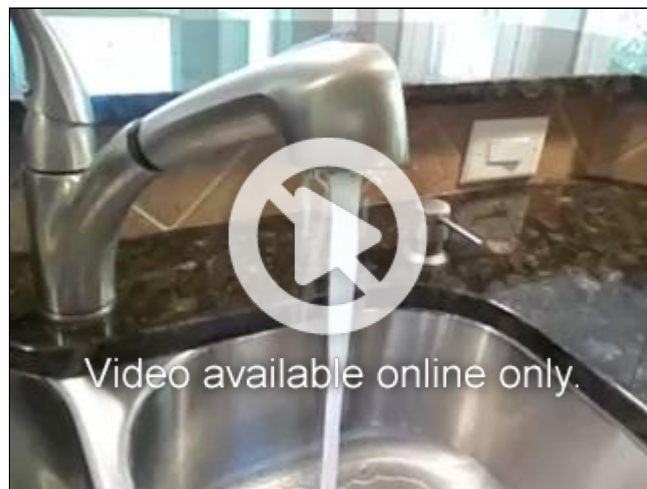
(3) The kitchen sink faucet is in marginal condition.

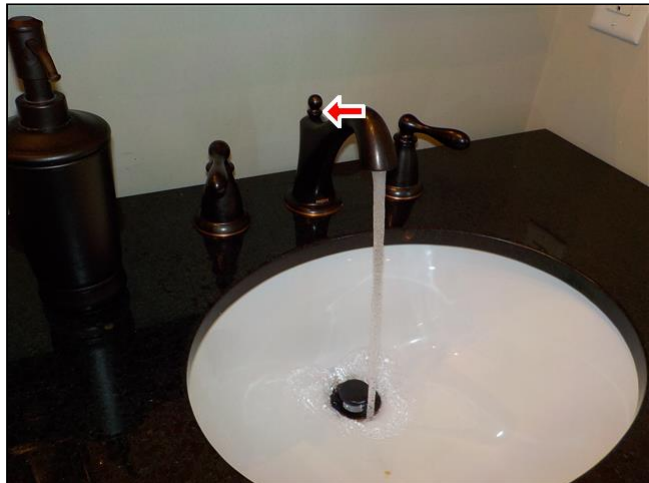
(4) The half bath sink stopper pull is loose.

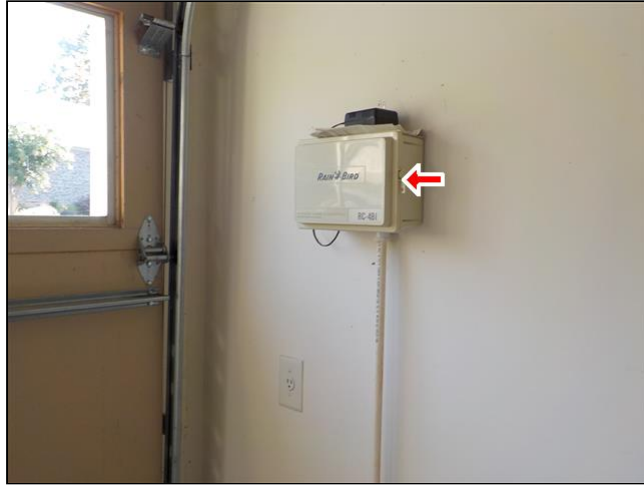
(5) A irrigation system control panel was observed in the garage but is a specialized component that was not tested. Contact the seller to provide information on how it operates or have evaluated by a qualified irrigation professional.

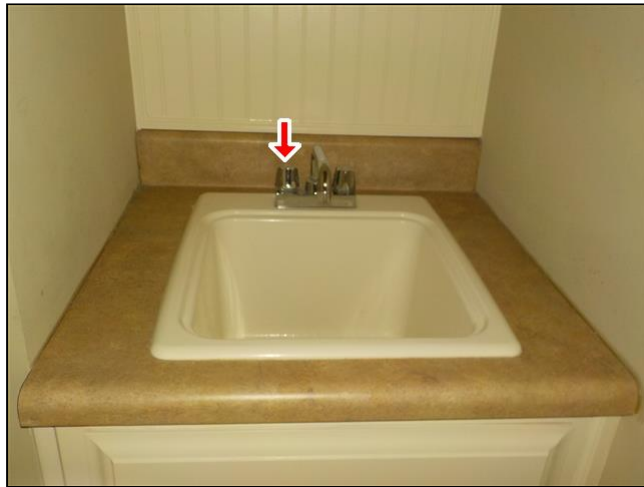
(6) There was no water flow to the hot side of the laundry sink, and the valve is likely off. Contact the seller for more info or have evaluated and repaired as needed.

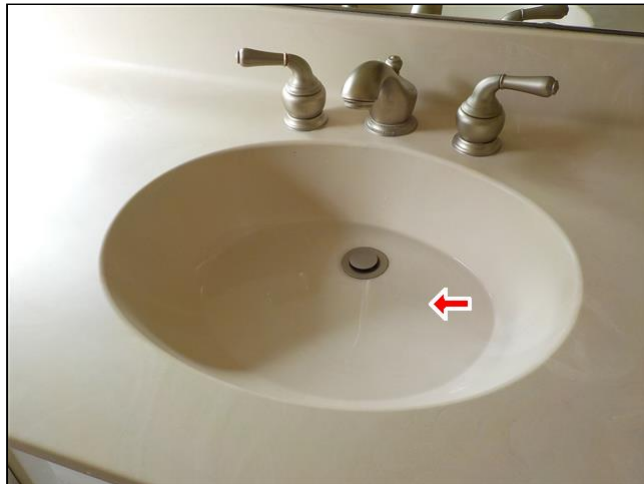
(7) The master sink near the tub is draining slowly.

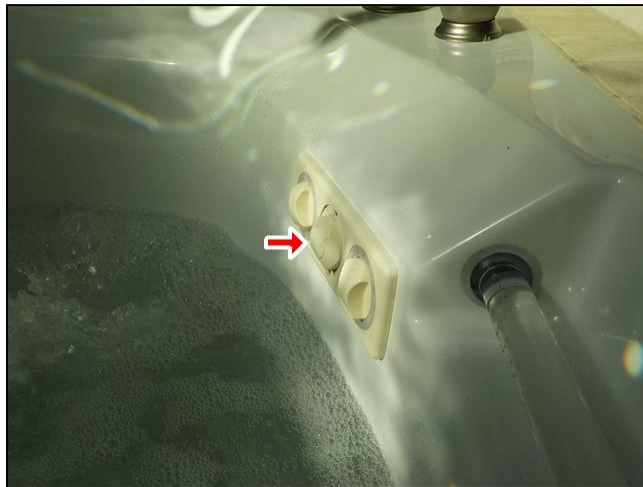
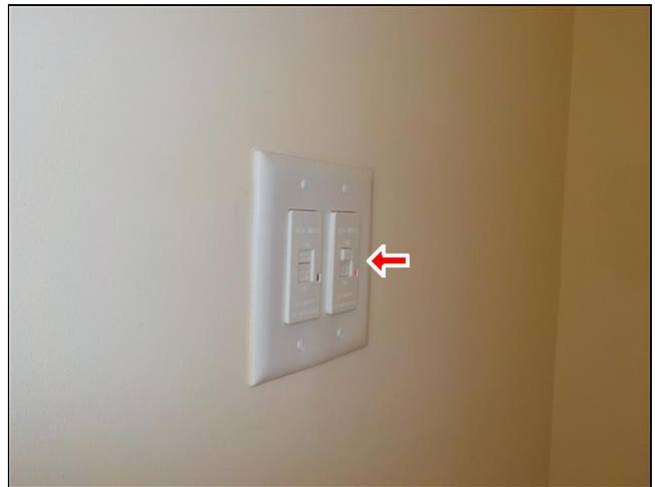
(9) The master tub turned on using the available button control, but then would not turn off. I had to turn it off using the nearby GFCI switch. Have further evaluated and repaired by a qualified plumber.

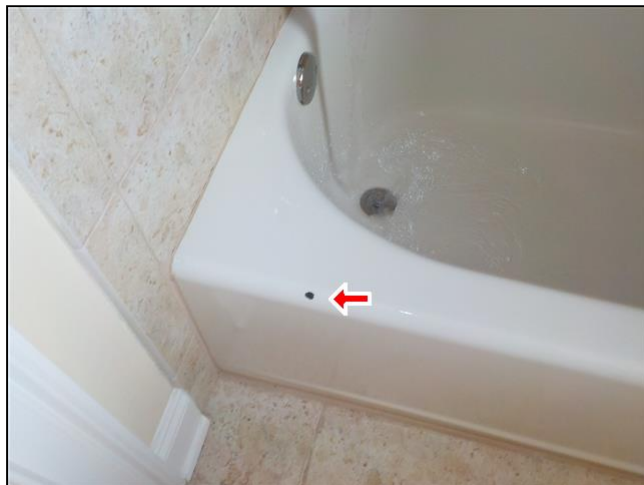
(10) Chipped enamel was observed in the 2nd floor bathtub.

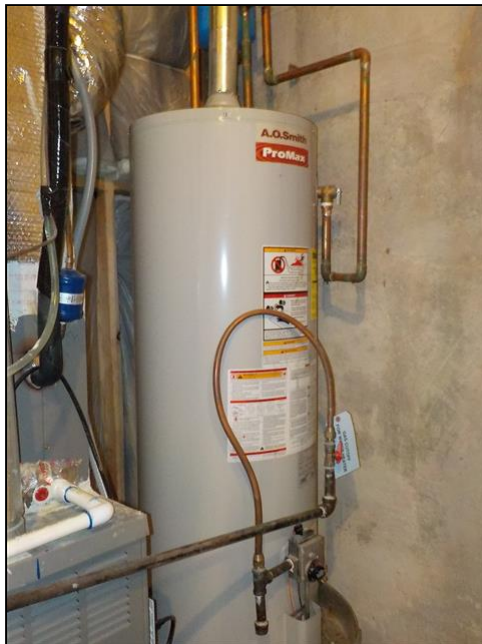
The water heater is 15 years old and at the end of its useful life. It may require replacement within the next 5 years.

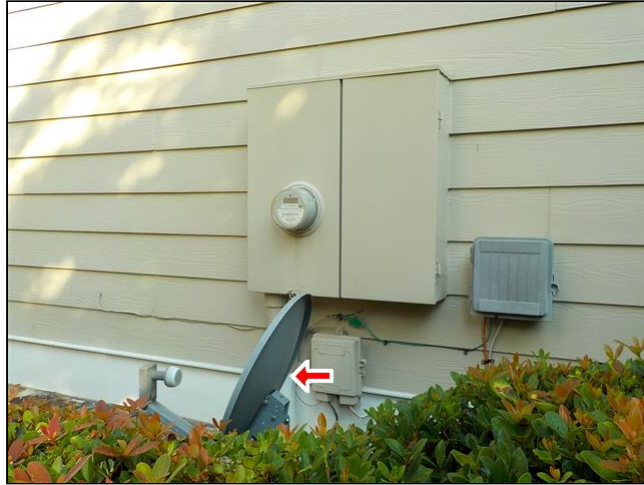
(1) A satellite dish was placed in front of the electrical meter box at the exterior left, which is not allowed.

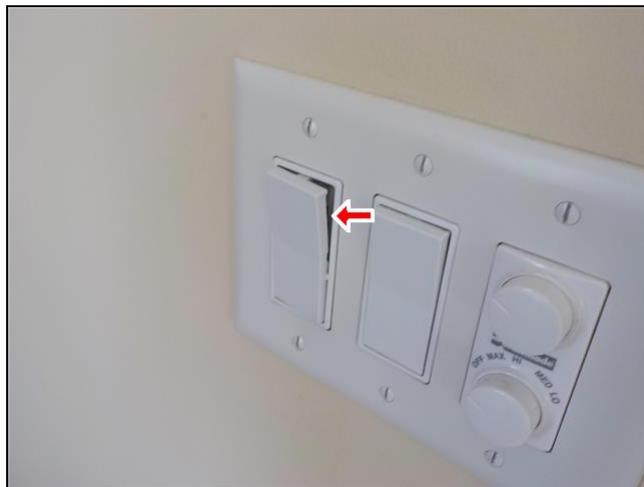
(1) The master bath vanity light switch is worn but operable.

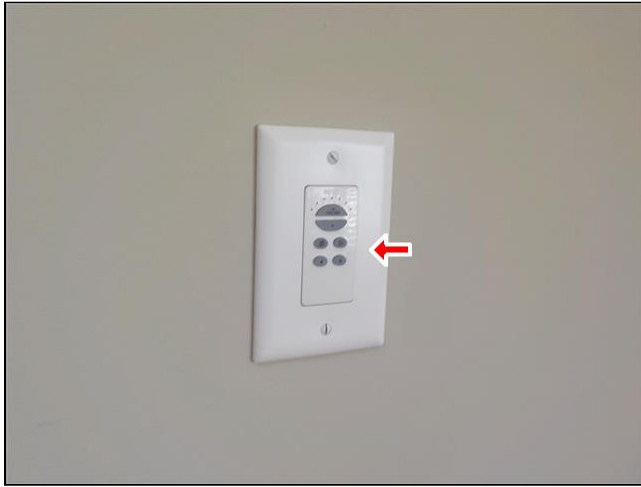
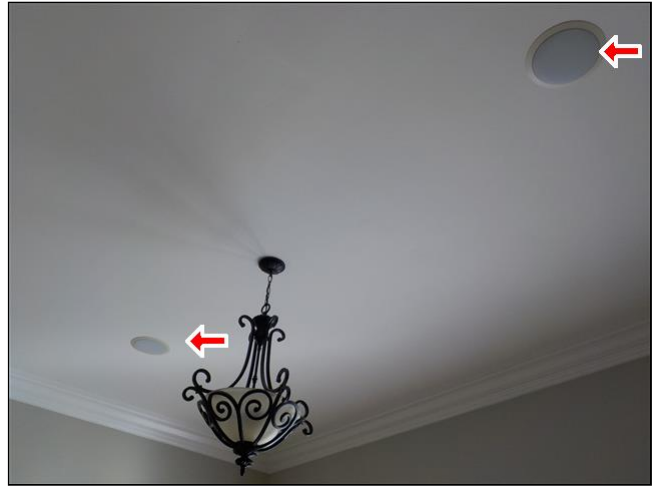
(2) A built-in sound system was observed but is beyond the scope of the inspection.

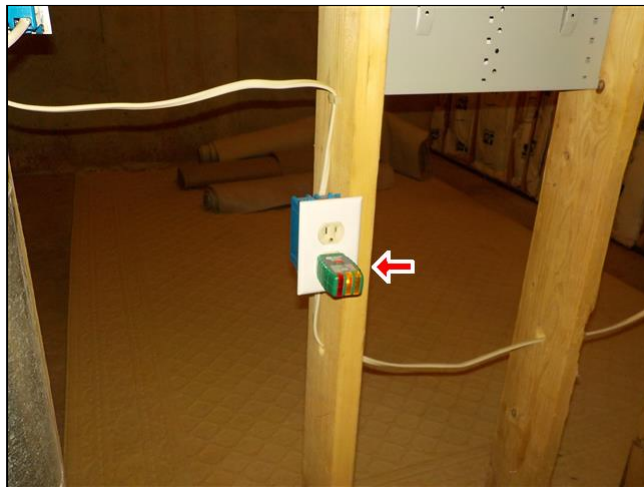
(4) The outlet behind the low voltage panel in the basement is showing an open ground.

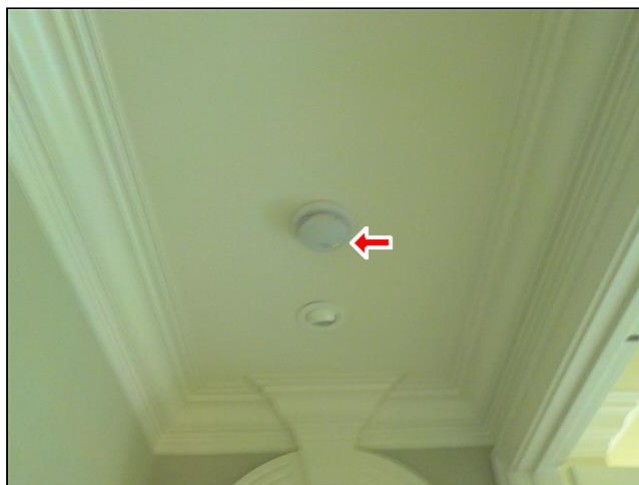
(1) The smoke alarms are likely over 10 years old and should be replaced with new models.

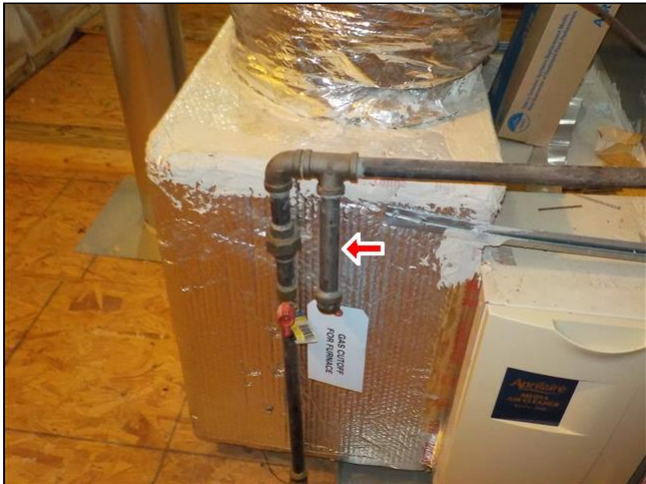
The requirement for sediment traps for gas appliances has changed since the house was built, and the existing sediment trap in the attic for the furnace is no longer considered adequate. However, this will not have any negative impact and can be changed at some point in the future.

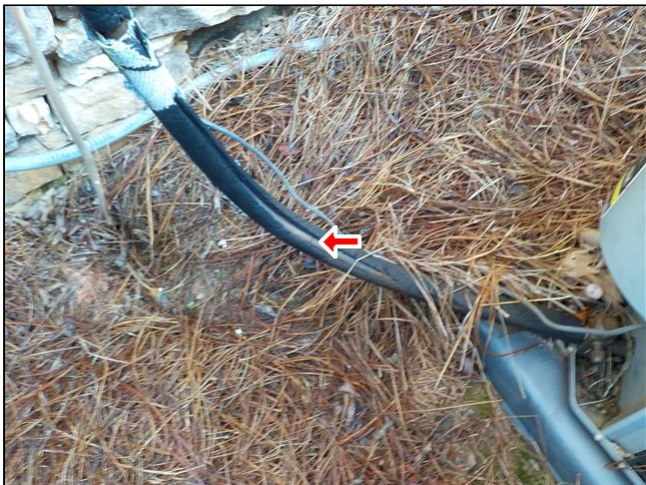
(1) Insulation is needed at the exterior suction lines where the existing insulation is missing or worn.

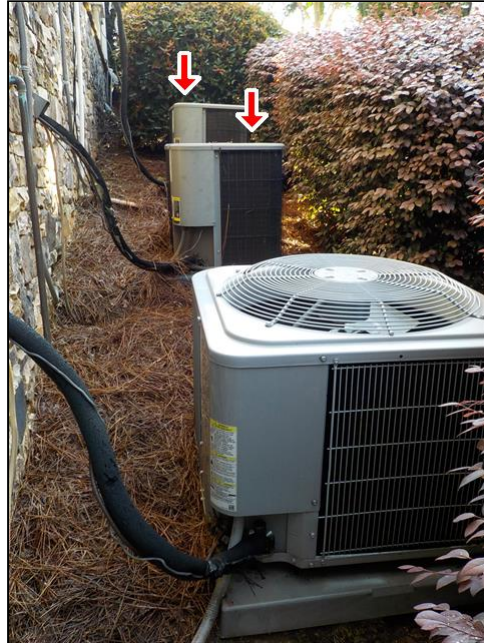
(2) Two of the A/C condensing units are at the end of their useful lives due to them being 15 years old. These may require repair or replacement within the next few years.

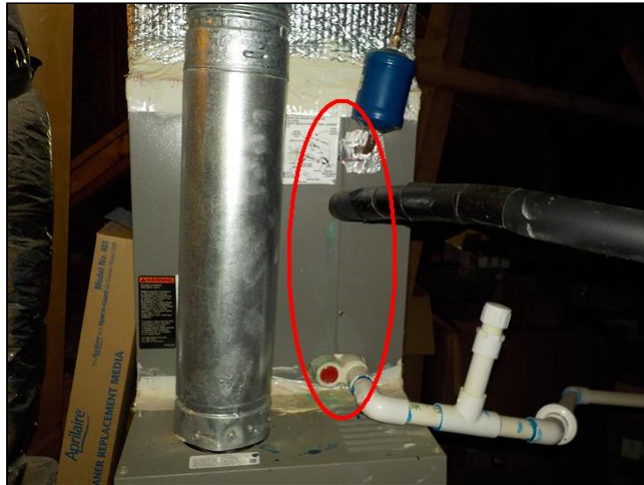
(3) The evaporator coil box in the attic is not adequately sealed to prevent air loss.

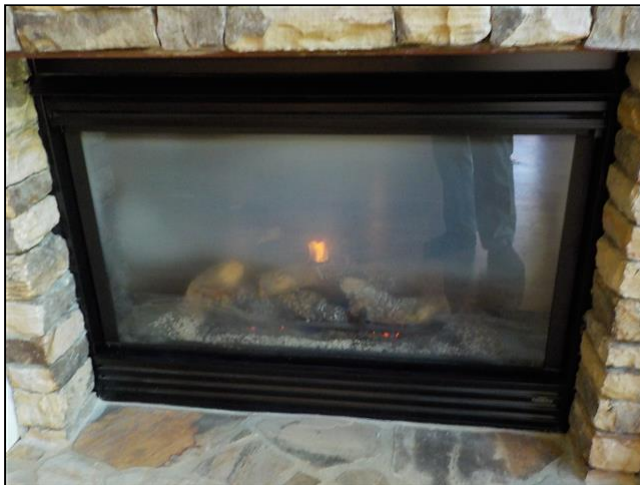
(1) The current gas fireplace on the 1st floor does not have a protective screen, creating a burn hazard with the exposed glass that gets extremely hot. Contact the fireplace manufacturer or a local fireplace company for repair.

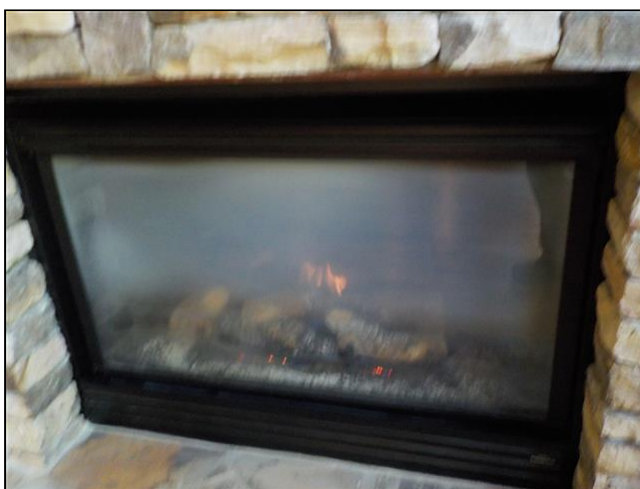
(2) The fireplace glass is cloudy and should be evaluated and cleaned as needed by a qualified fireplace professional.

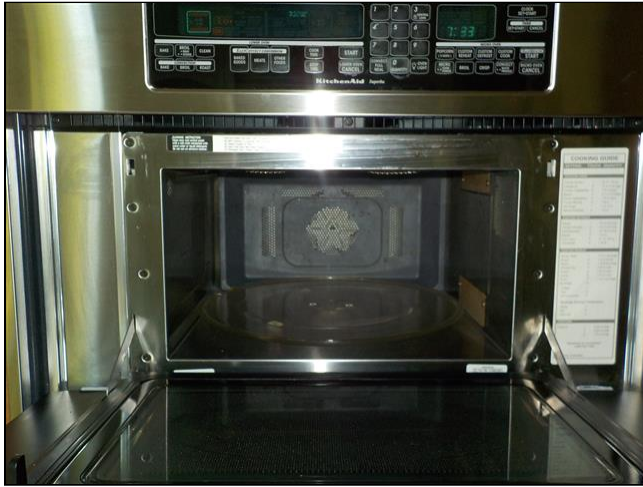
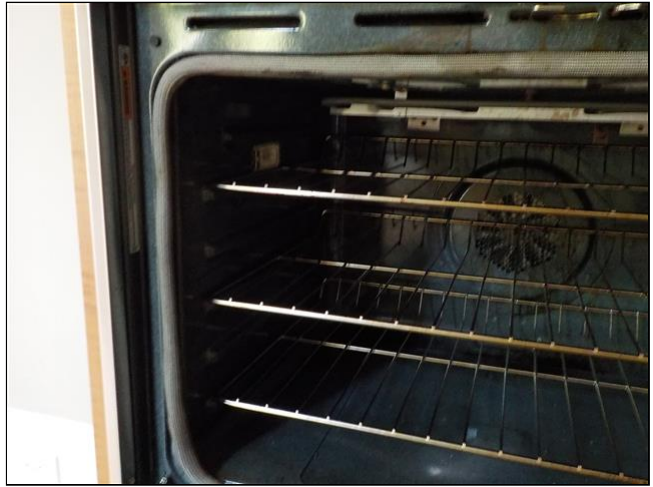
(1) The oven and microwave lights appear to be burnt out.

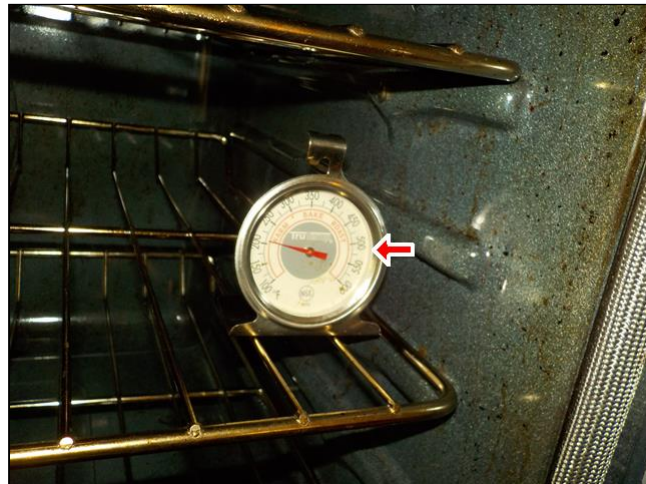
(2) The oven seemed to be heating properly, but the stand-alone temperature gauge did not seem to match. I suspect this stand-alone gauge is not working properly anymore.

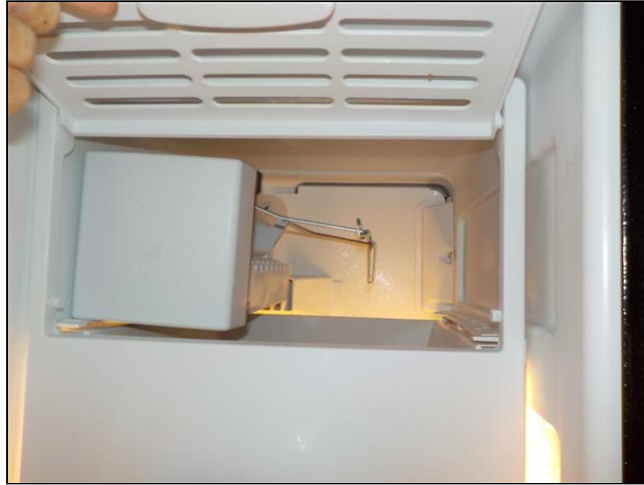
The icemaker was observed in the OFF position and could not be verified as operable.
