Arena Home Inspections

Home Inspection Report

Property address: **1508 Walker Ridge Dr SW
Marietta GA 30064-4168**

Inspection date: **Tuesday, August 25, 2020**

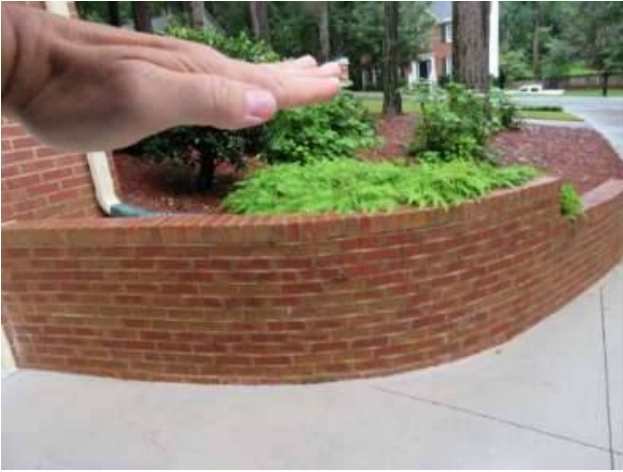
Retaining wall(s) higher than 30" exist on this property and no guardrail(s) are installed above. This is a safety hazard. Recommend having a qualified contractor install adequate guardrails above retaining walls higher than 30" where necessary and as per standard building practices (gaps no wider than 4", min. 36" high, vertical balusters so rail can't be used as a ladder, etc.)

Photo 1-1 Left Side Retaining Wall - recommend guardrail

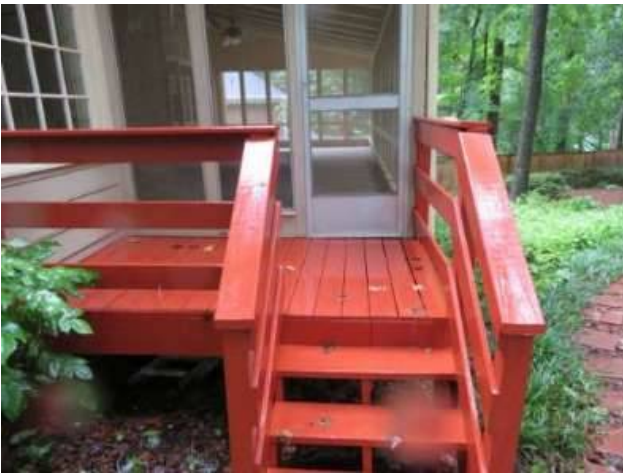
Gaps larger than 4" were found in one or more guardrails. This is a safety hazard, especially for small children. Recommend that a qualified contractor make modifications as necessary, such as installing additional balusters, so gaps in guardrails don't exceed 4".

Photo 2-2 Rear Deck Guardrail - excessive gap(s) (more than 4")

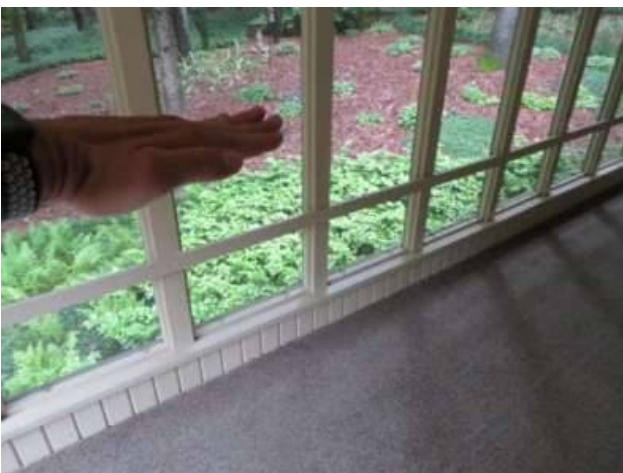
Photo 2-3 Rear Covered Deck - improper guardrail(s)

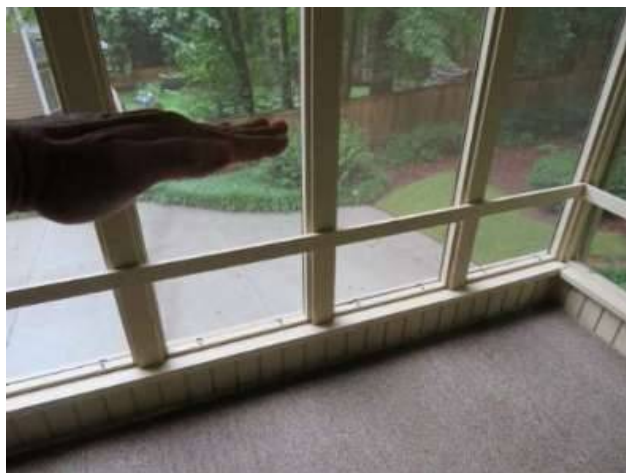
Photo 2-4 Rear Covered Deck - improper guardrail(s) - note: there are only screen(s) installed - the deck needs to follow the same safety guidelines as full exterior deck

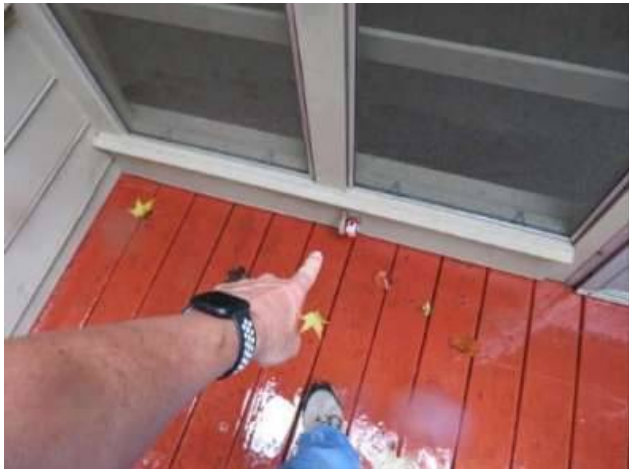
One or more exterior receptacles aren't waterproof or rated for use in wet areas. This is a safety hazard and poses a risk of both fire and shock.

Photo 3-1 Rear Electrical Outlet Box - should be GFCI

Recommend having a qualified, licensed electrician make repairs as necessary. For example, install waterproof covers, replace interior rated receptacle boxes, etc., so all exterior receptacles are waterproof as per standard building practices.

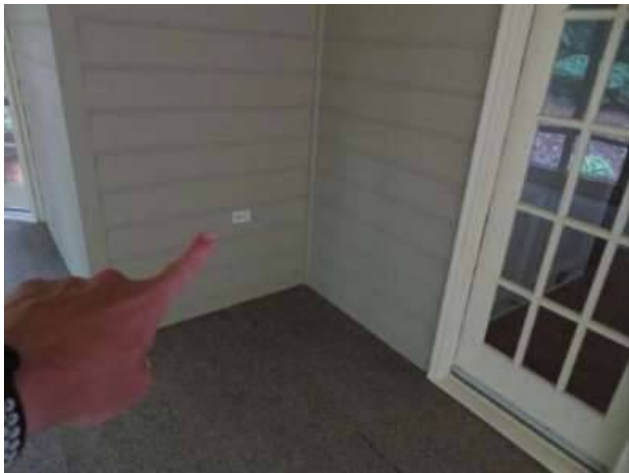
Photo 3-7 Rear Covered Deck - outlet(s) are not waterproof & should be GFCI

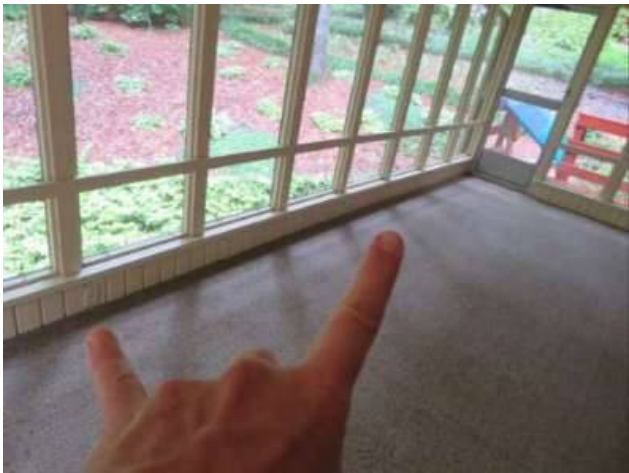
Photo 3-8 Rear Covered Deck - outlet(s) are not waterproof & should be GFCI

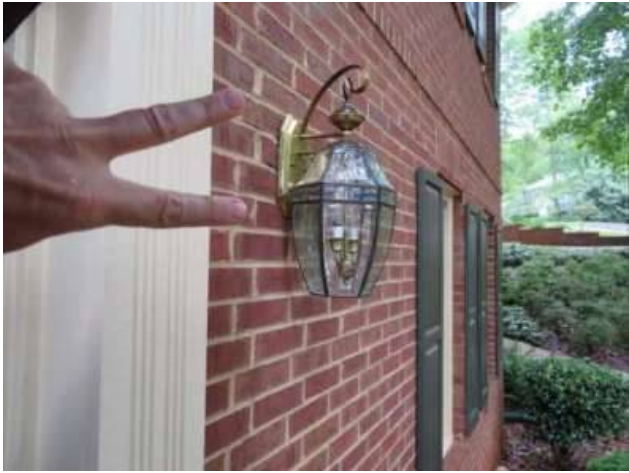
Photo 4-2 Front Light Fixture(s) - missing caulk at base perimeter(s)

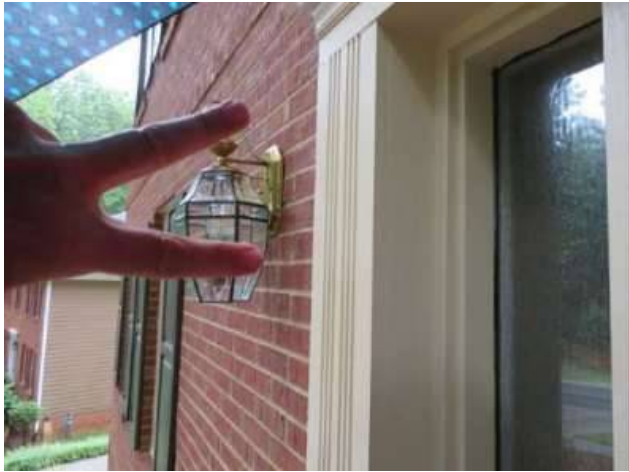
Photo 4-3 Front Light Fixture(s) - missing caulk at base perimeter(s)

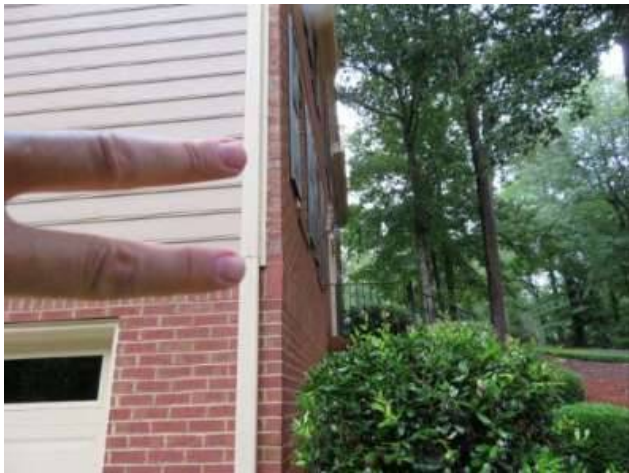
Photo 4-5 Left Side Trim/Brick - caulk missing/incomplete at junction(s)

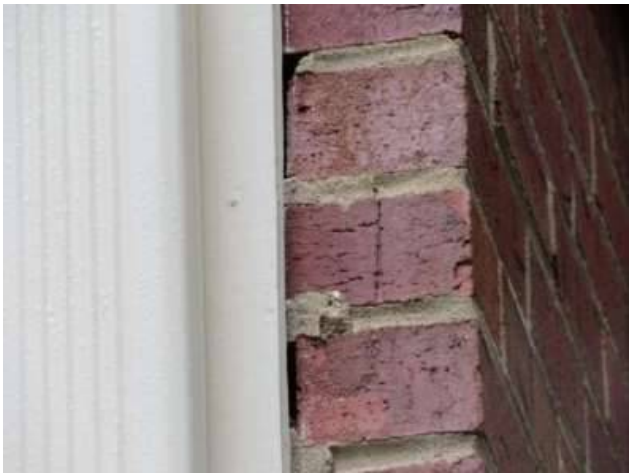
Photo 4-6 Left Side Trim/Brick - caulk missing/incomplete at junction(s) (zoom view)

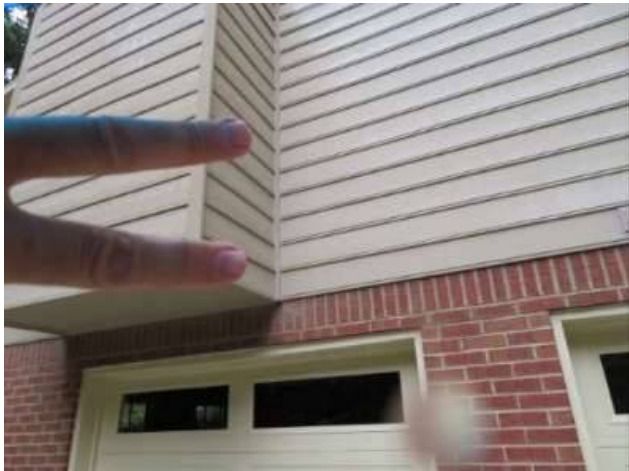
Photo 4-7 Left Side Siding/Trim - caulk deteriorated/incomplete at junction(s)

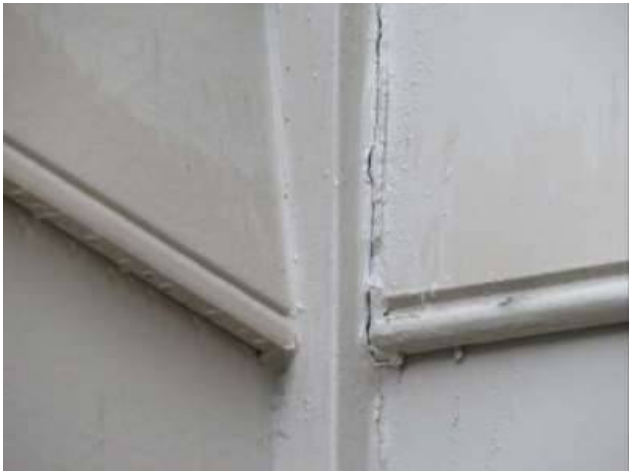
Photo 4-8 Left Side Siding/Trim - caulk deteriorated/incomplete at junction(s) (zoom view)

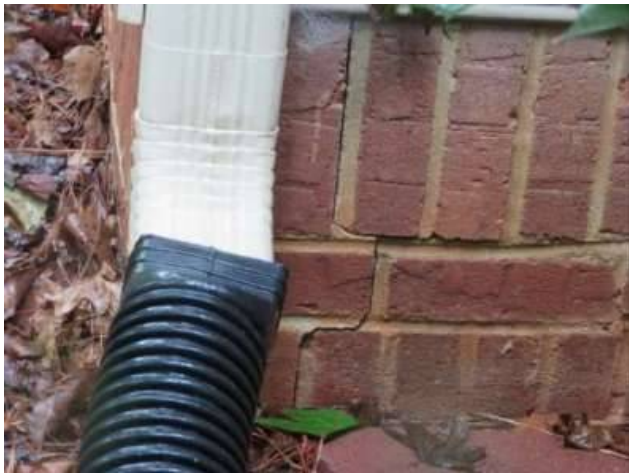
Photo 4-11 Rear Brick Mortar - crack(s) (zoom view)

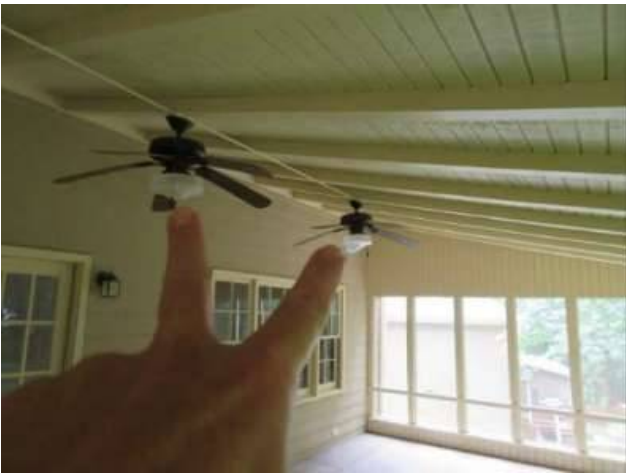
Photo 4-12 Rear Covered Deck Fan Fixture(s) - blade(s) are deteriorated/warped

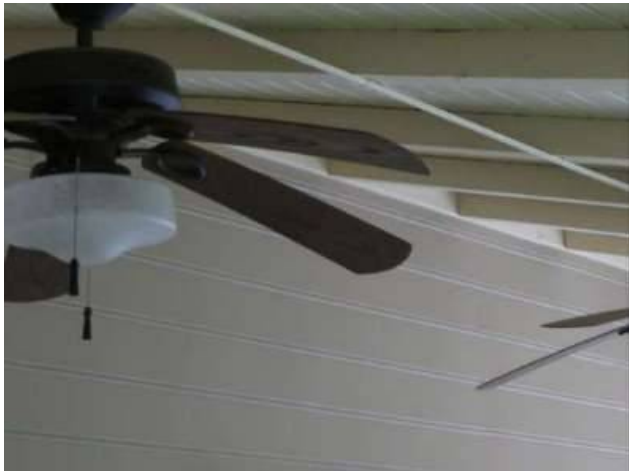
Photo 4-13 Rear Covered Deck Fan Fixture(s) - blade(s) are deteriorated/warped (zoom view)

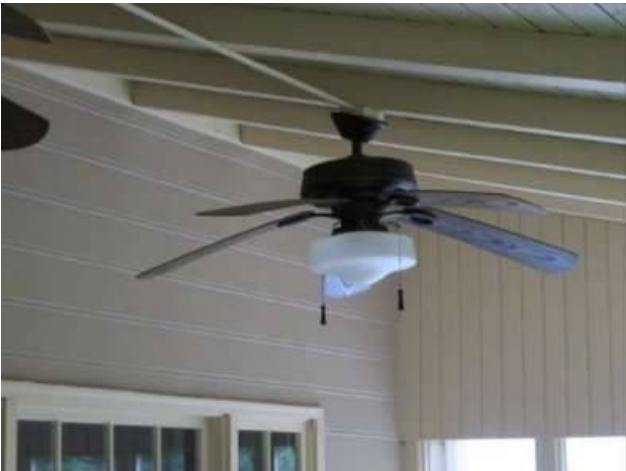
Photo 4-14 Rear Covered Deck Fan Fixture(s) - blade(s) are deteriorated/warped (zoom view)

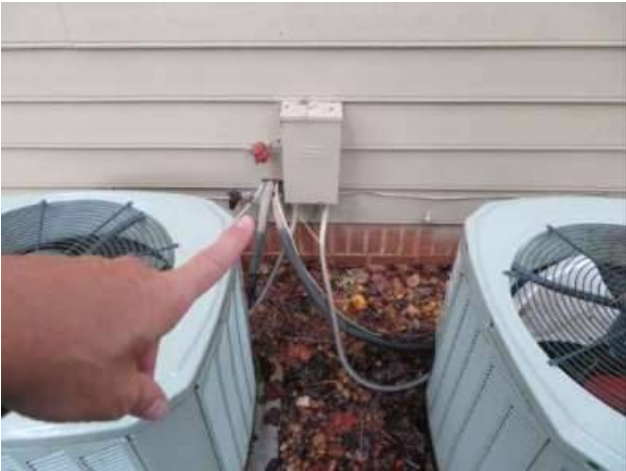
Photo 4-16 Right Side Siding - caulk/sealant missing/incomplete at piping penetration(s)

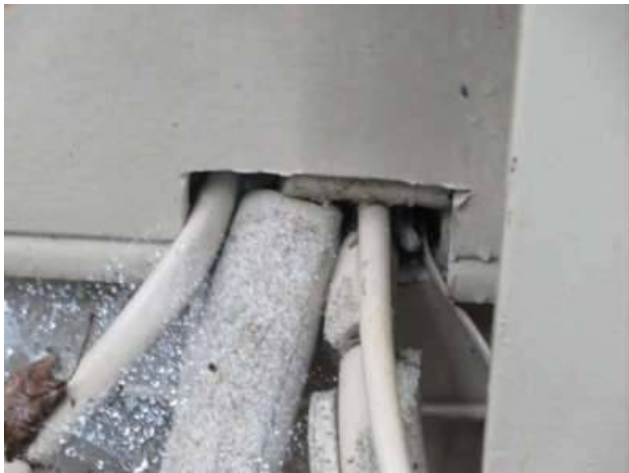
Photo 4-17 Right Side Siding - caulk/sealant missing/incomplete at piping penetration(s)

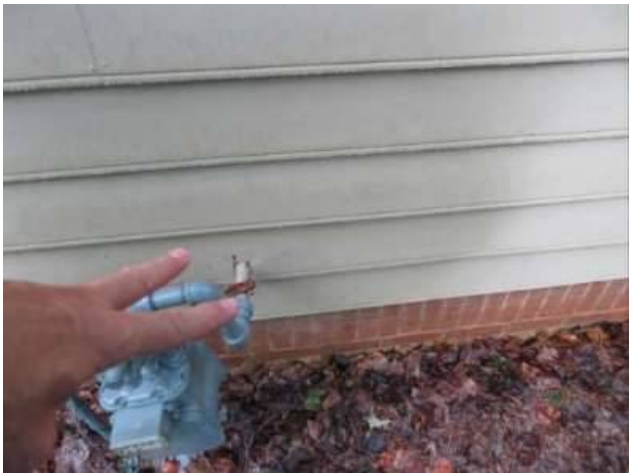
Photo 4-18 Right Side Siding - caulk/sealant missing/incomplete at piping penetration

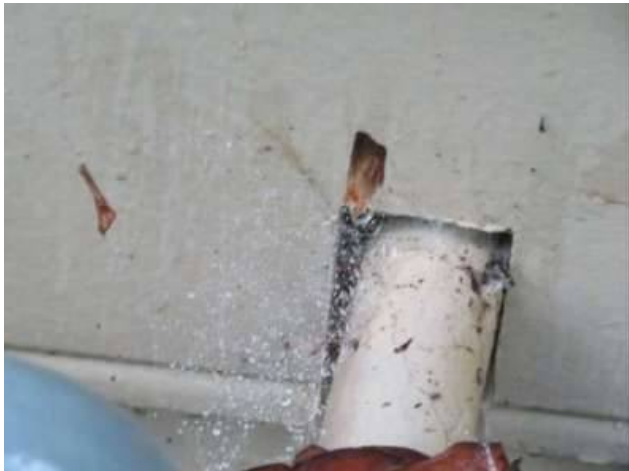
Photo 4-19 Right Side Siding - caulk/sealant missing/incomplete at piping penetration (zoom view)

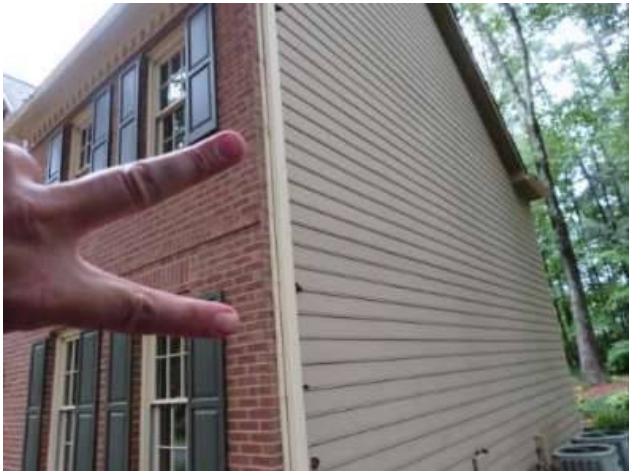
Photo 4-20 Right Side Trim/Brick - caulk missing/incomplete at junction(s)

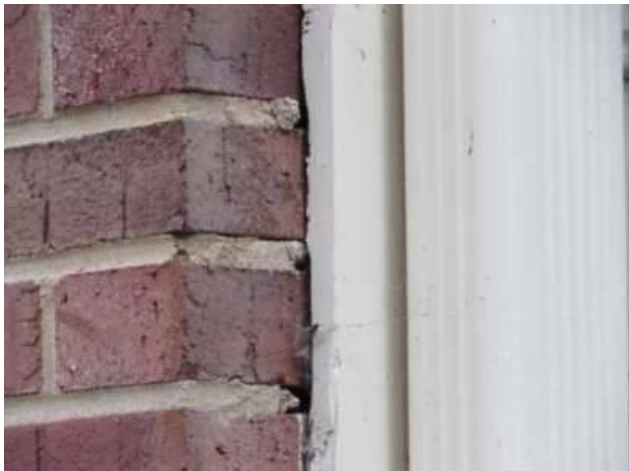
Photo 4-21 Right Side Trim/Brick - caulk missing/incomplete at junction(s) (zoom view)

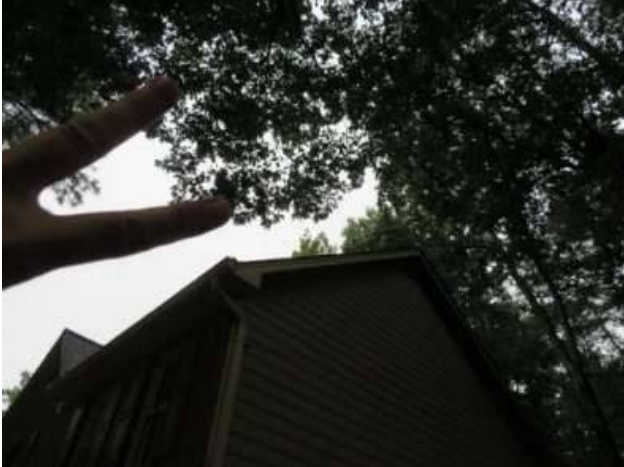
5) 🪚 Trees are overhanging roof and are within 10 feet of roof vertically. This is a conducive condition for wood destroying insects and organisms since organic debris is more likely to accumulate on the roof surface. Accumulated debris may cause water to enter gaps in the roof surface and leak into attic and/or interior spaces. Recommend pruning trees so they're at least 10 feet above roof, or don't overhang the roof.

Photo 5-1 Tree(s) - overhanging roof

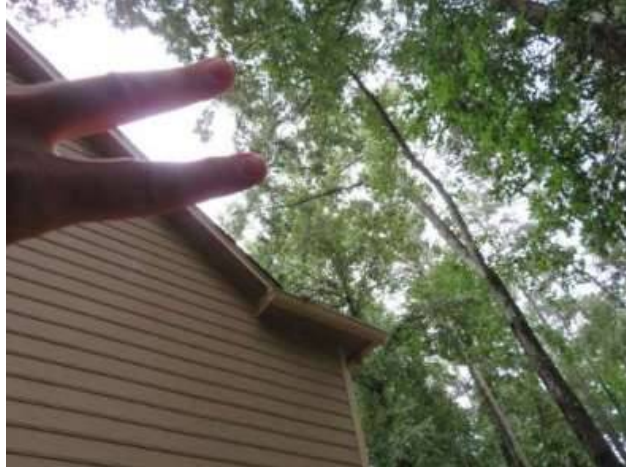
Photo 5-2 Tree(s) - overhanging roof

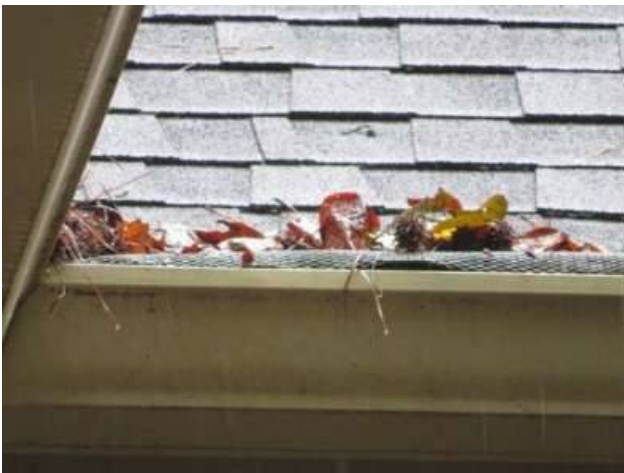
6) 🧰 Significant amounts of debris have accumulated in one or more gutters. Recommend cleaning gutters now and as necessary in the future.

Photo 6-1 Gutter(s) - excess organic debris

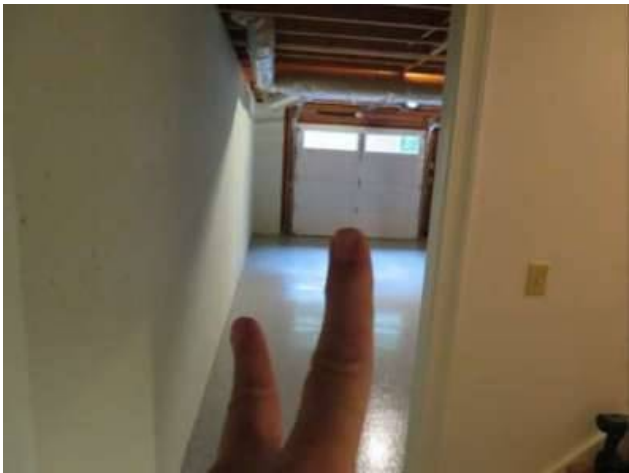
7) 🛠️ Garage/Basement House Door(s) - should be installed

Photo 7-2 Garage/Basement - should have one-hour fire proof door(s) & should be properly weatherstripped

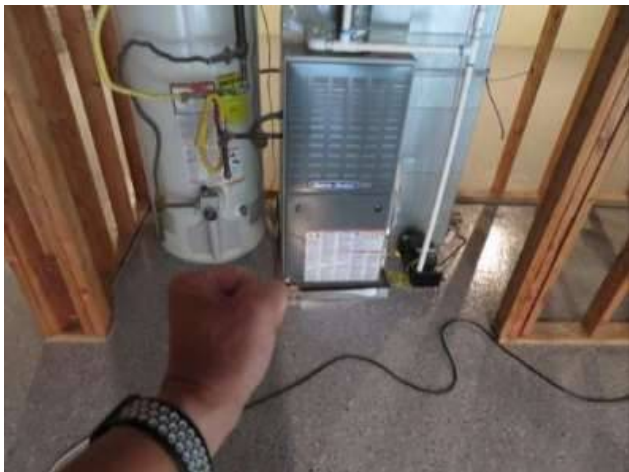
Appliances such as the water heater and/or furnace are subject to damage from vehicles because no protective barrier is installed in front of them. Recommend having a qualified contractor install an adequate barrier as per standard building practices (steel post anchored in concrete, wood partition, etc.).

Photo 8-1 Garage - should have a post to help prevent mechanical damage from vehicle(s)

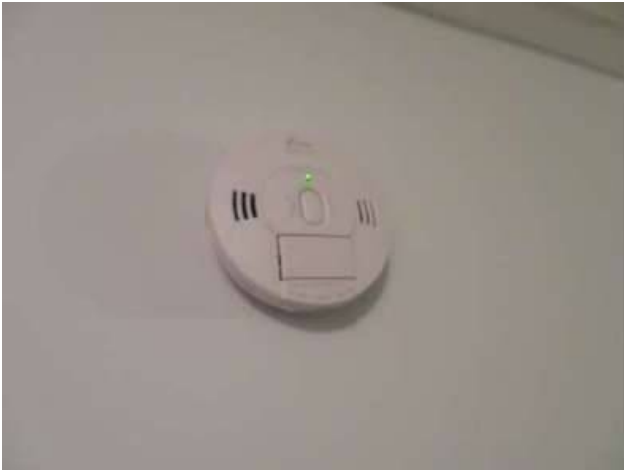
An insufficient number of smoke detectors are installed. Recommend installing additional smoke detectors as necessary so a functioning one exists in each hallway leading to bedrooms, in each bedroom, in the garage/basement, and in the attic.

Photo 9-1 Smoke Detector(s) - recommend installing additional

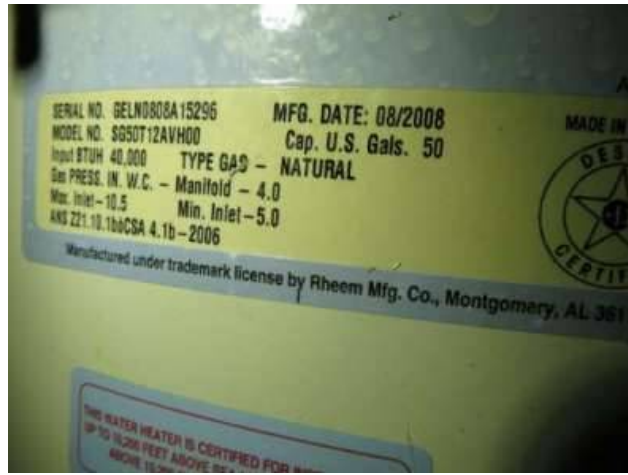
The estimated useful life for most water heaters is 10 to 15 years. This water heater appears to be at this age range. Recommend budgeting for a replacement in the near future.

Photo 10-2 Water Heater info (2008 - 50 gal)

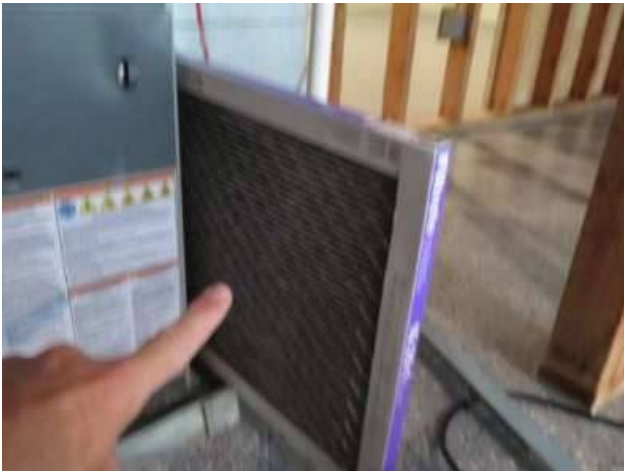
12) These system(s) are equipped with throw-away filter(s). They appear to be dirty. Recommend replacing filter(s) now and every 3-6 months in the future.

Photo 12-1 HVAC #1 Filter - dirty - replace now

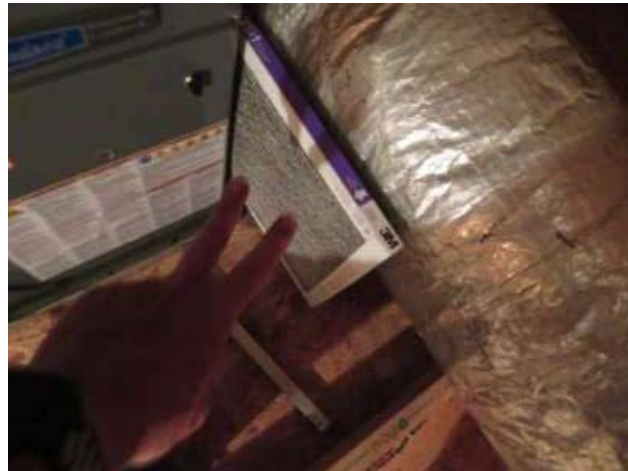
Photo 12-2 HVAC #2 Filter - dirty

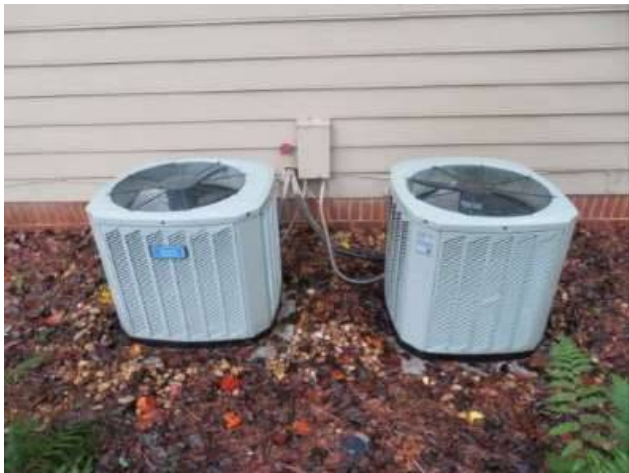
13) The estimated useful life for exterior air conditioning and/or heat pump compressors is 10 to 15 years. Both units are at this age range and may need replacing at any time.

Photo 13-1 A/C Units

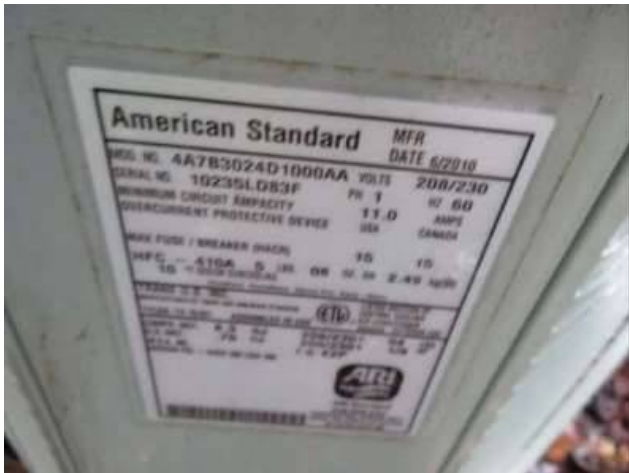
Photo 13-3 A/C Unit #1 info (2010)

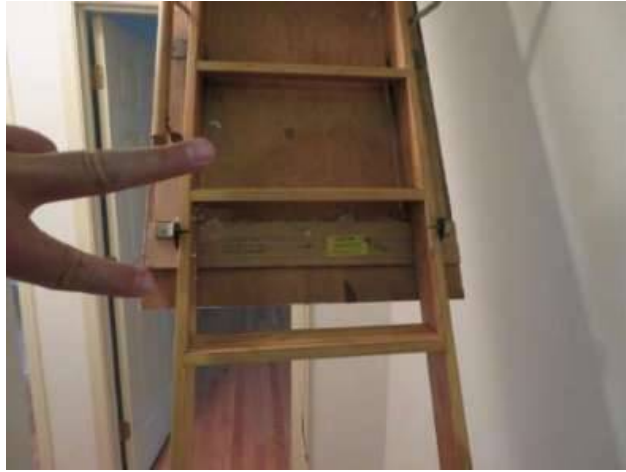
14) Pull-down stairs are installed for the attic access. No insulation is installed above the stairs and no weatherstripping is installed around the hatch perimeter. To reduce air leakage, recommend installing weatherstripping and an insulated hatch cover. Interior air leaking into the attic results in heating and cooling losses, increased energy costs, and a possible increase in moisture levels in the attic due to condensation forming on the underside of the roof sheathing during cold weather.

Photo 14-2 Attic Door - recommend weatherstripping & insulation

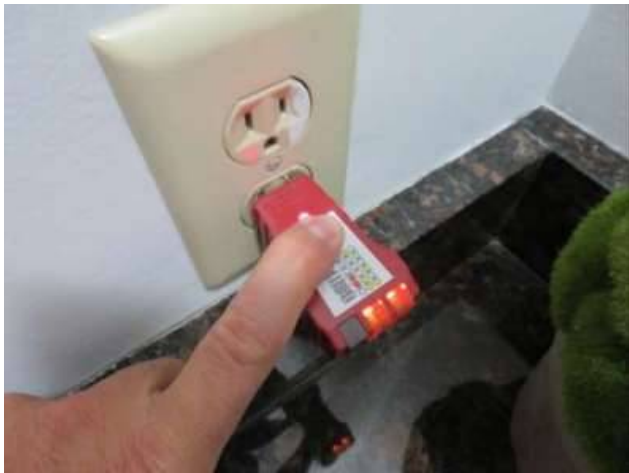
15) 🛠️🔍📌 Electrical Outlet(s) - should be GFCI in Kitchen & near sink(s) and/or missing ground(s)

Photo 15-3 Wet Bar - outlet box should be GFCI (zoom view)

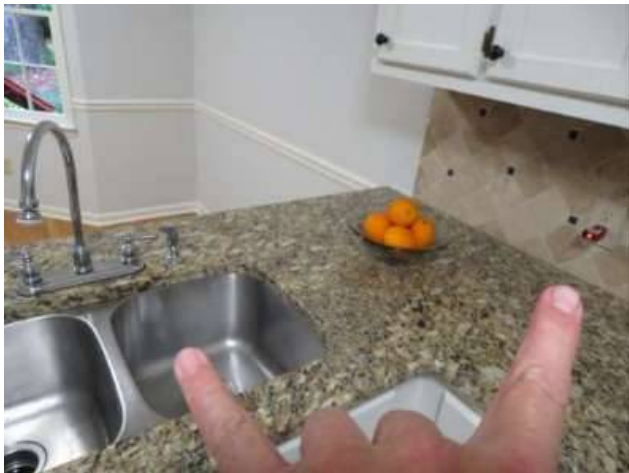
Photo 15-5 Kitchen - counter-top outlet(s) should be GFCI & some have open ground(s)

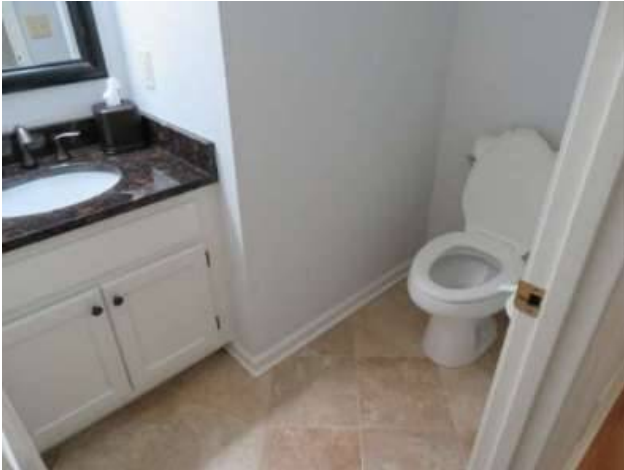
One or more ground fault circuit interrupter (GFCI) receptacles are tripped and won't reset. This is a safety hazard and may pose a risk of fire and/or shock. Recommend having a qualified, licensed electrician evaluate and make repairs as necessary.

Photo 16-1 Powder Room

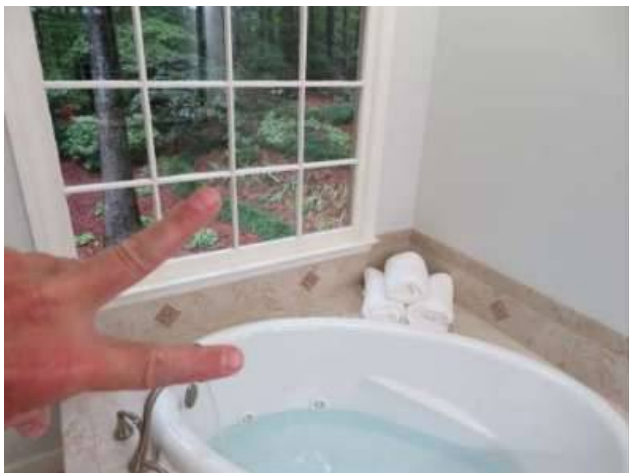
Master Bathroom - window(s) above tub should have safety rated glass

Photo 17-1 Master Bathroom - window(s) above tub should be safety rated glass

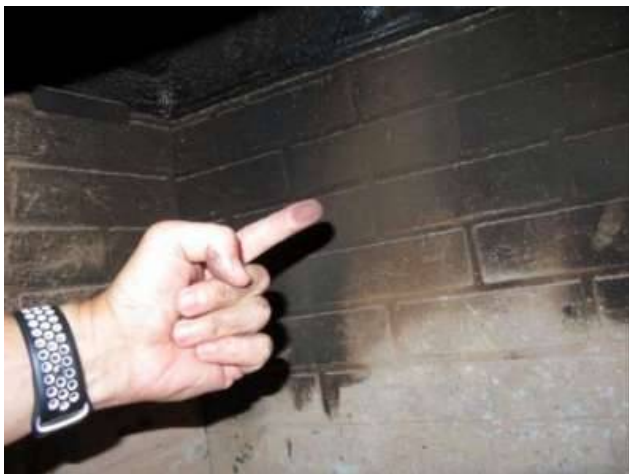
18) 🔧🔪🔪 Fireplace - recommend professional cleaning

Photo 18-3 Fireplace - excess creosote - recommend professional cleaning

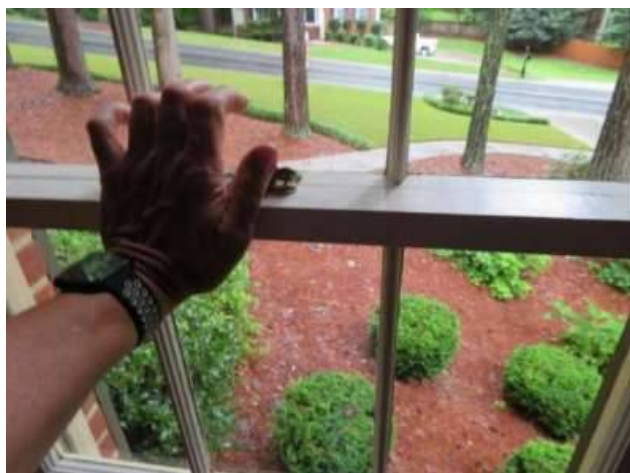
Photo 19-1 Window(s) - stuck shut - should be easily open-able

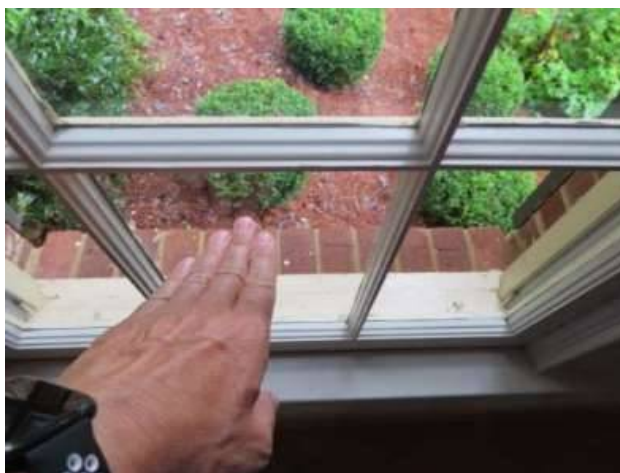
Photo 19-2 Window(s) - missing screens

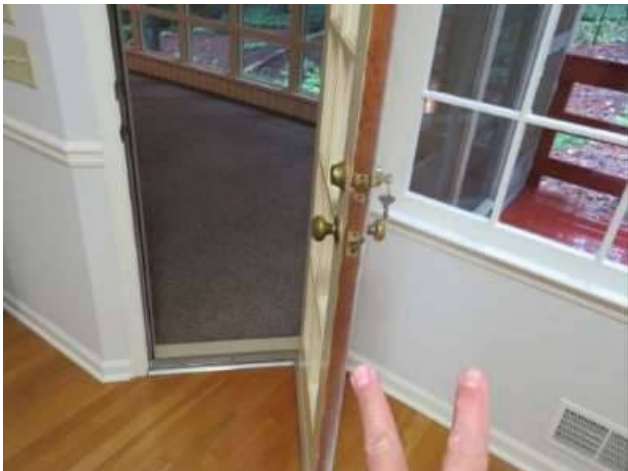
Photo 19-8 Rear Entrance to Covered Deck - door missing stop hardware
