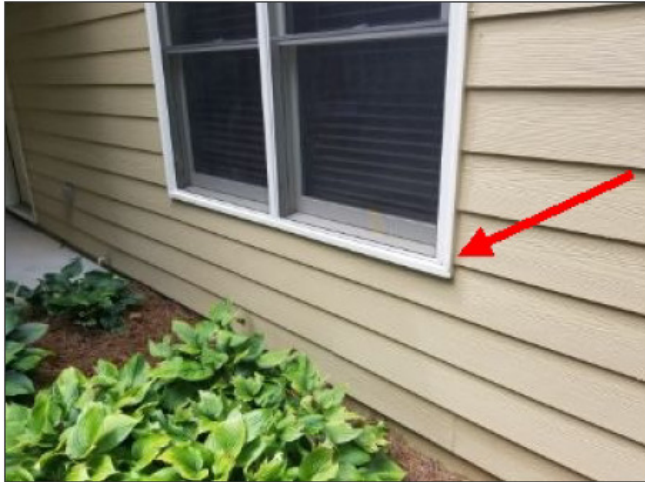
Damaged wood trim at rear basement windows

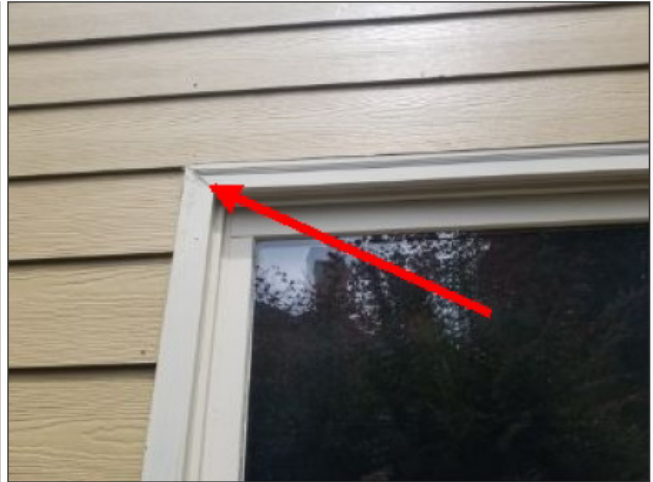
Damaged wood trim at basement window behind AC units
