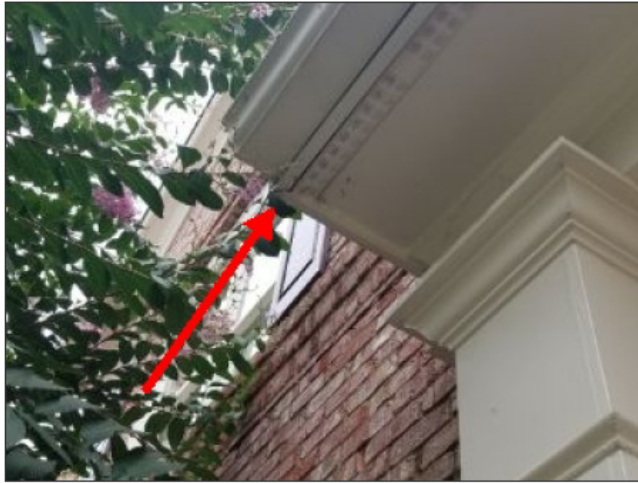
- Damaged wood was observed at the fascia board located at the left corner of the front porch roof, and at the front roof to the left of the master bedroom window (see photos). Replacement of the damaged wood is recommended; further evaluation is recommended to determine the source of the water damage and to make necessary repairs.

Damaged fascia at front left porch roof

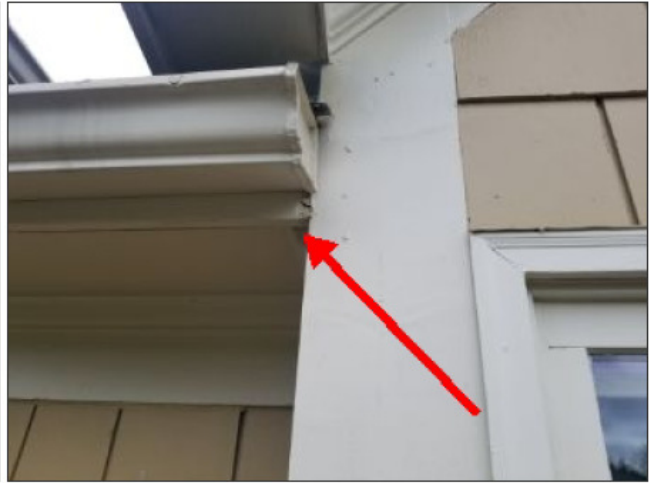
Damaged fascia at front master roof
