**House Smart**

**860 Longstone Landing  
Alpharetta GA 30022**

Client(s): Koller  
Inspection Date: 9/10/2020  
Inspector: Keith Cook , ASHI 202558

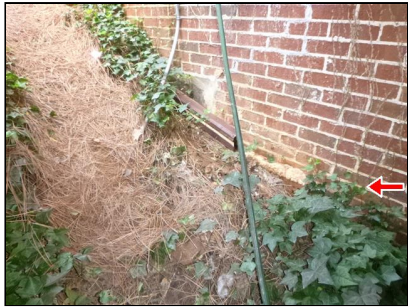
Item 1 - Picture 1

- ❌ 1. **SERVICE / REPAIR:** Low area in grading noted outside Breakfast side. Requirements of proper drainage are to slope the ground away foundation to avoid accumulation that forces water into lower areas. Regrading should be employed to reduce ground water in this area.

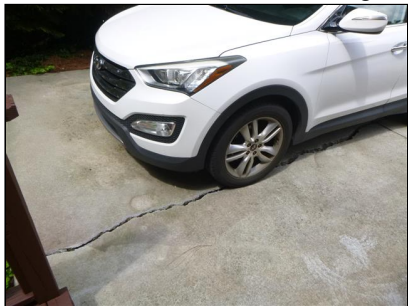
Item 2 - Picture 1

- ❌ 2. **MAJOR DEFECT:** Settling of the concrete surfaces observed. Repair can consist of either mud-jacking (injecting concrete under the slab to raise it) or replacement. Recommend having professionally repaired to raise surface back to or at least near the original position and reduce chances of continued settling occurring if not addressed.

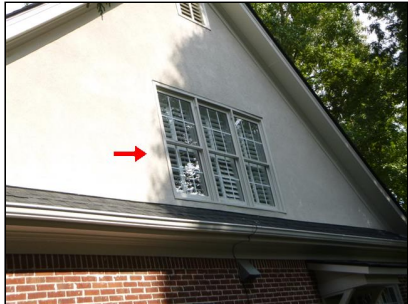
Item 4 - Picture 1

- ✖ 4. **SERVICE / REPAIR:** Window sash of Bedroom facing driveway side is damaged beyond point of repair and recommend having replaced.

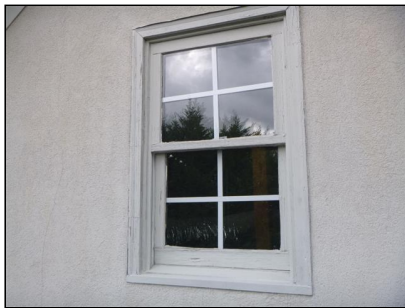
Item 7 - Picture 7

- ❌ 7. **SERVICE / REPAIR:** Paint on the window trim found in weathered condition. Sand, prime bare wood, caulk and paint to prevent moisture damage to the affected areas.

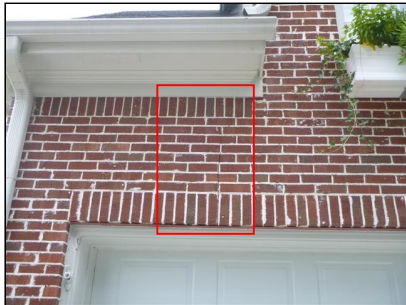
Item 9 - Picture 1

9. **SERVICE / REPAIR:** Hairline crack in brick veneer above garage door opening. Although structural deflection or settling exceeded the tolerance of brick, not significant at this point and likely to be the extent of failure. Repointing or sealing could be done but in many cases looks worse than leaving alone and not likely to be a significant problem if not sealed.

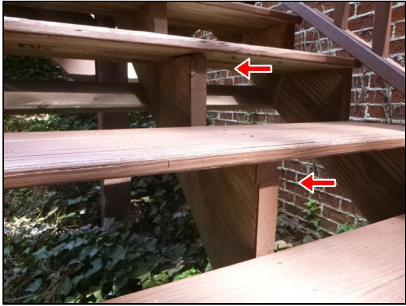
Item 12 - Picture 1

12. **SAFETY / HEALTH:** Stringers on deck stairs found to be split and weakened overall to various degrees. Recommend having reinforced by deck contractor although replacements may be the best long term solution to problem.

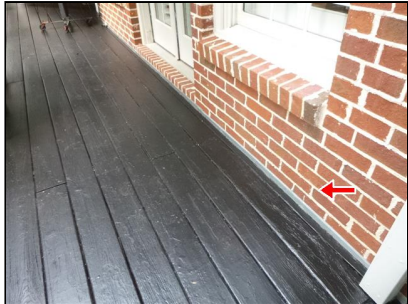
Item 13 - Picture 1

13. **SERVICE / REPAIR:** Deck flashing does not extend into brick veneer and is not sealed at intersection with brick. This can allow moisture behind flashing, which is meant to prevent moisture entry between siding and deck band at house. Seal with silicone caulk.

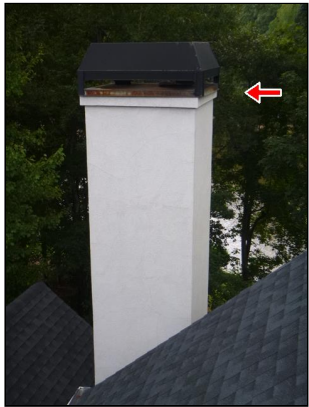
Item 14 - Picture 1

14. **SERVICE / REPAIR:** Rusting noted in cap of both chimneys. Clean and paint with rust inhibitor to prevent future rust through. Also clean and seal cap ring around flue to prevent leaking into chase.

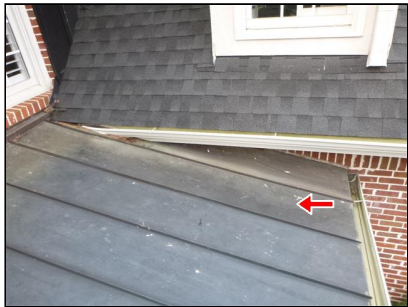
Item 16 - Picture 1

- ❌ 16. **SERVICE / REPAIR:** Metal roof on front porch found to be very soft in area next to Bonus dormer. Expect that roof deck has deteriorated from a leak but ceiling below has only slight damage. There may be a bright side that it's not actively leaking when raining BUT, if someone steps in the wrong spot much heavier than me, the metal may do more than just flex. Recommend having reviewed and repaired for best long term performance.

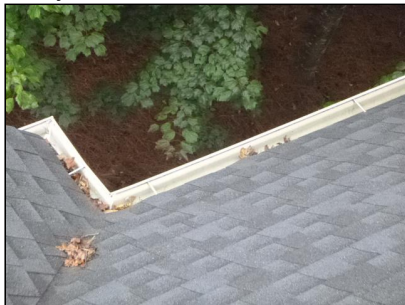
Item 19 - Picture 1

- ✘ 19. **SERVICE / REPAIR:** Its the time of year when the leaves are beginning to fall and gutters will need to be cleaned either now or soon. Gutters need to be cleared as much as twice a year to insure that proper drainage is made away from foundation and out of eaveline.

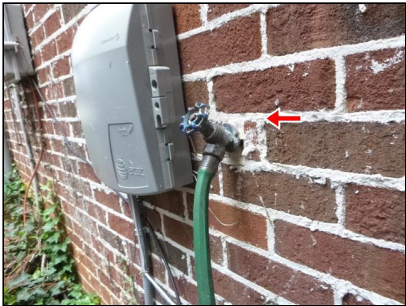
Item 21 - Picture 1

21. **SERVICE / REPAIR:** Hose bibb found to drip from handle when turned on. Have valve corrected to avoid leaking onto ground by foundation when using.

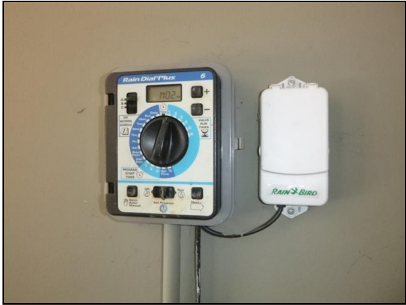
Item 23 - Picture 1

23. **SERVICE / REPAIR:** Various defects found in lawn sprinkler system such as Heads found spraying the house, and should be thoroughly reviewed and repaired as necessary to operate as designed. Recommend having seller demonstrate specific features of this system including cut off valve (usually in the lawn near the street), winterizing procedures and location of solenoids.

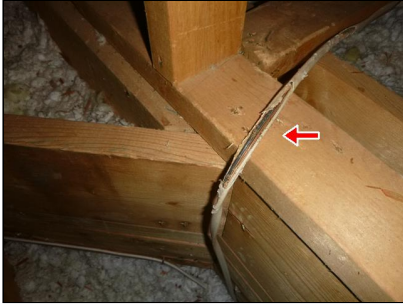
Item 24 - Picture 1

- ❌ 24. **SAFETY / HEALTH:** Electrical circuits in attic found to have been damaged by rodents mainly on the lower attic master side. Exposed circuits have the potential of arcing that produces heat. Proper repair includes replacing wiring of same size and type through extent of damage and providing splice connections enclosed in junction box. (Consult electrician for proper and safe repair process). Electrical tape only advised for minor damage closely reviewed on outer insulating sheathing.

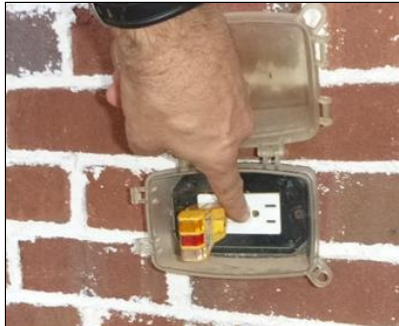
Item 25 - Picture 2

- ❌ 25. **SAFETY / HEALTH:** GFCI receptacle measured dead at Front porch and would not reset. All other resets throughout property were checked to verify reset and would recommend having electrician review and correct as necessary.

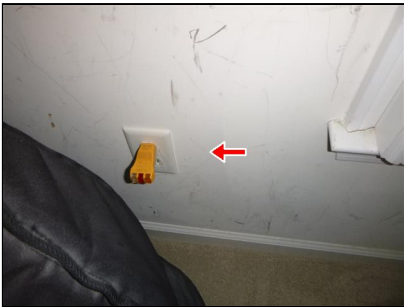
Item 27 - Picture 2

- ❌ 27. **SERVICE / REPAIR:** Inoperable receptacles observed at Master tub (tempered) and Master closet front. Recommend a licensed electrician to evaluate the condition and correct for compliance.

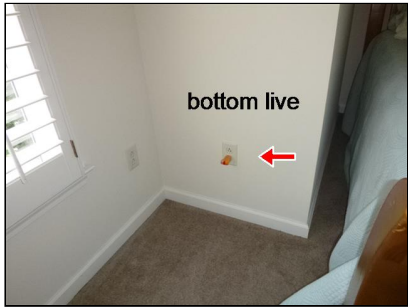
Item 28 - Picture 1

28. **GENERAL NOTE:** Receptacles in at least two of upstairs bedrooms has one half live and the other one dead. Often found in switched devices but not wired that way.

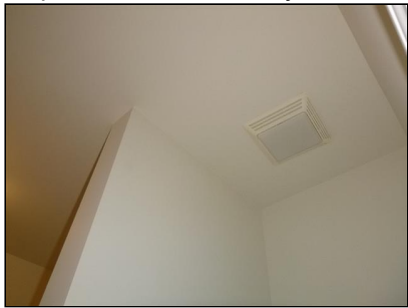
Item 29 - Picture 1

29. **SERVICE / REPAIR:** Inoperable lights observed at the time of inspection at: 1) Jack & Jill bathroom fan. Replace bulbs and verify that the fixture is operational. If not, consult an electrician for repairs.

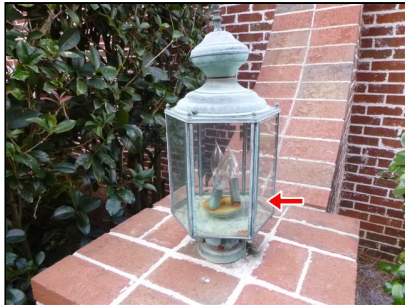
Item 30 - Picture 1

- ❌ 30. **SERVICE / REPAIR:** Damage noted in light fixture on accent wall at left side of house front. Recommend having repaired or replaced.

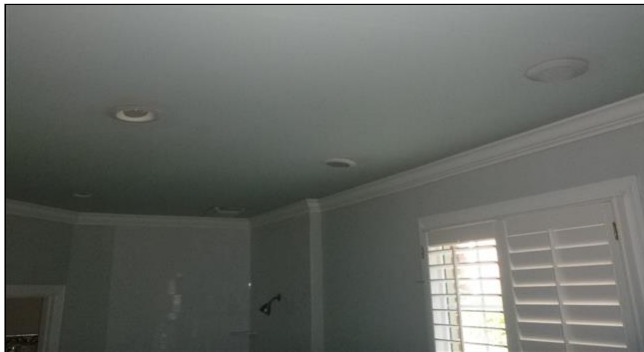
Item 31 - Picture 1

- ❌ 31. **SERVICE / REPAIR:** Can light found loose and should have trim ring mounting flush to ceiling at Master bathroom. Recommend condition be corrected to prevent stress on wires and the potential for electrical shock/short.

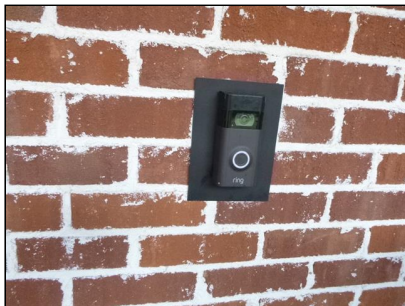
Item 32 - Picture 1

- ❌ 32. **SERVICE / REPAIR:** Door bell operates through an app and should either be given information on transferring to new owner OR have device removed and restore the standard door bell system.

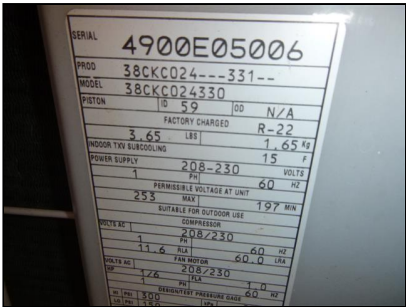
Item 33 - Picture 1

- ❌ 33. **GENERAL NOTE:** The Basement A/C system is at the end of its expected life span. (20 years old). Replacement may be necessary in the near future and can be expected to be a significant expense.

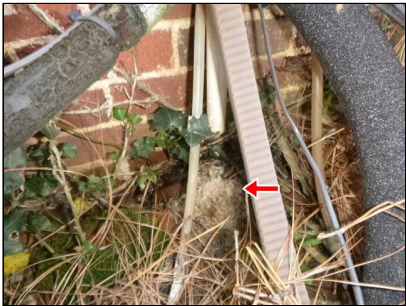
Item 34 - Picture 1

34. **SERVICE / REPAIR:** The condensation drain line terminates next to the building. This will release a considerable amount of water next to the foundation. Recommend the drain line be extended to terminate at least three feet from the foundation and beyond the A/C condensation units. This is also to reduce conducive conditions for termites.

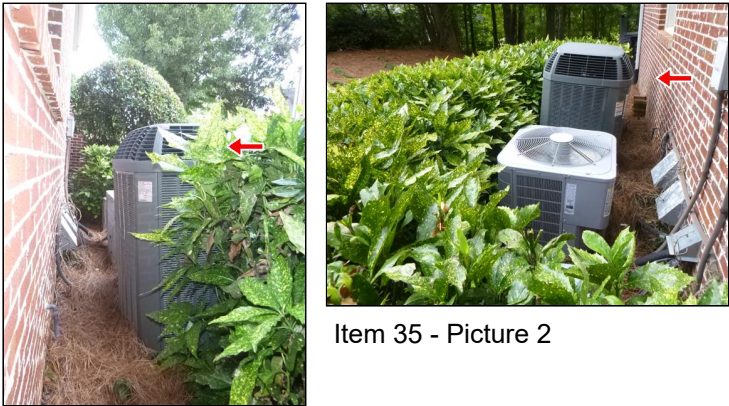
Item 35 - Picture 2

35. **SERVICE / REPAIR:** Tipping the compressors more than 10 degrees can damage the unit and voids the manufacturers warranty. Unit(s) should be leveled. **ALSO:** Shrubs or other vegetation found too close to A/C units outside and should be trimmed back or relocated to give equipment at least 12 inches of clearance required for design performance.

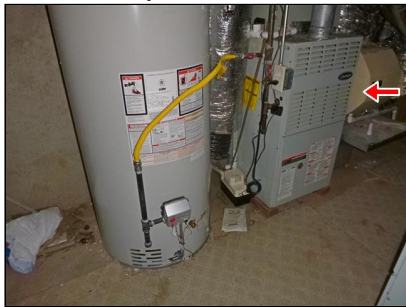
Item 37 - Picture 1

37. **SERVICE / REPAIR:** The Basement and Living level furnace are 20 years old where the average life expectancy is 17 to 22 years. There is a limited view of the furnace heat exchanger without a physical tear down and because of the age of the equipment, a HVAC service technician should evaluate the unit(s) periodically and advise condition (which may include replacing at some point in the future). Consider budgeting for replacement or have warranty program established. Also have CO detector installed in sleeping areas where older system serves for added safety.

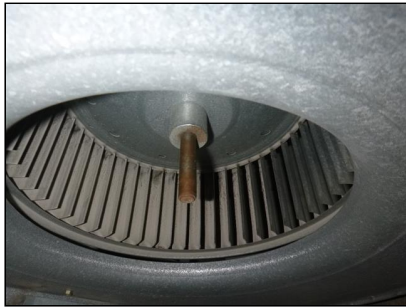
Item 38 - Picture 1

38. **SERVICE / REPAIR:** There is considerable dust and dirt found on blower fins and motor seen from return plenum. Have HVAC service clean and lube as necessary to allow system to operate properly, efficient and safely.

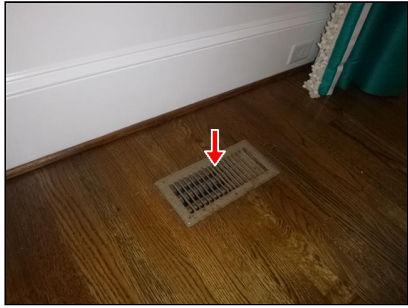
Item 40 - Picture 1

- ❌ 40. **SAFETY / HEALTH:** Debris within floor registers is limited but would recommend having vacuumed to reduce spread of dust during system operation. Although duct cleaning is available professionally, would at least have shop vacuumed to reduce dust.

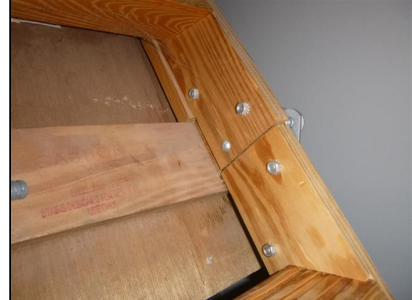
Item 41 - Picture 3

- ❌ 41. **SAFETY / HEALTH:** The pull down stairs to attic is damaged, fails to close completely and is possibly beyond the point of repair. Have reviewed by carpenter and repaired OR replaced as necessary to provide normal and safe ascent to attic level for storage purposes.

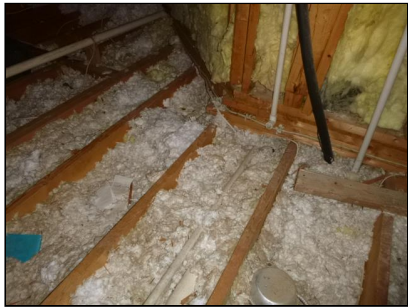
Item 43 - Picture 4

- ❌ 43. **SERVICE / REPAIR:** Insulation matted and value reduced by animal activity and trails in attic. Insulation value should be restored by matted conditions to at least amount required when built. The code has listed R-30 as the bench mark to achieve for nearly the last 20 years.

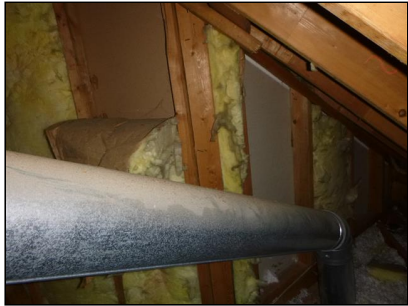
Item 44 - Picture 1

- ❌ 44. **SERVICE / REPAIR:** Insulation between studs in framed wall is missing / out of place at many locations around attic spaces. Recommend insulation be restored with vapor barrier toward heated space to meet required energy conservation.

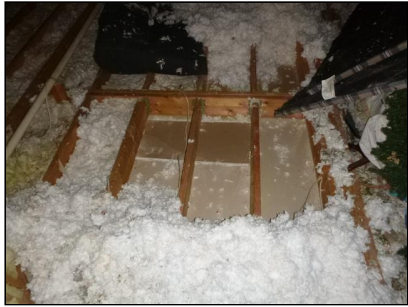
Item 45 - Picture 1

- ❌ 45. **SERVICE / REPAIR:** Insulation missing in one large area above Master. Either a step through or renovation revision.

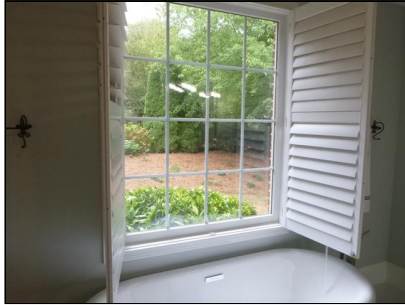
Item 49 - Picture 1

- ❌ 49. **MAJOR DEFECT:** Condensation and / or hazing was noted between insulated window panes. - Location: 1-2) Master tub, 3) Family room picture window, 4) Keeping room transoms - The thermopane insulated glass has lost its vacuum seal and may eventually completely cloud over. Broken seals also reduce the original insulation value of the window. (Dirty windows should be cleaned to assure that conditions do not exist in other units and

were not obvious at time of inspection.) Recommend replacement of all damaged windows listed plus any others throughout house that may be identified by glass service.

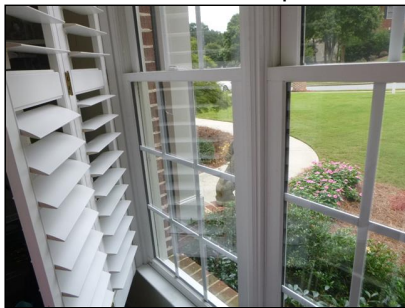
Item 50 - Picture 1

- ❌ 50. **SAFETY / HEALTH:** Although most windows tested do open with some effort, paint causes many to stick and should be modified to open normally for the average person.

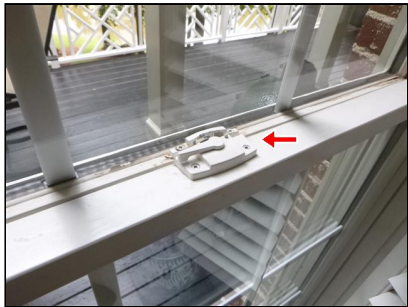
Item 52 - Picture 1

52. **SERVICE / REPAIR:** Recommend having damaged window latch replaced at Master bedroom. Recommend having latch installed at upper Foyer unit.

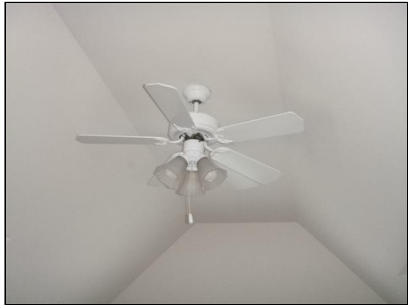
Item 53 - Picture 1

53. **SERVICE / REPAIR:** Ceiling fan somewhat out of balance at higher speed settings. Correct by balancing to function normally at Bonus room or consider having fixture replaced.

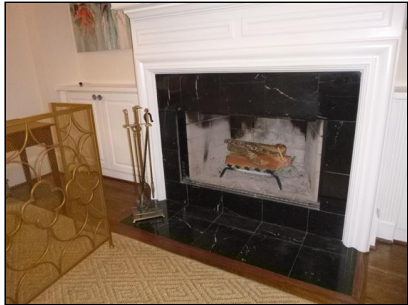
Item 54 - Picture 1

54. **SAFETY / HEALTH:** No permanent fireplace screen installed although a decorative one is in place. Must have some type screen provided when burning especially real wood. If screen is taken when seller, buyer should have one provided before using.

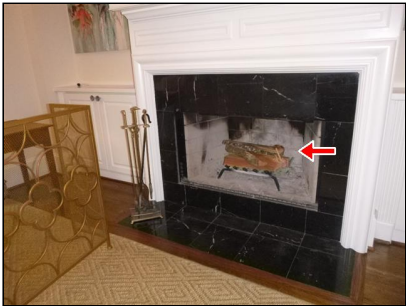
Item 56 - Picture 1

56. **SAFETY / HEALTH:** Firebrick panel in back wall of firebox has cracking at both wood burning fireplaces. Advise replacement of panel for safety to avoid panel falling apart during use.

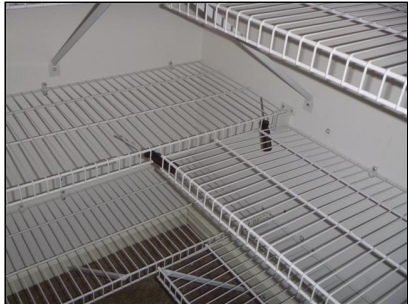
Item 58 - Picture 1

58. **SERVICE / REPAIR:** Shelving in upstairs hall closet found held up with screw drivers. Recommend a more formal repair.

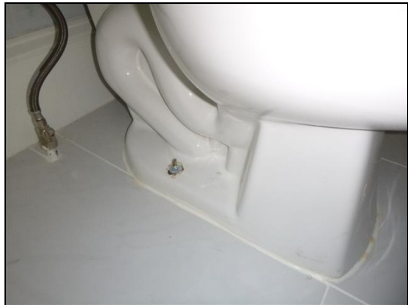
Item 60 - Picture 1

- ❌ 60. **SERVICE / REPAIR:** The toilet base bolts are missing caps on toilet located at Master bathroom. Have installed where missing to protect metal from corrosion.

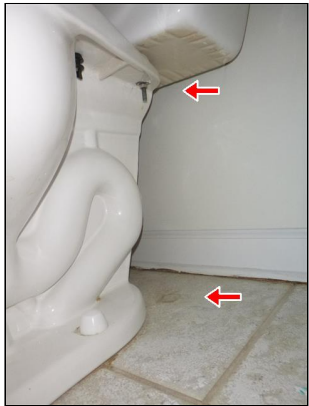
Item 61 - Picture 1

- ❌ 61. **SERVICE / REPAIR:** Toilet tank loose at bolt connection of tank to base mounting located at Basement bathroom. Recommend securing of bolt assembly by plumber to avoid resulting in leaking.

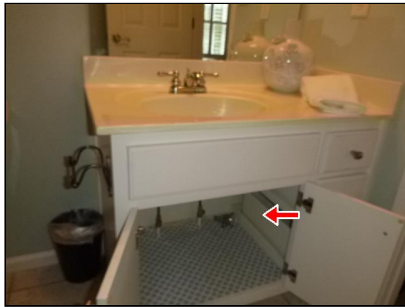
Item 63 - Picture 1

- ❌ 63. **SERVICE / REPAIR:** Drain assembly found to leak below Upstairs private bathroom sink when filled with water and then drained. Recommend a licensed plumber to correct.

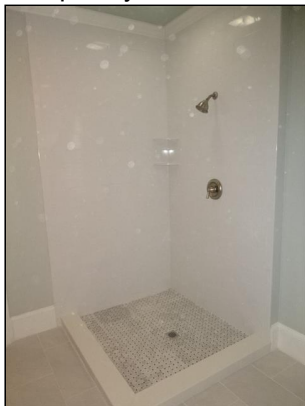
Item 64 - Picture 1

- ❌ 64. **SERVICE / REPAIR:** The glass enclosure for the shower is not installed at time of this inspection at the Master bathroom. Verify conditions once installed confirming that tempered glass is used and that assembly has been adequately sealed from the inside to resist leaking outside of enclosure. Seal opening in grout below threshold.

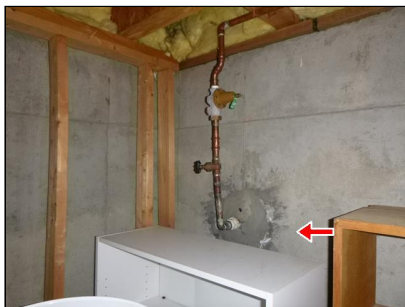
Item 67 - Picture 1

67. **GENERAL NOTE:** There appears to have been efforts made to manage or prevent seepage through to basement area. Have warrantee information provided to buyer for future reference.

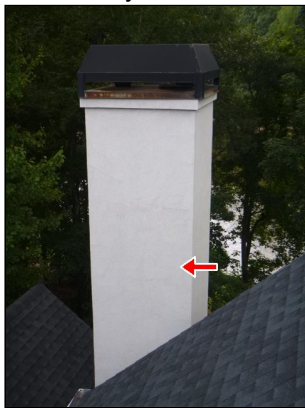
Item 70 - Picture 1

70. **GENERAL NOTE:** Common stucco cracks observed. Because stucco is a concrete-like material some cracking is certain and is not considered significant. Periodic application of a sealant to the cracks is recommended to prevent water entry.

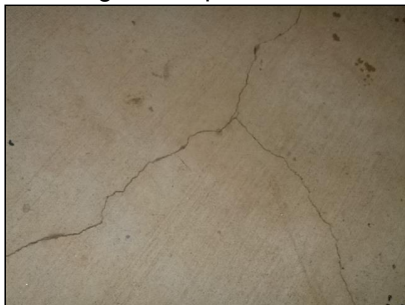
Item 71 - Picture 1

71. **GENERAL NOTE:** Hairline cracks noted in the slab of patio. Although an unsightly condition, very rarely develop into a significant problem. Causes are either shrinkage and/or minor settling.

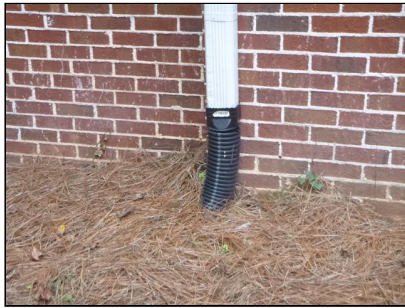
Item 76 - Picture 1

76. **GENERAL NOTE:** Underground water collection and dispersion for the gutters noted. Because the system is underground we are not able to inspect the drainage or determine its effectiveness. Seek disclosure on where lines terminate and monitor during rains to insure adequate drainage. Have cleared if found blocked.

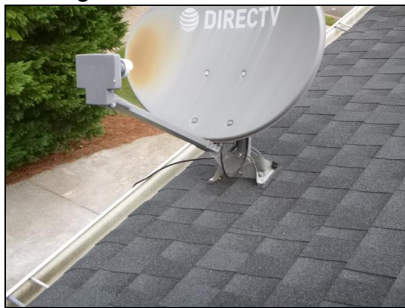
Item 77 - Picture 1

77. **GENERAL NOTE:** Satellite dish found mounted to roof but equipment cannot be checked as part of inspection. Have provider consulted if electing to use this equipment. If dish is removed, mounting brackets are usually left in place to limit potential of leaking. If brackets are removed, be sure to have mounting holes sealed up to avoid leaking.

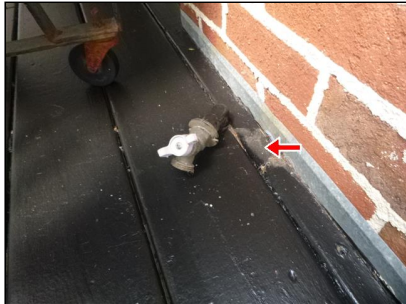
Item 79 - Picture 1

79. **GENERAL NOTE:** Exterior spigot had been run to deck level but appears to have been taken apart. Recommend having removed.

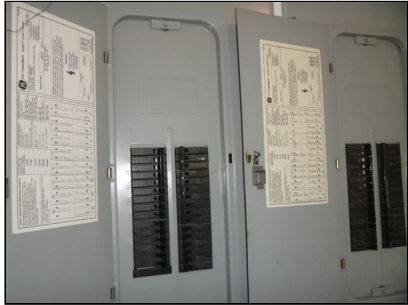
Item 82 - Picture 1

82. **GENERAL NOTE:** The interior of the electrical panel was observed and appears normal.

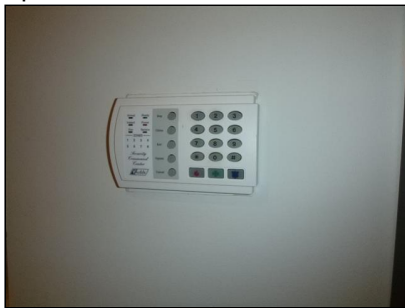
Item 86 - Picture 1

86. **GENERAL NOTE:** House is fitted with security system and appears currently functional. There is no extensive testing done to system during home inspection. Contact a provider to review system if electing to make operational and monitored.

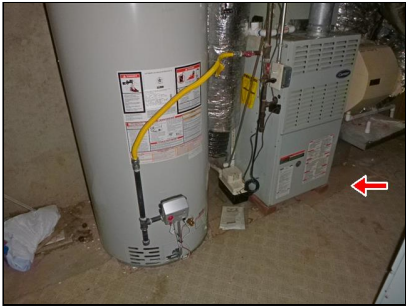
Item 89 - Picture 1

89. **GENERAL NOTE:** Today's requirements for HVAC systems is to install units in pans on basement level where condensate drainage failure could result in flooding finished areas. Consider some form of moisture detection for safety of finished if pan is not provided.

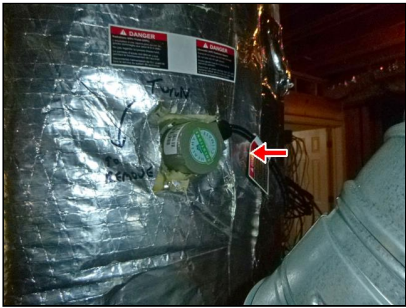
Item 91 - Picture 1

91. **GENERAL NOTE:** UV bulbs installed in plenums designed to kill bacteria and viruses. Seek disclosure on maintenance schedule so that next replacement can be scheduled. Warnings exist to avoid viewing exposed bulb and should be off when replacing.

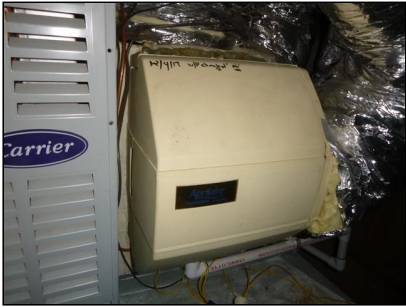
Item 92 - Picture 1

92. **GENERAL NOTE:** Routinely service humidifier for sanitary conditions of unit if electing to use. Media can become dirty allowing fungal growth on damp surfaces. Expect to replace periodically.

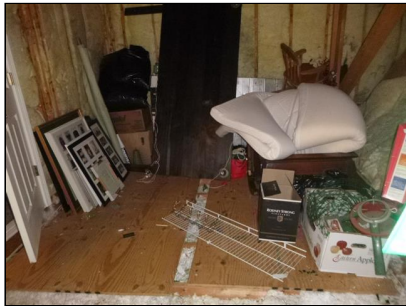
Item 94 - Picture 1

94. **GENERAL NOTE:** Storage items found in attic location which are normally removed prior to closing.
