Inspection Report

956 McDonald Rd
Dahlonega GA 30533

Superior Home Inspections

Date: 9/11/2020	Time: 10:00 AM	Report ID: 091120
Property: 956 McDonald Rd Dahlonega GA 30533	Customer: Anthony Wasilewski

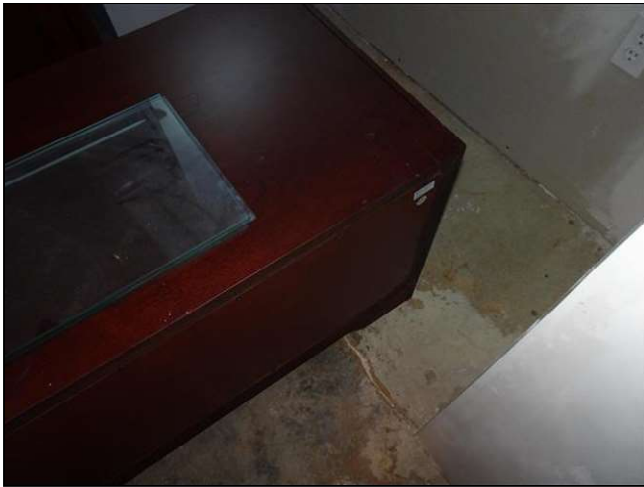
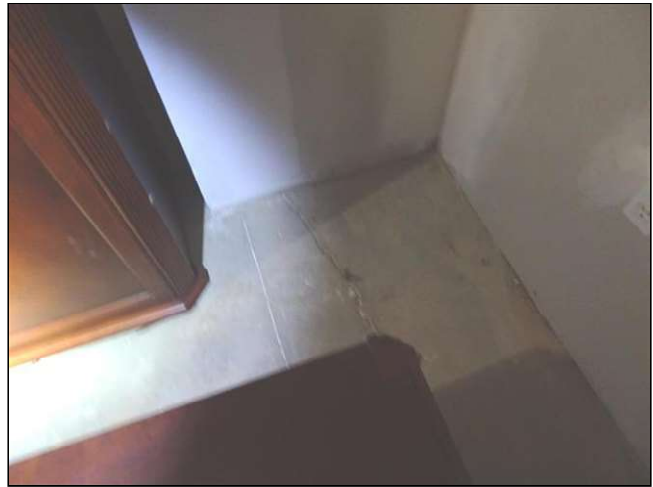
Basement concrete slab had large settlement crack below the chimney chase area. It does not appear to be structurally significant. Recommend evaluate by a qualified foundation contractor and seal crack.

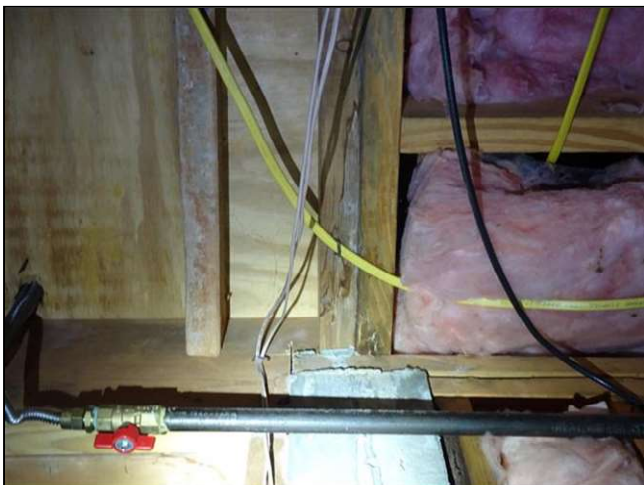
1.3 Item 1(Picture)

Evidence of moisture staining in basement at wood floor structure below the chimney chase. No active moisture observed at time of inspection. However, recommend evaluation by a qualified contractor as needed.

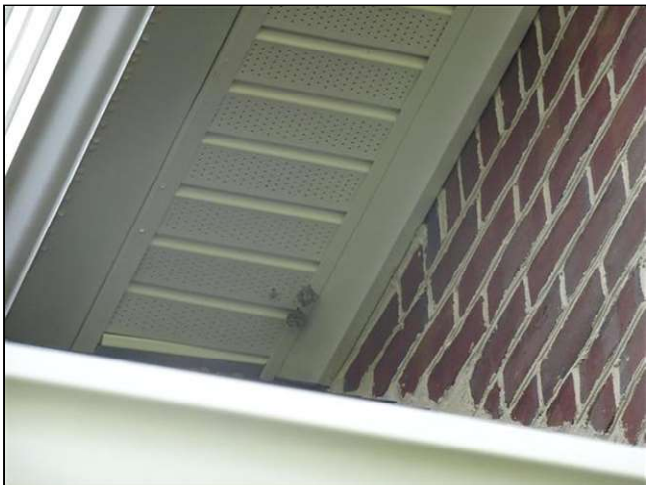
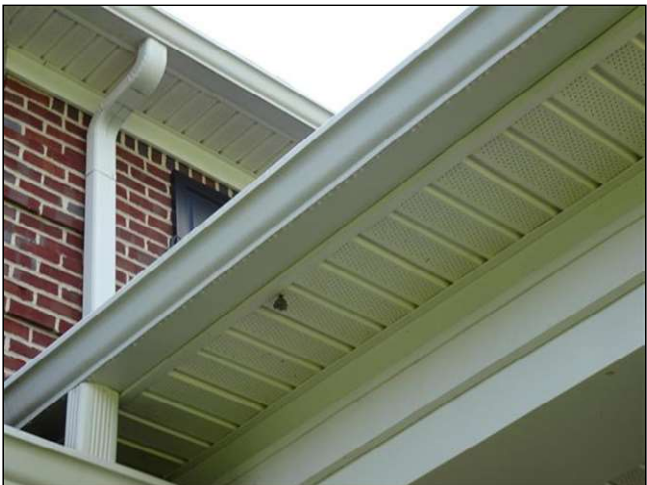
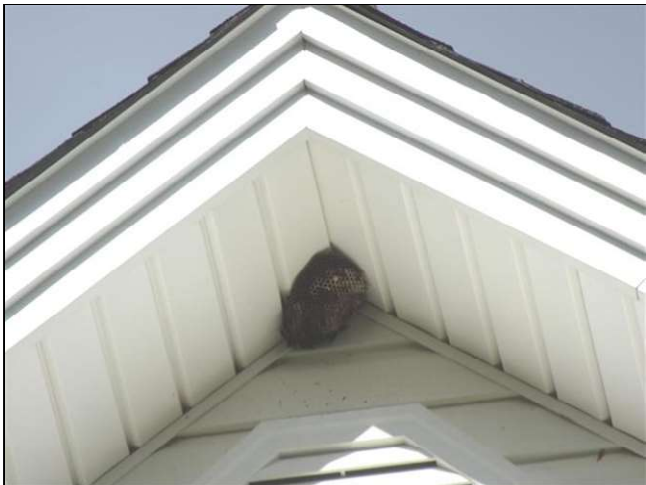
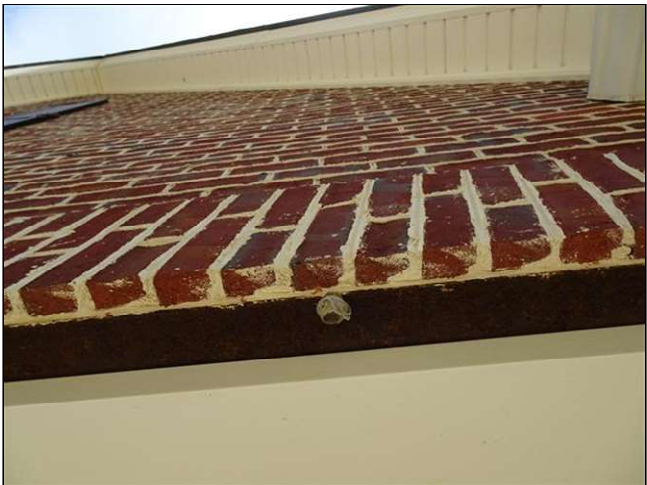
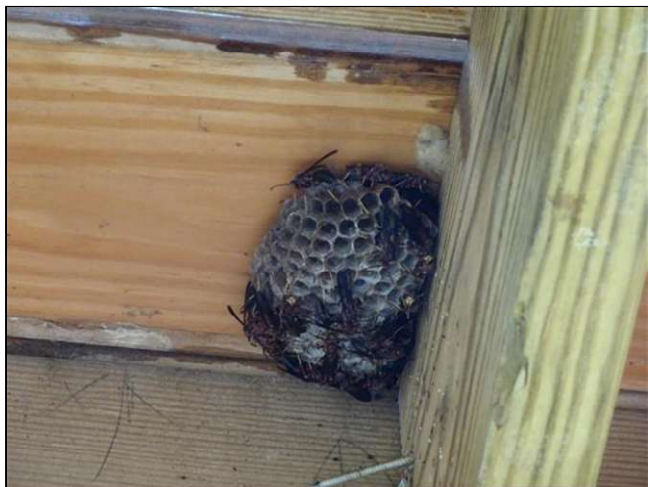
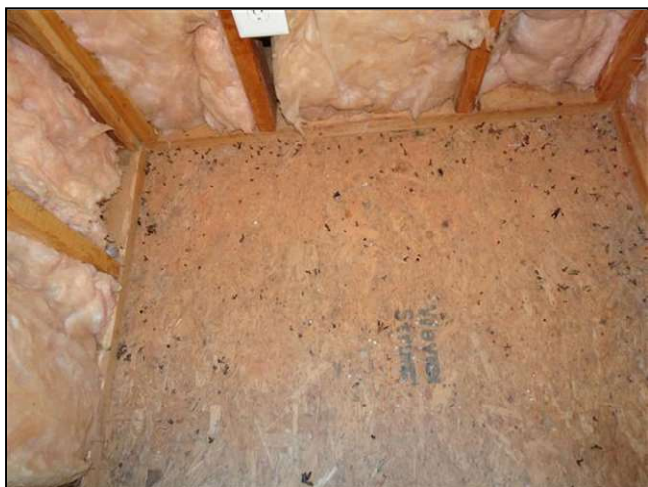
Insect such as hornets, wasps, yellow jackets had multiple nests around exterior of home and in attic spaces. Recommend treatment or removal as needed by a qualified pest contractor.

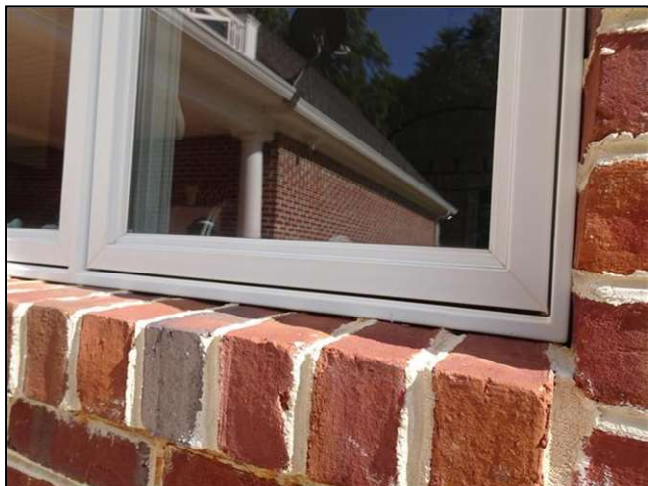
2.2 Item 1(Picture)

Windows need sealant/caulking where missing at edge trim where it meets brick cladding. Deterioration, leaks, and energy loss may occur if not corrected. Recommend repair as needed by qualified contractor.

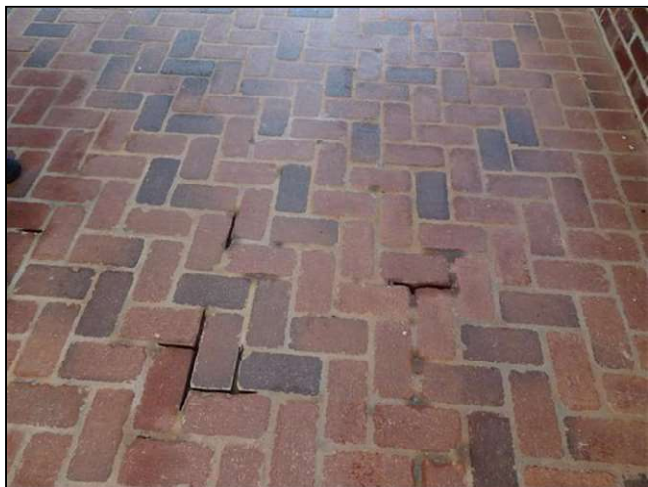
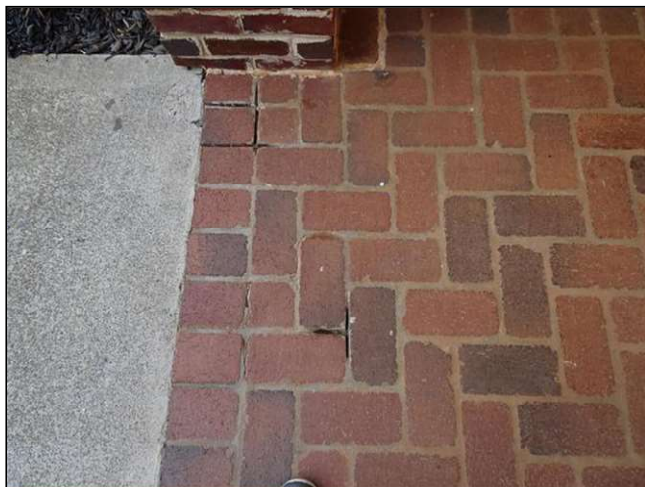
Front breezeway brick drive had cut/missing mortar. No drainage system installed. Recommend repair joints by a qualified contractor as needed.

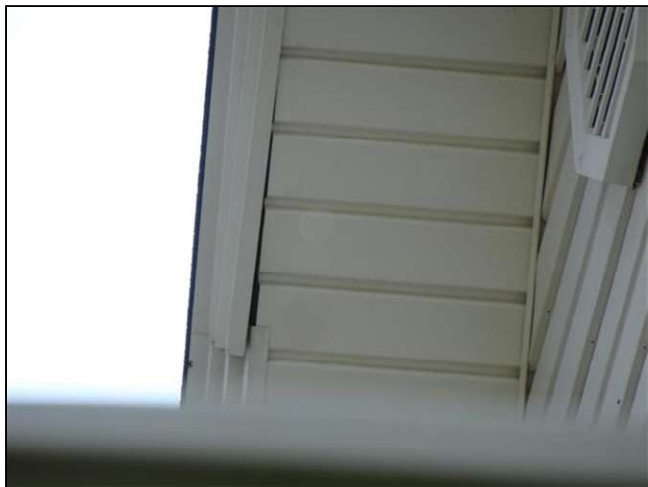
2.6 Item 1(Picture)

(1) Front upper left soffit/fascia wrap is loose. Recommend fasten or repair by a qualified contractor.

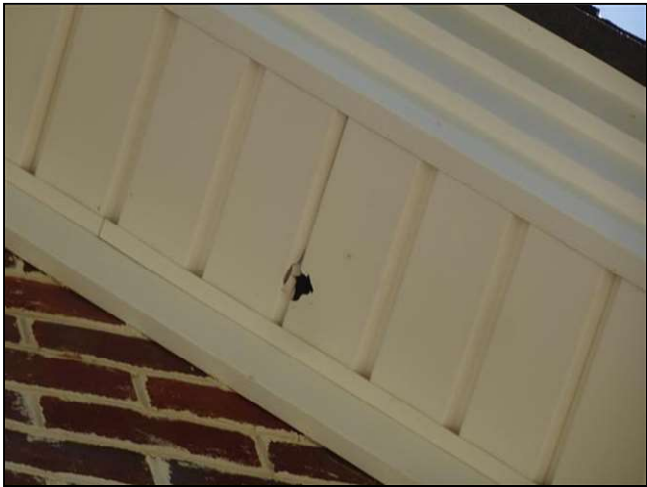
2.6 Item 2(Picture)

(2) Right side above garage entrance at gable soffit there is a small hole. Recommend correct by a qualified contractor.

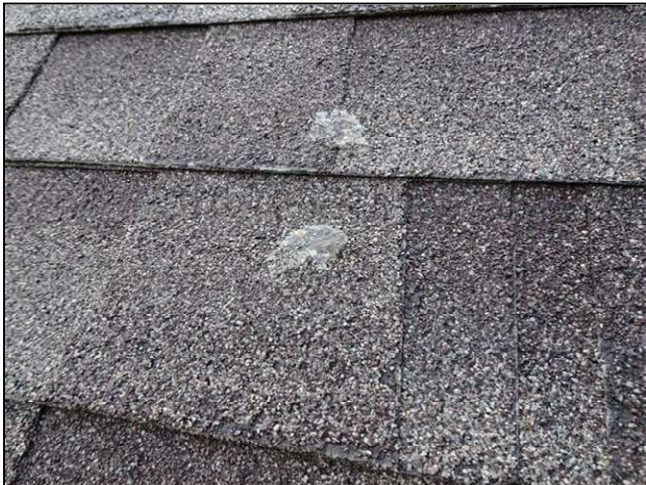
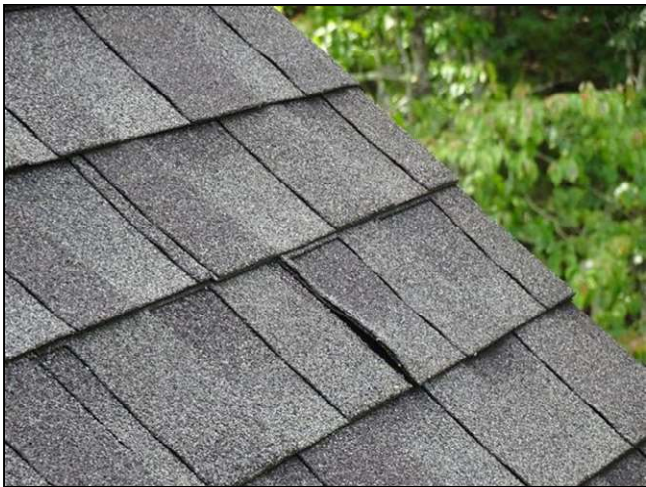
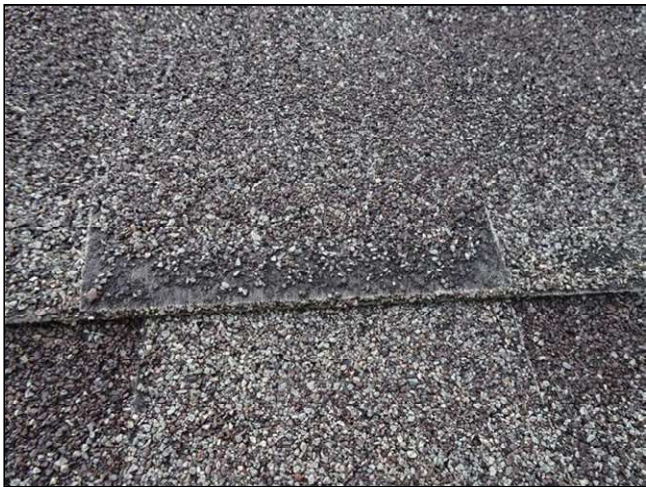
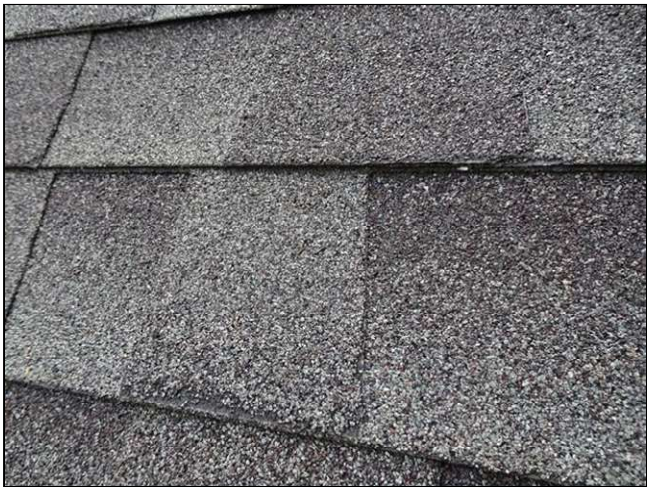
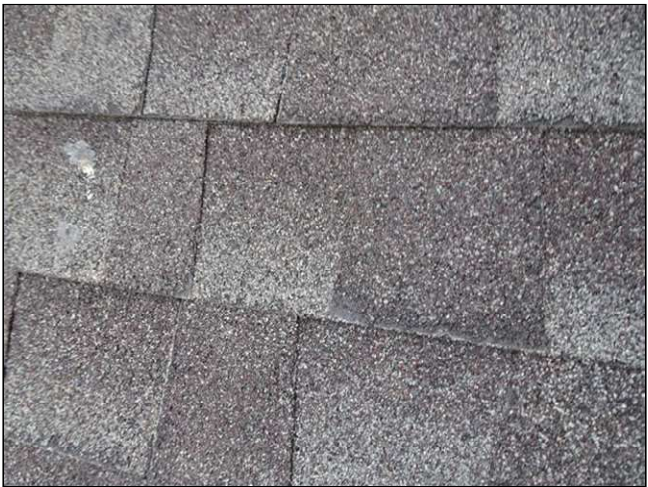
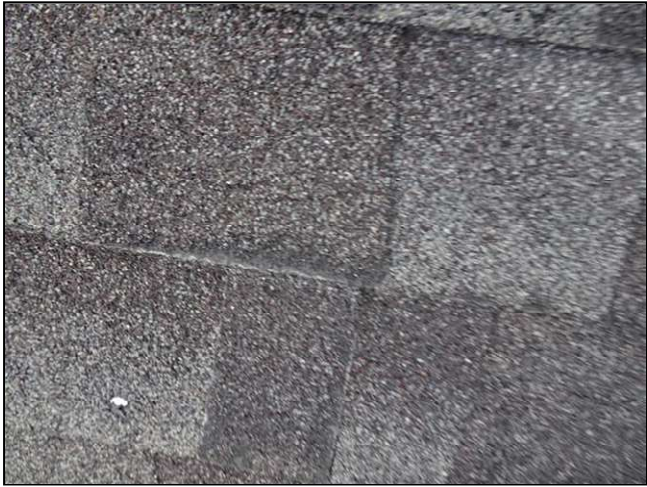
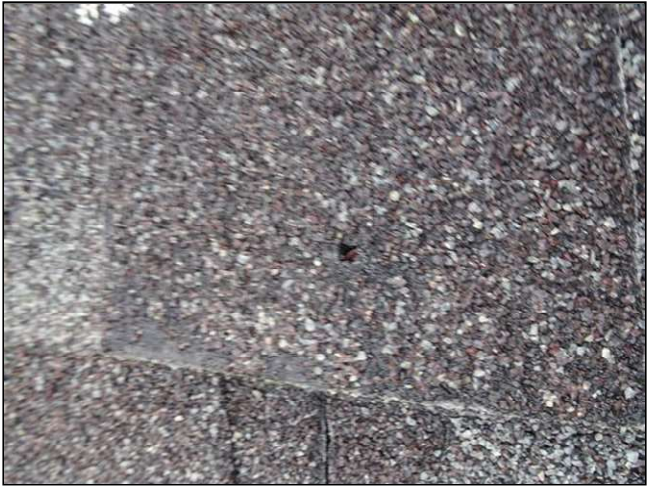
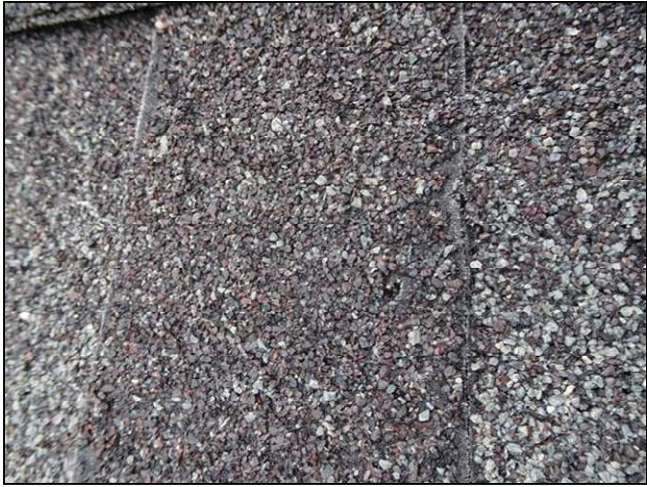
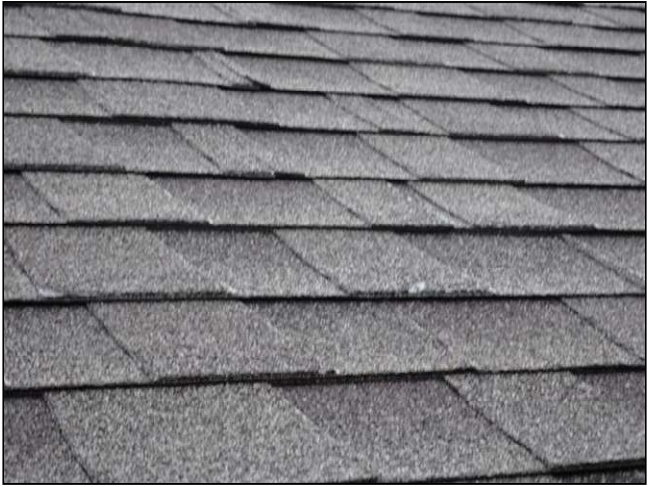
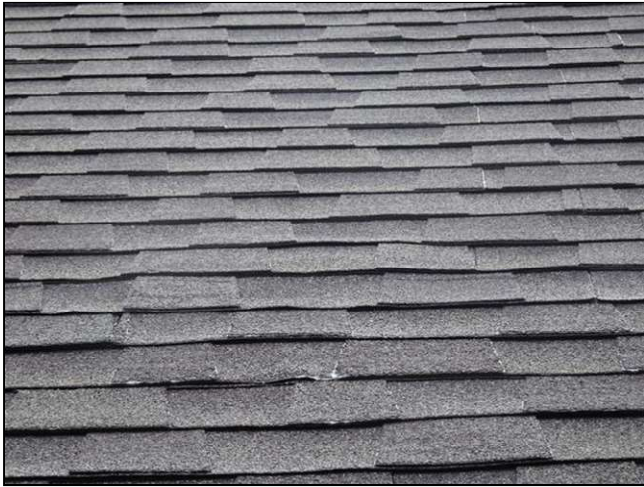
Roof shingles had evidence of wear, notably front sides. There was granule loss and wear with fiberglass mat being exposed. Additionally there were multiple areas of nail pops, lifted shingles or nail holes. Recommend further evaluation by a qualified roof contractor for corrections, repairs or replacement.

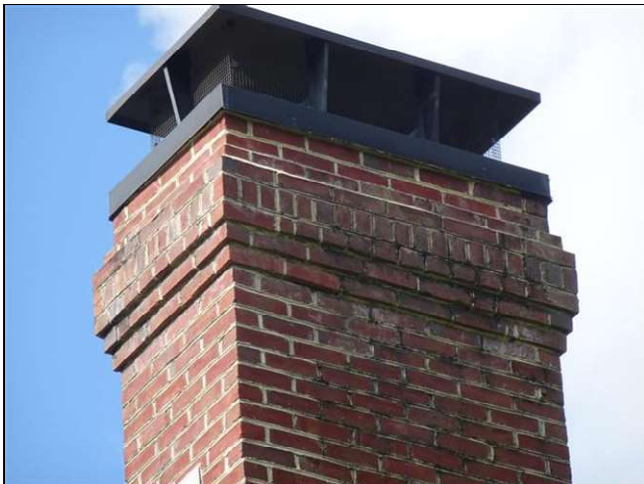
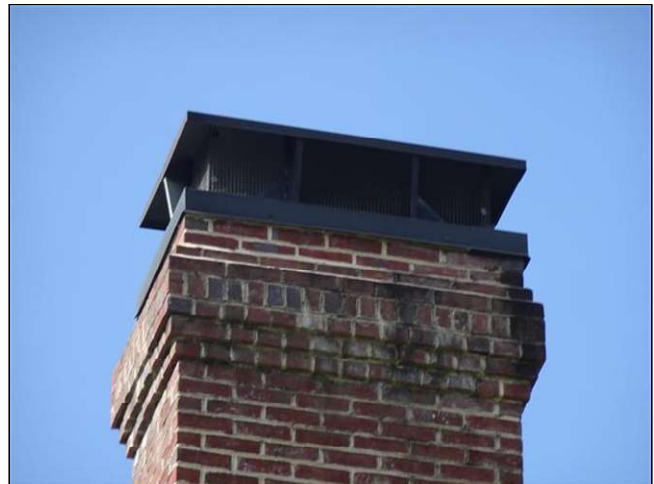
Chimney chases had evidence of moisture saturation and staining toward top. Recommend evaluate by a qualified chimney contractor to prevent long term moisture issues.

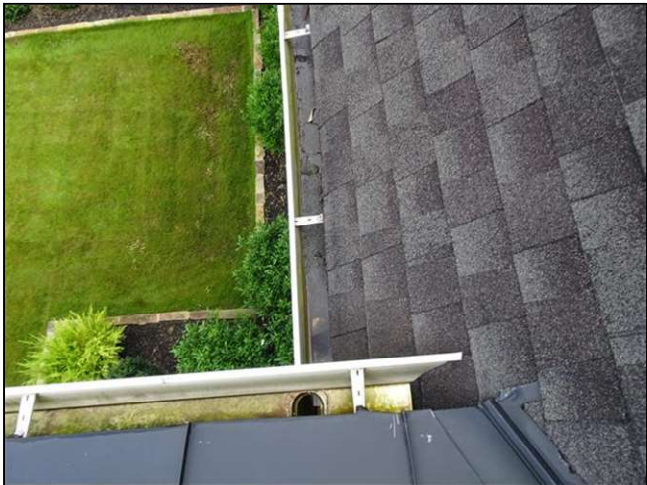
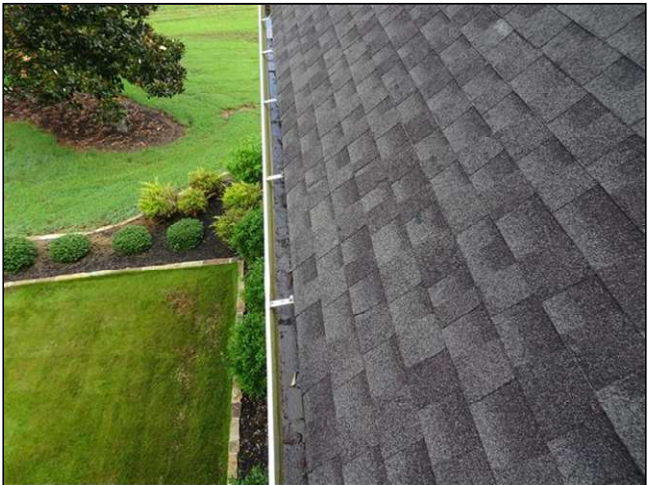
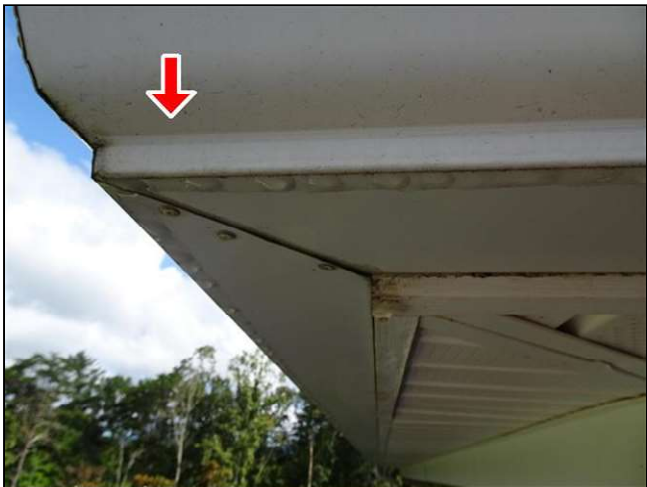
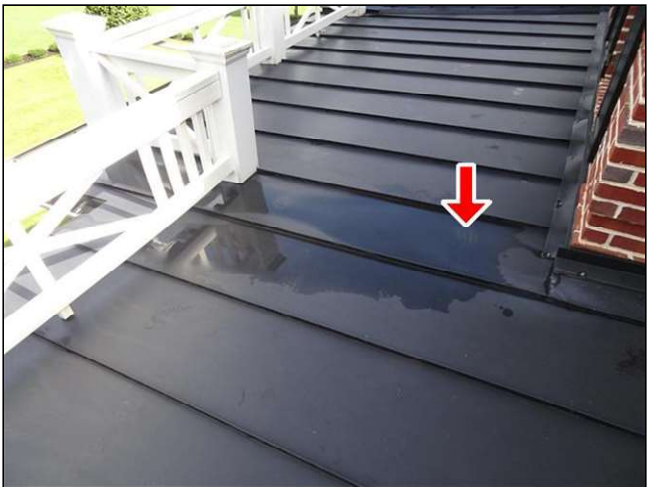
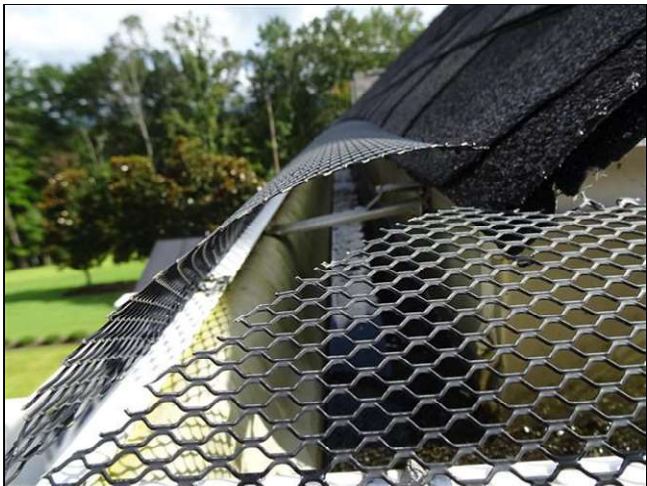
(1) Gutters had ponding water at a few locations. The gutter seams at corners were leaking (needs new sealant). Recommend corrections as needed by a qualified gutter contractor.

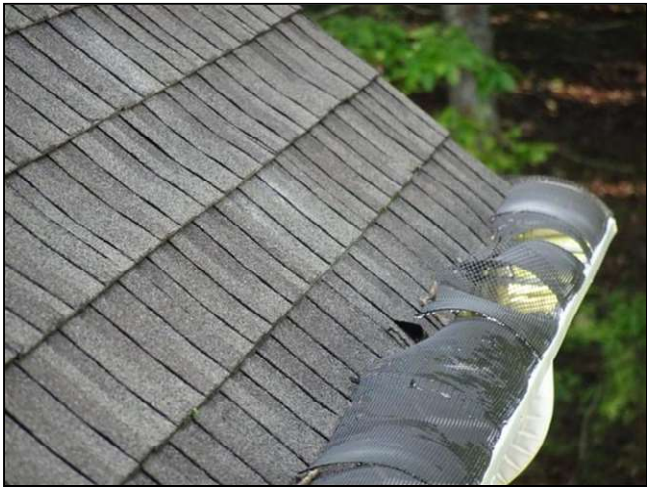
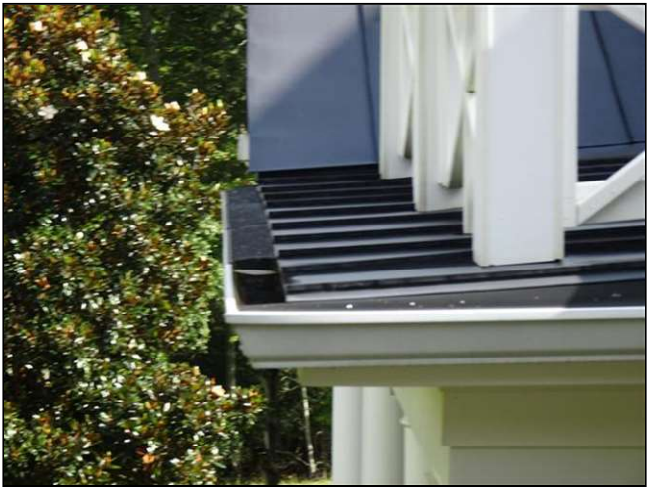
(2) Gutters have metal covers present. Some covers were missing, bent, loose, etc. Recommend correction as needed.

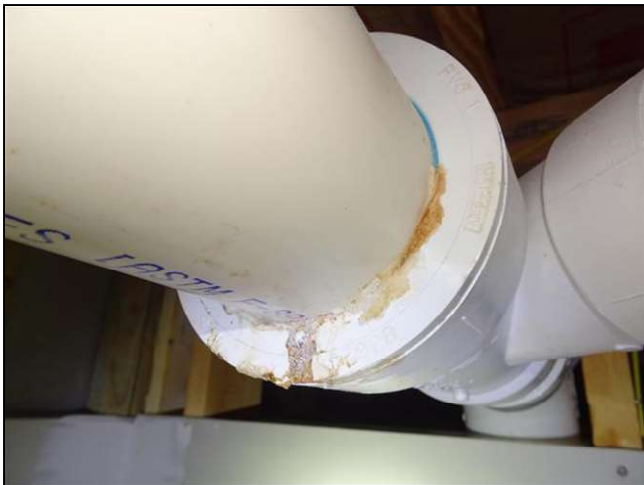
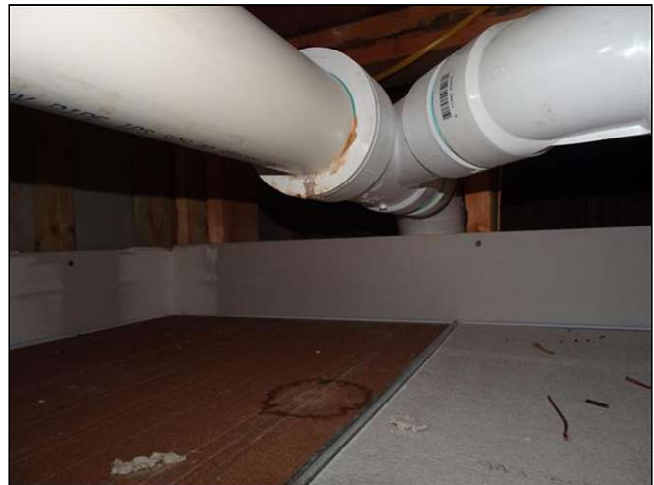
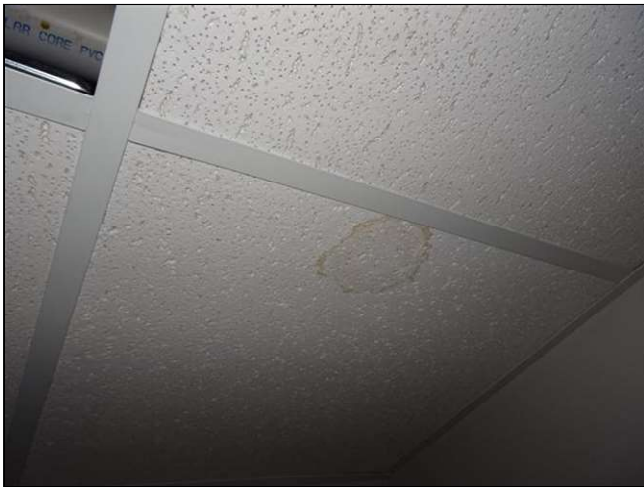
(2) Basement sewer pipe above the center room drop ceiling tile had evidence of leaking. Recommend correction by a qualified plumber.

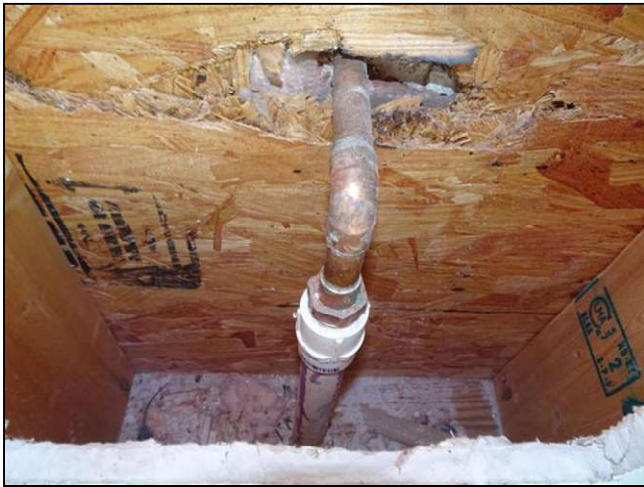
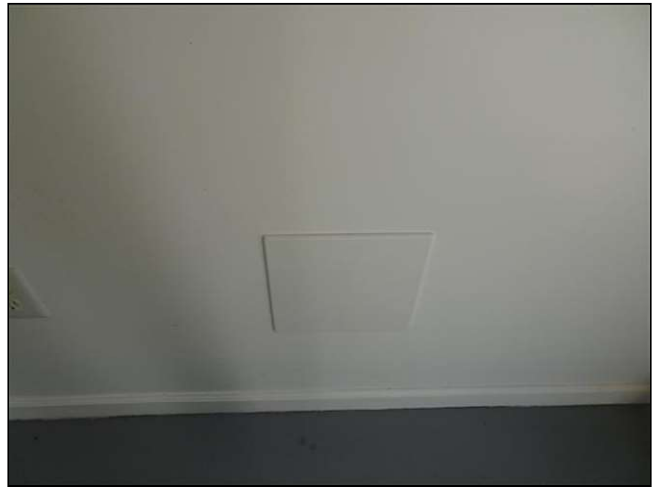
(2) Garage hose bib did not have a shut-off valve. Recommend installing one by a qualified plumber. Access panel is located at garage.

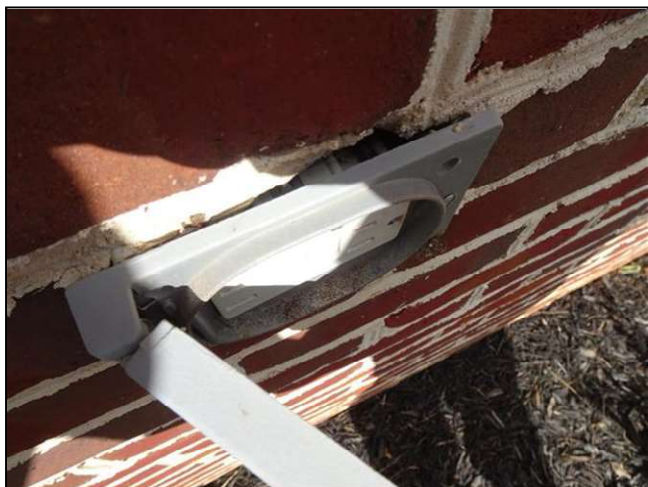
5.5 Item 1(Picture)

A few of the exterior GFCI weather covers were aged/worn and loose. Recommend correction by a qualified electrician.

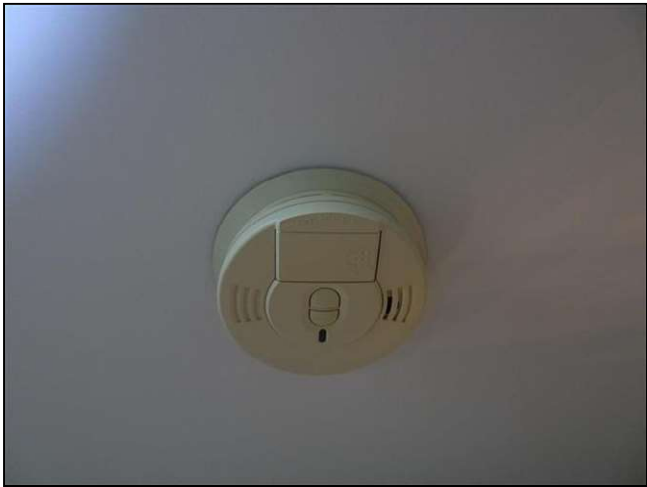
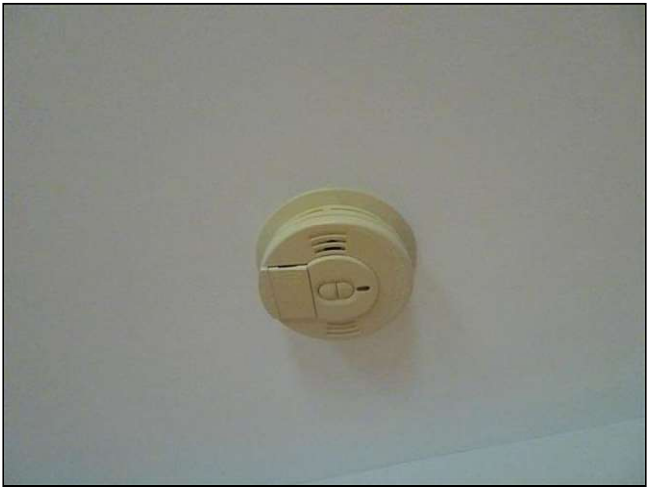
Smoke detectors older than 10 years should be replaced for safety. Carbon monoxide detectors were not required for this year built home, however there were units present.

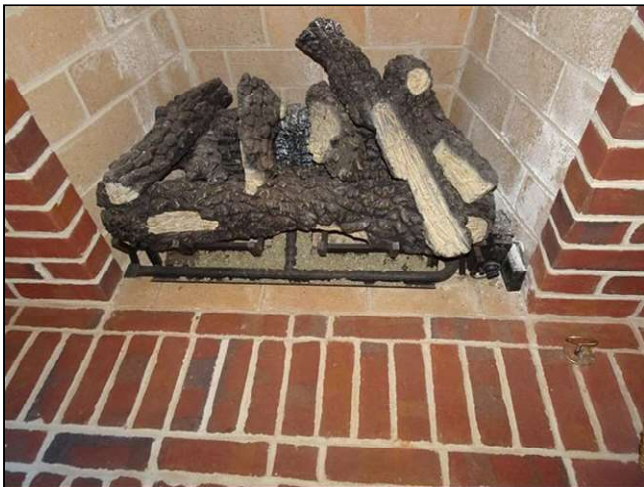
6.6 Item 1(Picture)

Sitting room gas log set, I could not get unit to ignite. It may need adjustment or cleaning. Recommend evaluate by a qualified chimney sweep.

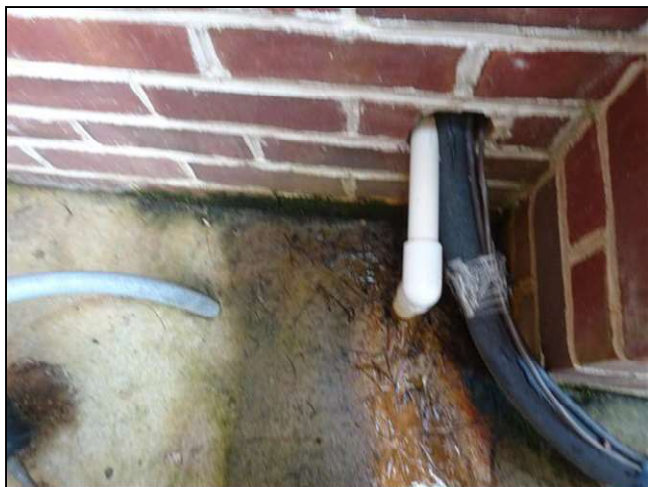
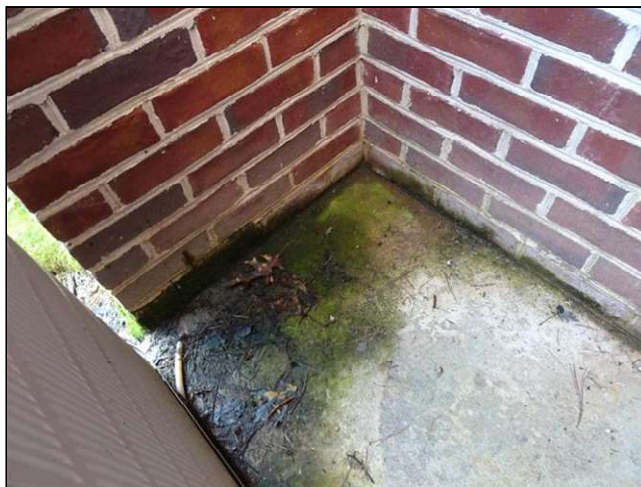
(1) AC condensation line discharges behind the AC units. It is causing moisture saturation against the brick and concrete floor. Recommend correction by a qualified contractor.

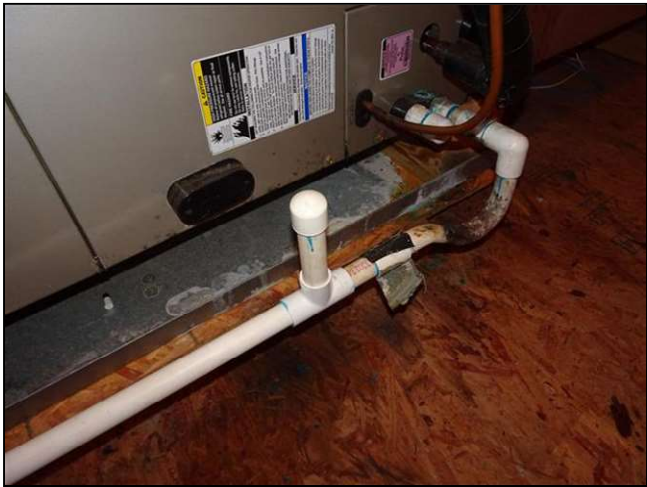
7.2 Item 3(Picture)

(2) Evidence of condensation leaking causing stains/damage at attic plywood floor and rust in drain pan.
No active leaking present at time of inspection. This is for your information.

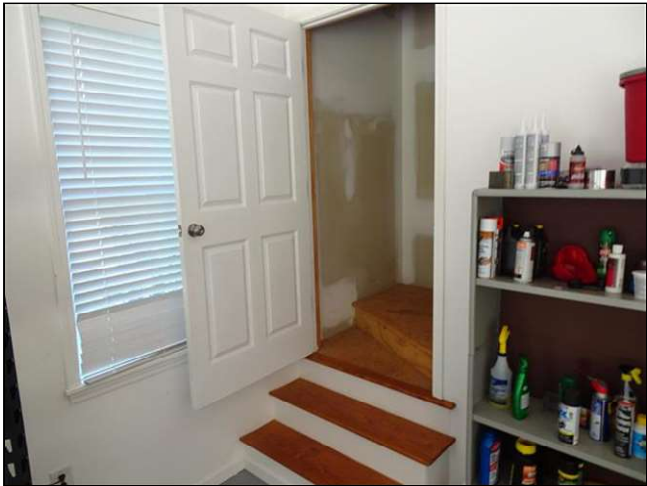
8.5 Item 1(Picture)

Garage upper bonus room door opens over stairs. This can be considered a safety hazard. Recommend correction as needed for safety reasons.

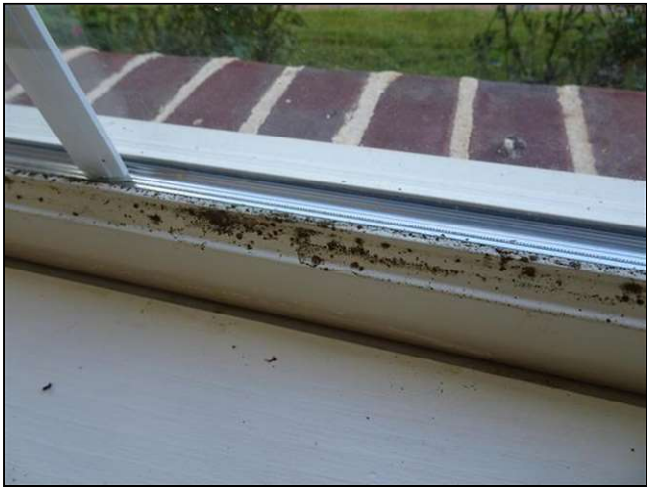
8.6 Item 1(Picture)

Garage interior window sash had small amount of microbial type growth toward bottom. Recommend sanitize or clean.

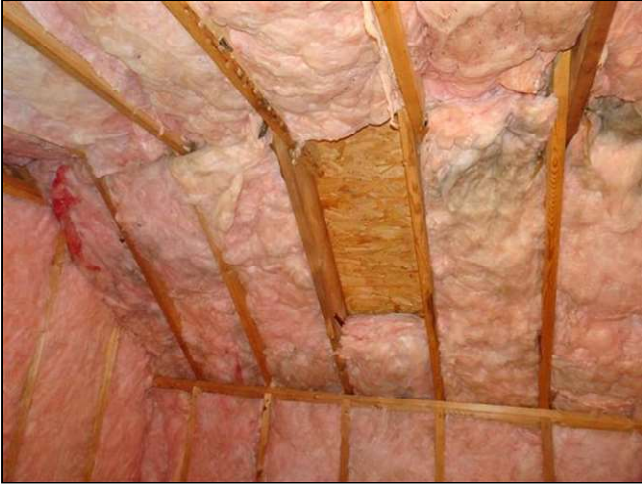
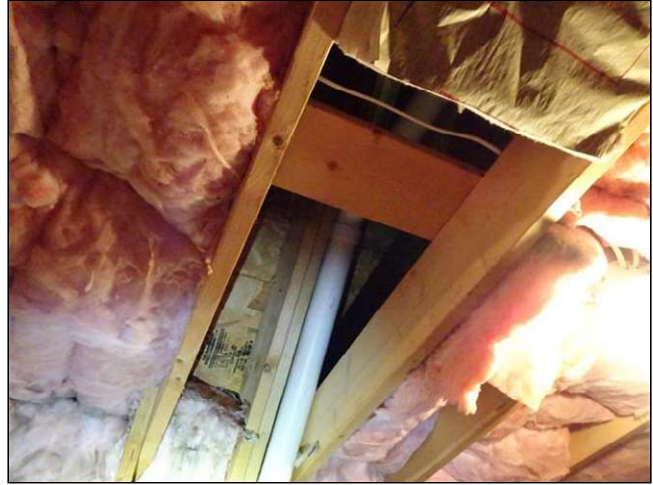
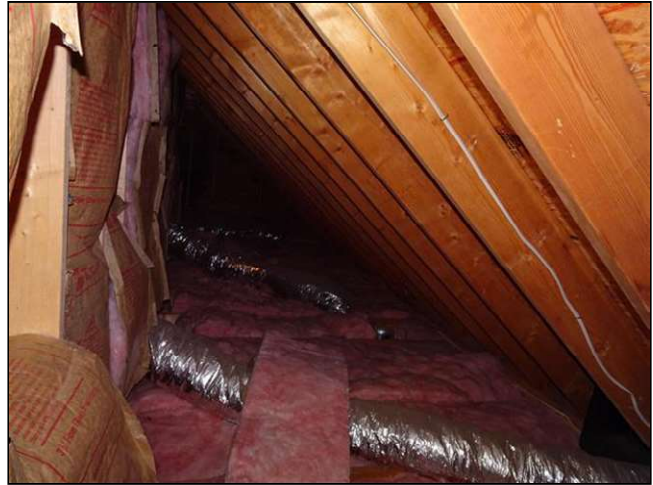
A few pieces of insulation were fallen or loose in attic. Recommend secure by a qualified contractor.

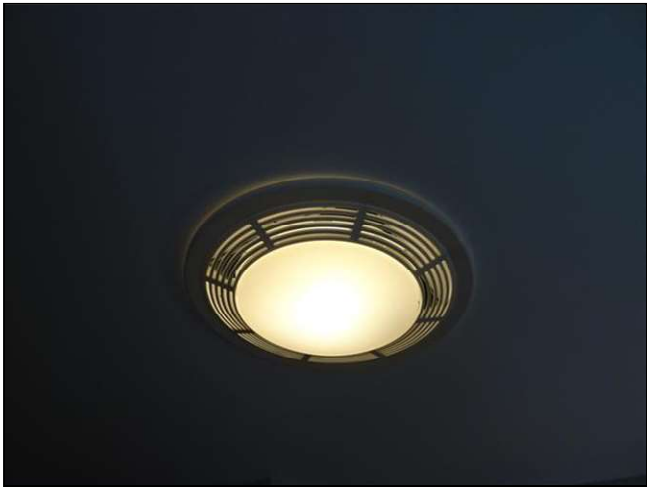
9.2 Item 1(Picture)

Bathroom exhaust fans had some dust build-up. A few fans made loud noise (from dust). Recommend service or cleaning.
